**Re: Request for Information Letter Dated December 20, 2019**

Site Name: Morrells Dry Cleaners  
Site Address: 608 N 1<sup>st</sup> Street, Tacoma, Pierce County, WA 98403  
VCP Project No.: SW1039  
Project No. 080190

Aspect Consulting, LLC (Aspect) is providing this letter in response to the referenced letter requesting information on the status of the cleanup at the Morrells Dry Cleaners site (Site). Site cleanup activities in 2018 and 2019 included the following:

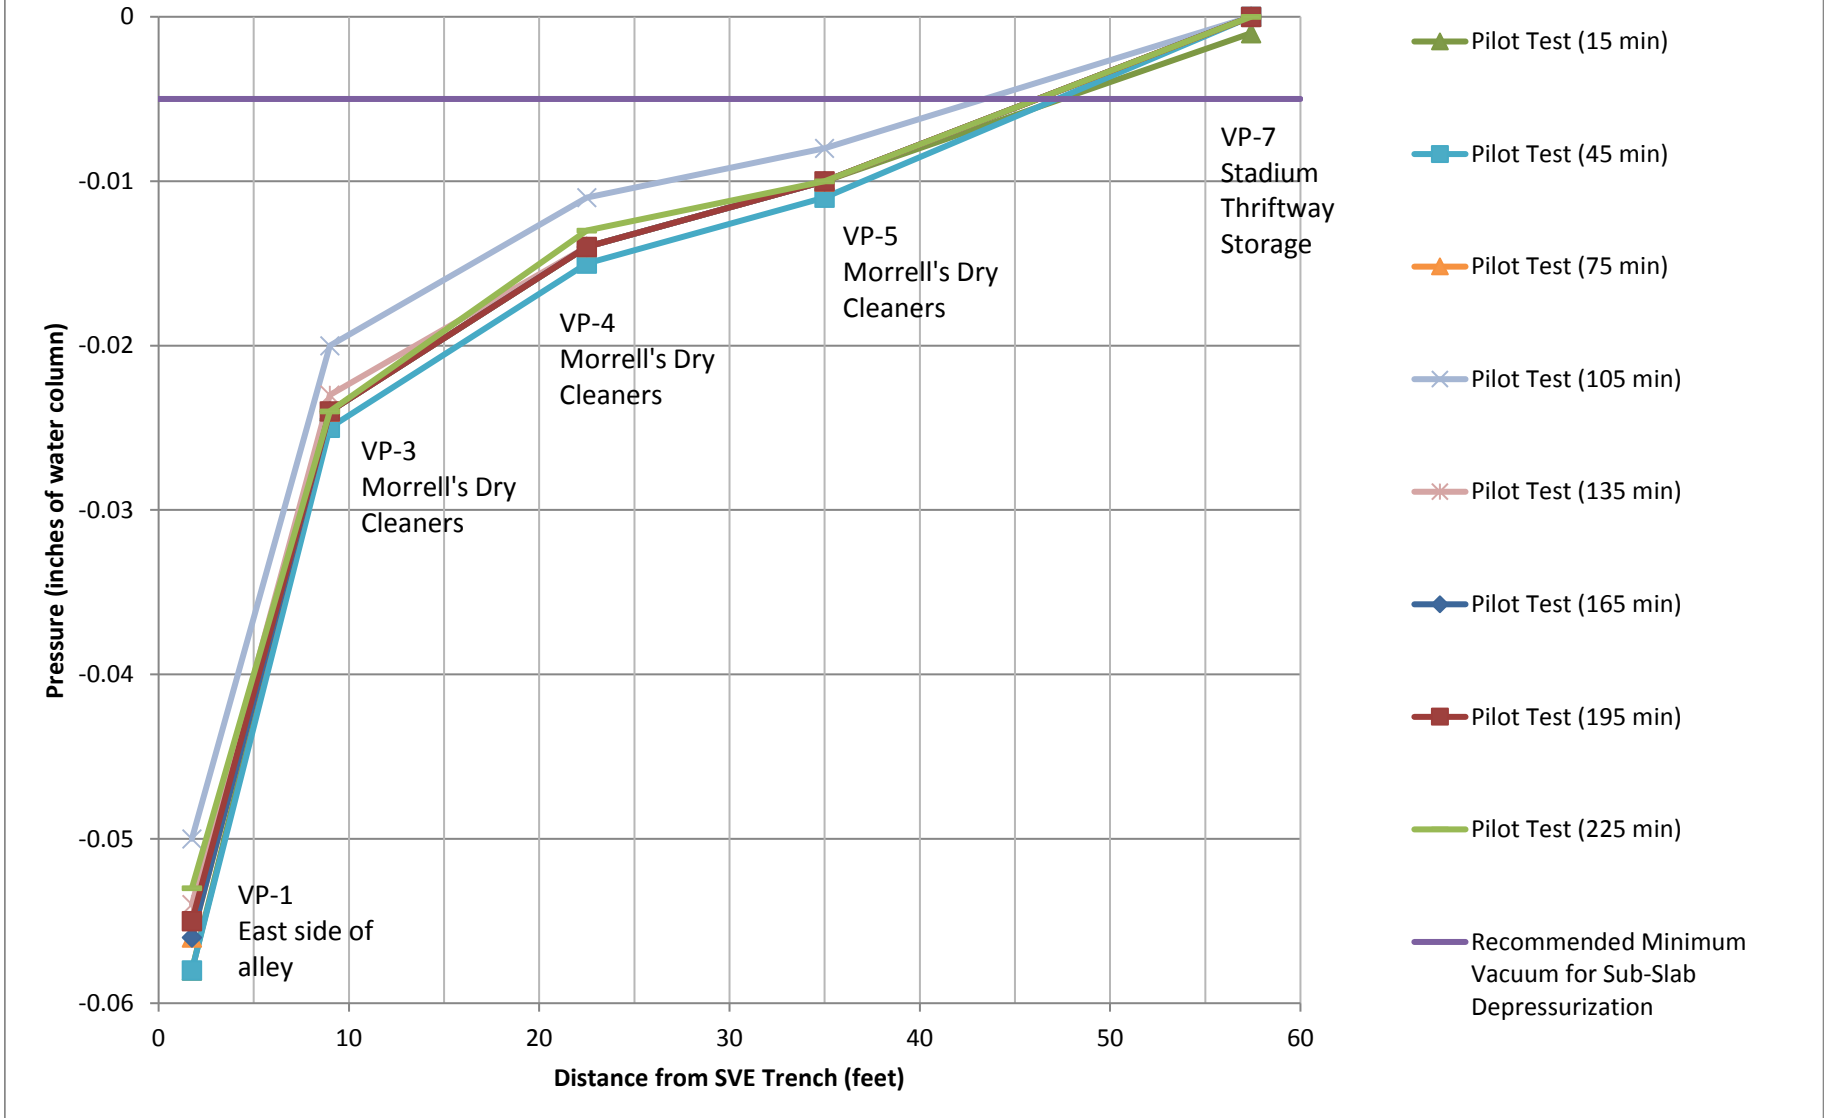
1-hp Regenerative Blower in Pilot Test, 2-hp Regenerative Blower continuously starting 10/15/2014
