Remedial Investigation Addendum

Site Name: **Adams Street Building**
Site Address: **6707-6709 S Adams Street**
Tacoma, Washington 98409

Prepared By:
Andrew S. Blake, L.G.
Succeed Environmental Consulting LLC
6028 NE 49th Avenue
Portland, Oregon 97218

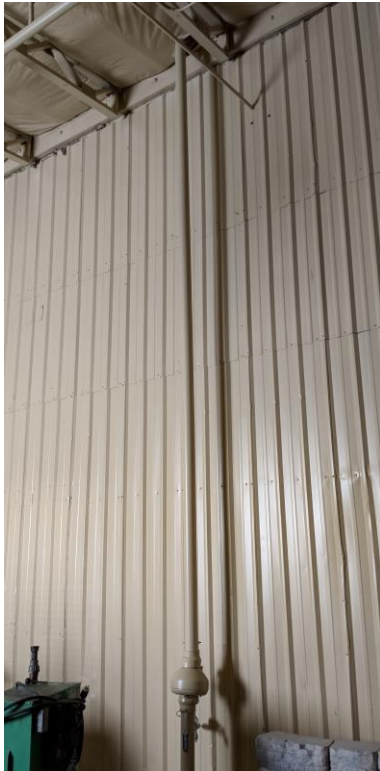
Fan-1

Between November 2017 and February 2018, SEC drilled two 4-inch-diameter holes through the concrete floor slab (near the former dry-cleaning machines) and placed 4-inch-diameter PVC vent pipes

equipped with an in-line fans in each hole. The base of the vent pipe was grouted in-place, the vent pipe was extended through the roof of the project site structure, and the in-line fans (Fan-1 and Fan-2) were activated. In July 2019, a third in-line fan (Fan-3) was similarly constructed near the western exterior of the project site structure. All three fans have remained operational since that time. Photographs of the fans are provided below. The approximate fan locations are shown on Figures 2 and 3.

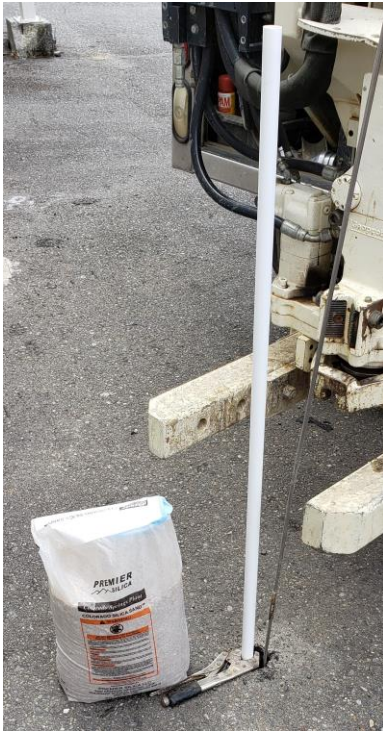
**PVC Point Installation.**

On July 30, 2019, Pacific Soil and Water of Tigard, Oregon installed seven heated air injection points at the project site. Each point was constructed as follows:

- A direct-push drill rig was used to advance a 3-inch-diameter macro-core soil sampler to depths ranging between 10 and 15 feet BGS.
- Each boring was backfilled with coarse silica sand and a slotted PVC pipe was installed at each location from a depth of approximately 1.0 to 6.0 feet BGS.
- The upper-most foot at each location was sealed with hydrated bentonite.

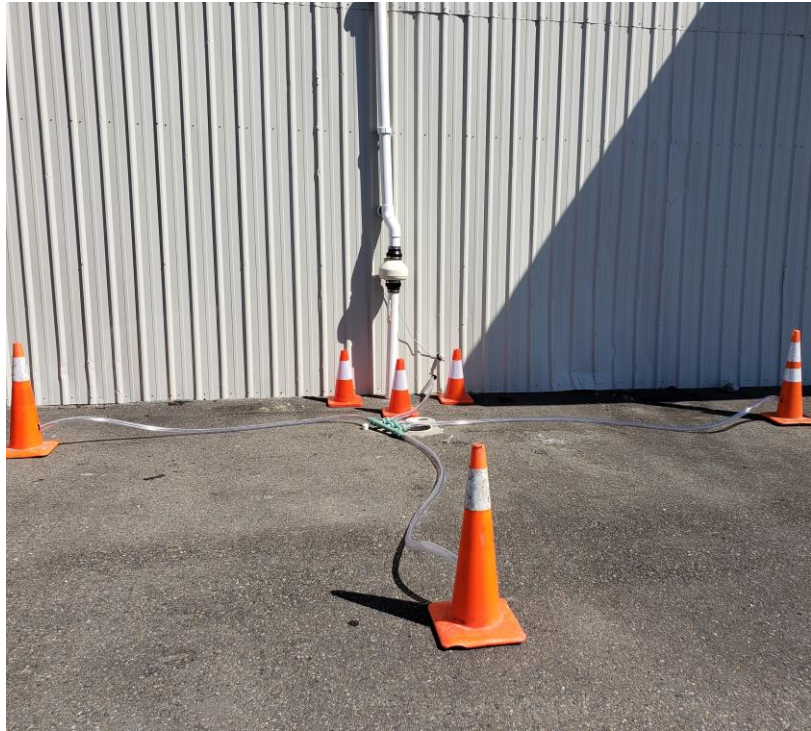
**Heated Air Connected to PVC Points and MW-4.**

Following installation of each temporary air injection point, SEC used 1-inch-diameter hoses to connect five CHAOLUN™ 2,400 watt/3.2 horsepower blowers capable of heating air to temperatures of up to 131° Fahrenheit with velocities of up to 70 meters/second to each point and to monitoring wells MW-3 and MW-4. The blowers were used to push hot air into the subsurface between approximately July 16 and September 5, 2019.

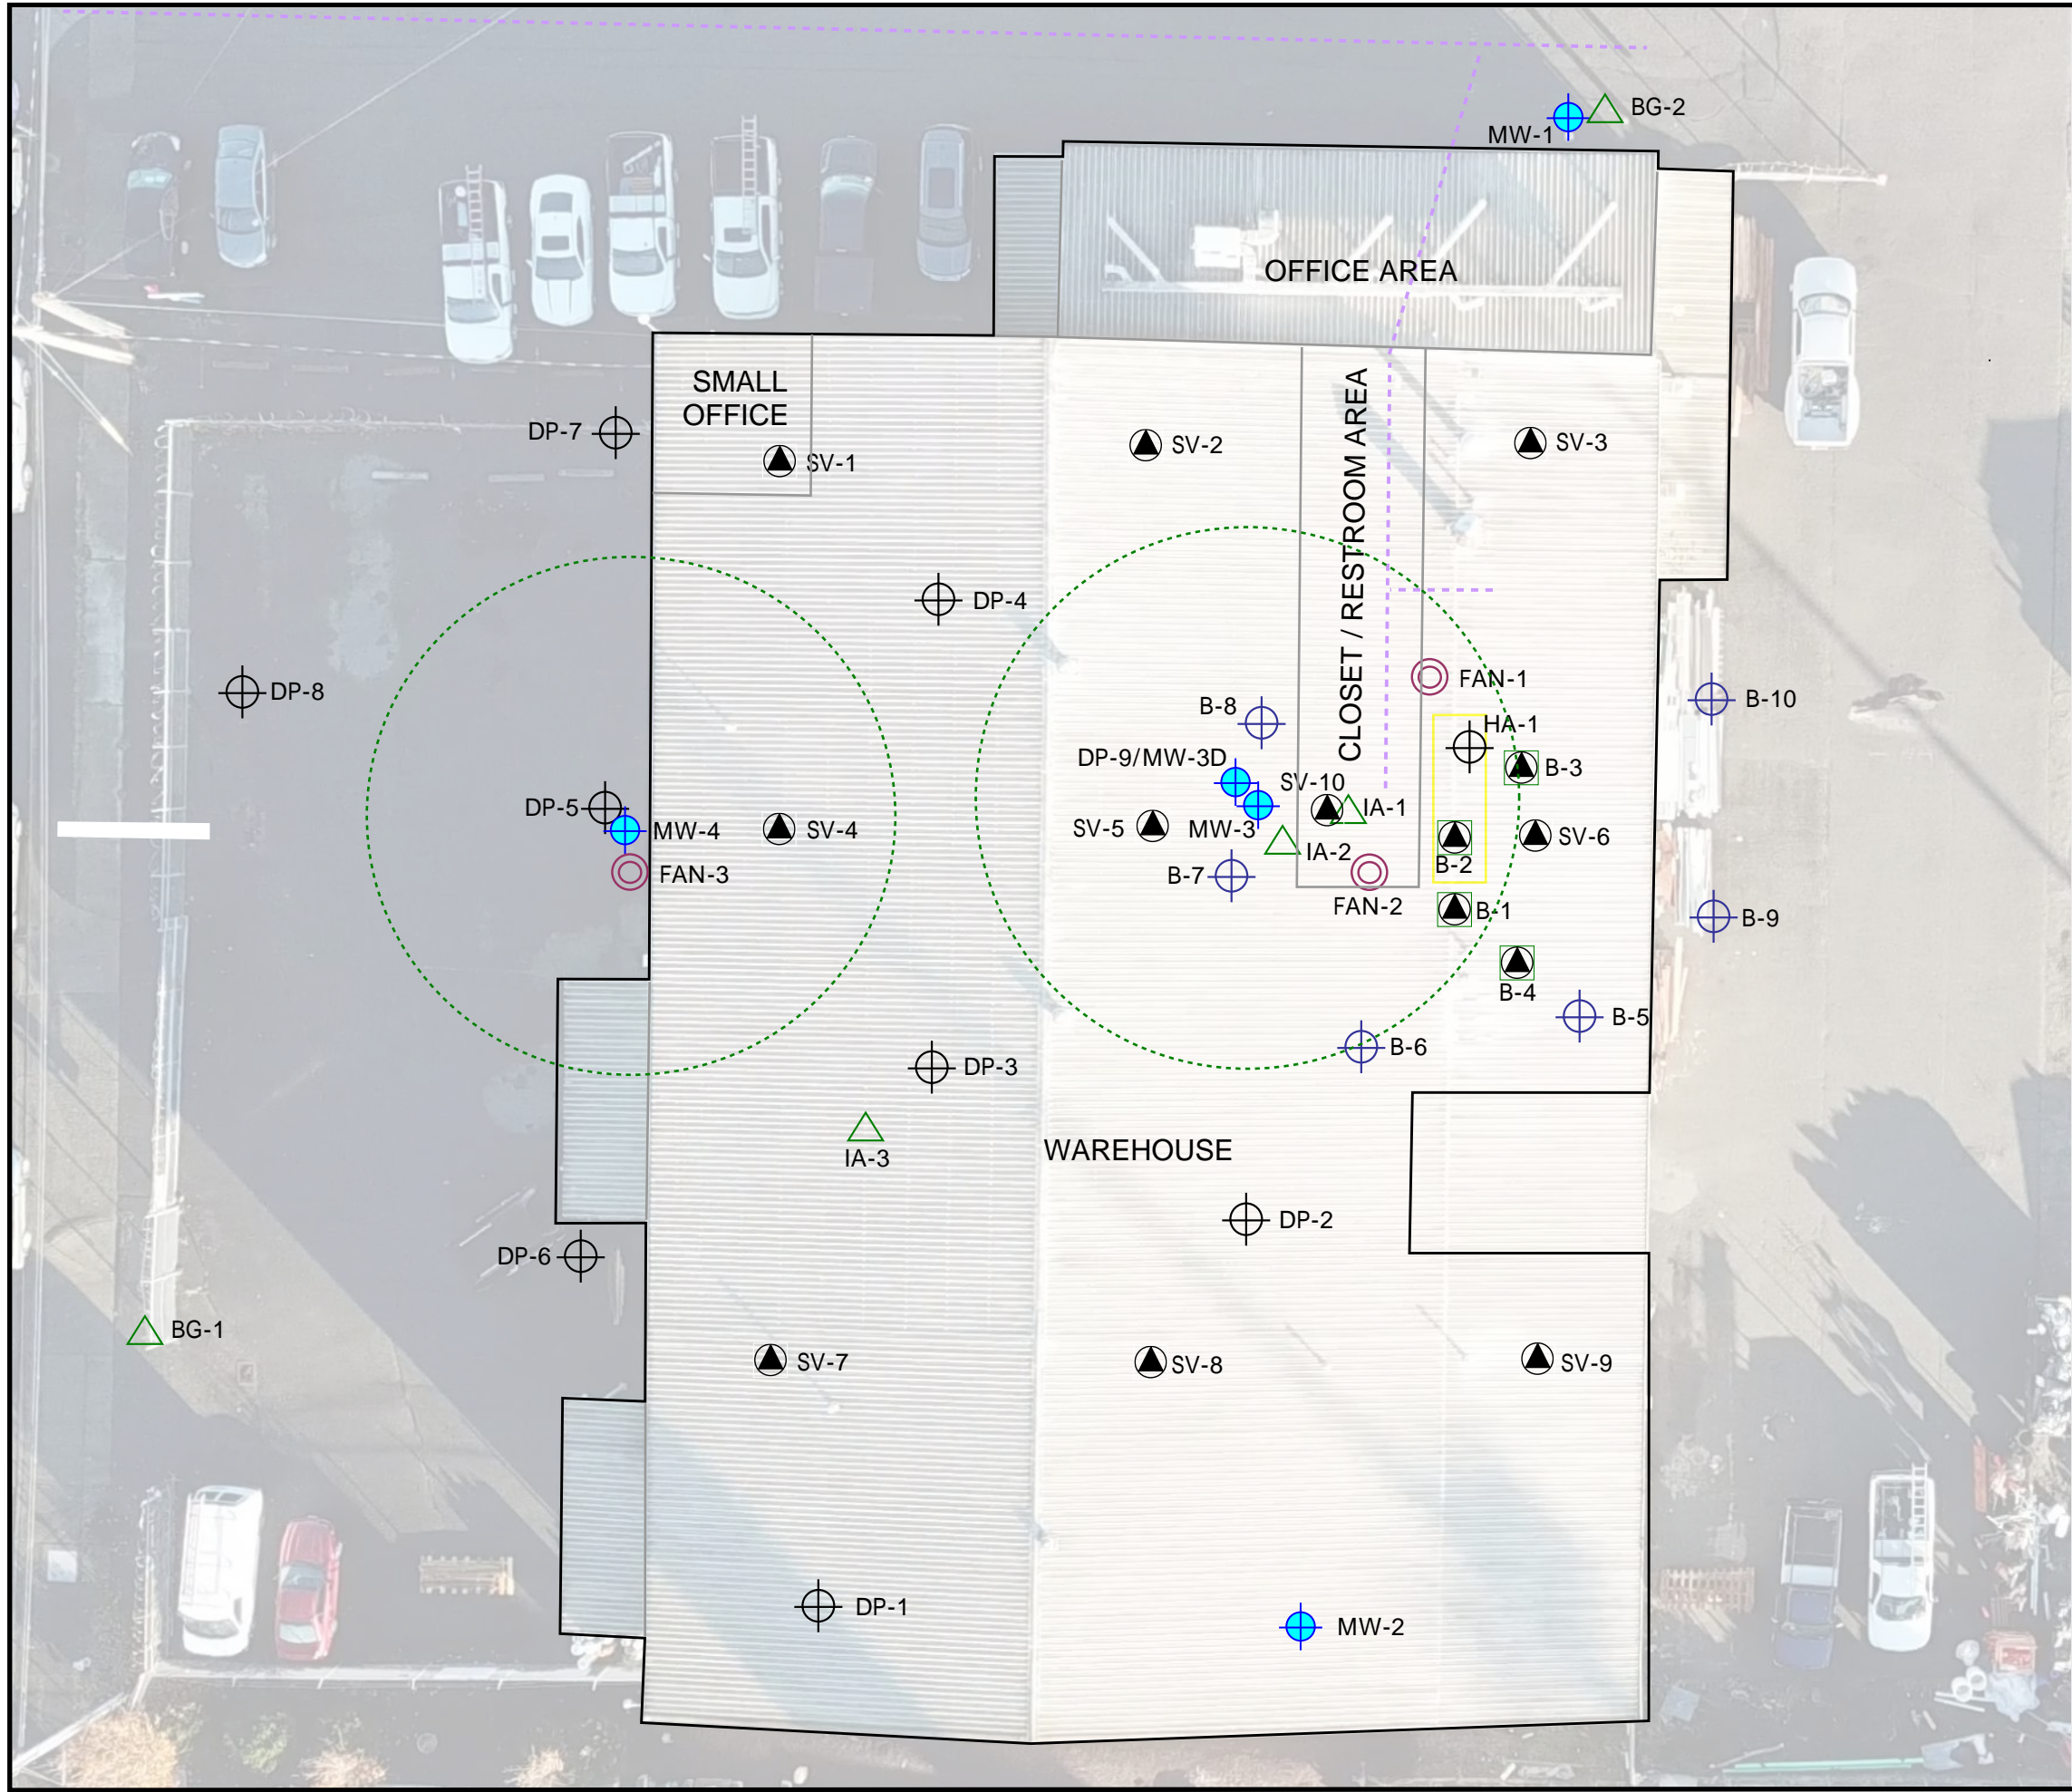
VADOZE SOIL TREATMENT AREA (SEE FIGURE 3 FOR DETAIL)

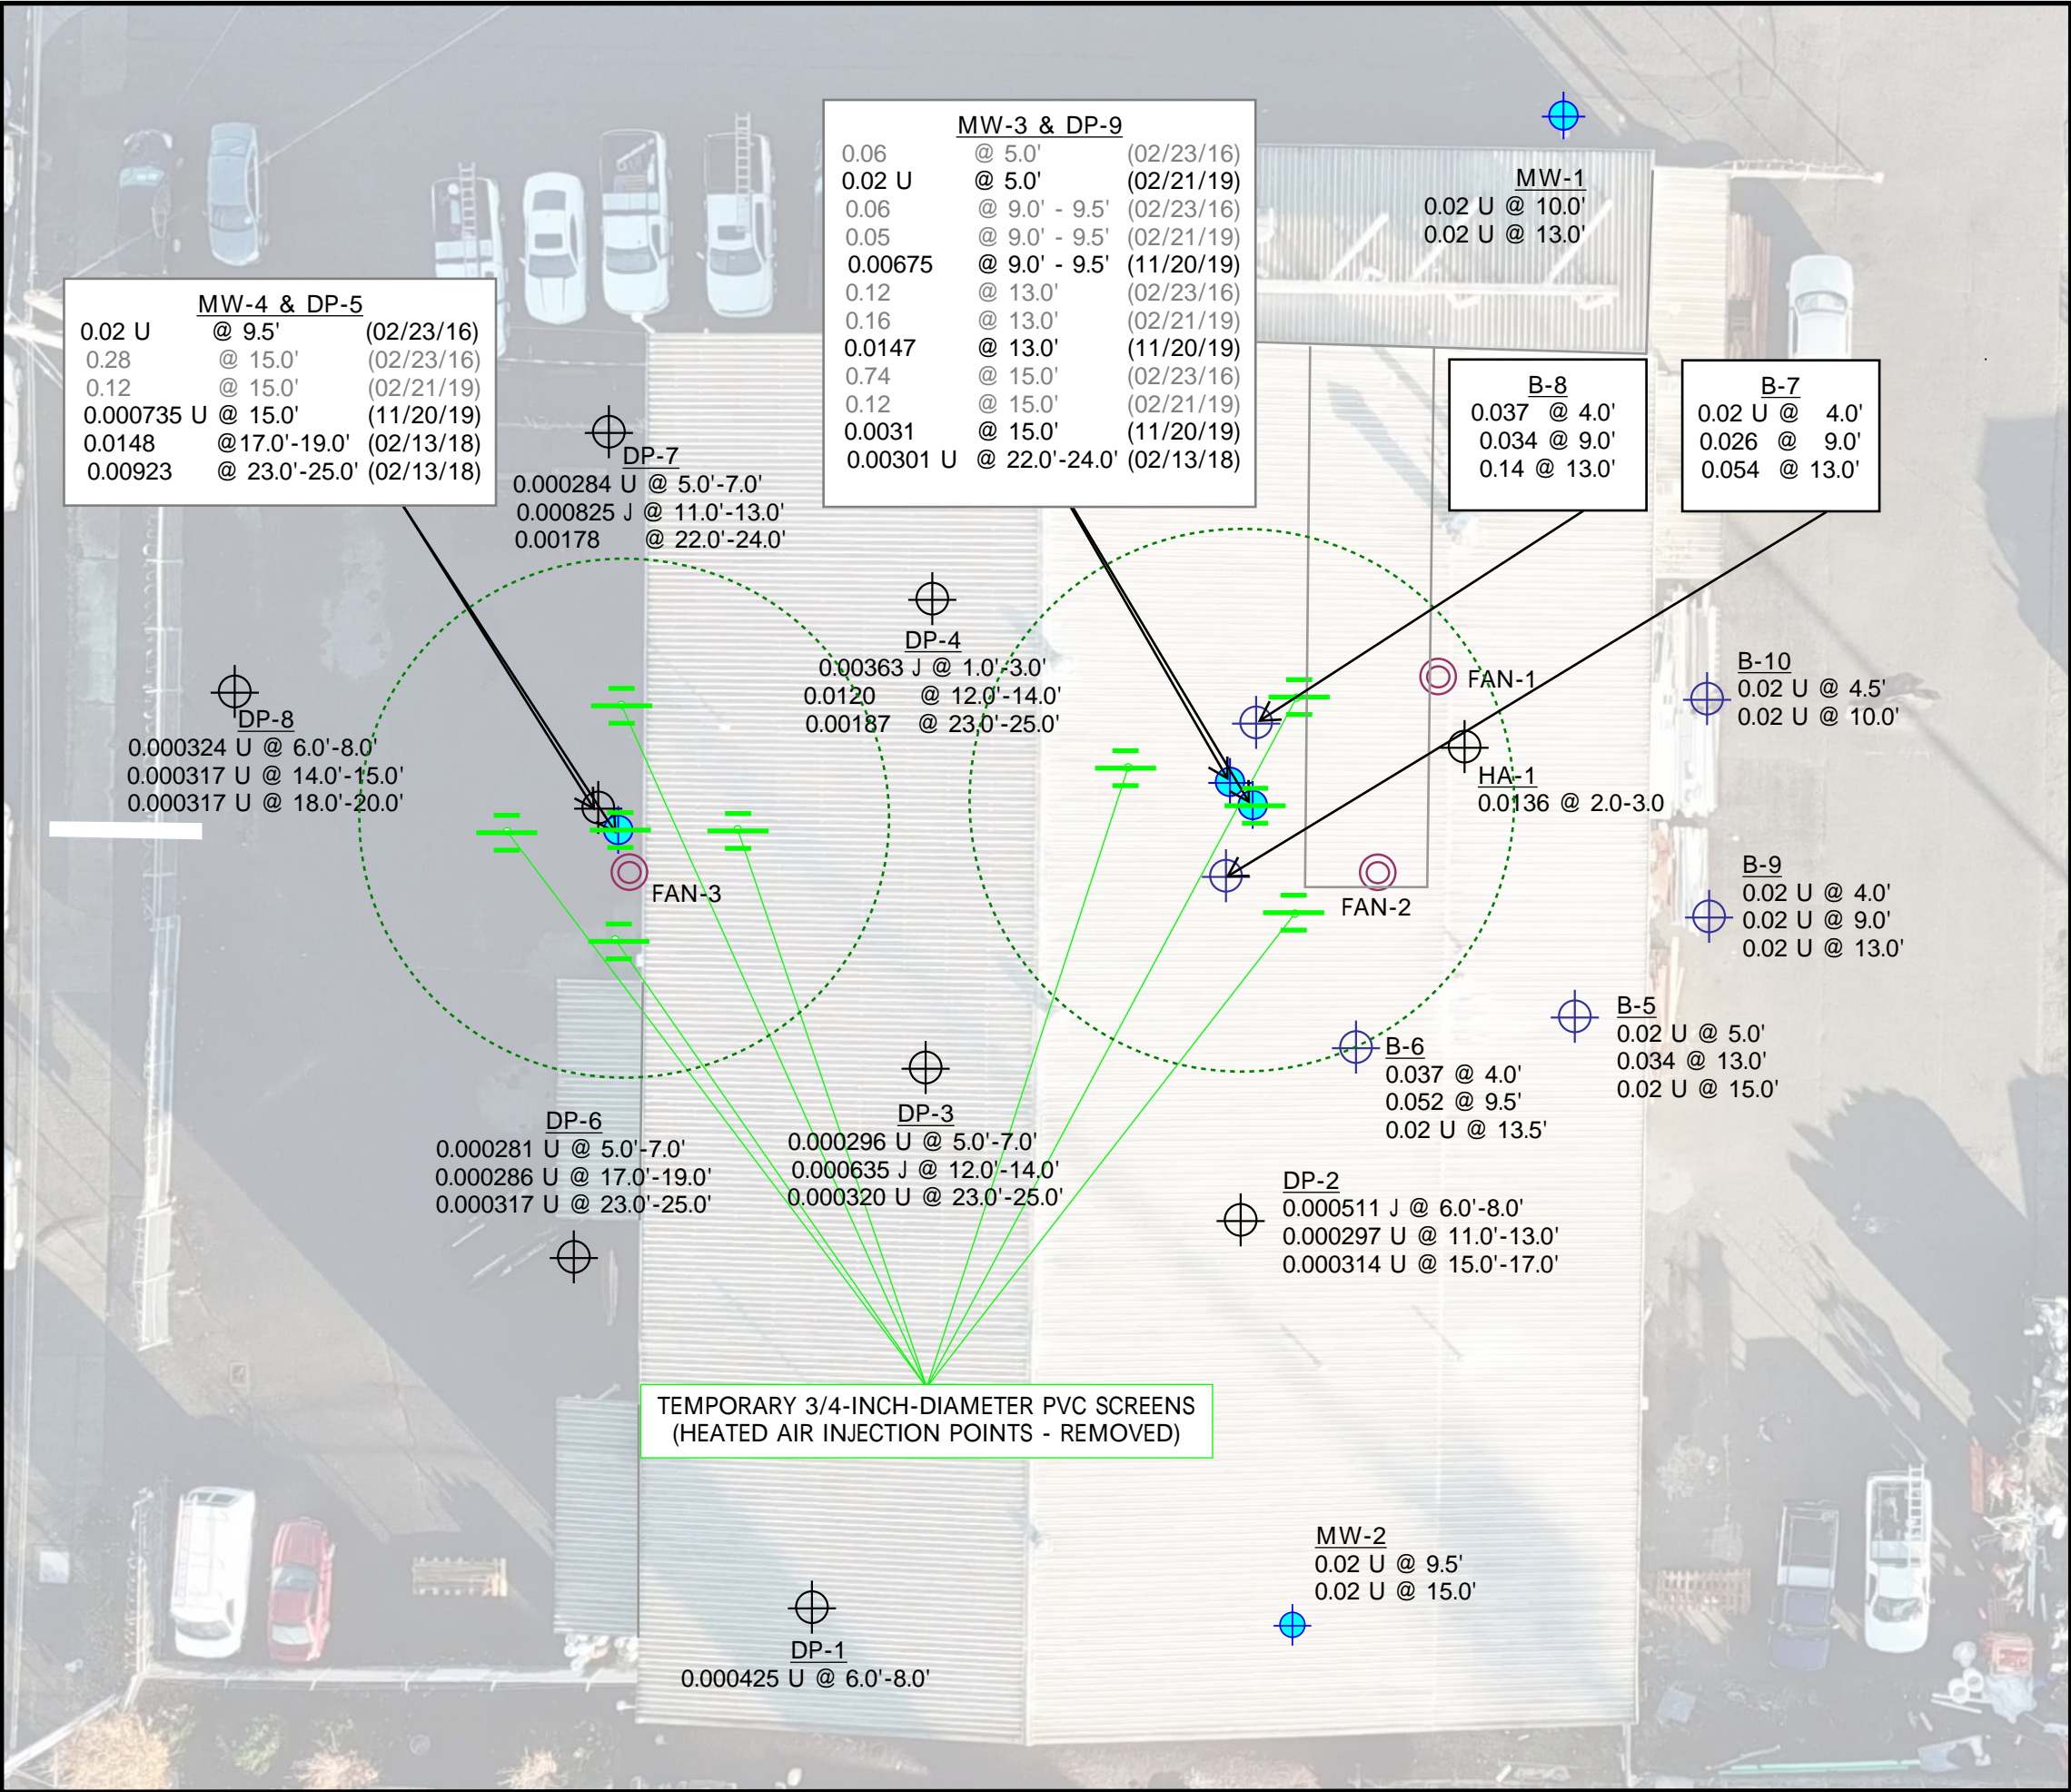
HEATED AIR INJECTION POINT (JULY & AUGUST 2019)

VADOZE SOIL TREATMENT AREA (EST. 15' FROM BLOWERS)

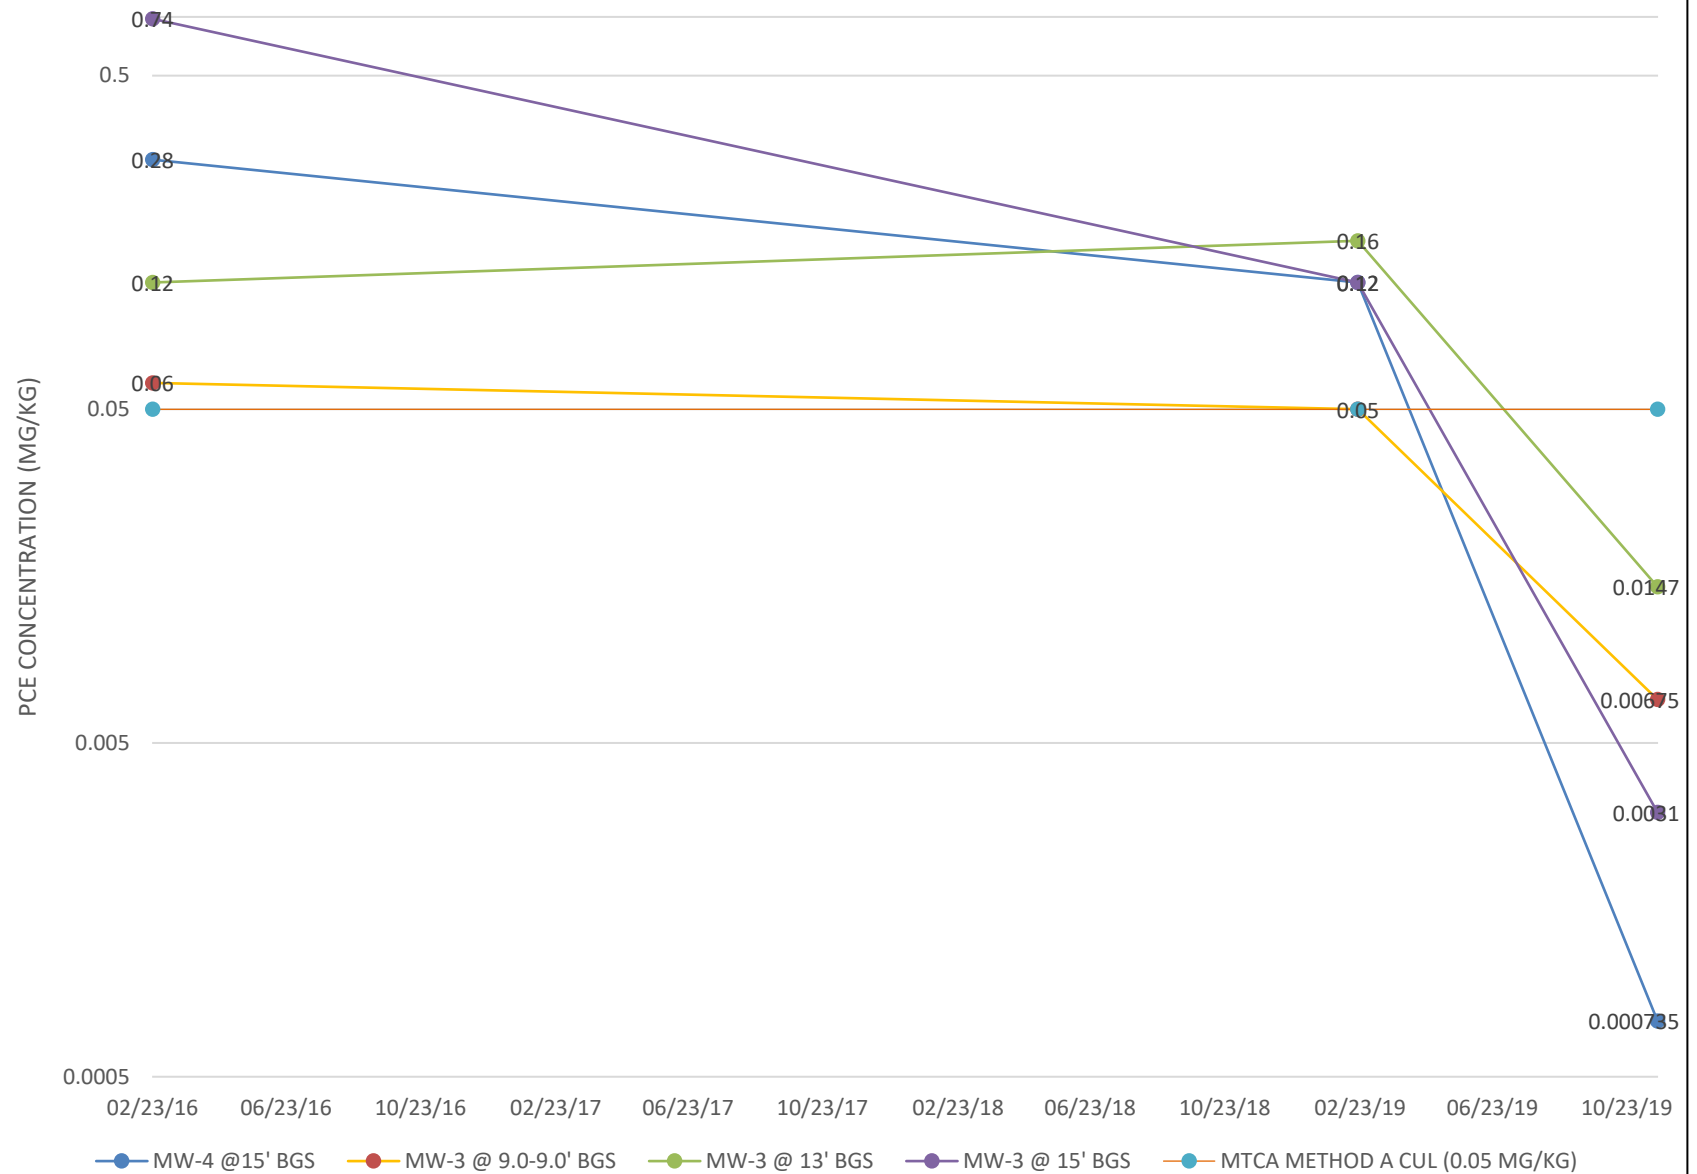
Chart 1: PCE in Soil. 6707 S Adams Street, Tacoma, Washington

The supplemental soil samples¹ collected by SEC were analyzed for the selected VOCs by EPA Method 8260C. Following the implementation of IRAMs discussed herein, VOCs were either not detected at concentrations greater than laboratory reported detection limits (RDLs) or were detected at concentrations less than the MTCA Method A CUL. The soil chemical analytical results are presented on Table 1.
