# **Construction Documentation Report**

**Implementation of Cleanup Action Under  
Model Toxics Control Act (MTCA)**

**Soil Excavation/Groundwater Monitoring**

**Aladdin Plating  
1657 Center Street  
Tacoma, Washington  
FSID 1277**

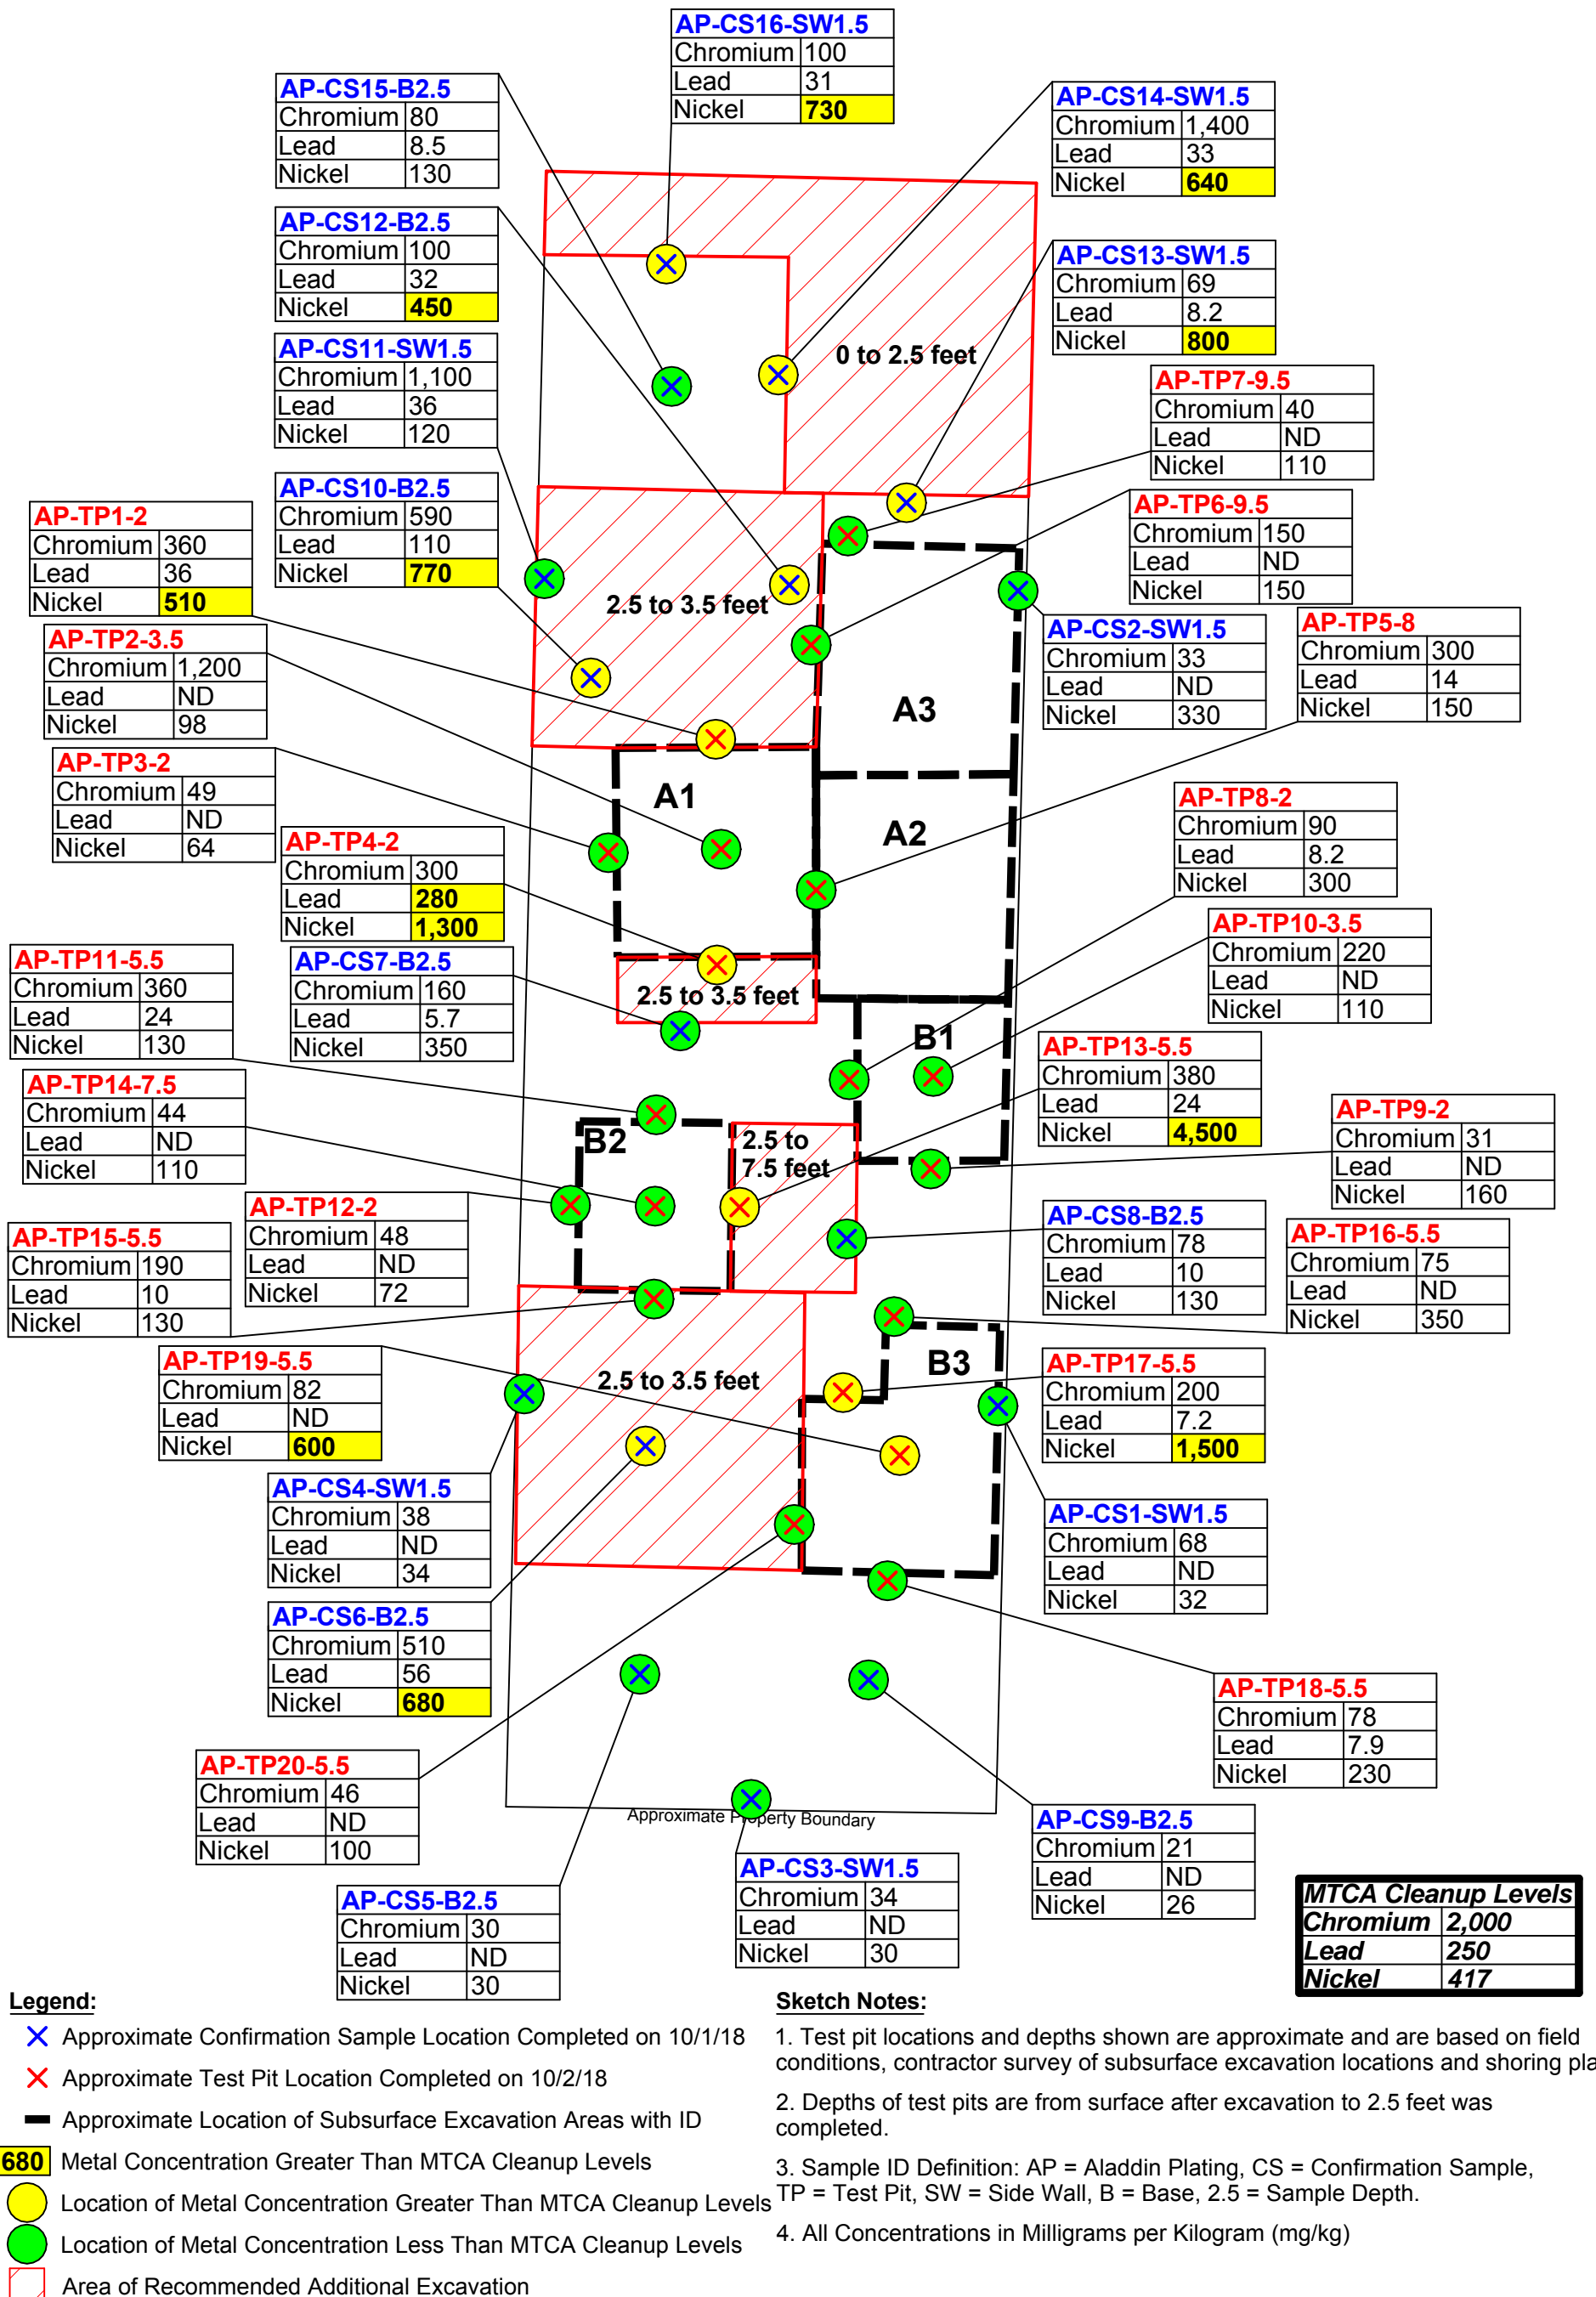
**Figure 2**

**Site Sketch: Confirmation Sampling and Test Pit Sample Locations with Preliminary Confirmation Sample Results**

After the excavation of the contaminated soil, the confirmational soil samplings showed, in some locations soil exceeding the Nickel soil cleanup level of 417 mg/kg remain in place. The range of depths of Nickel exceedance were 4 feet to 8 feet below ground surface (bgs) and the range of concentrations were 450 mg/kg – 4,500 mg/kg. Figure 2 shows the confirmational soil samples where exceedances occurred and the limits of the excavations.

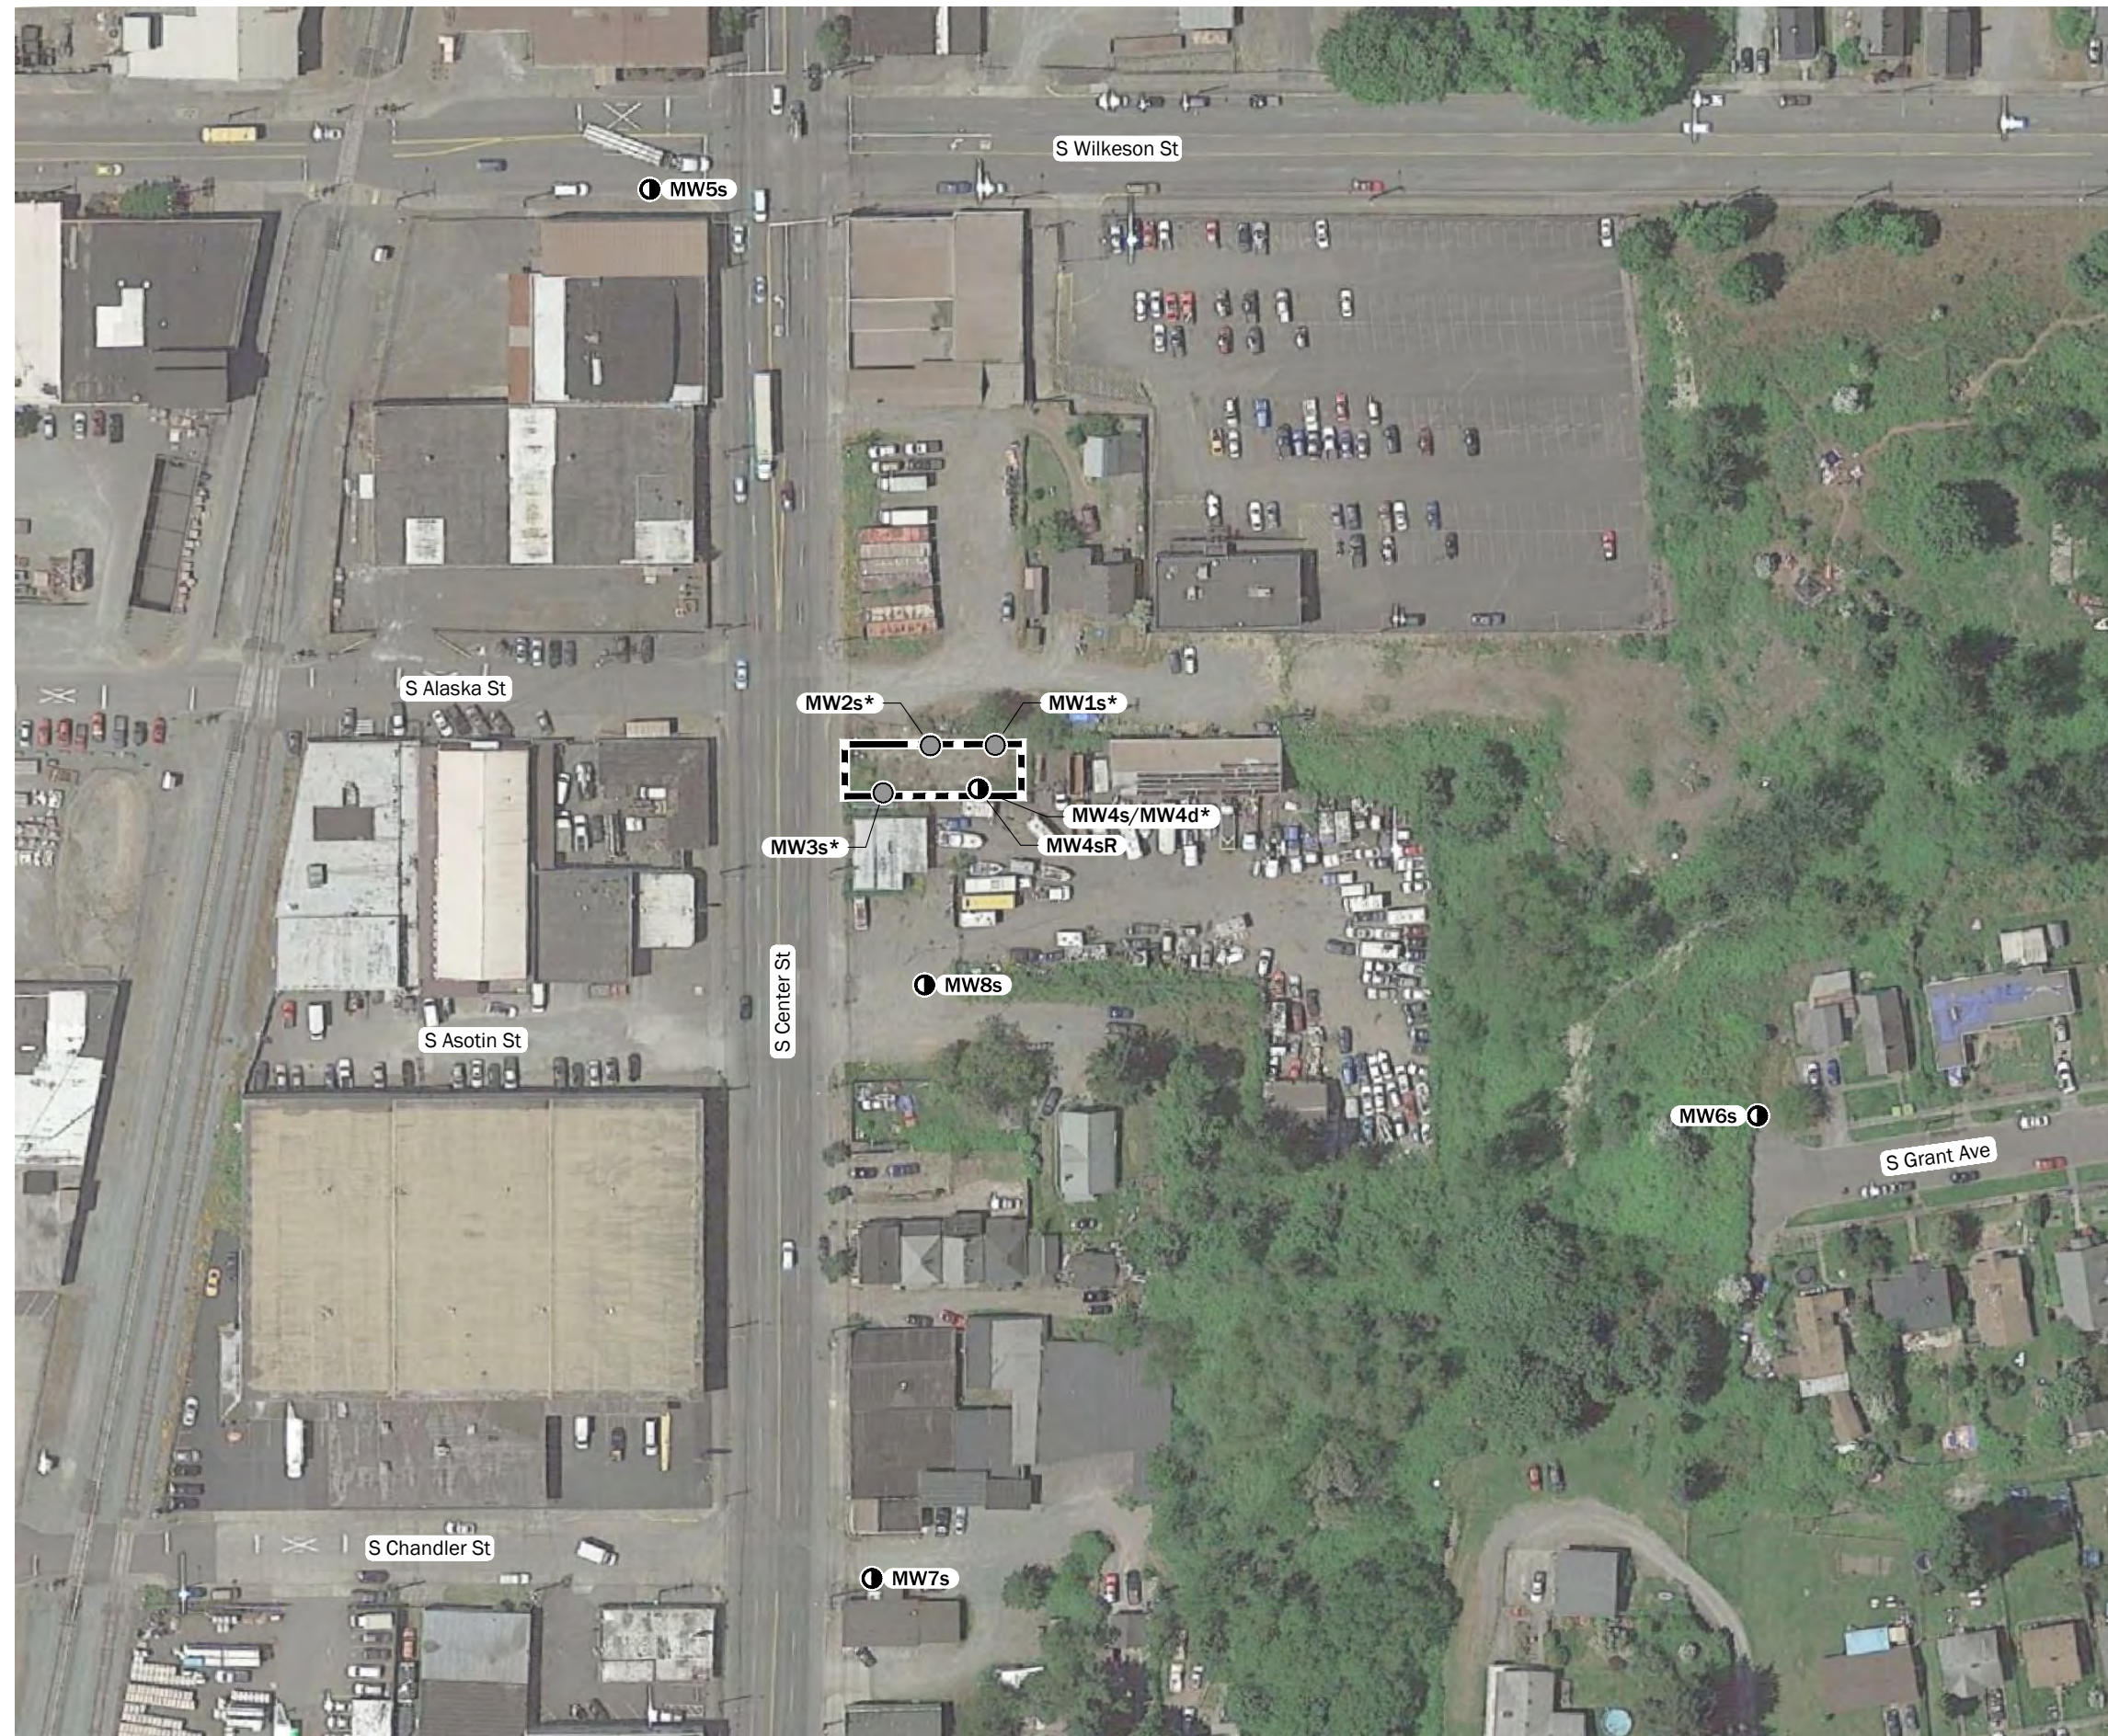
| | Figure 2 |

- Site Boundary
  - MW4sR ● Groundwater Monitoring Well
  - MW1s\* ● Decommissioned Monitoring Well
- \*Monitoring Well Decommissioned During Remedial Excavation Activities on 9/18/2018

Following construction, two monitoring wells were installed, one on and one off the property, in December 2018. The well installed on the property was given the identification of MW4sR as a replacement well for MW4s and was installed in generally the same location as the original. The other well installed off the property, MW8s, was located west of South Asotin Street and east of the gated entrance to Bills Towing. MW8s was installed on private property with the permission of the property owner who signed an access agreement with Ecology.

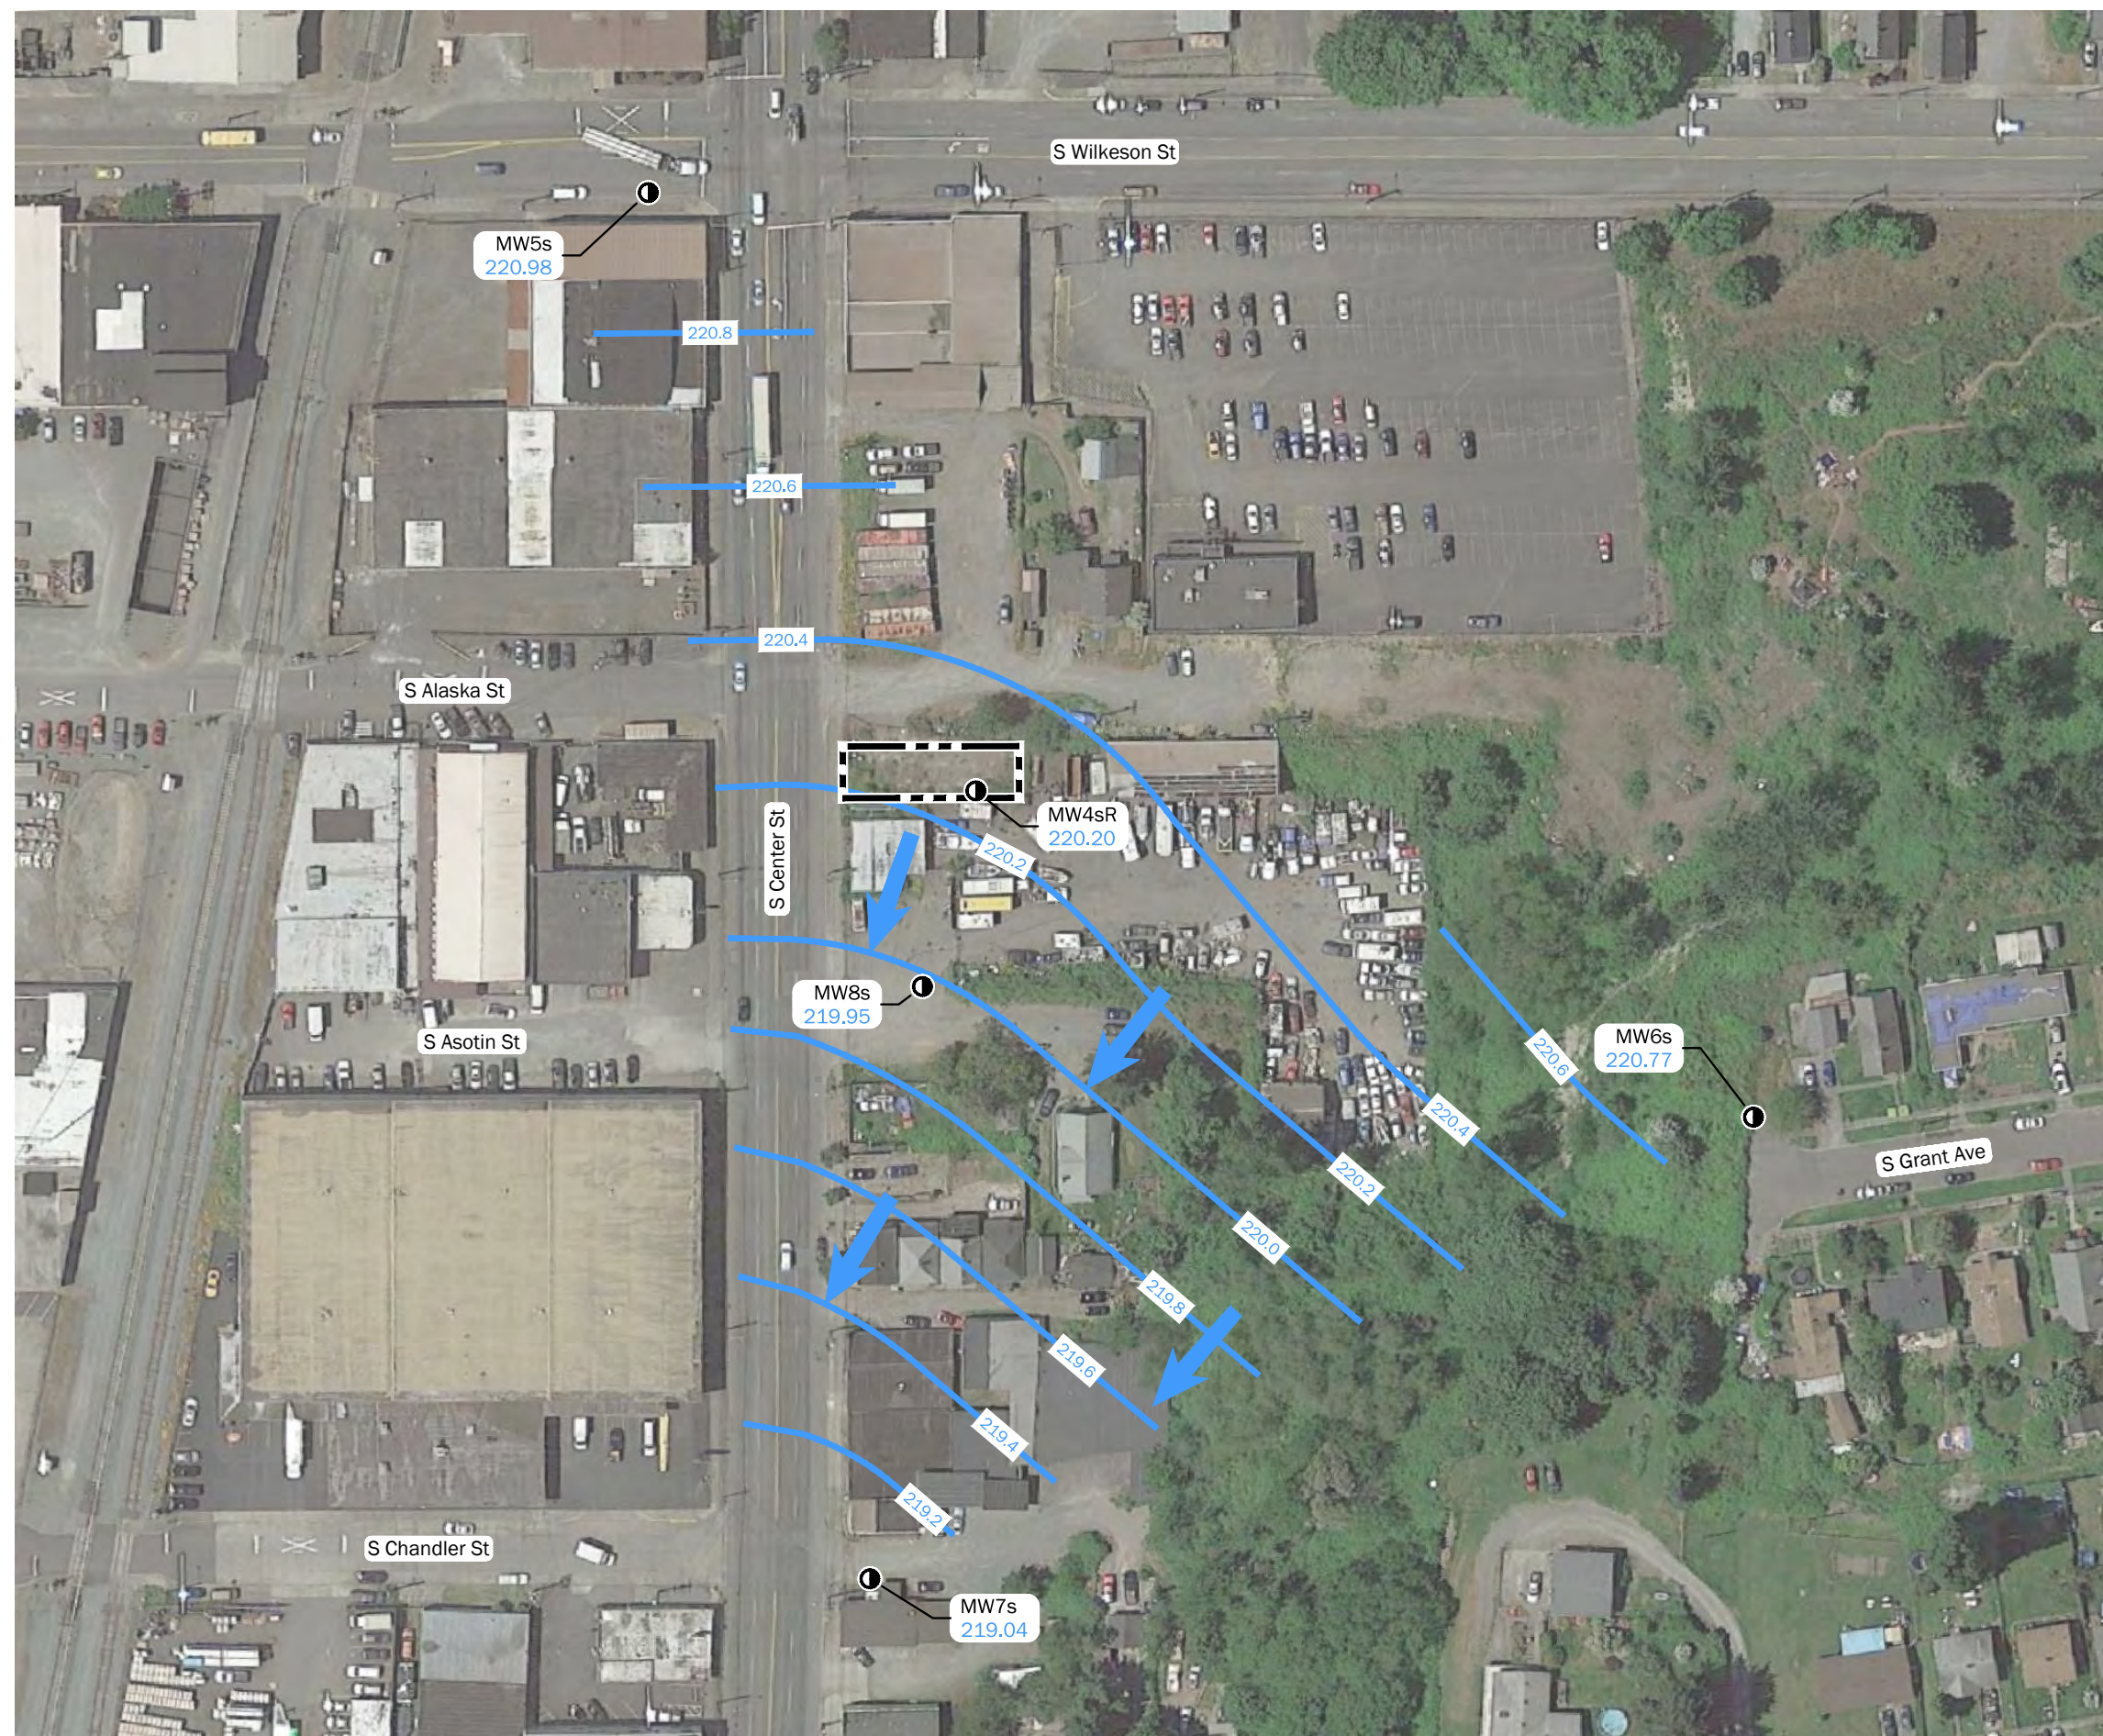
| | Figure 3 |

| <b>Groundwater Contour Map</b> | |

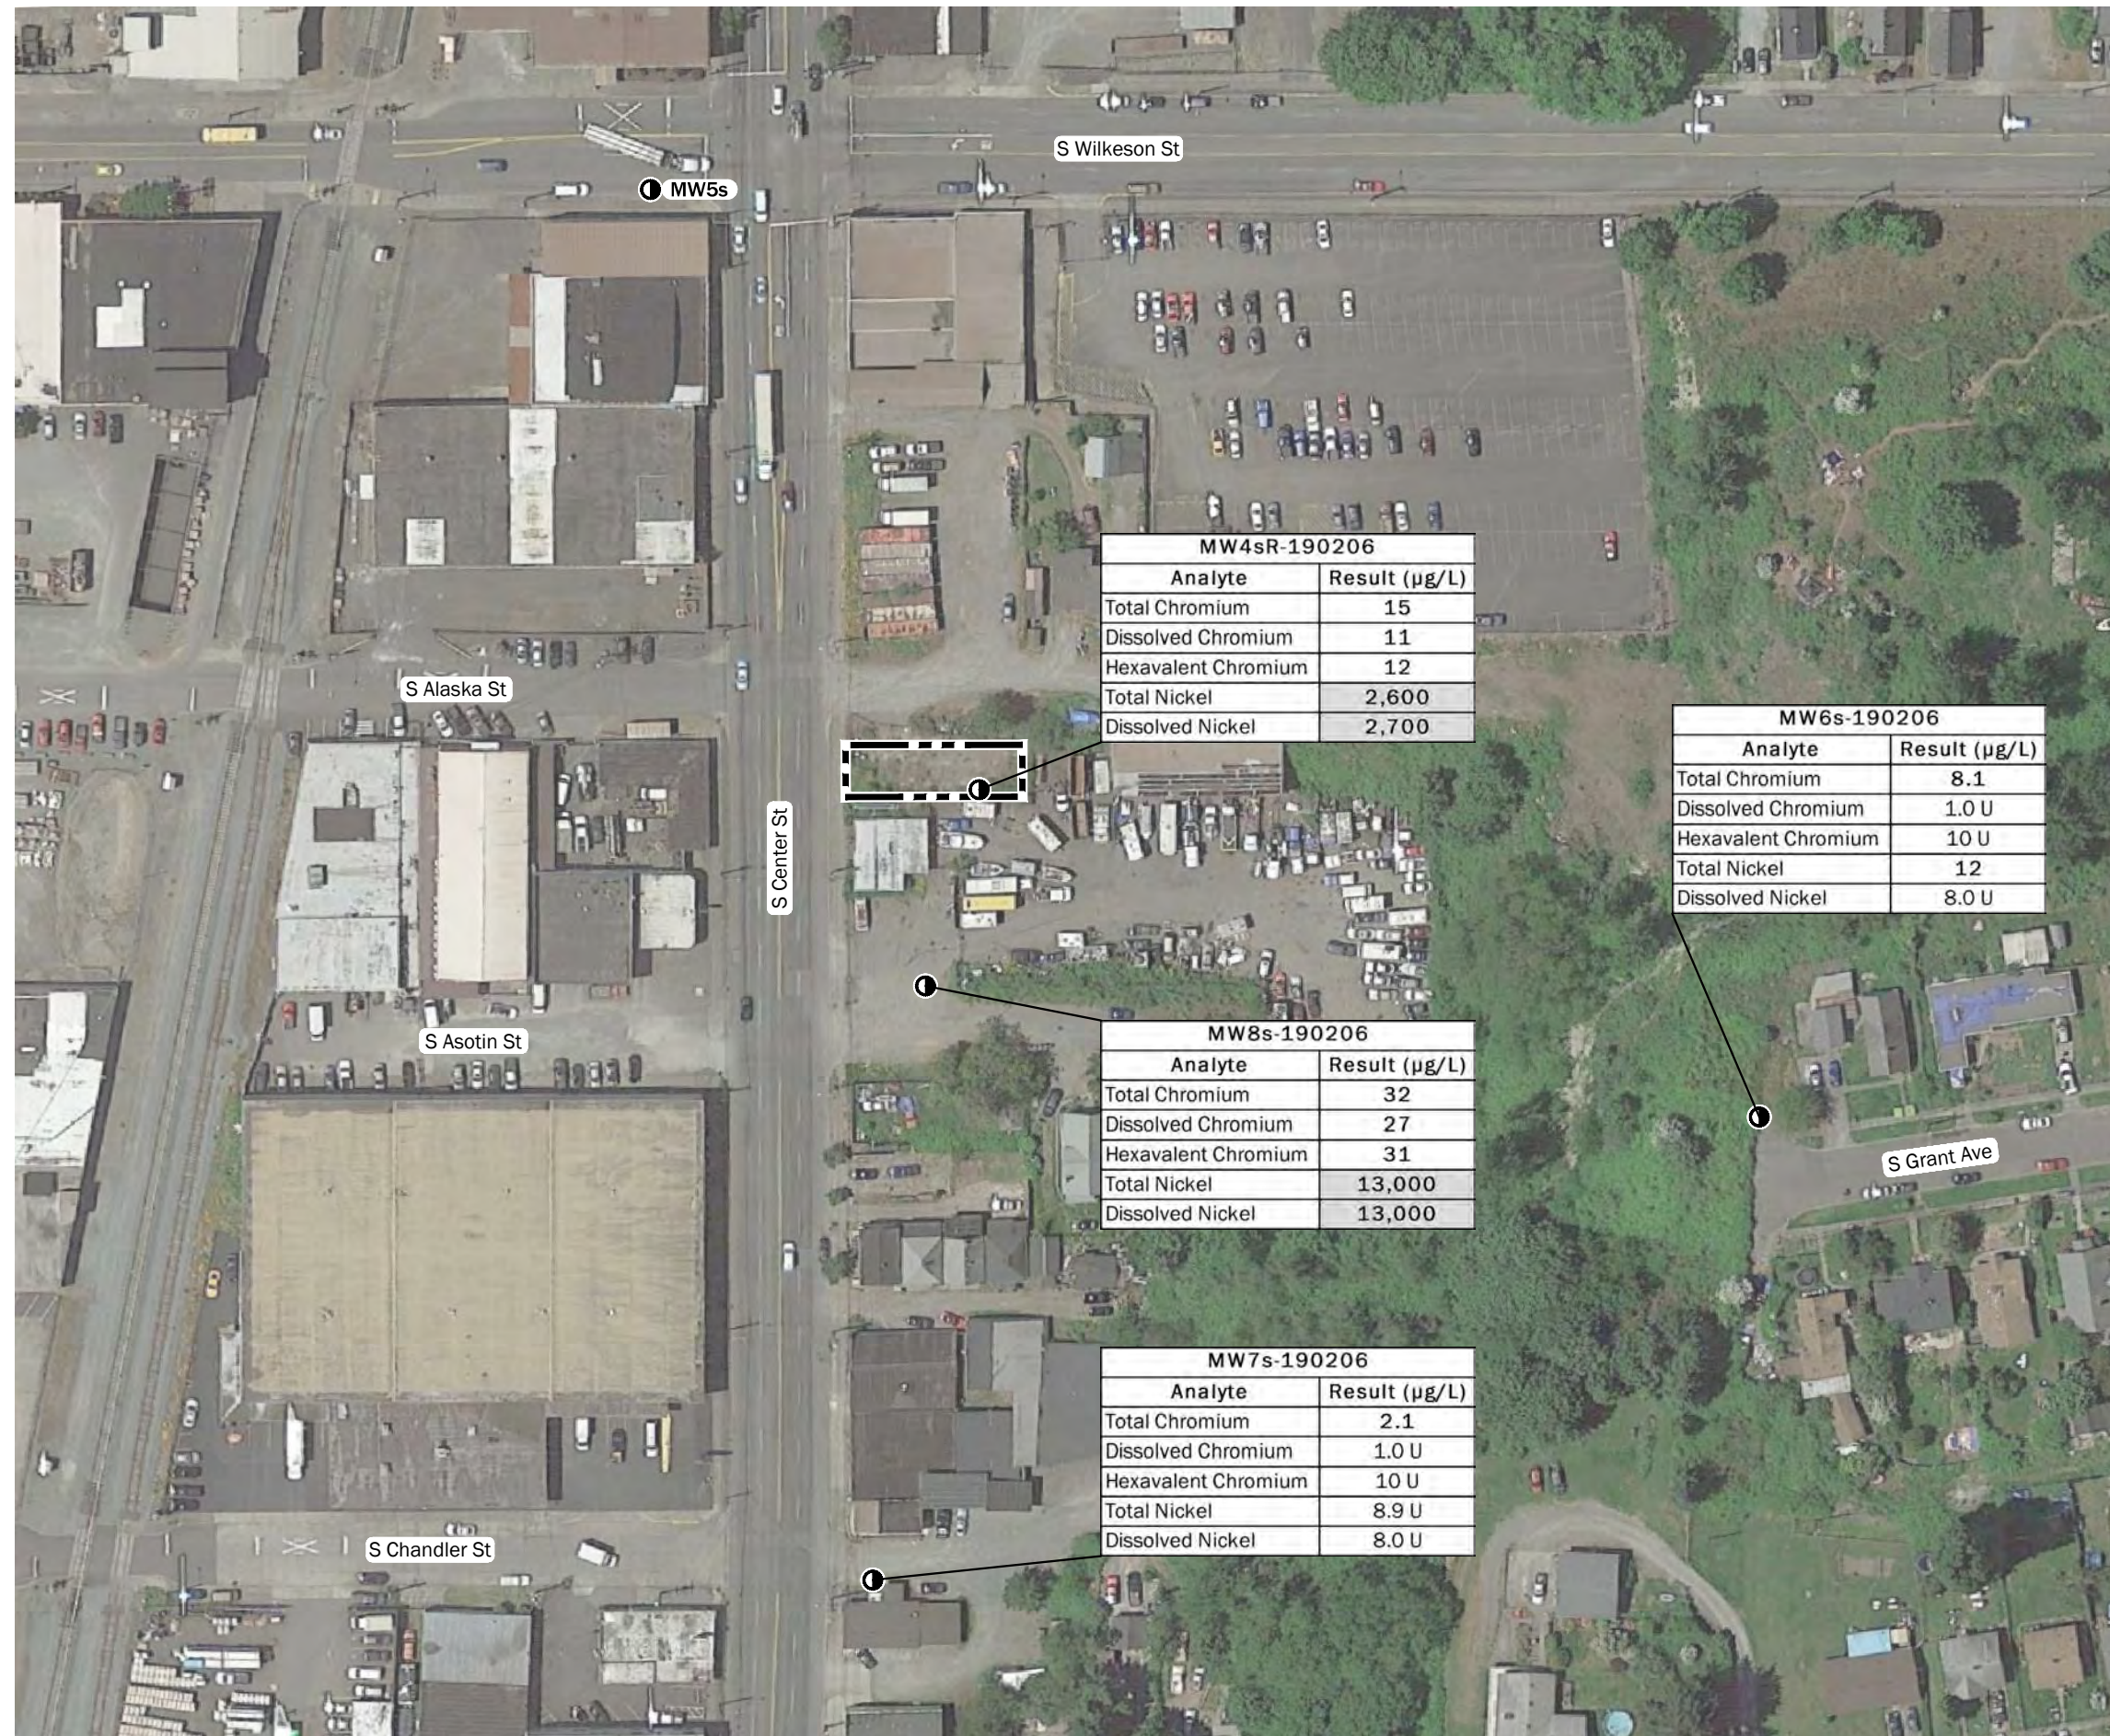
- Site Boundary
- MW4sR ● Groundwater Monitoring Well
- µg/L = micrograms per liter
- Bolding indicates analyte was detected.**
- Gray Shading indicates exceedance of MTCA cleanup level.**

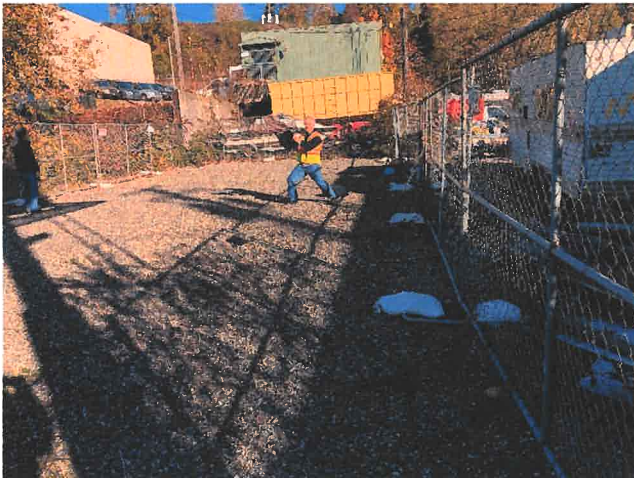
Photo 3 - Gravel in Back 2/3<sup>rd</sup> of Lot Looking North

There does not appear to be any visible settlement of the gravel covered portion of the site. There were tire tracks left on the surface of the gravel from the Waste Management forklift that was used to pick up the drums in August 2019. The forklift did not leave ruts in the gravel.

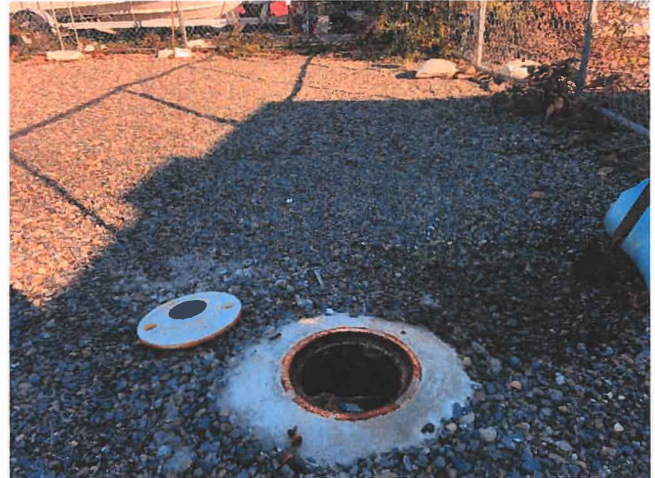
Photo 6 - Replacement Monitoring Well MW4sR

The replacement monitoring well MW4sR was visible and not covered with gravel, debris or vegetation and was secured in the well box. The offsite monitoring well MW8s located east of the site was visible and not covered with gravel, debris or vegetation and was secured in the well box. The well J-plug in MW4sR and MW8s were each secured with a padlock.

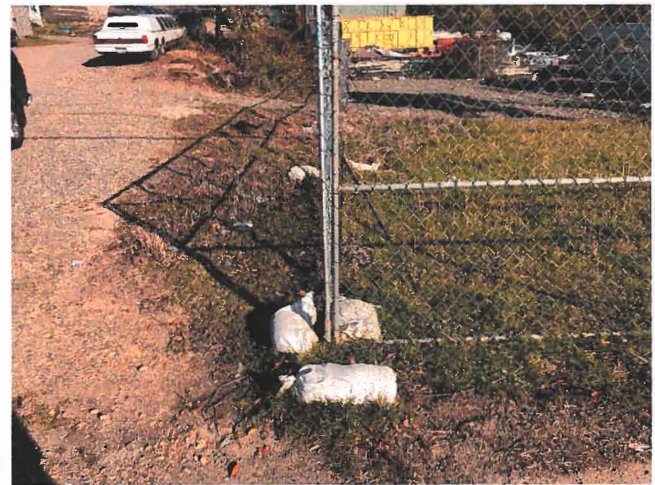
Photo 10 - Southwest Corner of Fencing and Alaska Street

The fencing appeared to be secure and in good condition and preventing access to the site and the adjacent property. The feet of the fencing were secured with sandbags and there were bracing installed around the perimeter of the fencing preventing.
