Technical Memorandum

Date:	February 7, 2020	From:	Timothy S. Brown, L.Hg. Kellie M. Andrews, G.I.T.
To:	Washington State Department of Ecology	Project Manager:	Timothy S. Brown, L.Hg.
	3190 160 th Avenue SE	Principal/Associate in Charge:	Timothy S. Brown, L.Hg. <i>TSB</i>
	Bellevue, Washington 98008	Project Name:	Former Mill E/Koppers Facility
Attn:	Mr. Ron Timm	Project No:	20050654V001
Subject:	2019 Annual Performance and Compliance Monitoring Report

Associated Earth Sciences, Inc. (AESI) performed the 2019 annual performance and compliance monitoring for the Former Mill E/Koppers Facility (Site) in Everett, Washington on September 24, 2019 in accordance with the "Performance and Compliance Monitoring Plan" (PCMP; EMCON, 1998) and the "Performance and Compliance Monitoring Plan Addendum" (PCMP Addendum; Floyd|Snider, 2017). The most recent monitoring report titled "Former Mill E/Koppers Site 2018 Annual Performance and Compliance Monitoring Report" prepared by Floyd|Snider in November 2018 (2018 Annual Monitoring Report; Floyd|Snider, 2018) provided a summary of monitoring activities completed from October 2017 to September 2018. This report provides a summary of performance and

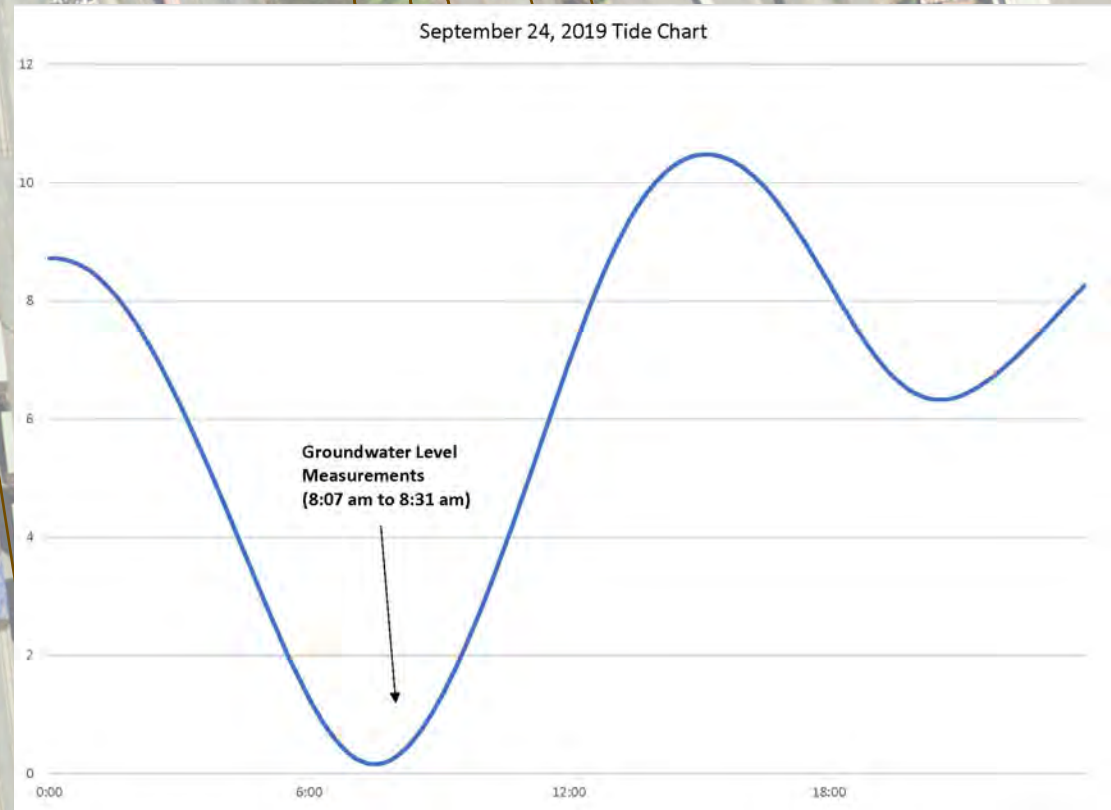
PROJ NO. 050654V001 DATE: 11/19 FIGURE: 2

(LLWM-19D, PZ-2D, and LLMW-20D). A site plan showing the approximate well locations, groundwater elevations measured on September 24, 2019, and the approximate timing of the measurements relative to the 24-hour tidal cycle is presented as Figure 2.

The groundwater levels were collected within 2 hours of the daytime low tide, consistent with Section 2.1 of the PCMP Addendum. Daytime low tide (0.16 feet elevation) was at 7:31 am on September 24, 2019 based on the National Oceanic and Atmospheric Administration tide chart for Everett, Washington (Station 9447659). AESI personnel opened the piezometers/wells to provide for water levels to equilibrate with atmospheric pressure before obtaining depth-to-water measurements. Water levels were measured relative to the top of casing to an accuracy of 0.01 feet using an electronic water level indicator. The electronic water level indicator was cleaned using an Alconox[®] wash and potable water rinse prior to each groundwater level measurement. Groundwater level measurements were collected between 8:07 am and 8:31 am, following the daytime low tide.

**SITE PLAN AND SEPTEMBER
GROUNDWATER ELEVATIONS**
FORMER MILL E/KOPPERS FACILITY
EVERETT, WASHINGTON

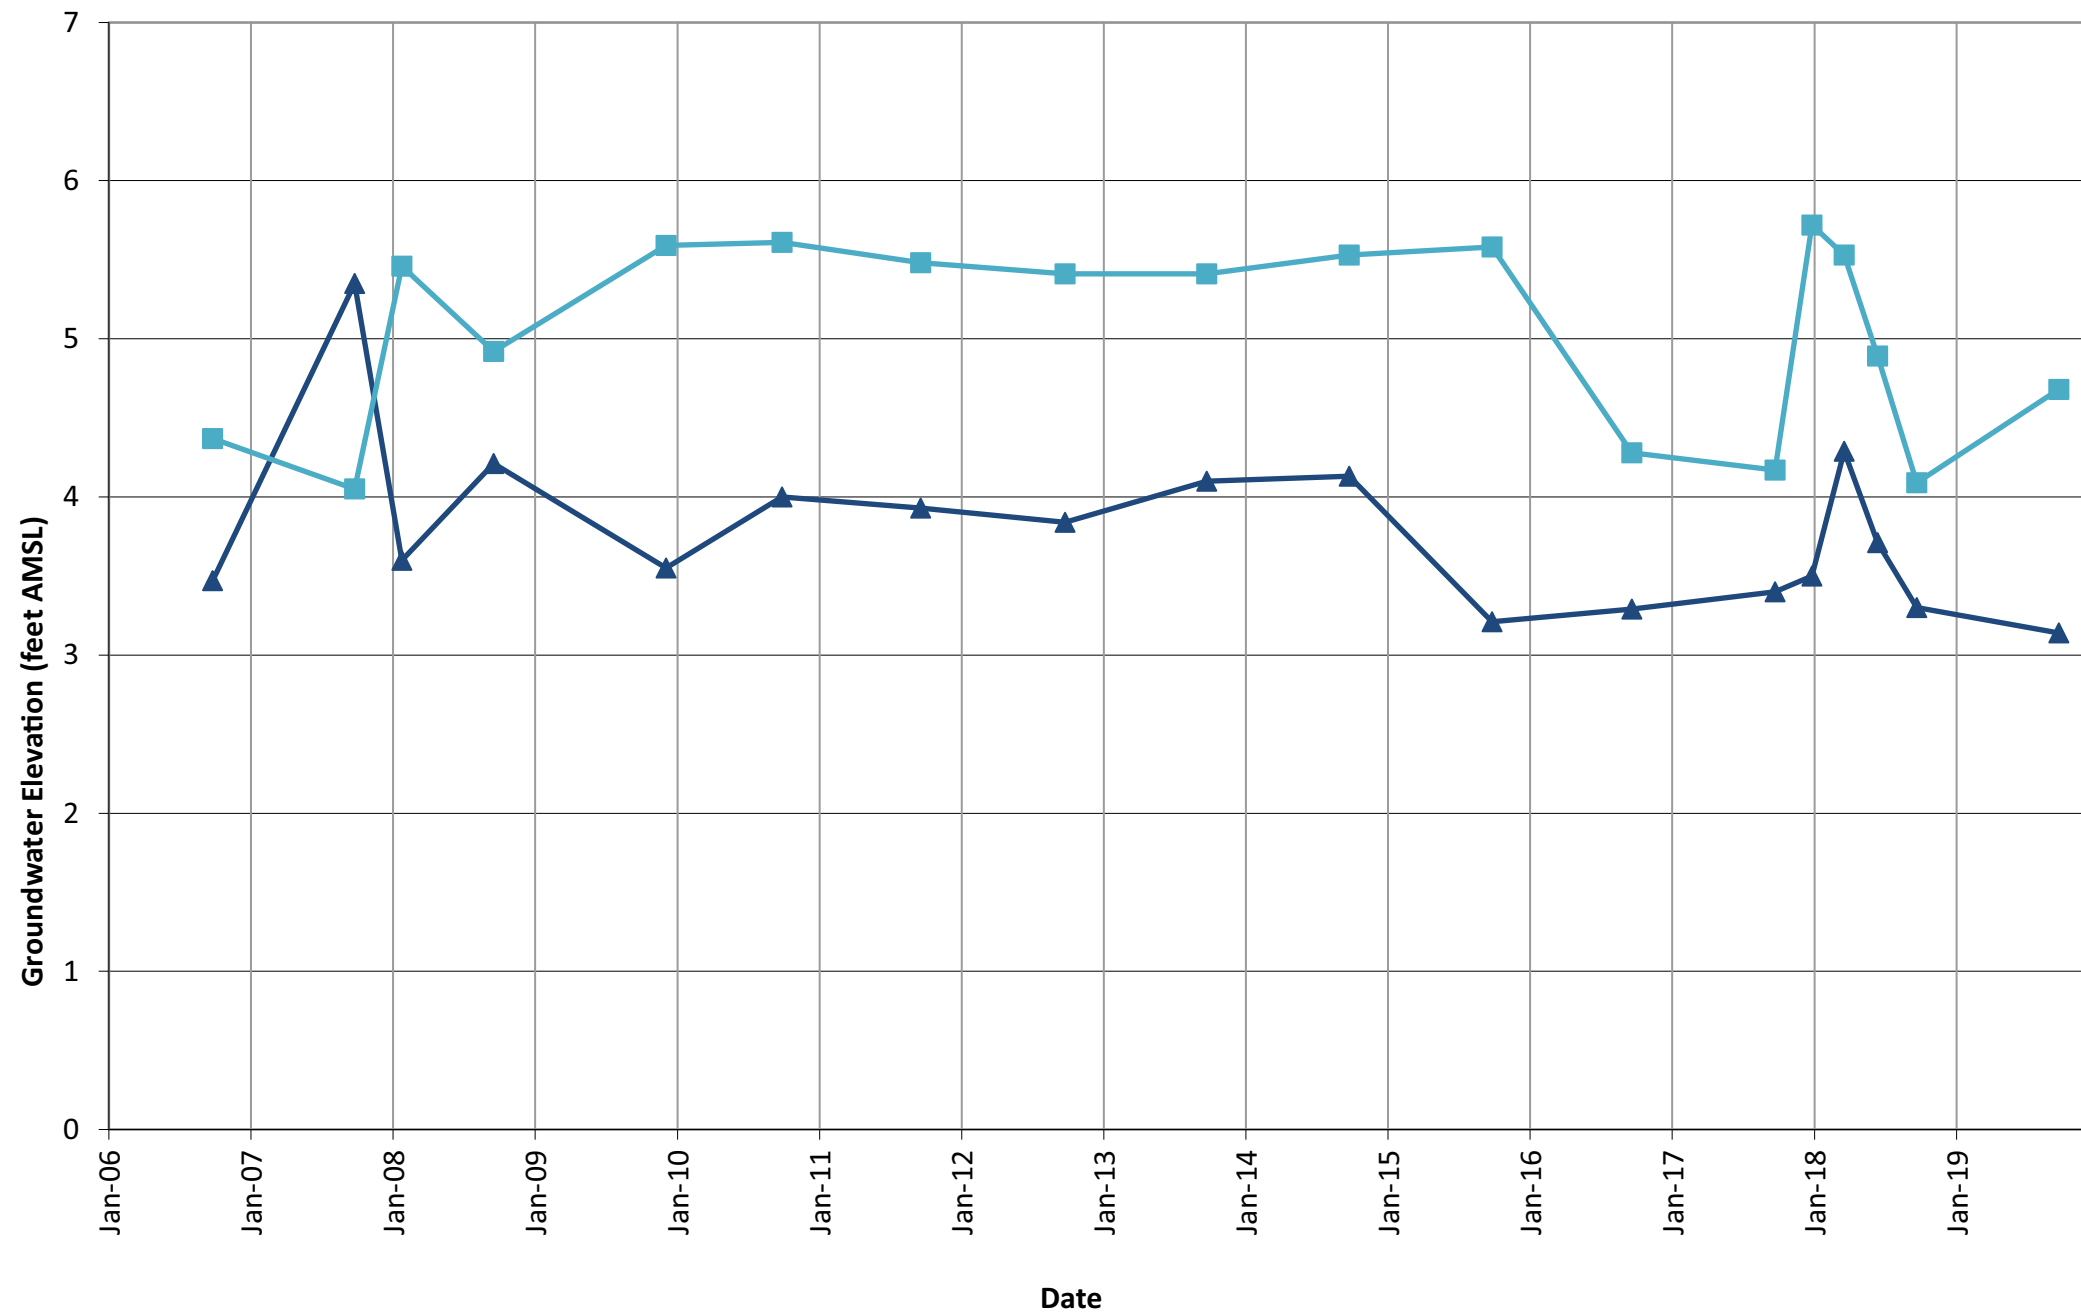
PROJ NO.	050654V001	DATE:	1/20	FIGURE:	3
----------	------------	-------	------	---------	---

Groundwater elevation trends for each piezometer pair are presented on Figures 3 through 5 and show a comparison of historical groundwater elevation data over time obtained for the Site. Review of the data indicates that consistently the groundwater elevations outside of the barrier wall are higher than inside the barrier wall with the exception for piezometer PZ-1A in 2007. The higher than expected water level in piezometer PZ-1A in 2007 was assessed and it was determined to be a result of surface water collecting in the well monument. After this observation, the top of the well monument was raised to prevent surface water from seeping into the monument (AESI; Technical Memorandum dated December 17, 2009).

The groundwater elevation data for the piezometers suggests the barrier wall is performing as intended and isolating groundwater inside the barrier from that outside the barrier.

**GROUNDWATER ELEVATION TRENDS
PZ-1A AND PZ-1B
FORMER MILL E / KOPPERS FACILITY
EVERETT, WASHINGTON**

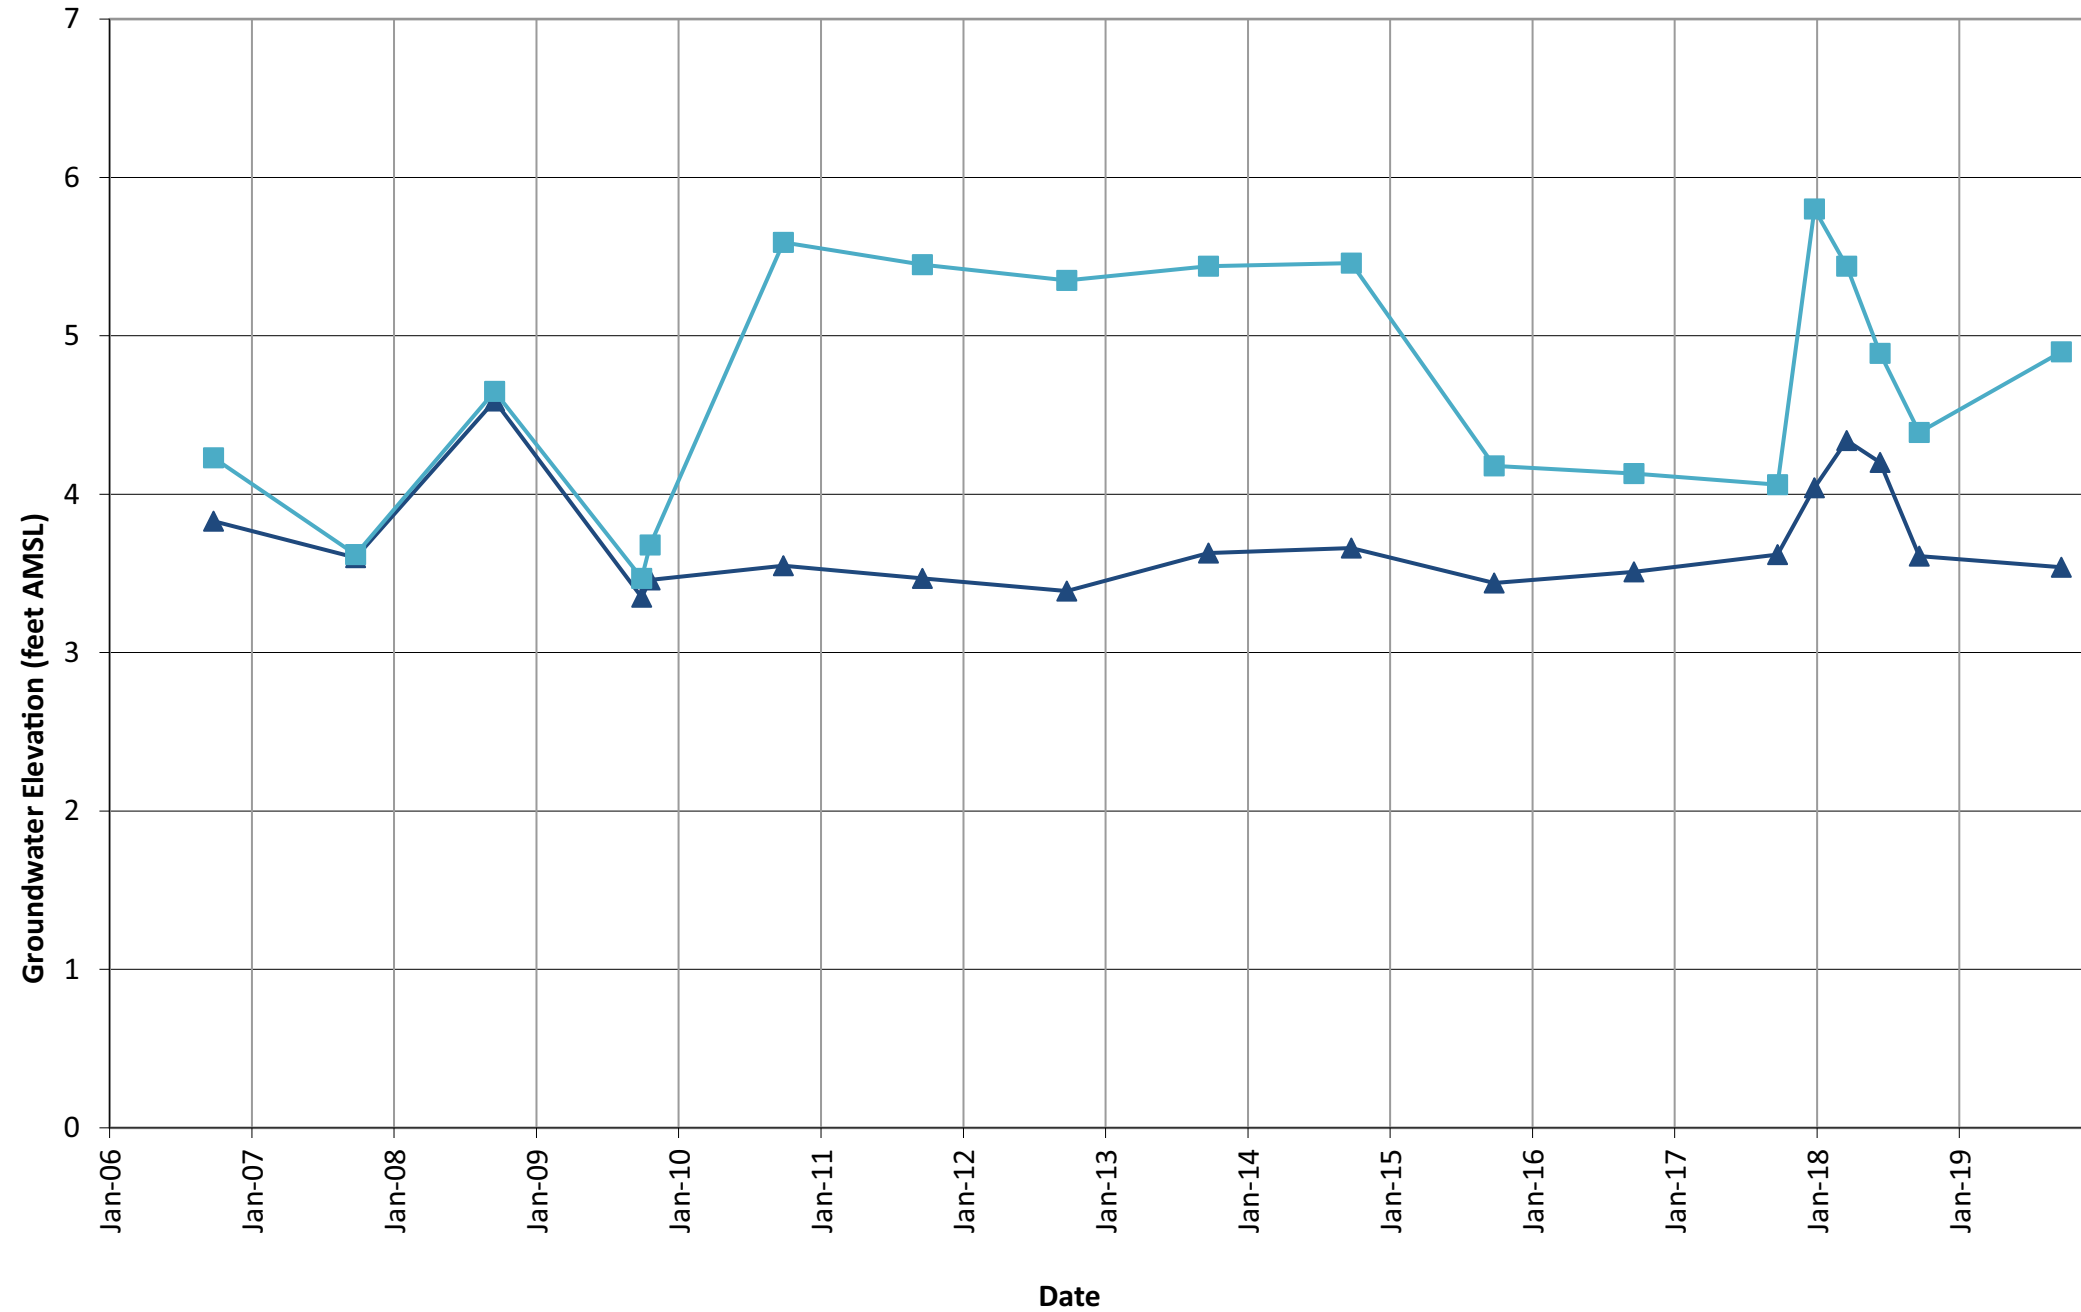
PROJ NO. 050654V001	DATE: 1/20	FIGURE: 4
------------------------	---------------	--------------

**GROUNDWATER ELEVATION TRENDS
PZ-2A AND PZ-2B
FORMER MILL E / KOPPERS FACILITY
EVERETT, WASHINGTON**

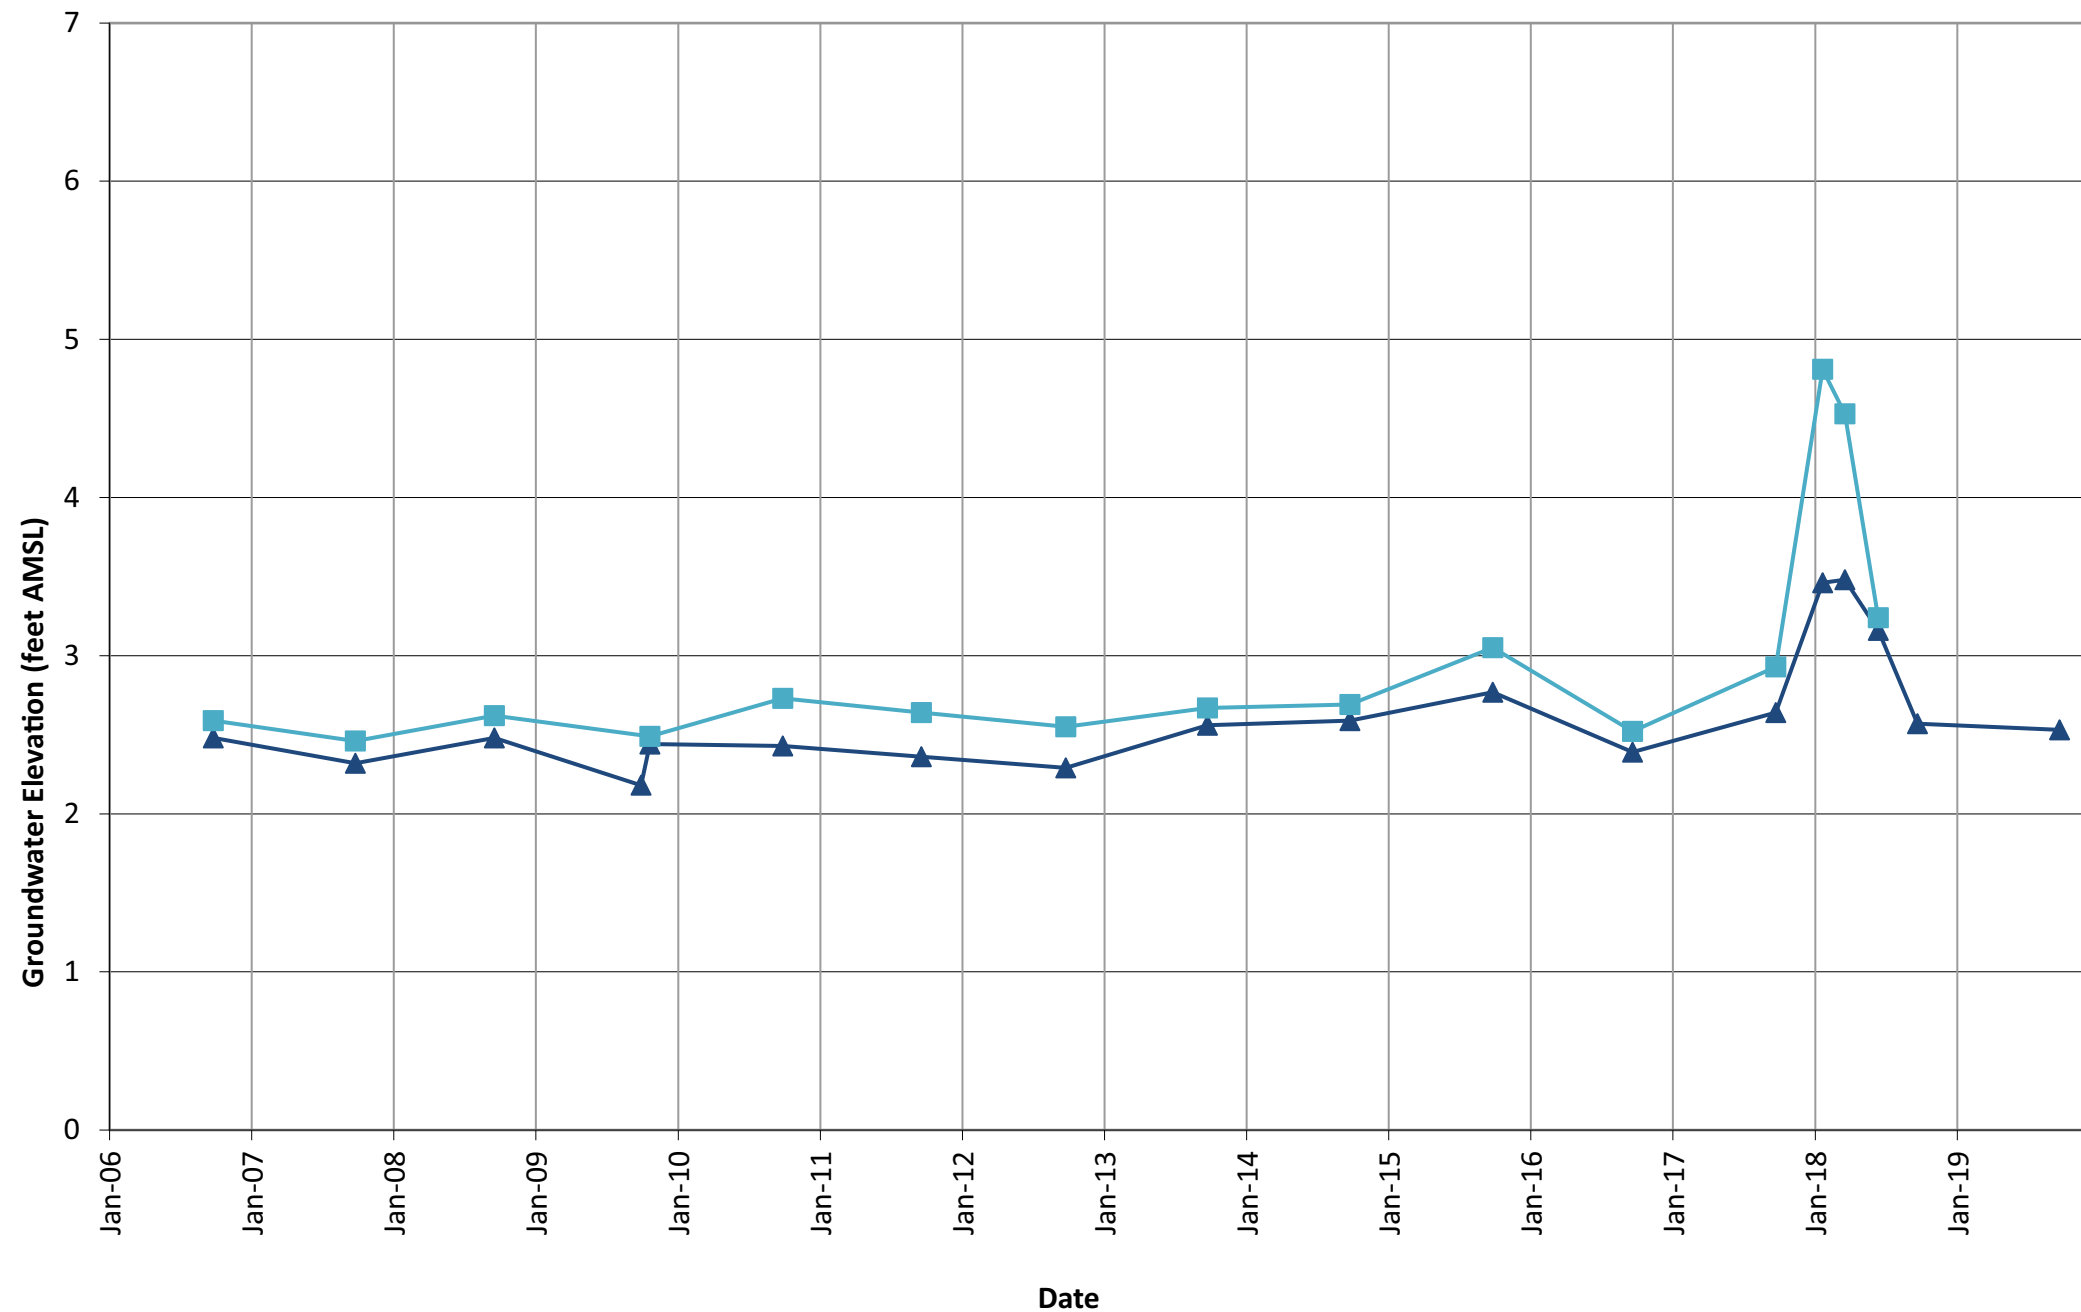
PROJ NO.	050654V001	DATE:	1/20	FIGURE:	5
----------	------------	-------	------	---------	---

1. "A" WELLS ARE LOCATED INSIDE THE BARRIER WALL (IN THE UPPER SAND AQUIFER);
2. "B" WELLS ARE LOCATED OUTSIDE THE BARRIER WALL (IN THE UPPER SAND AQUIFER).
3. PZ-3B WAS DRY DURING THE SEPTEMBER 2018 AND 2019 EVENTS.

**GROUNDWATER ELEVATION TRENDS
PZ-3A AND PZ-3B
FORMER MILL E / KOPPERS FACILITY
EVERETT, WASHINGTON**

In addition, it is recommended that an additional water level monitoring event be performed prior to the end of the wet season to measure groundwater elevations in the piezometer/well triplets PZ-3A, PZ-3B, and LLMW-20D due to observed dry conditions at piezometer PZ-3B. The results of this additional monitoring event will be included in the 2020 Annual Performance and Compliance Report.

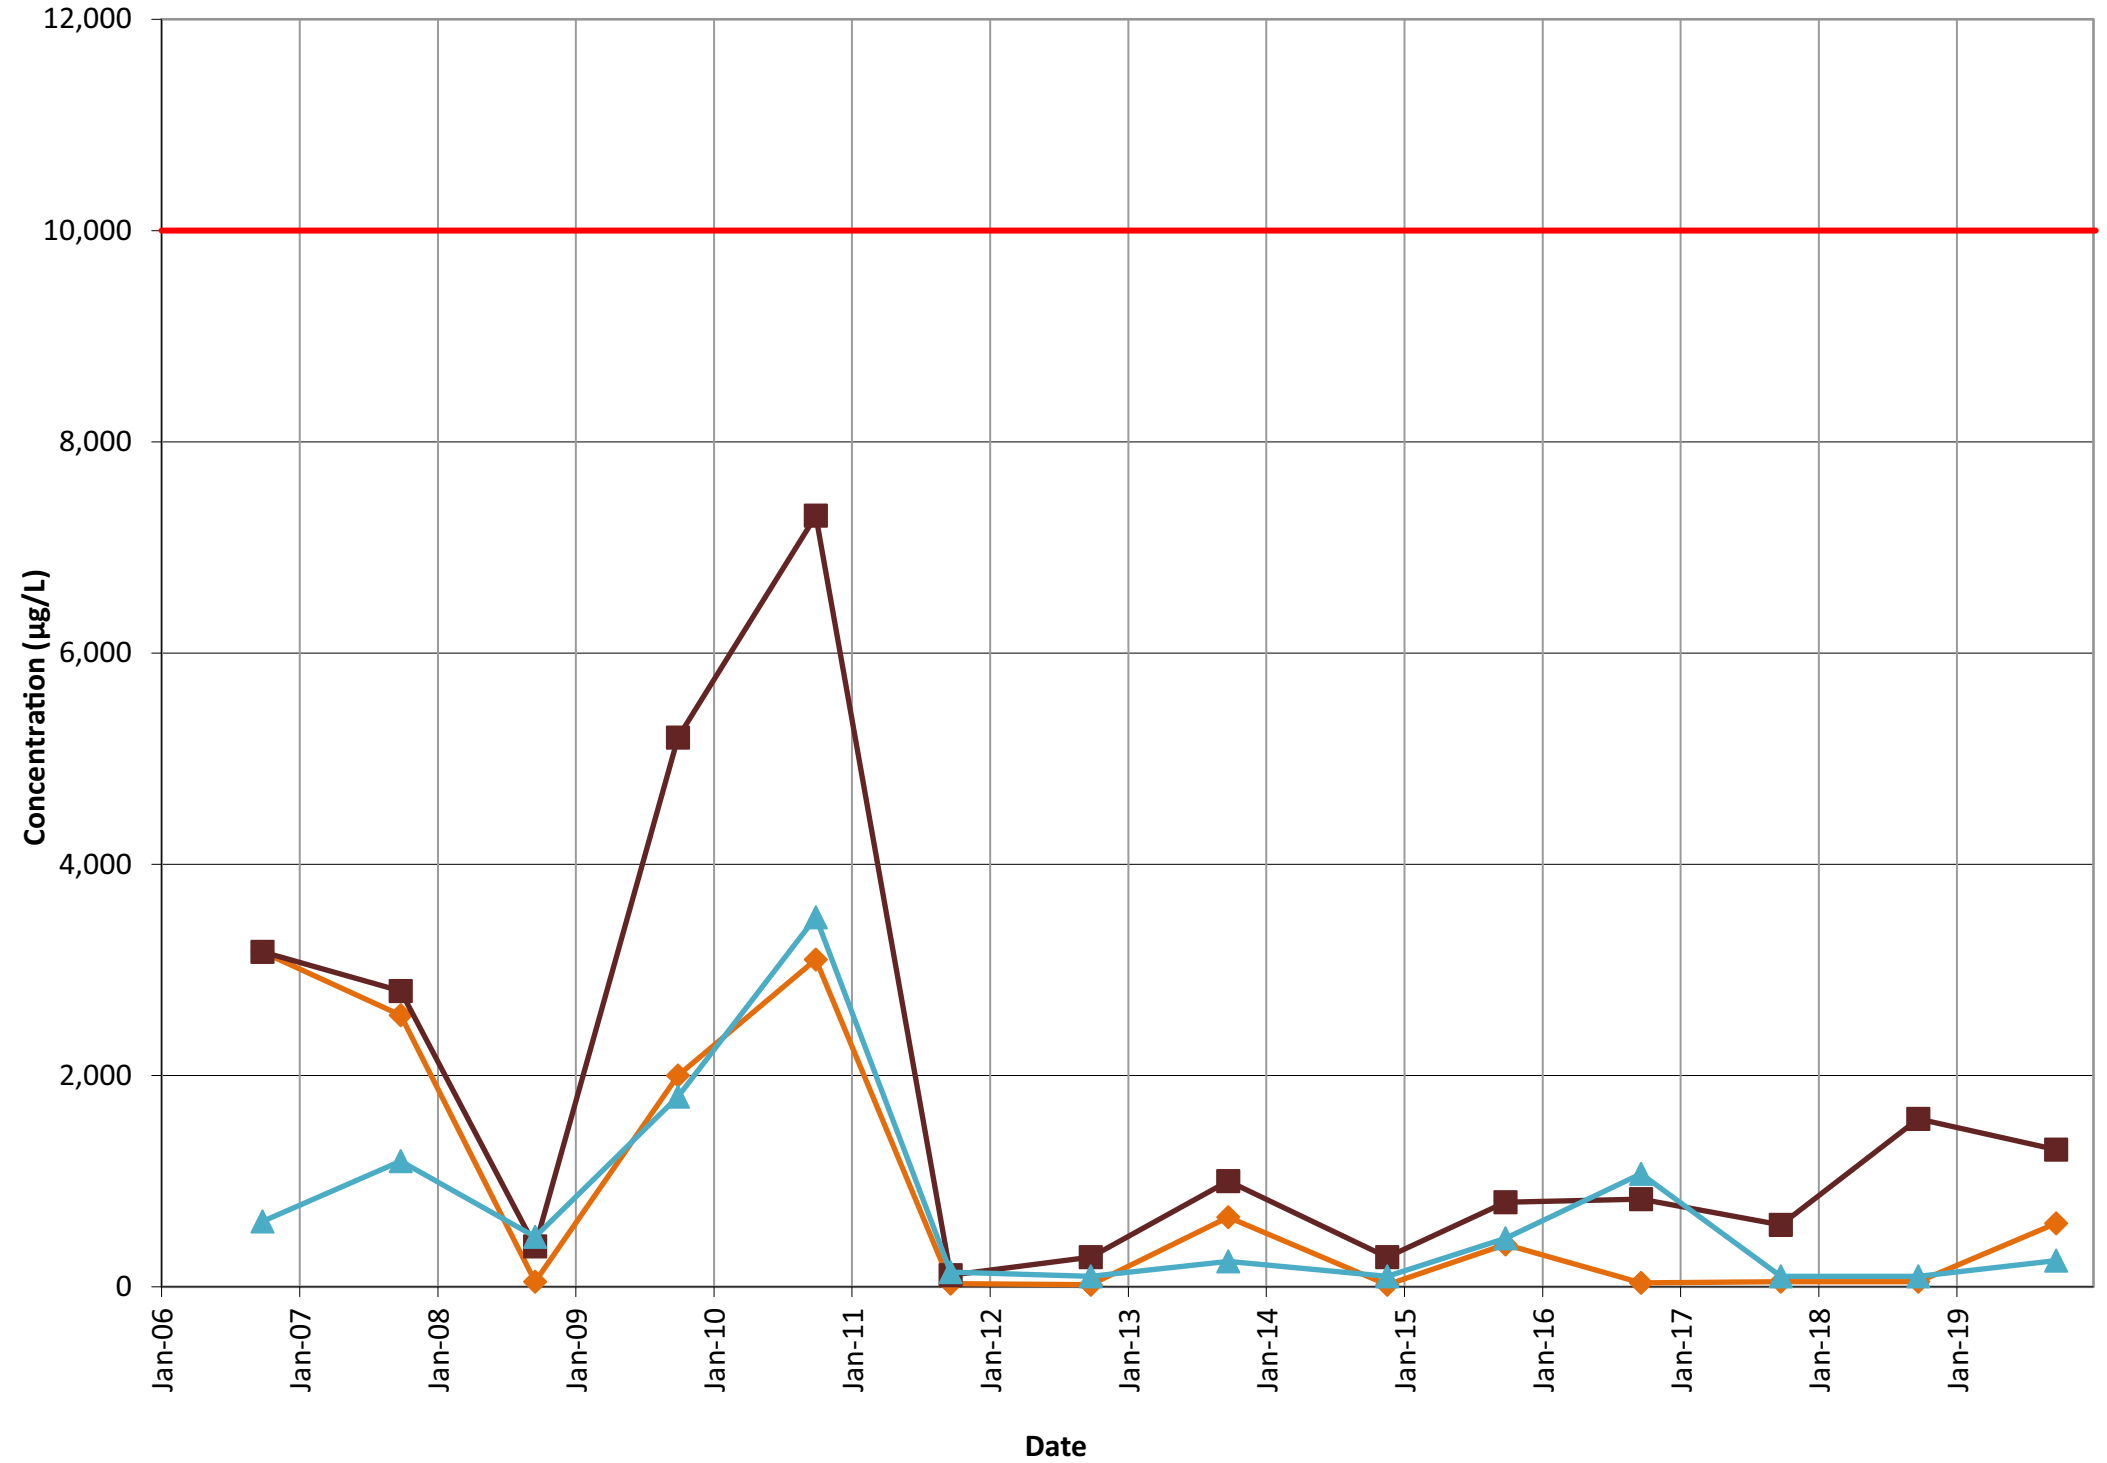
PROJ NO.	050654V001	DATE:	1/20	FIGURE:	6
----------	------------	-------	------	---------	---

Groundwater analytical results are presented in Table 4 and a copy of the analytical laboratory report and chain-of-custody is included as Attachment 1. The results are compared to the Washington State Model Toxics Control Act (MTCA) Method A and Method C cleanup levels that were established for the Site during the 1998 Consent Decree. GRPH and DRPH were detected at concentrations below the established MTCA cleanup level of 10,000 micrograms per Liter ($\mu\text{g/L}$). ORPH and PCP were not detected at concentrations exceeding their laboratory reporting limits. Total arsenic was detected at a concentration of 546 $\mu\text{g/L}$, which exceeds the established MTCA cleanup level of 5 $\mu\text{g/L}$ and is consistent with previous data. Groundwater quality concentration over time trends (time-concentration) graphs over the past several years for total petroleum hydrocarbons (TPH), PCP, and arsenic are presented on Figures 6 through 8, respectively.

Total Petroleum Hydrocarbon Concentrations

GROUNDWATER QUALITY TRENDS
TPH
FORMER MILL E / KOPPERS FACILITY
EVERETT, WASHINGTON

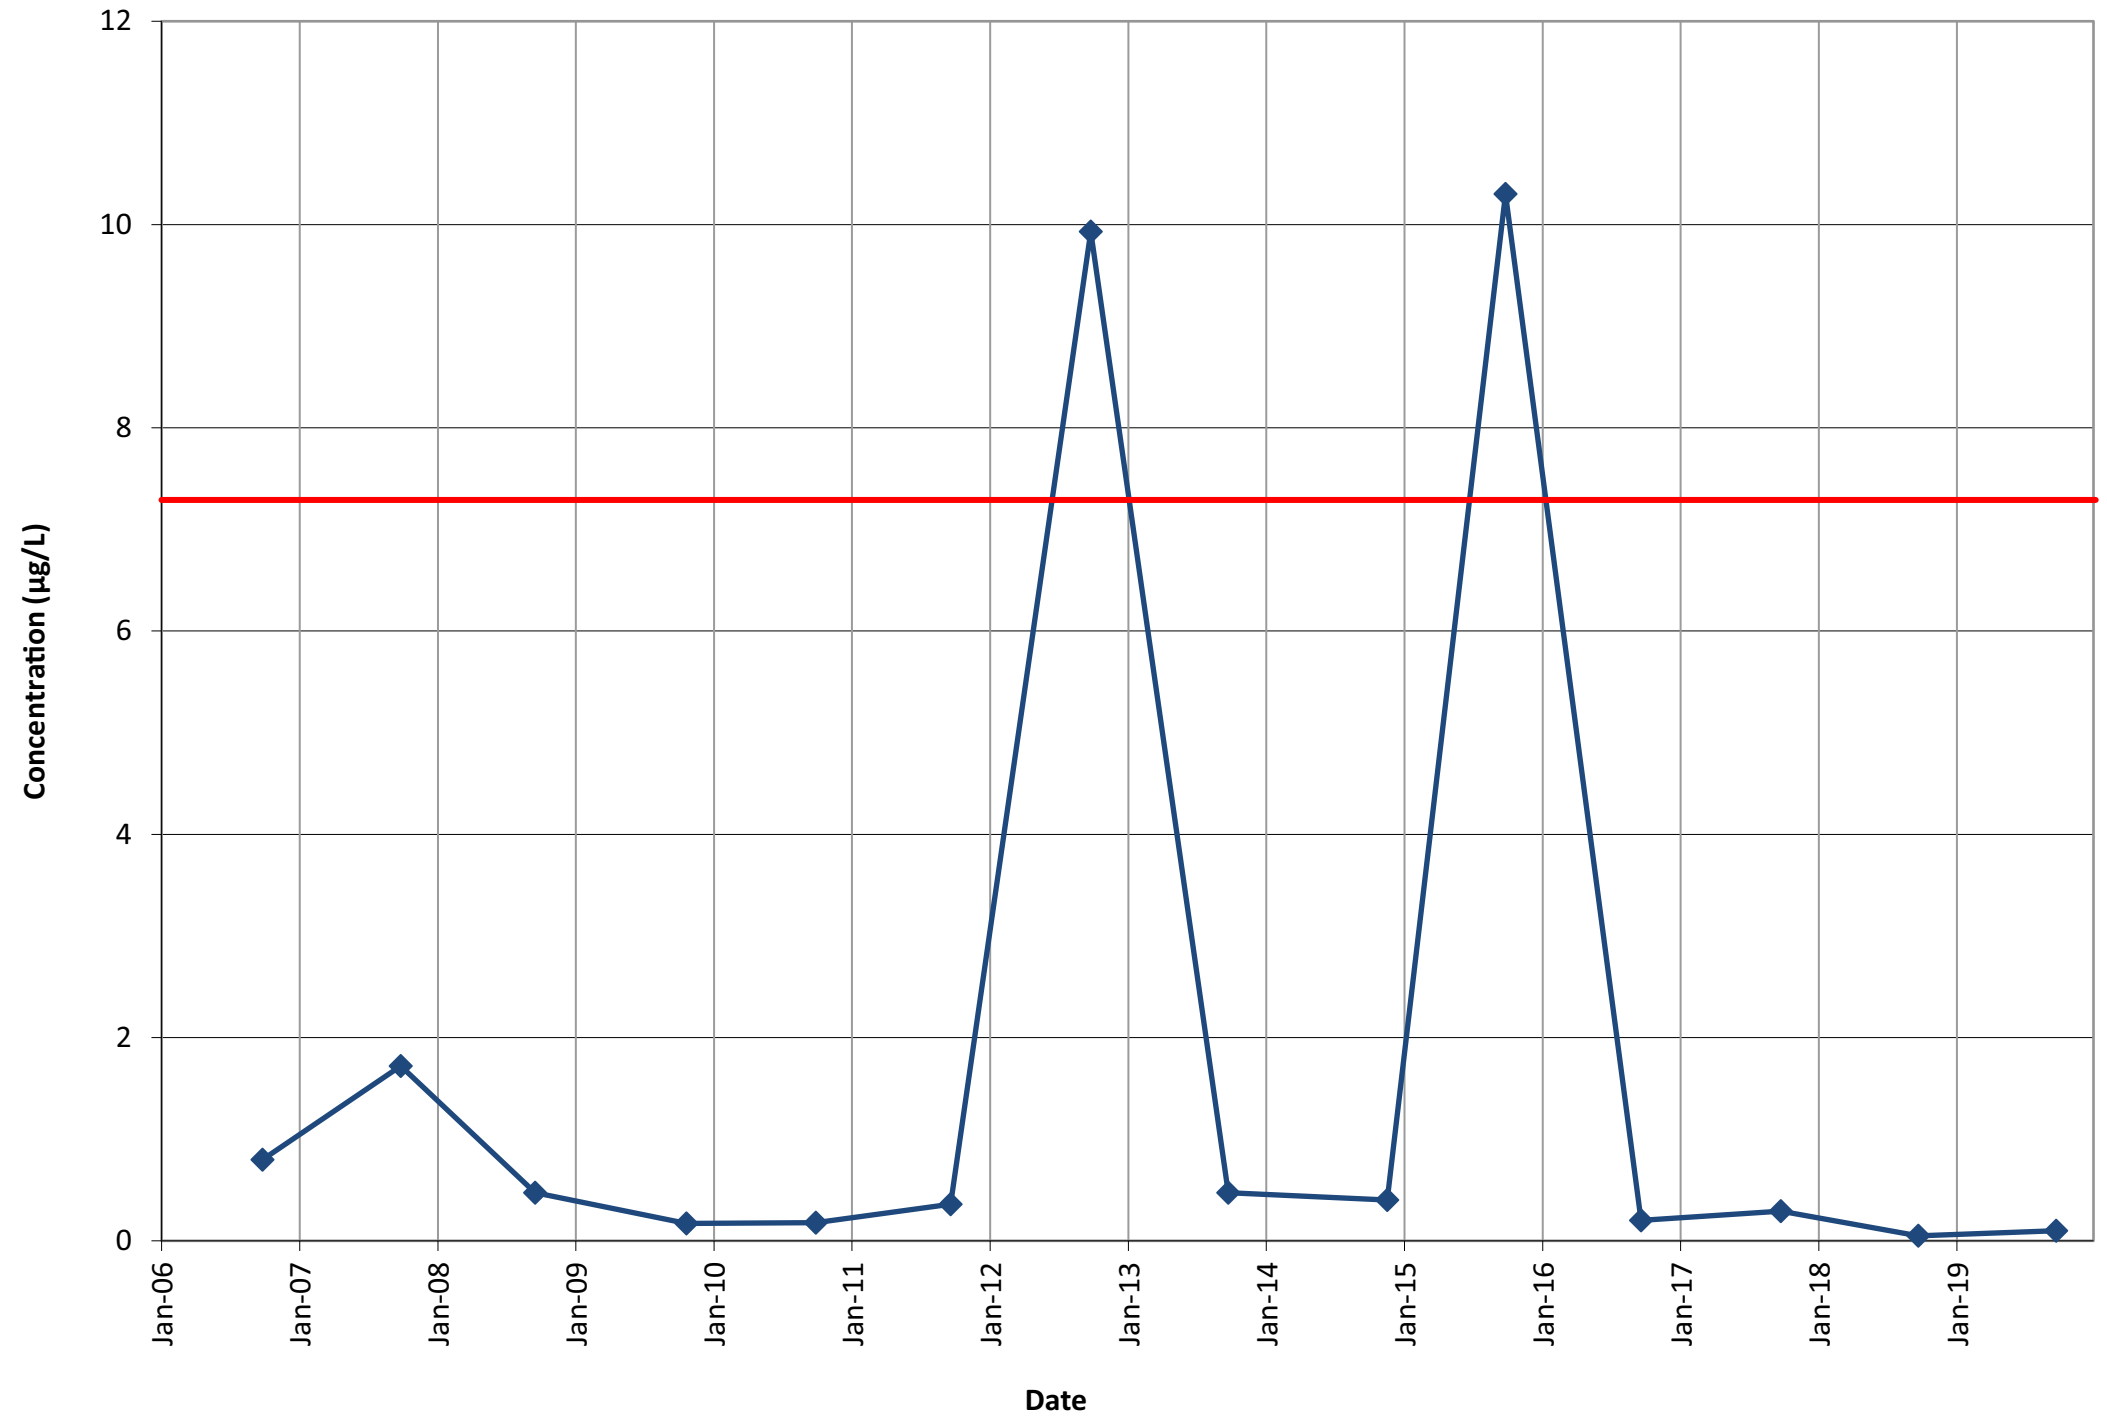
PROJ NO. 050654V001	DATE: 1/20	FIGURE: 7
---------------------	------------	-----------

Pentachlorophenol Concentrations

GROUNDWATER QUALITY TRENDS
PCP
 FORMER MILL E / KOPPERS FACILITY
 EVERETT, WASHINGTON

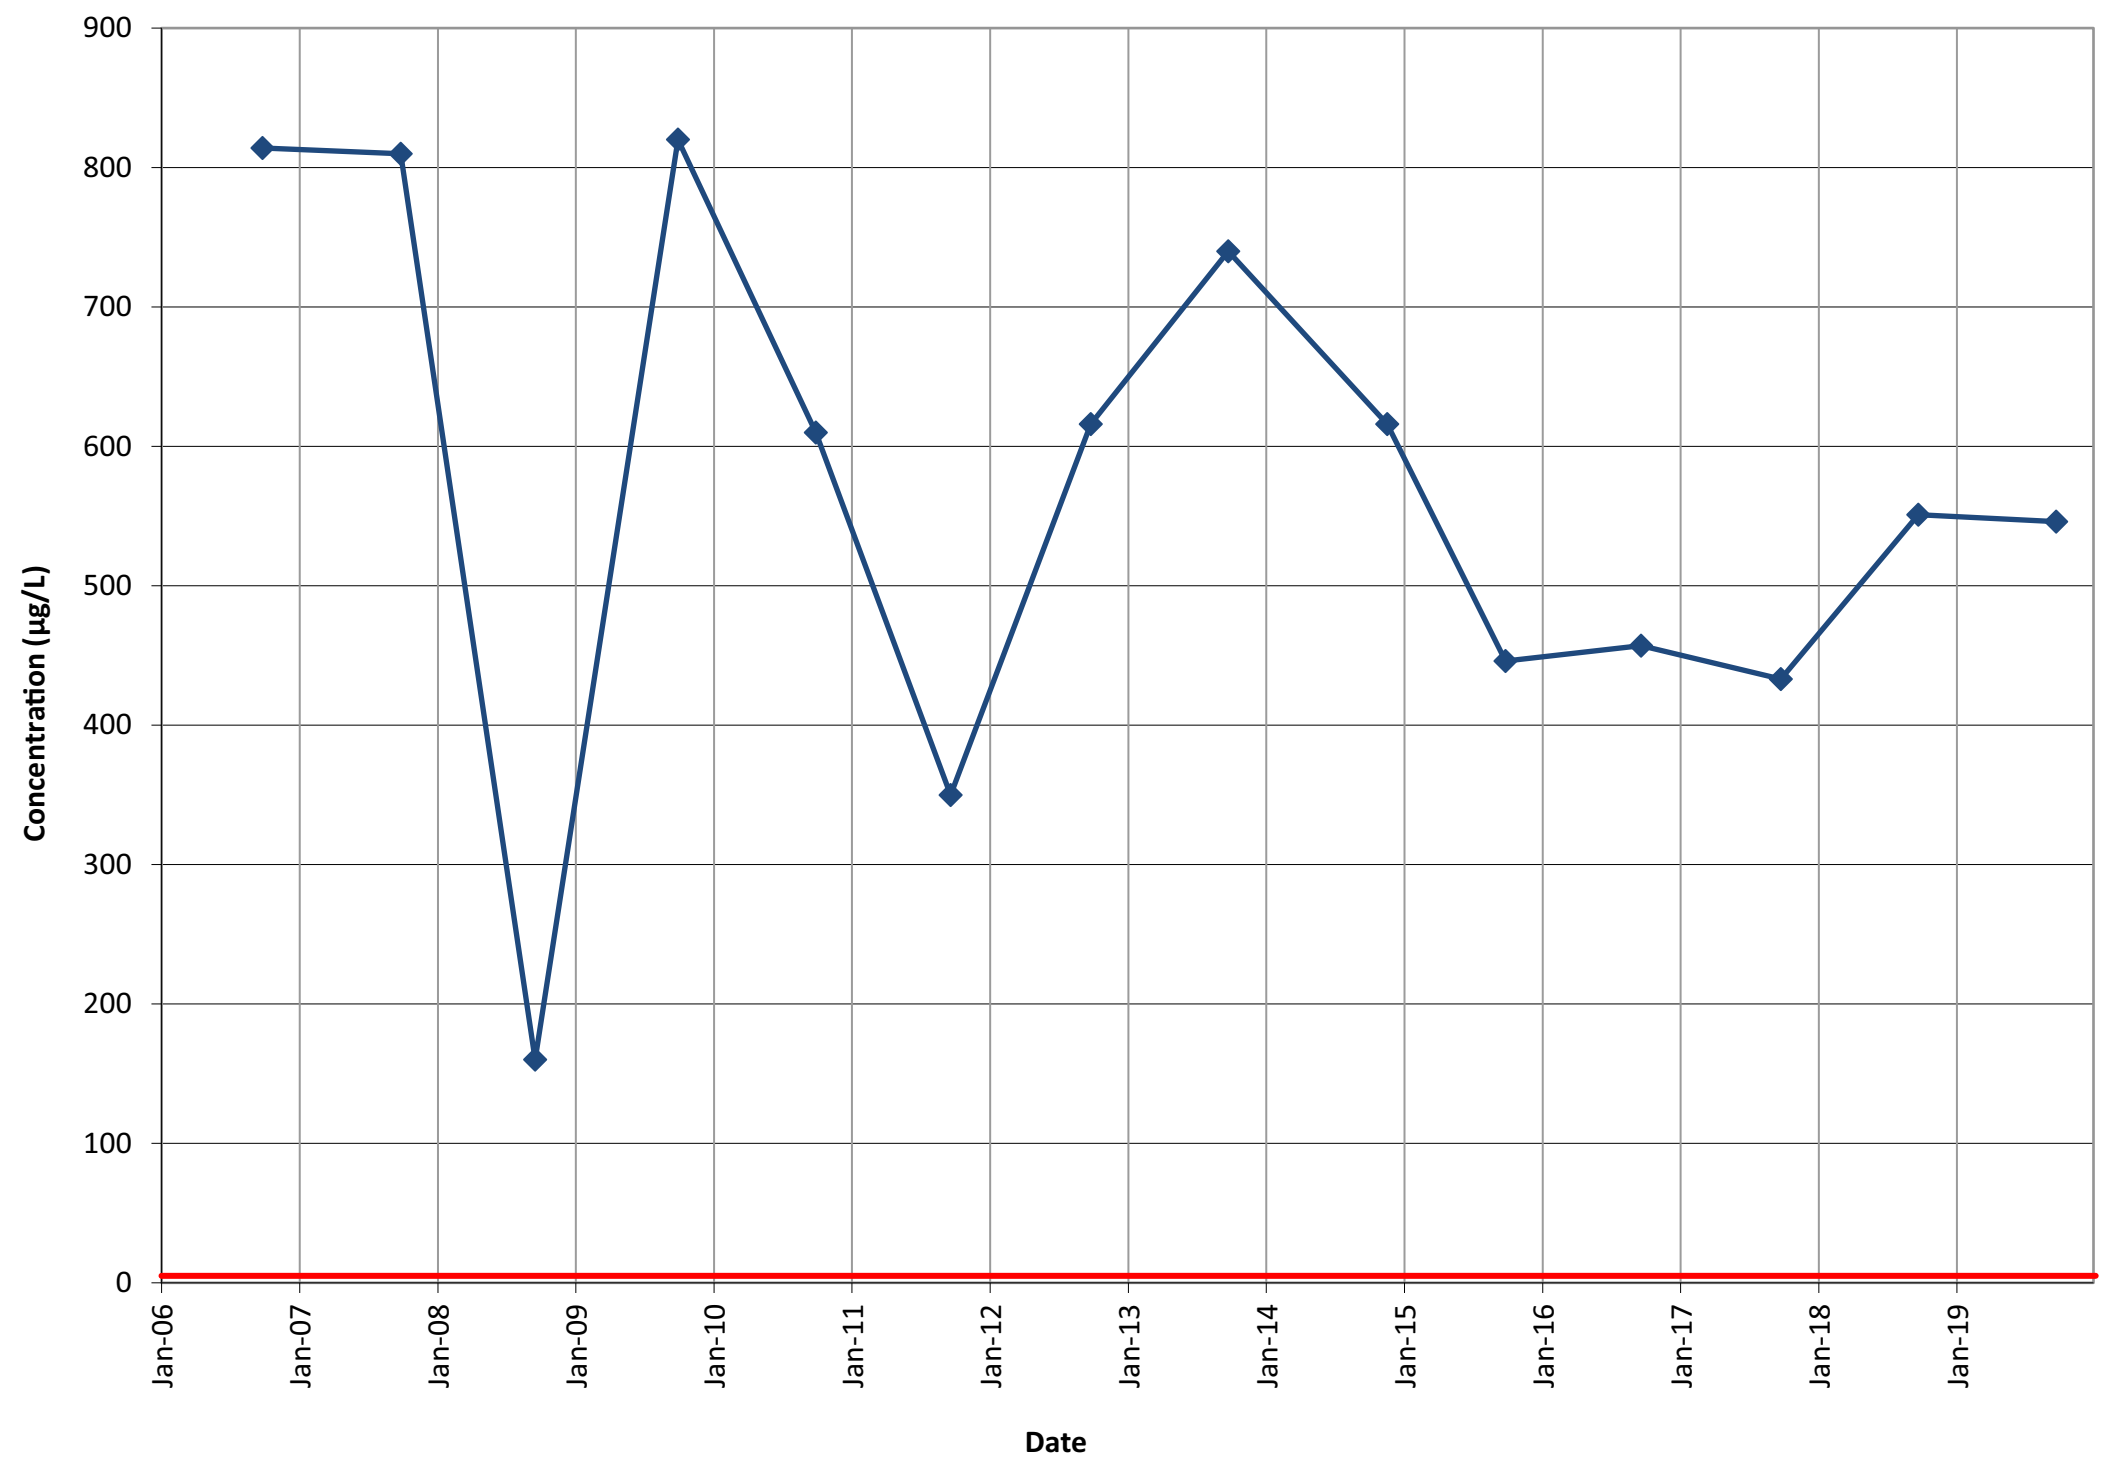
PROJ NO.	050654V001	DATE:	1/20	FIGURE:	8
----------	------------	-------	------	---------	---

Arsenic Concentrations

GROUNDWATER QUALITY TRENDS
ARSENIC
 FORMER MILL E / KOPPERS FACILITY
 EVERETT, WASHINGTON

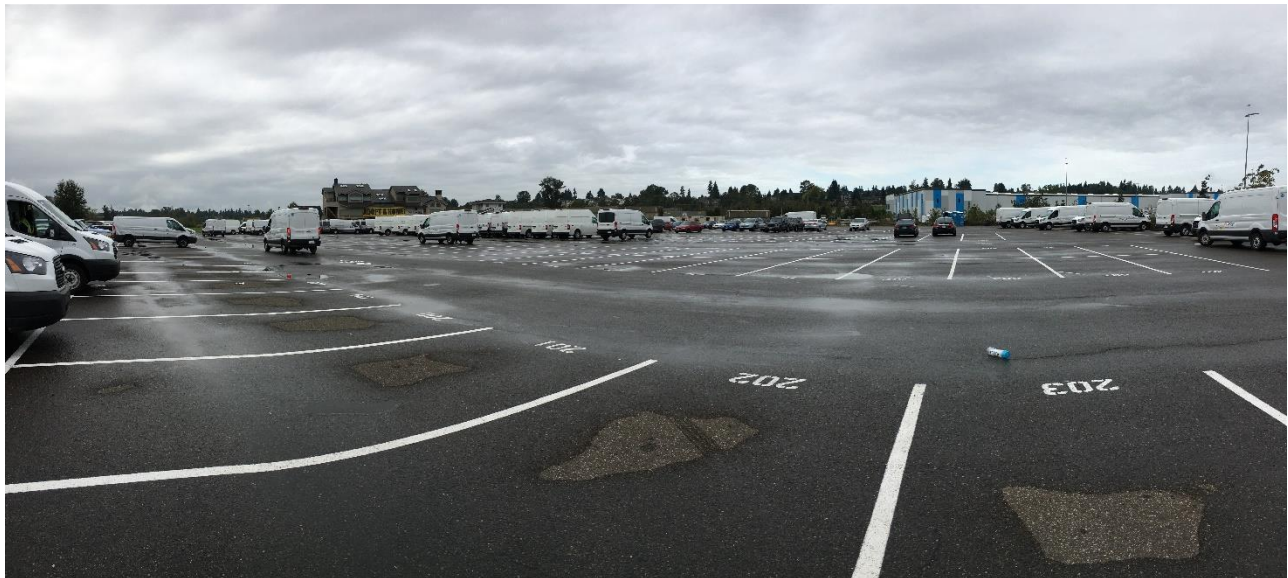
Where observed, the asphalt cap exhibited little evidence of deterioration and no signs of excessive settlement. Small shallow depressions in the cover were observed in some places. The asphalt cap is functioning as intended and meeting performance objectives. Photographs taken at the time of the Site visit are included in the attached field report.

Kellie M. Andrews with AESI was onsite to perform site observations. The property is currently occupied by an Amazon delivery service and several vehicles were parked at the time of our visit. White paint has been used to mark parking spaces on the site. Majority of the cap, approximately 90 to 95 percent was visible at the time of the site visit. The asphalt cap was observed to be in serviceable condition with no obvious signs of cracking, fissures, or pumping. There are areas where shallow depressions were observed, which were less than 2-inches in depth from recent rainfall. These shallow depressions were less than 10 feet in diameter. Drainage ditches had minimal accumulated sediment, less than 1-inch, and no major cracks or vegetation was observed in the drainage ditches.

Facing west-southwest from the northeast corner of the property, observing the asphalt cap.

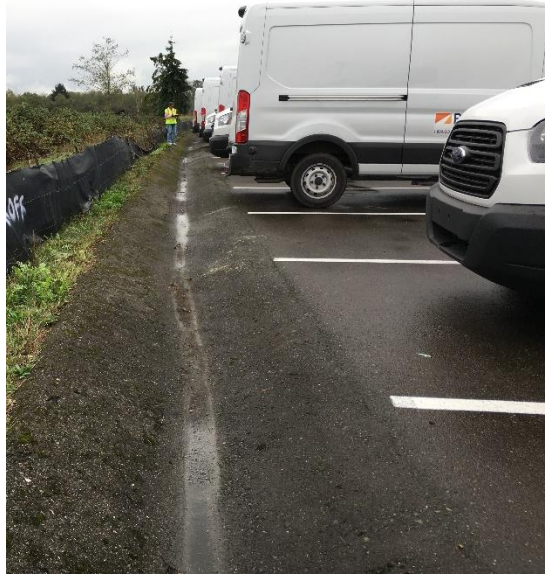
Facing south from the northwest portion of the property at one of the drainage ditches.

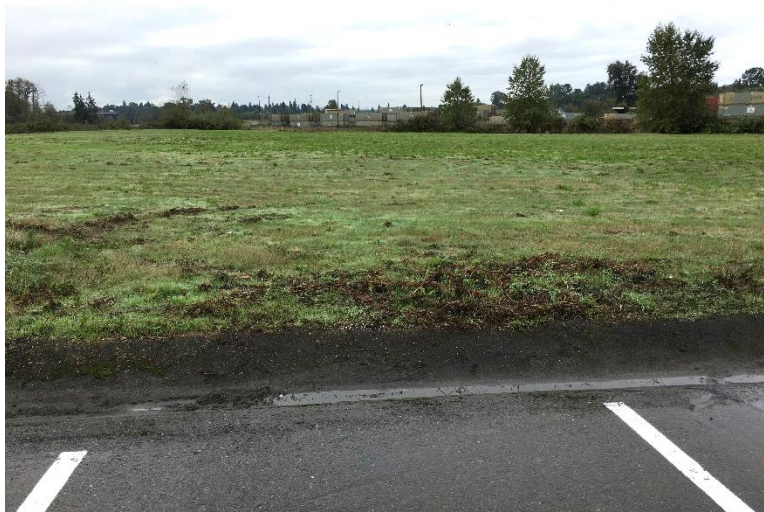
The soil cap to the south of the asphalt cap appeared intact and is performing as intended. No major ponding or erosion was observed. Photographs of general observations are provided below.

Facing south-southwest from the southern portion of the asphalt cap at the soil cover and the southern drainage ditch.
