# Focused Subsurface Investigation Report

**Acrowood Corp**  
Site Address: 4425 S 3<sup>rd</sup> Avenue  
Everett, Washington 98203

February 6, 2020

ECI Project No.: 0377-07

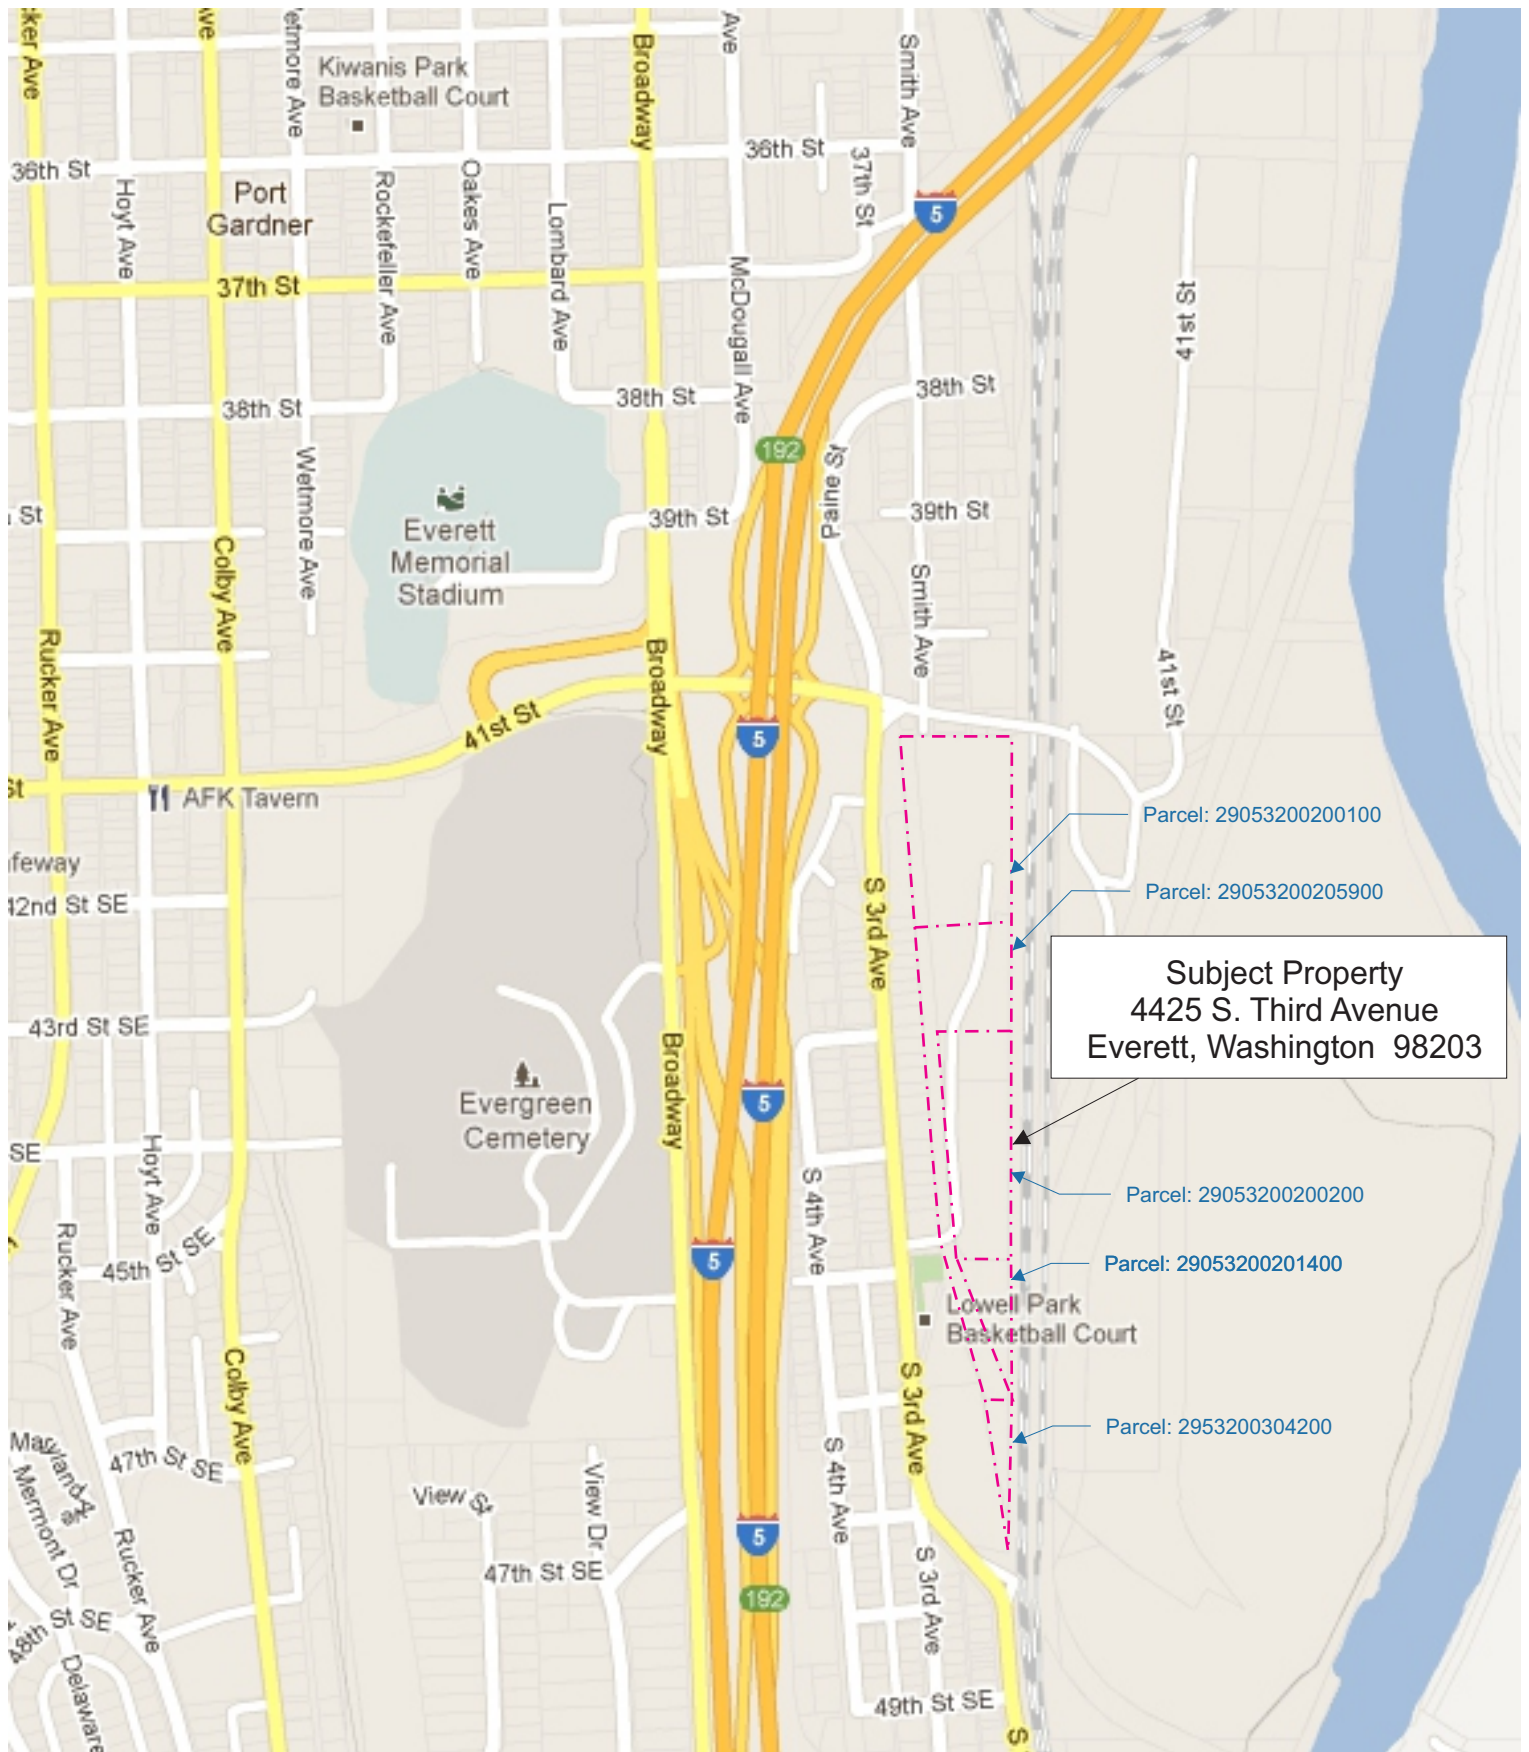
Figure No.:  
**04**  
Sheet 04 of 07

Foundry Derived Fill

The total area of cPAH impact remains undefined, but the total area of WFS has been partially delineated during this FSI. Based on the boring logs and observations made by ECI personnel on site, the WFS appears to extend between the north of the parking lot to the edge of the wooded area, and extends west toward the road, and east down the slope adjacent to the parking lot. WFS was not observed in any of the test pits excavated in the wooded areas of the Property. Boring B5 was the western-most advanced boring and did not exhibit any sand containing characteristics typical of the WFS observed elsewhere at the Site (Figure 3, Appendix A). Figures 4 and 5, Appendix A present cross-sections through the area of the fill.
