Subject: Carnation Dairies Spokane Garage Historical UST Release
444 West Cataldo Avenue
Spokane, Washington
File No. 0110-148-16

This letter summarizes current and historical conditions related to a leaking underground storage tank (LUST) at the Carnation Dairies of Spokane Site located at 444 West Cataldo Avenue in Spokane, Washington (herein referred to as the “site”) as depicted in Vicinity Map, Figure 1. Key site features are depicted in Site Plan, Figure 2. For the purposes of this report, the site is identified as tax parcel 35181.4206.

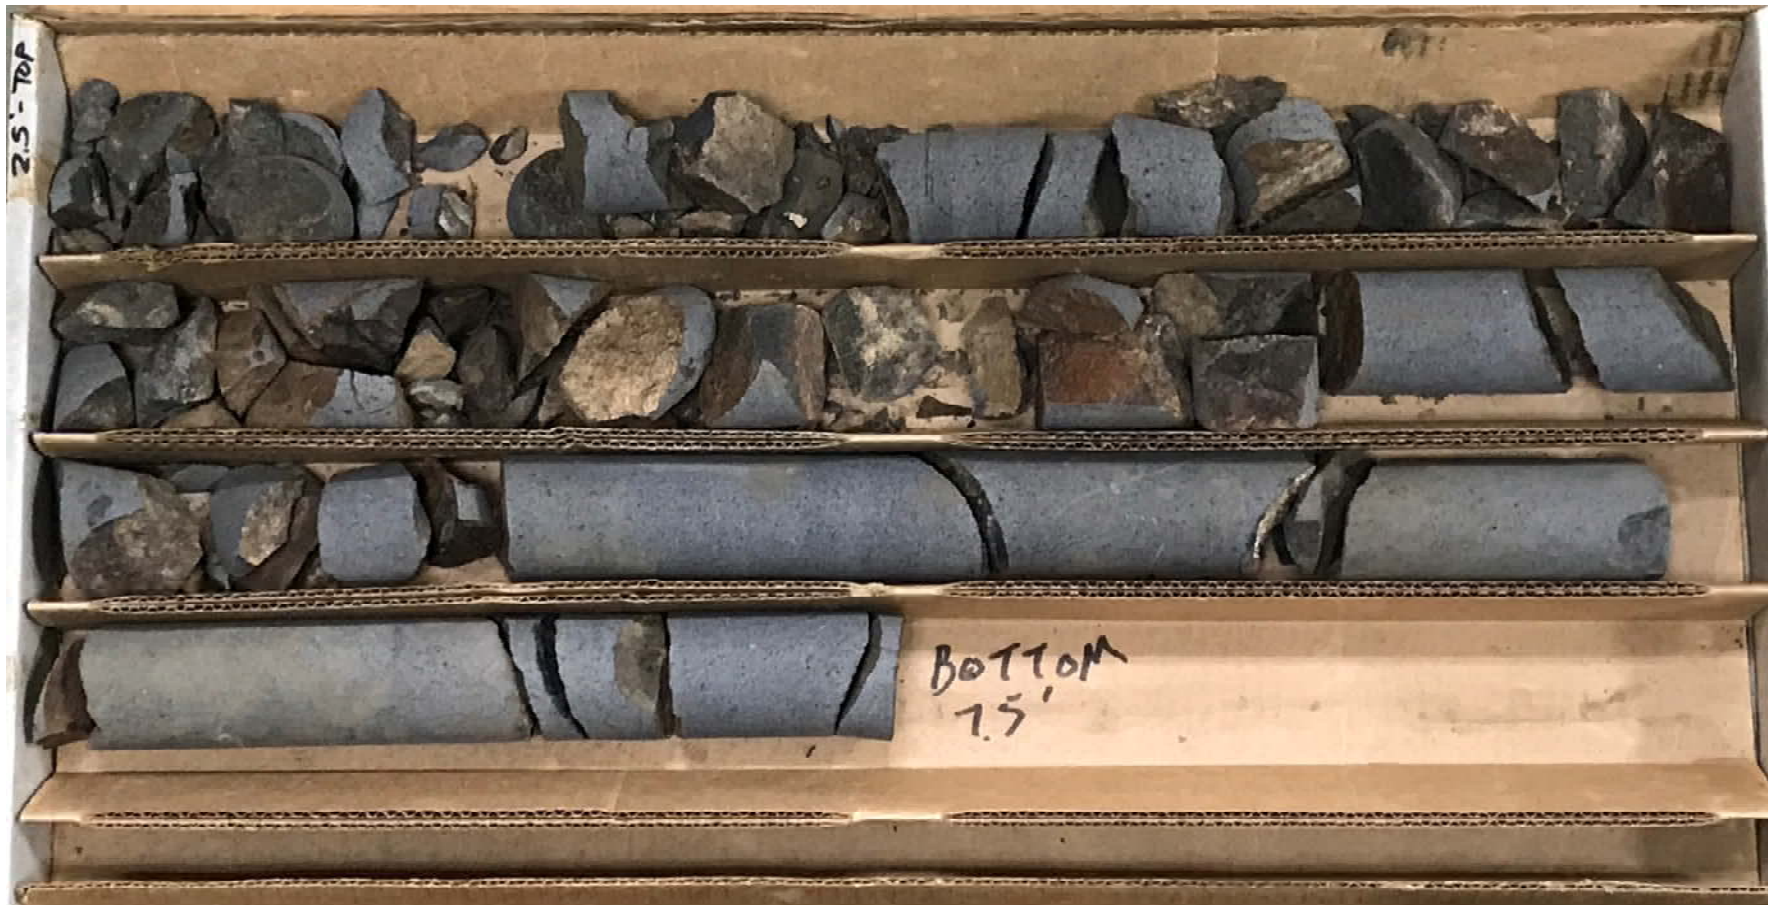
Figure A-19

Rock Core, B-11 from 2½- to 7½-Foot Depth	
Spokane Sportsplex Facility Spokane, Washington	
GEOENGINEERS
