Construction Soil Management Plan Lake Chelan Community Hospital

Lake Chelan Community Hospital
503 East Highland Avenue
Chelan, Washington 98816

File No. 18155-001-03

September 5, 2019

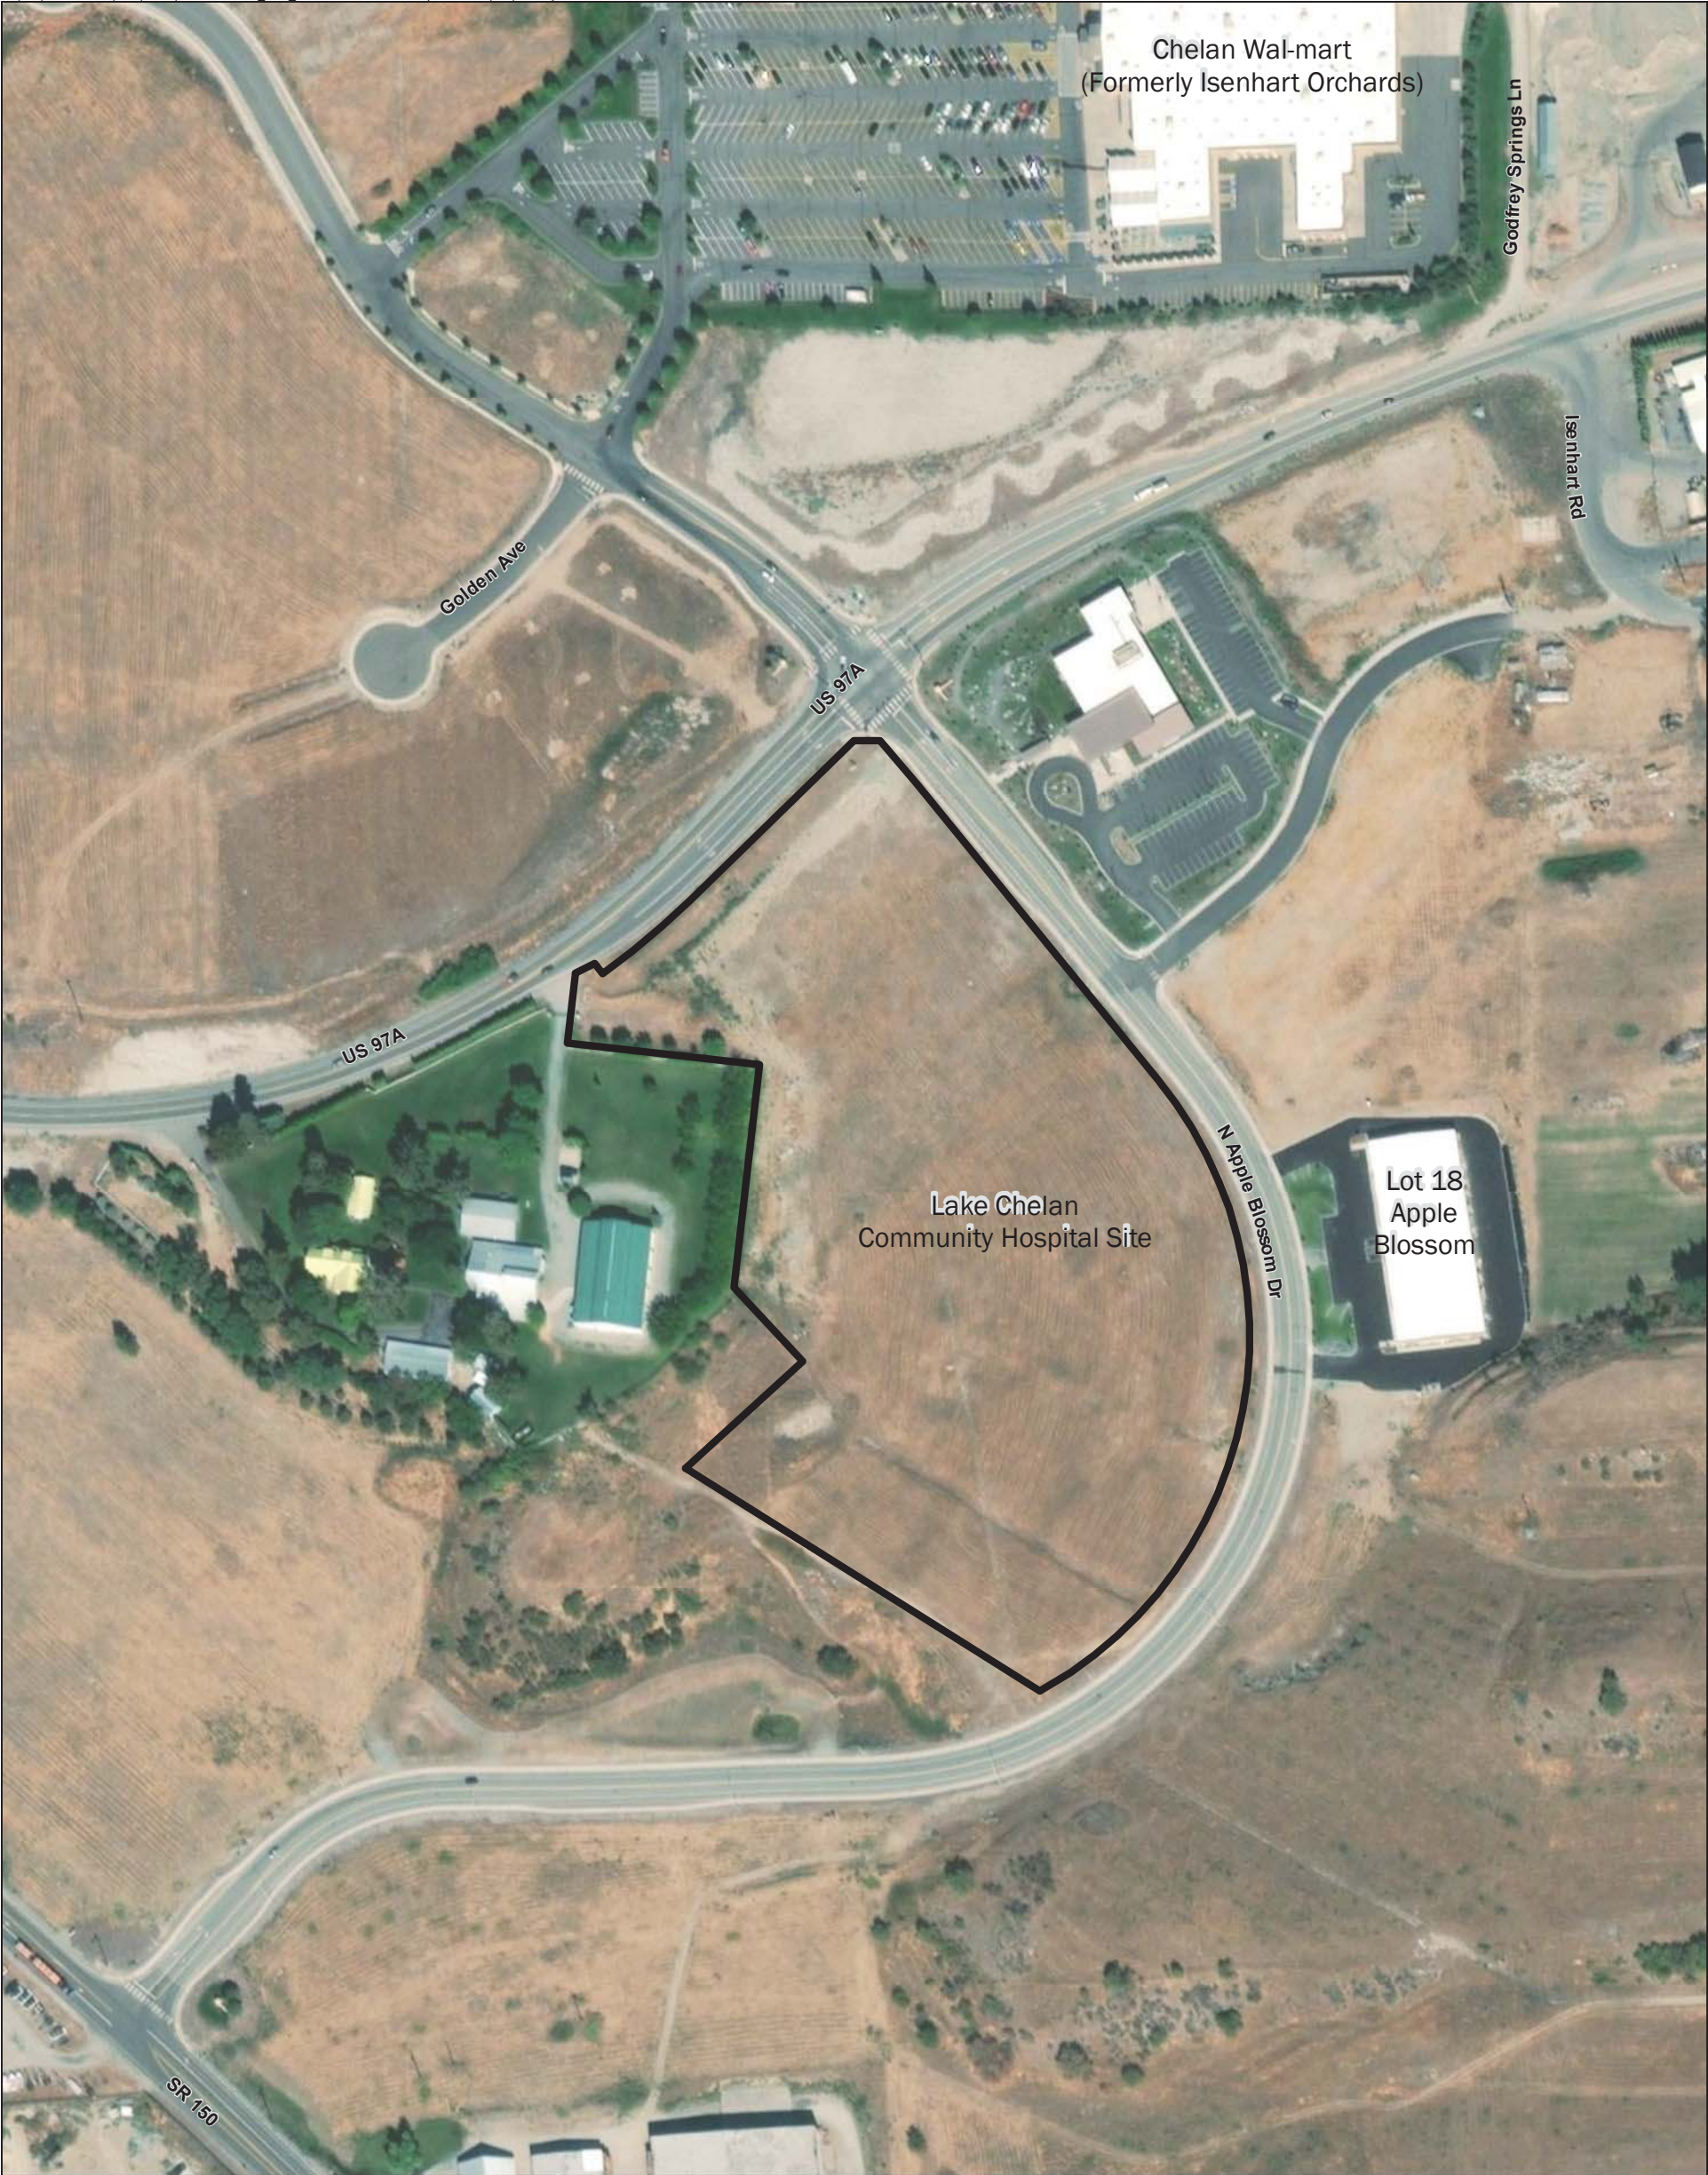
| | Figure 2 |

| Site Plan | |

The Site is located at Apple Blossom Drive, Lots 20 through 26 and the adjacent Open Space Tract in Chelan, Washington. The property is currently undeveloped but was previously an apple orchard. The property location is generally shown relative to surrounding features in the Vicinity Map, Figure 1. The site layout is shown in the Site Plan, Figure 2.
