August 10, 2016

**SUBJECT: SECOND QUARTER 2016 GROUNDWATER COMPLIANCE MONITORING REPORT  
Former Olympia Dry Cleaners Site  
601 Union Avenue SE  
Olympia, Washington**

**Quarterly Groundwater  
Compliance Monitoring  
Former Olympia  
Dry Cleaners Site  
Olympia, Washington**

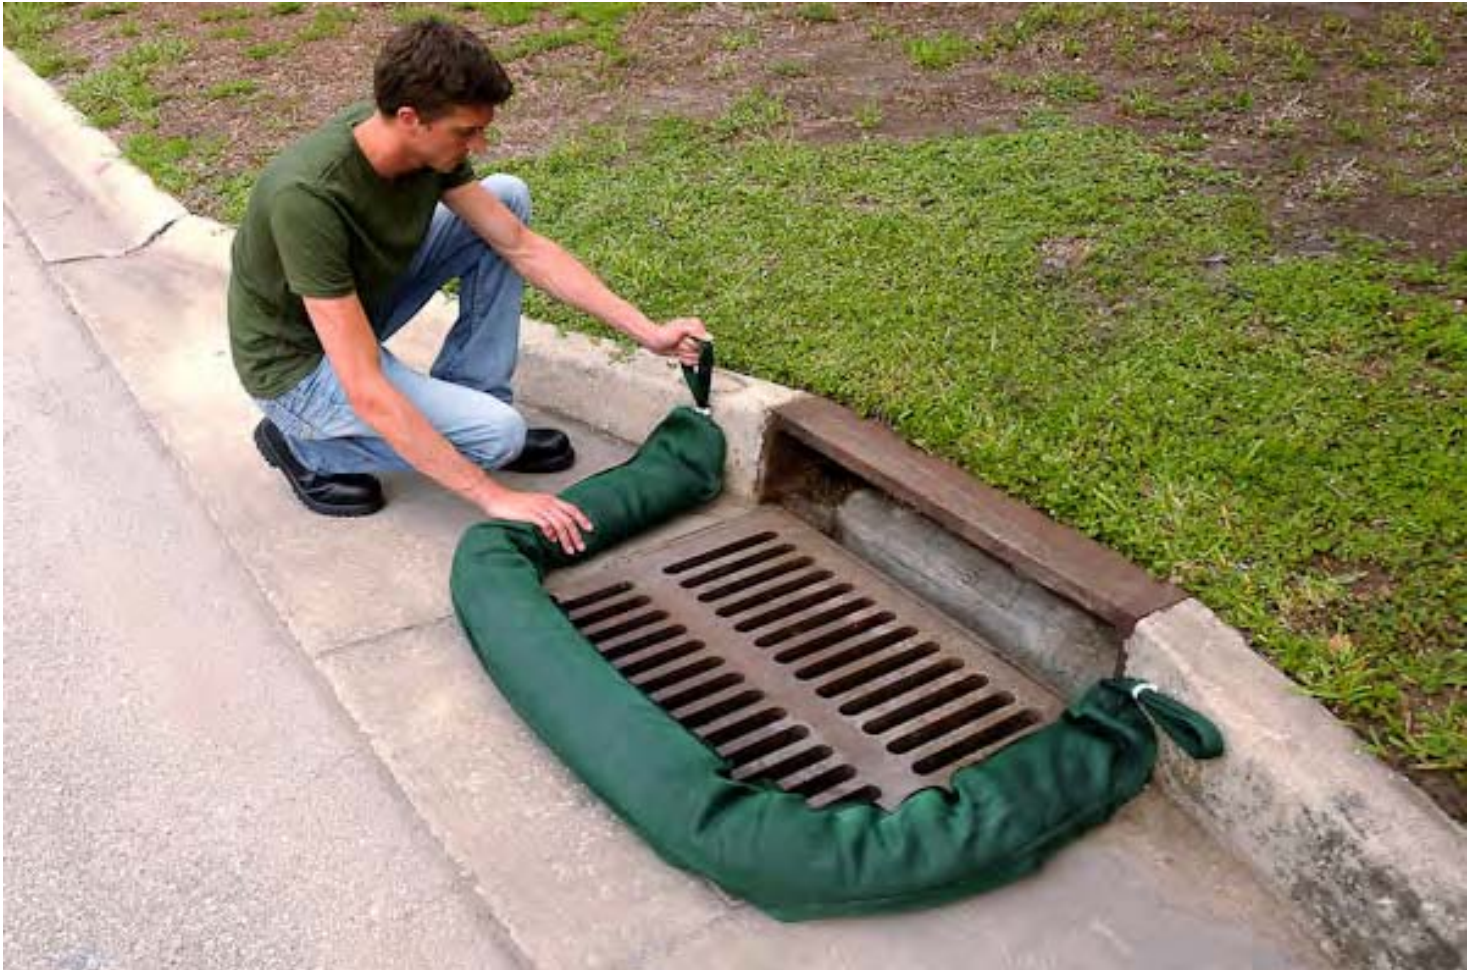
# Part#: 37BFS3

made of a heavy duty geotextile fabric sock that contains activated carbon. The specification for the filter sock is included as Attachment 3. It is 9 feet long and would be tied down tight (using bolts) in the gutter in front of the seep and immediately downslope. A small berm would be placed on the up-hill side so stormwater is diverted around the sock. A City right-of-way Obstruction Permit will be required for the installation of a filter sock. The City will require that the filter sock be bolted to the curb and routinely checked to make sure it doesn't become detached from the curb, that it is immediately replaced if it gets damaged, and that, if possible, it is removed within 6 months of the date of permit issuance and bolt holes filled. This option was verbally discussed with Ecology on July 27, 2016. The application for the right-of-way Obstruction Permit was submitted for preliminary review on August 9, 2016. The sock will be installed within 1 week of permit issuance.

Part #	Description
37BFS3	9453 ACTIVATED CARBON FILTER SOCK FOR STORMWATER 108" X 7" X 4"
