**Former Olympia
Dry Cleaners Site**

Remedial Action Completion Report

November 2015

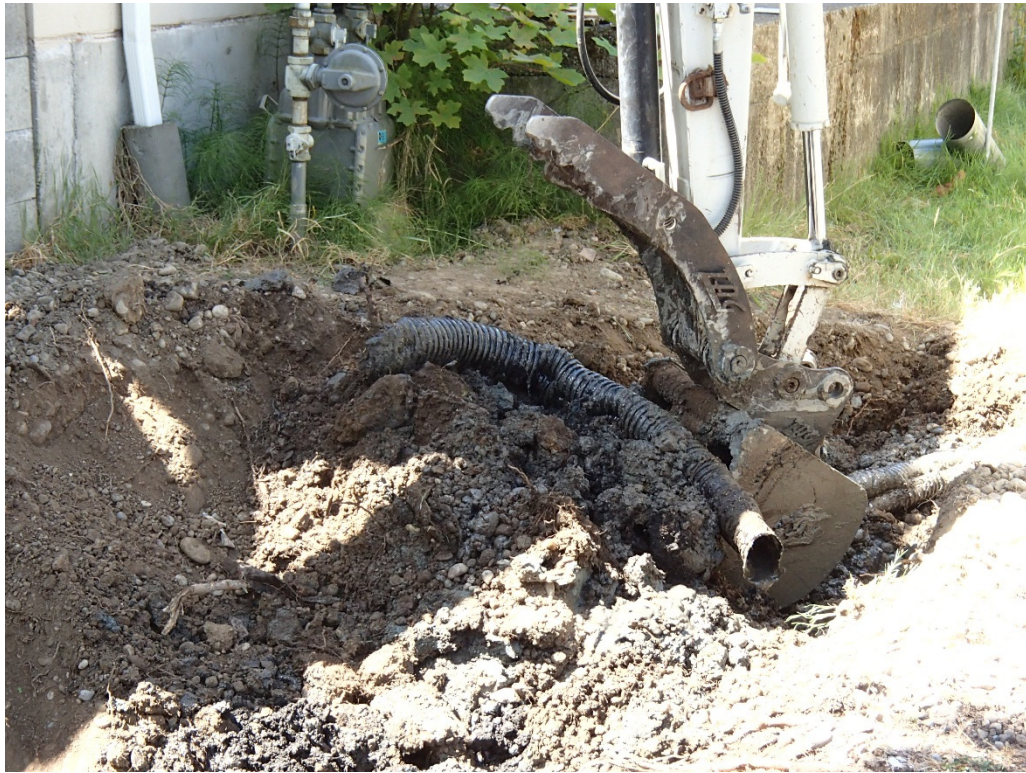
Photograph 1. Corrugated Drain Pipe in Secondary Excavation Area

During excavation, a 4-inch-diameter corrugated drain line was encountered at approximately 1.5 feet bgs. When the segment of drain pipe within the secondary excavation area was removed, it was found to be full of standing water, which was released to the excavation upon breakage.

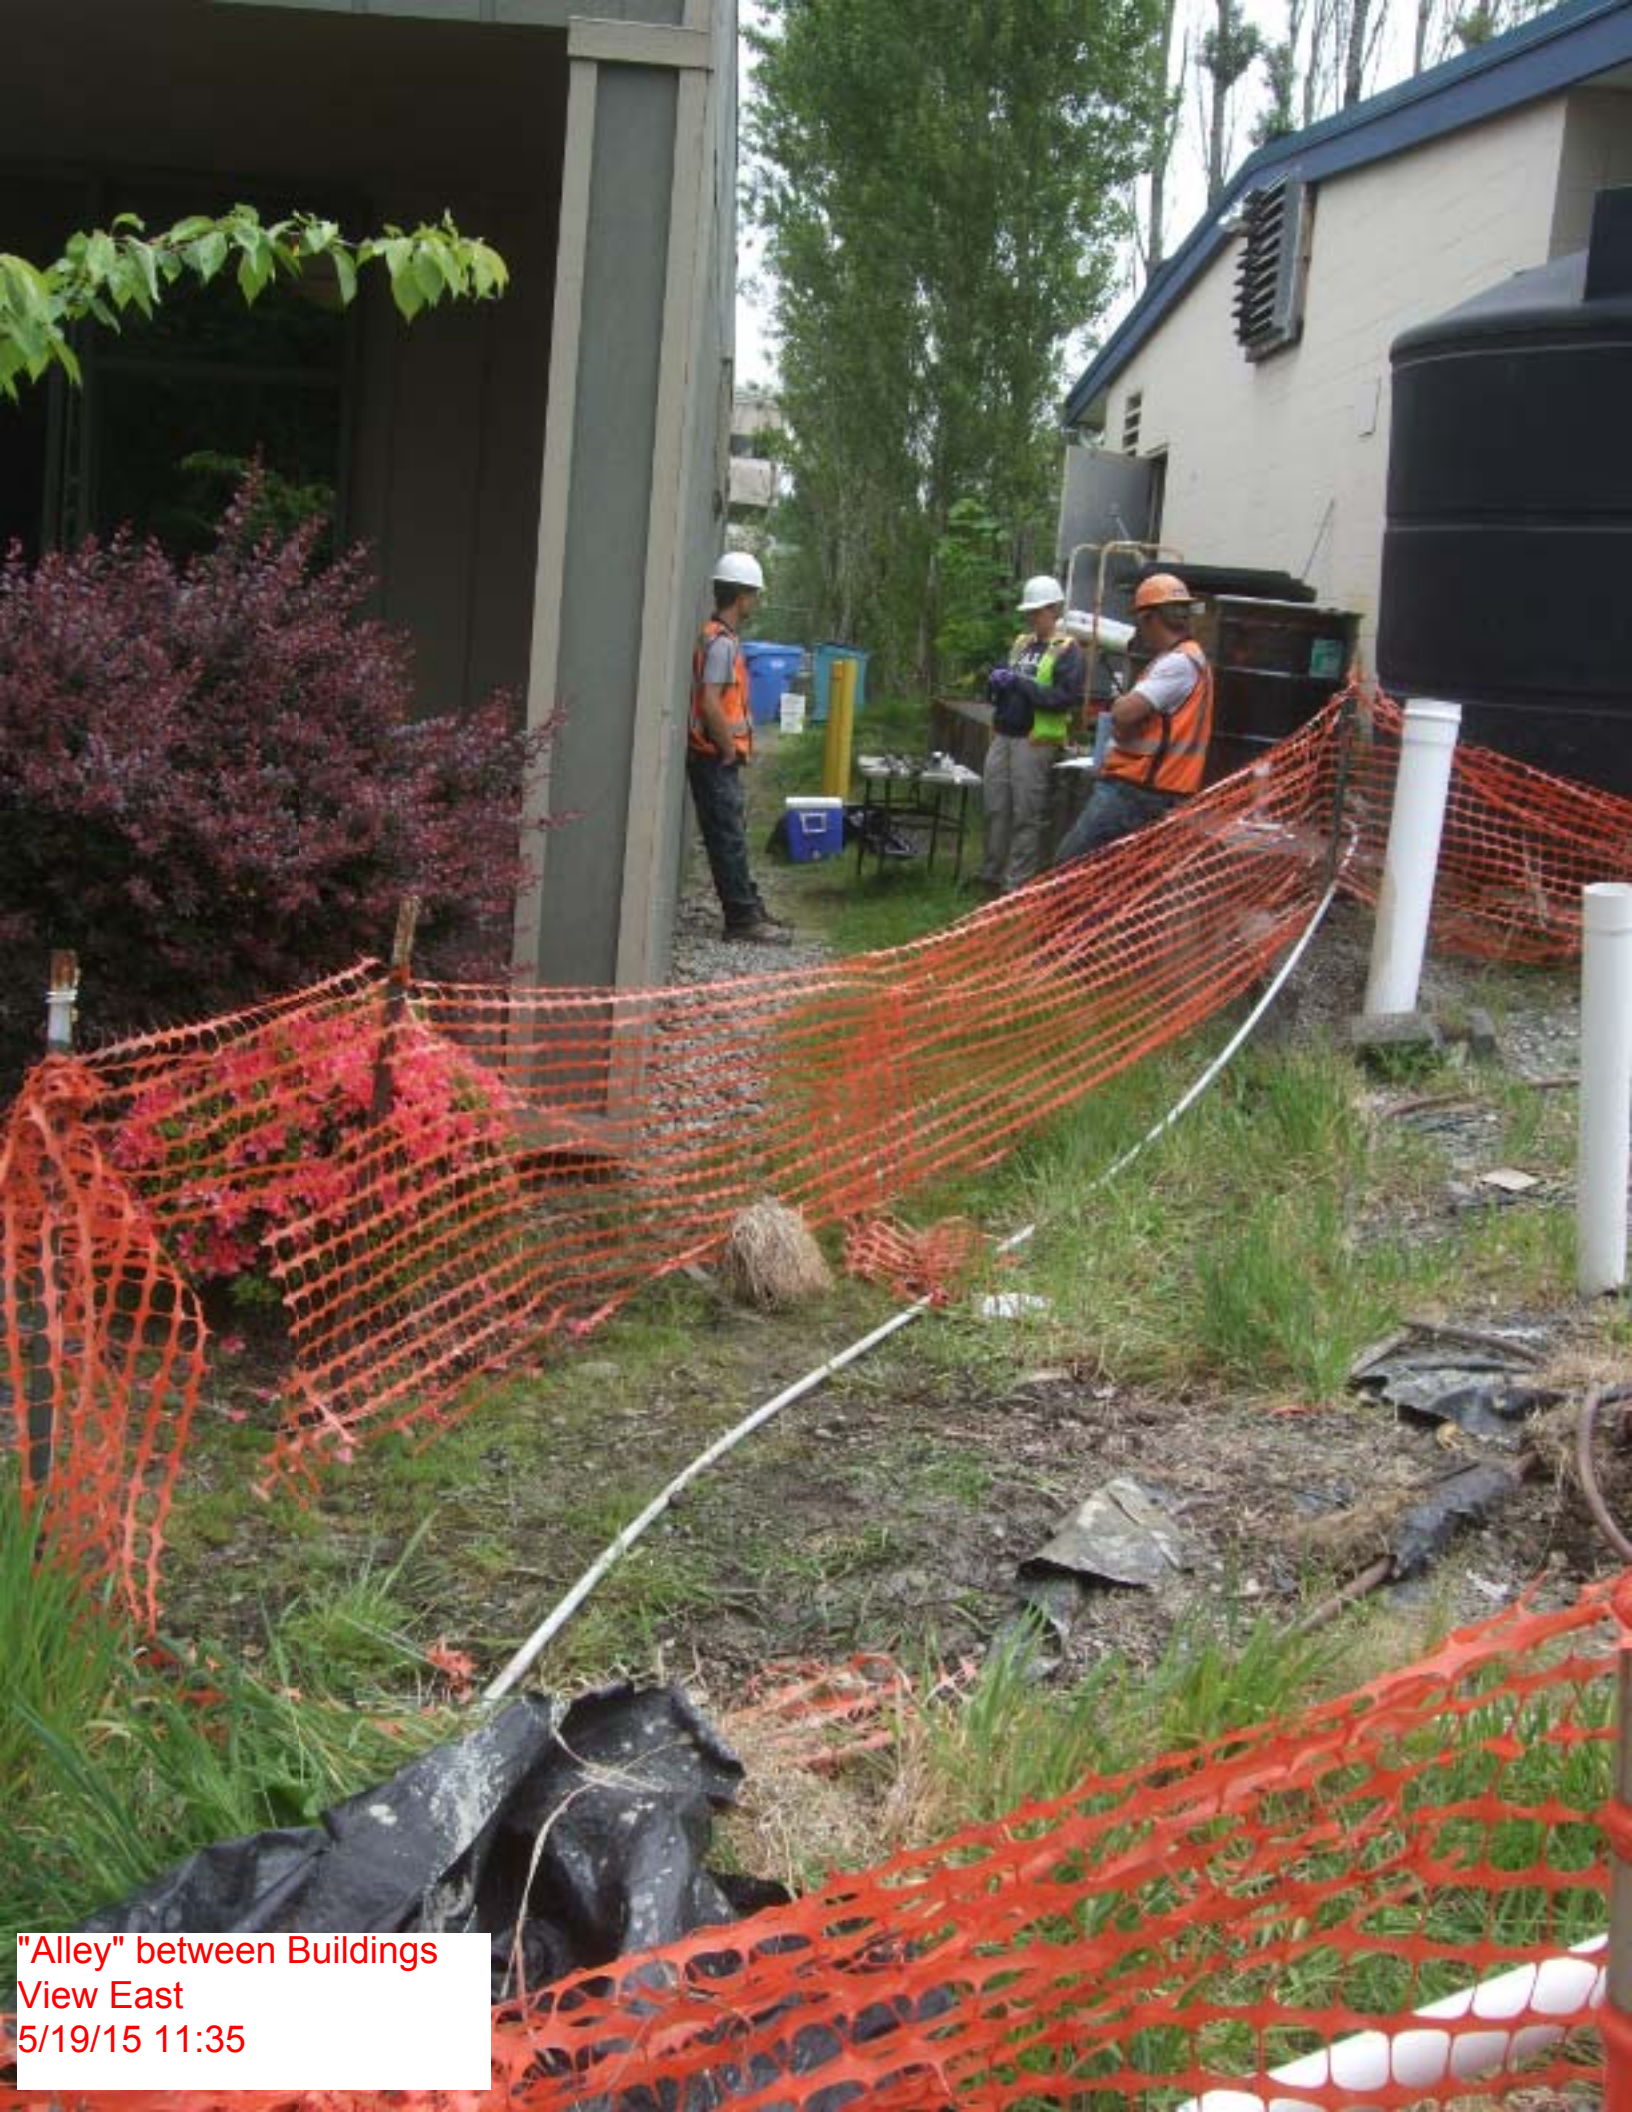
"Alley" between Buildings
View East
5/19/15 11:35

Clean Gravel backfill
underlying much of the site
from a previous environmental
cleanup

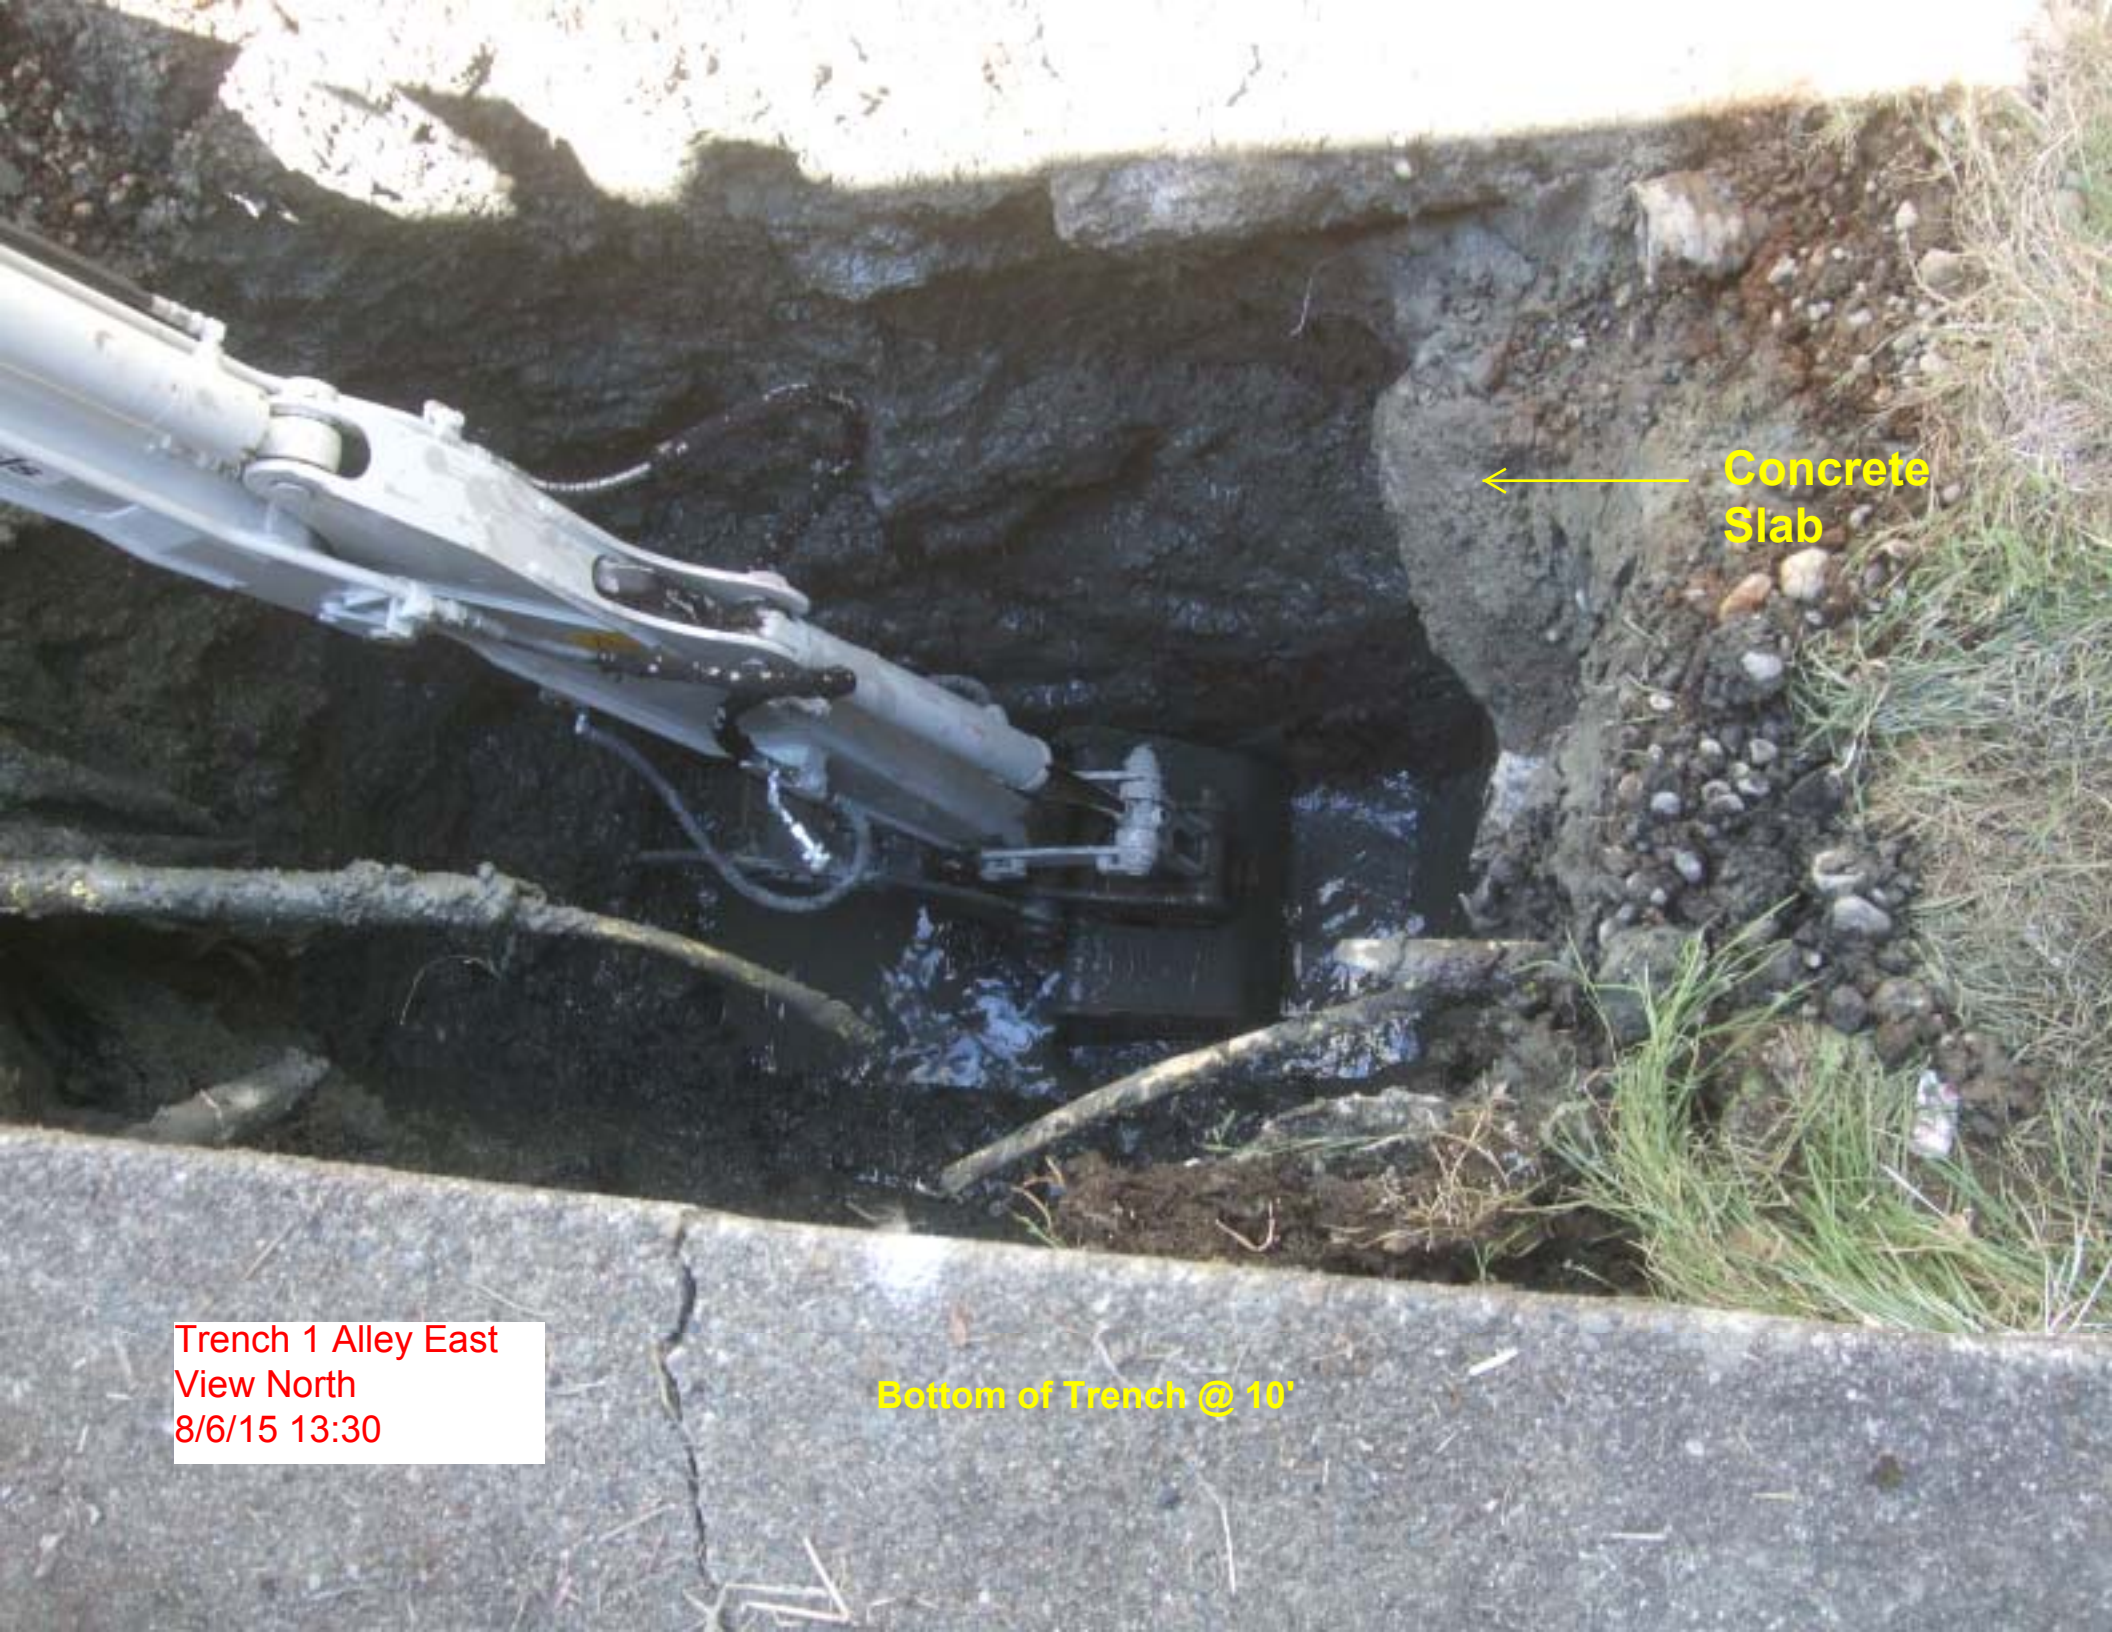
Trench 1 Alley East
View North
8/6/15 13:30

← Concrete
Slab

Bottom of Trench @ 10'

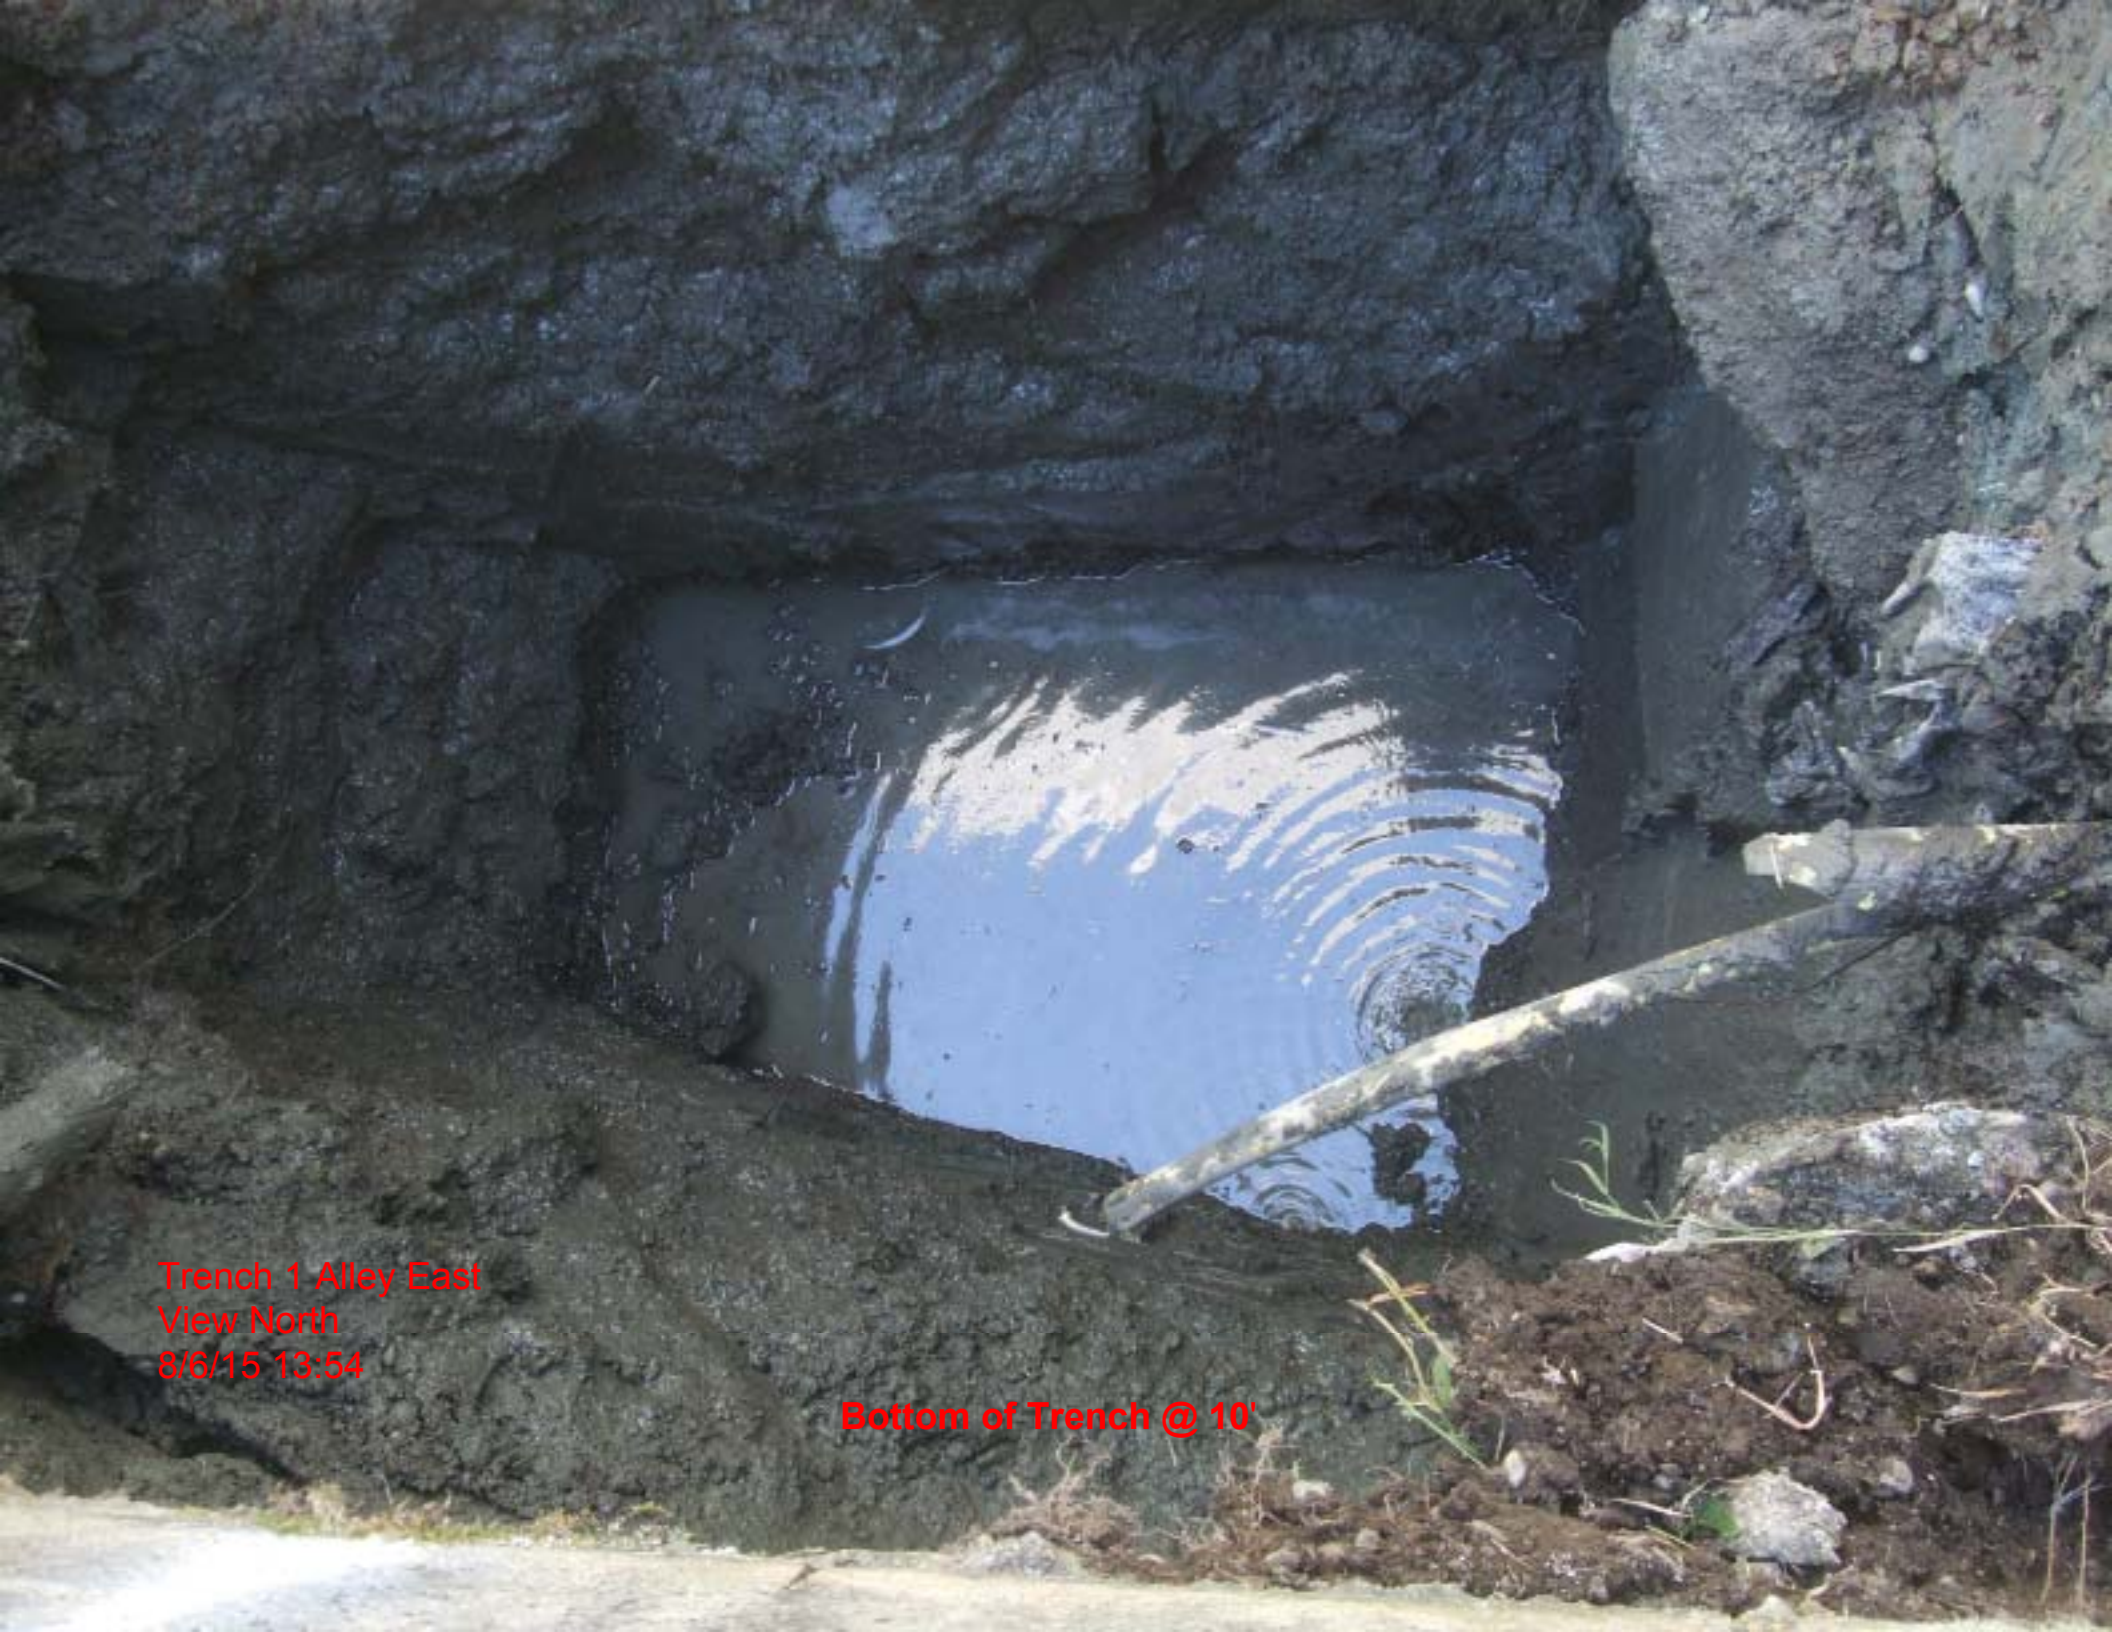
Trench 1 Alley East
View North
8/6/15 13:54

Bottom of Trench @ 10'

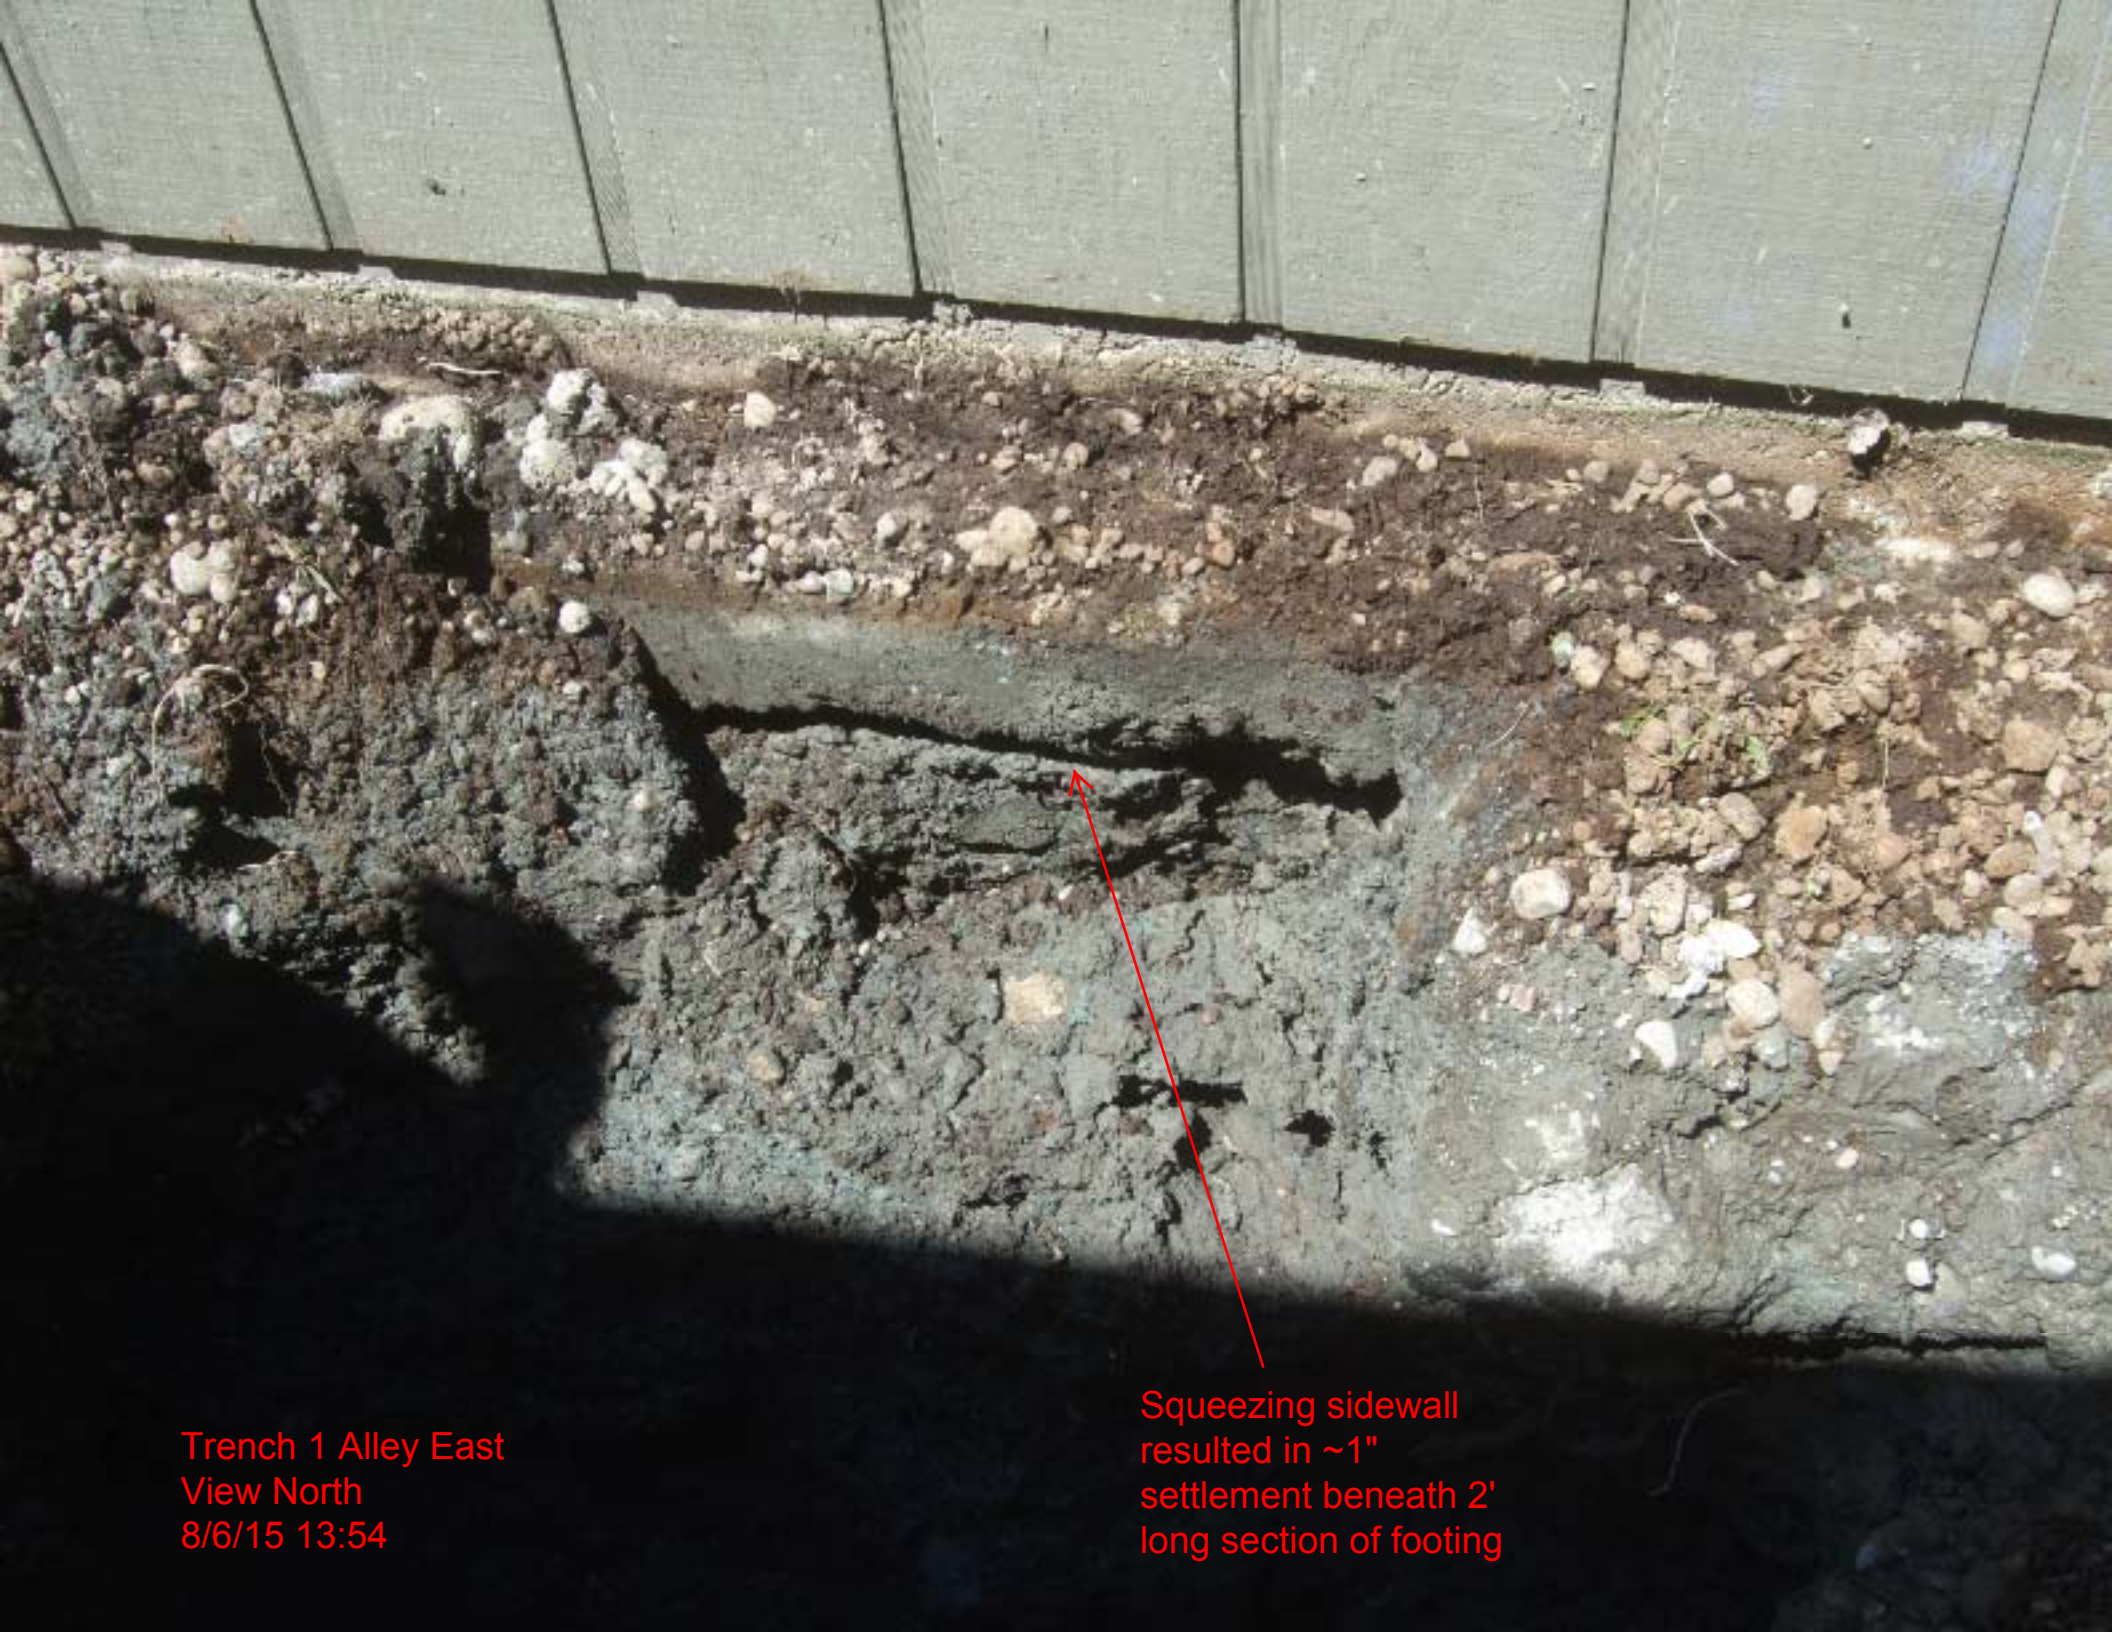
Trench 1 Alley East
View North
8/6/15 13:54

Squeezing sidewall
resulted in ~1"
settlement beneath 2'
long section of footing

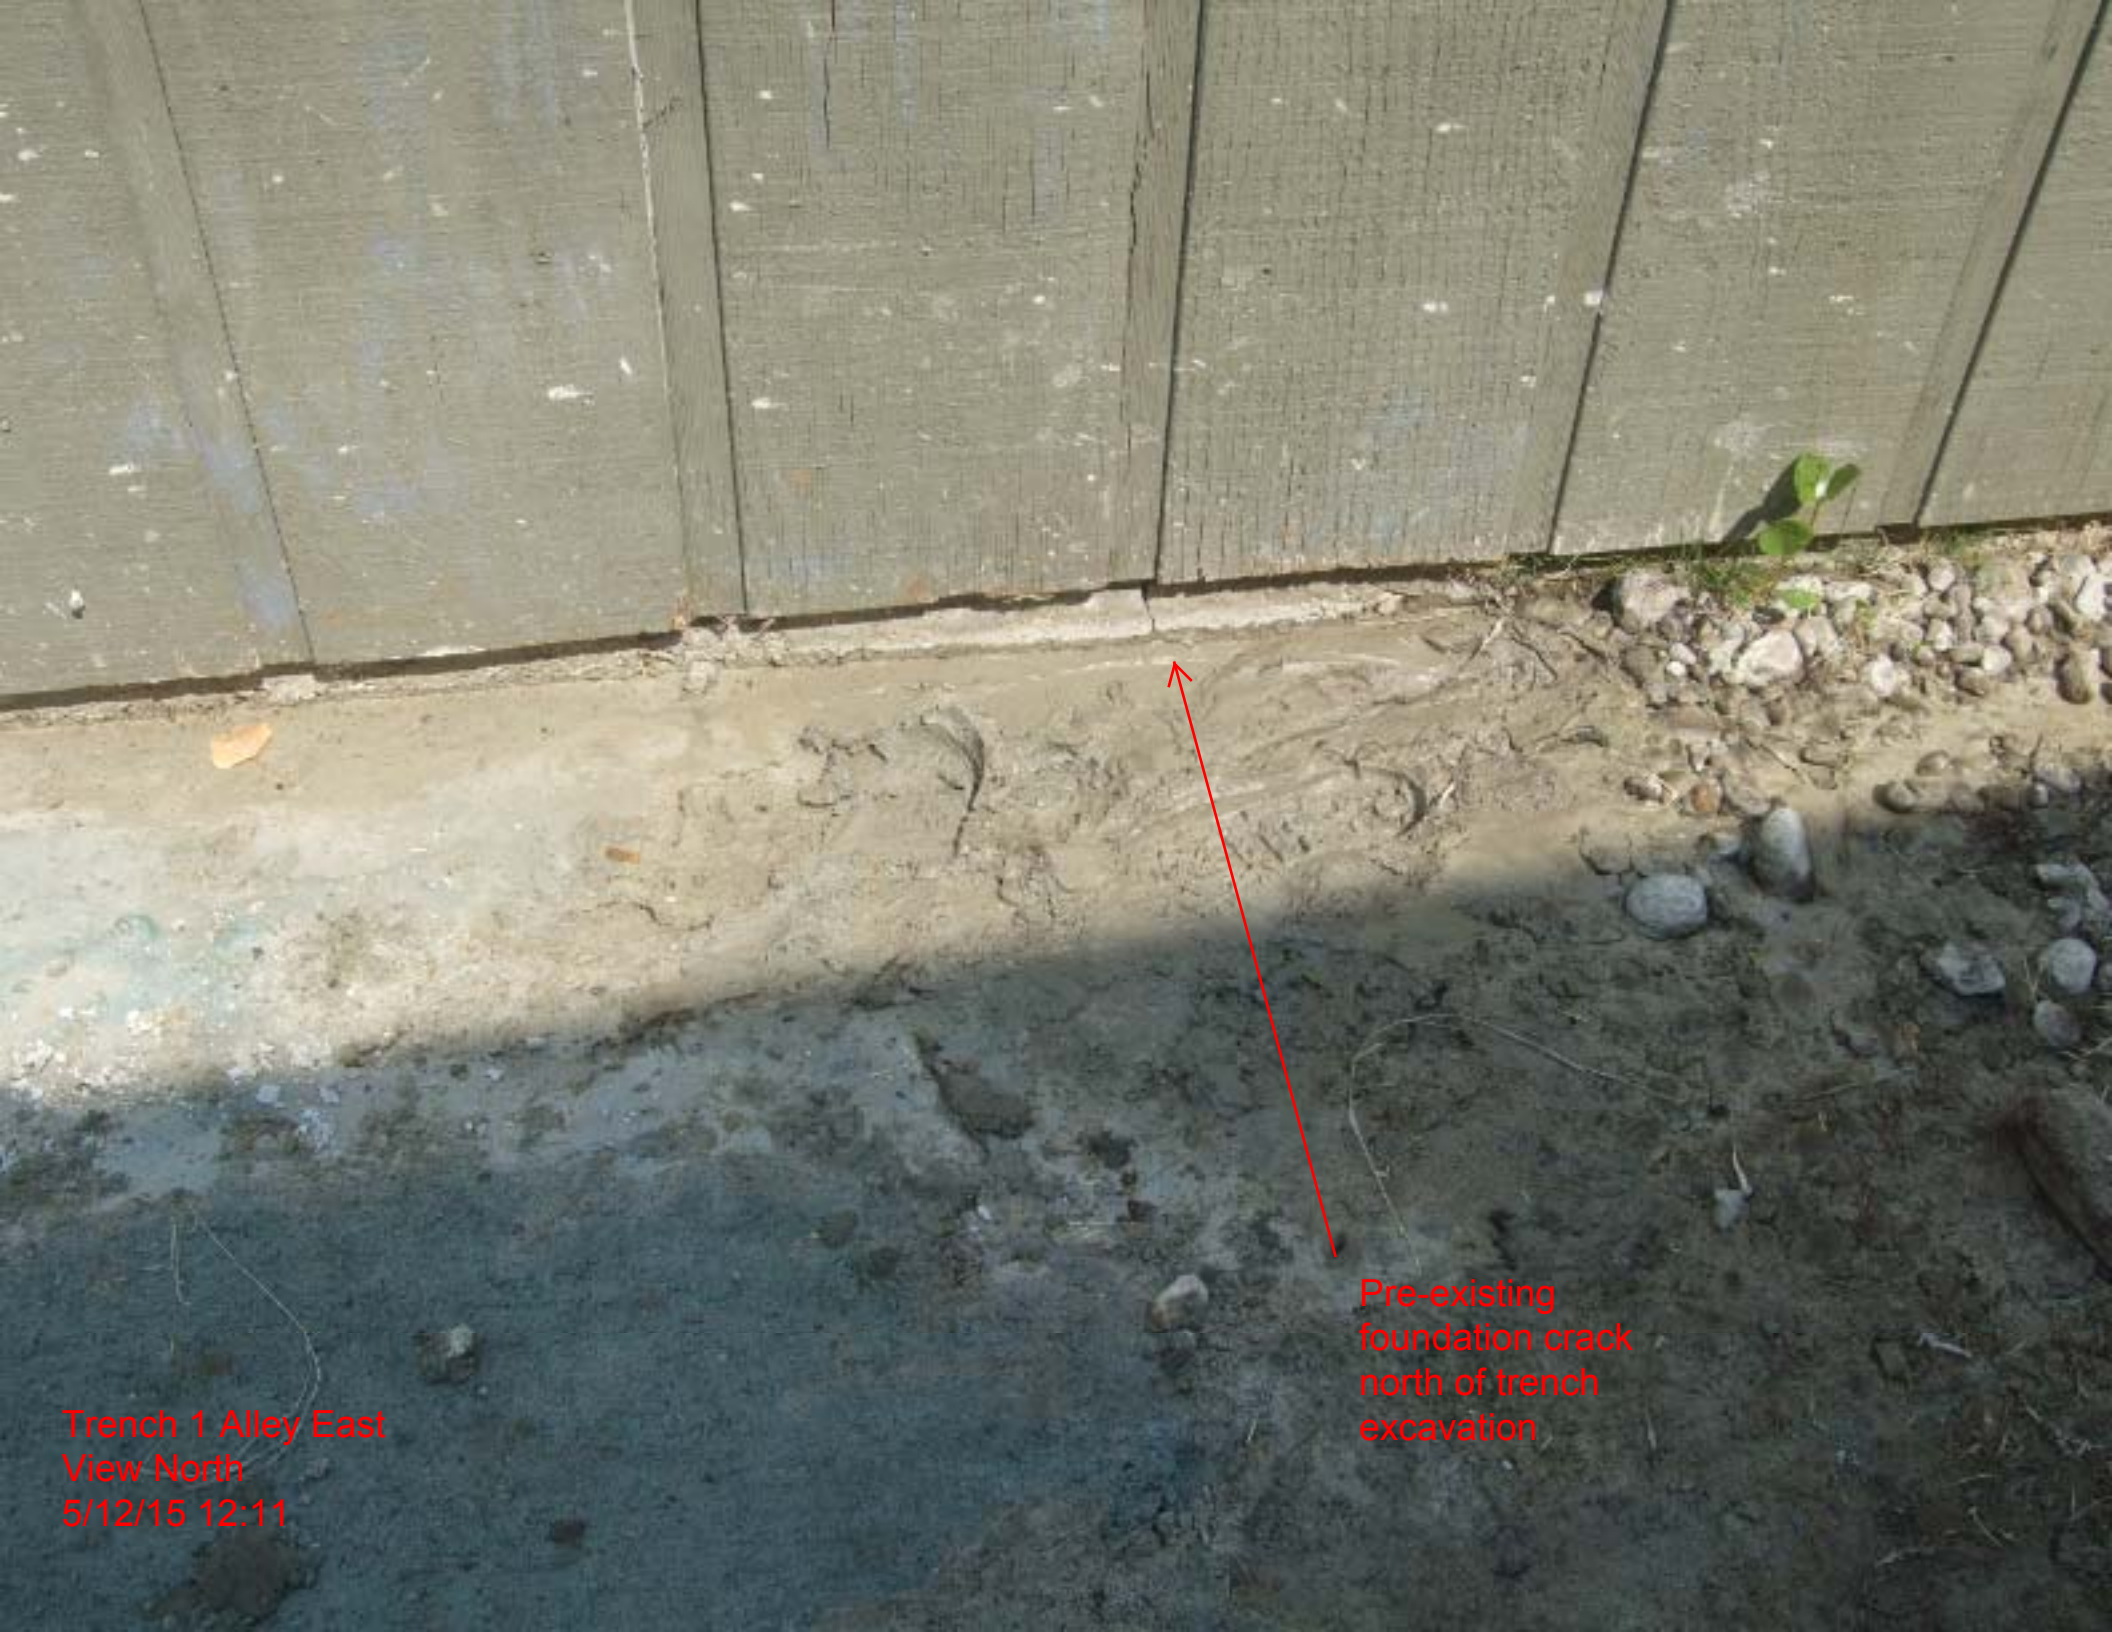
Trench 1 Alley East
View North
5/12/15 12:11

Pre-existing
foundation crack
north of trench
excavation

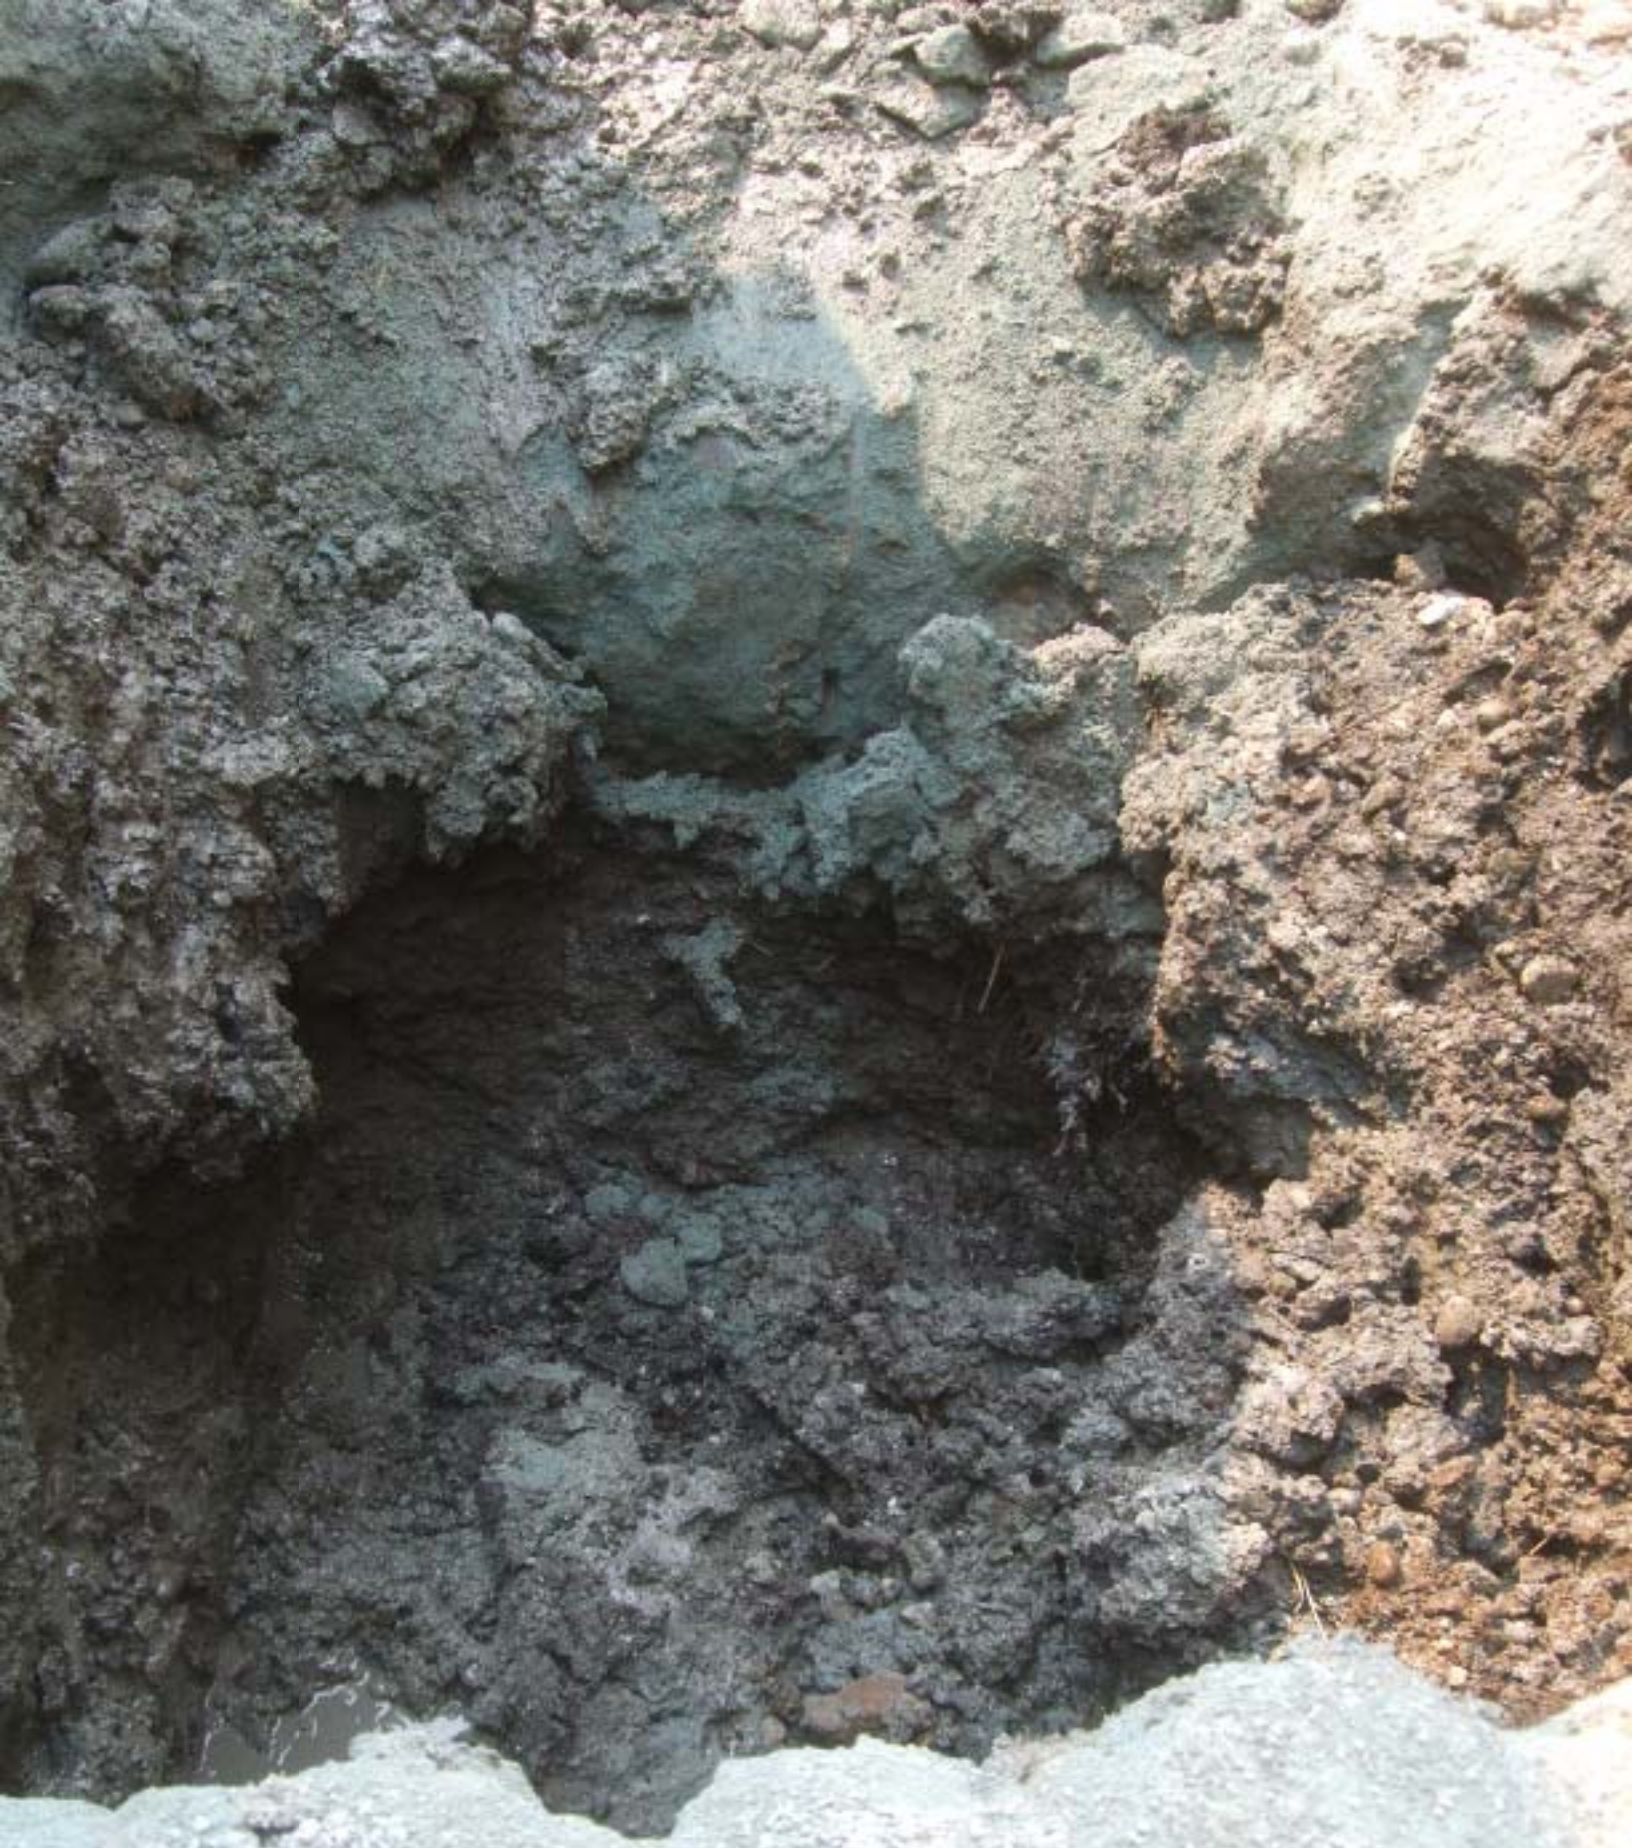
Trench 3 Alley West
View West
8/12/15 14:05

**Trench 3 located
between Trench 2
(west) and Trench 1
(east)**
