**Former Olympia
Dry Cleaners Site**

Remedial Action Completion Report

November 2015

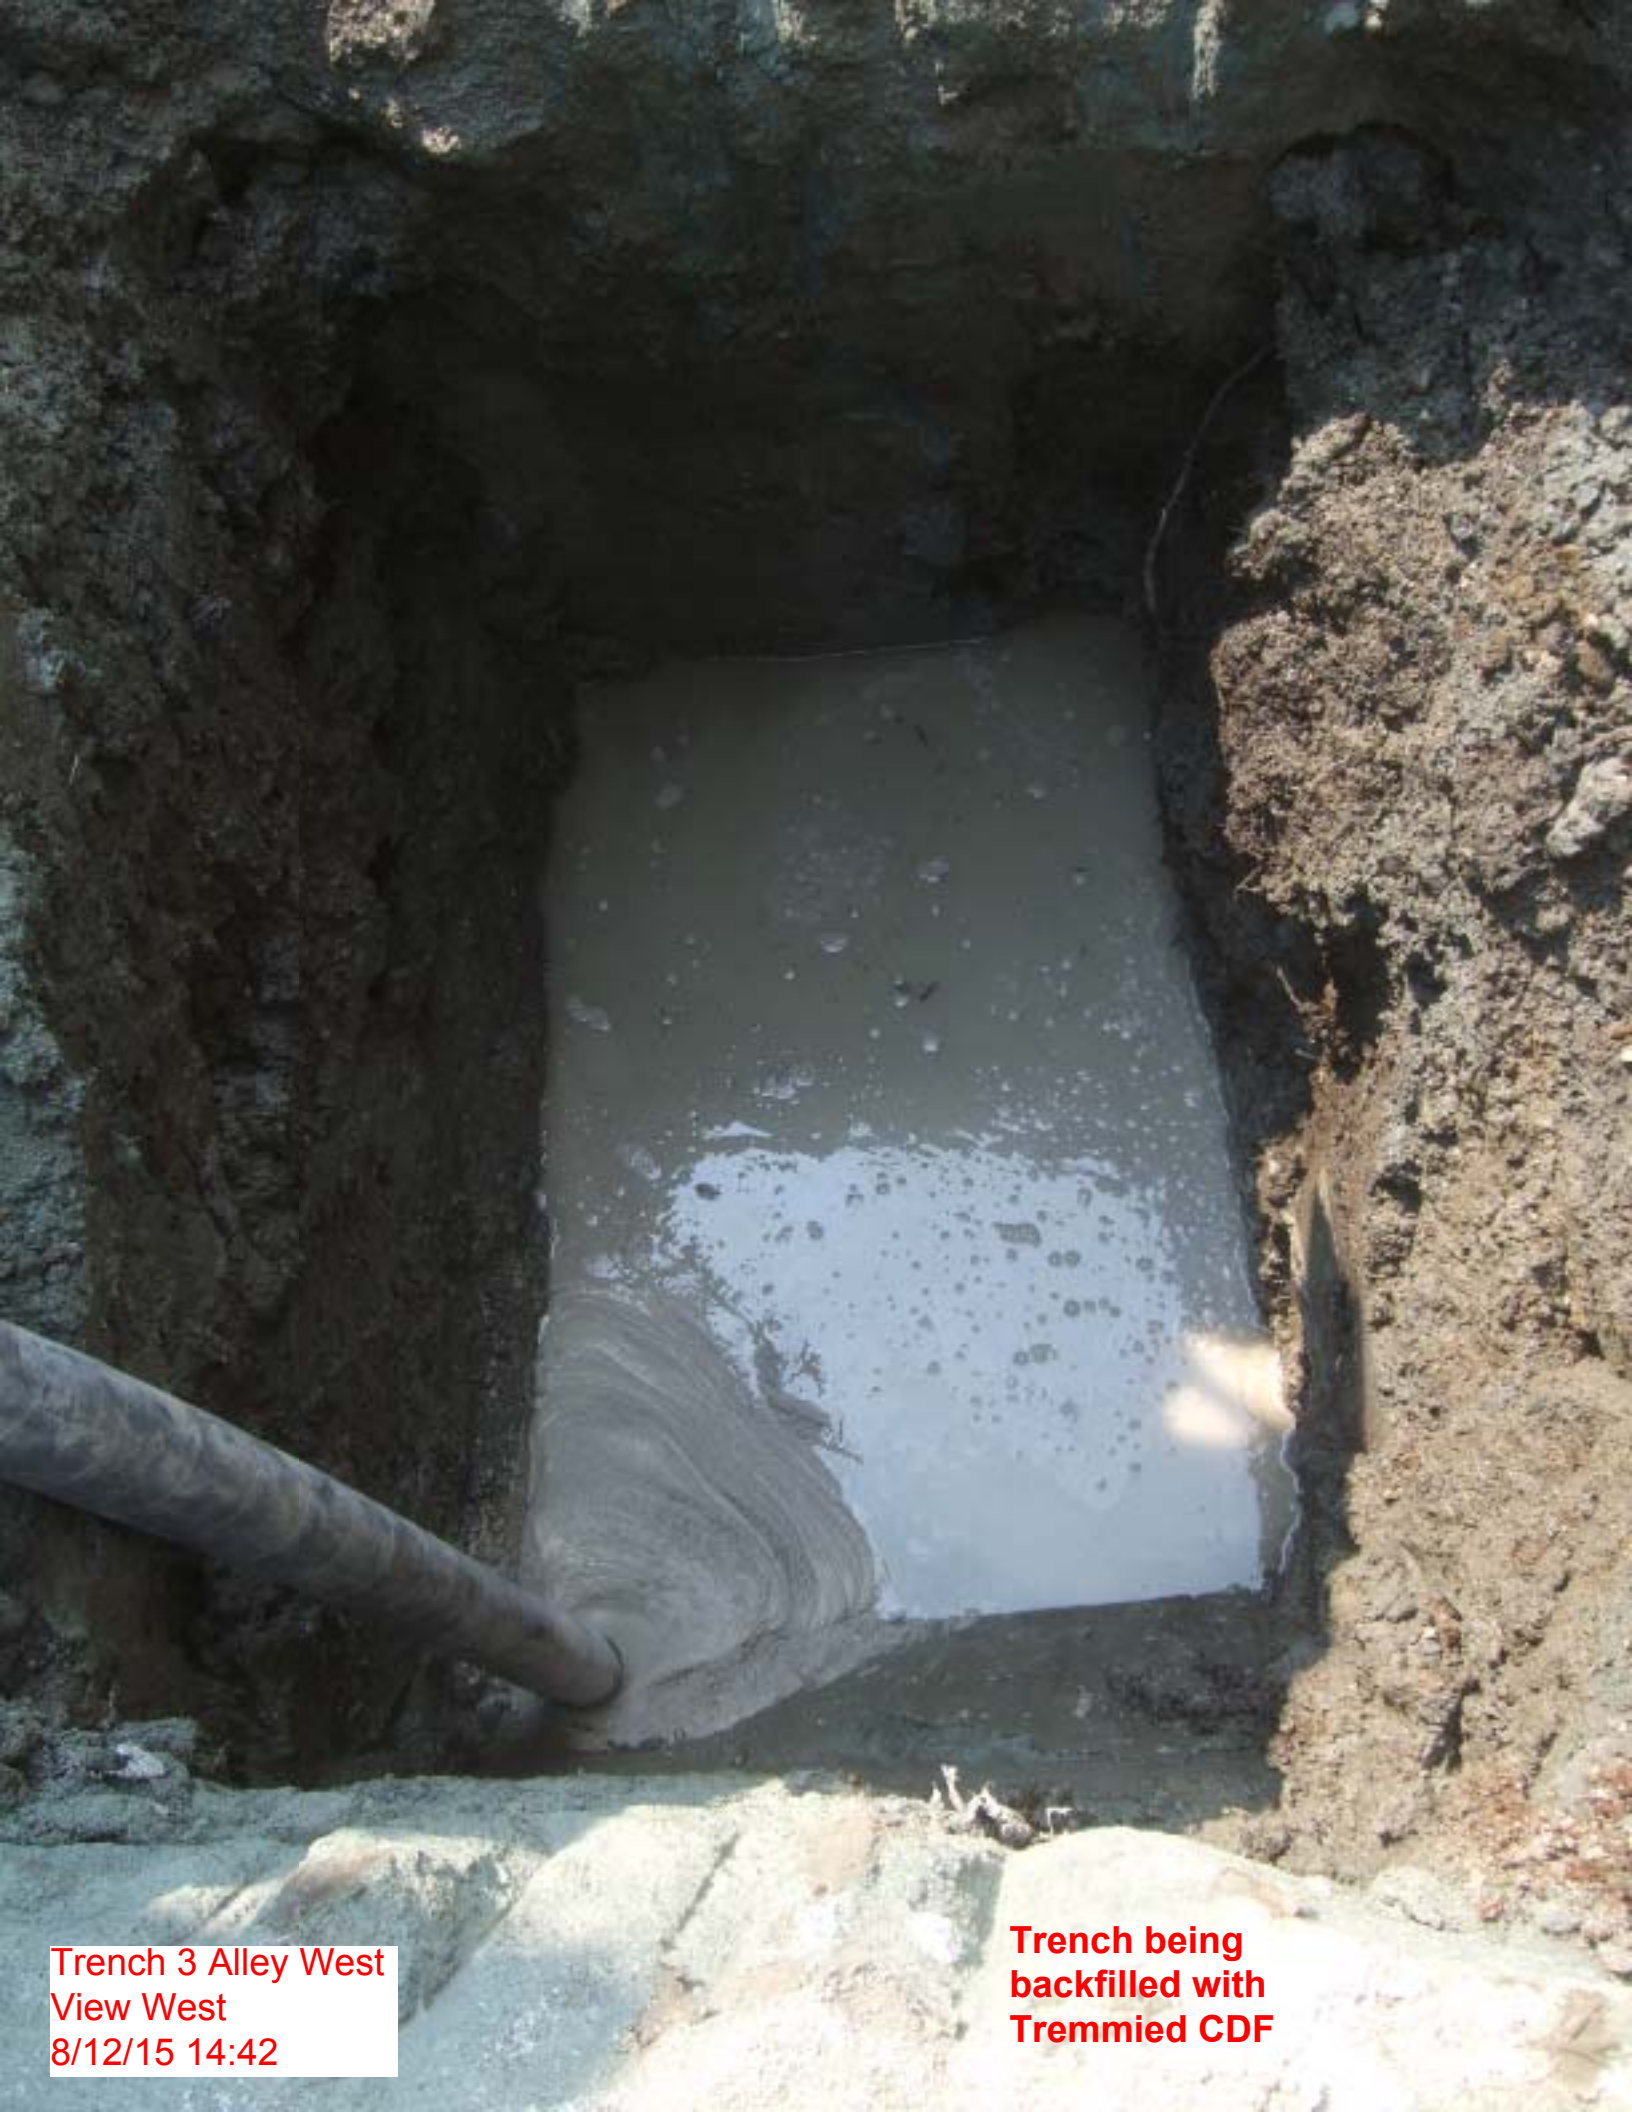
Trench 3 Alley West
View West
8/12/15 14:42

**Trench being
backfilled with
Tremmie CDF**

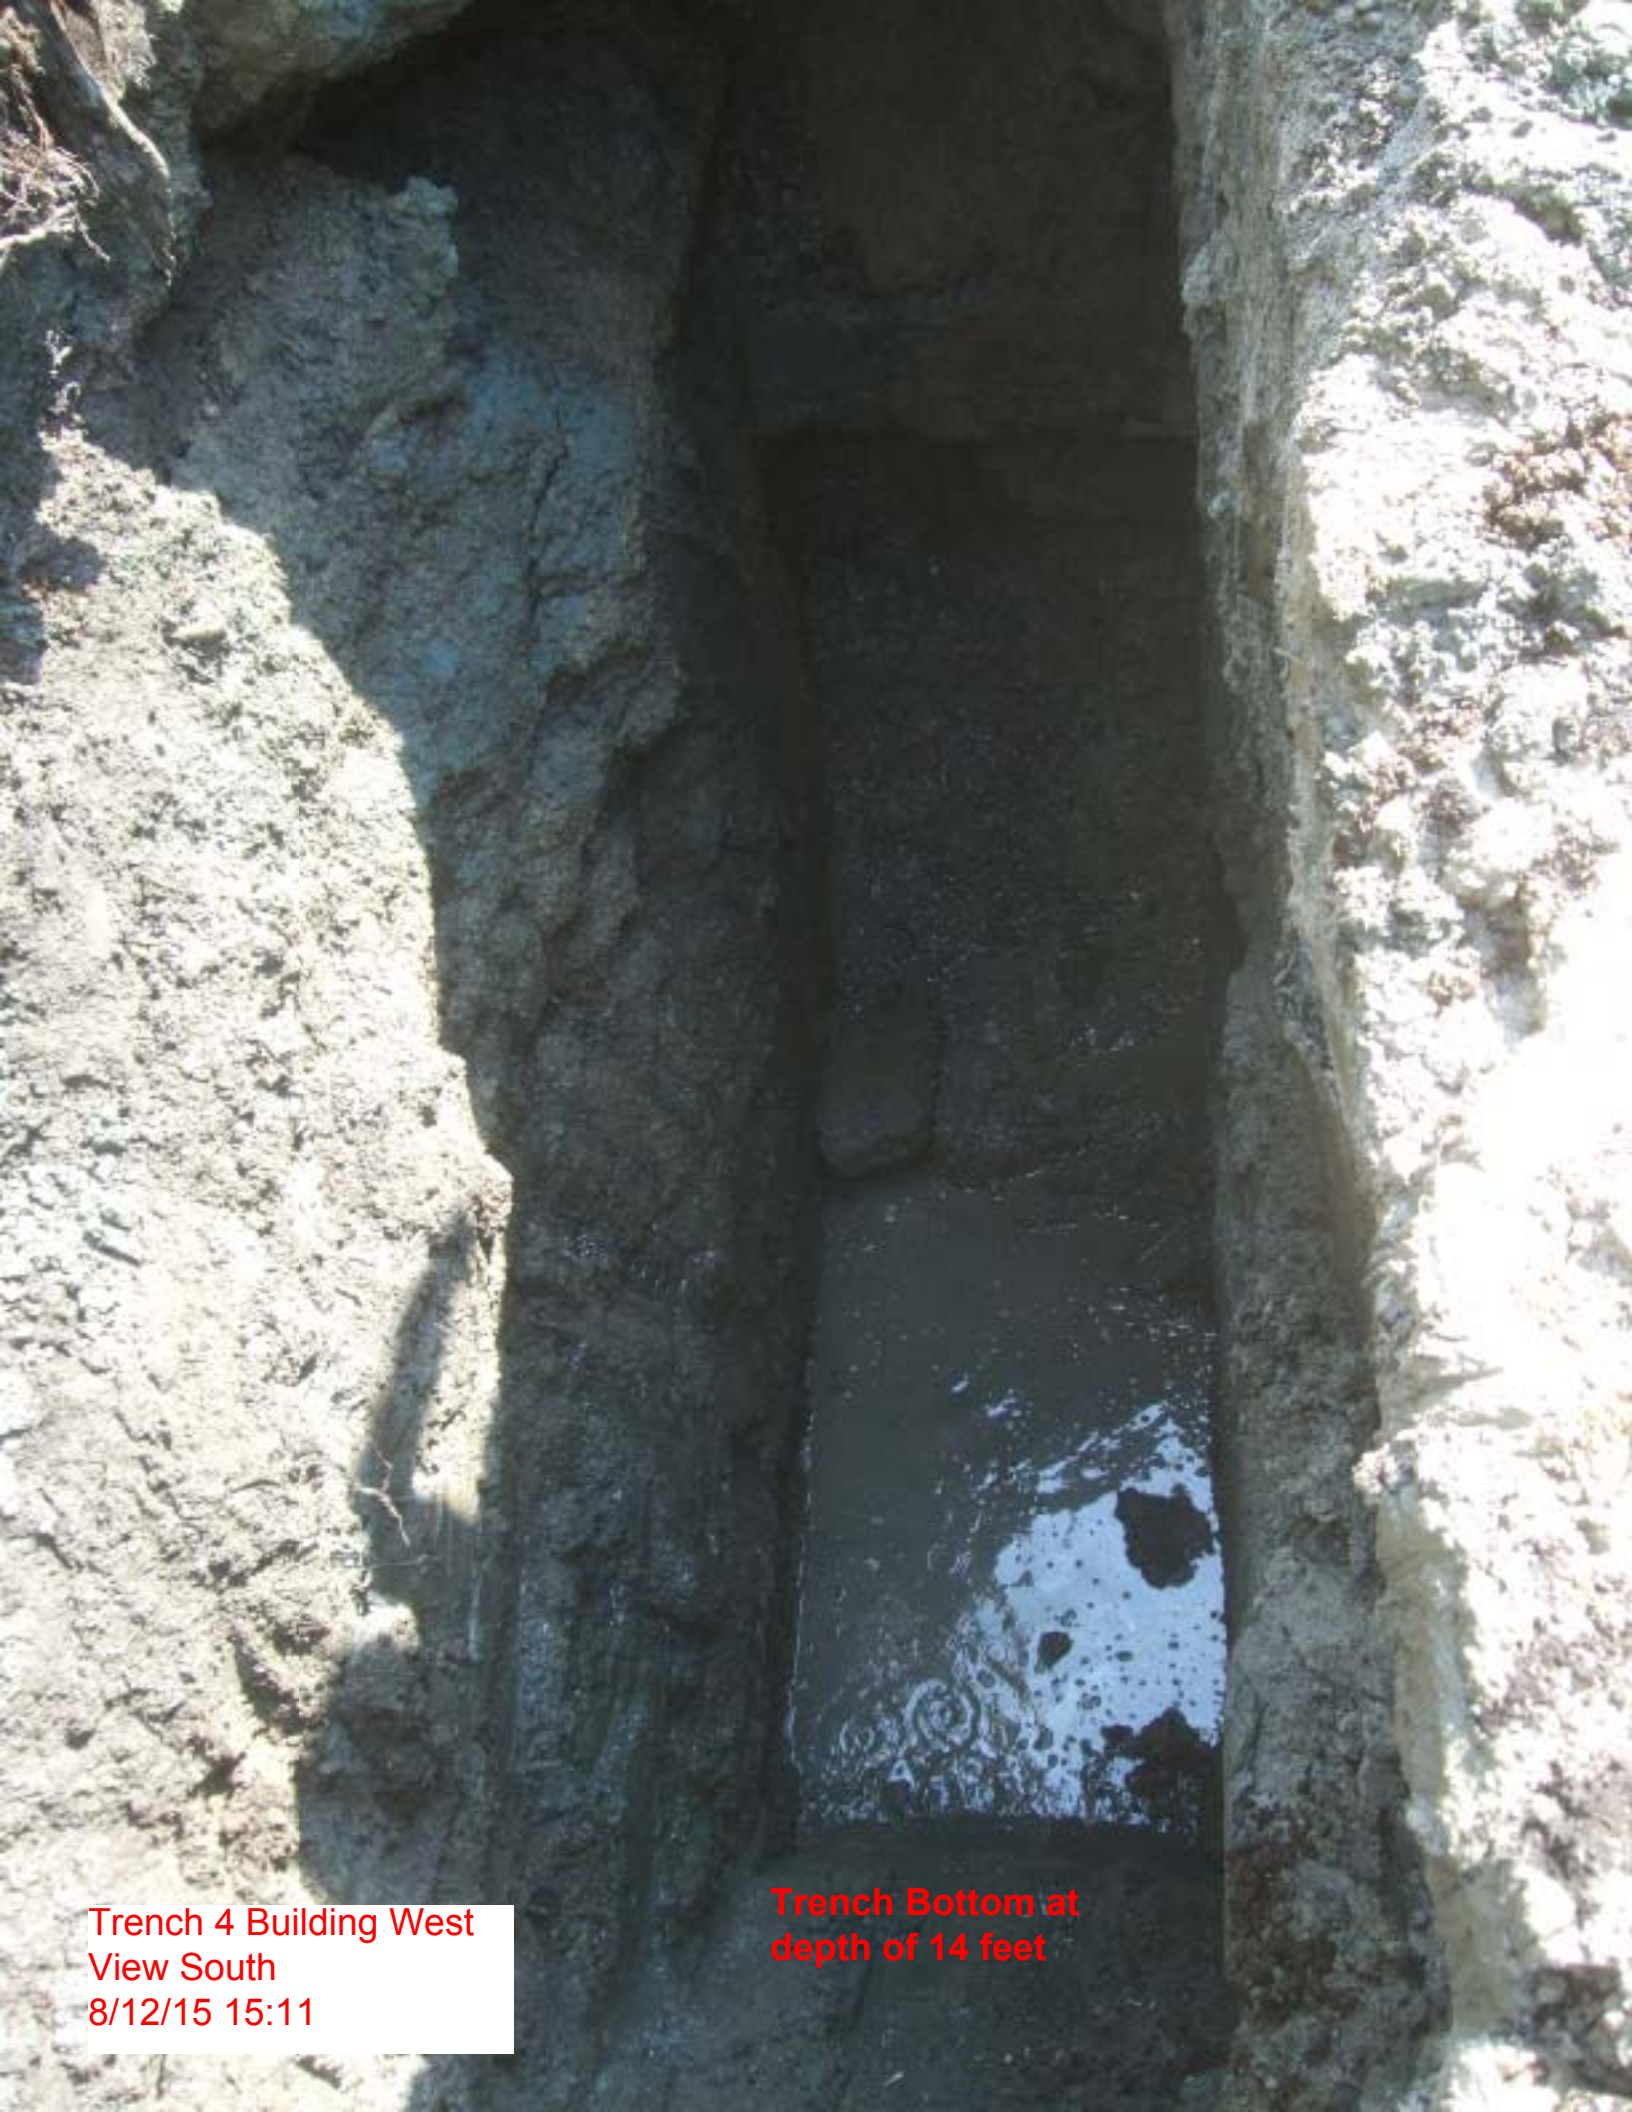
Trench 4 Building West
View South
8/12/15 15:11

Trench Bottom at
depth of 14 feet

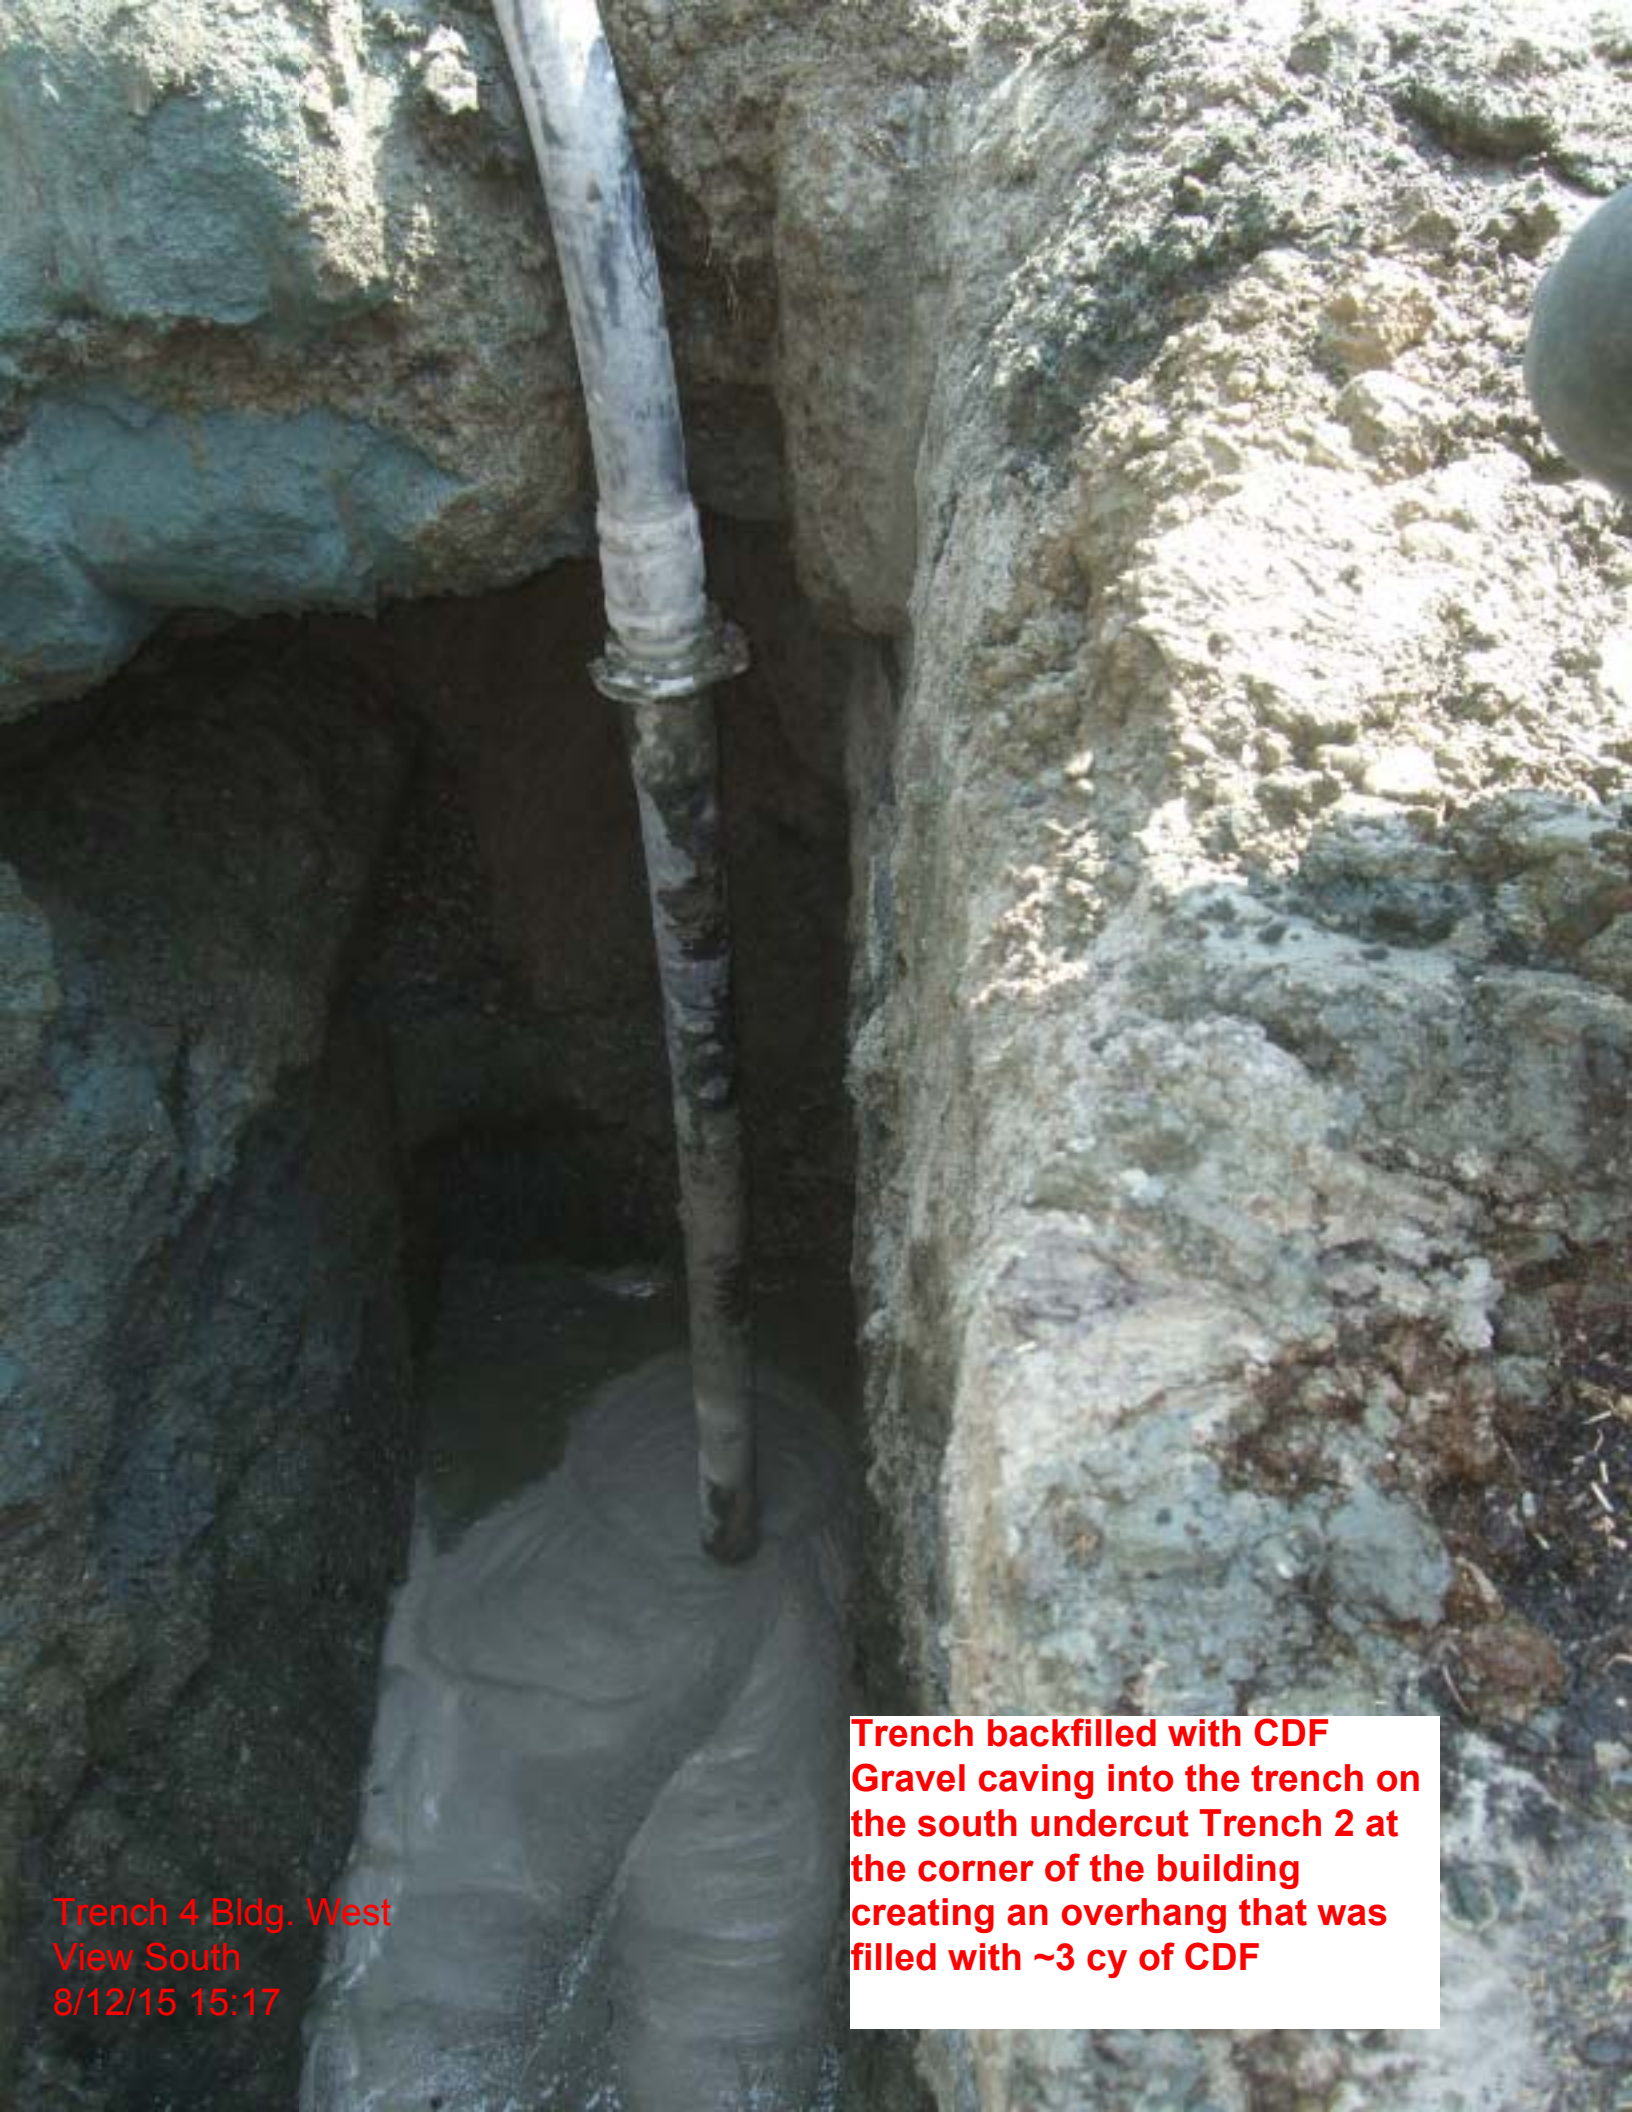
Trench 4 Bldg. West
View South
8/12/15 15:17

**Trench backfilled with CDF
Gravel caving into the trench on
the south undercut Trench 2 at
the corner of the building
creating an overhang that was
filled with ~3 cy of CDF**

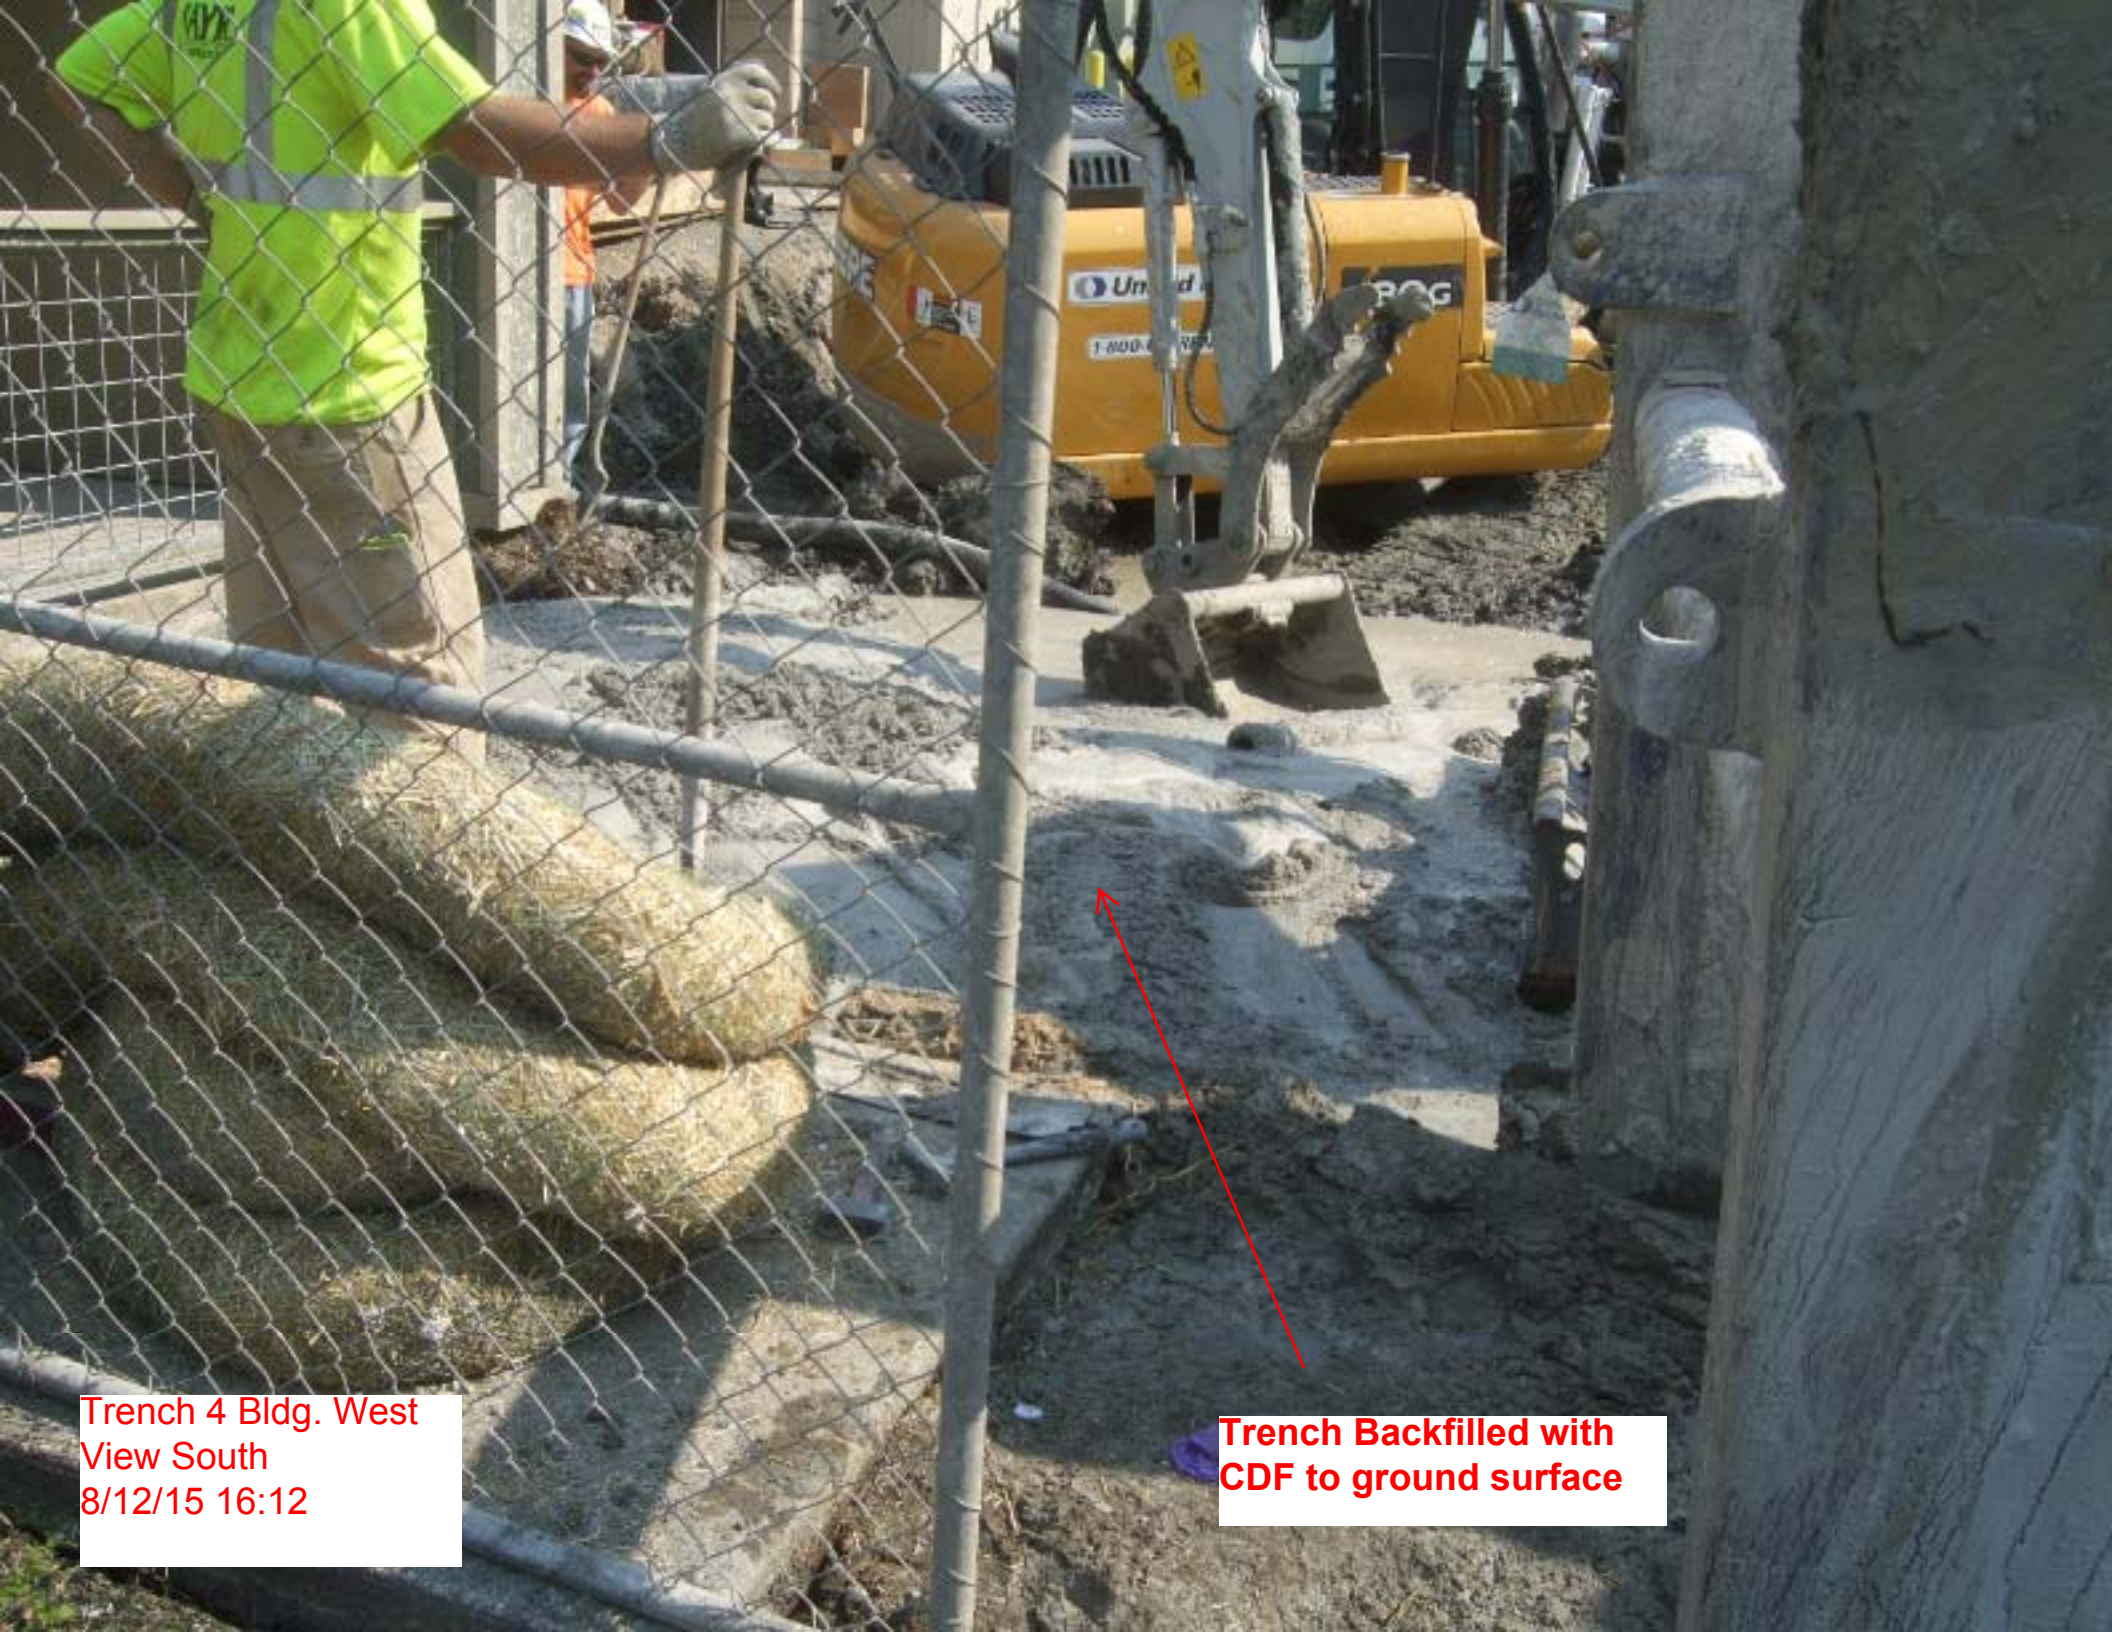
Trench 4 Bldg. West
View South
8/12/15 16:12

Trench Backfilled with
CDF to ground surface
