WHITMAN Environmental Sciences

Subject: Workplan for Source Investigation
SE Parking Lot Plume
12th & Yesler Redevelopment Property
Seattle, Washington

Proposed Redevelopment Property
104-124 12th Avenue & 1209 E. Fir Street
Seattle, WA

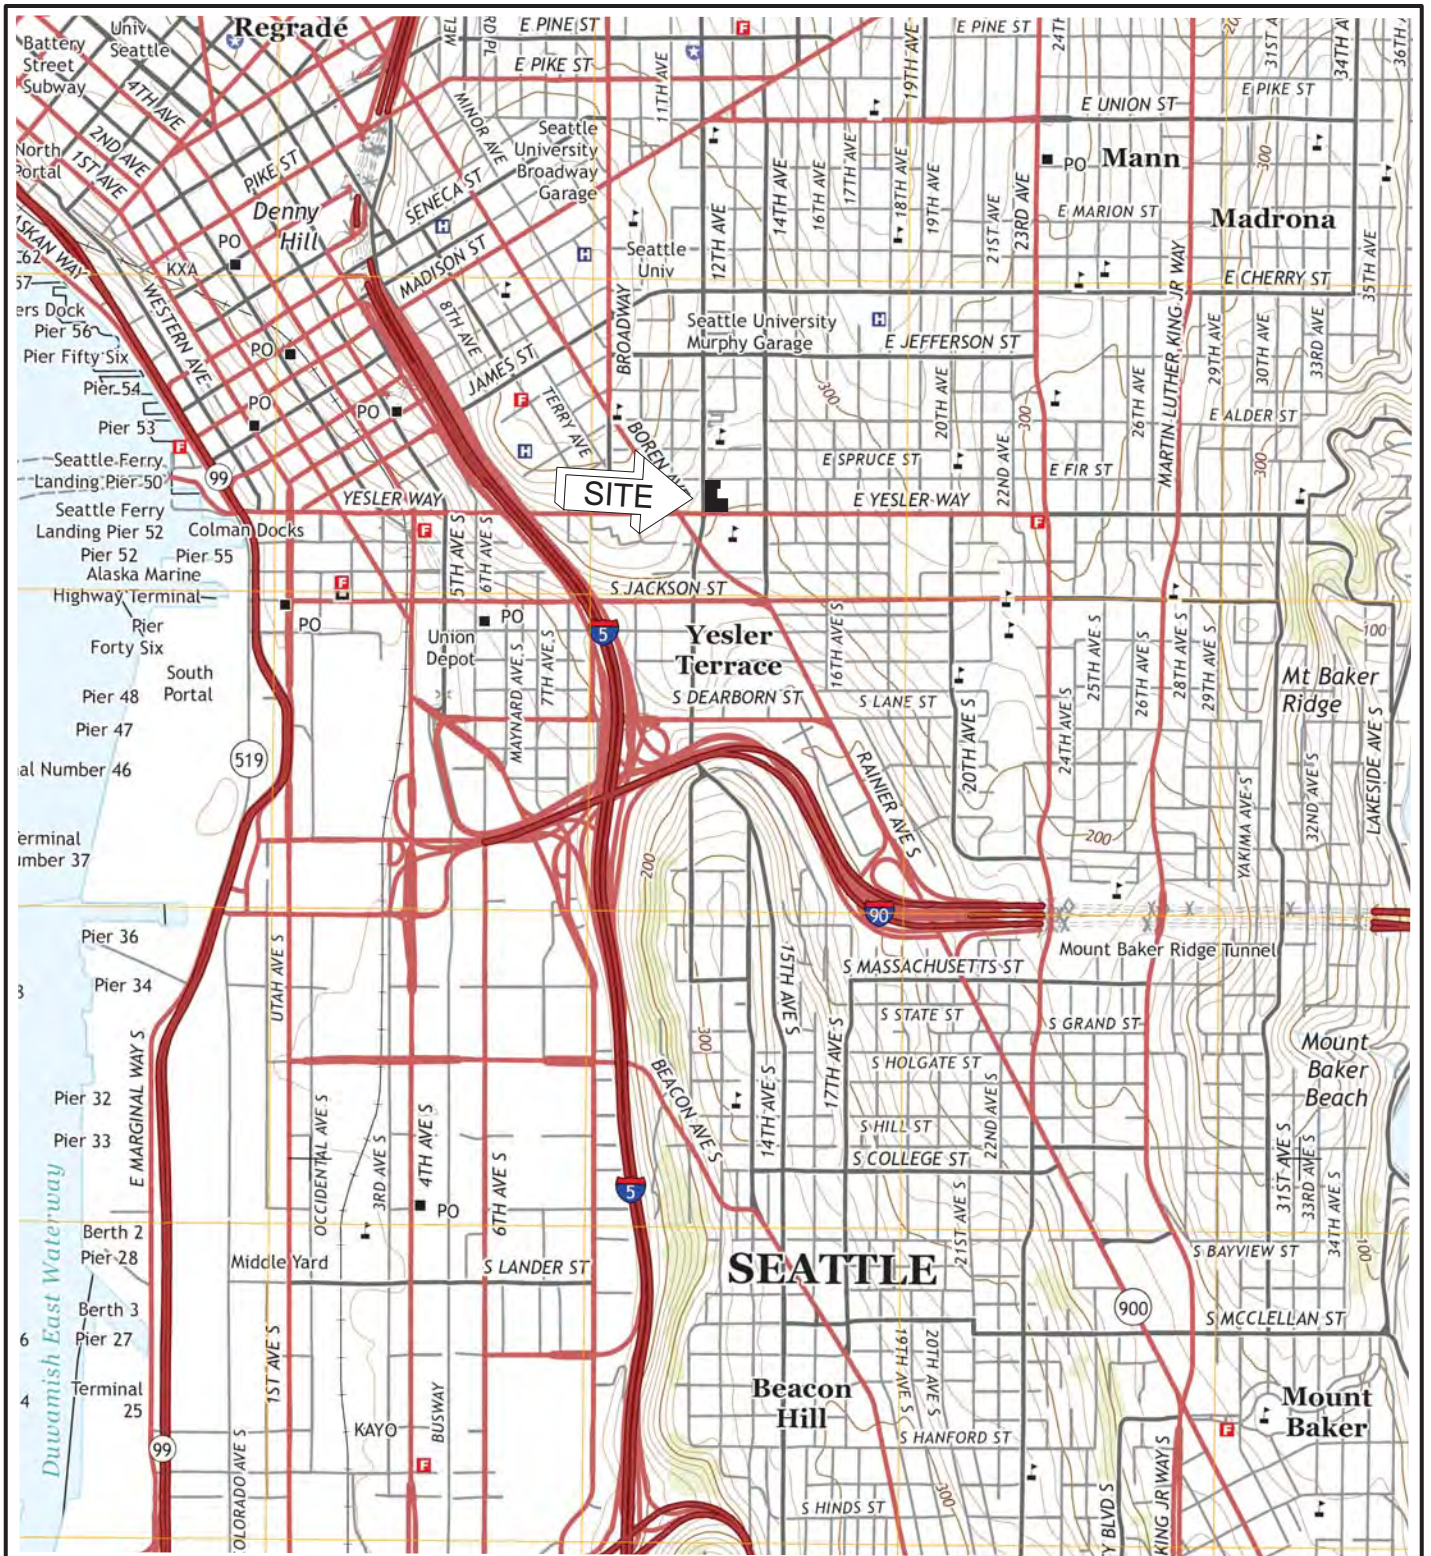
Figure 1 illustrates the four areas and their relation to the SE parking lot plume. The available information about these potential sources is discussed below.

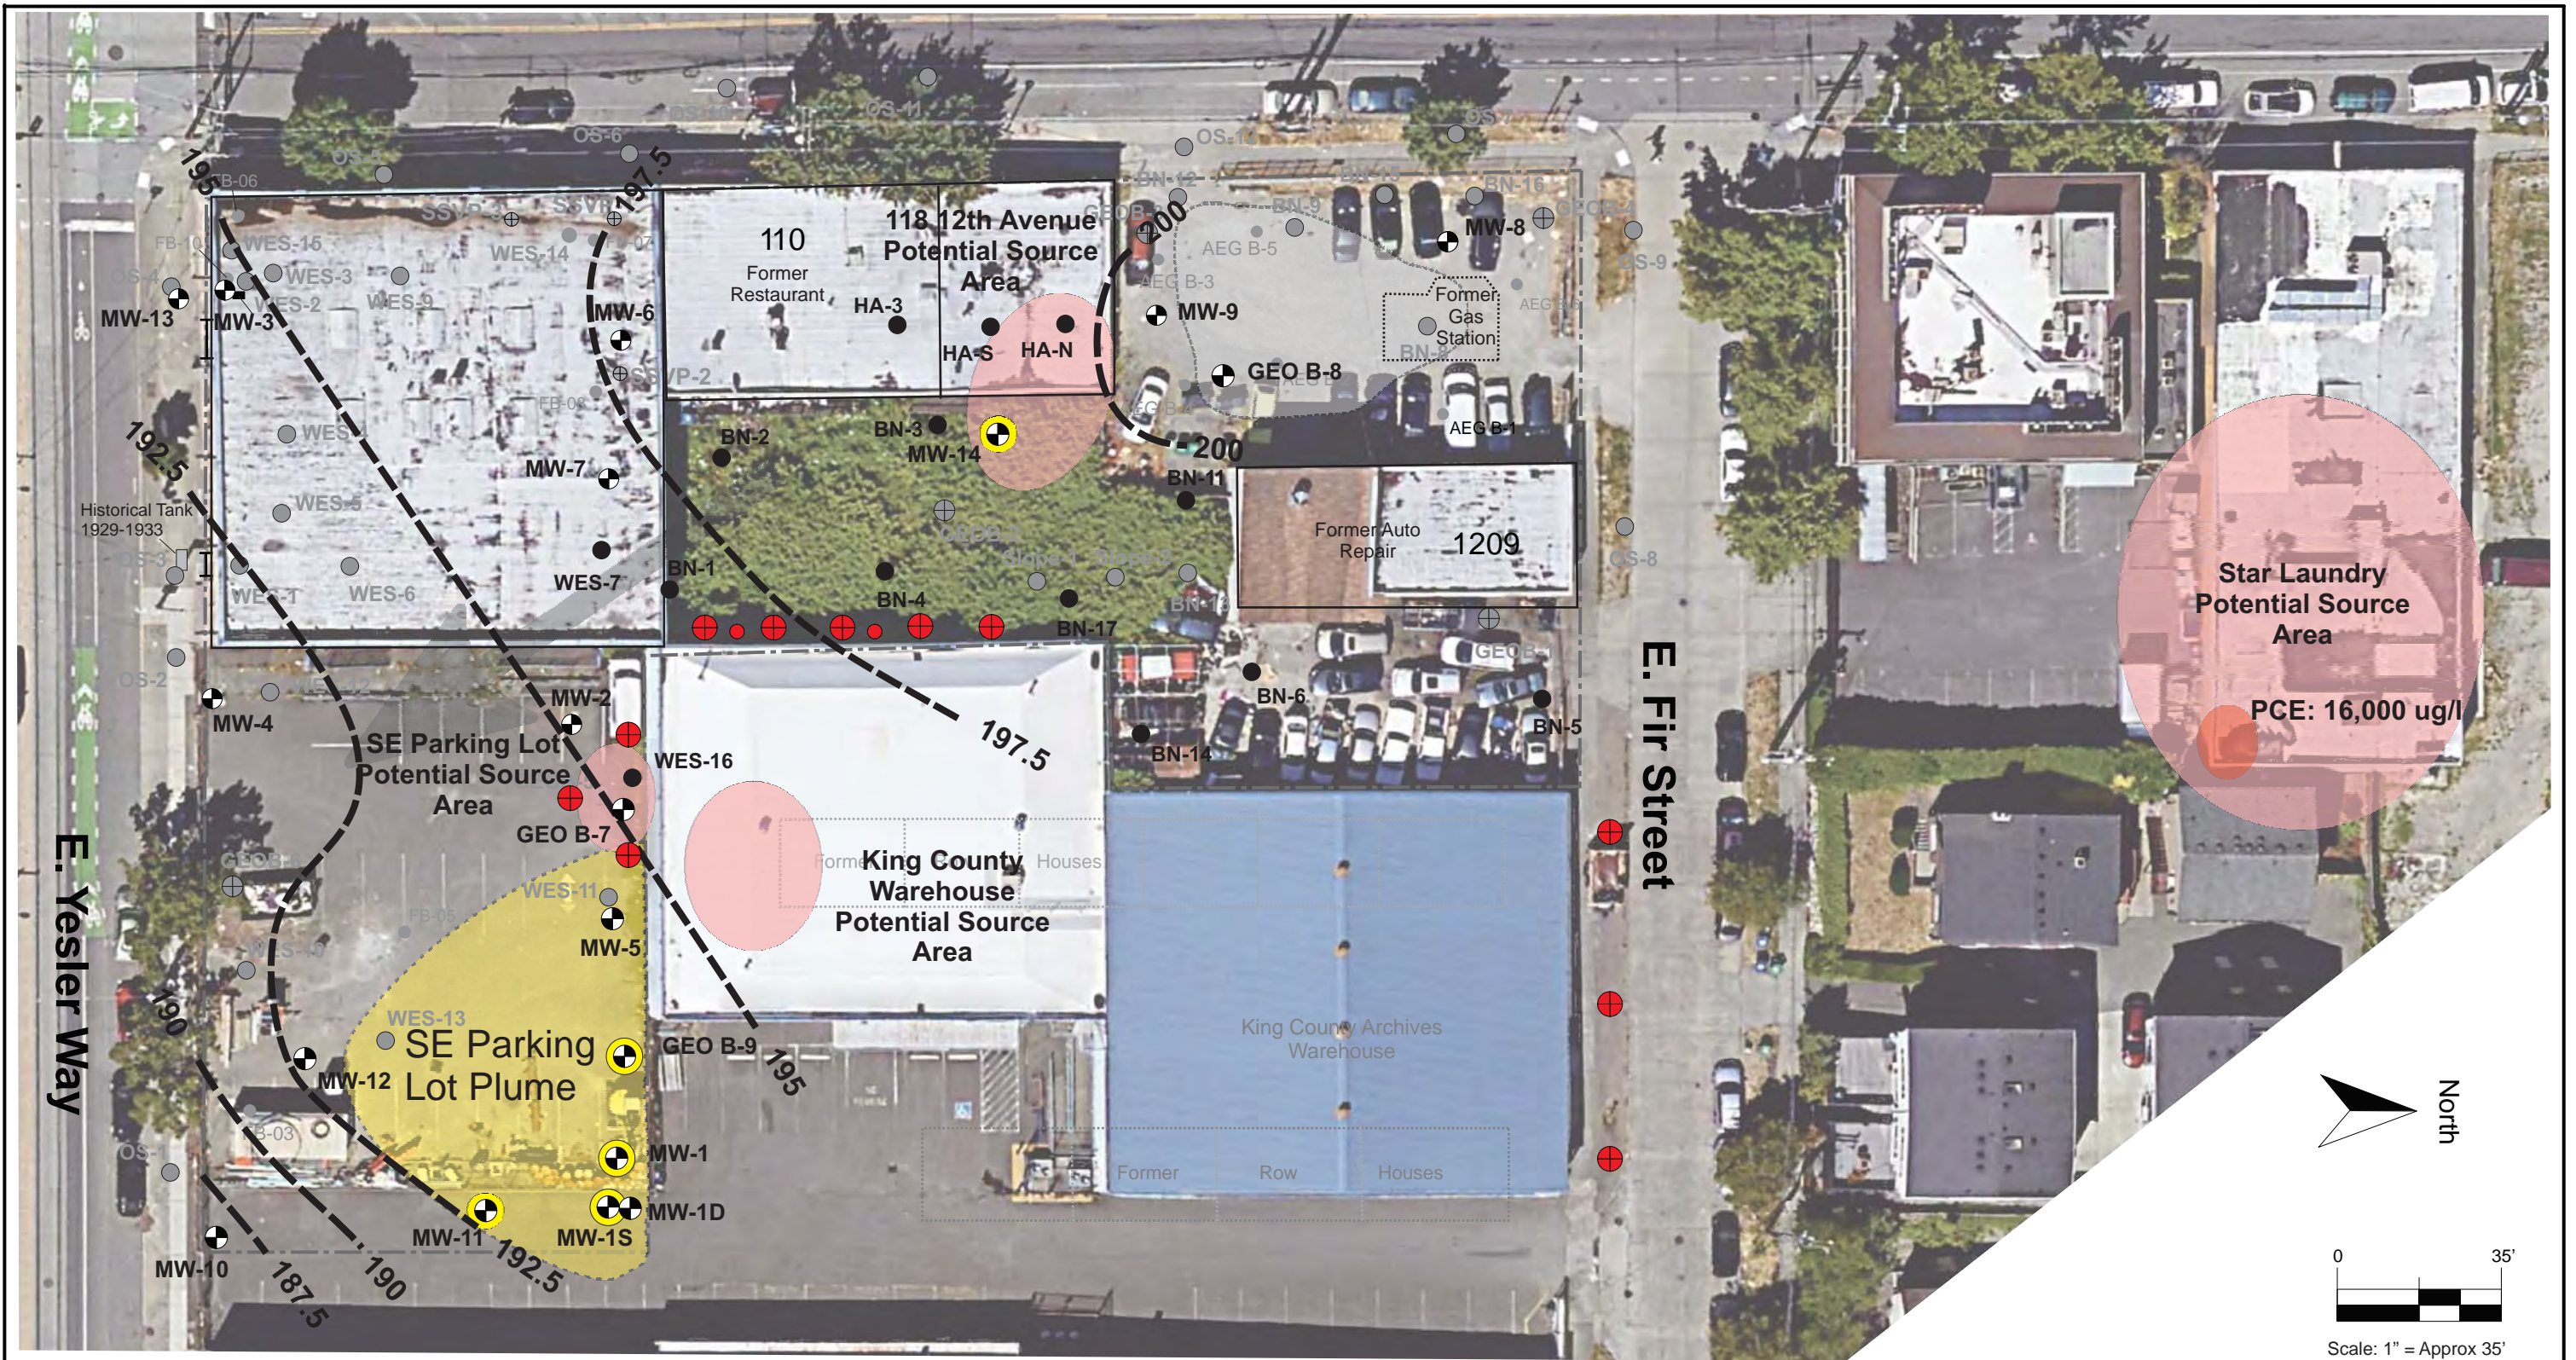
Figure 2 identifies the planned boring locations. Five borings will be drilled in the central part of the subject property along the western side of the King County warehouse. Including the prior borings BN-1, BN-4 and BN-17, this will space sampling approximately 15 feet apart along the length of the building to identify any preferential flow paths that could carry contaminants toward or beneath the building from the 118 12th Avenue area.

- Approximate Location of Monitoring Well
- Inferred Groundwater Elevation Contour 12/4/2019
- General Direction of Groundwater Migration
- Approximate Location of Soil Borings (2014-19)
- Approximate Location of Planned Soil & Groundwater Sampling
- Approximate Location of Planned Soil Vapor Probe
- Approximate Property Boundary
- Dec. 2019 Groundwater Sample Exceeding MTCAL Method A CUL for Vinyl Chloride

Two soil vapor probes will also be installed along the west side of the building. The soil probes will be completed at a depth of five feet below the surface, constructed with a 1" stainless steel porous filter surrounded by a silica sand pack, attached to teflon tubing. The remaining borehole will be sealed with bentonite and the probe will be allowed to stand for at least one week before sampling vapors. Samples will be obtained using laboratory prepared 1-liter Summa canisters attached to the tubing, following appropriate purge and sample techniques.

Four borings will be drilled in the City of Seattle boulevard on the south side of Fir Street, directly north of the King County property. These borings are intended to identify any plume extending from the Star Laundry building to the north.

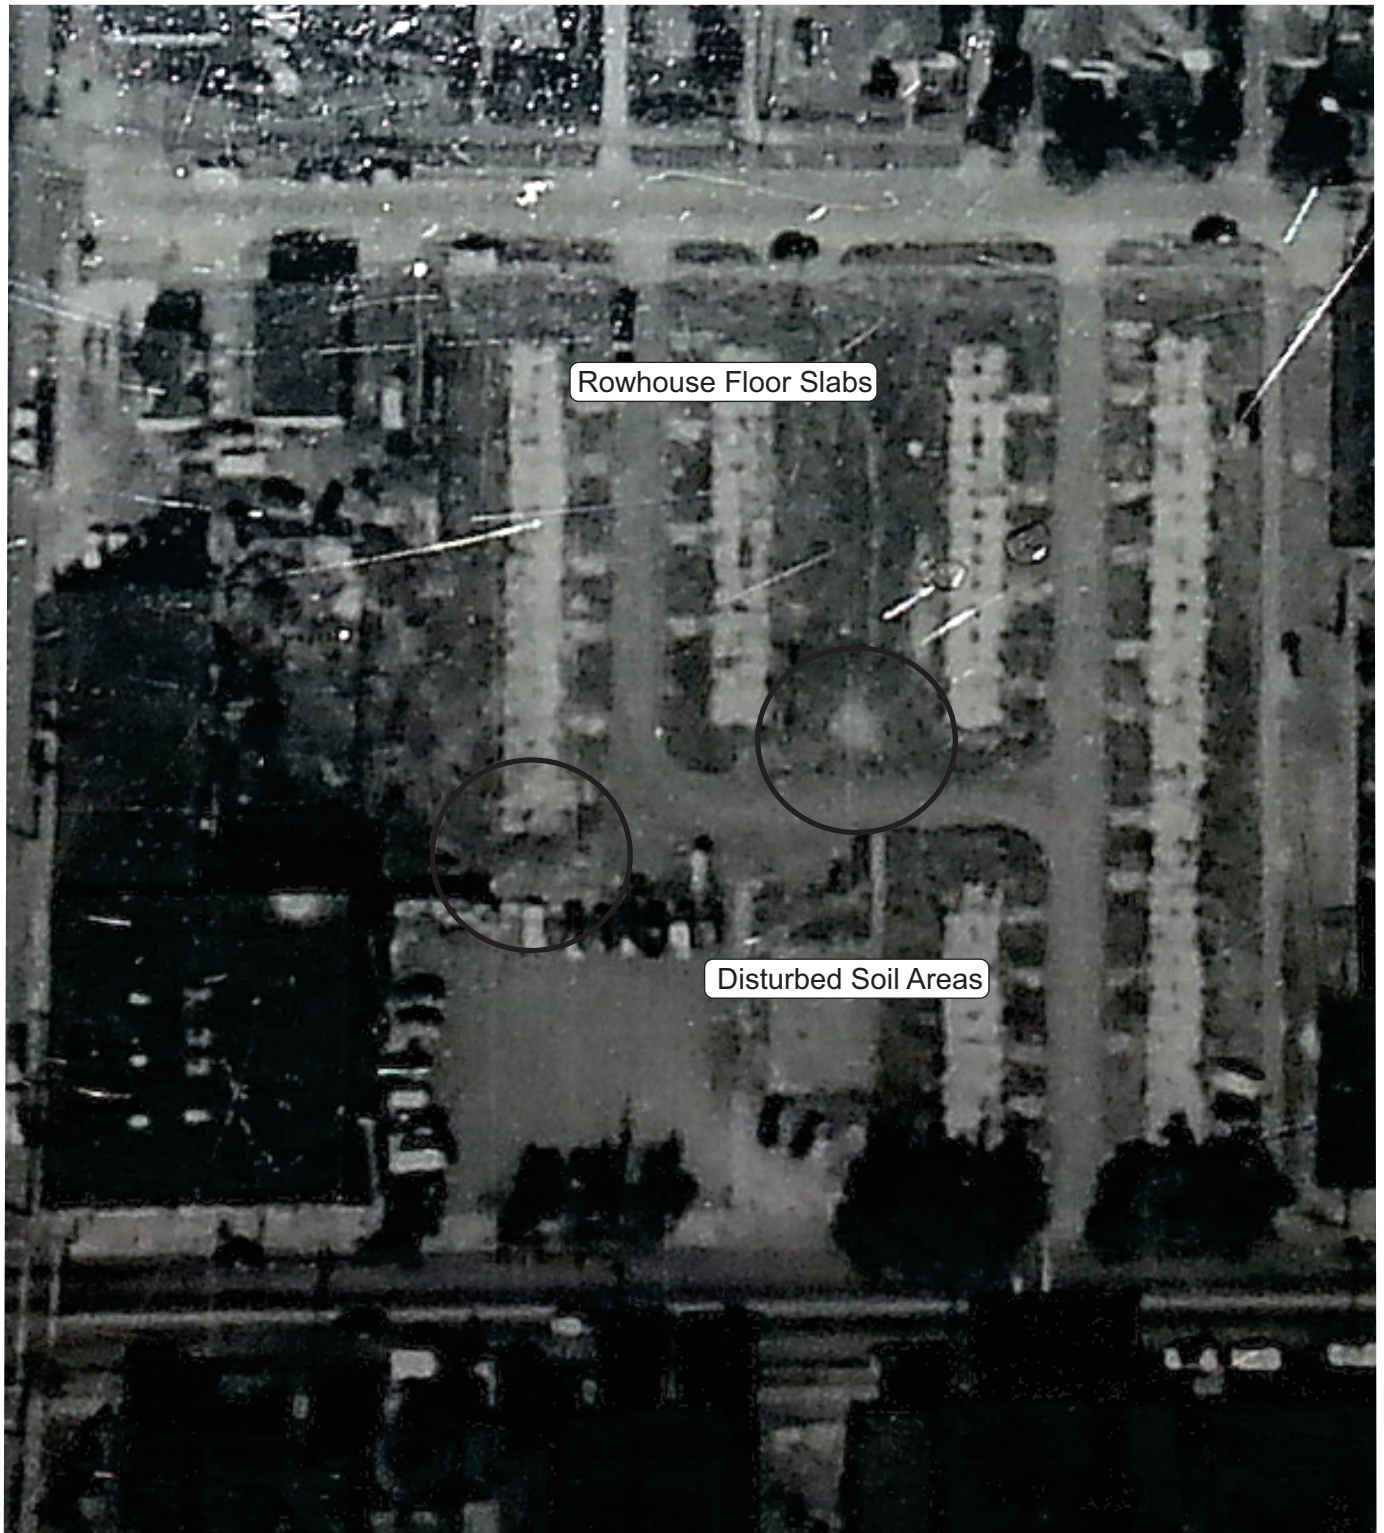
The row-houses that pre-dated the warehouse are also considered a potential source. Historical aerial photographs and Sanborn Fire Insurance Maps show long, narrow row-house buildings, one of which directly underlies the current warehouse. At the time, there was a fence separating the SE parking lot from the row house property. By the date of a 1953 aerial photograph the homes and fence line had been removed in preparation for the warehouse construction, but the long narrow foundations and floor slabs were still in place and the photo shows a disturbed area at the southern end of the westernmost strip of slabs. The westernmost row-house and disturbed area are directly upgradient of the SE parking lot plume with respect to groundwater or contaminant migration. The warehouse area is considered a potential source of the plume due to historical uses or conditions and the location relative to the plume.

Rowhouse Floor Slabs

Disturbed Soil Areas
