Spill Response and Interim Remedial Action Report

**Gasoline Tanker Spill Site,
Mile Marker 80, Interstate 90
Cle Elum, Washington**

September 12, 2016

Environmental Partners, Inc.
1180 NW Maple Street, Suite 310
Issaquah, Washington 98027
(425) 395-0010

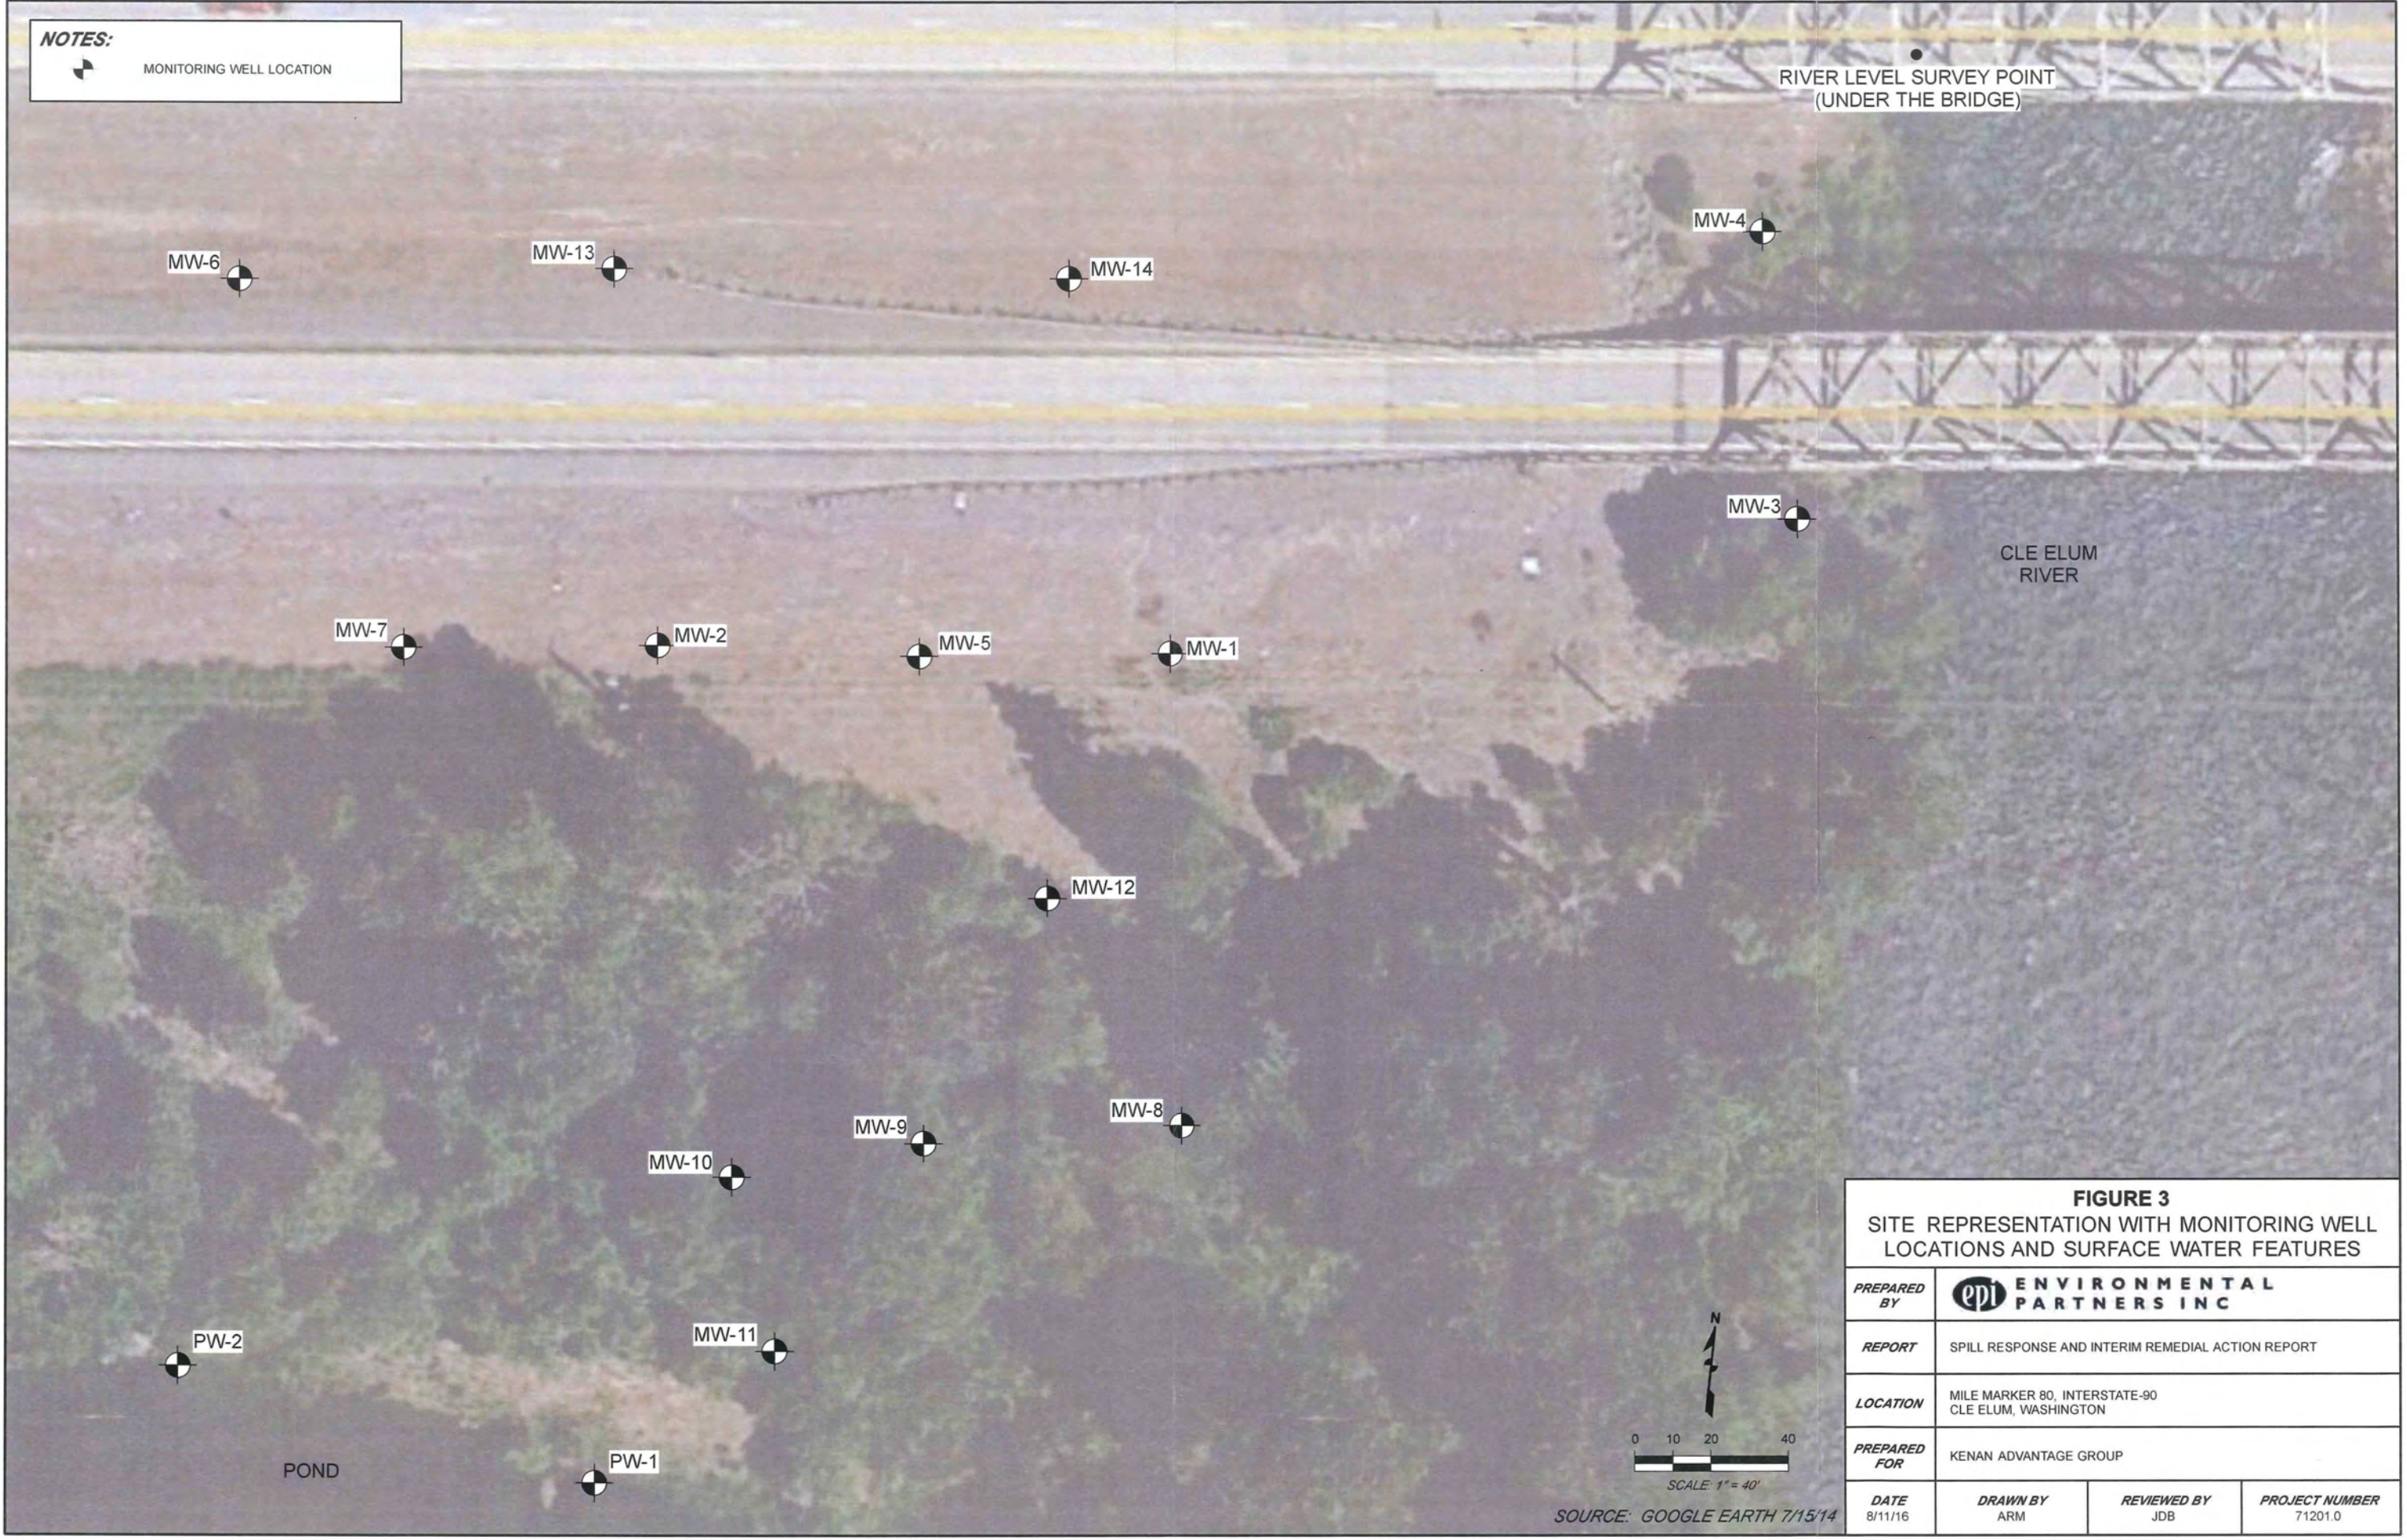
MONITORING WELL LOCATION

RIVER LEVEL SURVEY POINT
 (UNDER THE BRIDGE)

CLE ELUM RIVER

impacted groundwater. Based on the initial data obtained from the first six wells and observations that groundwater was likely high energy, additional wells (MW-7 through MW-12) were installed to assess conditions downgradient from the petroleum release. Following the remedial excavations, two more wells (MW-13 and MW-14) were installed in the excavation limits. A total of 14 groundwater monitoring wells were installed at the Site between December 9, 2015 and March 8, 2016. The locations of these monitoring wells are depicted on Figure 3.

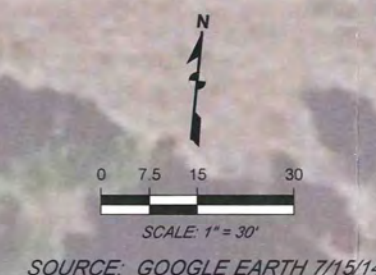
| FIGURE 5 INITIAL TEST PIT LOCATIONS WITH SOIL ANALYTICAL RESULTS (in mg/kg) | | | |

Each test pit was excavated until impacts were not detectable by standard field screening and olfactory methods. Vapors at each test pit were monitored for volatile organic compounds (VOCs) using a photoionization detector (PID). Petroleum staining, sheen, and/or odor was observed at some of the test pit locations and VOCs were detected with the PID at concentrations ranging from 0.1 to greater than 500 parts per million by volume (ppmv). The highest concentrations of VOCs were detected in vapors from the vicinity of test pit T-2 located north of the highway in the center of the median.

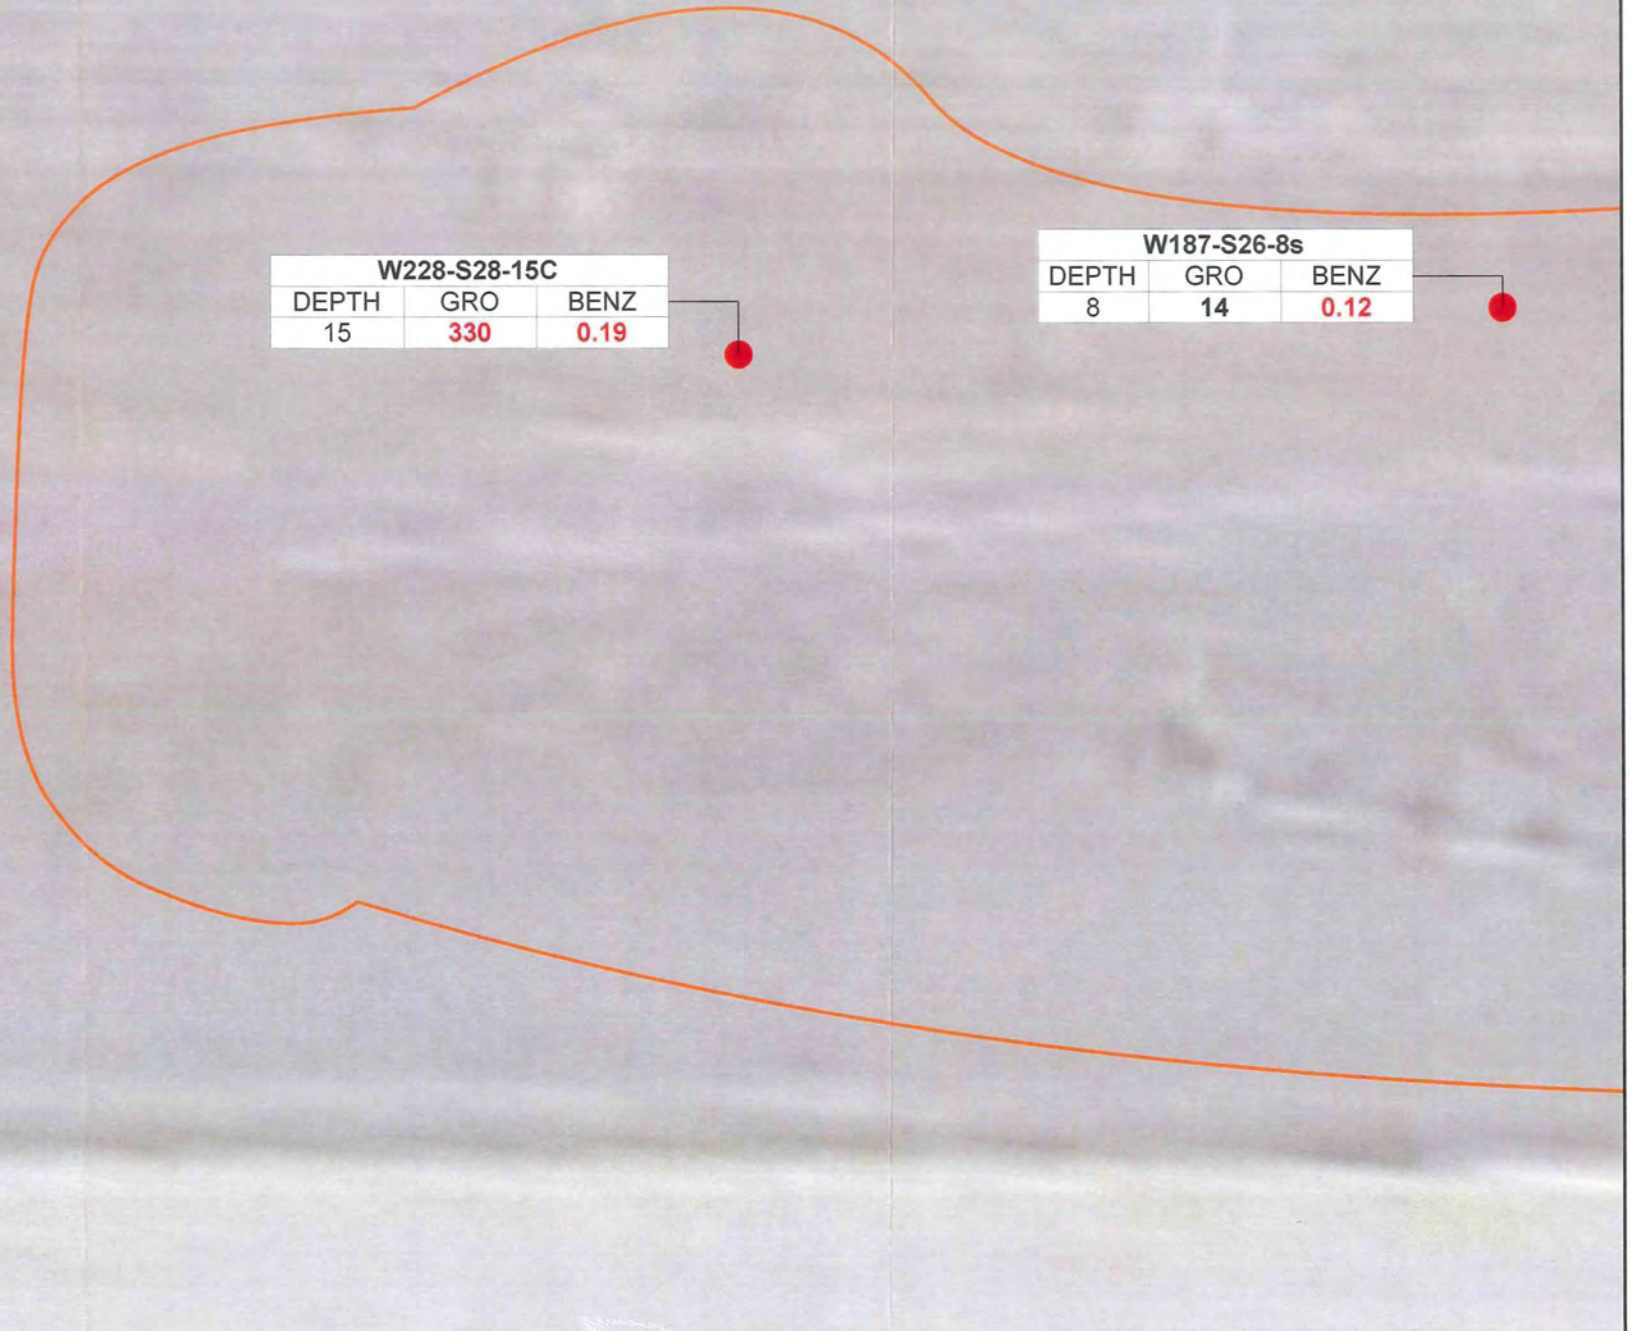
GRO = GASOLINE-RANGE ORGANICS
 BENZ = BENZENE

ALL SOIL RESULTS IN MILLIGRAMS/KILOGRAM
 ALL WATER RESULTS IN MICROGRAMS/LITER

As previously noted, the soil sampling locations for the excavation areas are shown on Figures 6 through 9. Each red or green dot represents where a soil sample was collected from or immediately surrounding the excavation areas. Red dots identify samples containing COC concentrations that exceeded an applicable CUL. Green dots identify samples with COCs at concentrations less than the CULs or PQL.
