FEDERAL WAY LINK EXTENSION

**Phase II Environmental Site Assessment Addendum  
Sound Transit – Federal Way Link Extension  
Parcel FL-358  
2200 South 320<sup>th</sup> Street  
Federal Way, Washington**

**File No. 4082-039-01**

**February 18, 2019**

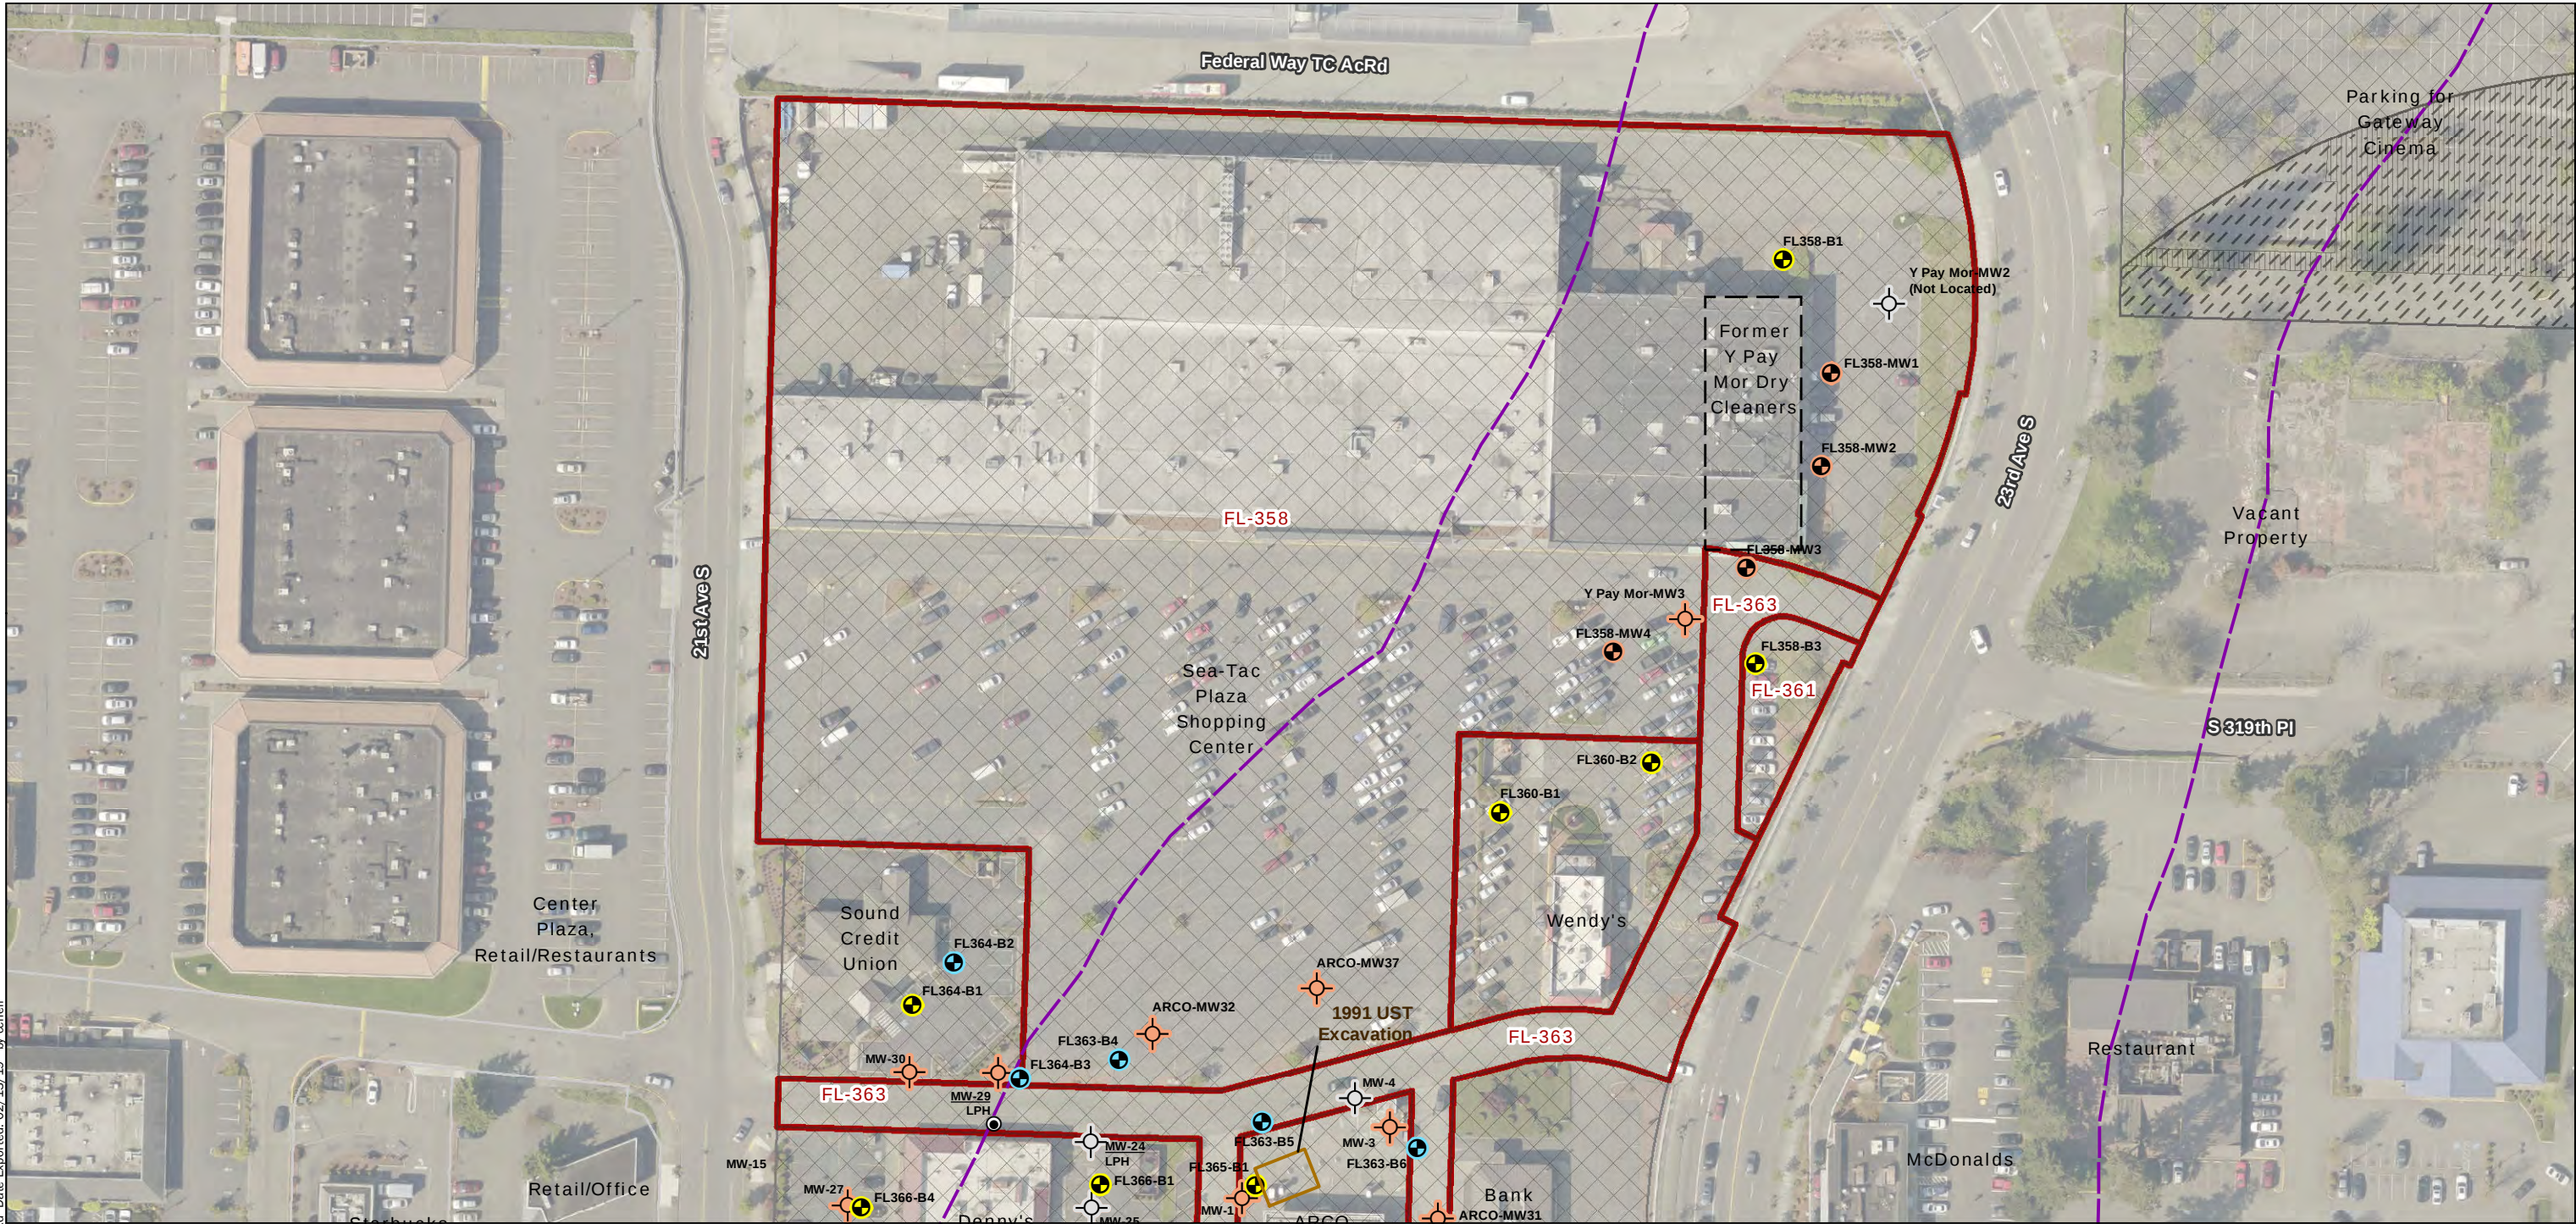
Figure 2

The location is shown relative to surrounding physical features in Figure 1. The current layout of the subject property and surrounding properties are shown in Figure 2.

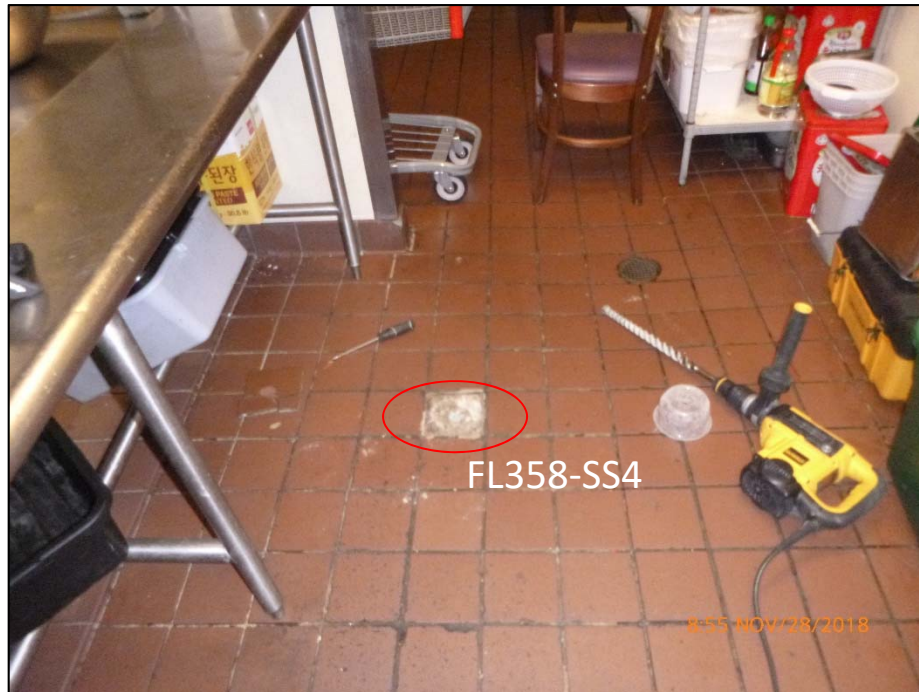
Photograph 1 – Passive sub-slab soil vapor sample location SS4, installed in kitchen of the Western Garden restaurant. Masonry drill and shroud at right of sample location.

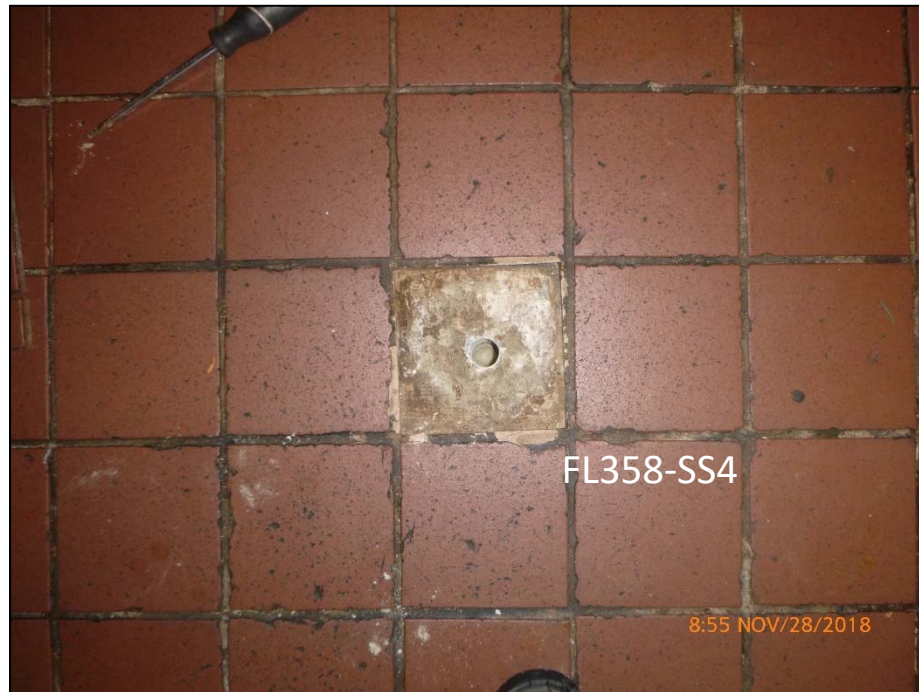
Photograph 2 – Detail of 1-inch hole advanced in slab at sample location SS4 in preparation of sampler installation.

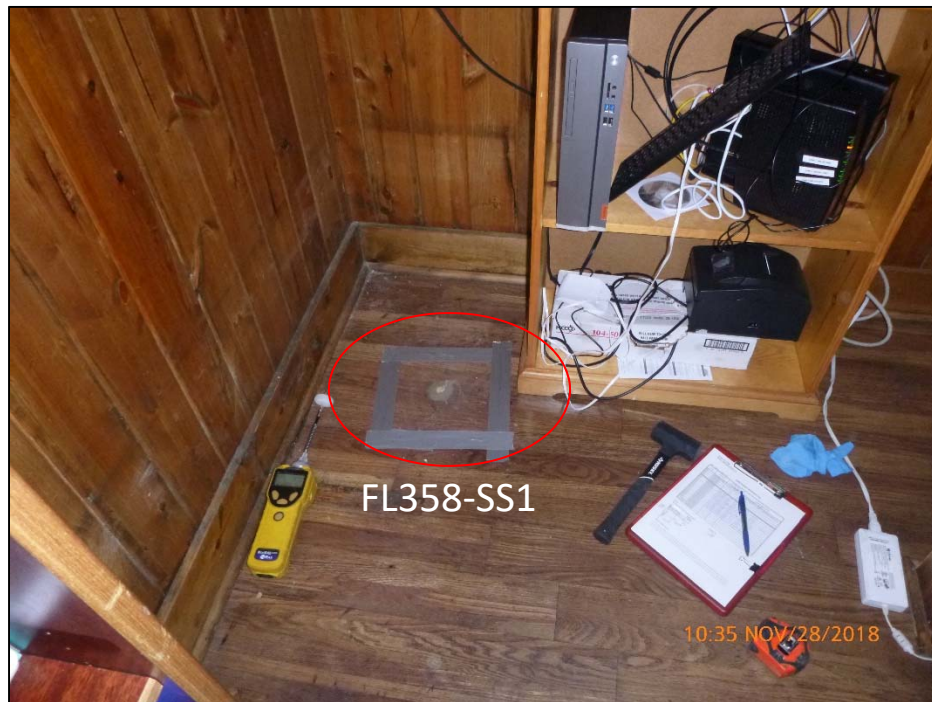
Photograph 3 – Completed passive sub-slab soil vapor sampler installation at location SS1 at the cashier station in the Western Garden restaurant. Field instrument (PID) visible surrounding location.

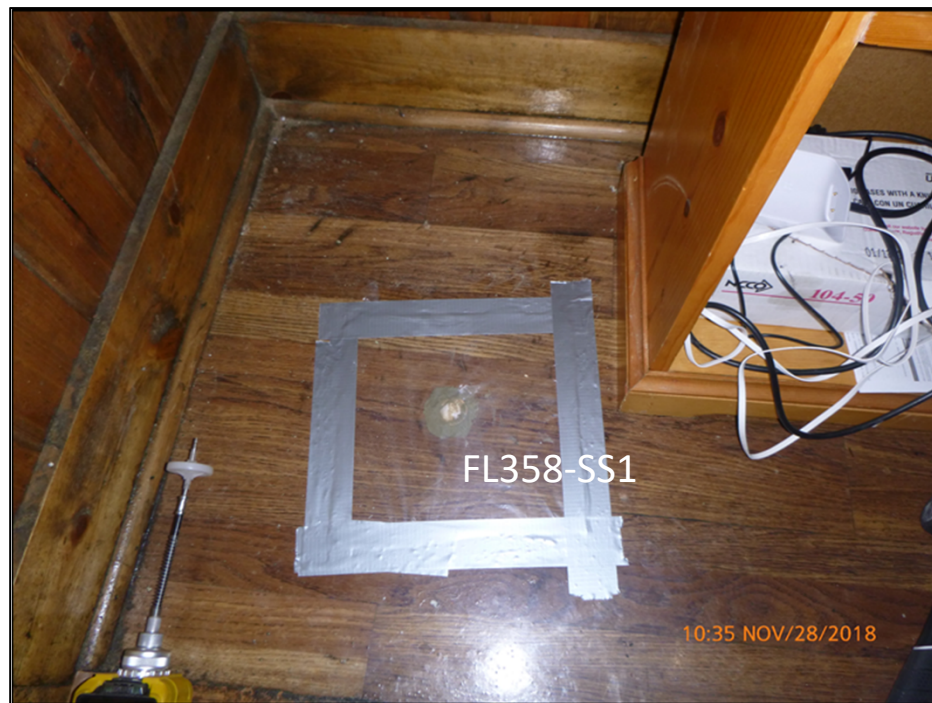
Photograph 4 –Detail of sample location SS1 showing cork in center of slab penetration, surrounded by bentonite seal and waterproof plastic sheet and tape.
