POST FIELDWORK MEMORANDUM

Re: Chinook Wind Cultural Resources Sub-Surface Investigations, King County, Washington (King County Water and Land Resources Division Contract E00555E18-1, Work Order # 1126895/2.4.07/E00454-14)

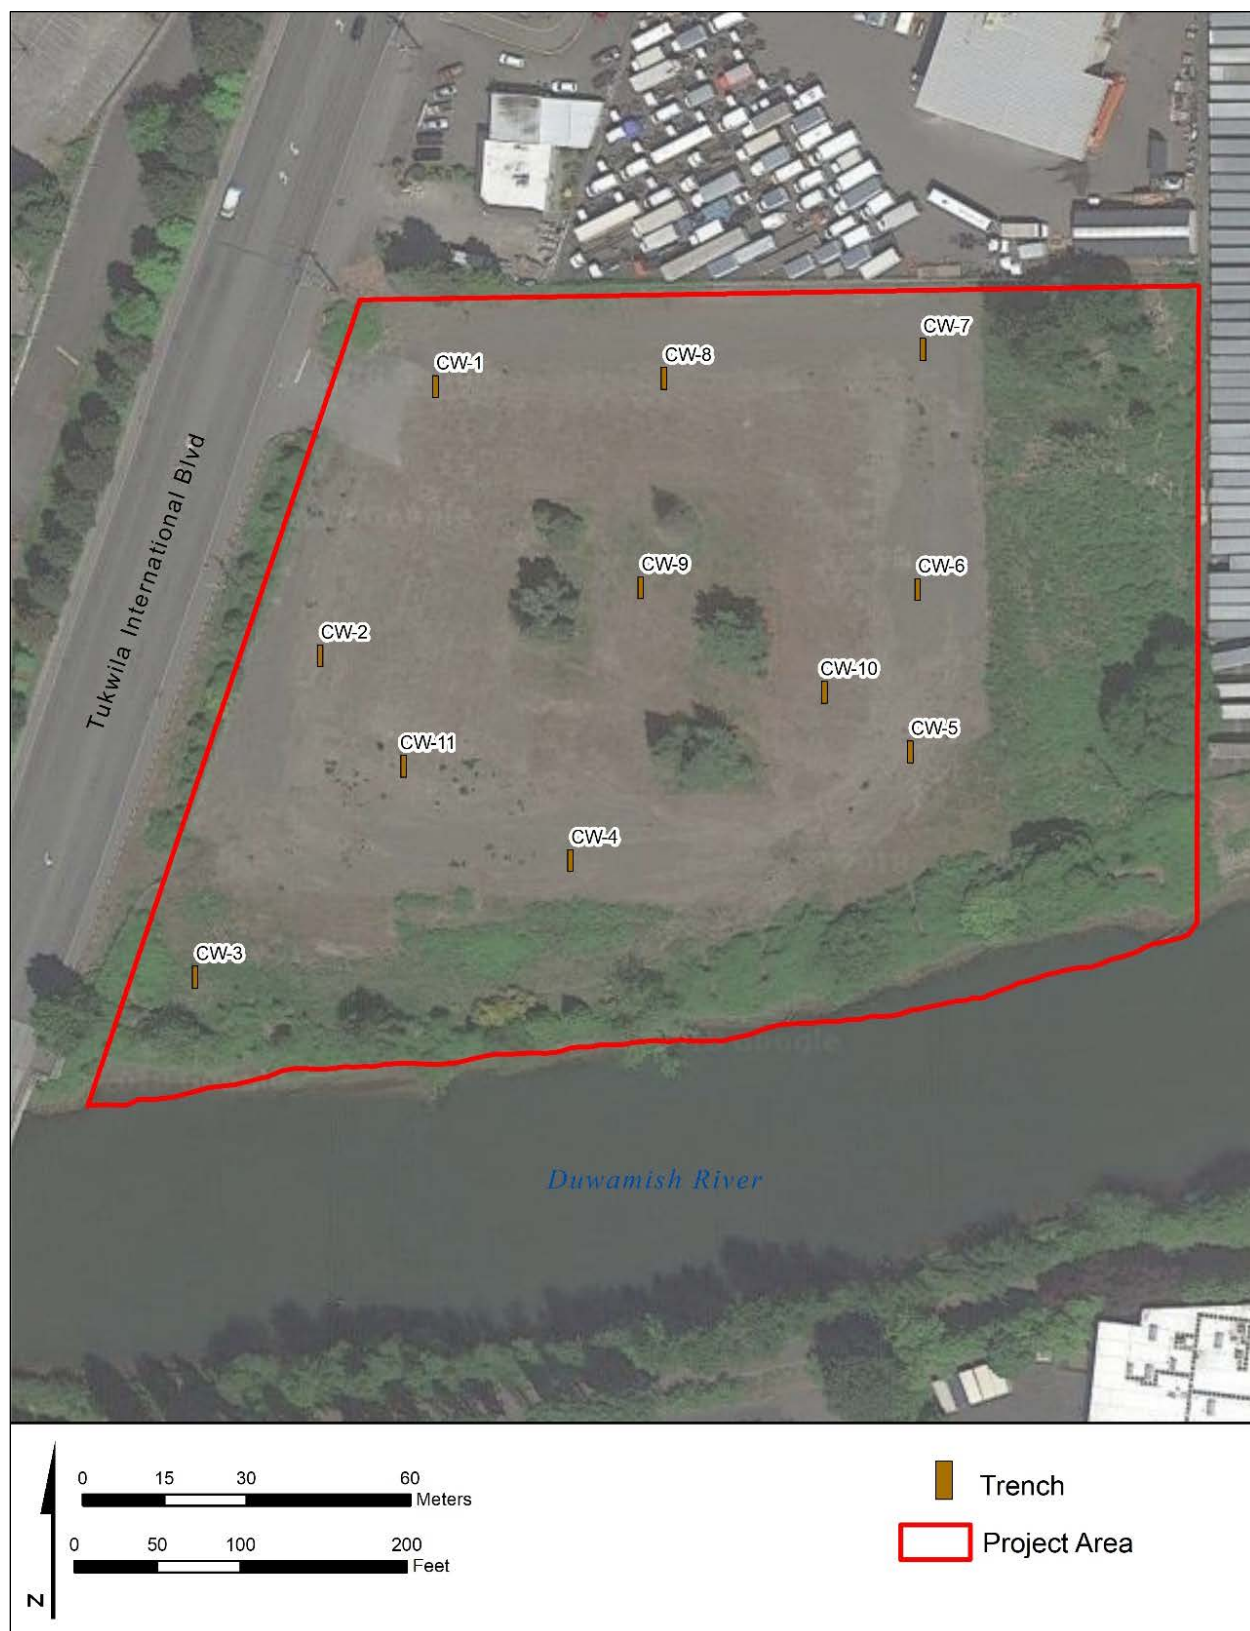
Figure 2. Locations of trenches excavated for Chinook Wind Cultural Resources Sub-Surface investigations.

A total of 11 trenches were started and 10 successfully completed to a target depth of between 11 and 12 fbs between Jan. 14 and Jan. 17, 2019 (Table 1, Figure 2). Trench CW-5 collapsed after reaching 8 fbs, but the walls remained stable long enough to clean out the heaved material and finish the trench to a total depth of 11.5 fbs. Trench CW-10 was abandoned at 6 fbs after the entire west wall of the trench collapsed and attempts at cleaning out the heaved material and continuing the excavation induced additional wall collapse (Figure 3).

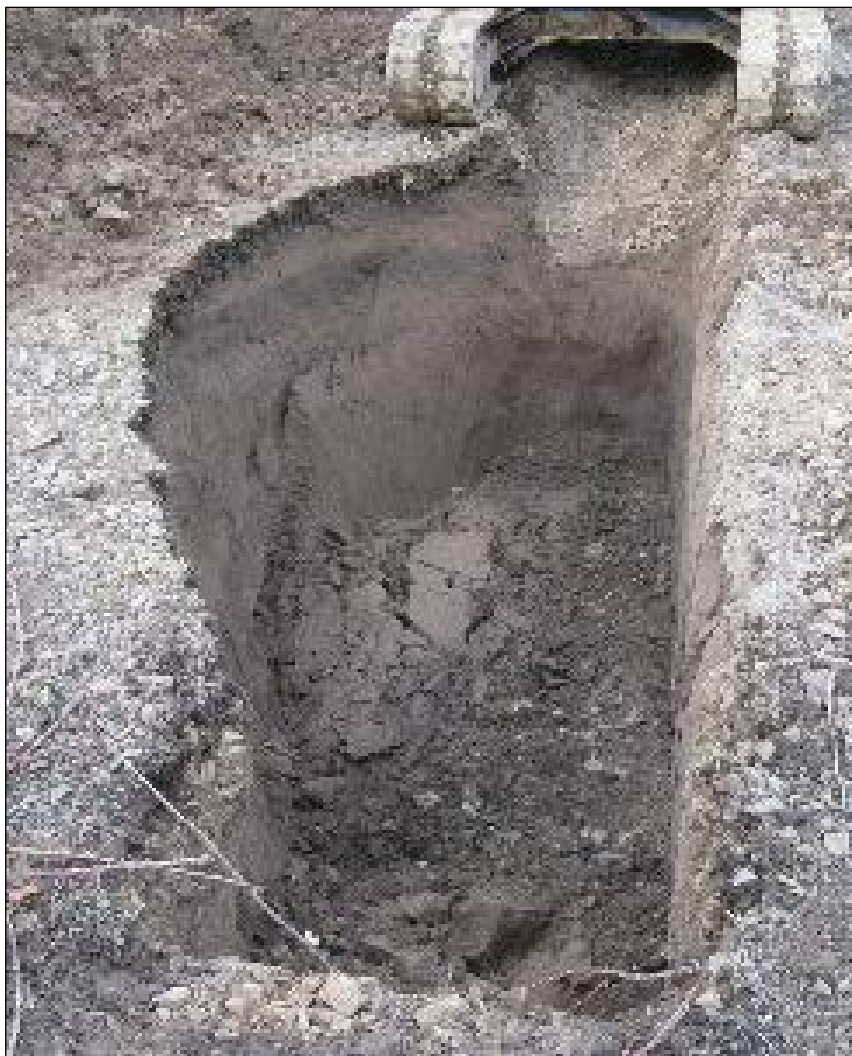
Figure 3. Photo of Trench CW-10 wall collapse (Photo by PGS).

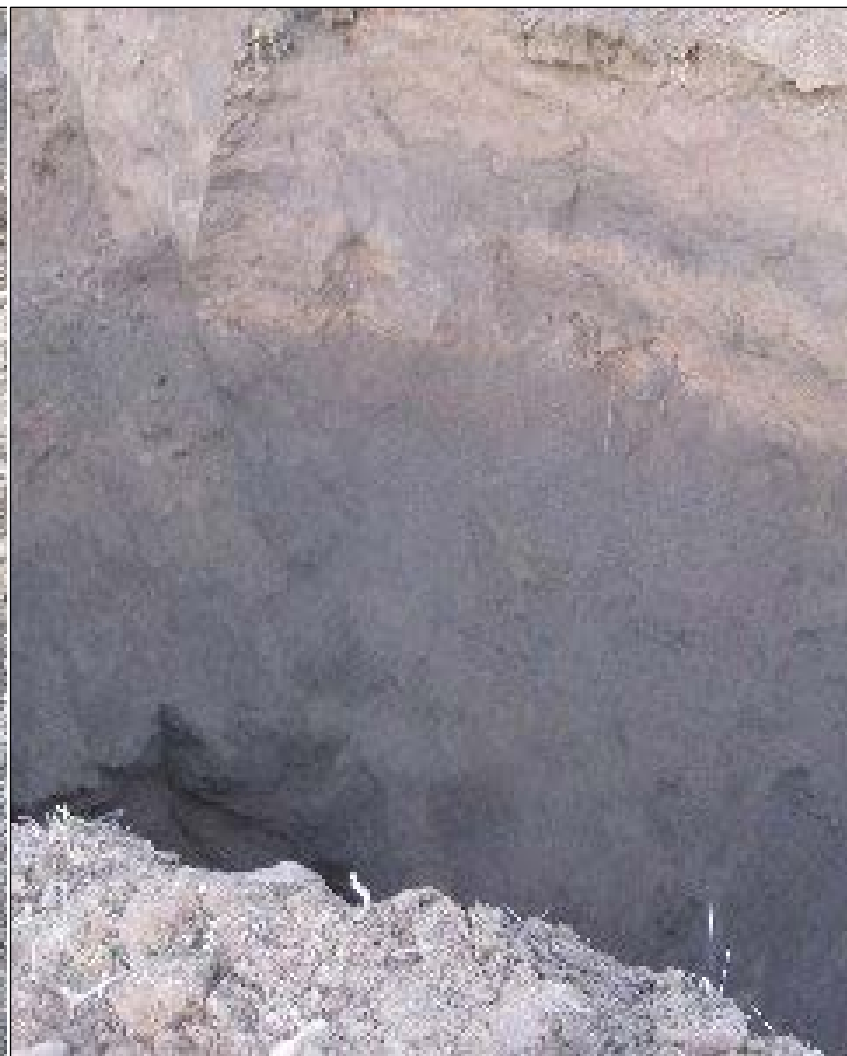
Figure 4. Photo showing dark gray laharic coarse sand in the lower portion of Trench CW-5. (Photo by PGS).

In general, all trenches exhibited a fining-upward trend in the dominant grain size of the sediment, with the basal portions of many trenches marked by a distinct, thick, dark gray laharic medium to coarse sand (Figure 4). The upper 4 to 6 feet of the trenches usually were dominated by poorly expressed thin stratified deposits consisting of flood couplets that had been overprinted by soil-forming processes between depositional events. These were typically characterized by a base of very fine to fine sand capped by drapes of silt mixtures incorporating varying amounts of very fine sand. With greater depth and as the sediments became increasingly coarse with depth, beds increased in thickness until at the greatest depths most sediments were dominated by massive dark gray laharic sand.
