**Re: March 2020 Fuel Spill Response and Cleanup**  
Reserve Silica Corp., Ravensdale, Washington  
Project No. 160315

**Property Location Map**  
Fuel Spill Response Report  
Reserve Silica  
Ravensdale, Washington

# Spill Response Map

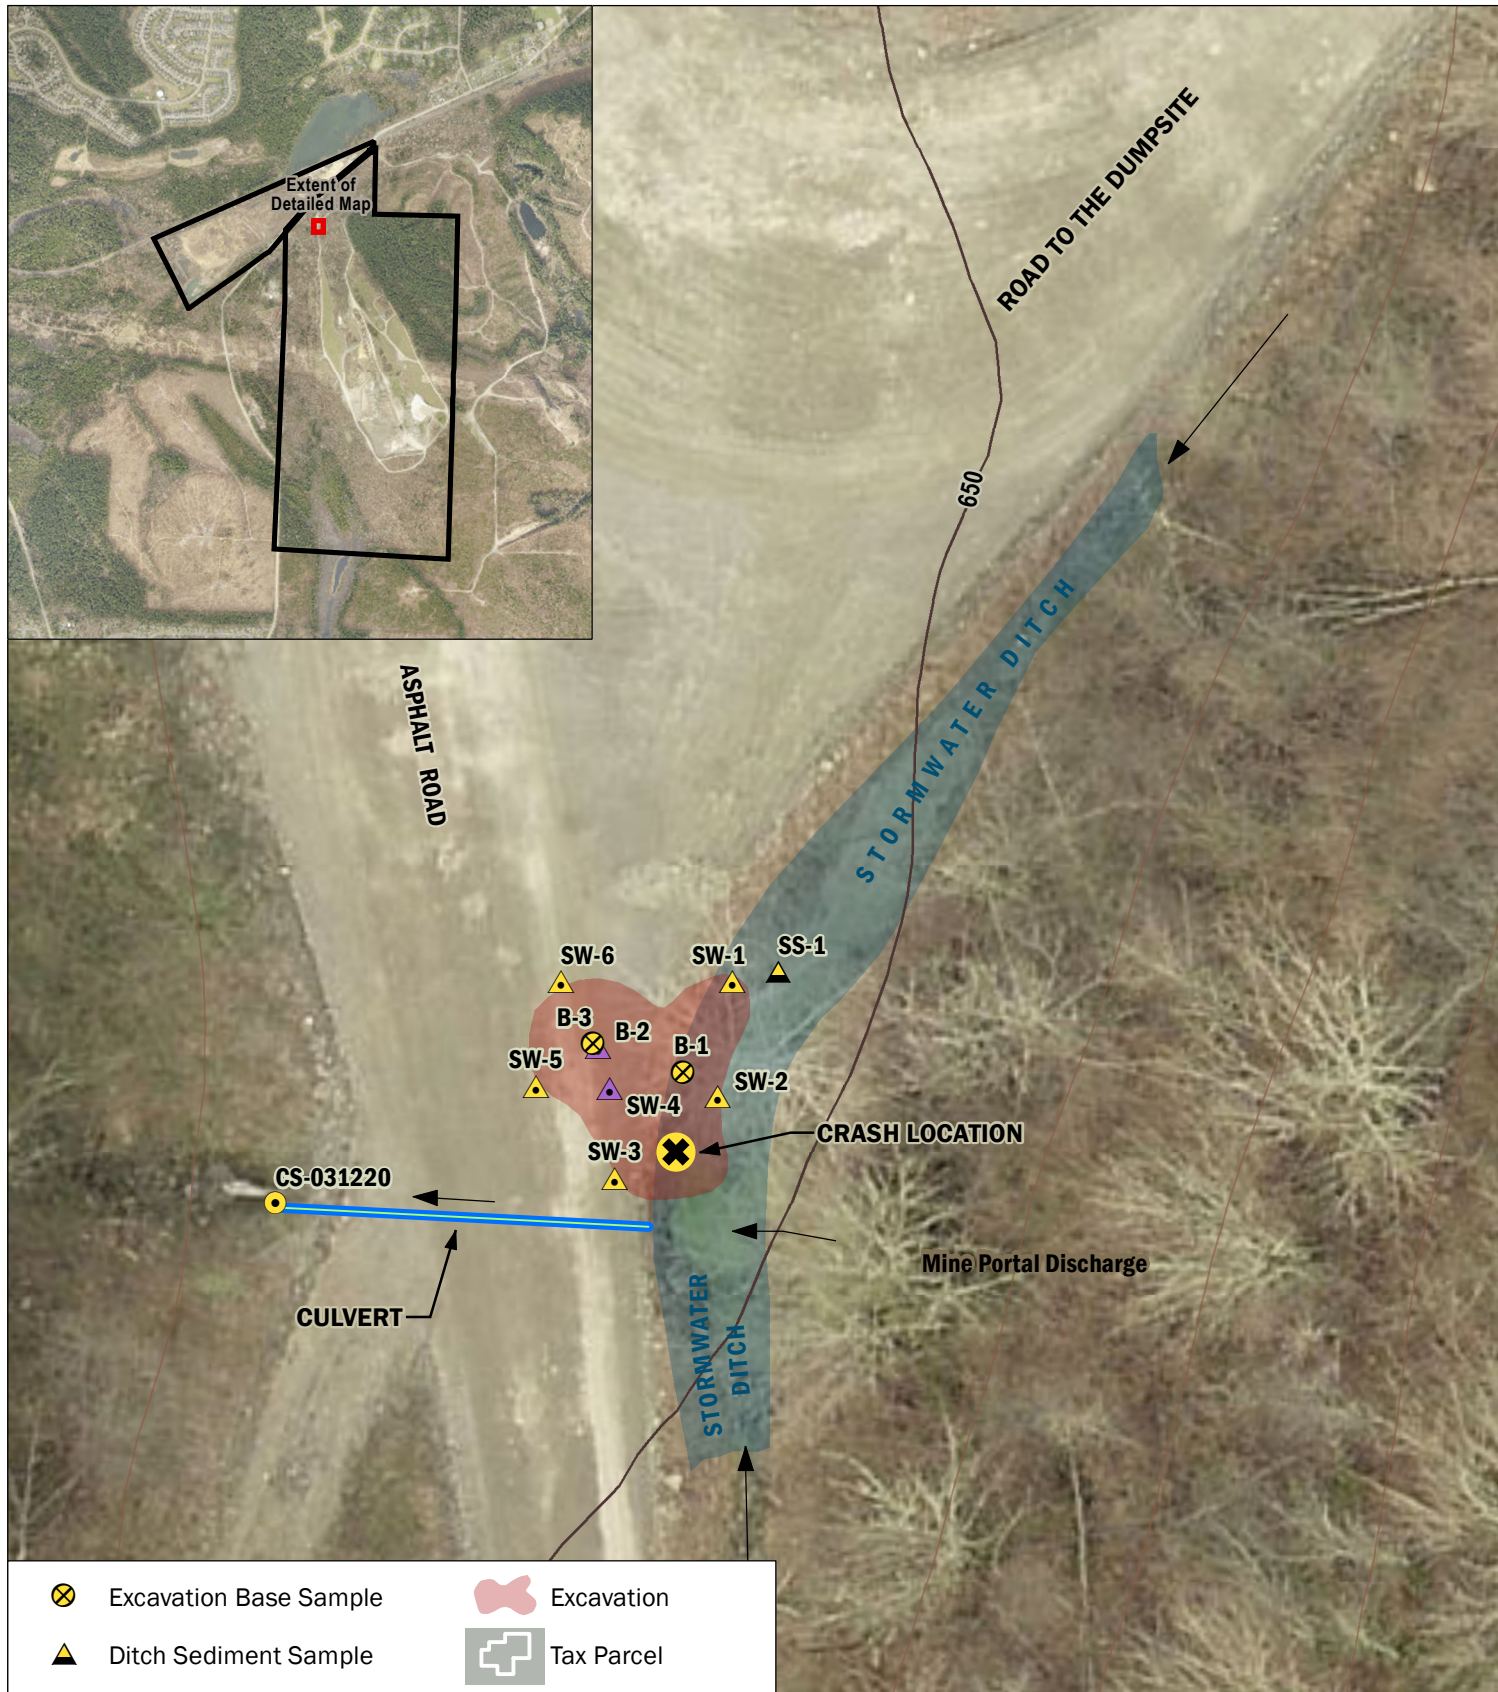
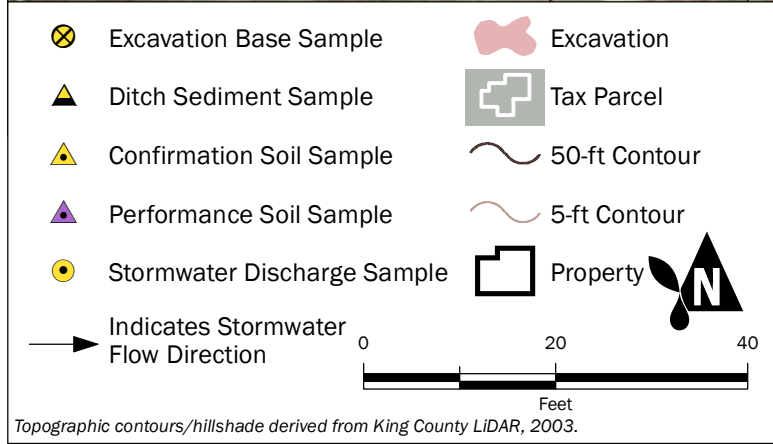
On Friday, March 6, 2020, an Aspect field geologist was on-site with Reserve Silica personnel and Ecology spill responder Andy Quast to observe removal of the truck from the ditch, evaluate the extent of the spill and develop a cleanup approach. The truck crashed into a ditch at the intersection of two haul roads at the facility, both of which lead uphill to the dumpsite. The stormwater ditch collects surface water runoff alongside the roads, which flows together into a culvert that extends beneath the road and discharges to the ground surface on the west side of the road (Figure 2).

Sidewall samples collected from the ditch sediments on the northeast end of the excavation (SW-1 and SW-2; Figure 2) contained concentrations of motor oil-range hydrocarbons above the MTCA Method A cleanup level (Table 1). The laboratory chemist reviewed the chromatograms for these samples and indicated that they contained a motor-oil component that is typical of asphalt, and did not contain diesel (x-flagged results reported in the diesel range are overlap from the motor

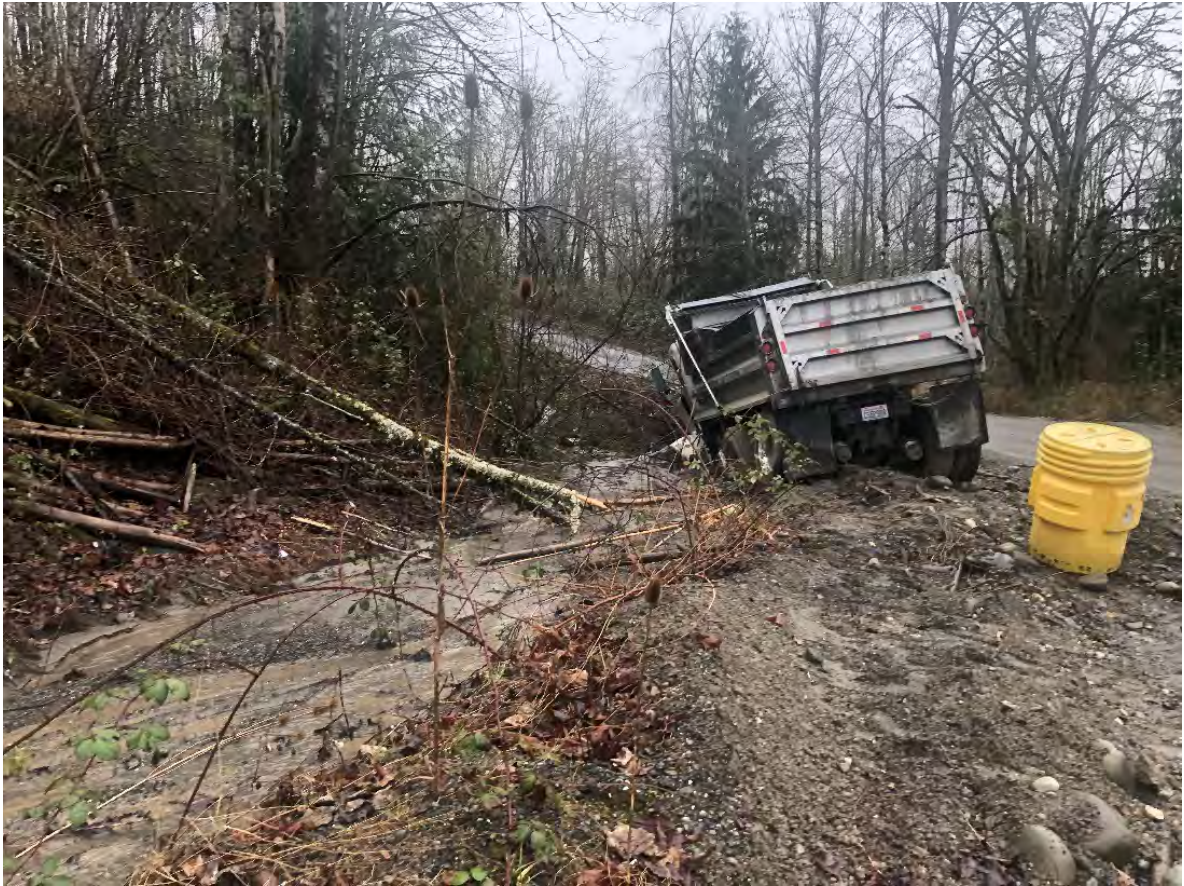
Photograph 1. View of crash site on 3/6/2020 (looking south).

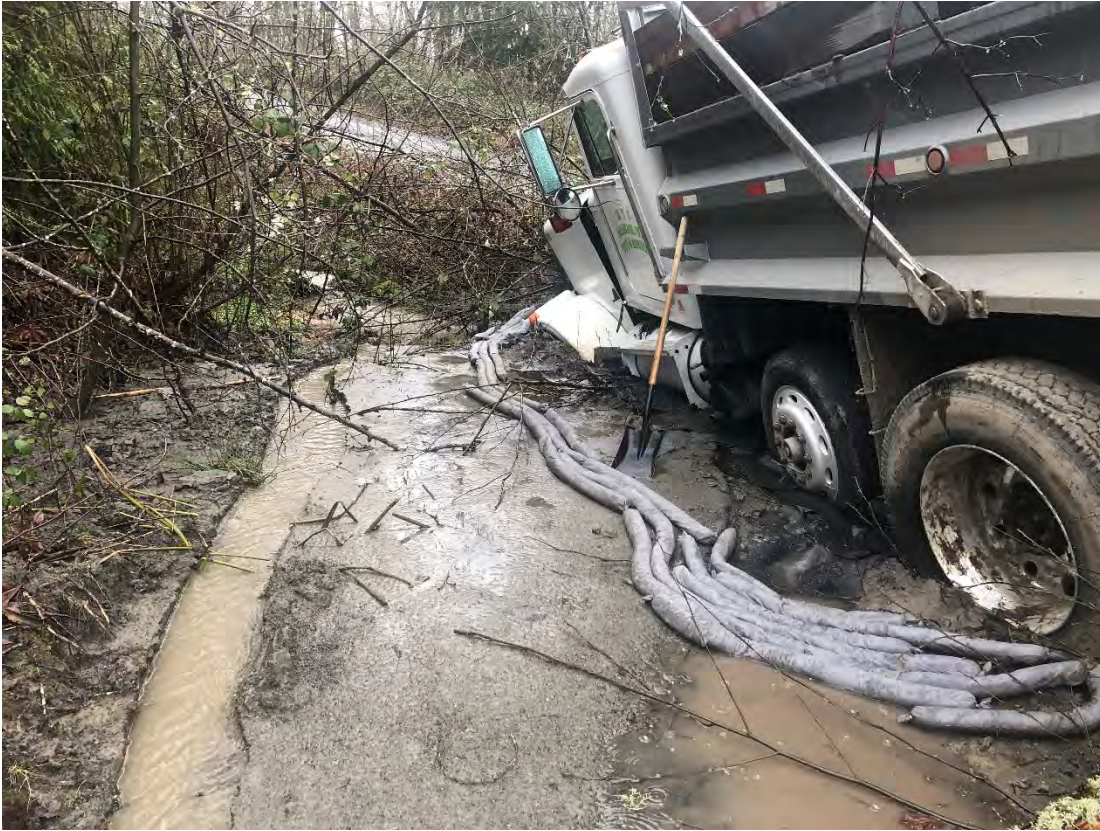
Photograph 2. View of stormwater bypass (left side) and absorbent socks containing diesel spill on 3/6/2020 (looking south).

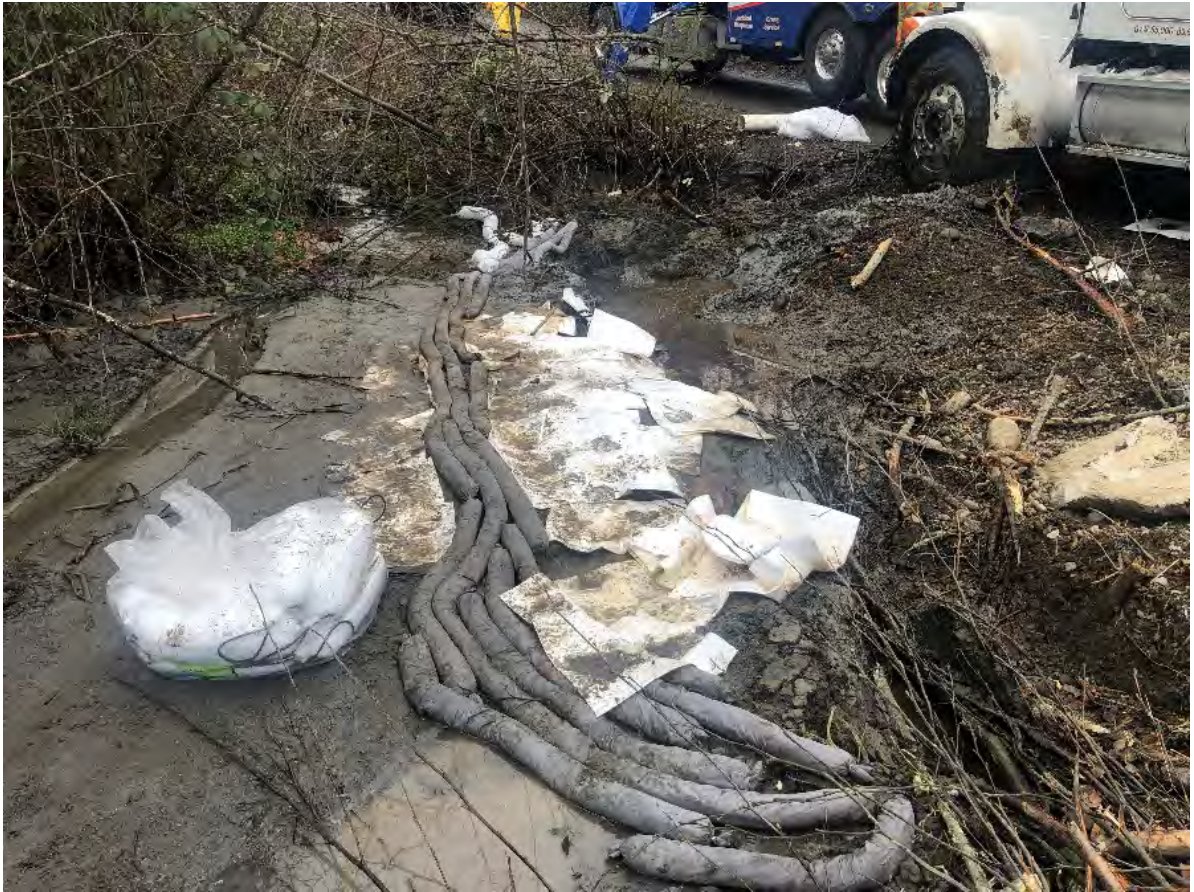
Photograph 3. Location of the spill site immediately following removal of the truck from the ditch on 3/6/2020 (looking south).

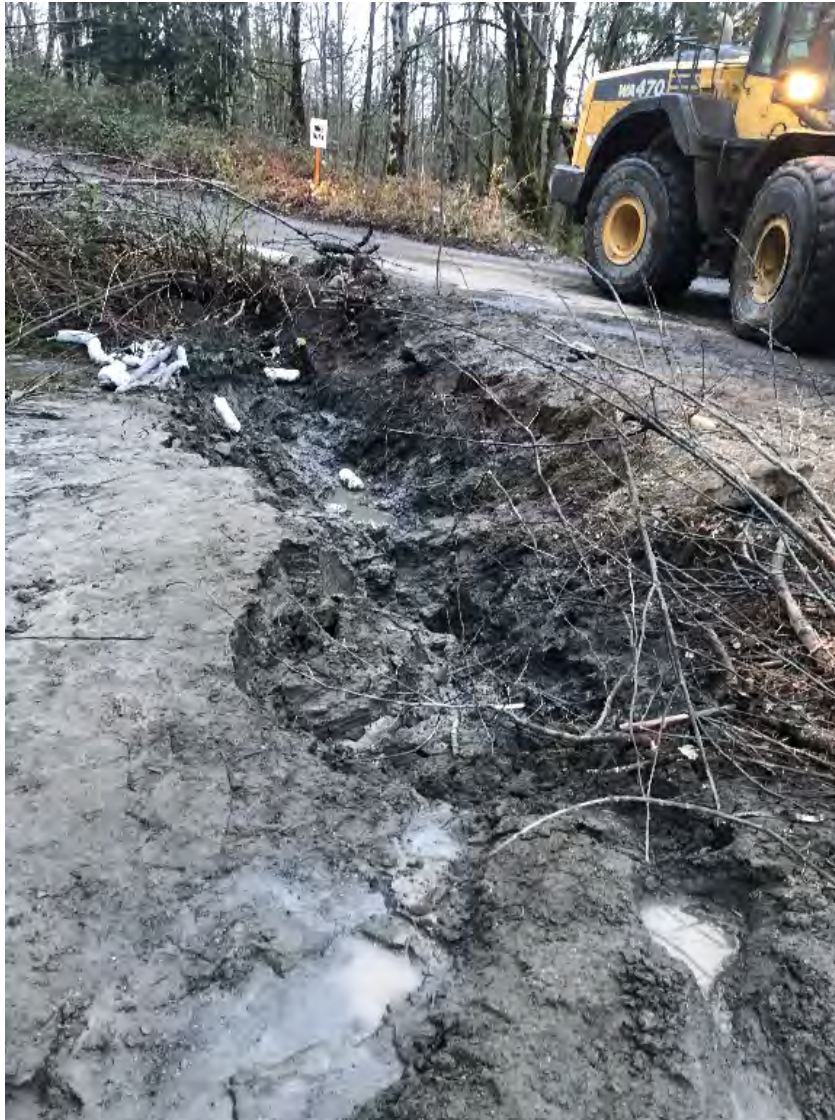
Photograph 4. Beginning of soil excavation on 3/6/2020 (looking south).

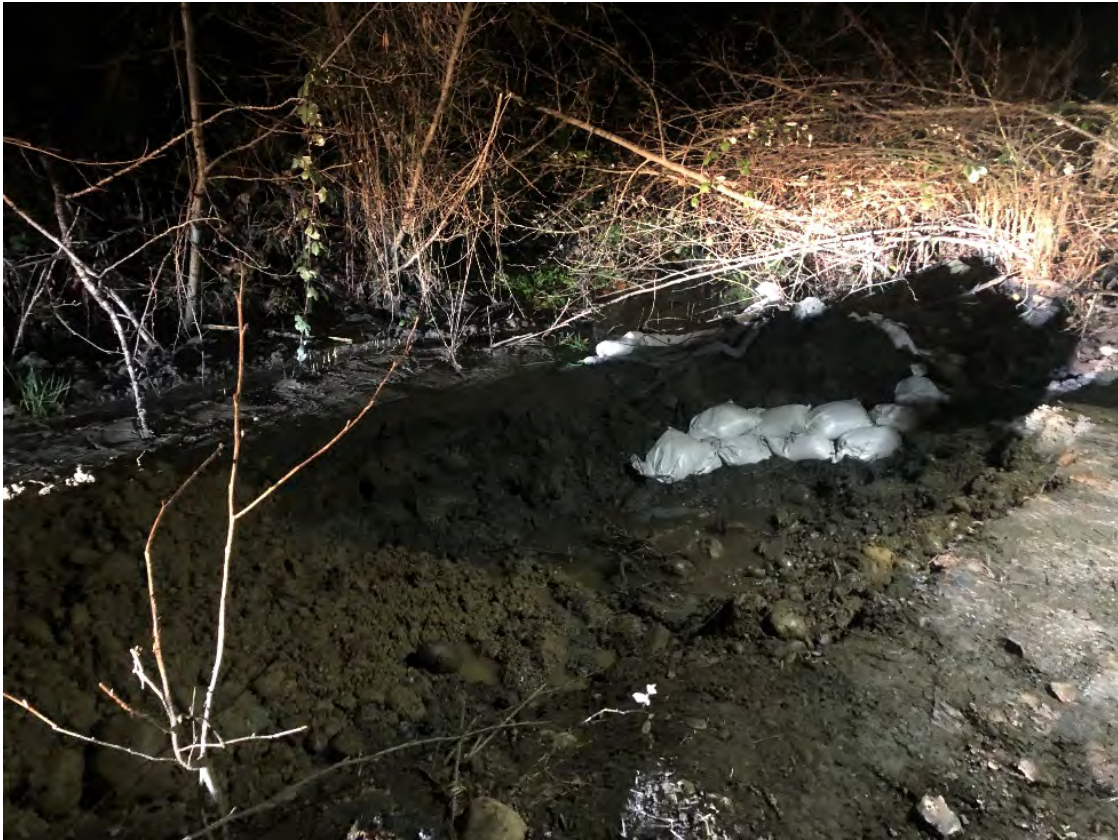
Photograph 5. Midexcavation, evening of 3/6/20. Sandbags set against soil berm below culvert to maintain separation from stormwater drainage (looking southeast).

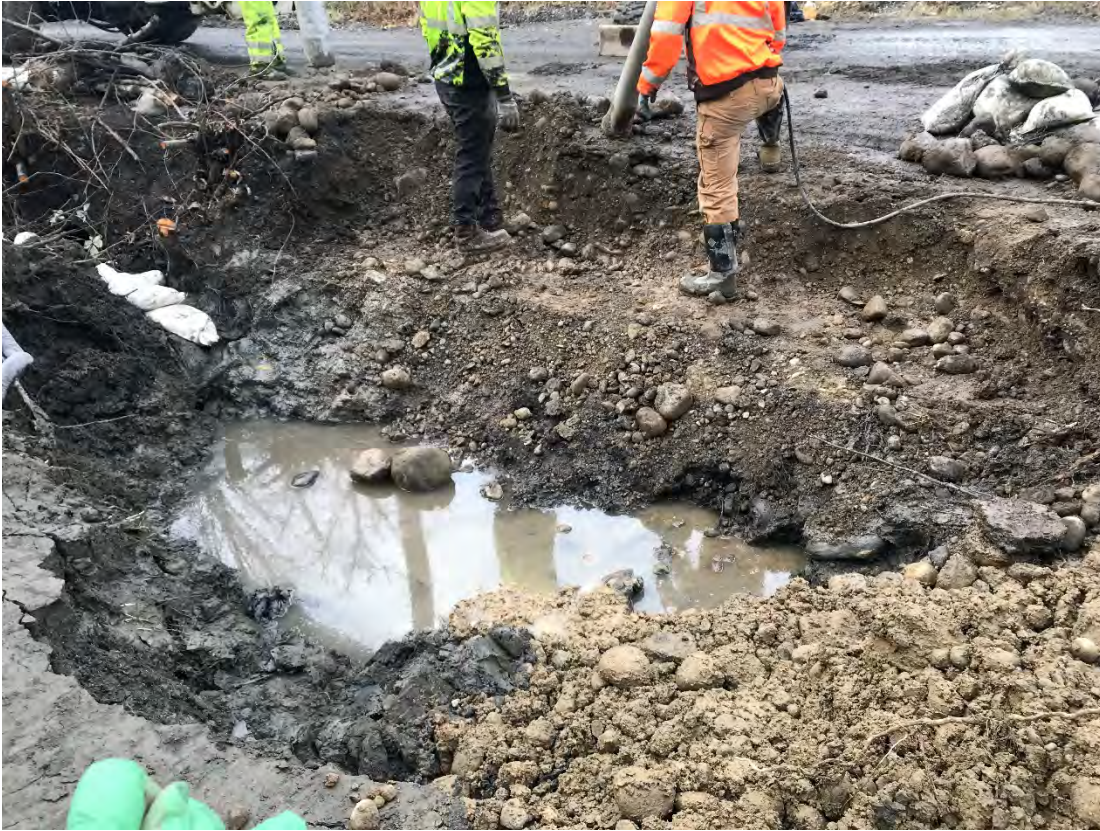
Photograph 6. Midexcavation on 3/7/2020 (looking west).

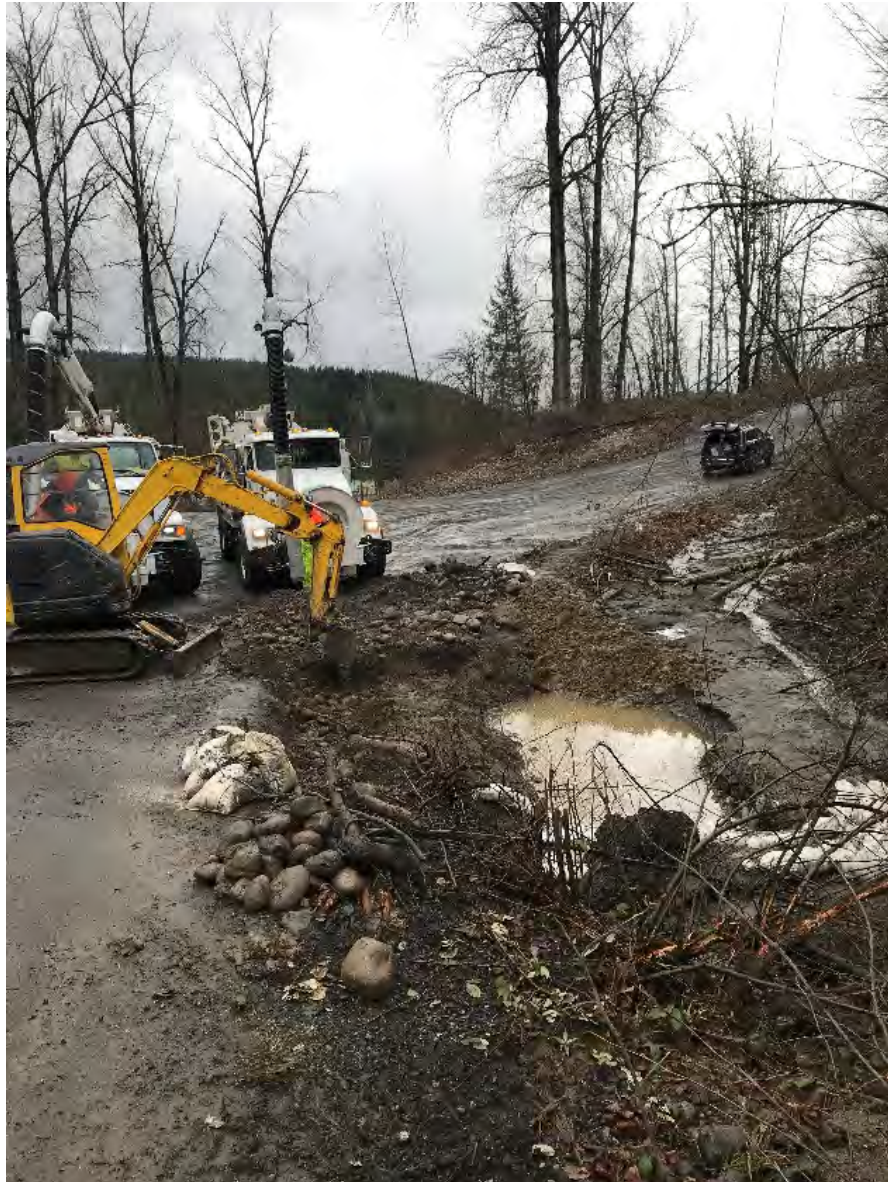
Photograph 7. Midexcavation on 3/7/2020 (looking north).

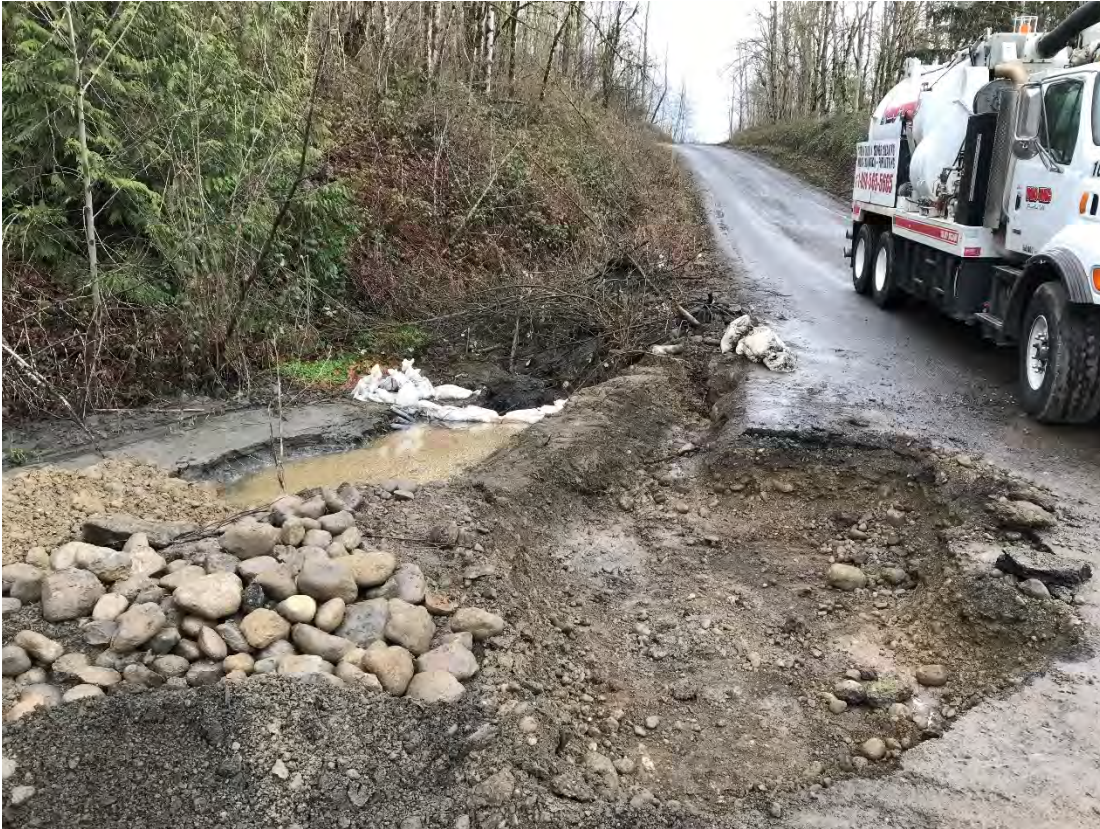
Photograph 8. Excavation extent at end of day on 3/7/2020 (looking south).

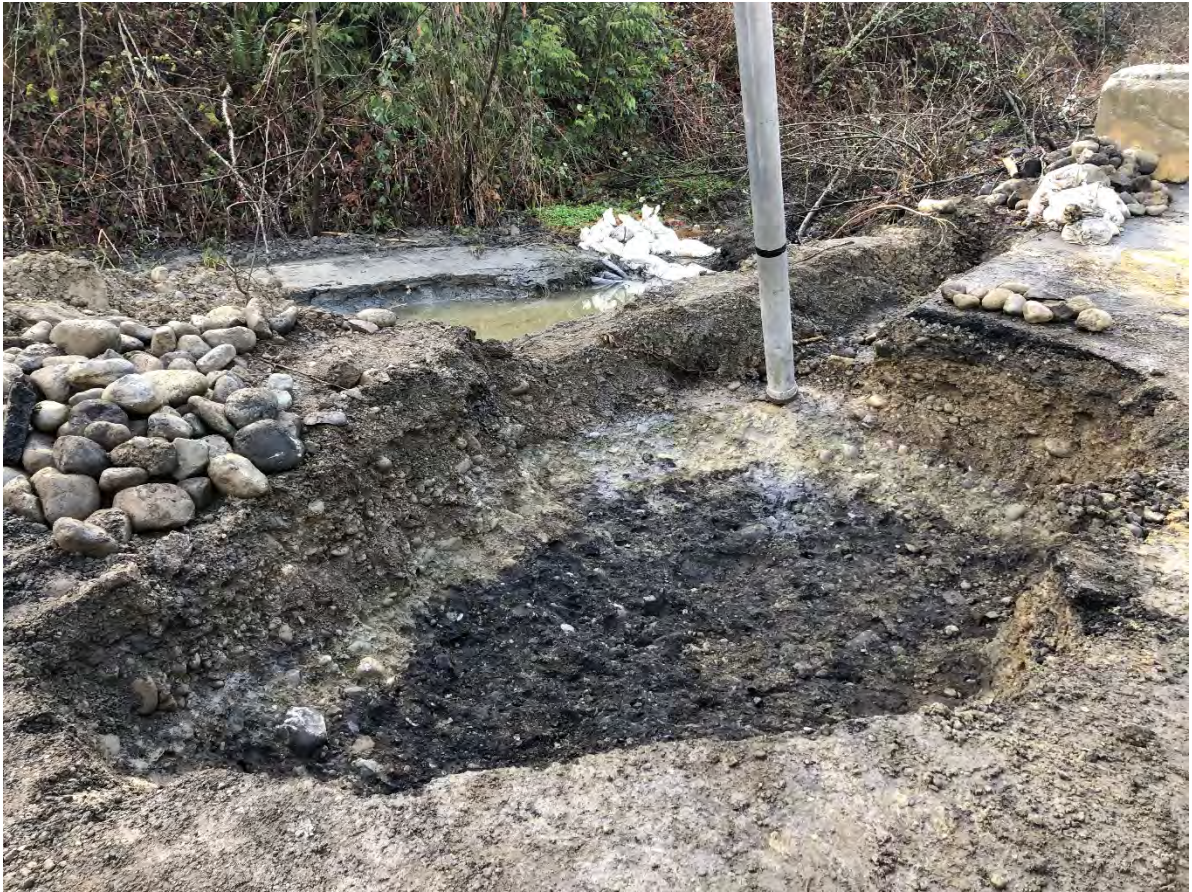
Photograph 9. Final extent of excavation on 3/12/2020 (looking southeast).
