## **2019 Riverfront Park Soil Management Report**

Riverfront Park  
Spokane, Washington

May 4, 2020

File No. 0110-148-06

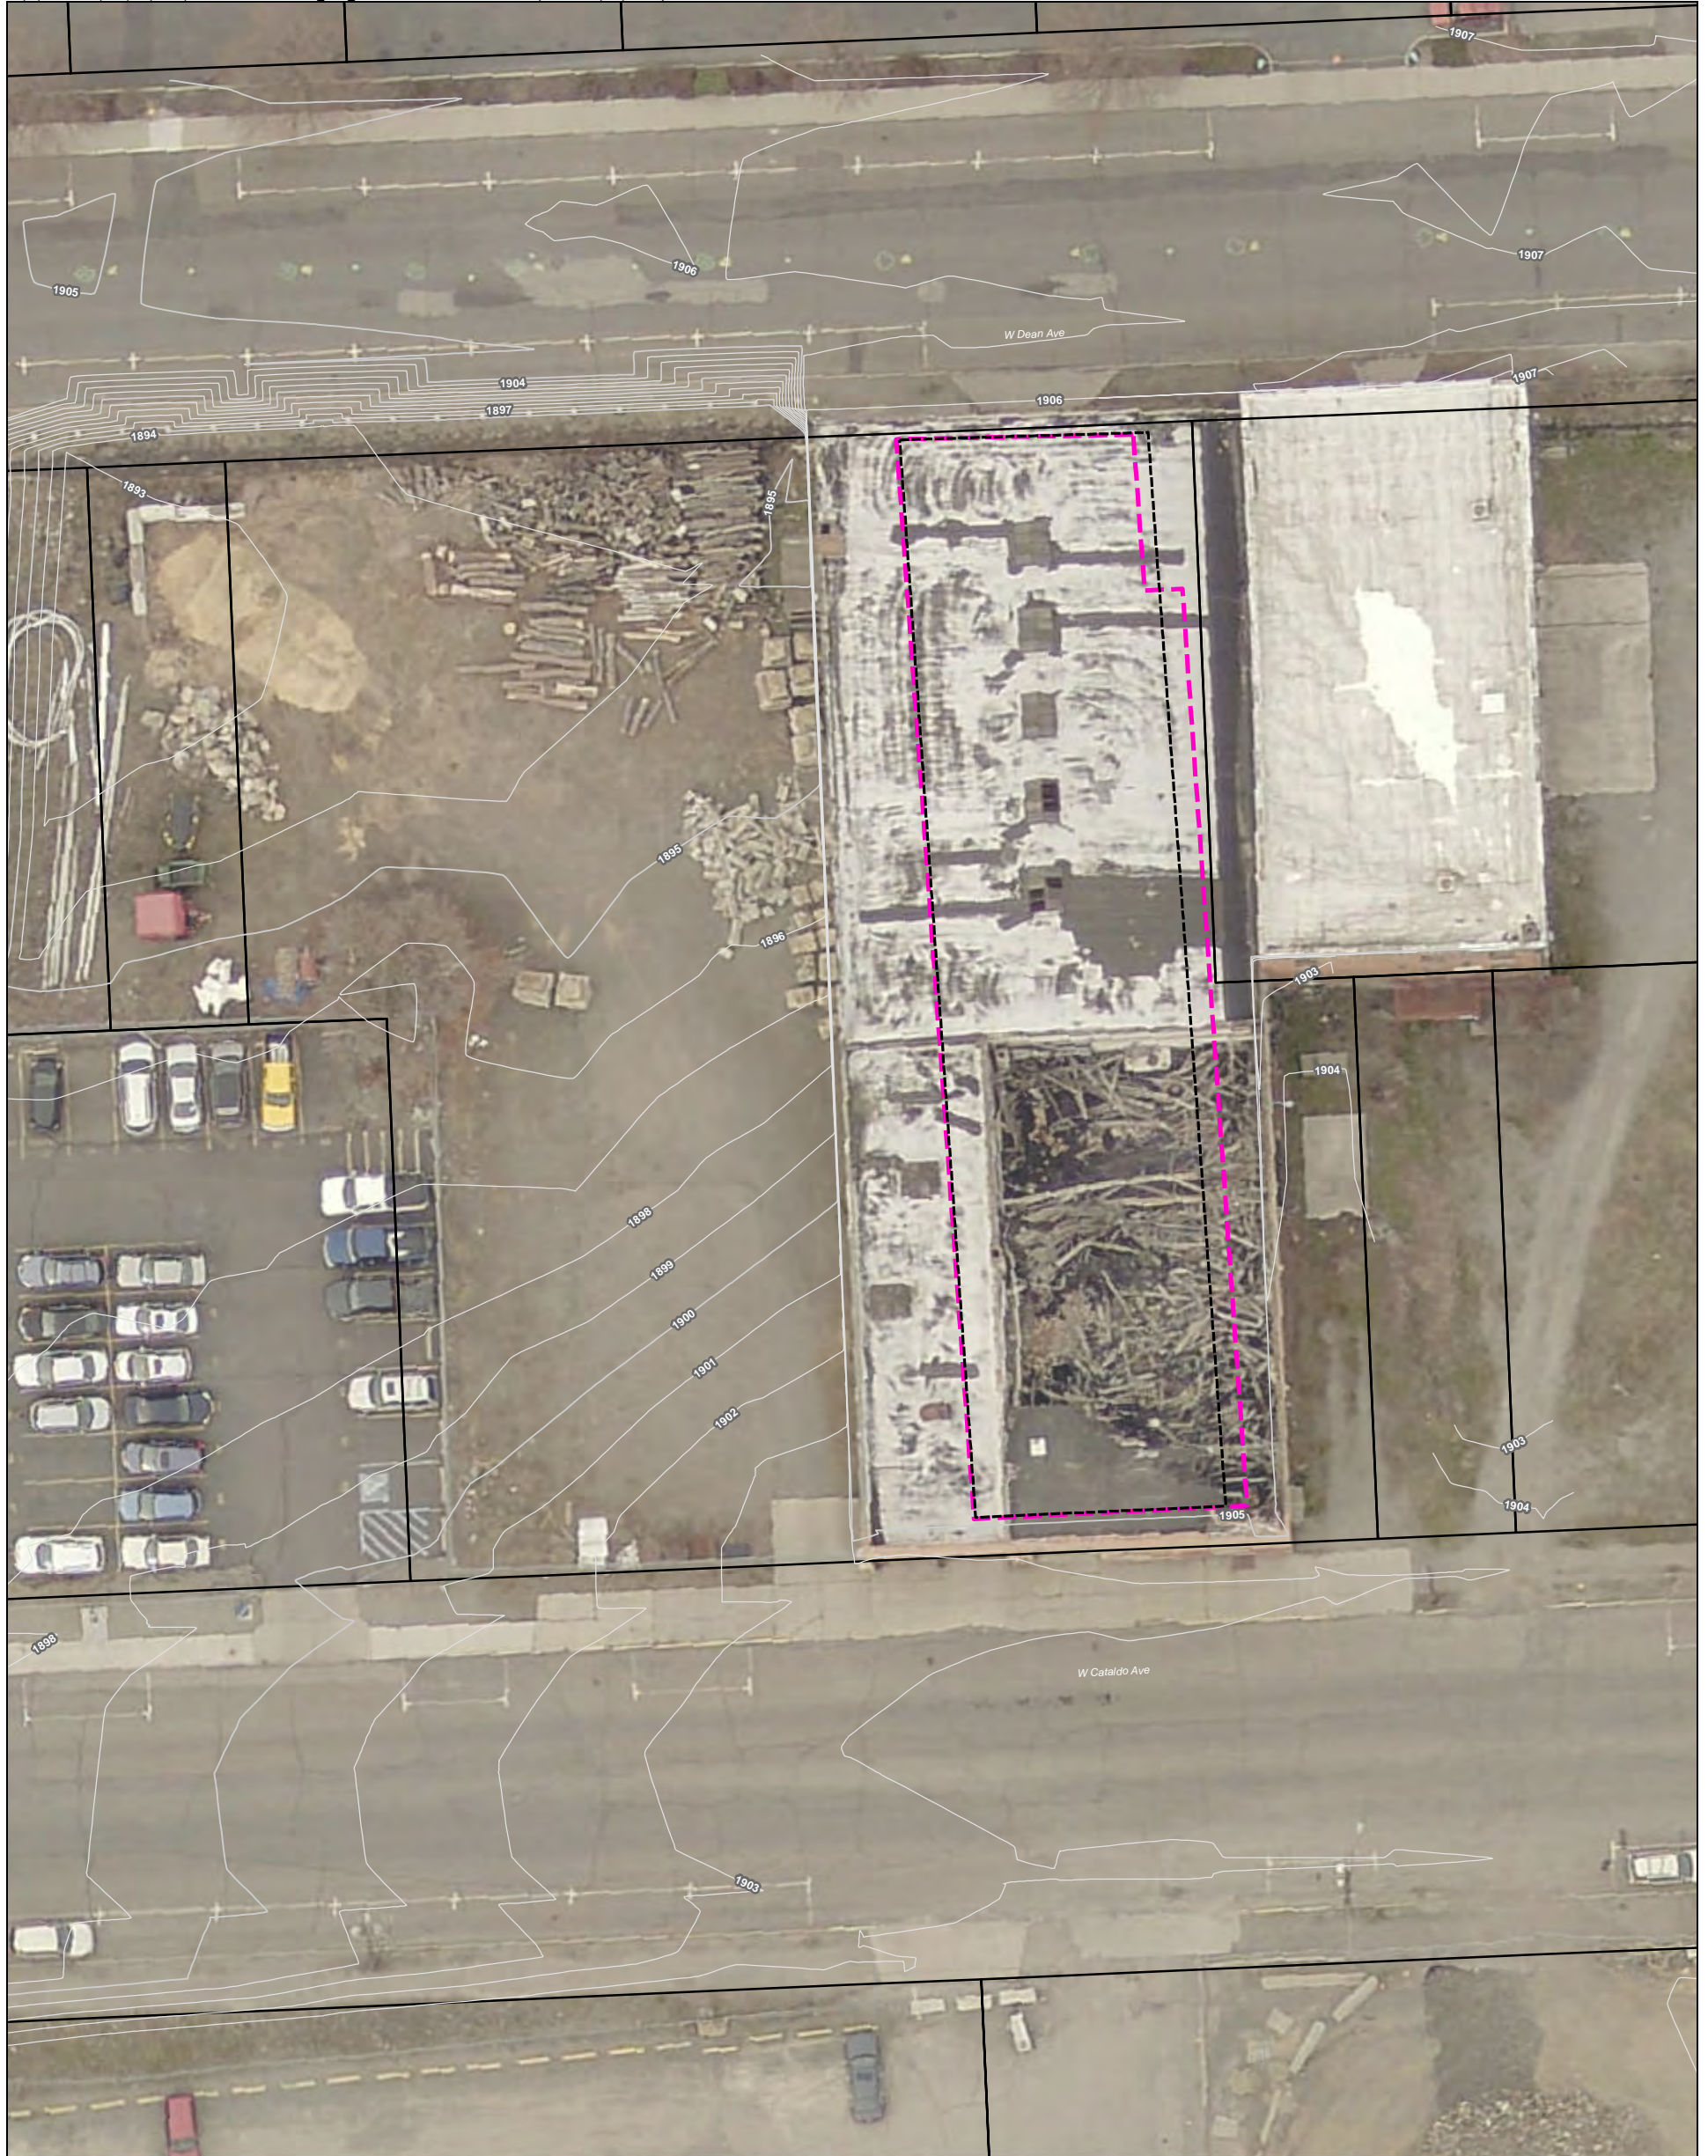
**Figure 2**

The soil was placed and compacted under the Sportsplex building footprint and within tax parcel 35181.4206 as shown on Spokane Sportsplex Riverfront Park Fill, Figure 2. The soil was placed between Elevation 1,894 and 1,901. The finished floor slab of the building is designed for Elevation 1,905. Tax parcel 35181.4206 was sampled as part of previous environmental investigations and a geotechnical investigation for the Sportsplex building. During these investigations, metals and PAHs were detected in soil samples at concentrations greater than the MTCA Method A cleanup levels within the parcel boundaries (GeoEngineers 2019a). Because of the parcel's proximity to Riverfront Park, and historical uses of the Sportsplex property and Riverfront Park, the sources of these contaminants are likely the same. Therefore, the contaminated site as defined in MTCA includes both the Sportsplex Parcels and Riverfront Park.

**Spokane Sportsplex Riverfront Park Fill**

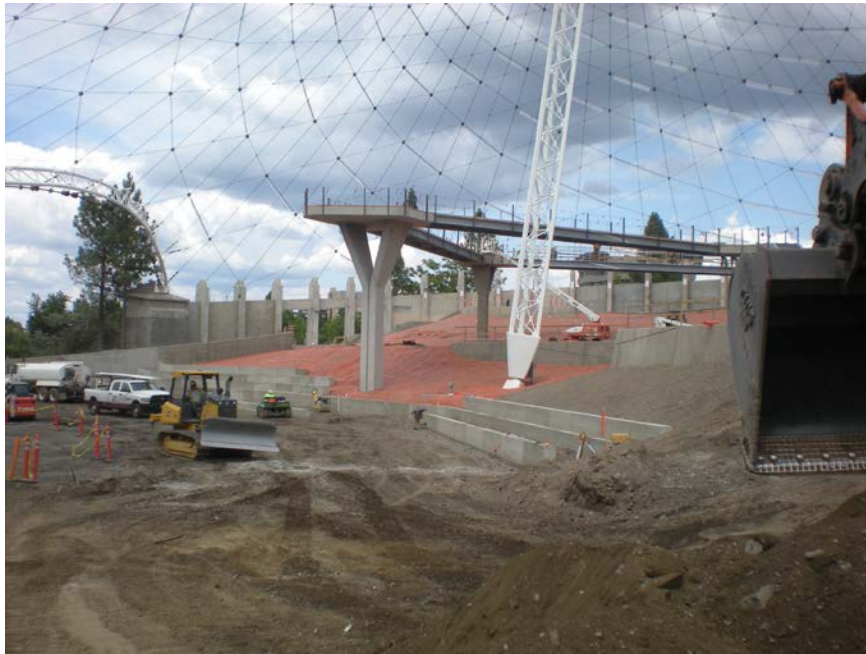
Rough grading was completed in early July 2019 and orange construction fence (visual indicator) was installed over the soil imported from the North Bank stockpile. The construction fencing was installed as a visual indicator and if it is exposed in the future, park maintenance crews will note that potentially metal and PAH-contaminated soil is present below the indicator layer. A minimum of 12 inches of imported cover soil (sand) was placed over the visual indicator and then sod was installed over the cover soil. Photos of the visual barrier and cover soil are provided in Appendix B.

Photograph 1. Installation of the orange construction fencing , used as a visual indicator.

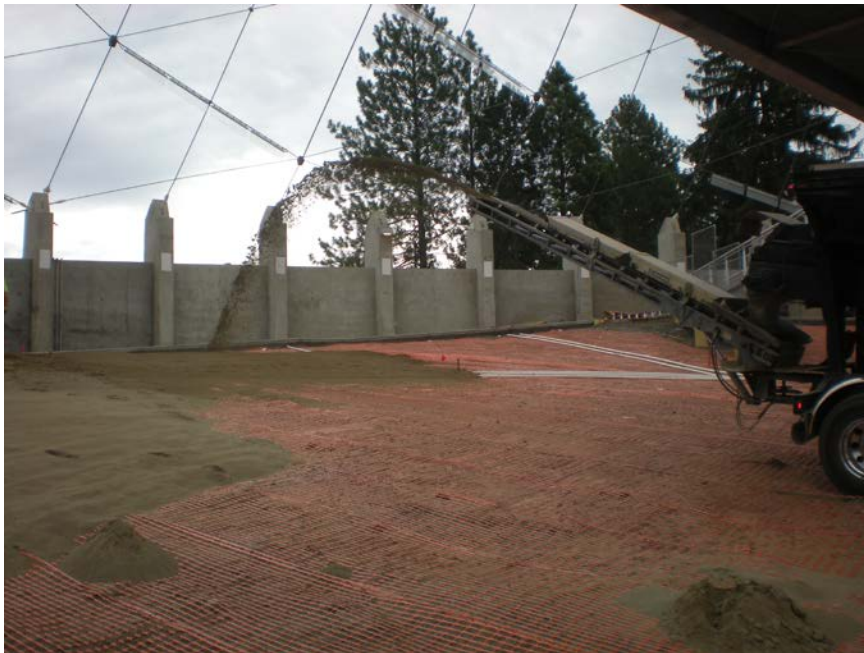
Photograph 2. Placement of cover soil over the orange construction fencing.

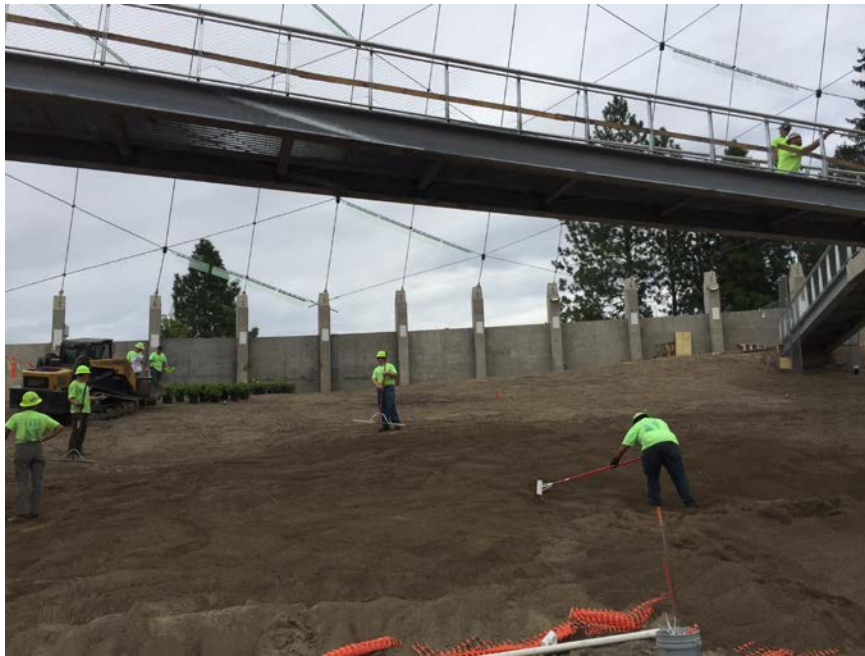
Photograph 3. Raking out the cover soil.

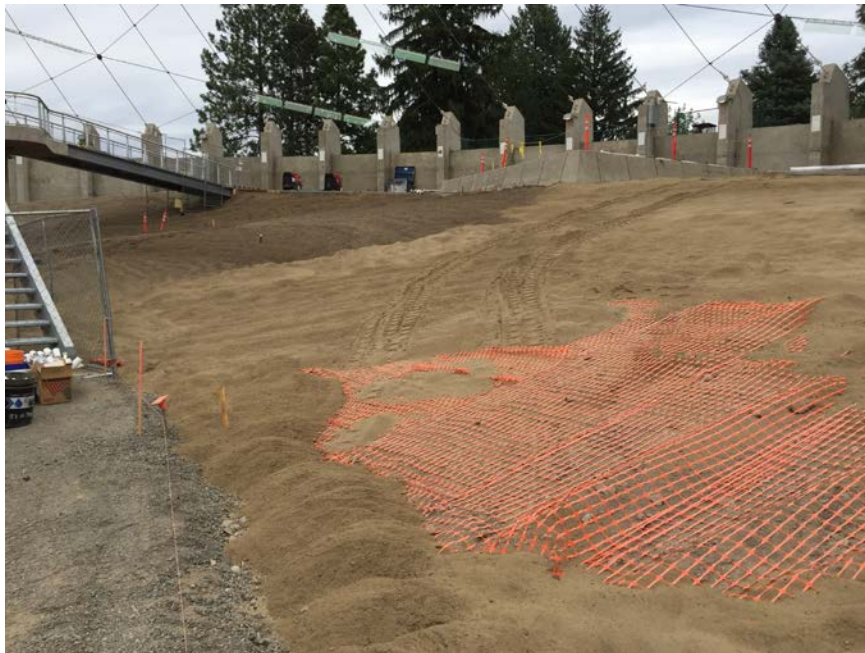
Photograph 4. Cover soil was deployed in two 6-inch lifts. The darker upper 6 inches was a turf builder product that had increased organics to enhance vegetation growth.

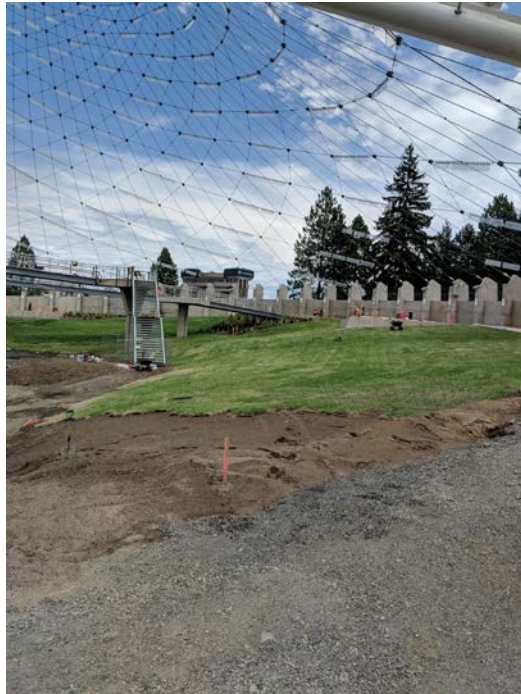
Photograph 5. Sod installed over the 12-inch cover soil.

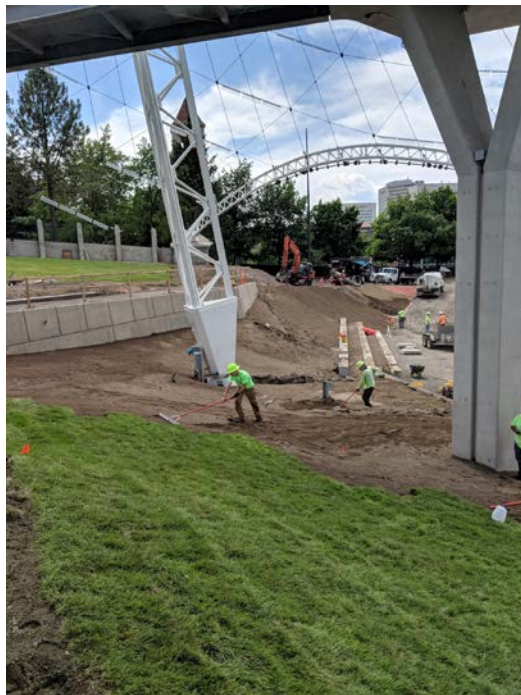
Photograph 6. Installing soil cover and sod.
