# CLEANUP ACTION REPORT

Lenora Building Site (aka Stratus Apartments),  
820 Lenora Street, Seattle, Washington  
Facility/Site #91413494  
Cleanup Site ID: 1802

Prepared for: Ninth and Lenora LLC

Project No. 170291 • March 26, 2020 FINAL

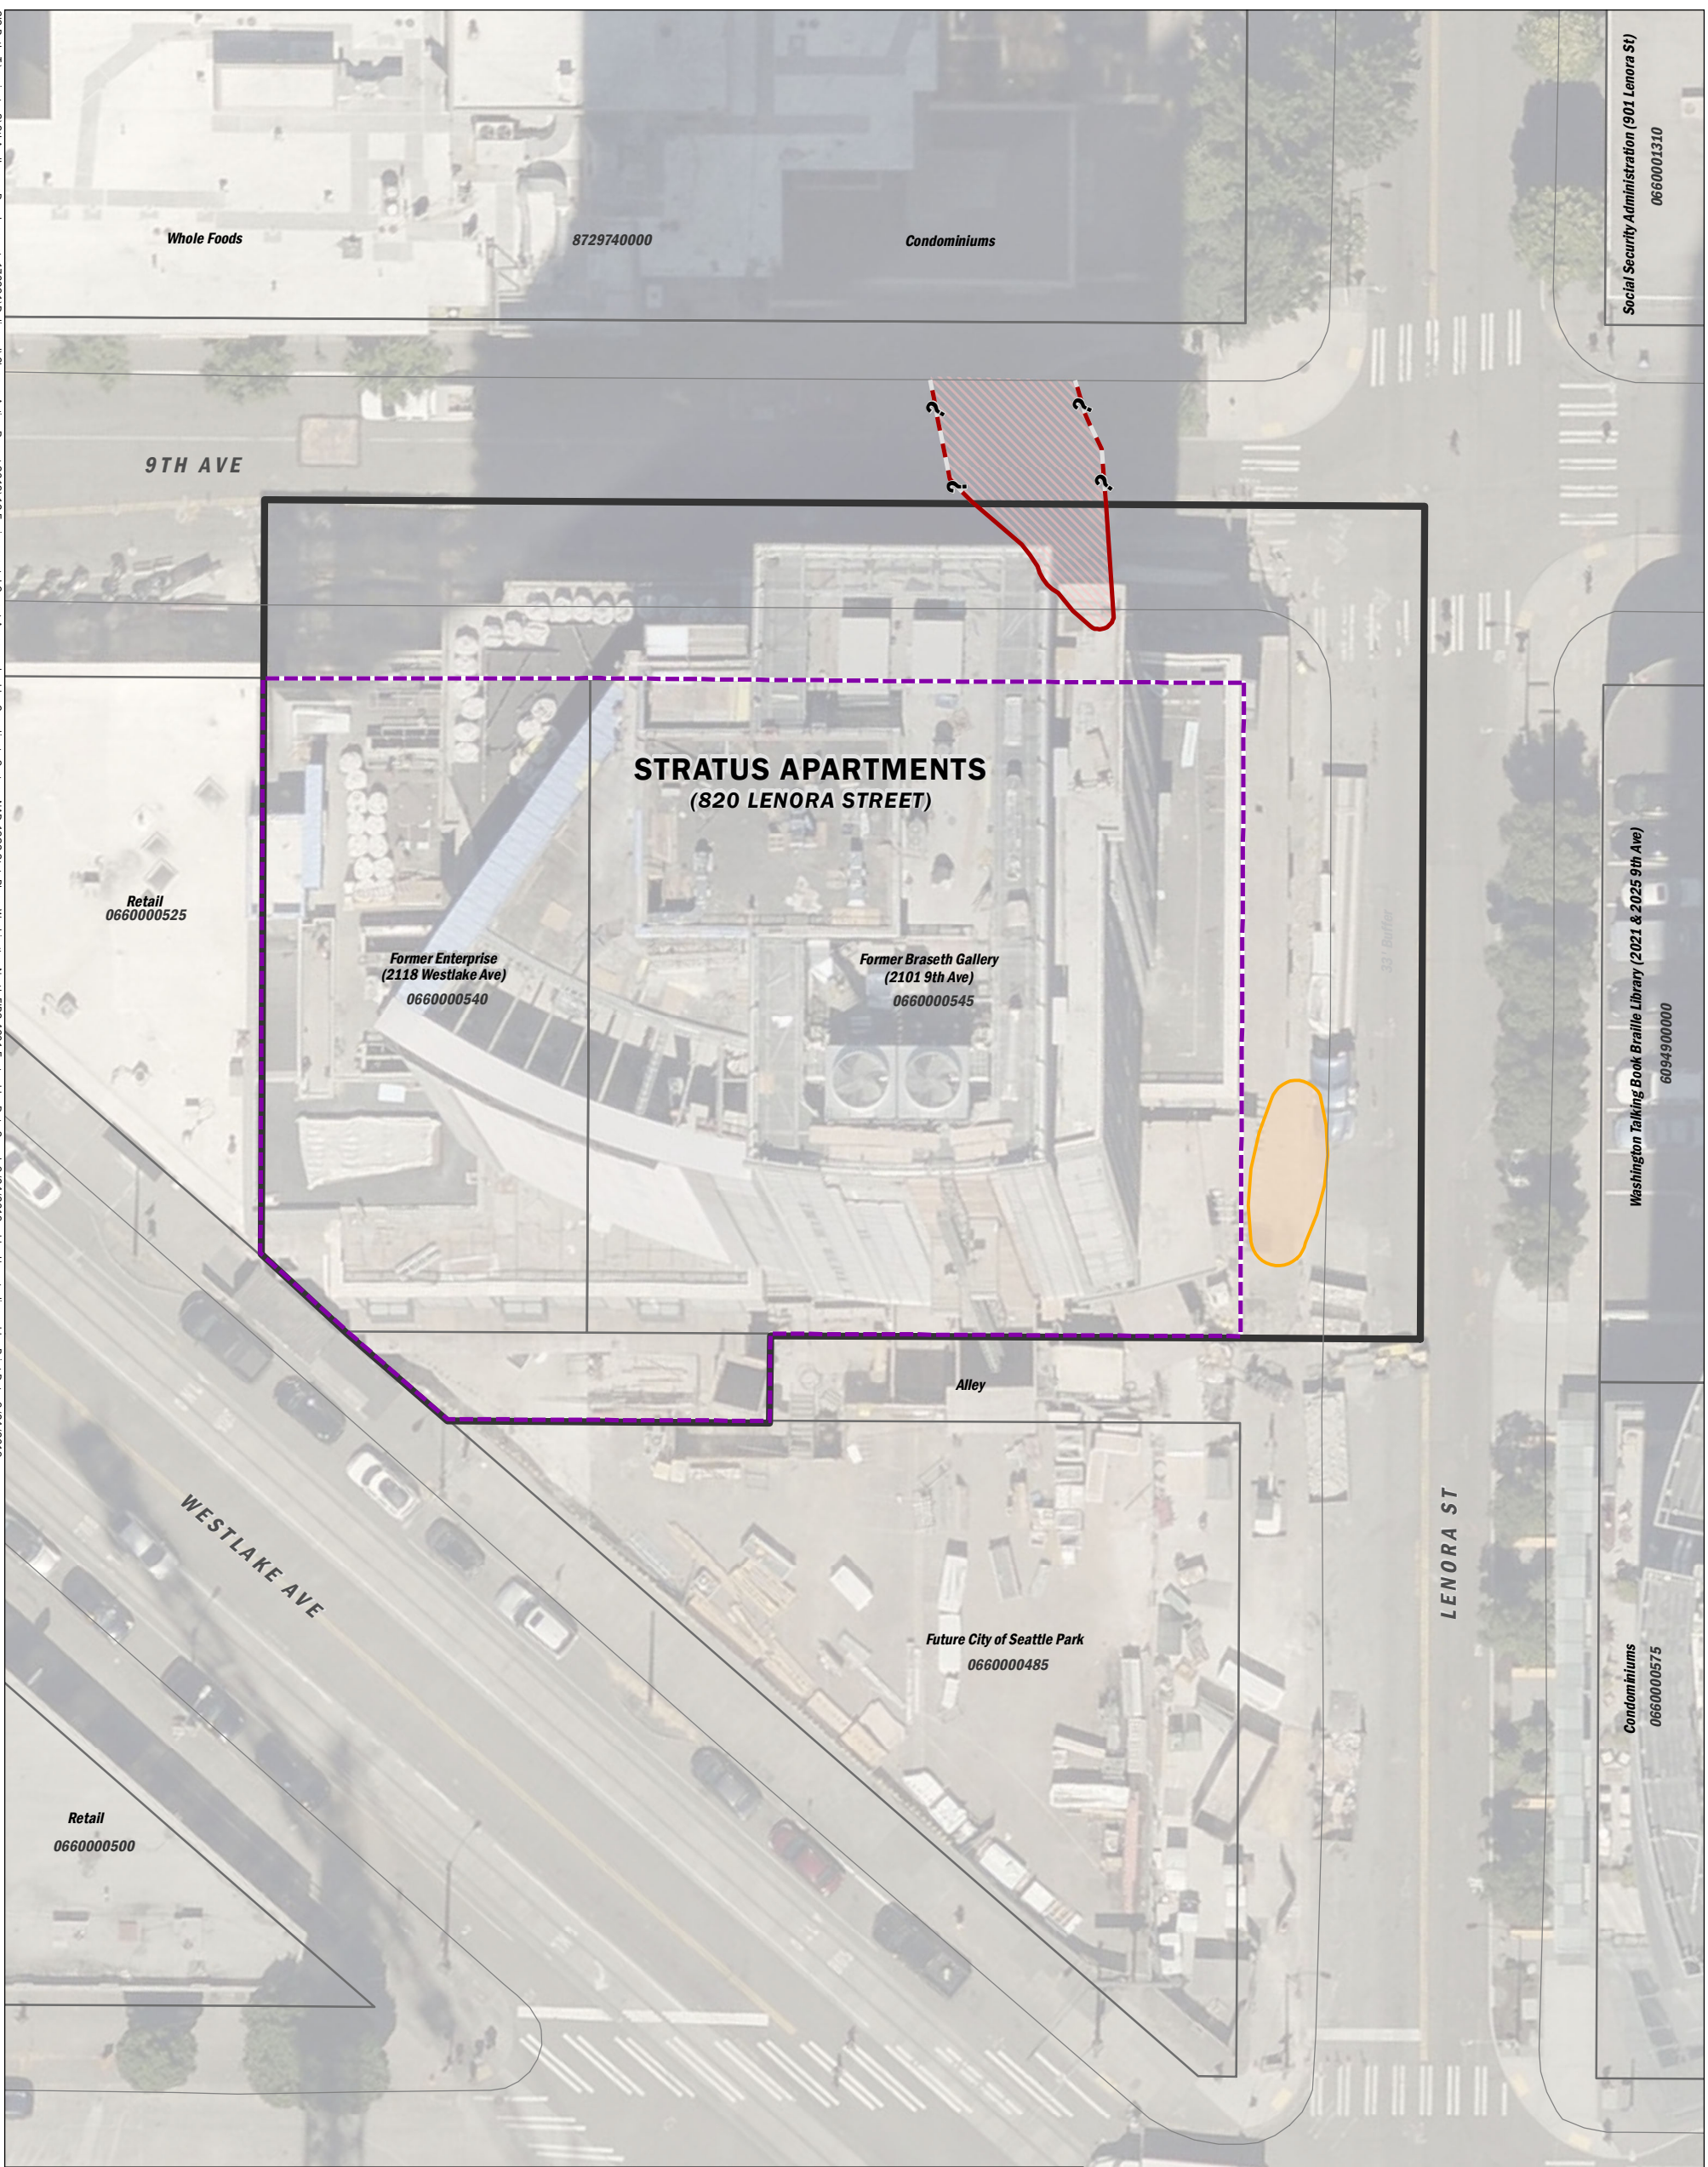
- **Environmental Covenant.** An environmental covenant will be recorded in accordance with Washington Administrative Code (WAC) 173-340-440, to implement institutional controls in areas where residual petroleum- and PAH-contaminated soil is present at the Subject Property (portions of 9<sup>th</sup> Avenue and Lenora Street) to ensure the integrity of the cap and prevent exposure to hazardous substances at the Property (Figure 12).
