**UNDERGROUND STORAGE TANK &
CONTAMINATED SOIL REMOVAL**

**WD FOODS
9029 CHUCKANUT DRIVE
SKAGIT COUNTY PARCEL P34734
BOW, WASHINGTON 98232**

February 10, 2020

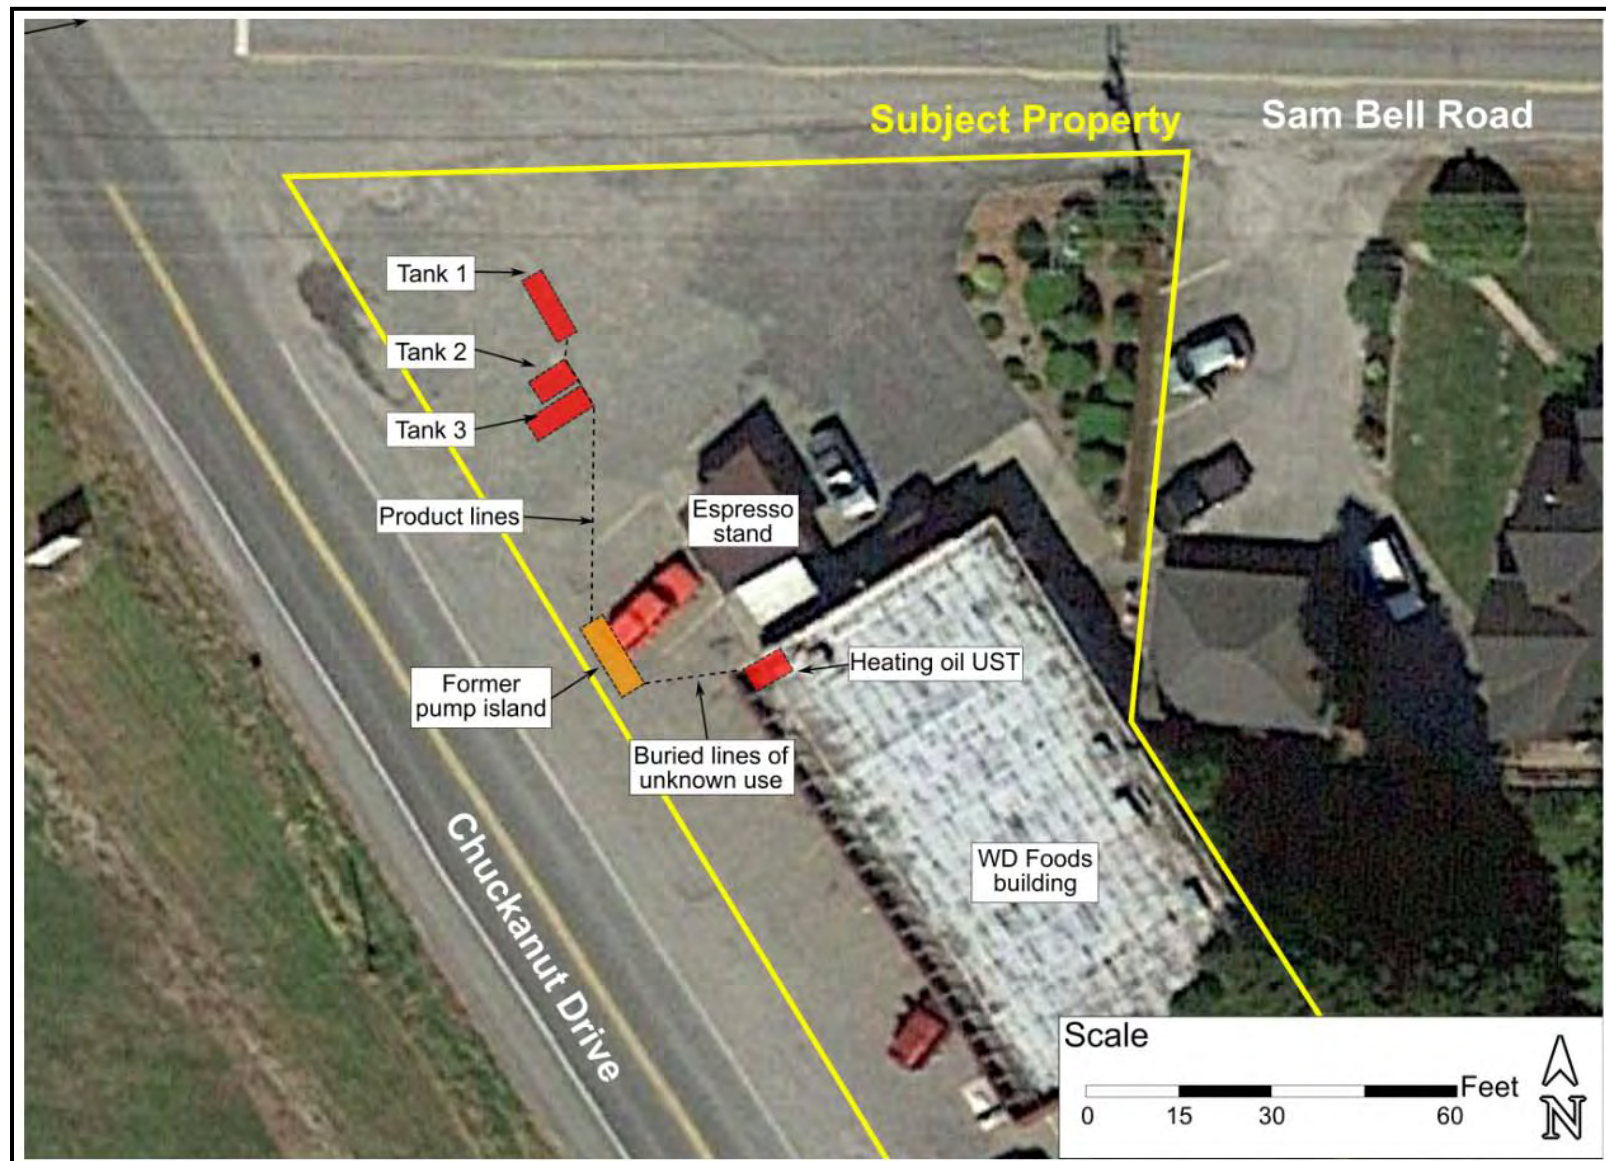
Figure 3. Map of USTs and former fueling equipment

A map showing the location of the identified USTs and fueling equipment is shown in Figure 3. Photos of the tanks before and after removal are provided in Figure 4.

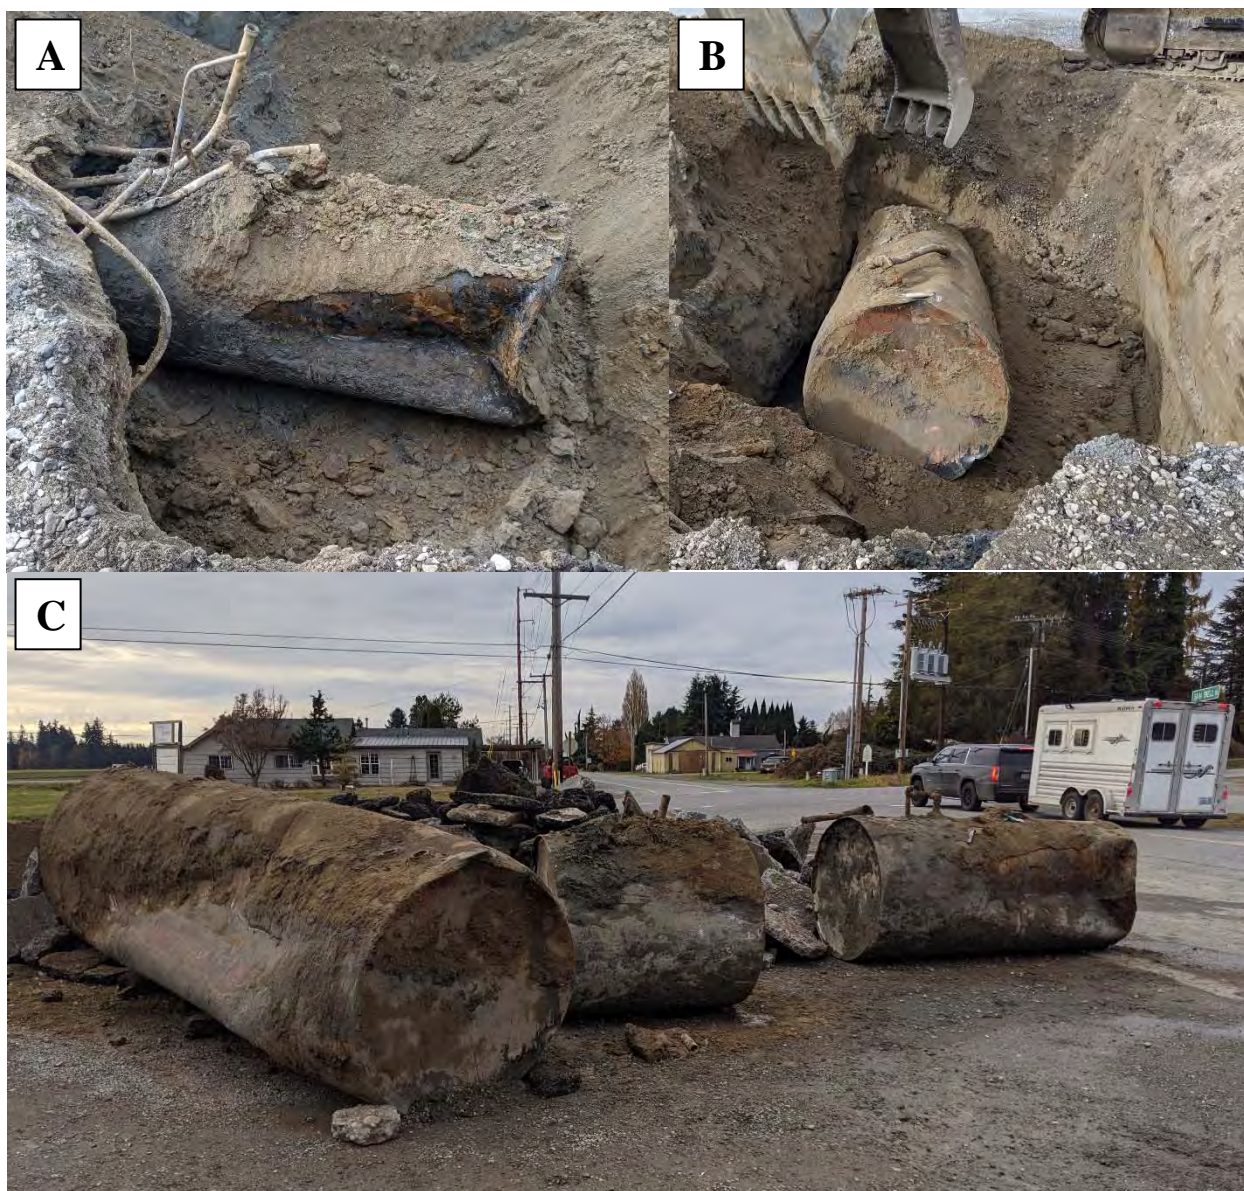
Visual inspection of the tanks identified significant rust and pitting of the tank walls in each tank, with holes up to 1/2-inch in diameter. Tank degradation was particularly severe in Tanks 2 and 3, while the surface of Tank 1 was significantly less rusted. The unusual layout of the tanks and their varied weathering indicates that they may have been installed as multiple generations.

Figure 4. A) Photo of Tank 3 with a significantly rusted exterior. B) Photo of Tank 1 being removed. C) Photo of all three tanks after being removed from the subsurface.

Strong odors of weathered gasoline, assumed to be a mix of fuel and water, were pumped out of the tanks and into a vacuum truck operated by AEC. The fuel/water mixture was removed from the site for disposal by AEC.

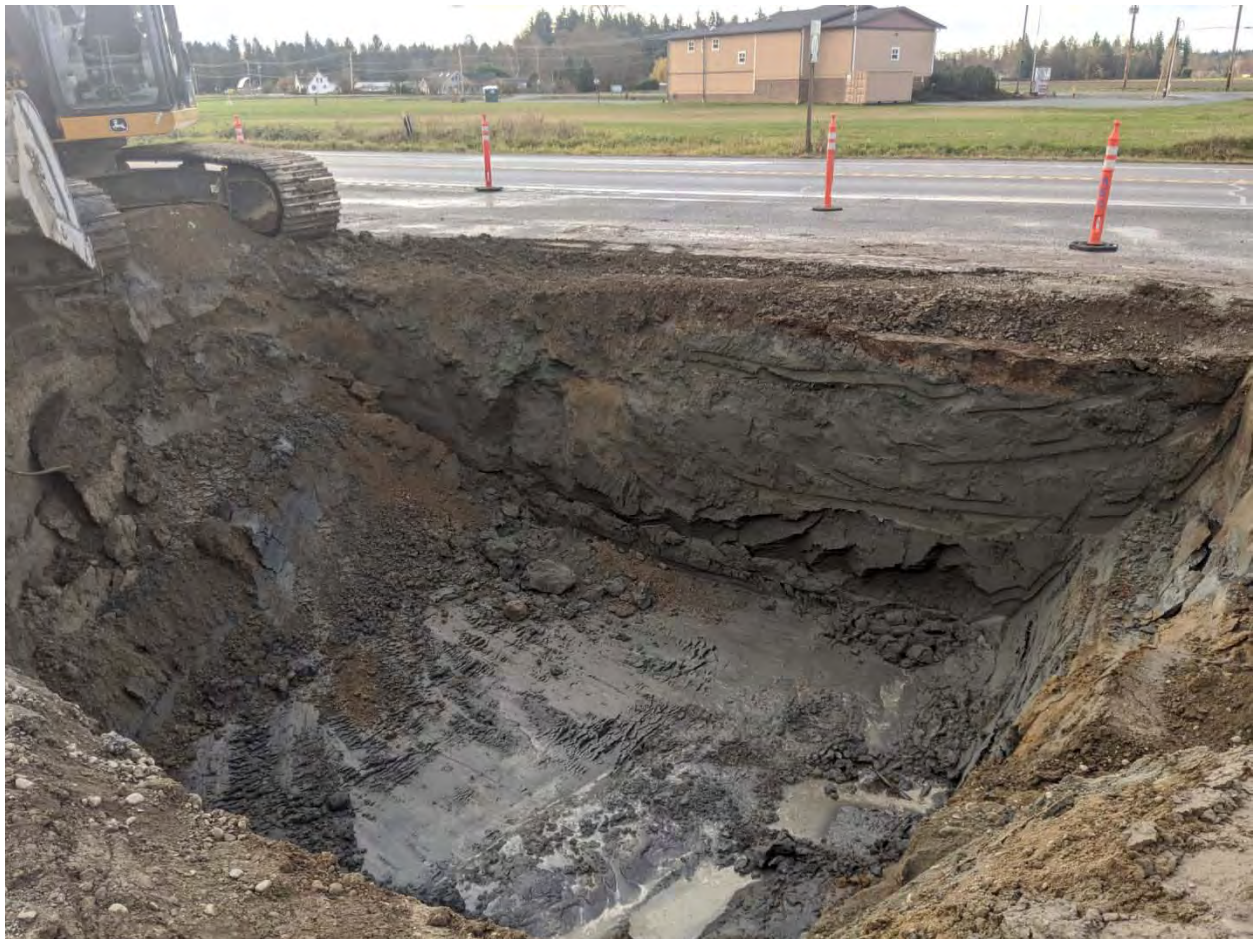
After cessation of excavation activities, soil from the excavation base and two sidewalls (east and south) still possessed a petroleum sheen. PID readings indicated the lowest levels of residual contamination in the north sidewall, with progressively higher readings present in the east, west, and south sidewalls, in that order. The highest PID readings were measured from the excavation base.

Figure 6. Photo of the UST pit excavation, near completion

The UST pit was then backfilled by AEC with pit run gravel sourced from a Skagit County gravel pit trucked to the site by Miles Sand & Gravel.

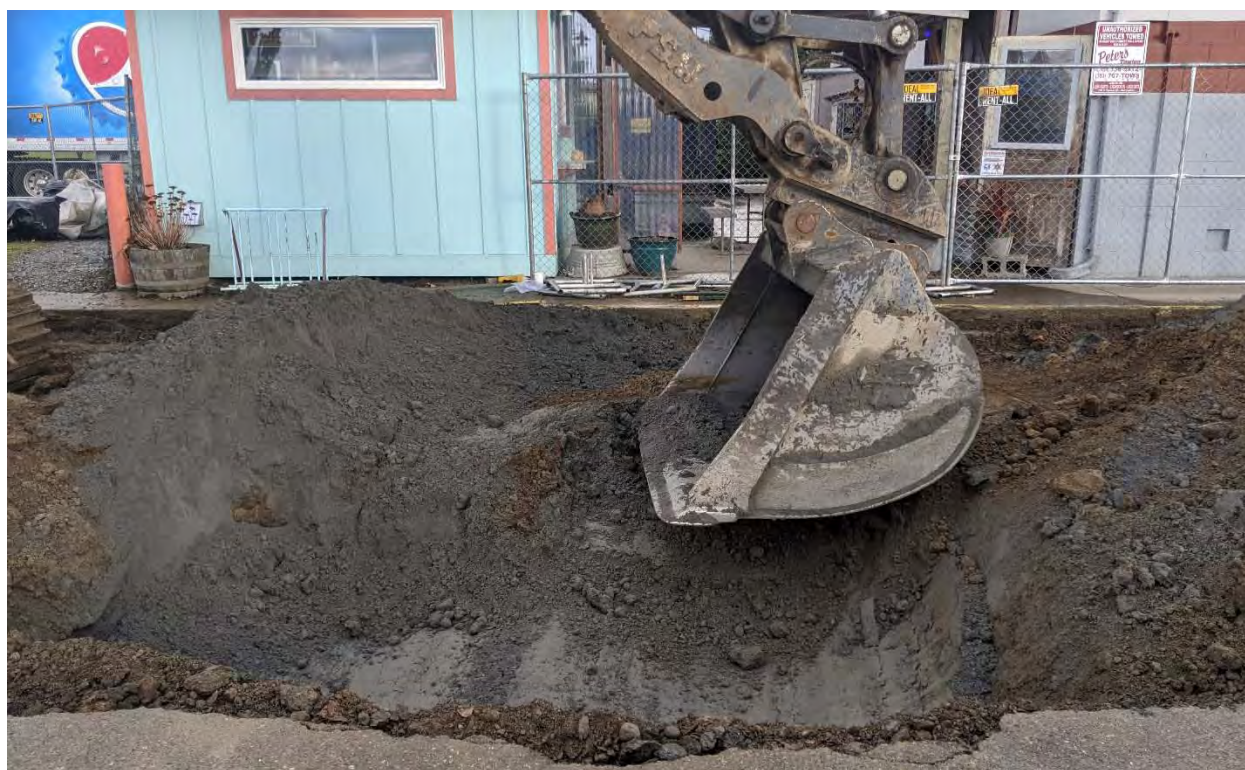
Petroleum-impacted soil excavation was also initiated in the vicinity of the former pump island where initial sampling and field indications suggested the presence of petroleum contamination (Figure 8). A pit was excavated approximately 12 feet long by 6 feet wide that reached a maximum depth of 10 feet bgs, just above the local water table. Although impacted soils appeared largely gone from the southern edge of the excavation, field indications suggested impacted soil remained in the base of the excavation as well as the north, east and west sidewalls. No soil samples were collected from the former pump island area.

Figure 7. Photo of the former pump island excavation. Grey discolored soil had strong petroleum odors.

Based upon the extent of impacted soil around the former pump island and limited available funding, soil that was initially excavated from the vicinity of the former pump island was placed back in the excavation and compacted by the excavator bucket.

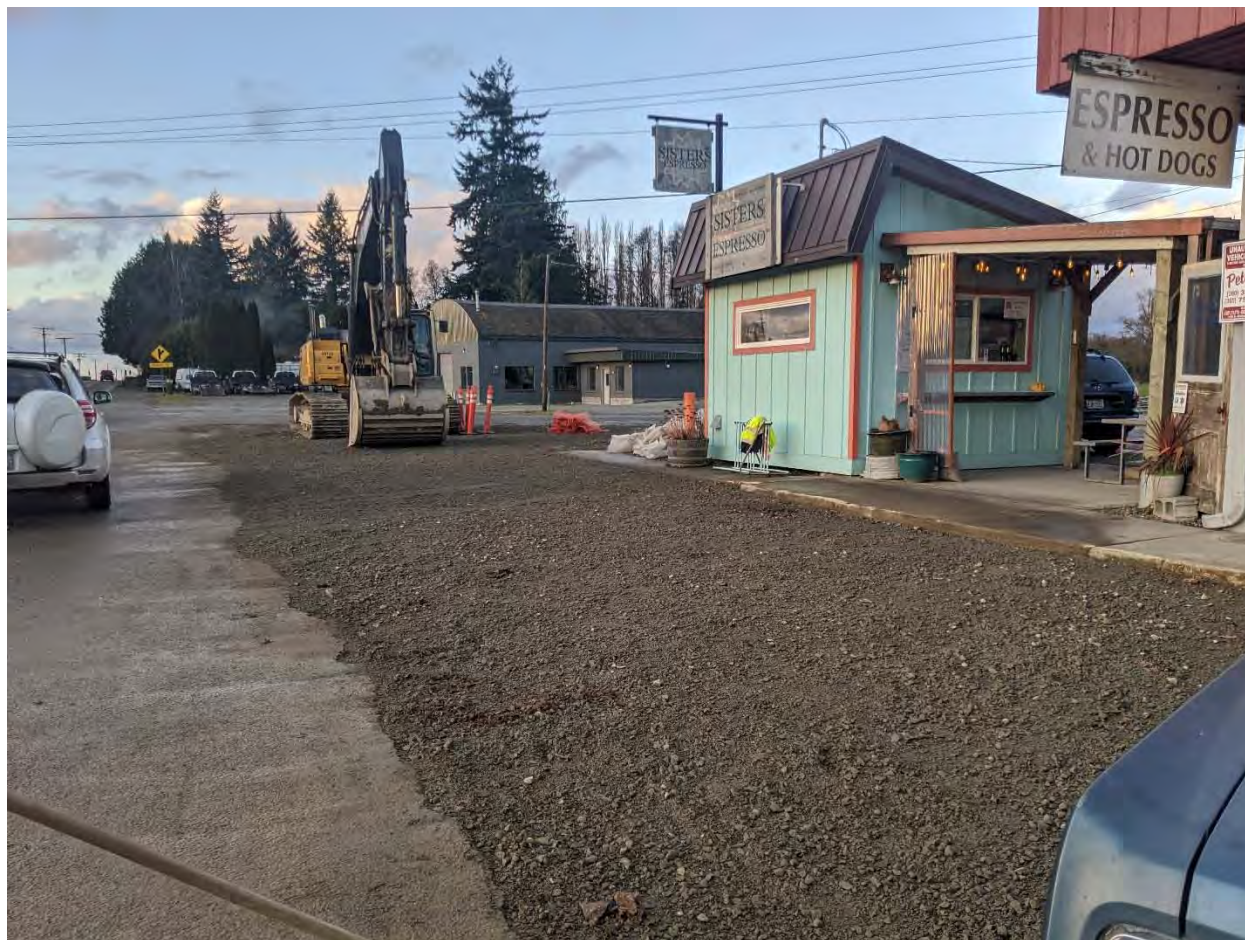
Figure 8. Photo of final site conditions after backfill

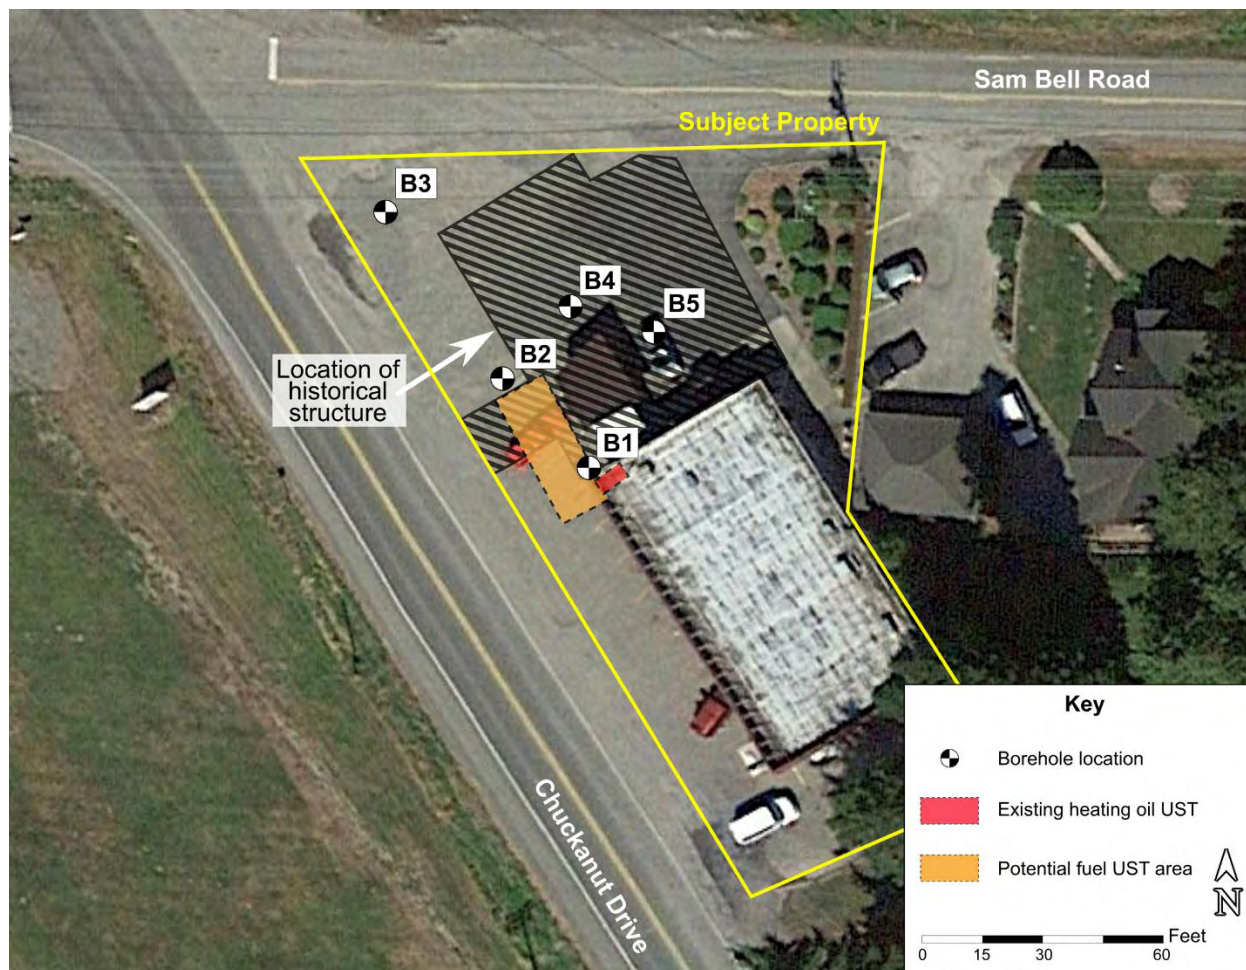
Five borings were completed on the site. The borings were labeled Boring B1 through B5, for reference. Boring B1 was completed down gradient of the existing heating oil tank. Borings B2, B3, B4, and B5 were completed down gradient of the suspected fuel USTs to the northwest, north, and northeast. Photographs of the drilling and sampling activities are provided in Appendix I.

Figure 4. Environmental boring locations

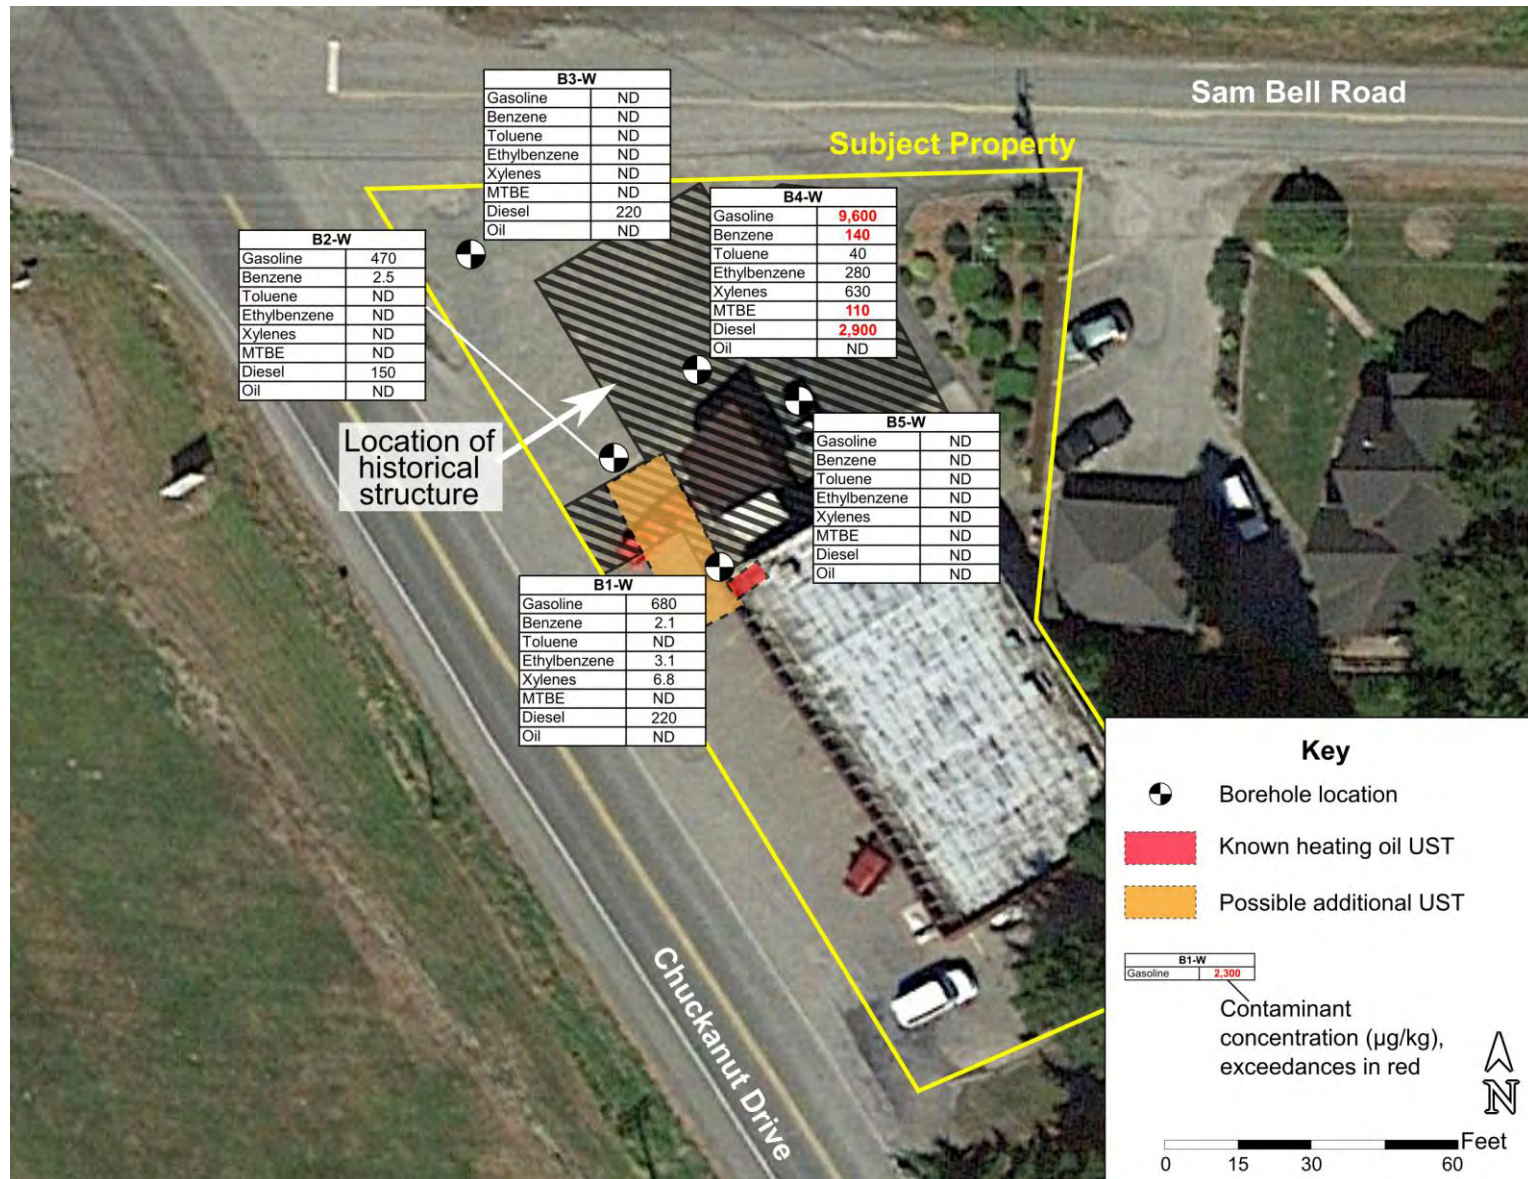
Figure 6. Groundwater sample locations. ND = non-detect
