JOHN'S AUTO WRECKING
411 93RD AVENUE SOUTHEAST, OLYMPIA, WASHINGTON
SUPPLEMENTAL REMEDIAL INVESTIGATION/CLEANUP ACTION
(VCP Project No. SW1613)
May 15, 2020

JOHN'S AUTO WRECKING
 411 93rd AVENUE SOUTHEAST, OLYMPIA, WASHINGTON
 SUPPLEMENTAL REMEDIAL INVESTIGATION/CLEANUP ACTION
 (VCP Project No. SW1613)
 May 2020

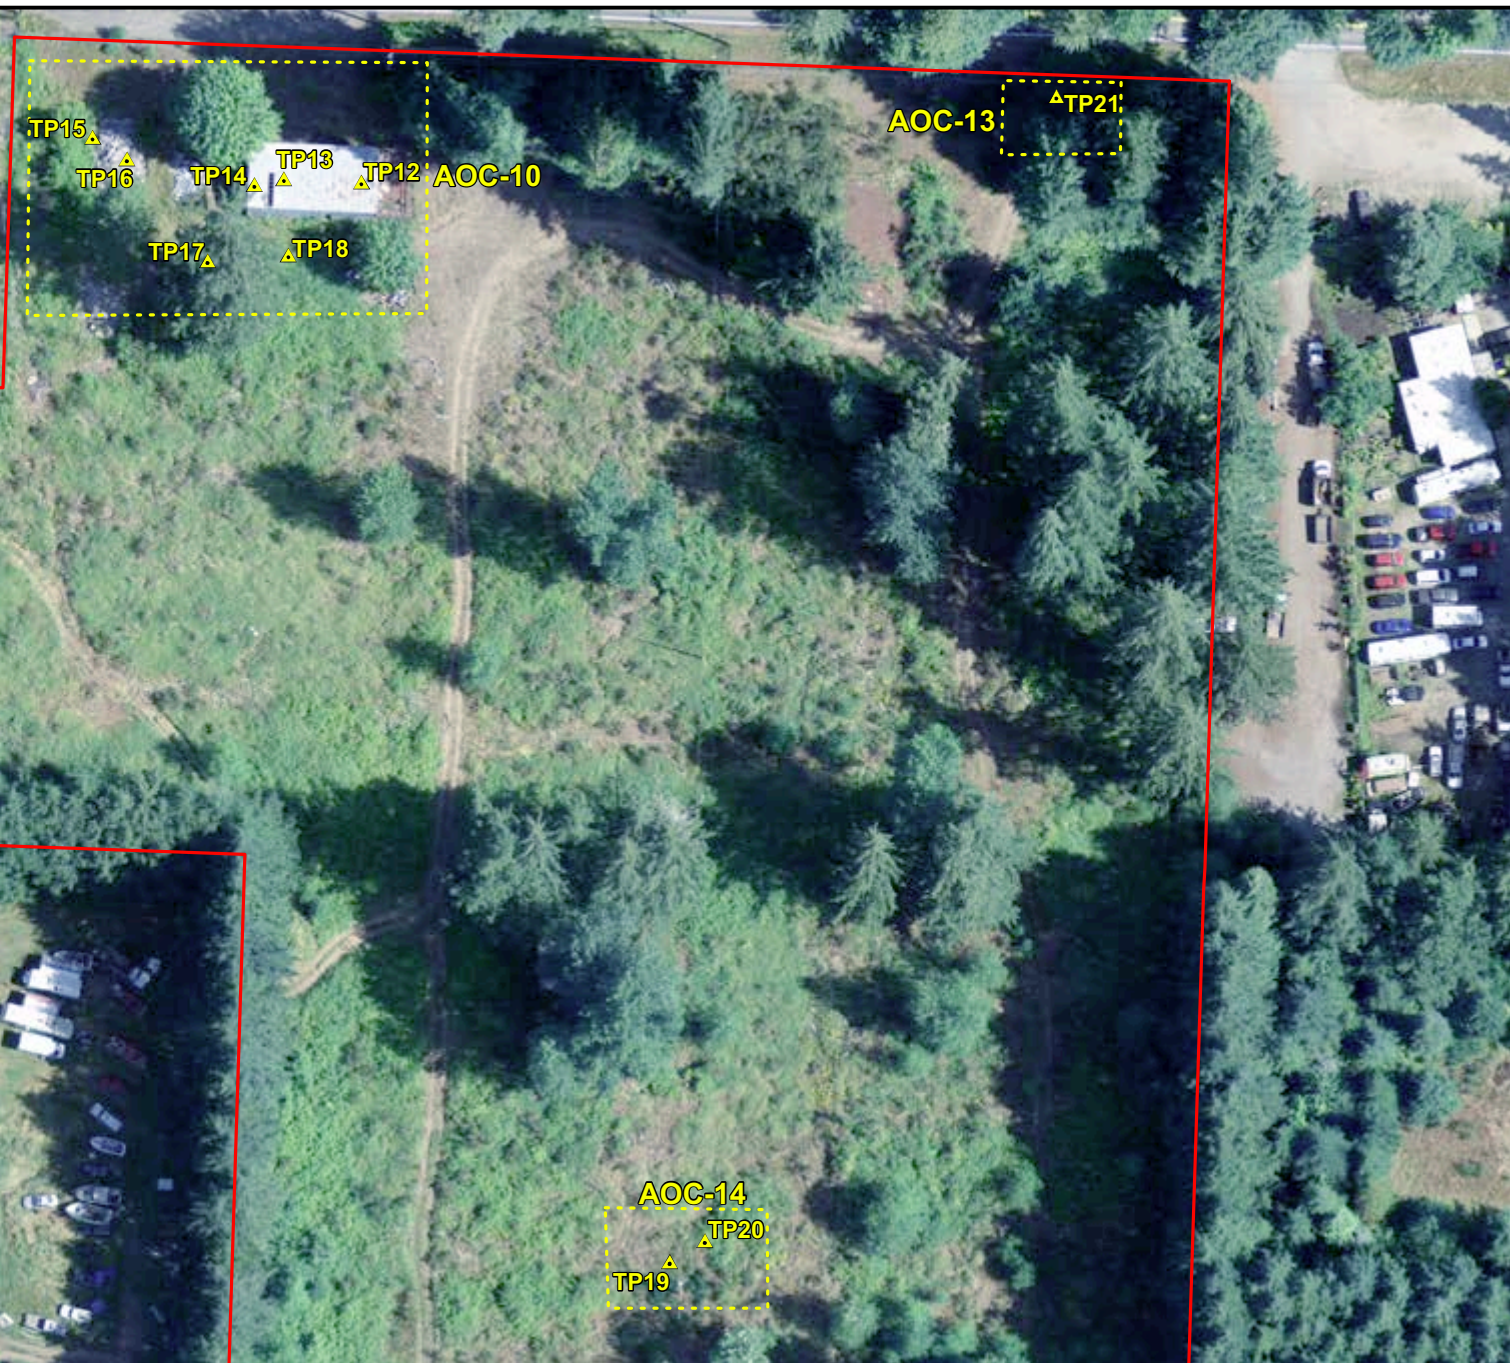
Figure 10B
Test Pit Location Map (South)
John's Auto Wrecking, Supplemental Remedial Investigation/Cleanup Action

On November 7, after the tire berm had been removed, a Robinson Noble geologist was on site with a crew from Langseth to evaluate the soil conditions below the area of the berm. This was accomplished by excavating a series of shallow test pits along the trace of the former berm and analyzing select soil samples from each pit. The locations of the tire-berm test pits, which are designated as TP26 through TP30, are shown on Figure 10. Logs of the materials encountered in each are presented in Figure 11.

During the 2013 site inspection, it was noted that illegal dumping was occurring in the area near the northeast entrance gate. Havens expanded the fence in this area to try to dissuade further dumping. At the start of the current project, Langseth removed the debris, which consisted largely of household trash and old furniture, from this area. Following debris removal, the underlying soils were evaluated through the excavation and testing of a single test pit, designated as TP21. The location of TP21 is shown on Figure 10 and the log of the materials encountered is shown on Figure 11.

During the 2013 site inspection, Ecology personnel noted a power pole near the center of the site that was equipped with two electrical transformers. Ecology noted that the transformers could potentially contain PCB-containing dielectric fluids and, that if there had been previous leaks, this could have impacted the soils in the area below the transformers. For this project, Robinson Noble tried to identify additional electrical transformers on the site, but no other power poles or transformers were identified on or near the site. Possible impacts to the soils below the two identified transformers were investigated by excavating two test pits directly below the power pole and analyzing the soils from each. The locations of these two test pits, which are designated as TP19 and TP20, are shown on Figure 10. Logs of the materials encountered in each test pit are present on Figure 11.

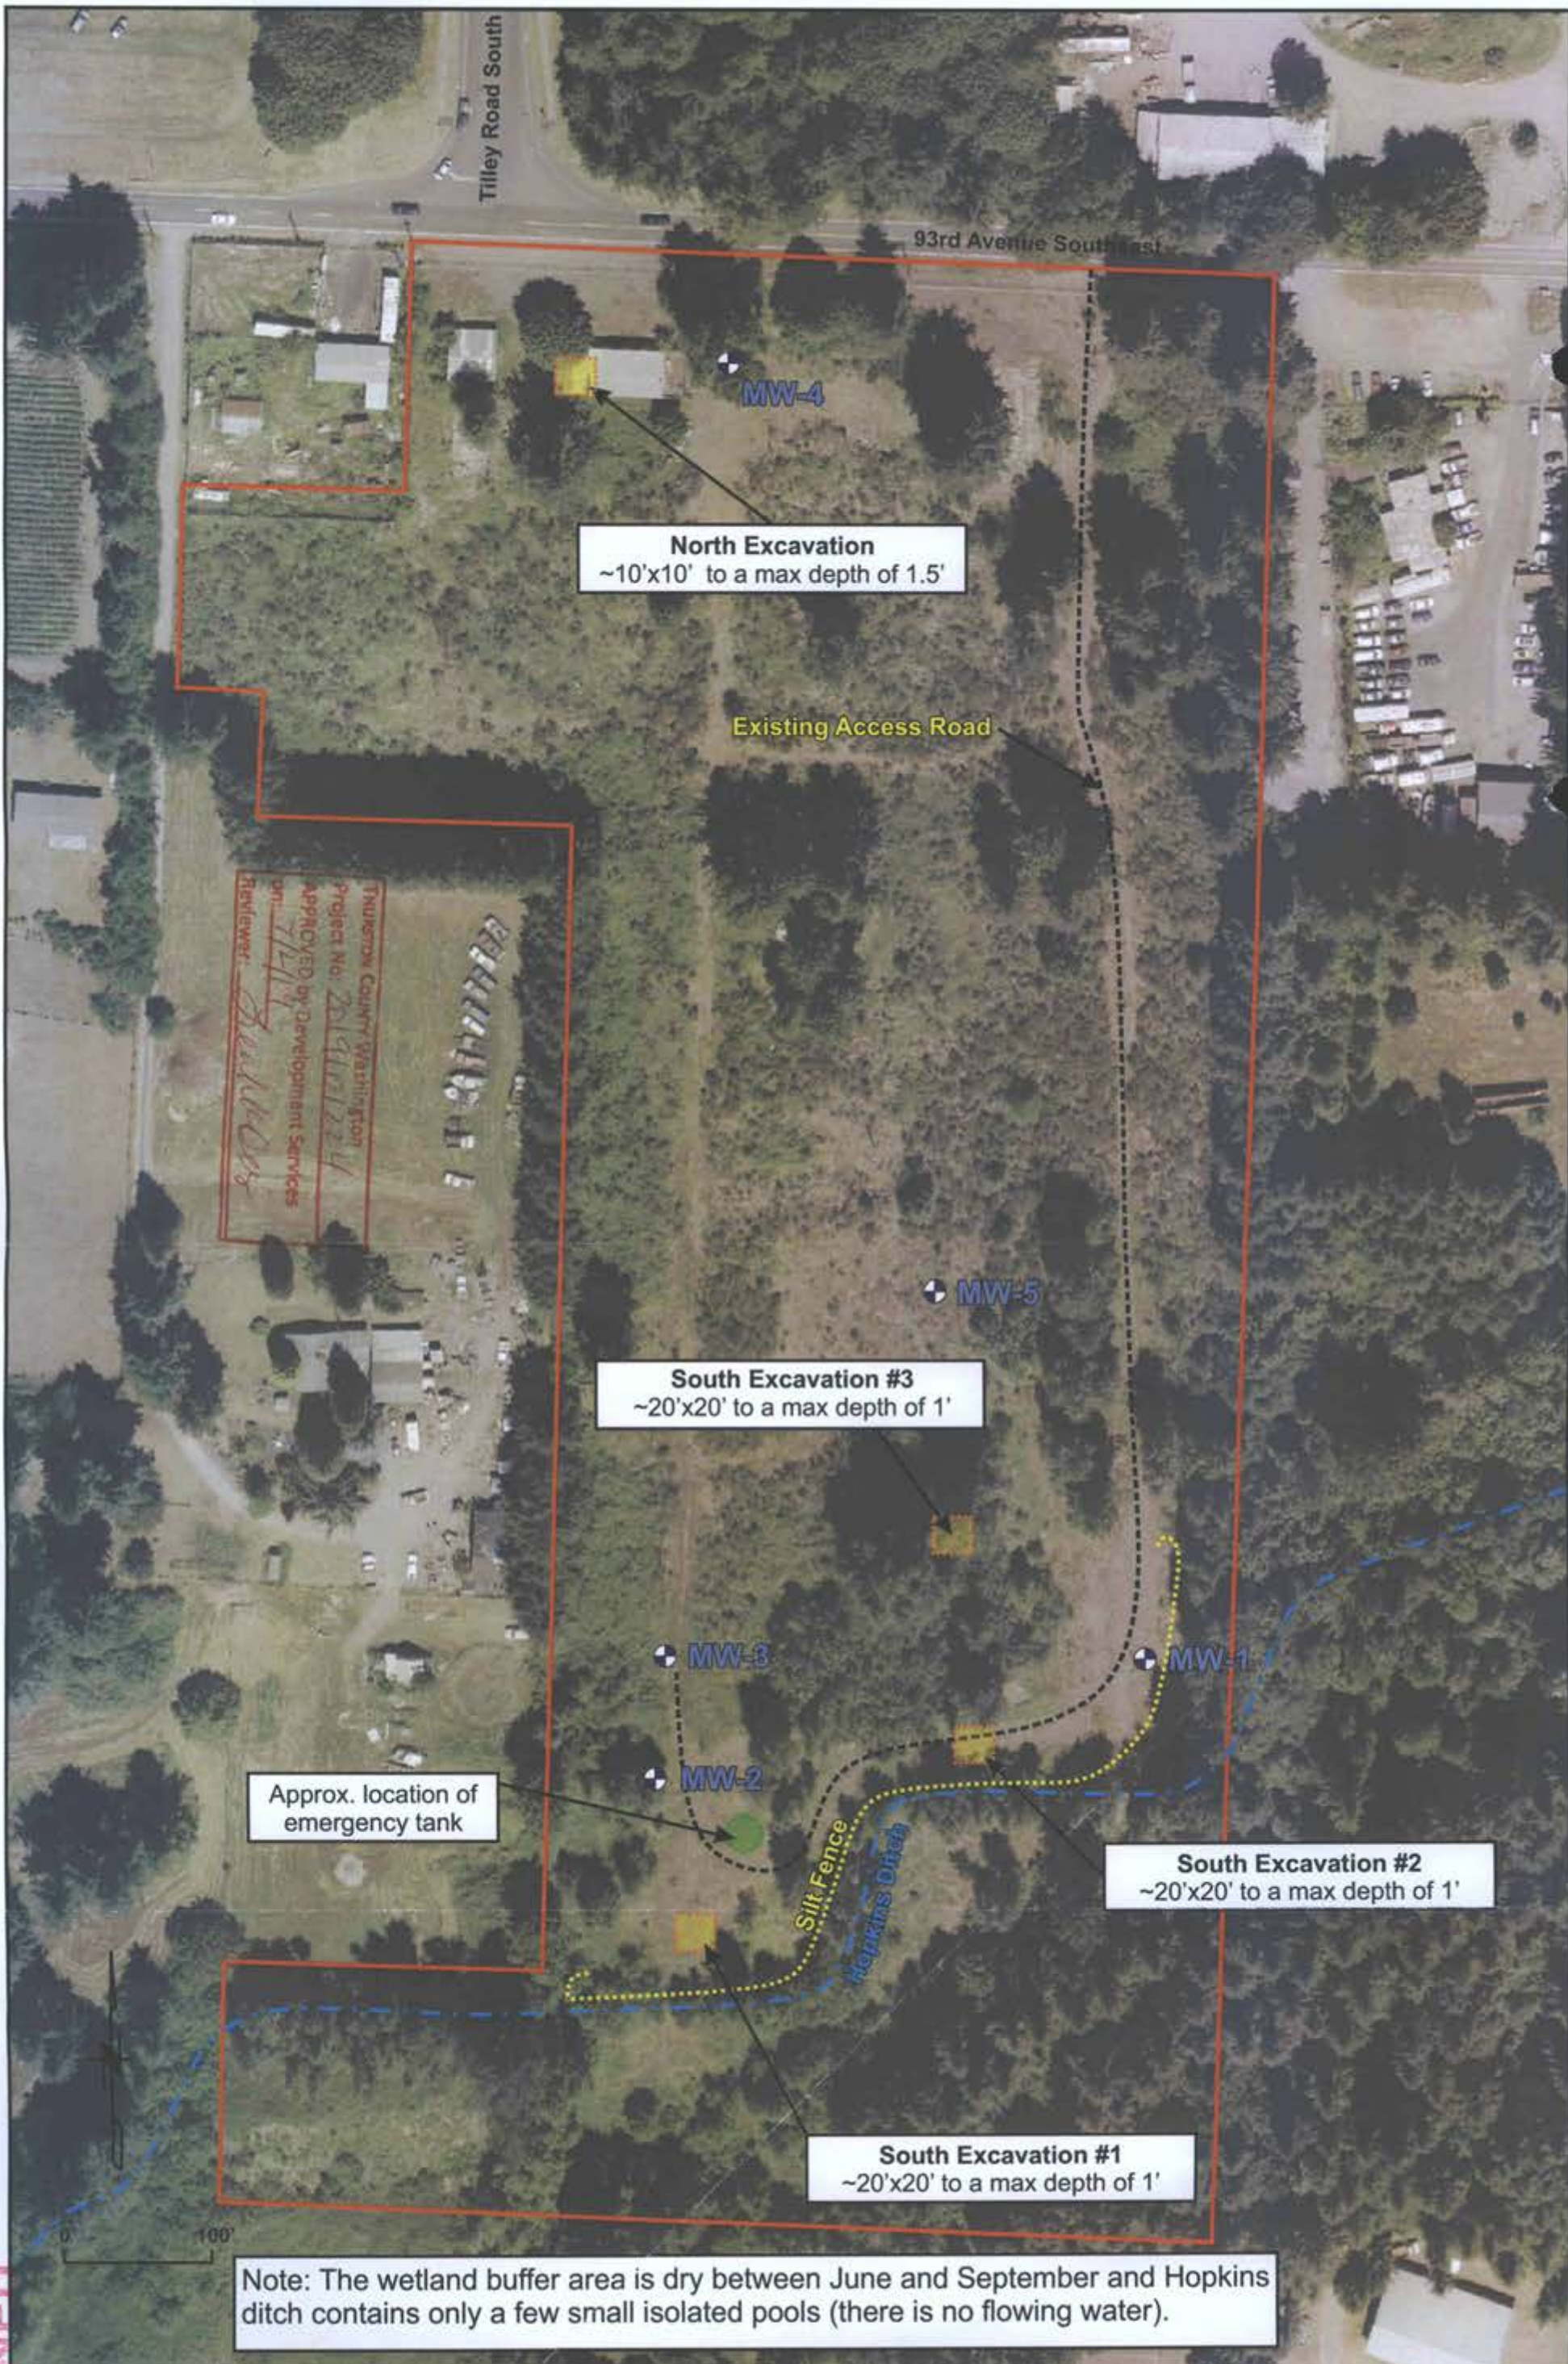
1). The northern half of the site is drier than the southern half and does not contain wetlands. Thirty soil sampling locations were included in the northern half of the site and 56 locations were included in the southern half of the site. All soil samples collected within the top six feet below ground surface (the assumed biologically active zone within MTCA) were compiled for this screening step.
