Phase I Cleanup Action Report

Franke Tobey Jones
Master Plan Phase I
Tacoma, Washington

May 18, 2020

File No. 10068-002-02

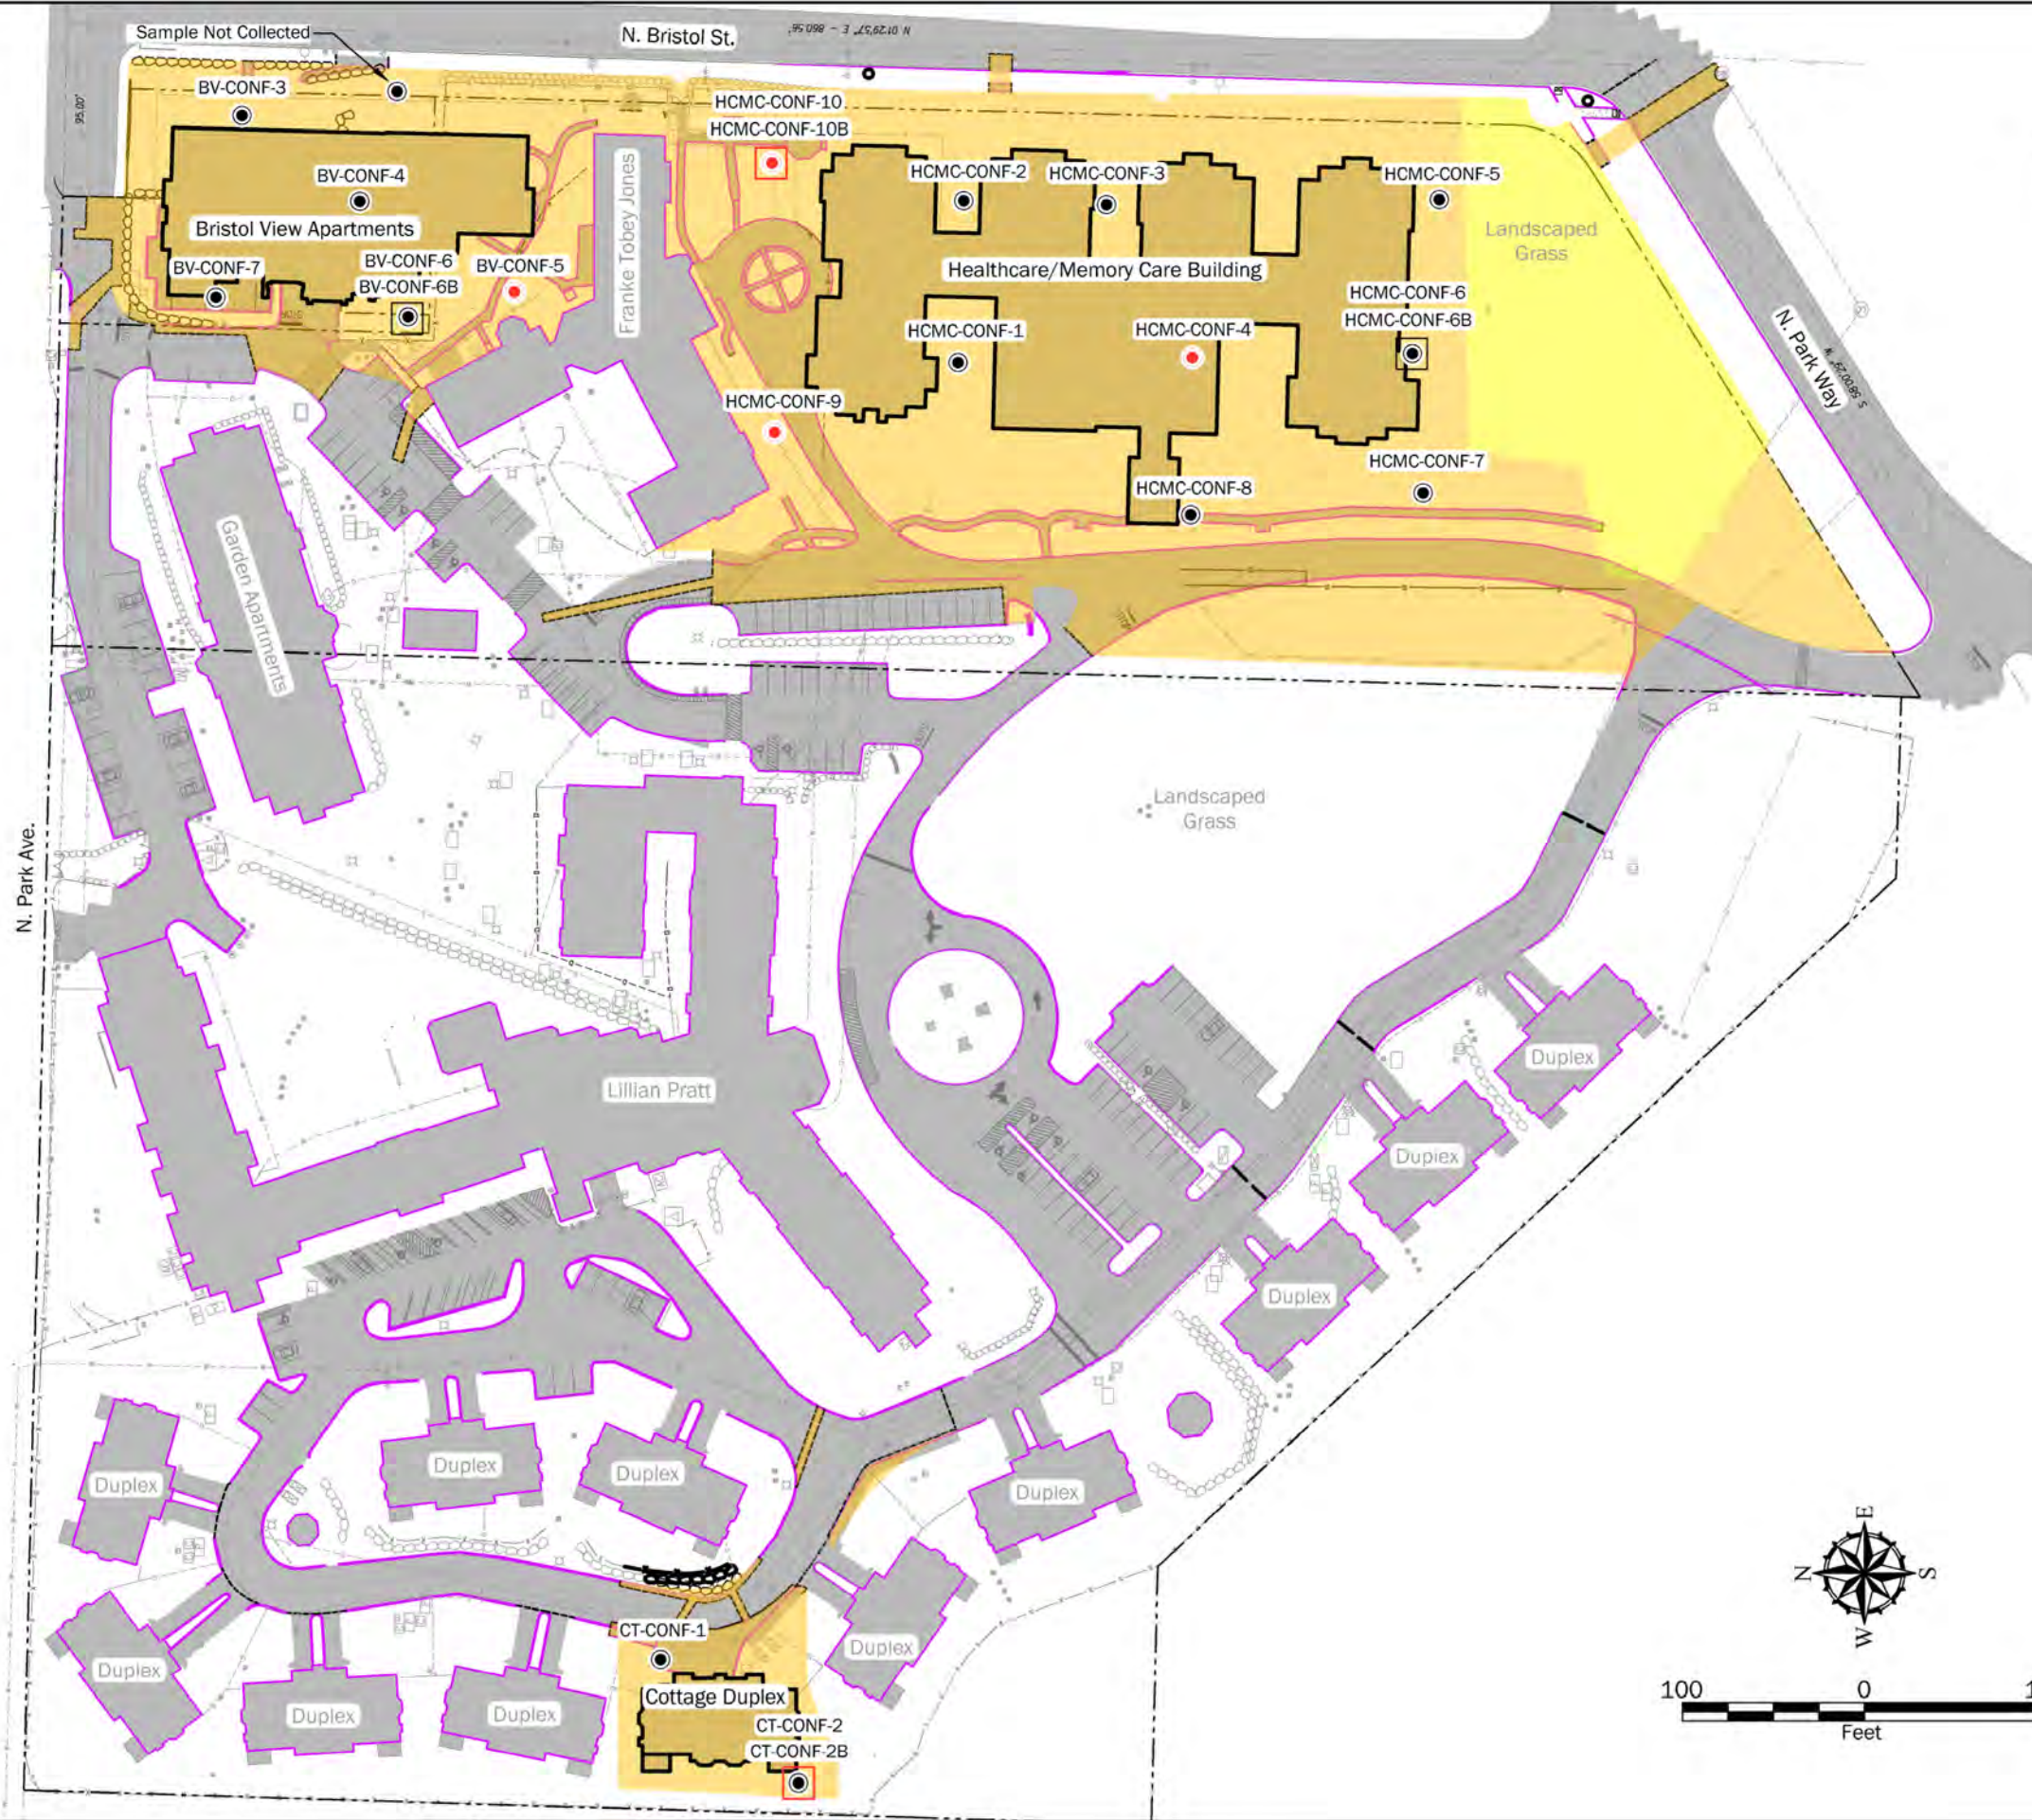
Phase 1 Remedial Action	
Franke Tobey Jones Tacoma, Washington	
	Figure 2

The primary cleanup actions completed during Phase I construction are summarized below. Two remedial areas (Remedial Areas 1 and 2) were identified in the CAP as shown in Figure 2. Remedial Area 1 is located within the southern portion of the site and is identified as the area where arsenic-contaminated soil was consolidated including placement of a Type 1 cap. Remedial Area 2 is located within the remainder of the Phase I construction area and consists of areas where soil was mixed with non-contaminated soil with placement of a Type 1 cap. A summary of sampling activities for confirmation and stockpile soil and construction water are presented in Sections 3.1 through 3.3. The following is a description of the general remedial action process.

This report summarizes the Phase I cleanup action completed at the Franke Tobey Jones (FTJ) facility expansion located at 5340 North Bristol Street in Tacoma, Washington. The FTJ facility is generally located north of Vassault Street and North Park Way in Tacoma, Washington (Pierce County parcel nos. 6390000413, 0221232025, 6930000393 and 6930000381). The FTJ facility location is shown on Figure 1, Vicinity Map. The existing FTJ facility layout and new Phase I buildings are shown on Figure 2.

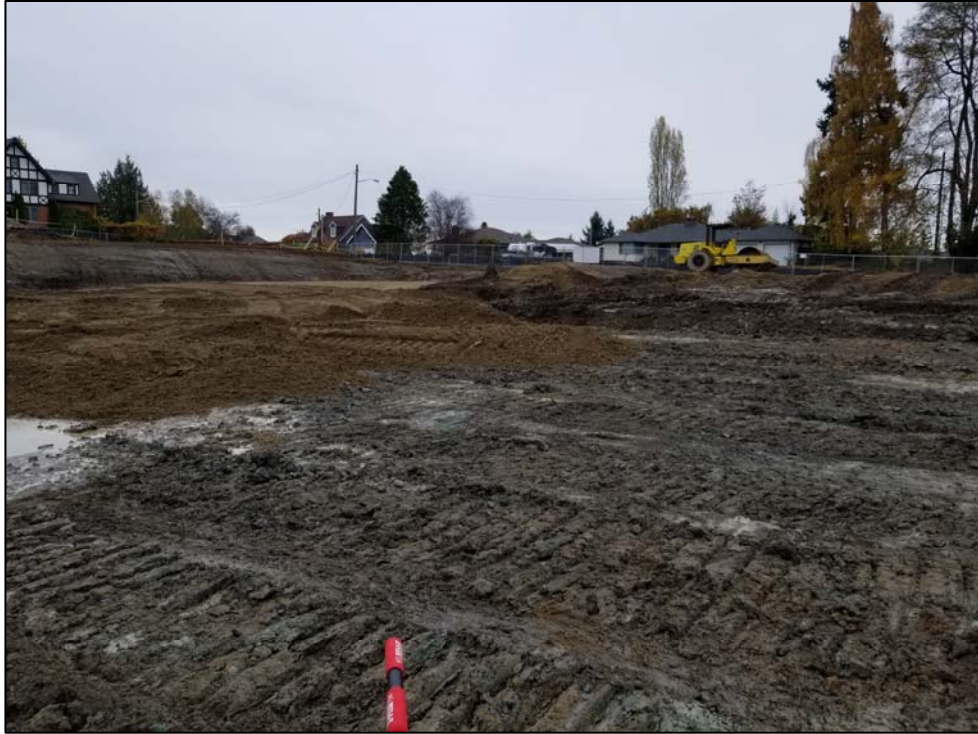
Site Photographs	
Franke Tobey Jones Tacoma, Washington	
 	Figure 3

View facing east showing the 4 to 6-inches of structural fill placed following excavation of 1 to 2 feet of surficial soil within Remedial Area 2 (HCMC building) – November 8, 2017.

- One to 2 feet of arsenic-contaminated soil was excavated from Remedial Areas 1 and 2, stockpiled on plastic, and covered with plastic.
- Non-contaminated soil was excavated from Remedial Area 1 to a depth of 25 feet bgs to increase storage capacity. The non-contaminated soil was stockpiled on plastic, sampled and covered with plastic for later use as fill material on other portions of the site during construction (Stockpile 1).
- The stockpile generated from the surficial 2-feet was placed in Remedial Area 1 following excavation of the non-contaminated soil.
- A retaining wall was constructed around Remedial Area 1 to increase storage capacity.
- Approximately 4 to 6 inches of non-contaminated structural fill was placed on top of Remedial Area 2 for protection of subgrade during construction and to allow for mixing of arsenic-contaminated soil.

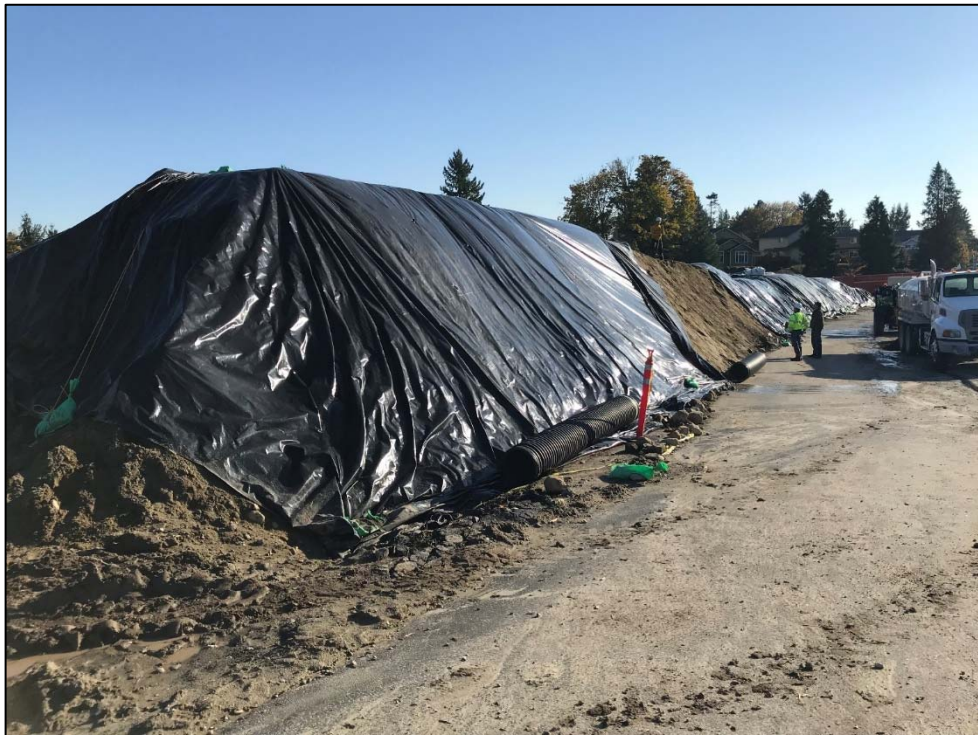
View facing south showing the west-facing slope of Stockpile 1 (STK1) – November 6, 2017.

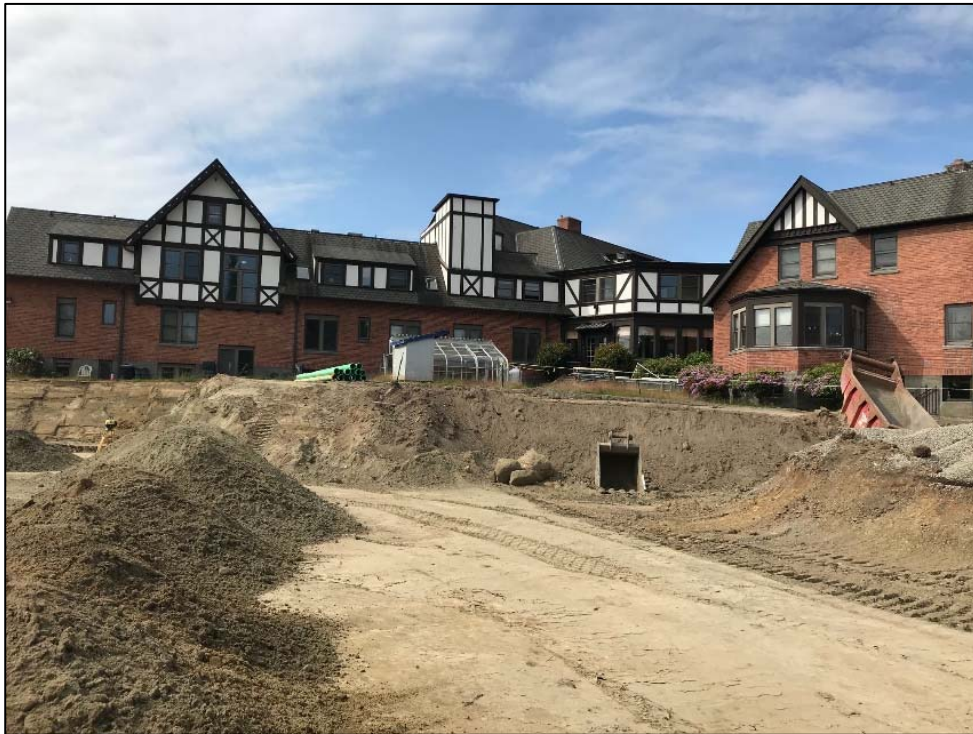
Site Photographs	
Franke Tobey Jones Tacoma, Washington	
 	Figure 4

View facing southwest of Bristol View Apartments construction area- June 5, 2018.

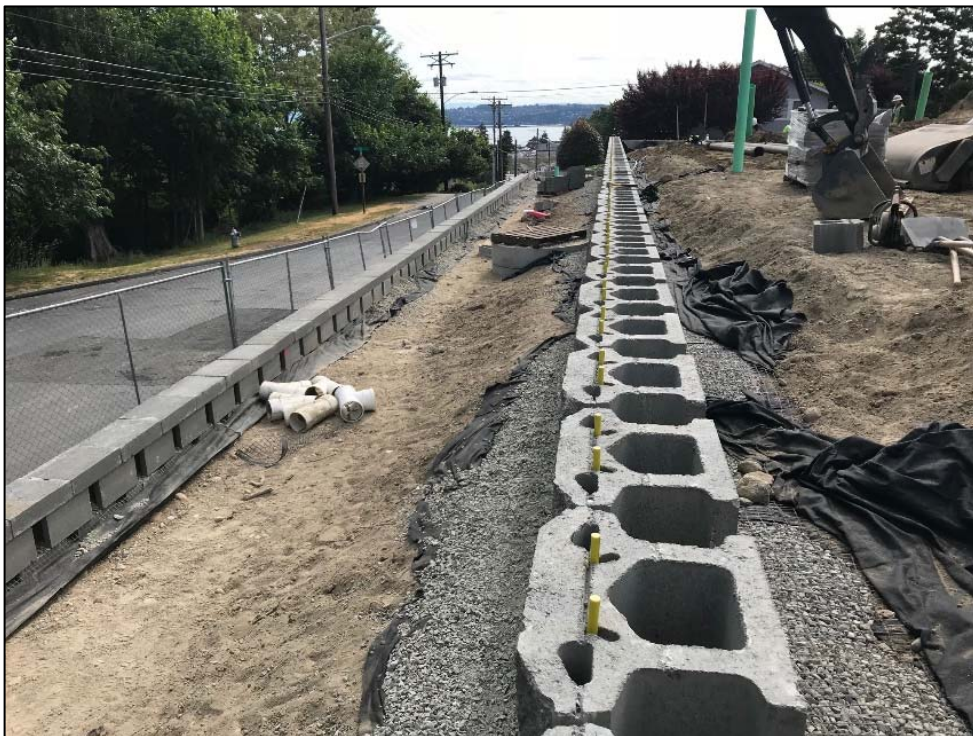
View facing east of Bristol View Apartments showing the western retaining wall along N. Bristol Street- June 5, 2018.

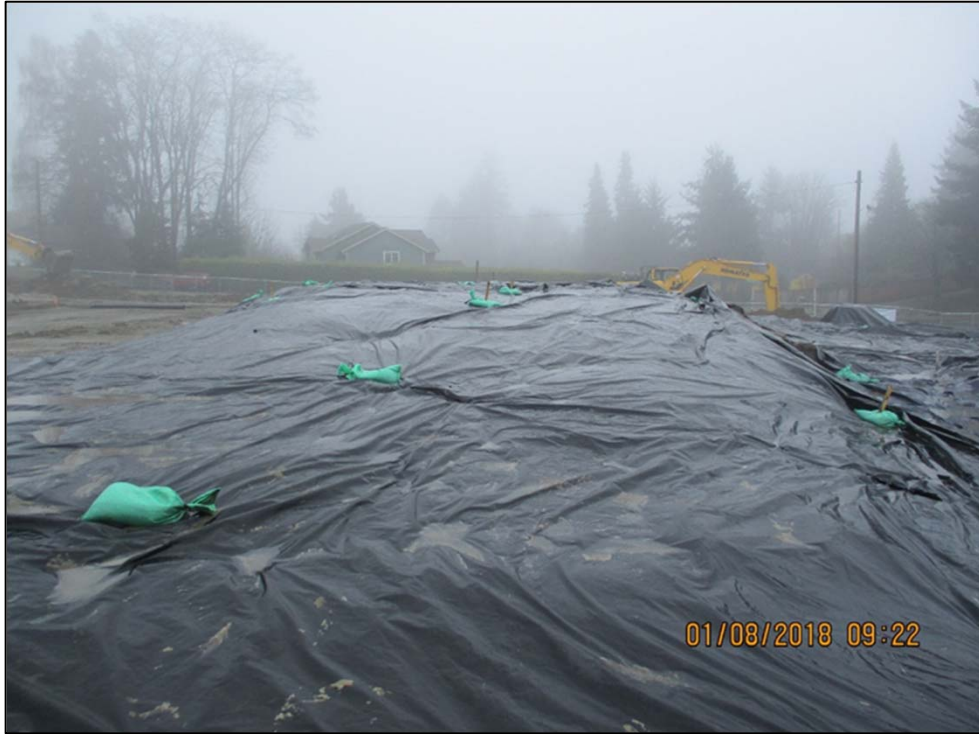
Site Photographs	
Franke Tobey Jones Tacoma, Washington	
GEOENGINEERS  	Figure 5

View facing east showing Stockpile 2 (STK2) – January 8, 2018.

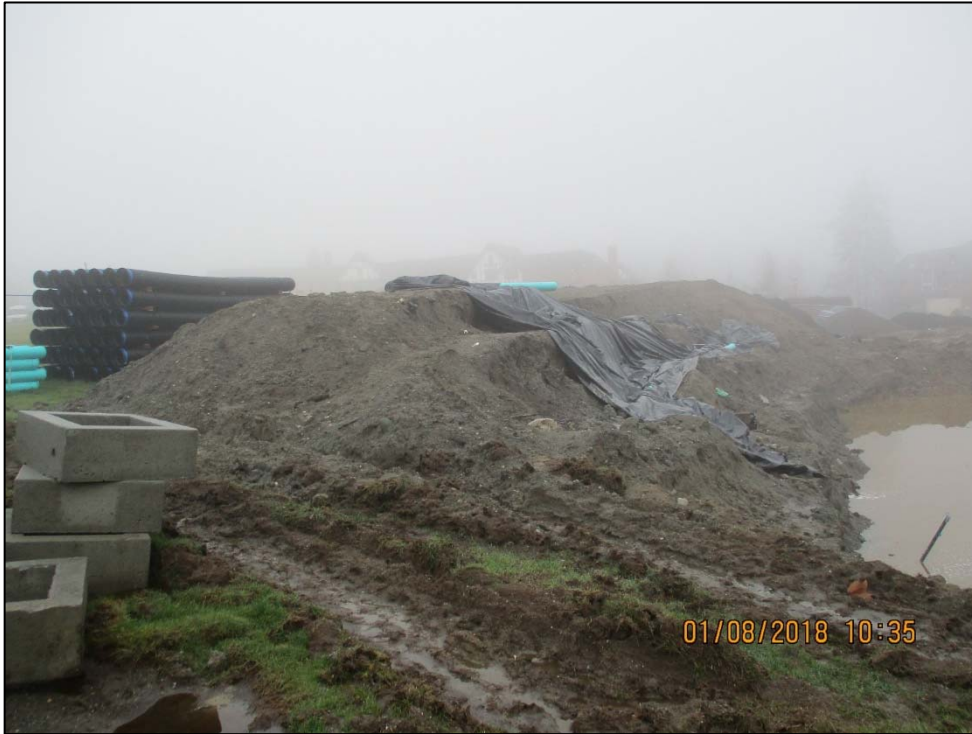
View facing north-northeast showing Stockpile 3 (STK3) – January 8, 2018.

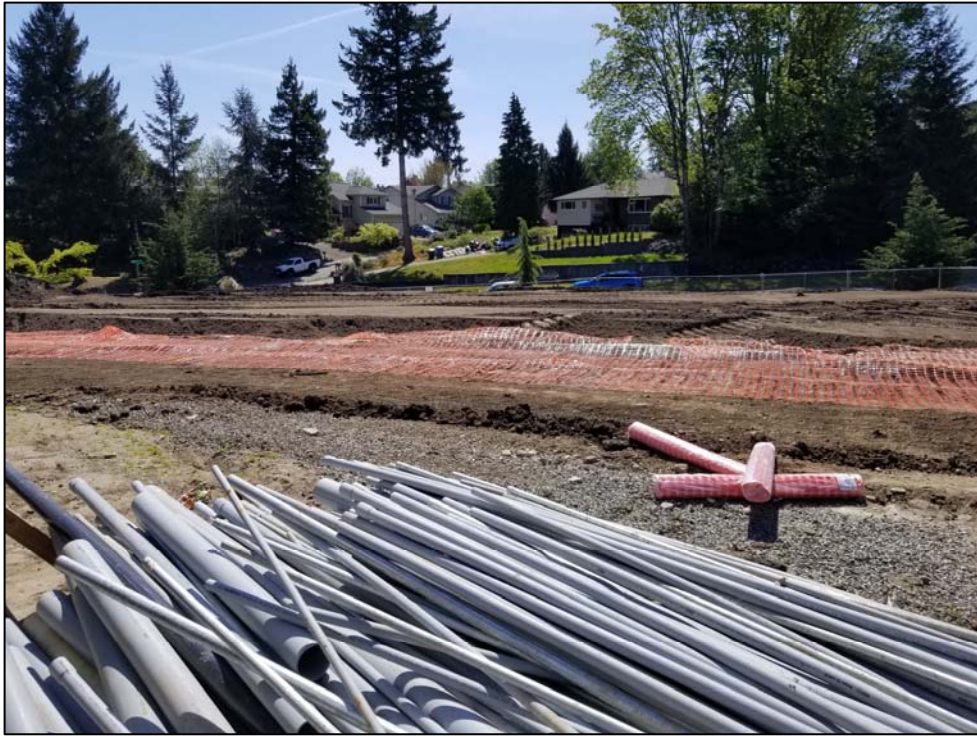
View facing east of modified Type 1 cap- May 1 , 2019.

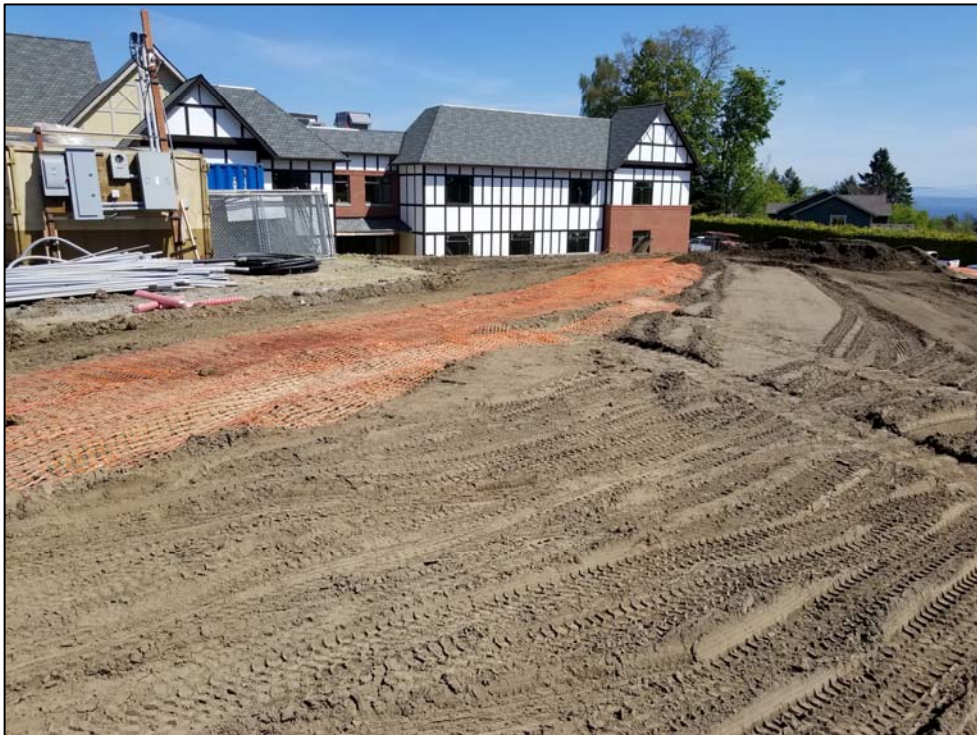
View facing northeast of modified Type 1 cap in area of HCMC-CONF-10B - May 1, 2019.

Arsenic was detected at concentrations greater than the 20 mg/kg but less than the maximum TSP Remediation Level (40 mg/kg) in four confirmation soil samples. The average arsenic concentration (15 mg/kg) in the ground surface to 0.5-foot interval (10 samples) is less than the average TSP Remediation level (20 mg/kg). The average arsenic concentration (24 mg/kg) in the 0.5- to 1-foot interval (two samples) is greater than the average TSP Remediation level (20 mg/kg).
