**Final
Independent Remedial Action Report
Verax Chemical Company Facility
Snohomish, Washington**

November 2006

Project No.26-040

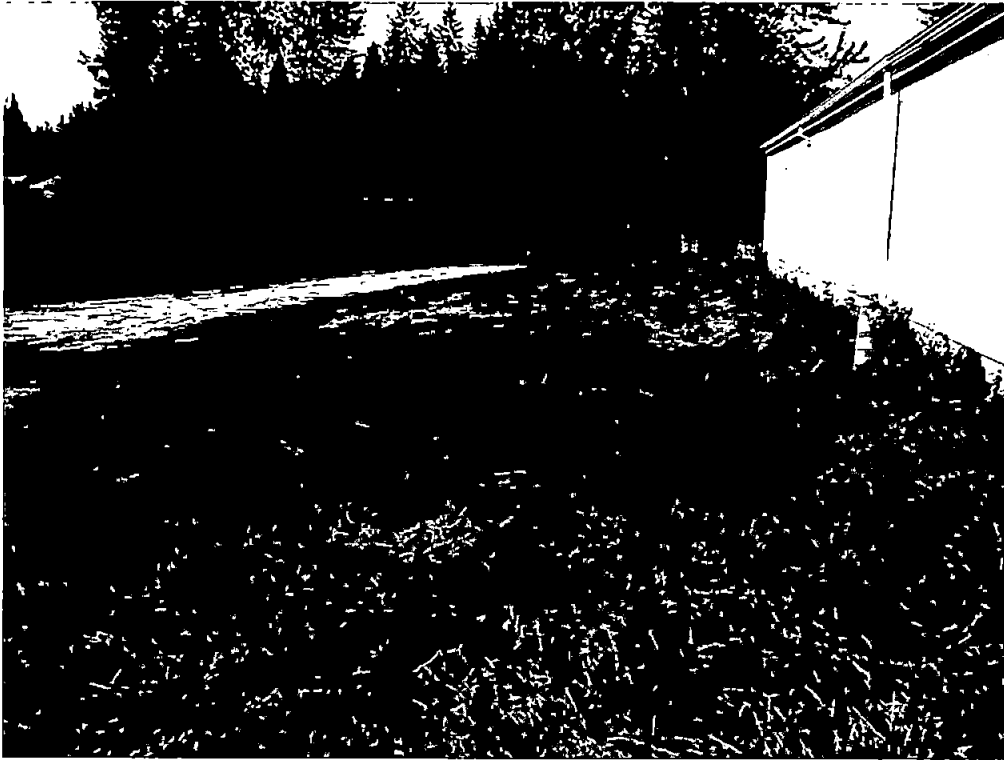
Photo 5. View of the excavation area following backfilling operations.

After confirmation sampling results documented that residual TPH-gro concentrations at the source area were below the site cleanup level, the excavation was backfilled with a combination of uncontaminated top soil, stockpiled sand from other parts of the property, and clean materials imported from a local source (Granite Falls quarry). Backfill was placed and compacted by a tractor to prevent surface erosion. Site restoration was completed on September 28, 2006.
