**CSID No. 3512 Avista Service Center Garage
Liner Repair and Groundwater Monitoring
Report**

Spokane Service Center Garage
1411 East Mission Avenue
Spokane, Washington

for
Avista Utilities

February 14, 2020

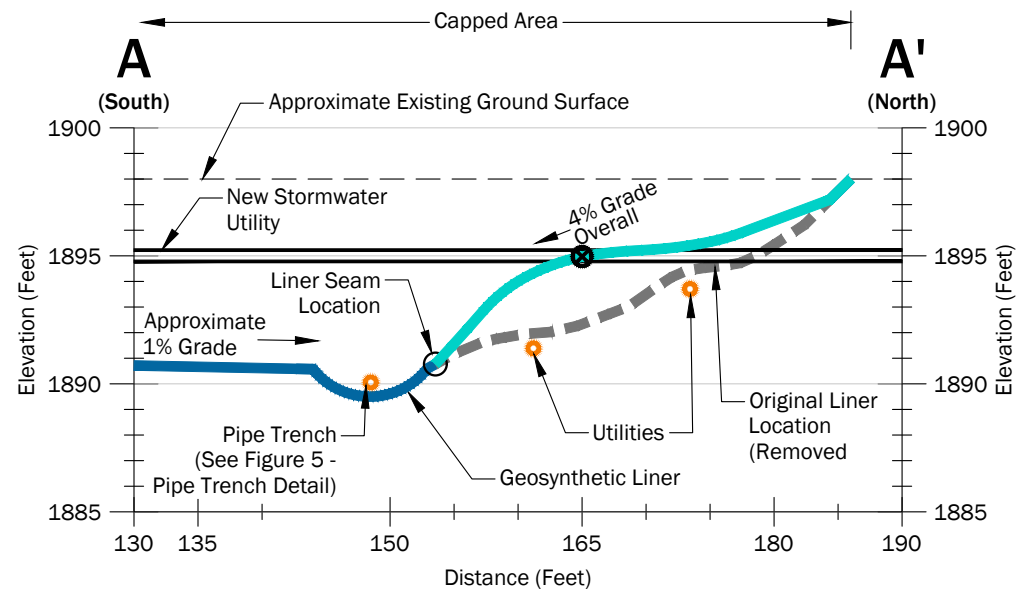
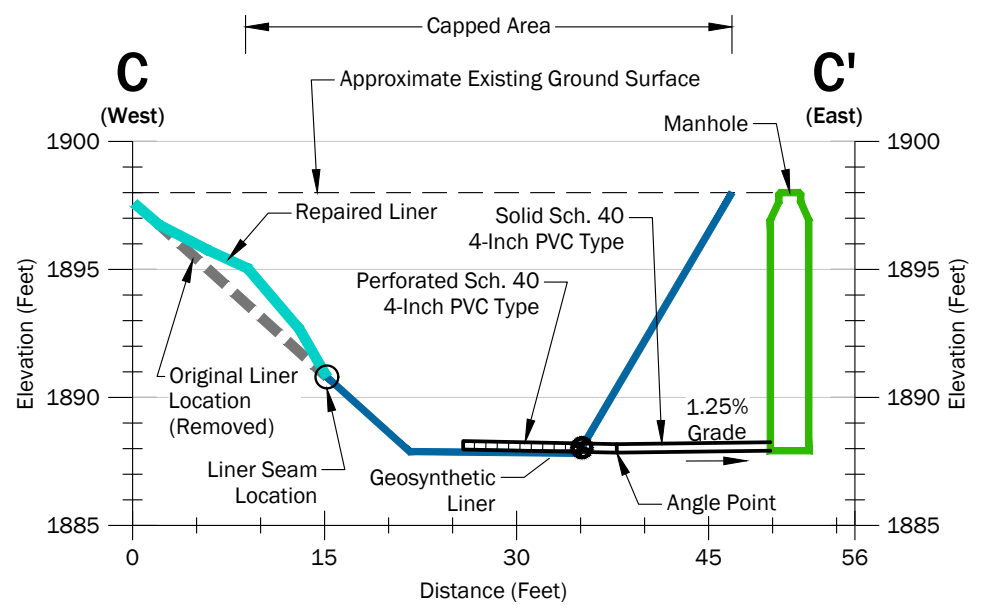
Cross Sections A-A', B-B' and C-C'	
Service Center Garage Liner Repair and Groundwater Monitoring Report Spokane, Washington	
	Figure 4

CROSS SECTION A-A'
SCALE: F09

CROSS SECTION B-B'
SCALE: F09

CROSS SECTION C-C'
SCALE: F09

SES mobilized to the site on January 6, 2020 to expose the liner for repairs. Figures 3 through 5 depict the former liner construction and configuration, the areas of the liner repairs, and final as-built diagrams of the completed and repaired liner in the north portion of the constructed liner area. Figures 7 through 16 provide photographs of the liner exposure and repair activities. The following activities were performed for liner repairs:

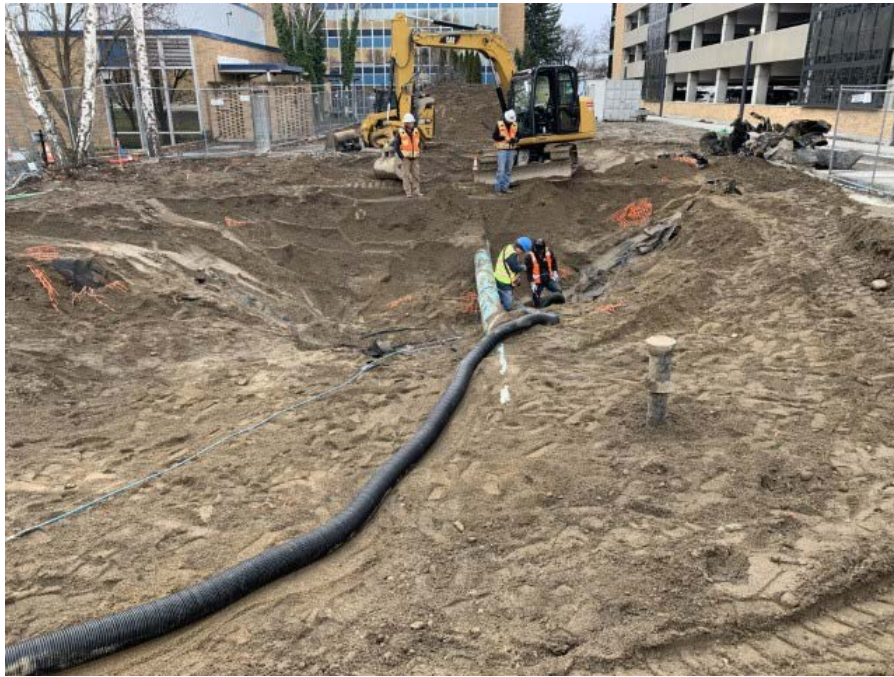
Photograph 1. SES over excavates to expose damaged liner at the north end of the site, looking South.

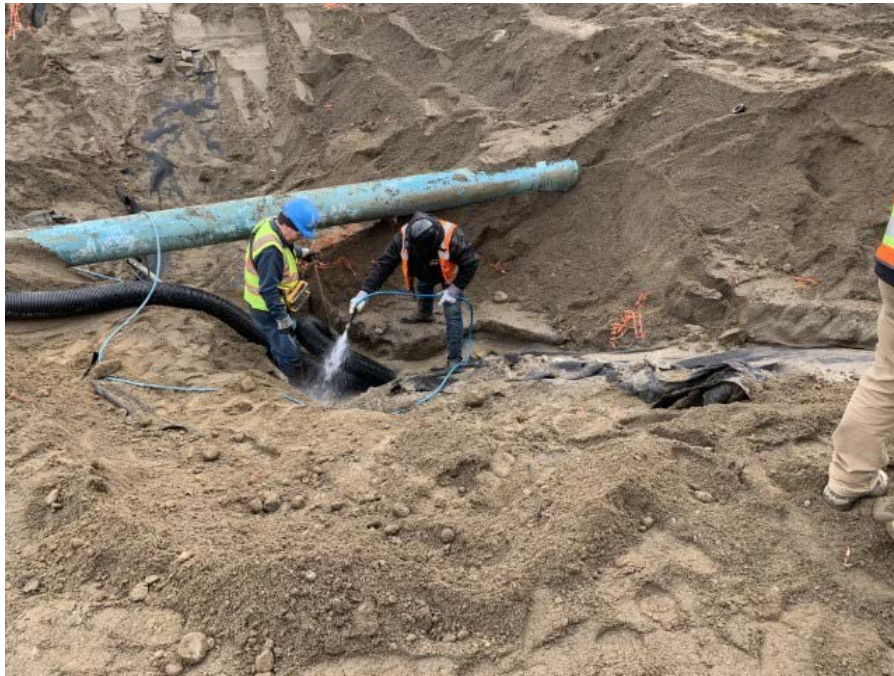
Photograph 2. SES exposes damaged liner using pressurized water and a Hydroexcavator vacuum truck, looking West.

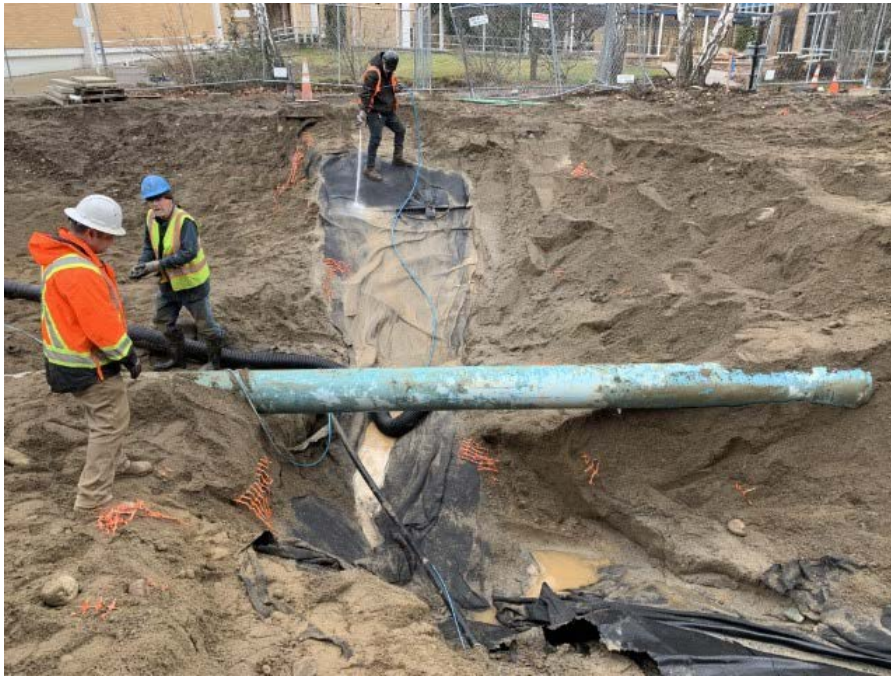
Photograph 3. SES exposes section of damaged liner, looking West.

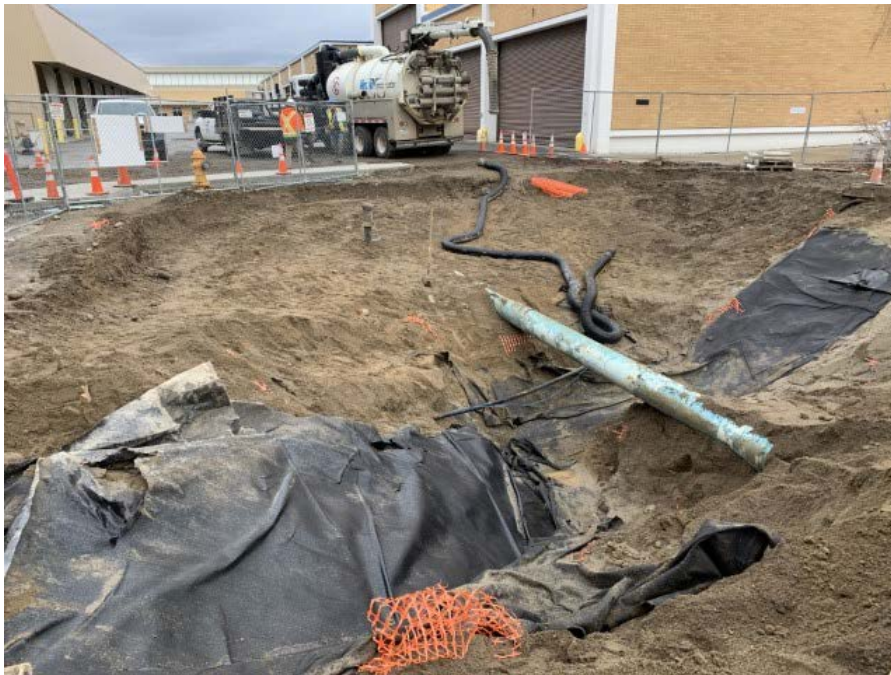
Photograph 4. Exposed section of damaged liner, looking North.

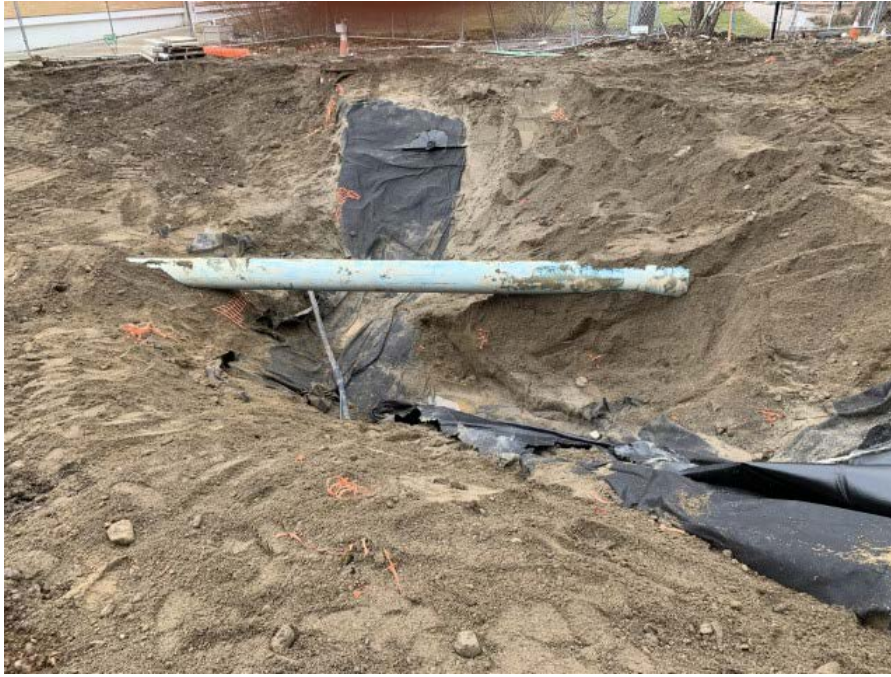
Photograph 5. Exposed section of damaged liner, looking East.

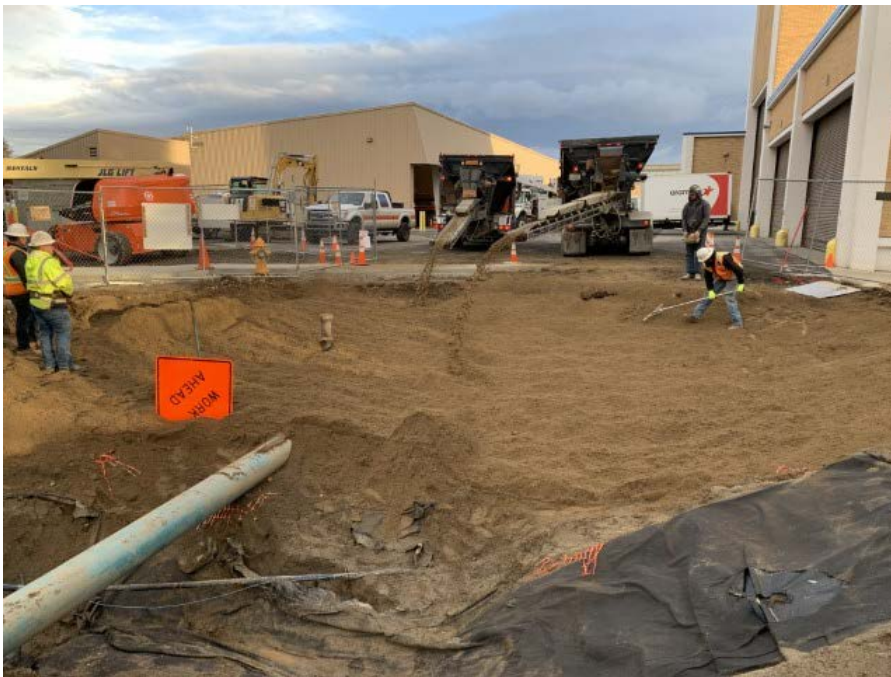
Photograph 6. SES places bedding sand for geosynthetic liner repair using two dump truck conveyor belt systems, looking North.

- SES graded the northern end of the excavation using the track hoe and hand tools.
- CAD mobilized to the site to place bedding sand within the excavation using a truck mounted conveyor belt system. CAD placed 30.26 tons of bedding sand from Central Pre-Mix in Spokane Valley, Washington. SES used hand tools to grade the bedding sand into an approximately 6-inch-thick lift to bed the new replacement liner.

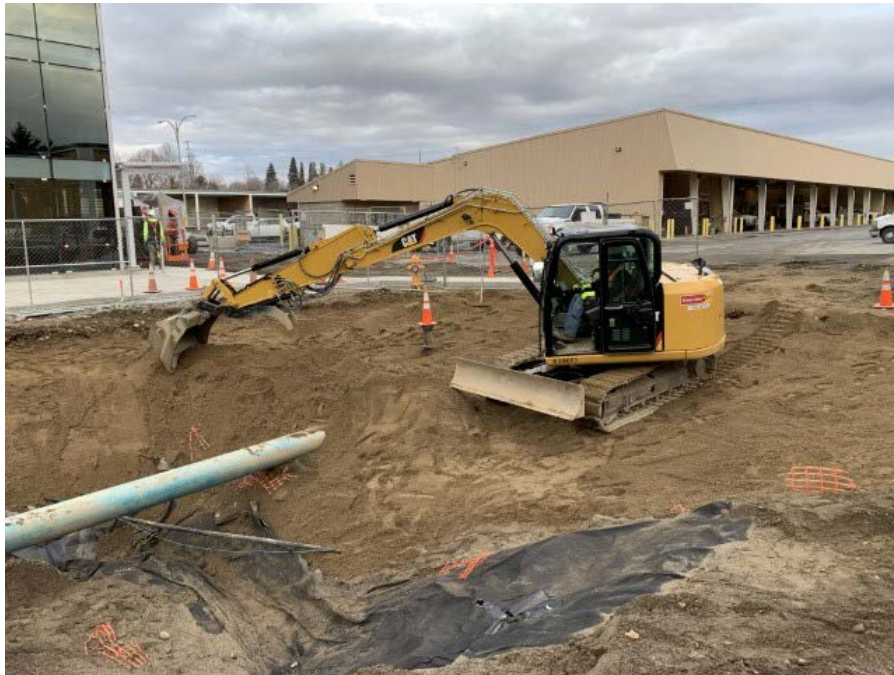
Photograph 7. SES prepares bedding sand for replacement liner section, looking Northwest.

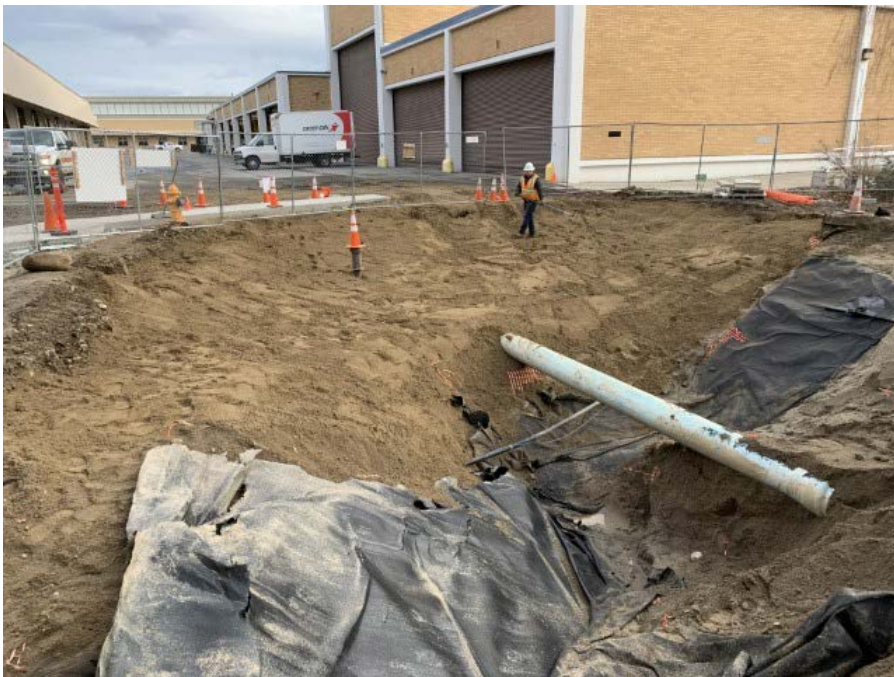
Photograph 8. Bedding sand prepped for geosynthetic liner layout, looking Northeast.
