# Five-Year Review Report

Fifth Five-Year Review Report  
for  
Lakewood/Ponders Corner Superfund Site  
Lakewood, Washington  
September 2012

United States Army Corps of Engineers

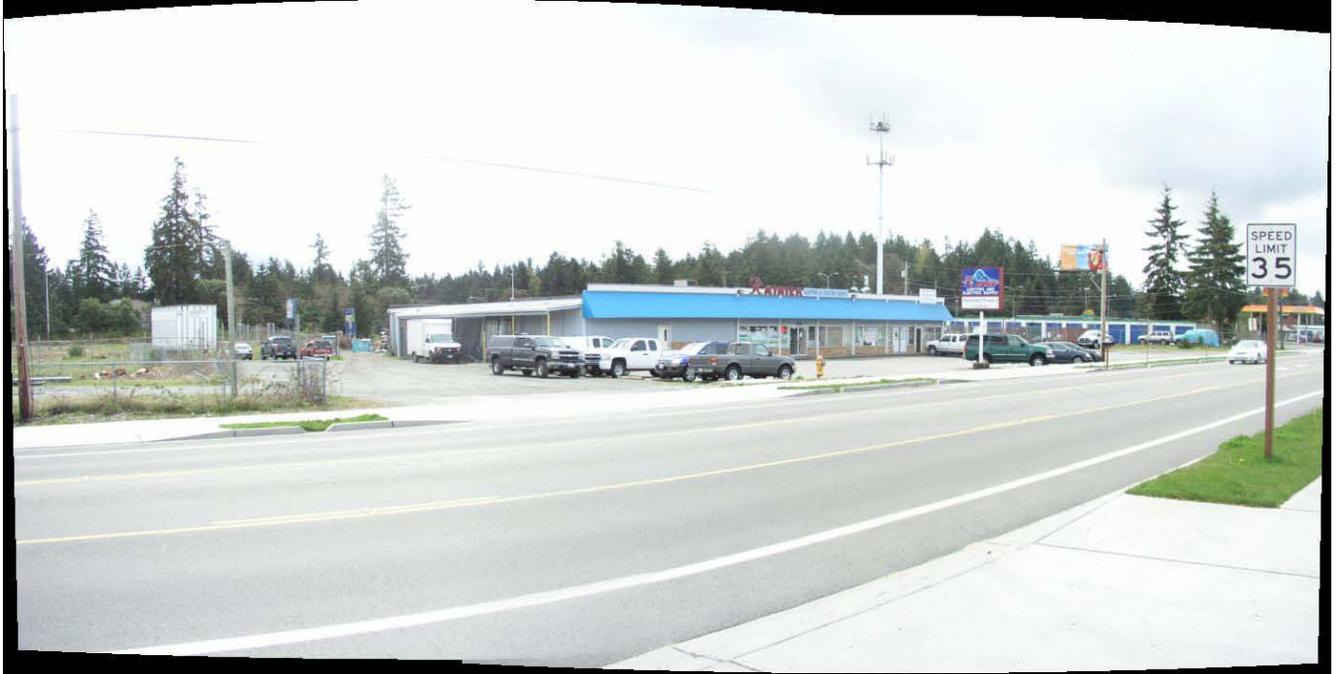
**Building once used as dry cleaning shop, now an electrical supply store.**

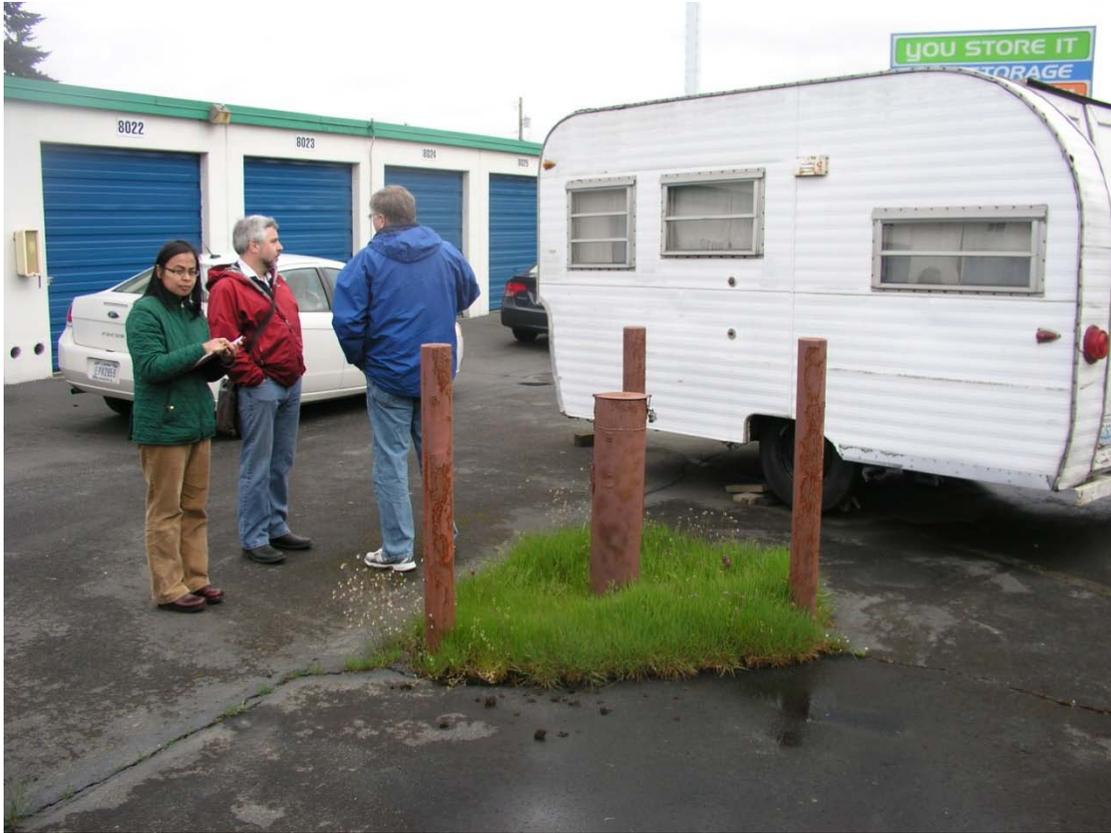
**Monitoring well MW-16. Two wells clustered within the protective casing. Located approximately 400 feet SW of the source site.**

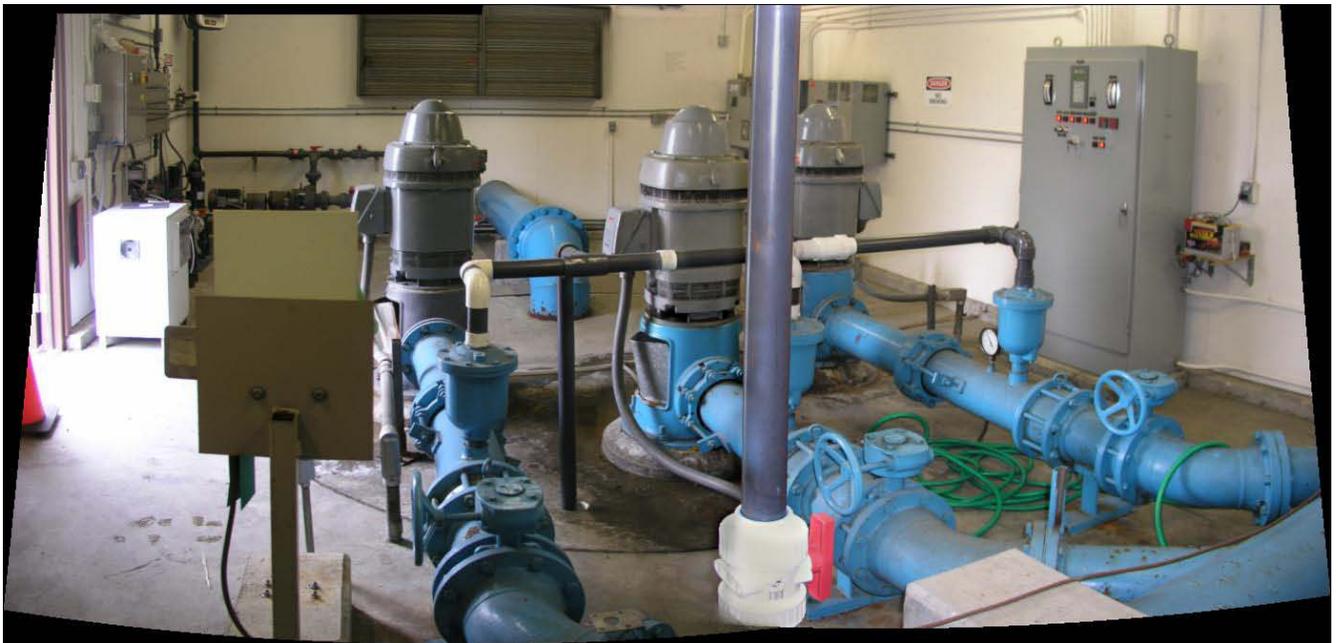
**Inside treatment building with chlorination system**
