FINAL STUDY AREA INVESTIGATION— AQUATIC LANDS LEASE

WEYERHAEUSER SAWMILL ABERDEEN/SEAPORT LANDING SITE
FACILITY SITE ID 1126, CLEANUP SITE ID 4987, AGREED ORDER ID 11225
WASHINGTON STATE DEPARTMENT OF NATURAL RESOURCES AQUATIC
LANDS LEASE NO. 22-092275

Prepared for
GRAYS HARBOR HISTORICAL SEAPORT AUTHORITY

June 19, 2019
Project No. 1044.02.06

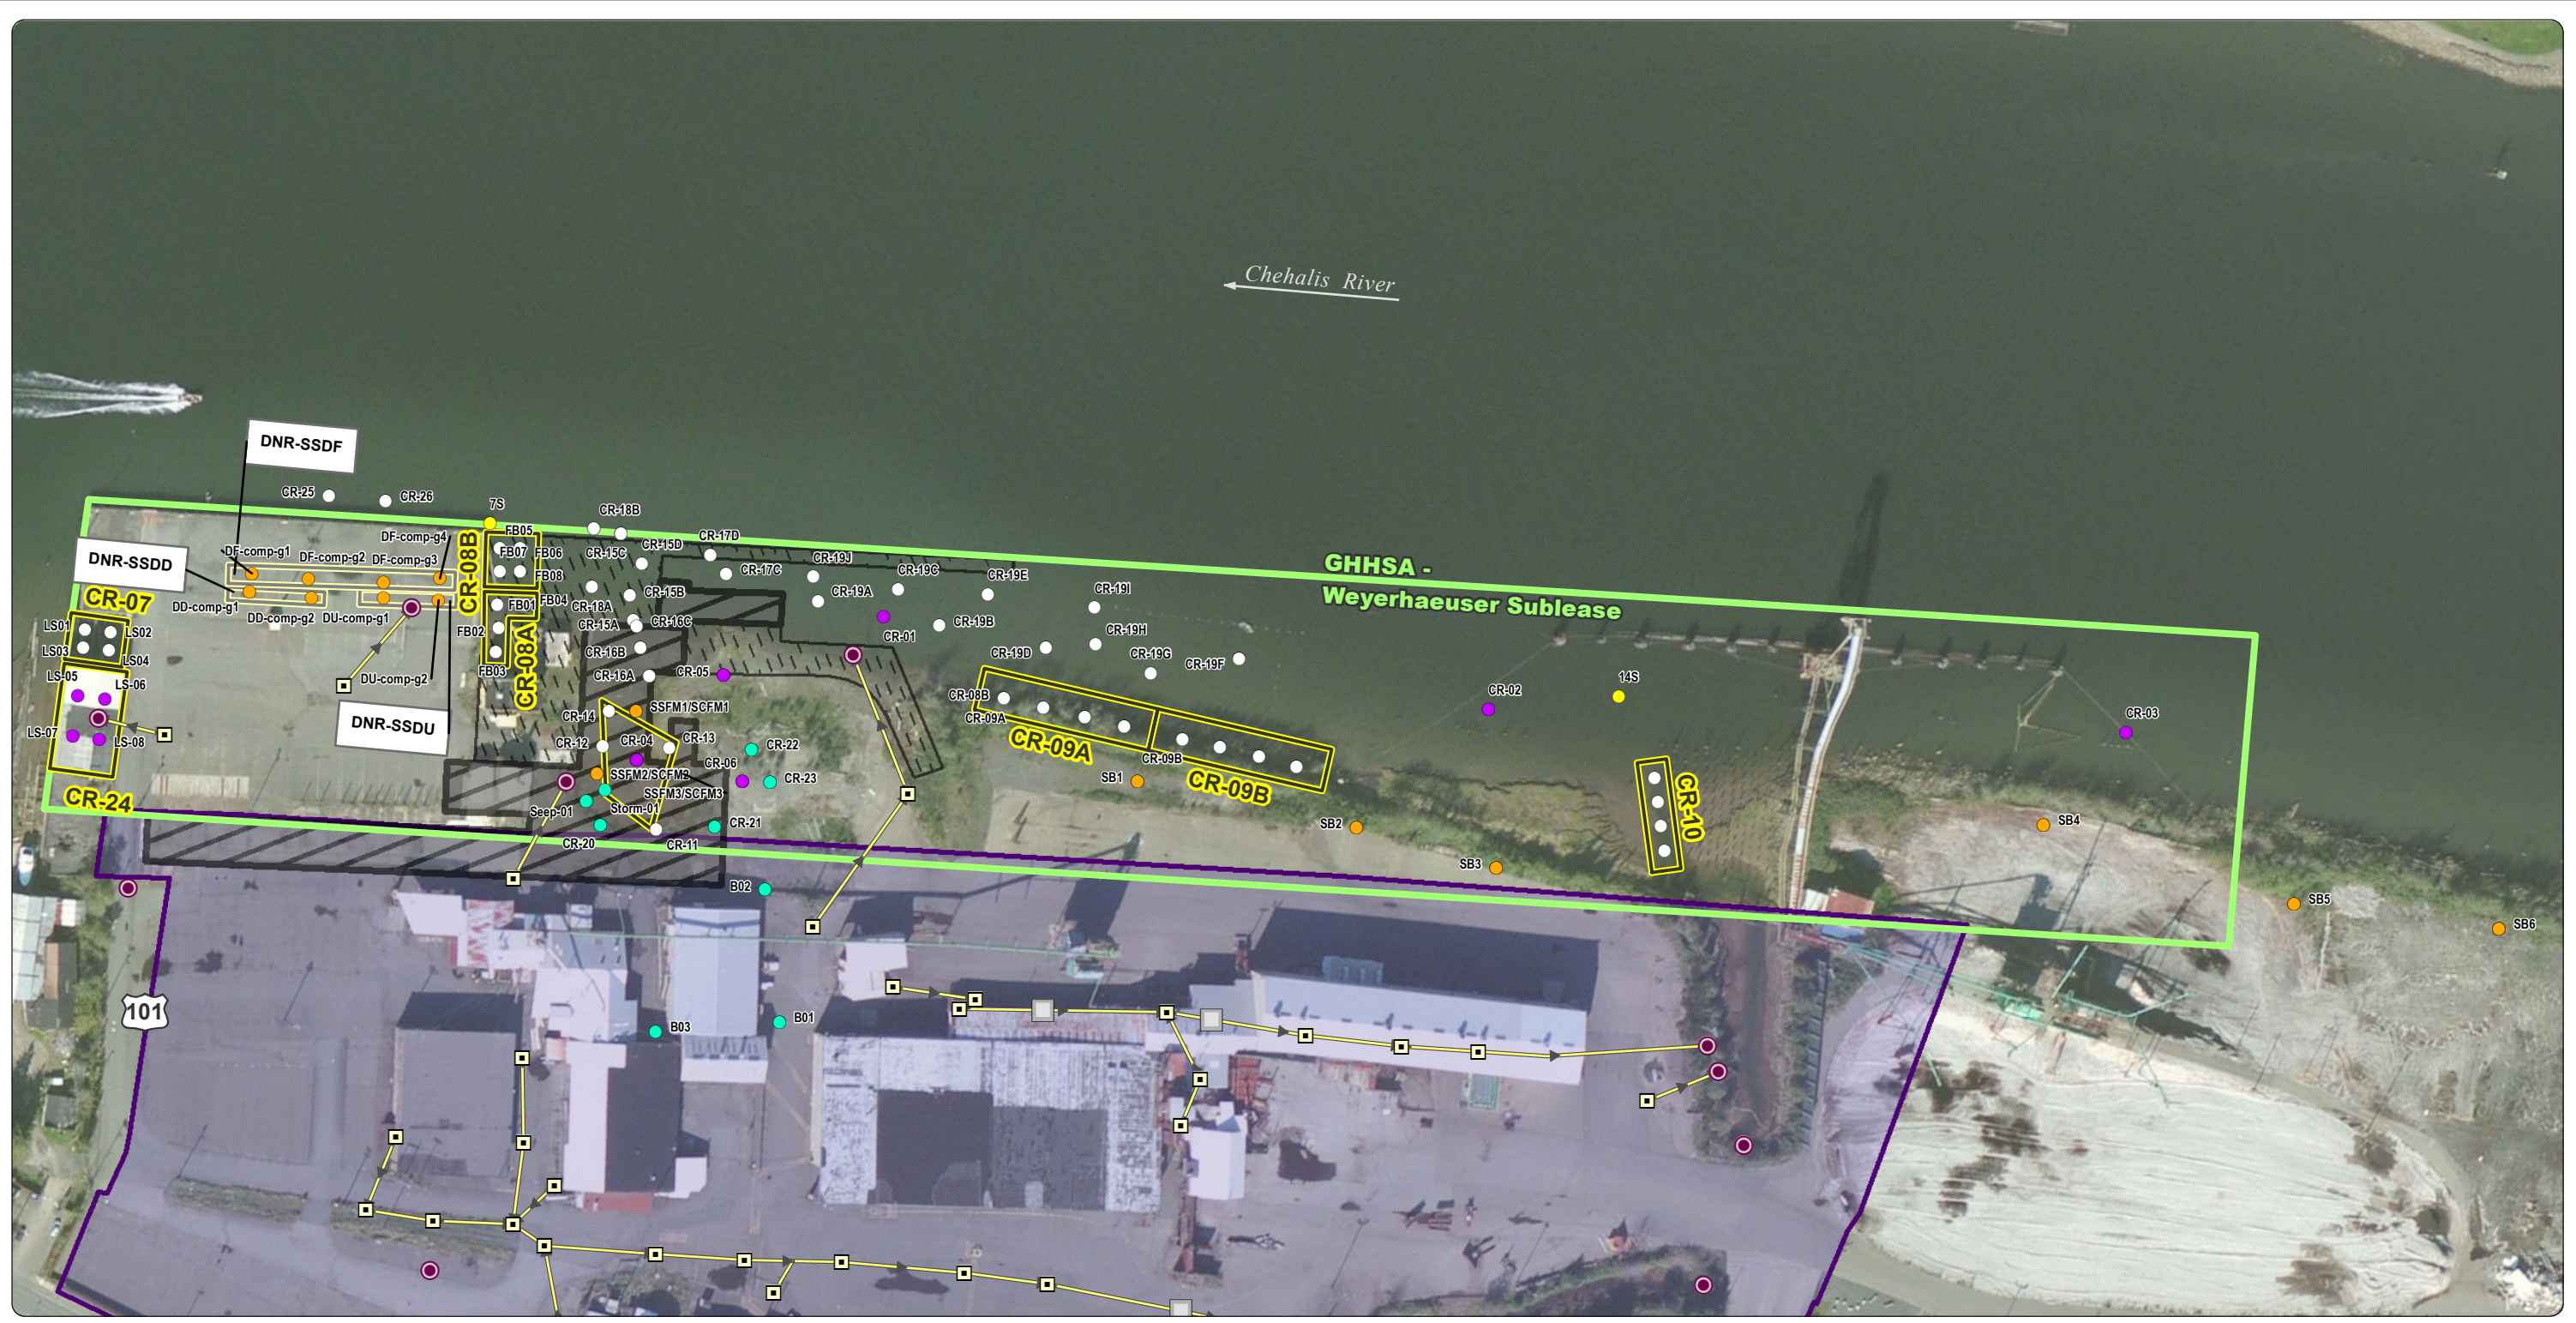
Project: 0863.01.01-02 Produced By: aguse Approved By: mstringer Print Date: 5/22/2019 Path: X:\11044.02.01-02 Grays Harbor Seaport Authority\Projects\Seaport_Landing_RL_FSI\Fig2-1_SampleLocationsLabeled_02.mxd

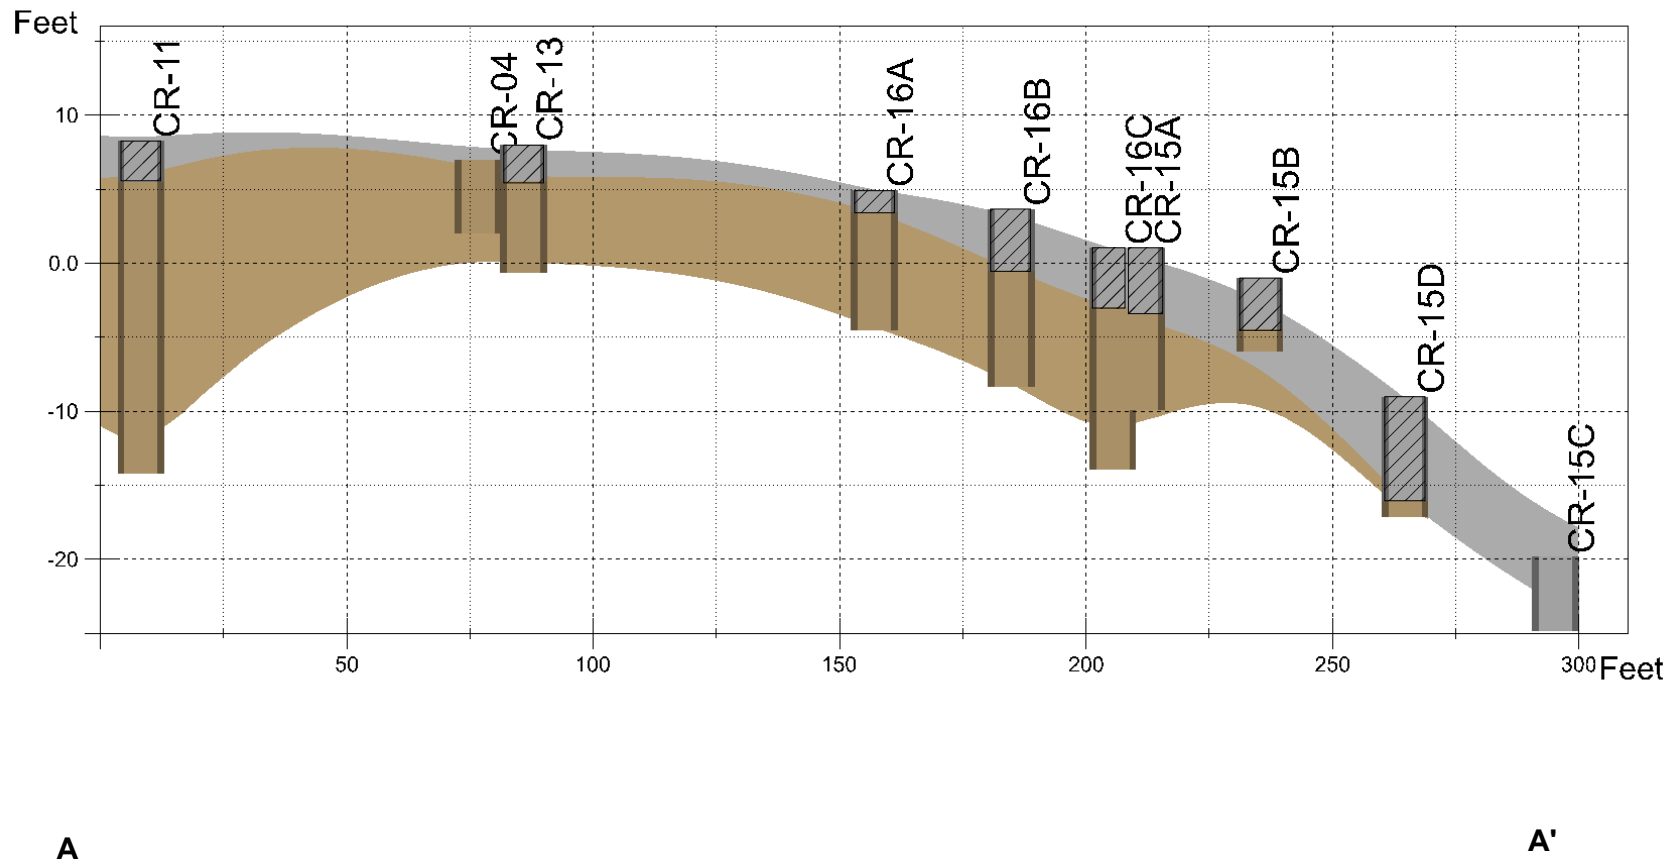
Figure 4-4
Woodwaste and Overlaying
Sediment Cross-Section
 Aberdeen, Washington

- Legend**
- Wood Debris
 - Sediment
 - No Recovery

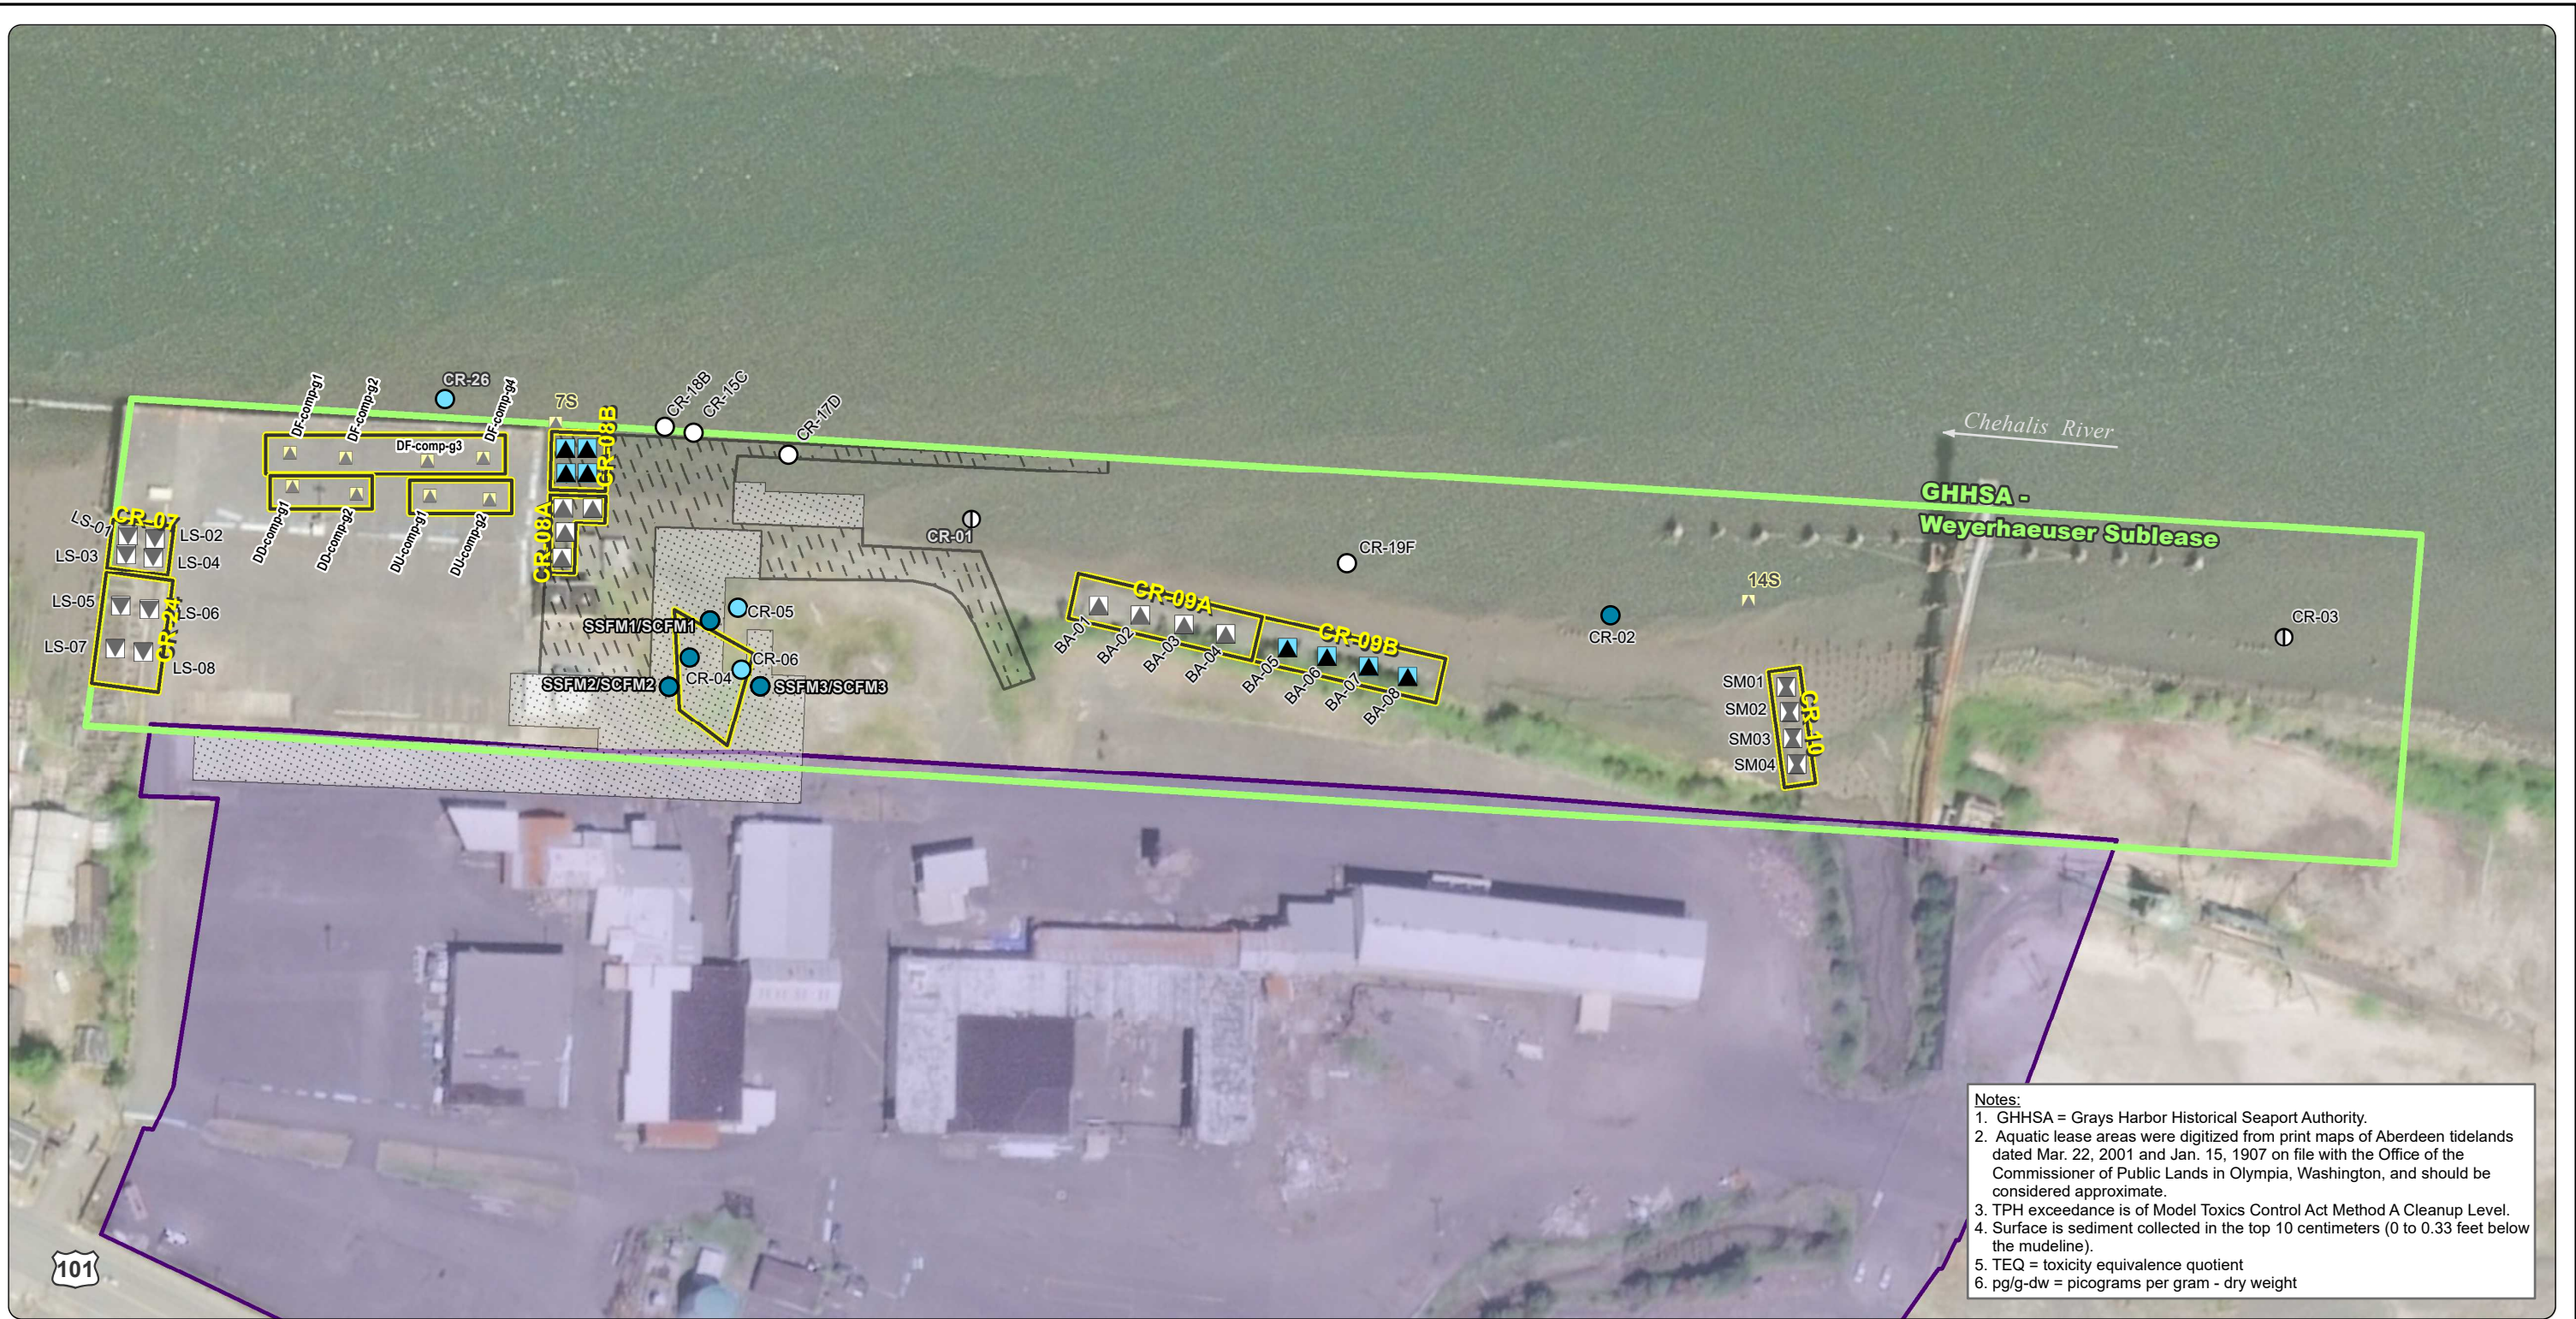
Notes:
 1. GHSA = Grays Harbor Historical Seaport Authority.
 2. Aquatic lease areas were digitized from print maps of Aberdeen tidelands dated Mar. 22, 2001 and Jan. 15, 1907 on file with the Office of the Commissioner of Public Lands in Olympia, Washington, and should be considered approximate.
 3. TPH exceedance is of Model Toxics Control Act Method A Cleanup Level.
 4. Surface is sediment collected in the top 10 centimeters (0 to 0.33 feet below the mudline).
 5. TEQ = toxicity equivalence quotient
 6. pg/g-dw = picograms per gram - dry weight
