## **DECOMMISSIONING REPORT**

Avis SeaTac

18811 16th Avenue South

Project No. SE11160290

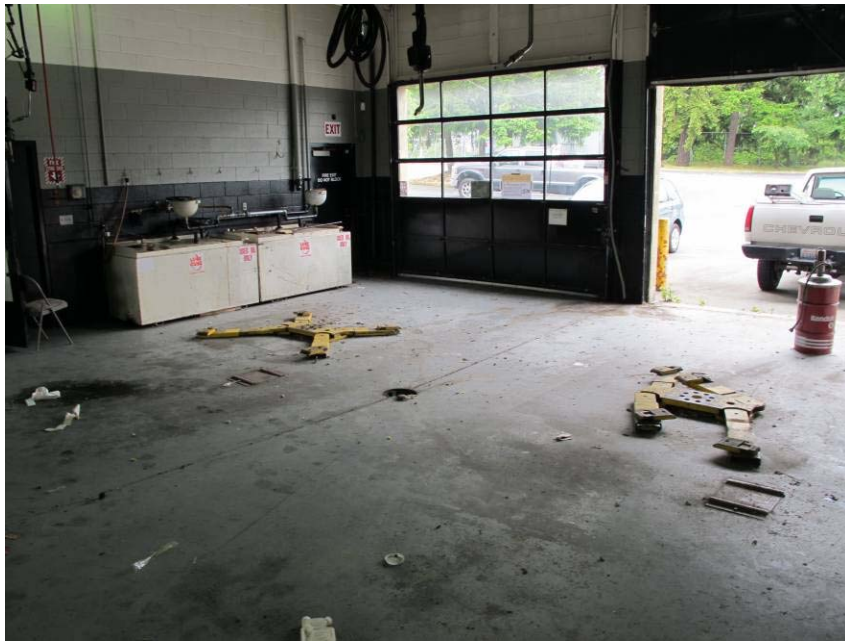
1. View inside maintenance bay showing hydraulic hoists prior to removal

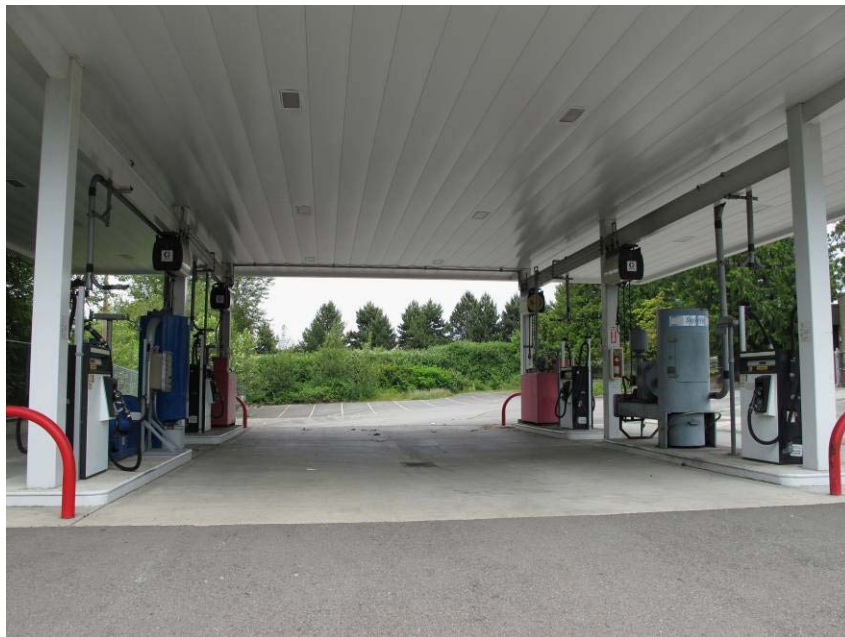
2. Fuel dispenser islands prior to decommissioning

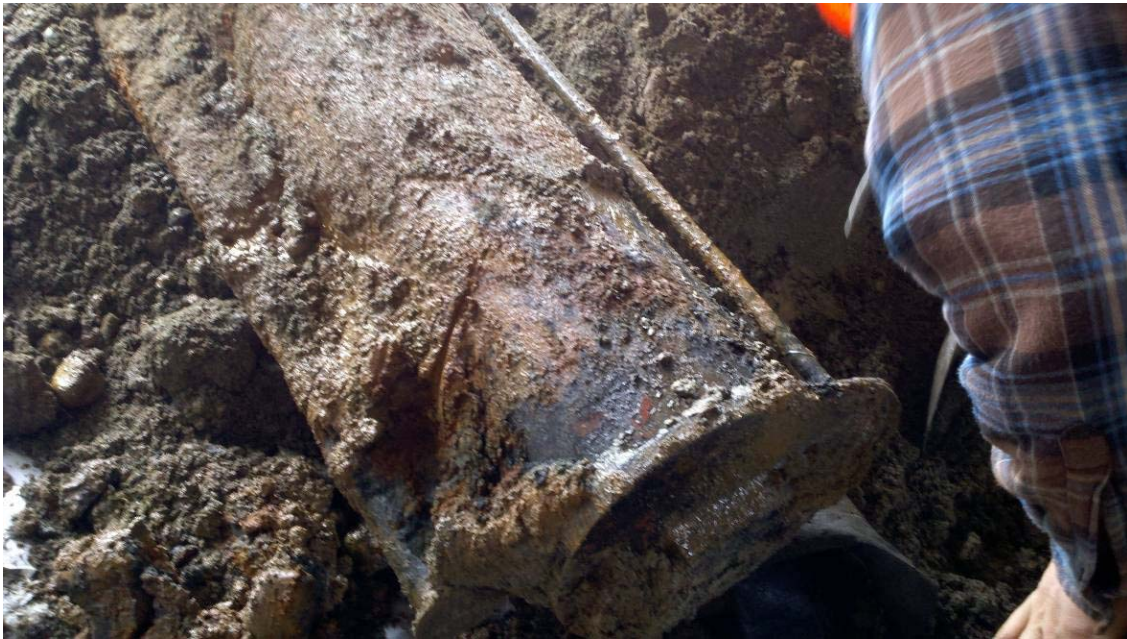
Field observations clearly showed that a release of hydraulic fluid from the corroded cylinder had occurred at the north hydraulic hoist cylinder. After excavation of approximately 17.7 tons of soil, soil confirmation samples from the four sidewalls and the bottom of the excavation showed that all soil affected by hydraulic fluid had been removed. No environmental issues remain that are associated with the north hoist cylinder release.

3. North hydraulic cylinder during removal showing corrosion at base of cylinder

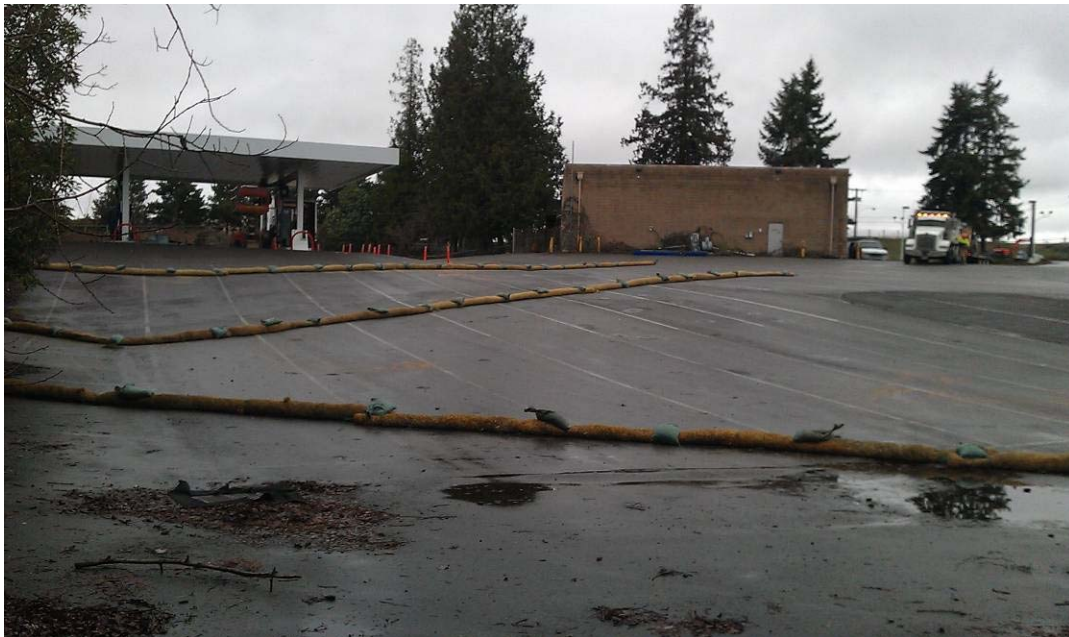
4. Temporary stormwater and erosion controls required by City of SeaTac

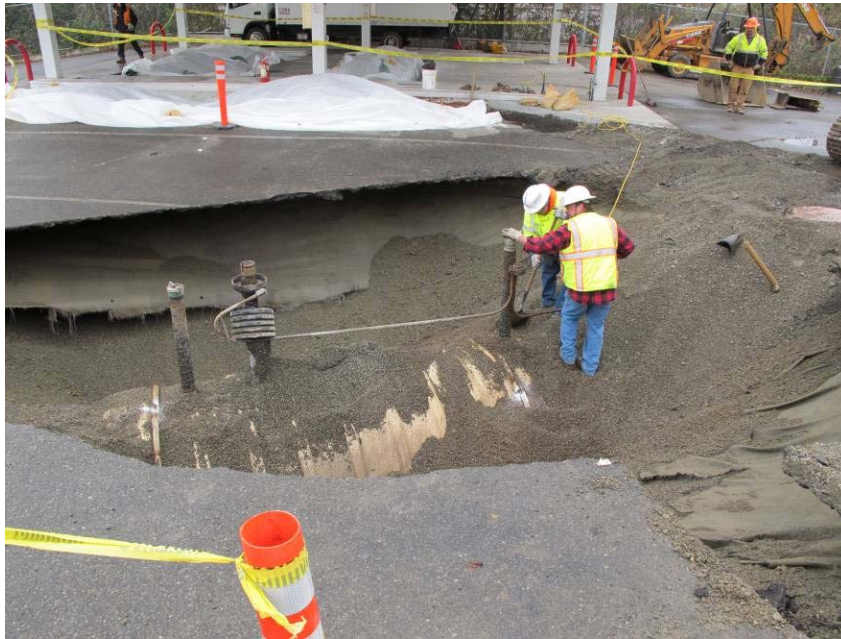
5. 12,000-gallon underground storage tank (UST) during excavation. Note extensive pea gravel in tank cavity.

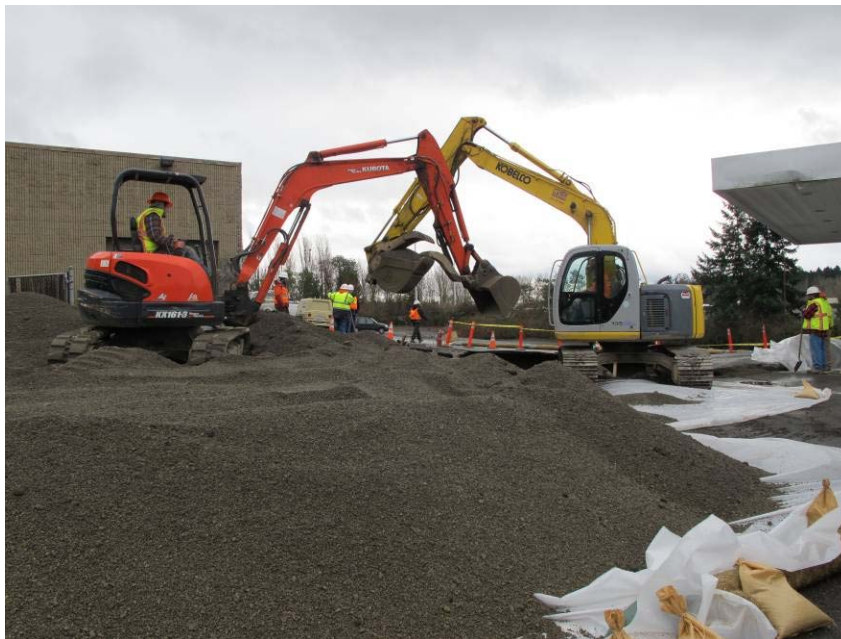
6. Stockpiled pea gravel during removal of 12,000-gallon UST

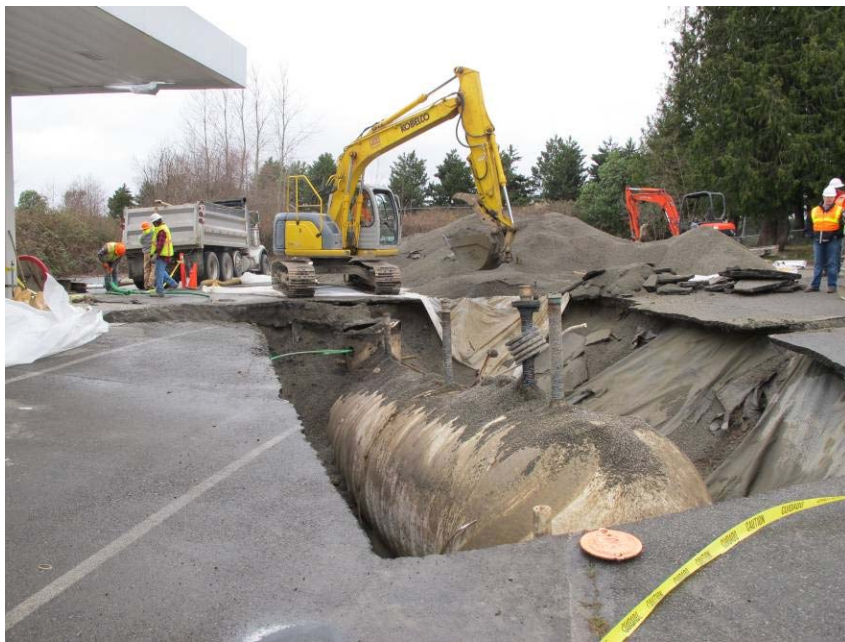
7. 12,000-gallon UST fully uncovered

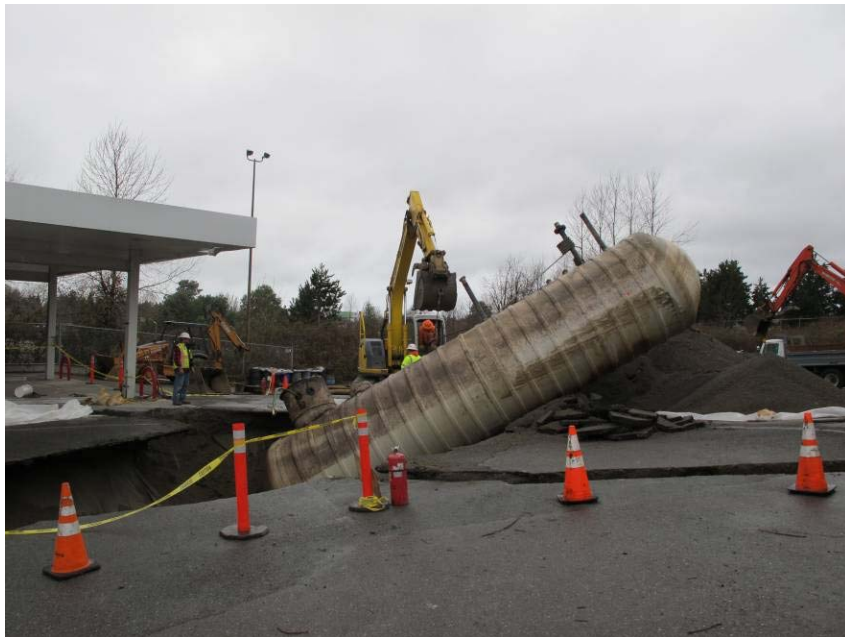
- The UST was secured and hoisted from the excavation using an excavator;
- The double-wall fiberglass UST was intact and in tank to be in good condition;

8. 12,000-gallon UST during hoist

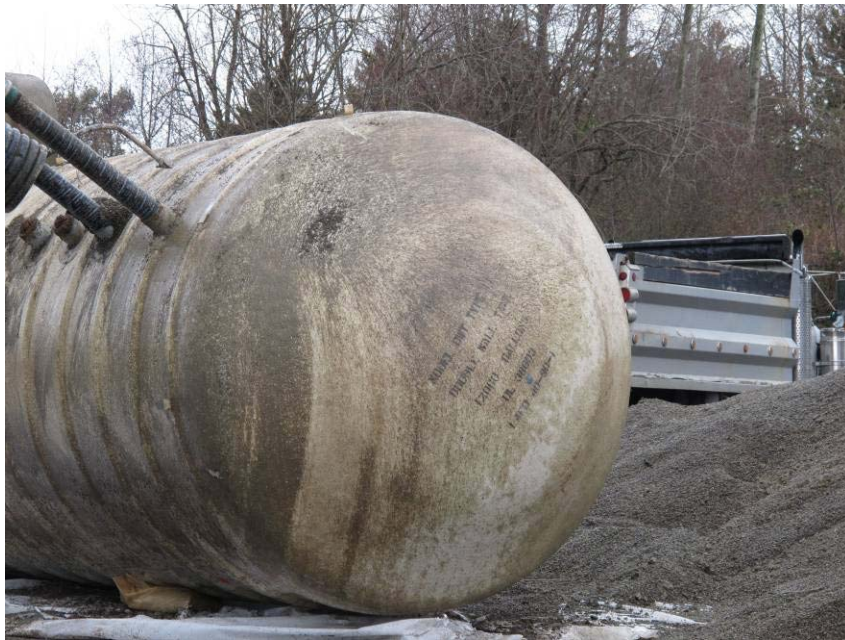
Tank 4 was a 12,000-gallon unleaded gasoline tank registered with Ecology as Tank ID 40652. It was installed in January 1992 by B & C Equipment Company (B&C) approximately 35 feet southwest of the main building in the approximate location of Tank 1 (Figure 3). The tank pump system was pressurized, with a spill bucket/box for spill prevention, an overfill alarm, corrosion-resistant flexible double-wall pipe, and automatic line leak detection. The tank was constructed of double-walled fiberglass, UL #38003 and a LAFD #40-90-1.

9. Labeled end of intact UST. Label reads "MODEL DWT TYPE II / DOUBLE WALL TANK / 12000 GALLONS / UL 38003 / LAFD 40-90-1"

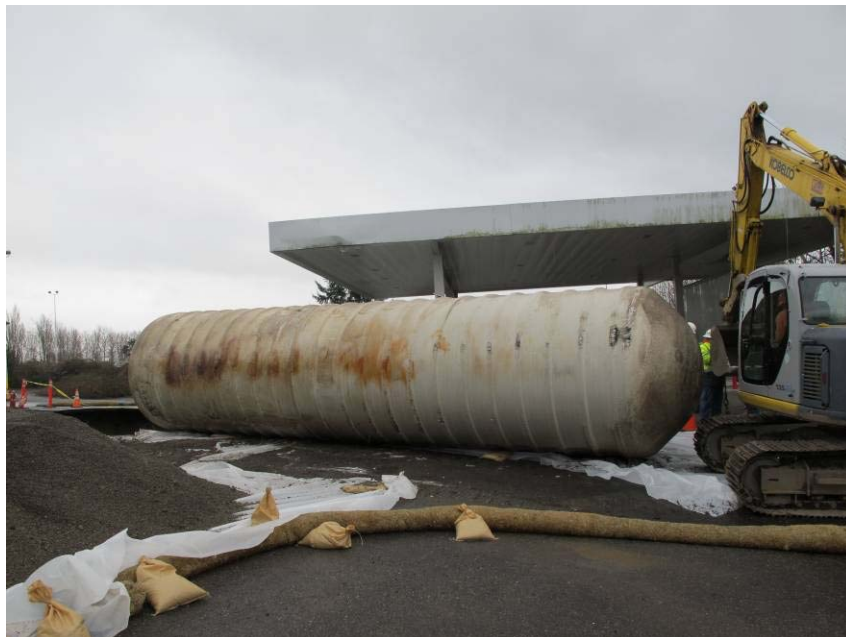
10. Intact 12,000-gallon UST following removal from cavity

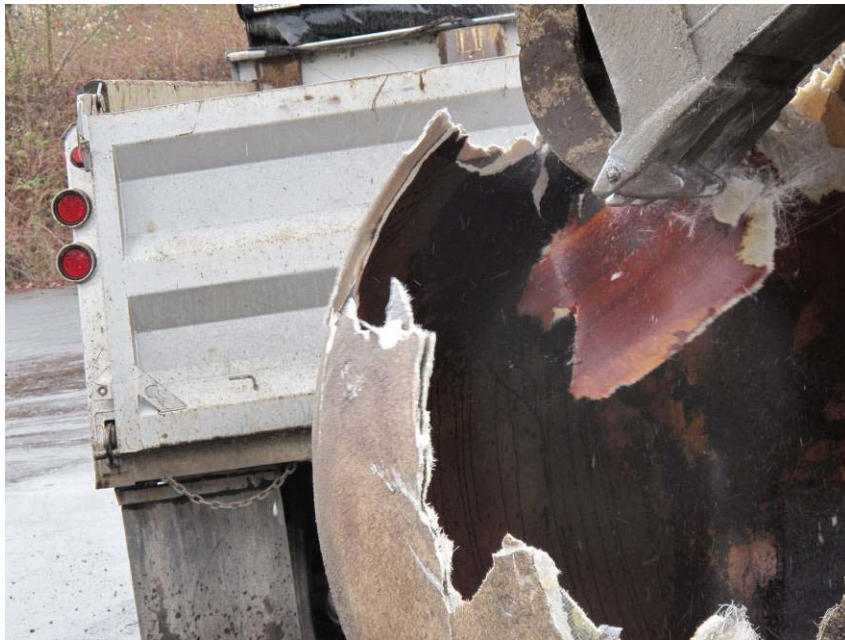
11. On-site crushing of 12,000-gallon fiberglass UST

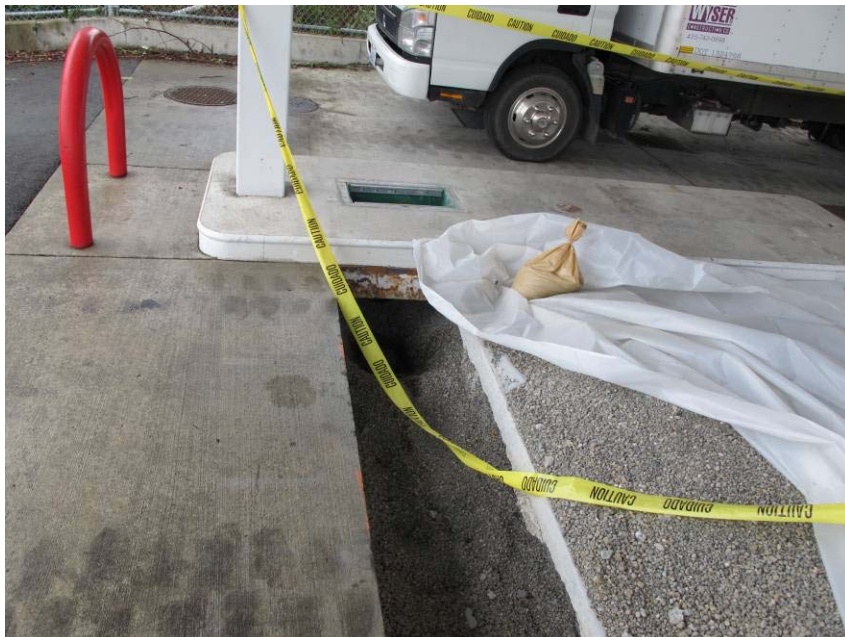
12. Fuel dispenser island piping excavation showing saw cut concrete and fuel dispenser sump

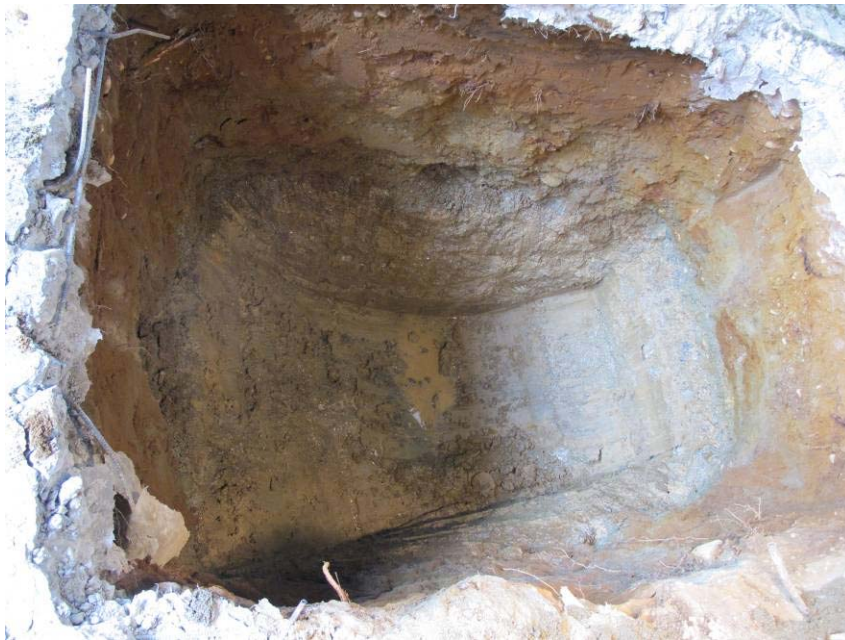
13. North hydraulic hoist soil excavation, measuring approximately 6 feet wide by 8 feet long and 9 feet deep

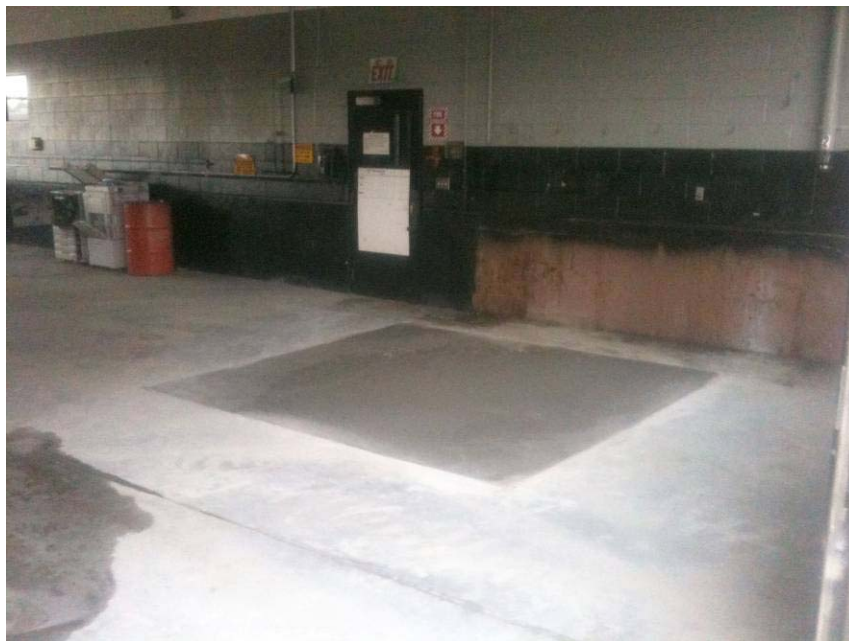
14. North hydraulic hoist following restoration of cement

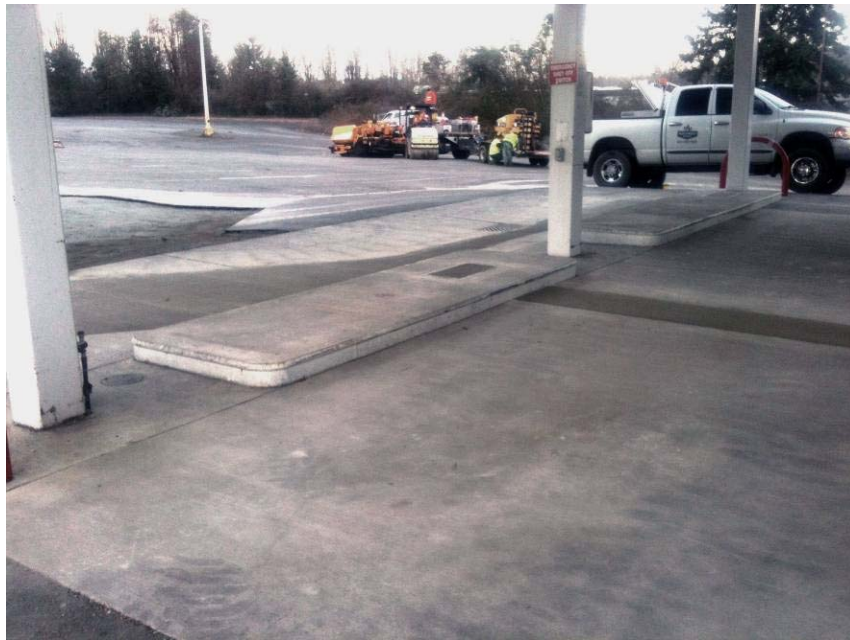
15. Fuel dispenser island following restoration of concrete paving

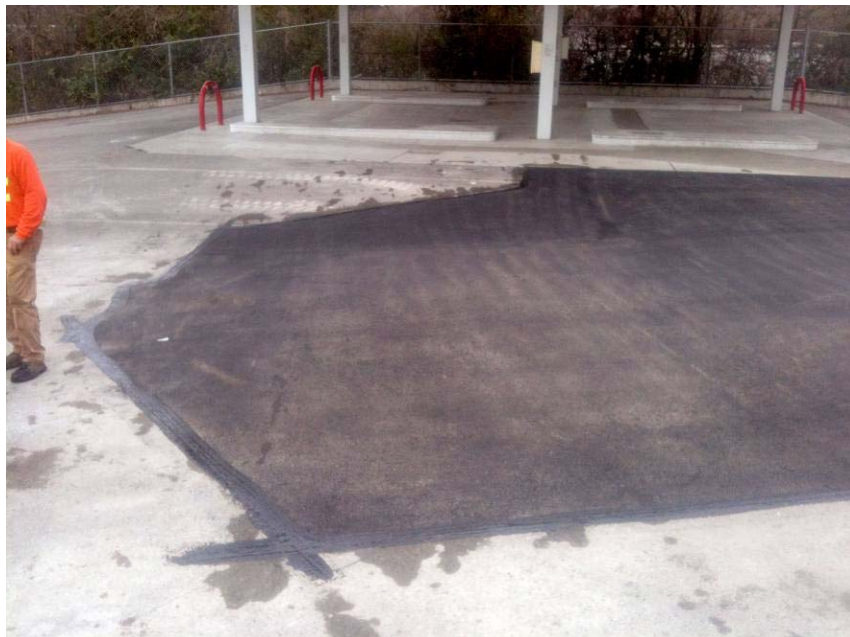
16. Former tank cavity following repaving

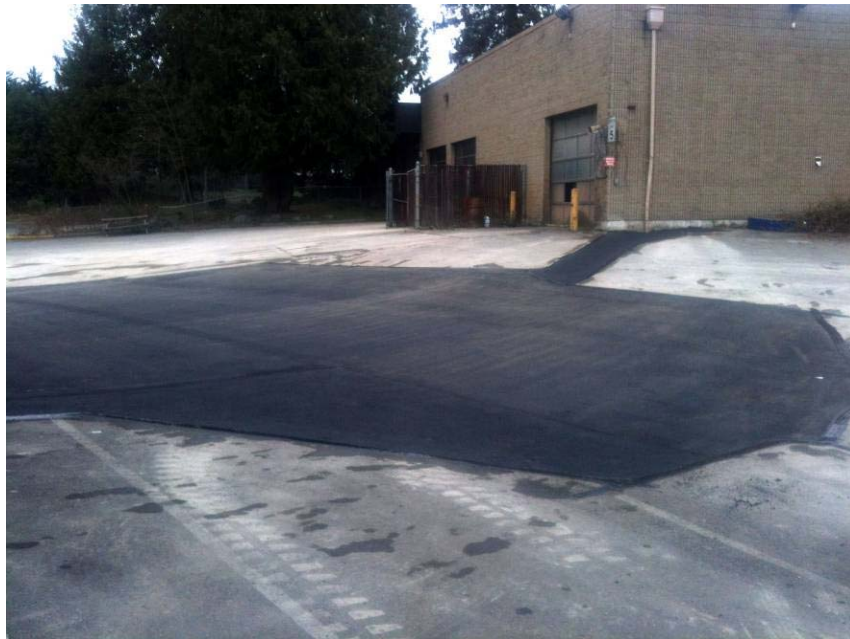
17. Former tank cavity following repaving

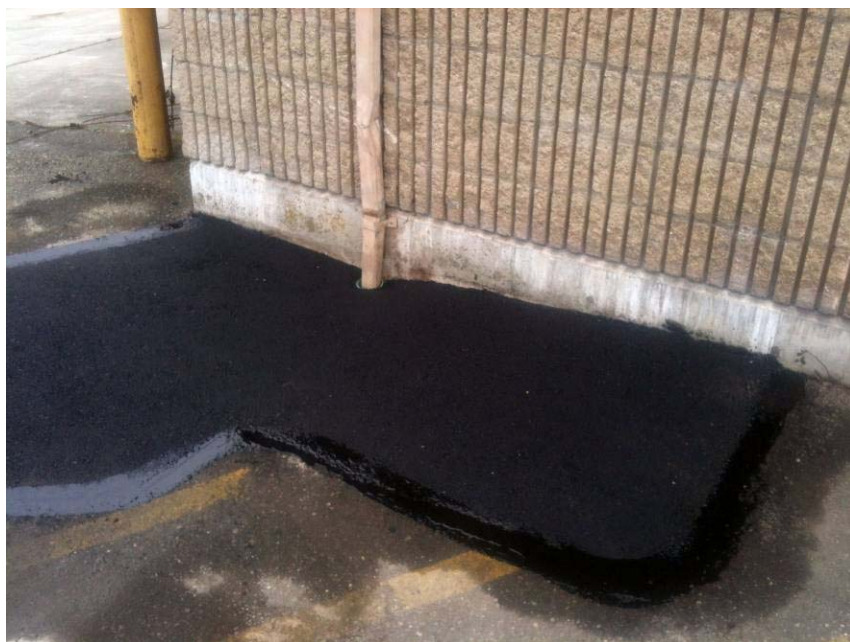
18. Repaved surface near building detail
