FINAL PRELIMINARY ASSESSMENT OF PER- AND POLYFLUOROALKYL SUBSTANCES

Yakima Training Center

Yakima, Washington

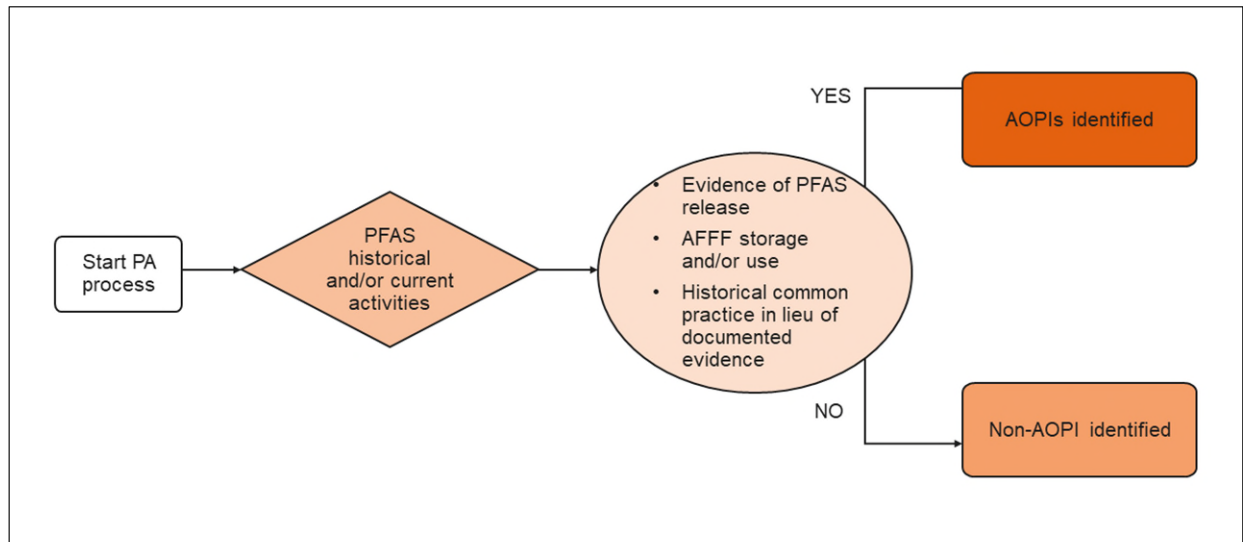
Figure 5-1: AOPI Decision Flowchart

The areas evaluated for potential PFAS use or storage and/or potential release to the environment at YTC were further refined during the PA process and classified either as an AOPI or non-AOPI. Of these areas, seven have been identified as non-AOPIs and three have been identified as AOPIs, in accordance with the established process for the PA program. The process used for refining these areas is presented on **Figure 5-1**, below.

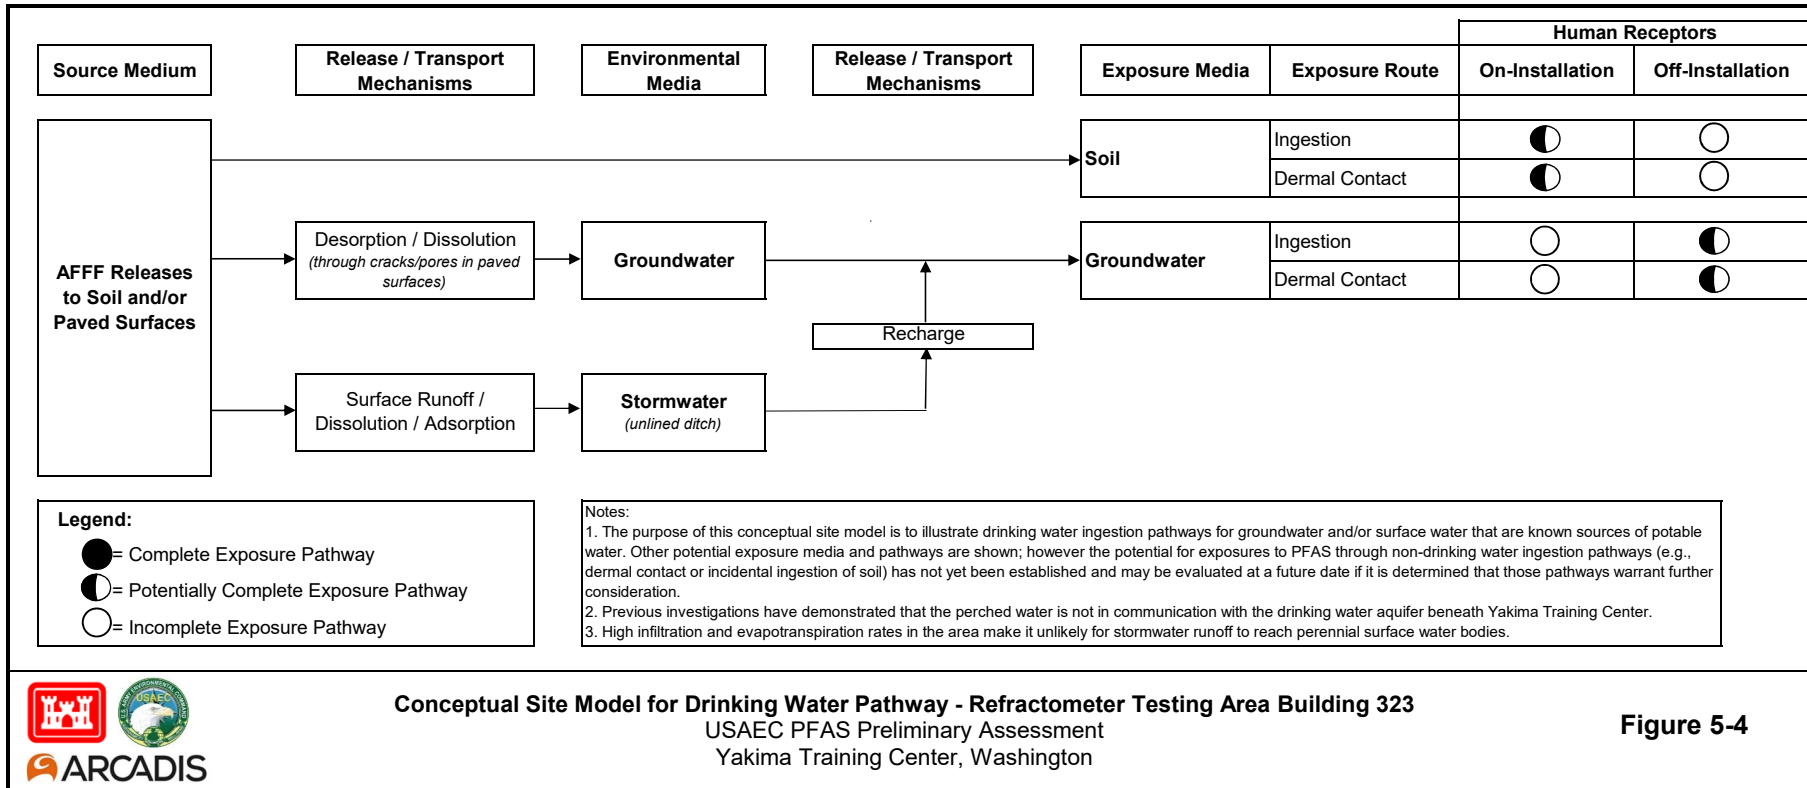
Figure 5-4

Conceptual Site Model for Drinking Water Pathway - Refractometer Testing Area Building 323
 USAEC PFAS Preliminary Assessment
 Yakima Training Center, Washington

Pavement wash waters from permitted external building wash-downs are treated through oil/water separators, including from the North 300 Motor Pool/Training Units (i.e., where the refractometer testing solutions area is located outside of Building 323; YTC 2015). Wash rack water waste from other wash rack facilities are plumbed either to a closed-loop/recycle/cleaning system, the WWTP, a vault for containerization and sent to One Stop Yard (who handles all hazardous waste generated by YTC with the exception of those generated by the National Guard), or to a retention basin for infiltration/evaporation. The retention basins are plumbed to oil/water separators prior to discharge (none of which discharges directly to a water body; YTC 2015).
