April 2019  
Whatcom Waterway Cleanup in Phase 1 Site Areas

# Year 1 Compliance Monitoring Report

Prepared for Port of Bellingham

**Prepared by**  
Anchor QEA, LLC  
1201 3rd Avenue, Suite 2600  
Seattle, Washington 98101

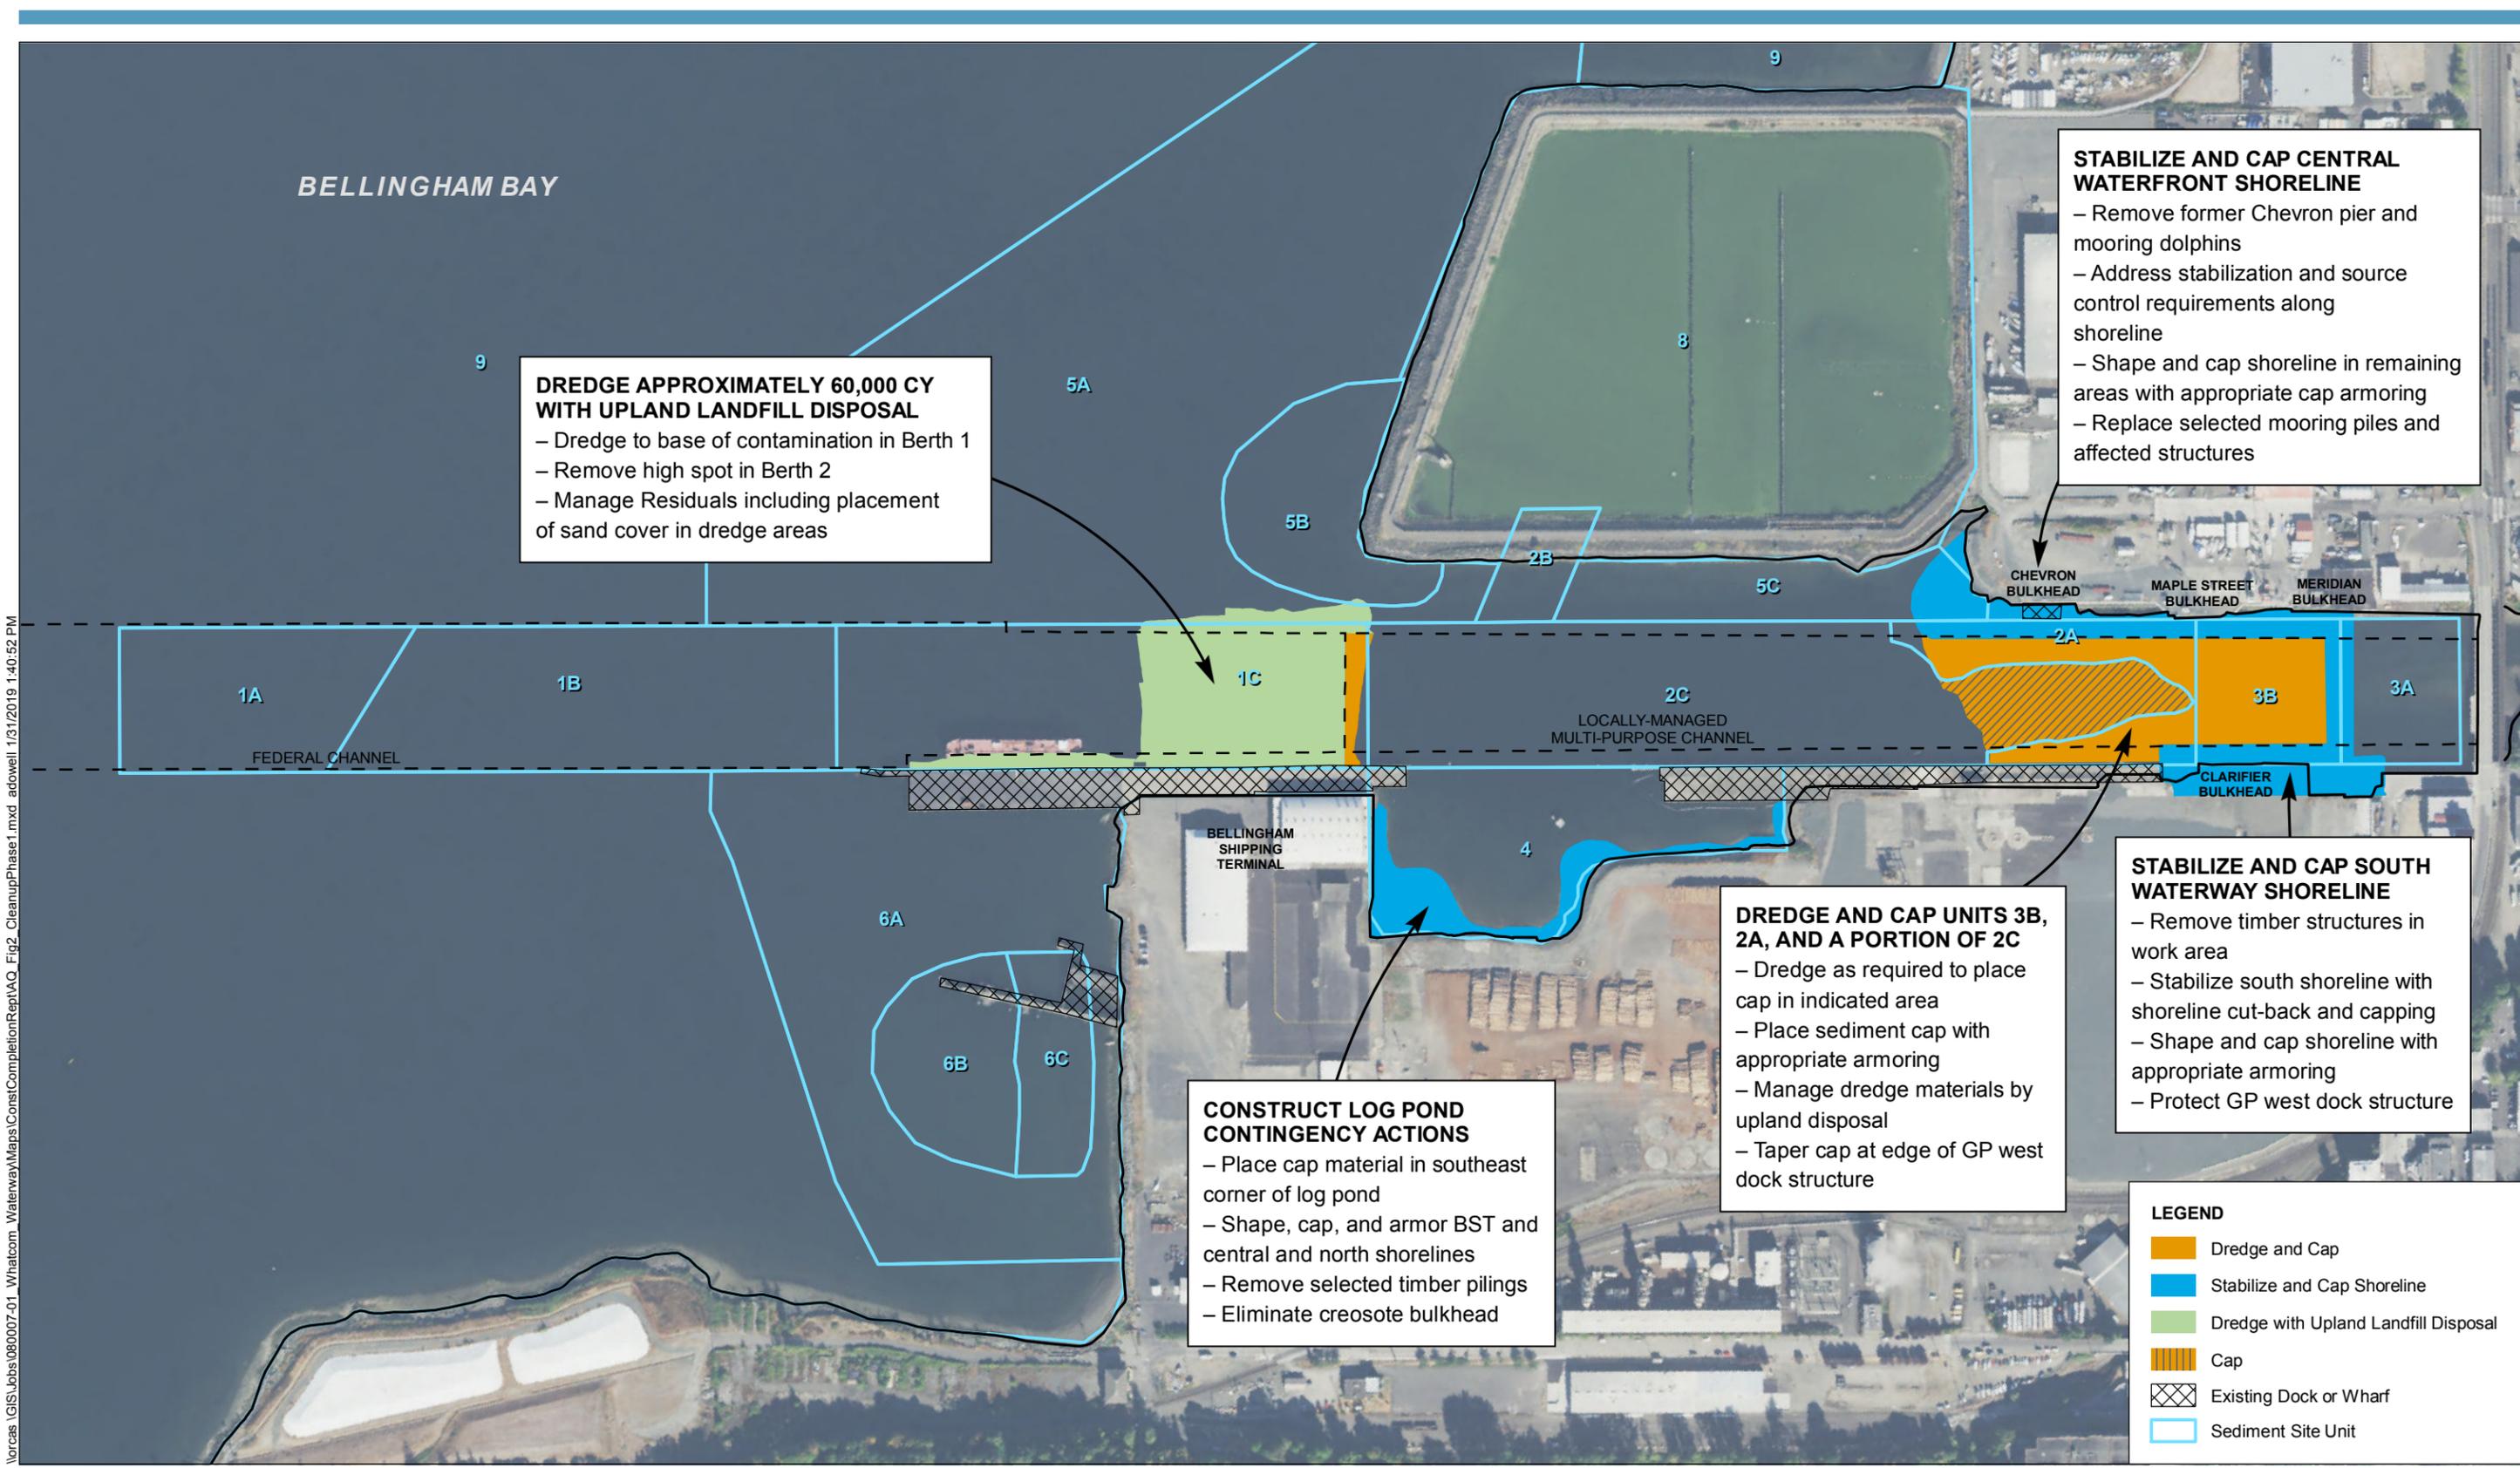
**Figure 2**  
 Cleanup Elements in Phase 1 Area  
 Year 1 Compliance Monitoring Report  
 Whatcom Waterway Cleanup in Phase 1 Site Areas

The Project included cleanup construction in the Inner Waterway area, the Log Pond, and the Bellingham Shipping Terminal (BST) area (Phase 1 site areas; Figure 2). Major activities included remedial dredging, engineered capping, containment wall installation, structure removal, structure replacement, and ancillary nearshore habitat improvements.

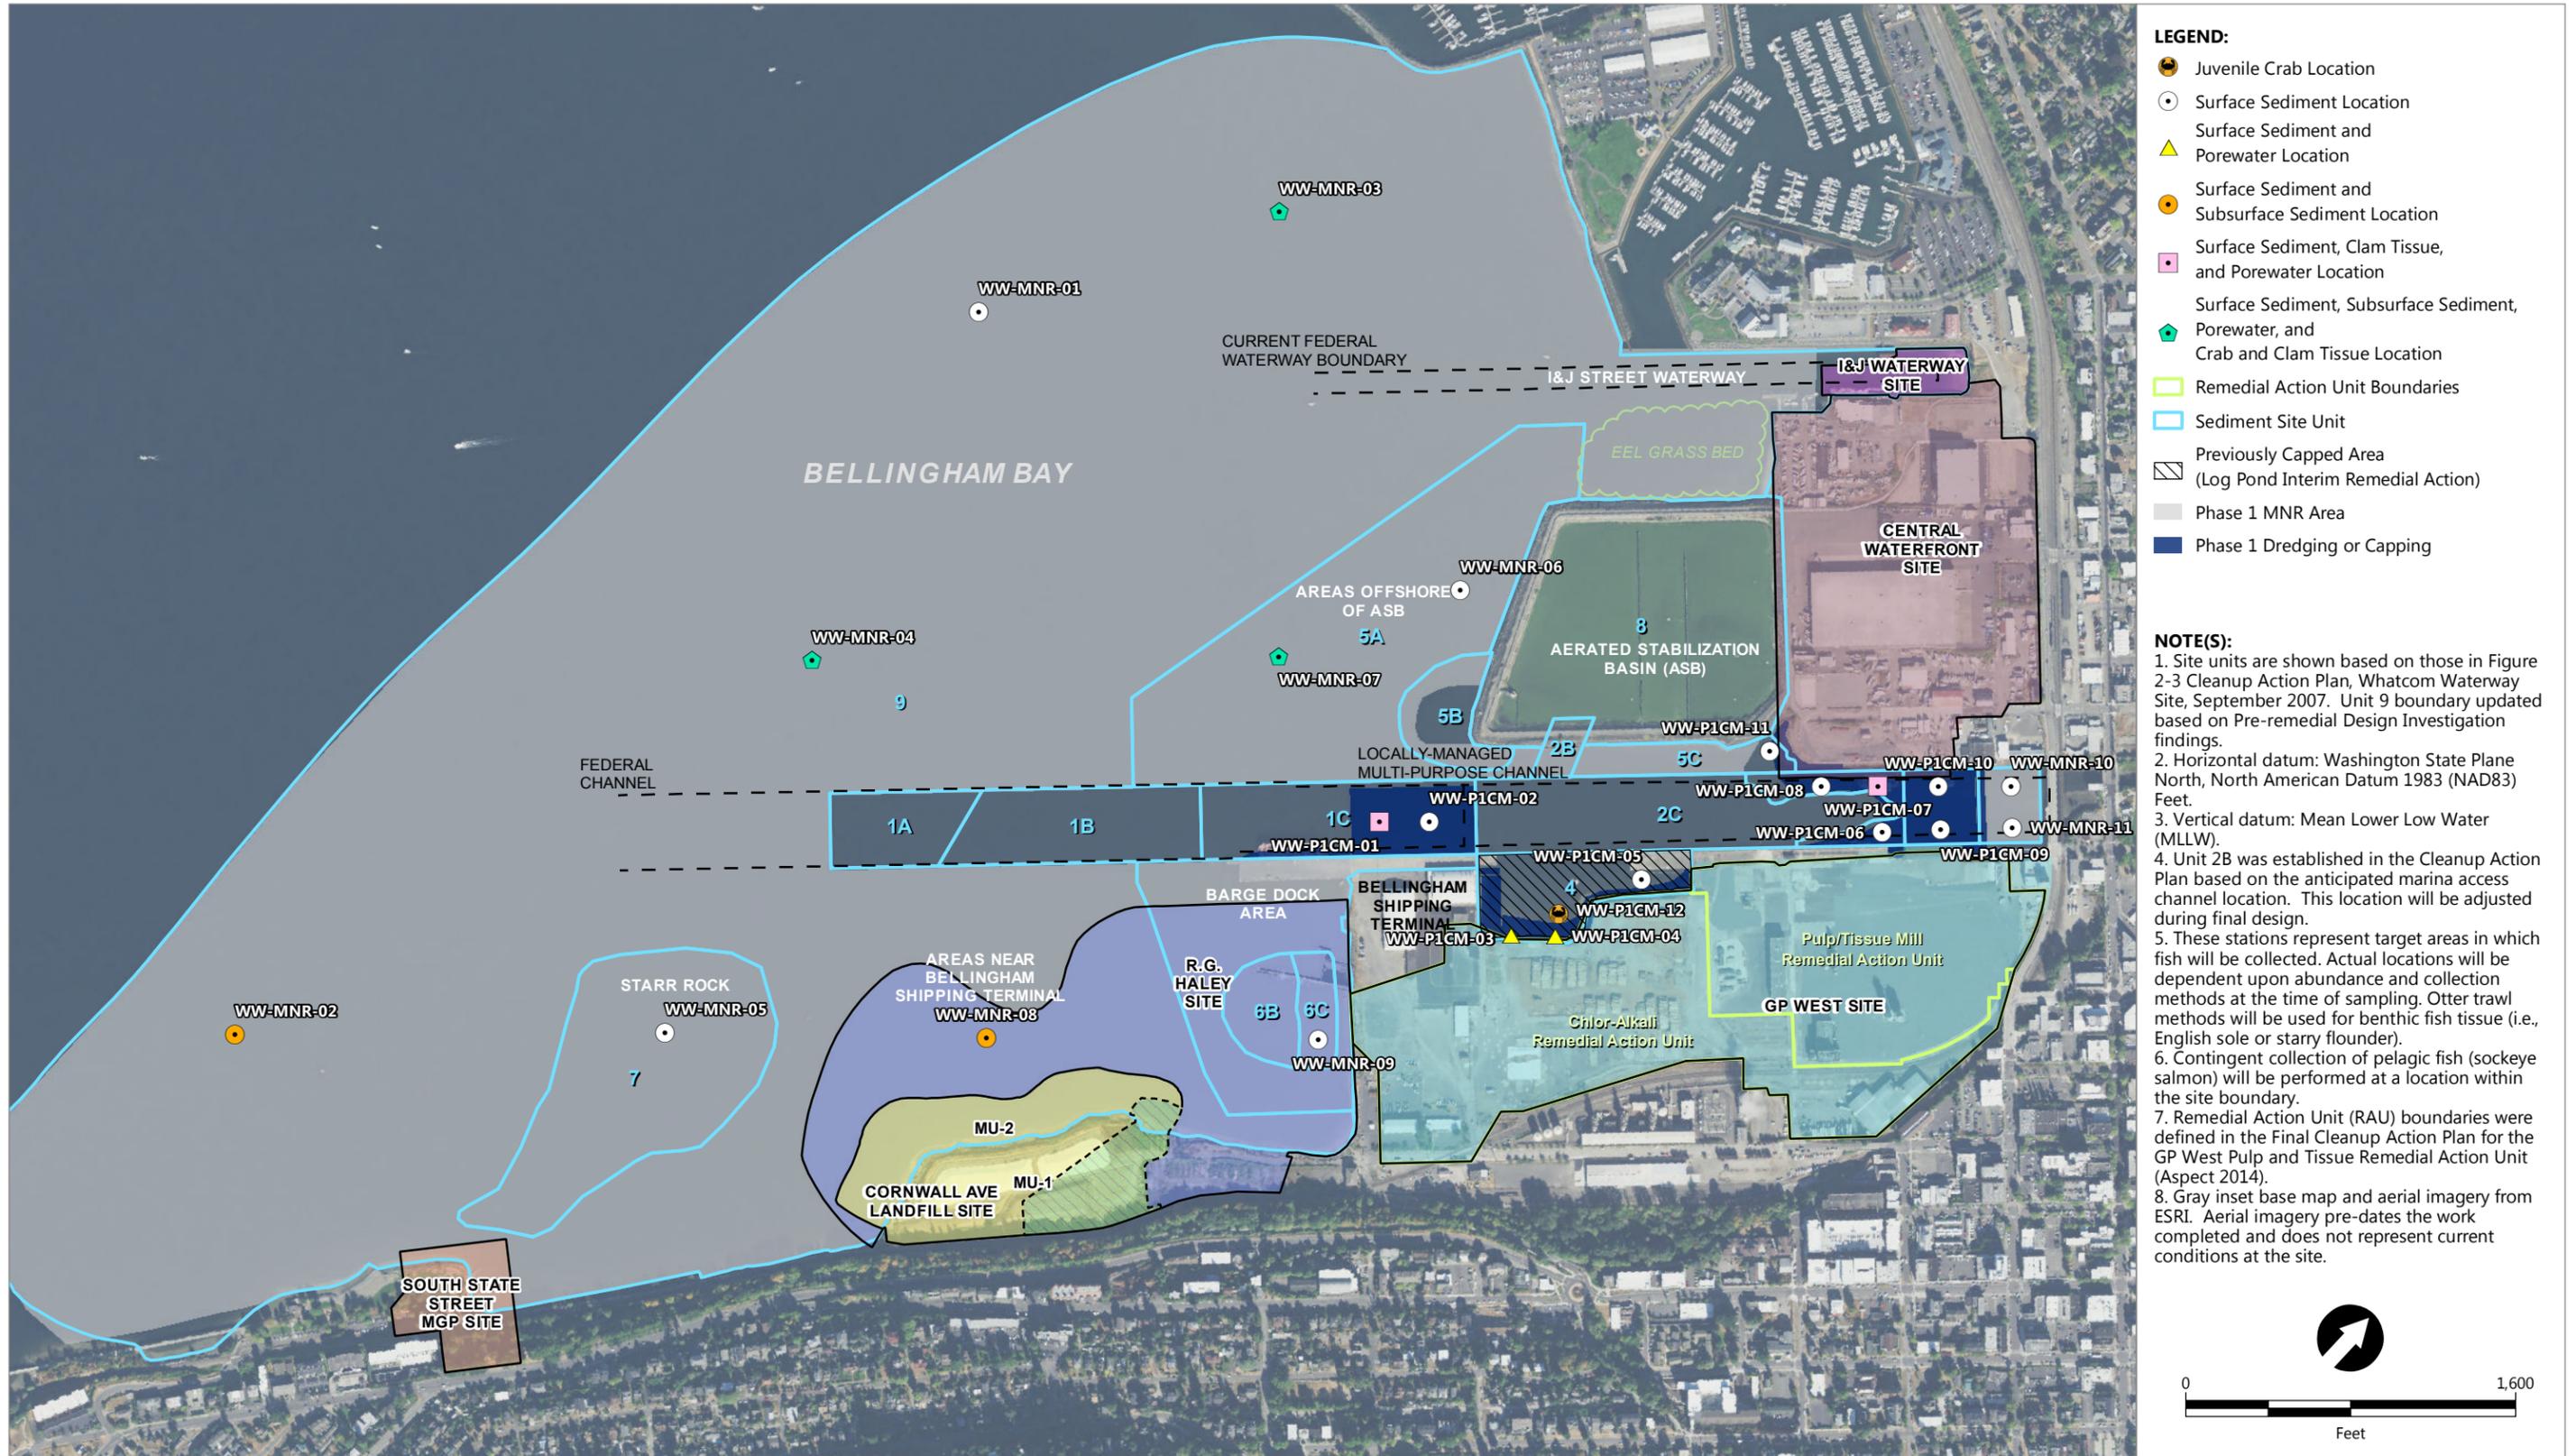
Sample collection and processing for each program was conducted in accordance with field, laboratory, and quality assurance and quality control methods detailed in the SQAPP (Anchor QEA 2016). Site environmental monitoring stations are shown in Figure 3, and reference monitoring stations are shown in Figure 4.

Compliance monitoring included the collection of subsurface sediment cores at five stations. These stations were co-located with MNR surface sediment monitoring (Figure 3). Subsurface sediment monitoring included the following sample locations within the MNR areas:

Adult crab were collected using crab traps deployed at three locations within the Site (Figure 3) and at two locations within the Samish Bay reference areas (Figure 4). Three adult male Dungeness crabs with a carapace width of 16.5 cm or greater were collected at each station. Two replicate samples for each station were created by homogenizing sternal plate, leg, and claw muscle tissue, resulting in a total of six composite samples from the Site and six composite samples from the Samish Bay reference area.

Juvenile Dungeness crab were collected using crab traps deployed along the shoreline of the Log Pond (Figure 3) and at a reference site located near Brant and Portage Islands (Figure 4). Juvenile crab tissue from these locations was previously sampled for mercury concentrations during 2001, 2002, and 2005 after completion of the Log Pond Interim Action, as well as during Year 0 Monitoring (Anchor QEA 2018) immediately following implementation of the cleanup in Phase 1 Site areas.

Year 1 monitoring activities included an in situ bioaccumulation testing using caged clams. As part of this testing, clams were placed in situ at the following locations (see Figures 3 and 4):

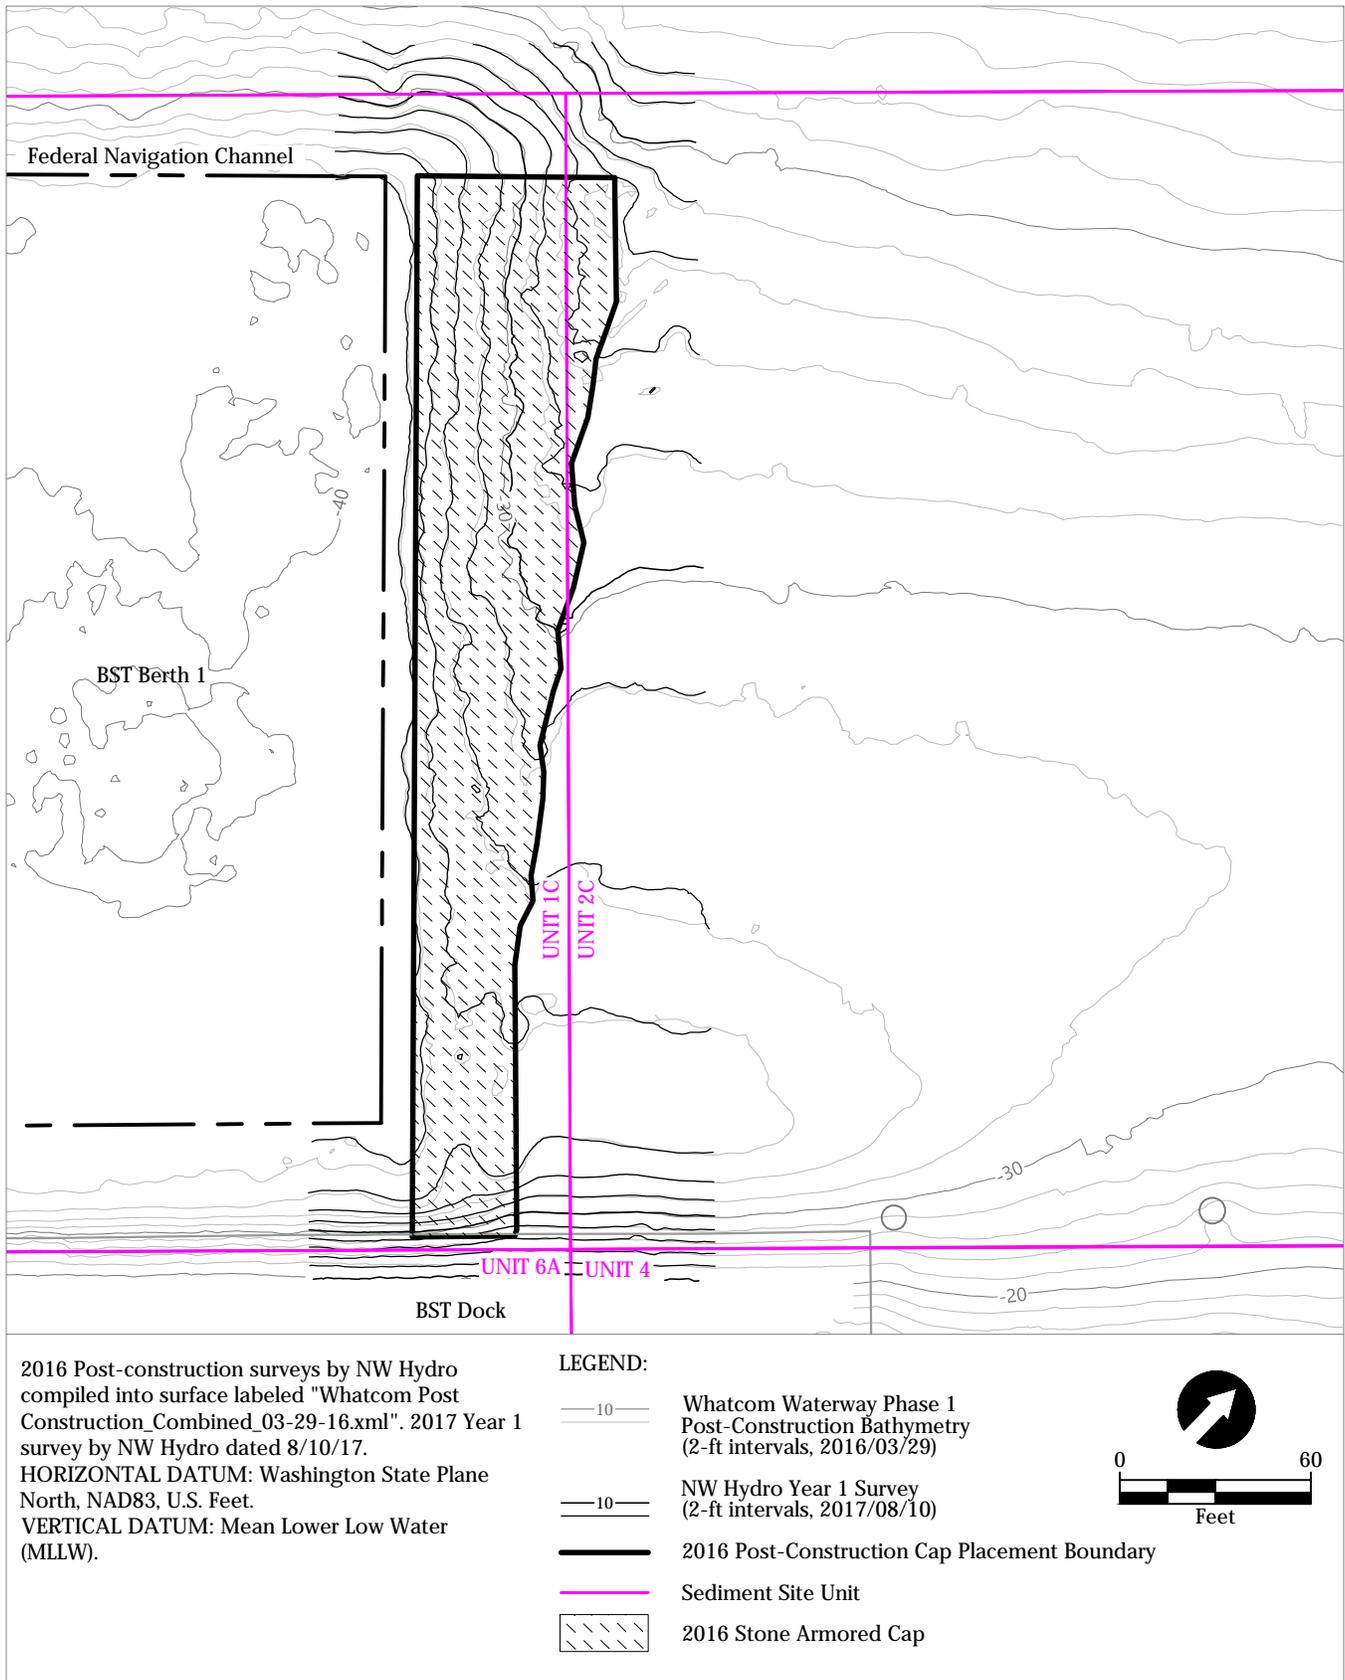
**Figure 5a**  
**Engineered Sediment Cap - BST**  
 Year 1 Compliance Monitoring Report  
 Whatcom Waterway Cleanup in Phase 1 Site Areas

Areas where the present-day mudline is between 0.5 foot and 1.0 foot lower than the post-construction mudline are indicative of consolidation of the underlying sediments due to the load from the engineering cap materials. Consolidation/settlement analyses were performed as part of the Whatcom Waterway Final EDR (Anchor QEA 2015). The observed values are consistent with estimated cap consolidation in other areas of the waterway.

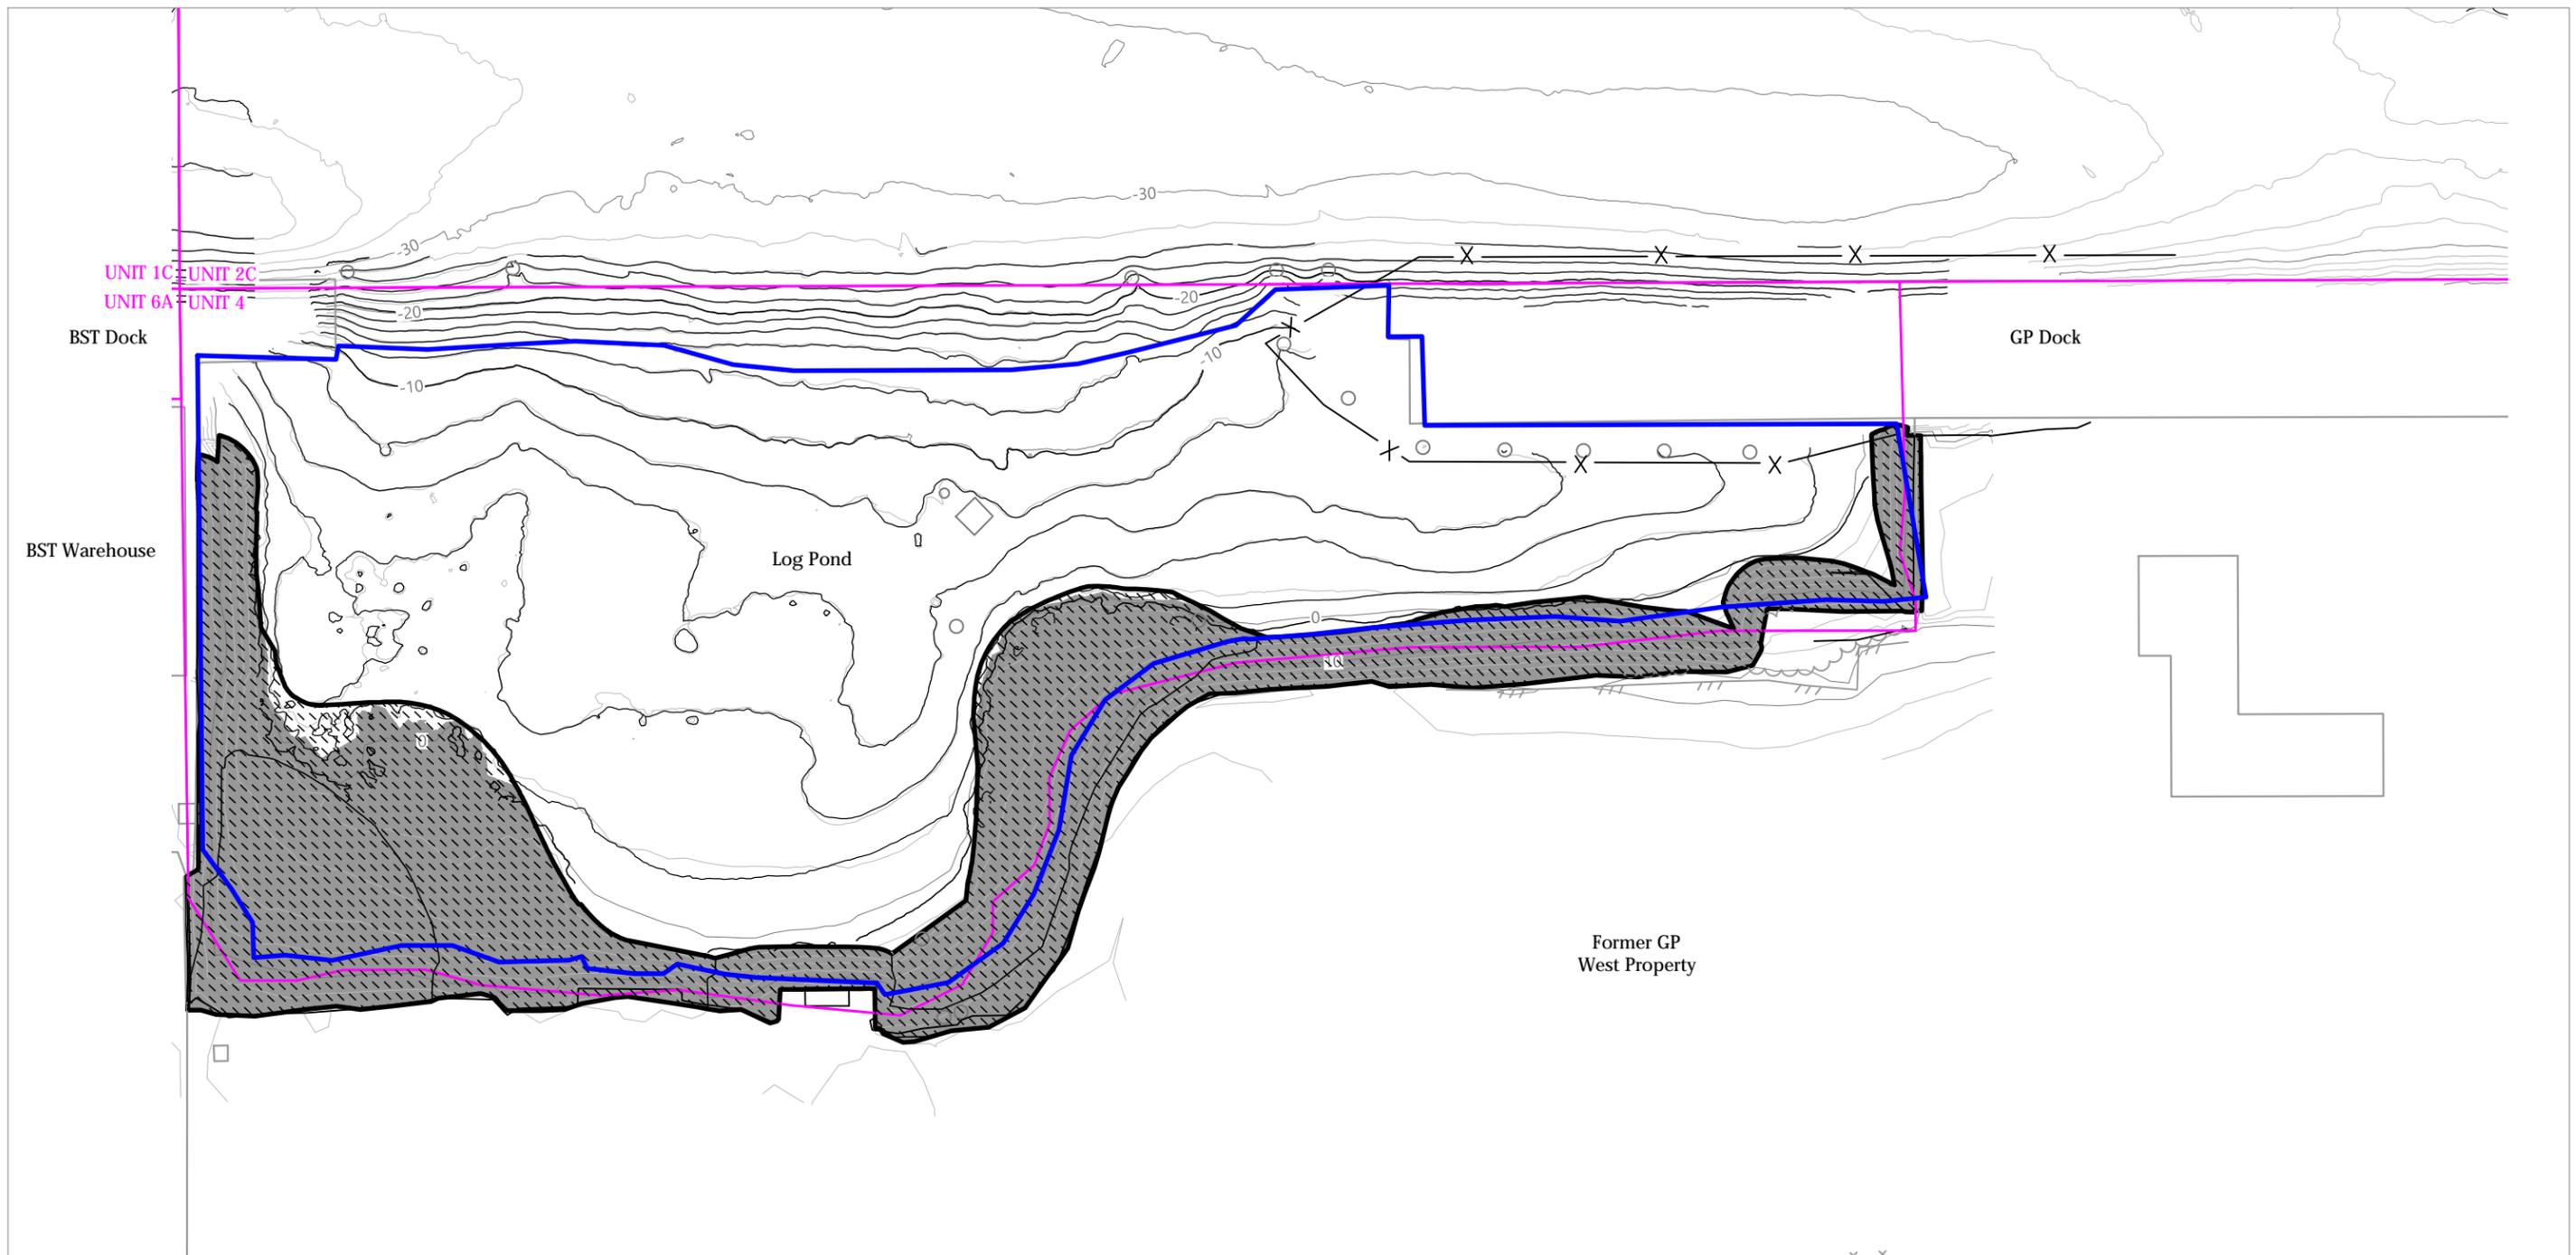
Figure 5b  
 Isopach for BST: 2016 Post-construction vs 2017 Year 1 Survey  
 Year 1 Compliance Monitoring Report  
 Whatcom Waterway Cleanup in Phase 1 Site Areas

SOURCE: 2016 Post-construction surveys by NW Hydro compiled into surface labeled "Whatcom Post Construction\_Combined\_03-29-16.xml".  
 2017 Year 1 survey by NW Hydro dated 8/10/17.  
 HORIZONTAL DATUM: Washington State Plane North, NAD83, U.S. Feet.  
 VERTICAL DATUM: Mean Lower Low Water (MLLW).

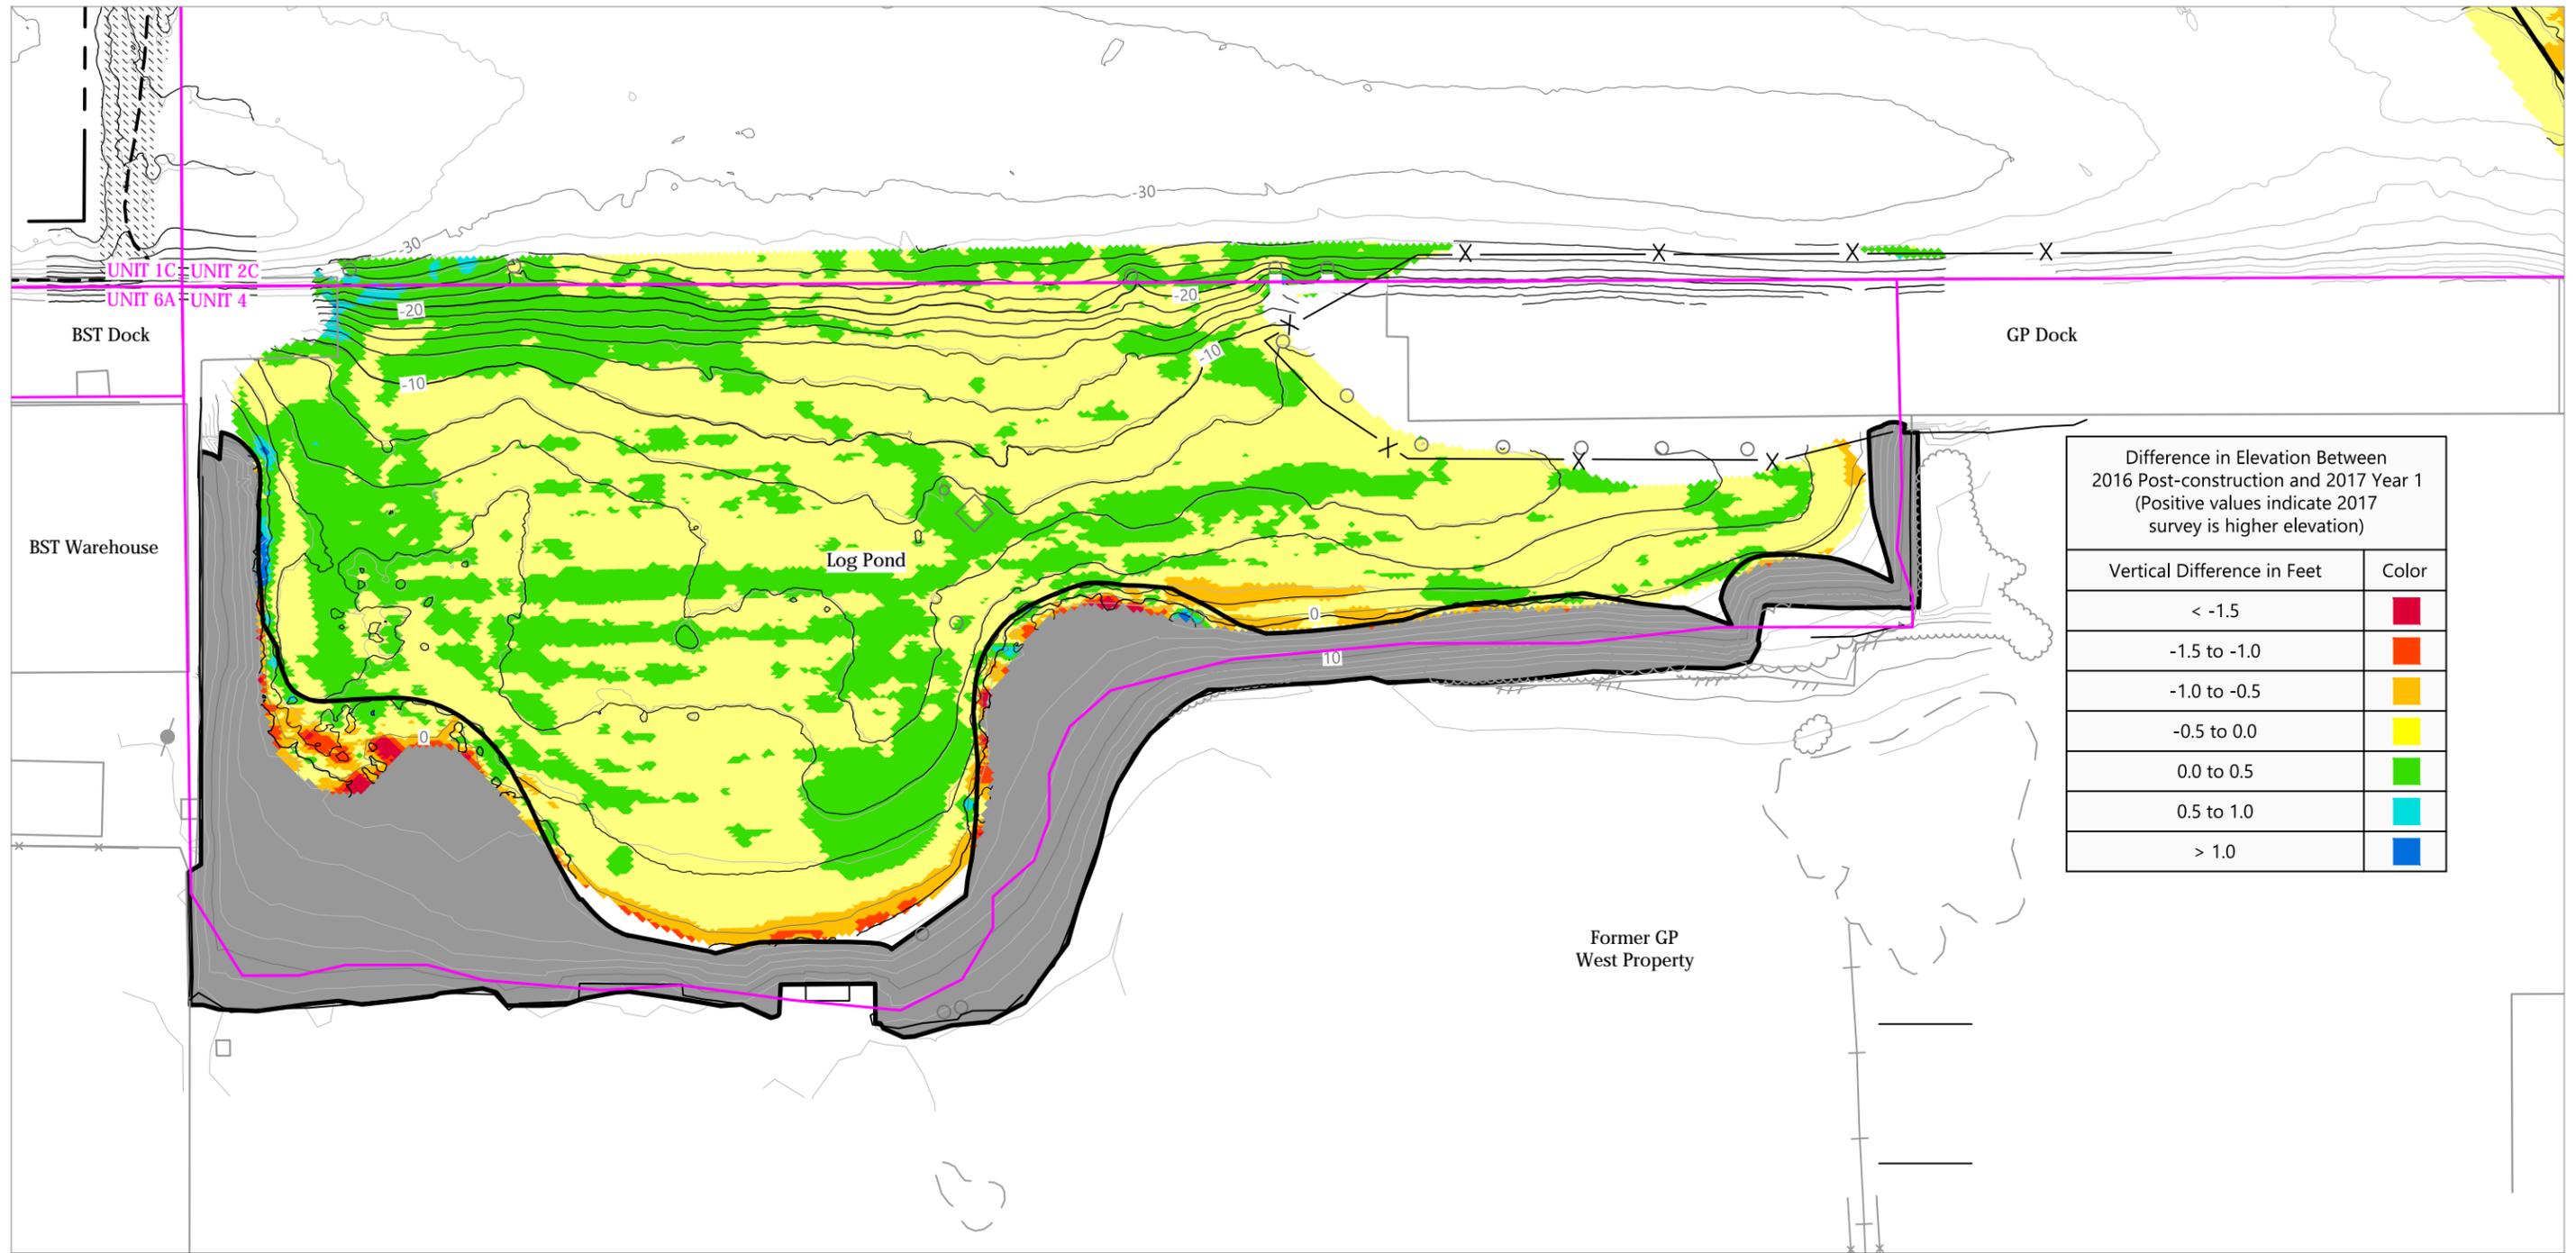
Figure 6b  
Isopach for Log Pond: 2016 Post-construction vs 2017 Year 1 Survey  
Year 1 Compliance Monitoring Report  
Whatcom Waterway Cleanup in Phase 1 Site Areas

Most of the bathymetric data collected in the Log Pond area is outside the extent of the caps placed as part of the Project, as shown in Figure 6b. The data that does lie within the cap placement boundary generally varies from 0.5 foot higher to 1.5 foot lower than the post-construction mudline, which is consistent with the values estimated in the EDR. Some larger elevation differences observed near the limits of the survey appear to be artifacts. These can be attributed to a lower density of data points leading to jumps in the survey surface. These areas, along with areas too shallow for completion of an in-water bathymetric survey, were addressed with the intertidal visual survey as described in Section 3.2.

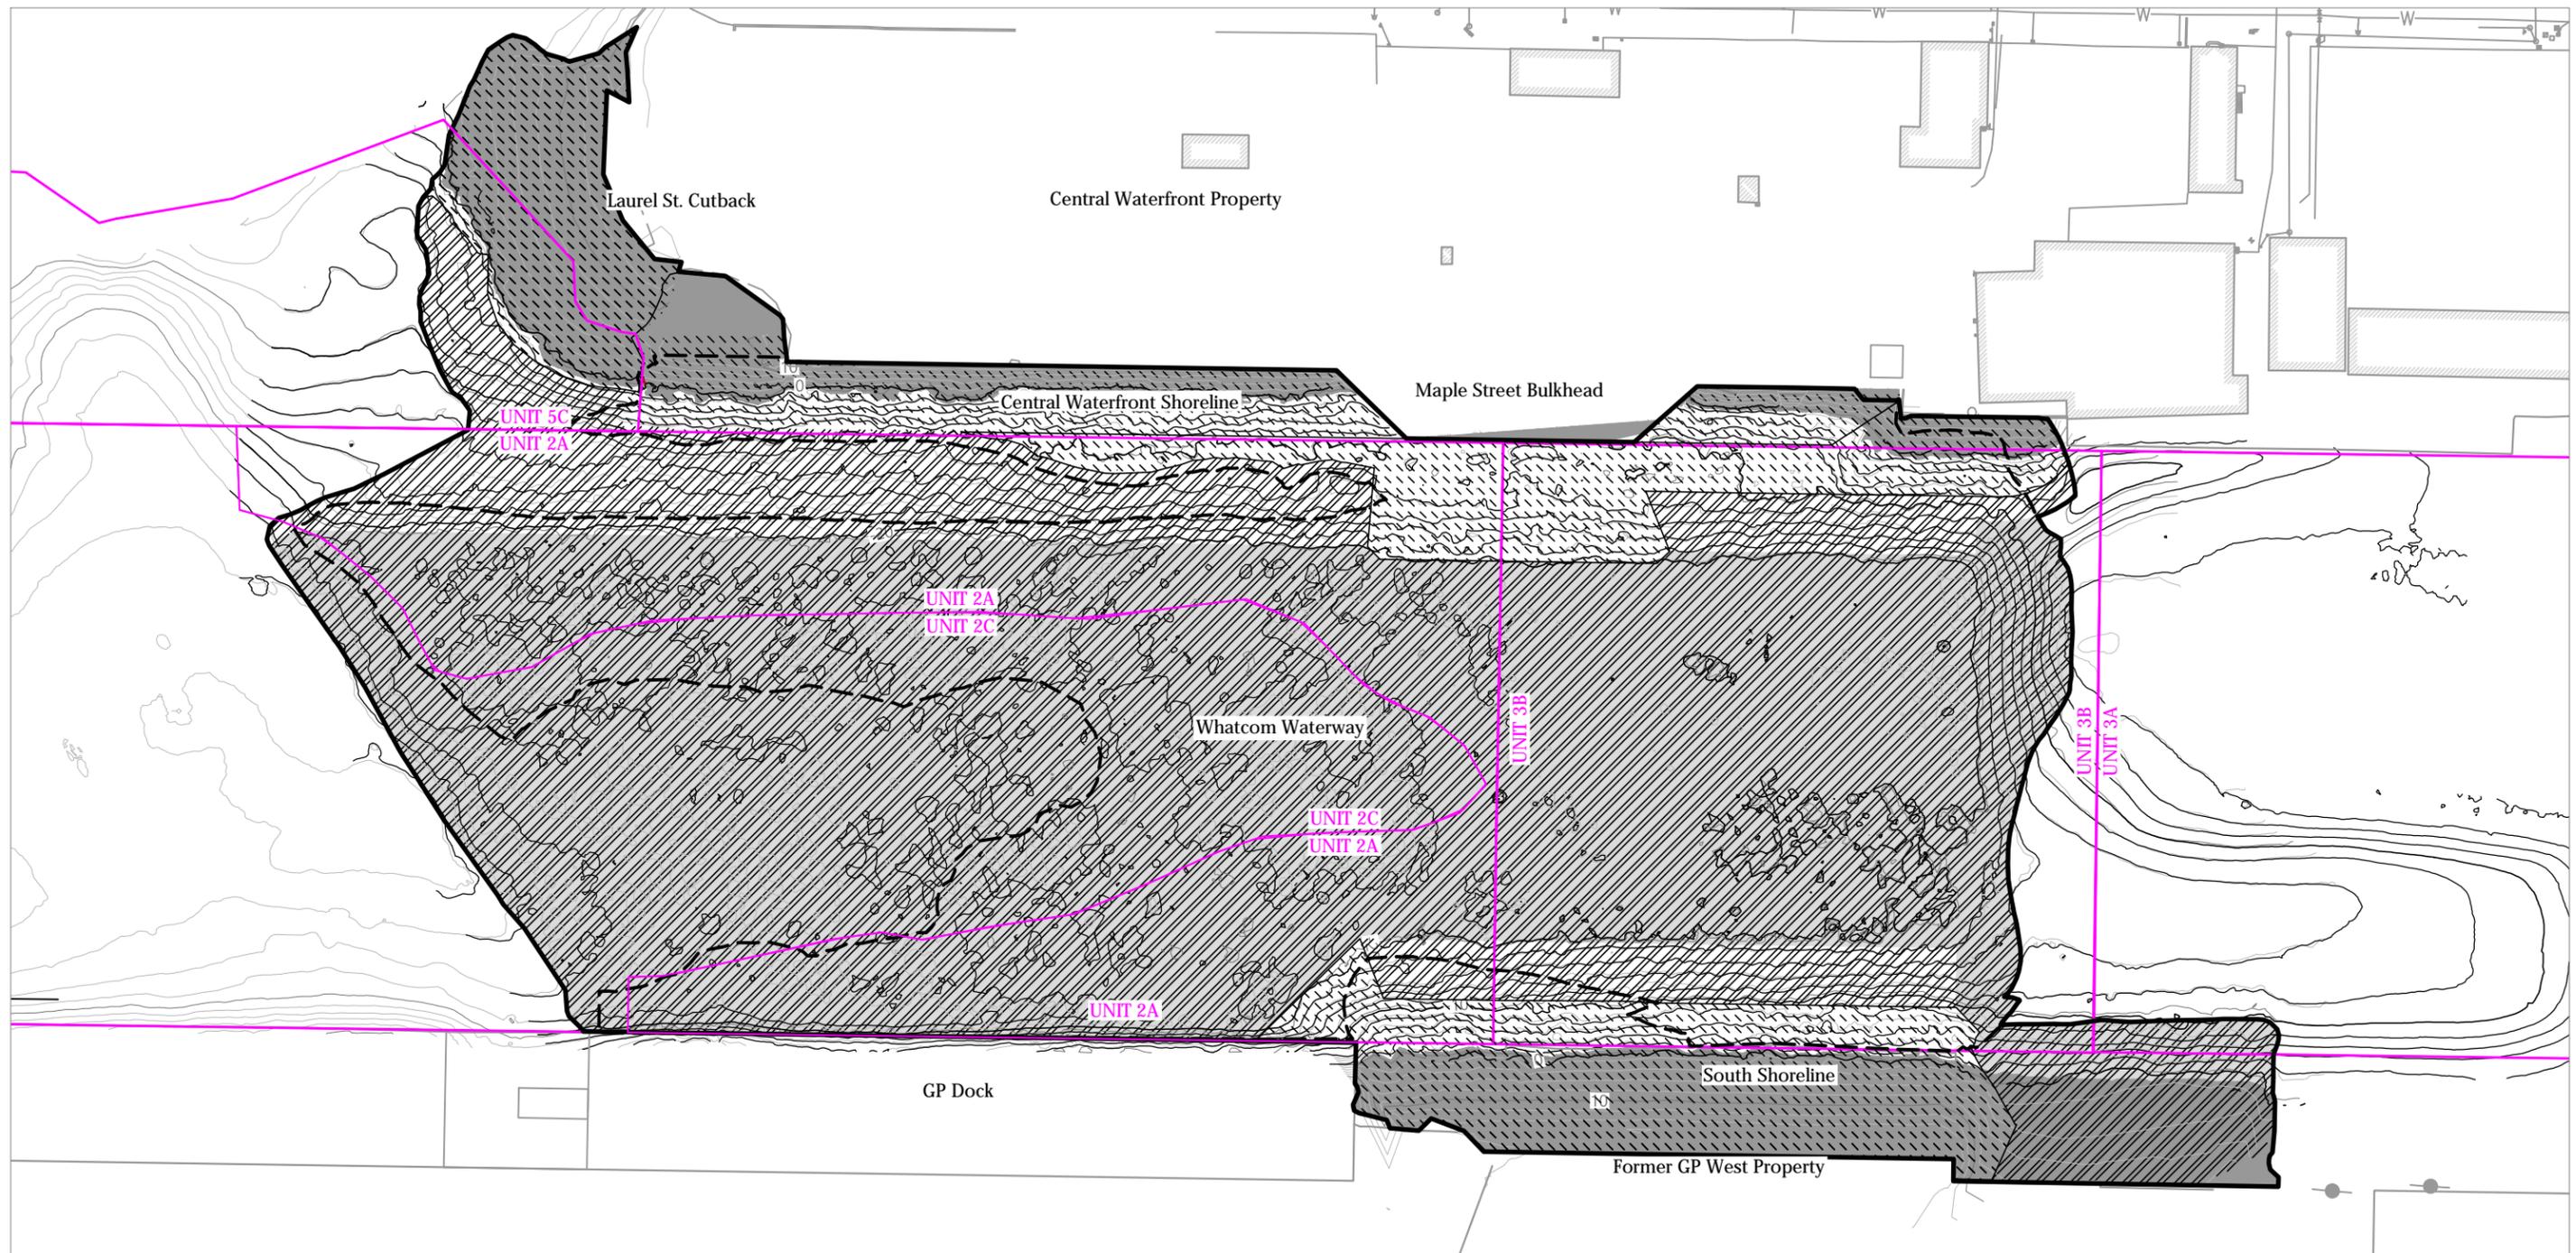
SOURCE: 2016 Post-construction surveys by NW Hydro compiled into surface labeled "Whatcom Post Construction\_Combined\_03-29-16.xml".  
 2017 Year 1 survey by NW Hydro dated 8/10/17.  
 HORIZONTAL DATUM: Washington State Plane North, NAD83, U.S. Feet.  
 VERTICAL DATUM: Mean Lower Low Water (MLLW).
