April 2019  
Whatcom Waterway Cleanup in Phase 1 Site Areas

# Year 1 Compliance Monitoring Report

Prepared for Port of Bellingham

**Prepared by**  
Anchor QEA, LLC  
1201 3rd Avenue, Suite 2600  
Seattle, Washington 98101

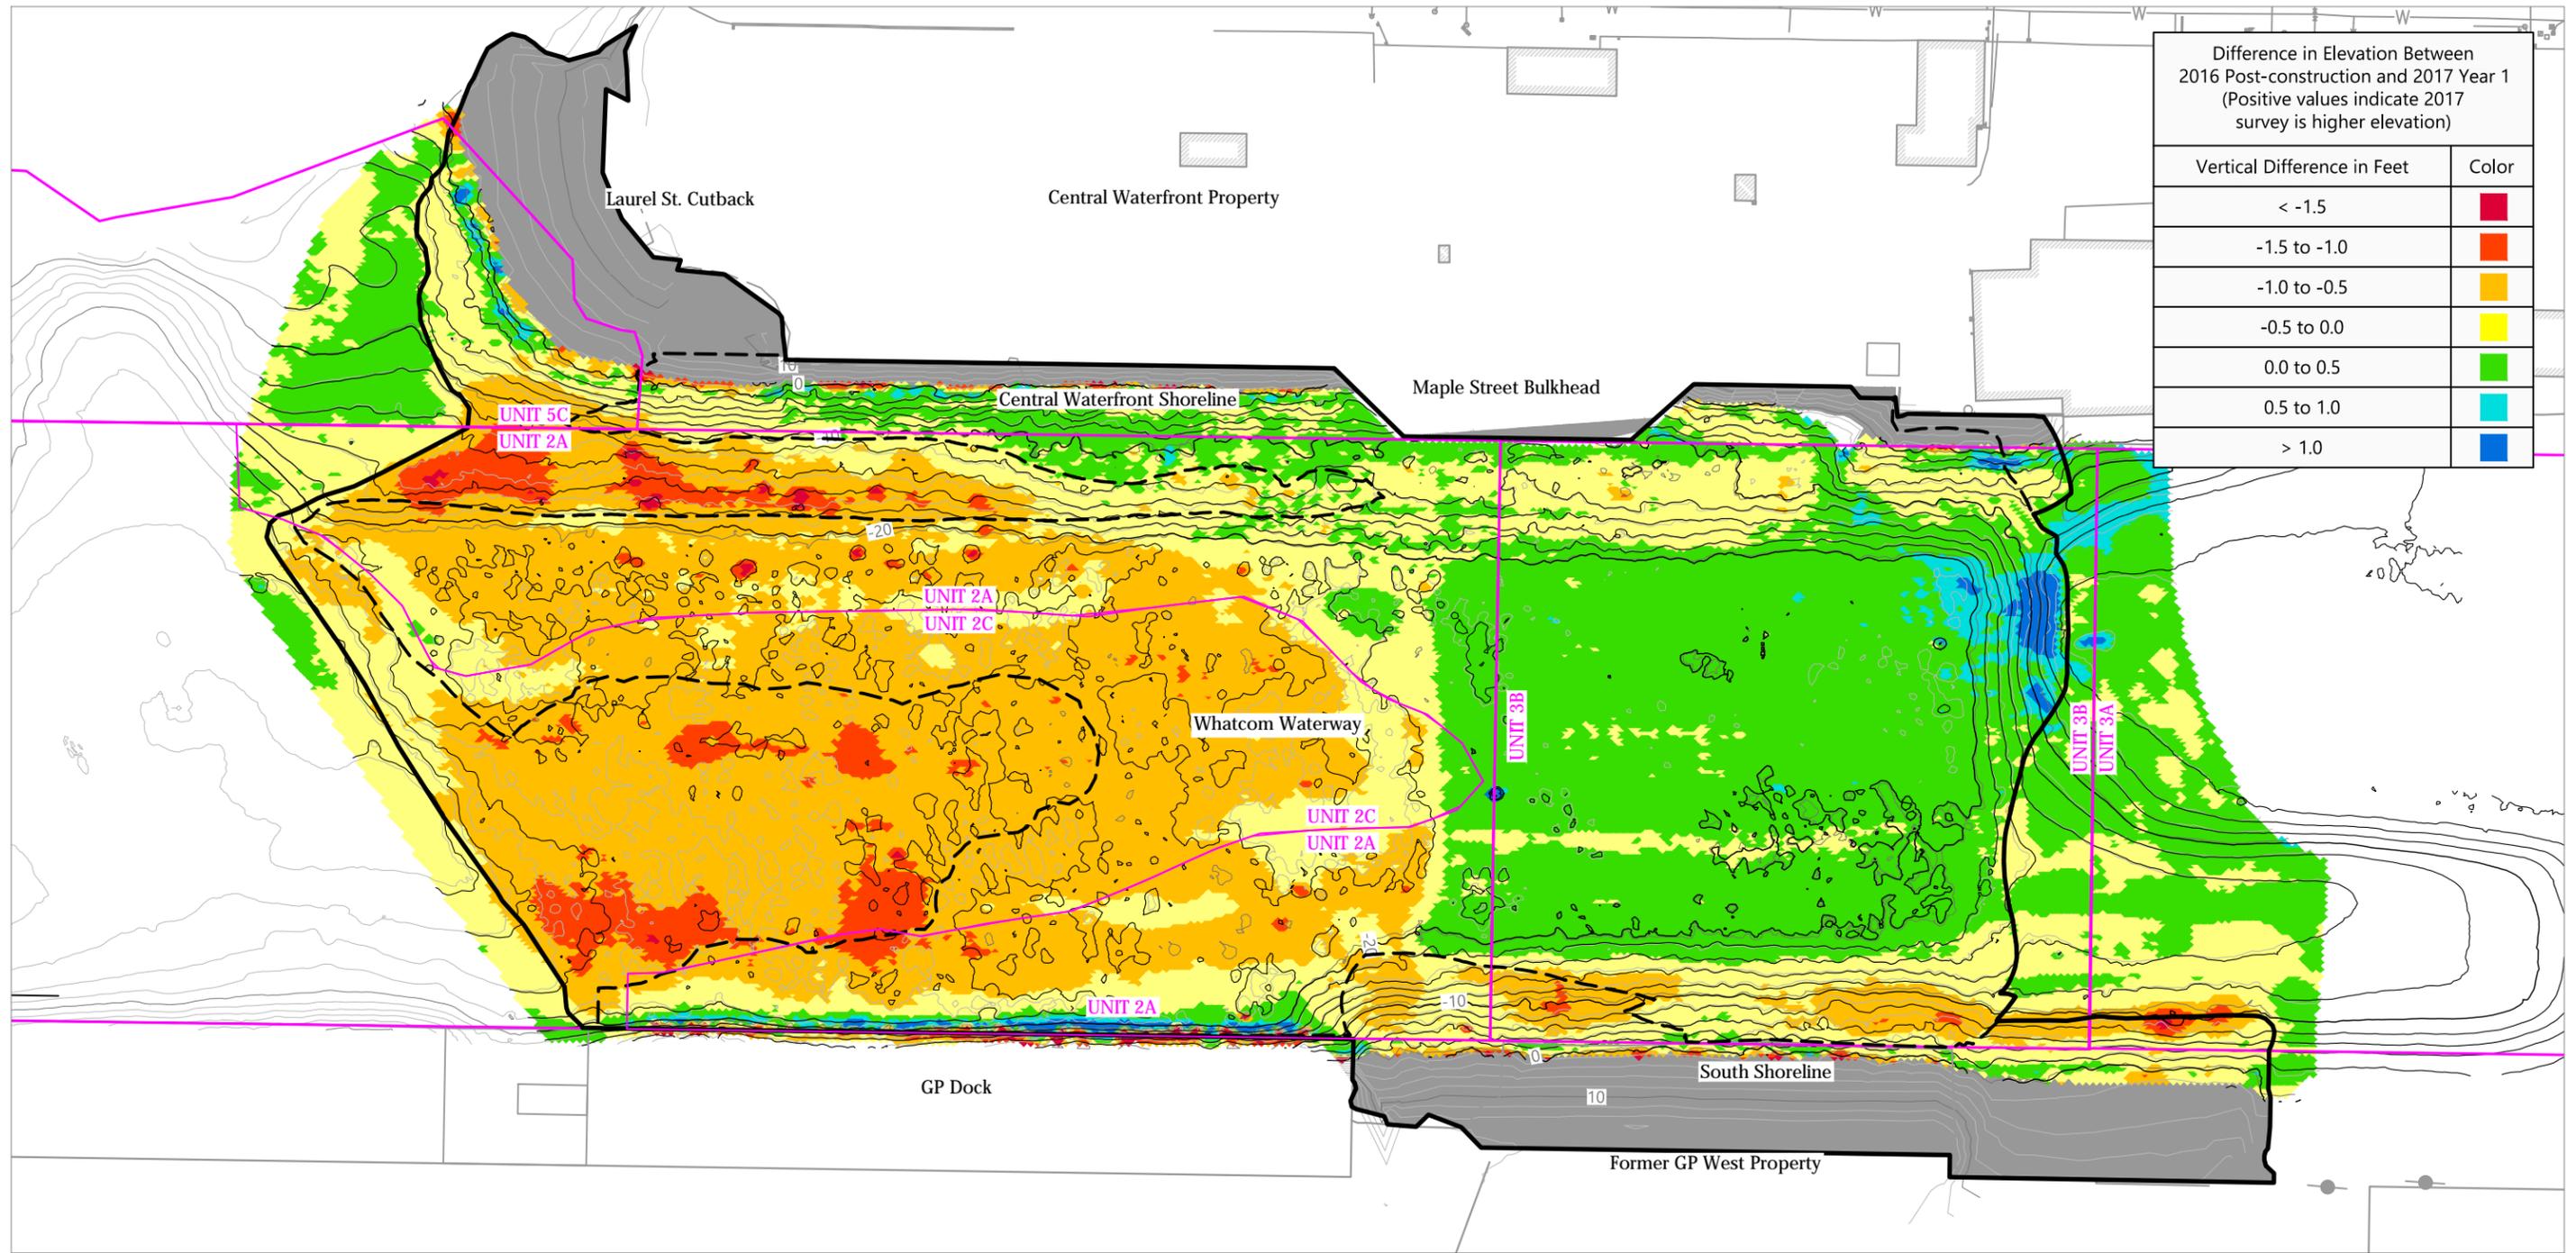
Figure 7b  
 Isopach for Inner Waterway: 2016 Post-construction vs 2017 Year 1 Survey

Differences in cap surface elevation between Year 0 and Year 1 monitoring events are shown on Figure 7b. Some of the general trends observed in the comparison of the post-construction survey with the Year 1 monitoring survey include the following:

- Some accretion of material is observed at the head of the waterway and is consistent with historical accumulation of material in this area due to loading from Whatcom Creek.
- Minimal settlement/consolidation has occurred in the flat portion of the Inner Waterway where dredge cuts were thickest. The thick dredge cuts exposed materials less prone to consolidation. More settlement was observed in the flat portion of the waterway where only thin cuts or no dredging was performed and cap materials were placed on existing softer sediments.
- A moderate amount of settlement and consolidation was observed along the shoreline slopes. The stone armored engineered cap was placed in these areas (South Shoreline and Central Waterfront Shoreline). Placement of this heavier material reasonably has resulted in more consolidation of the underlying capping materials and subgrade.

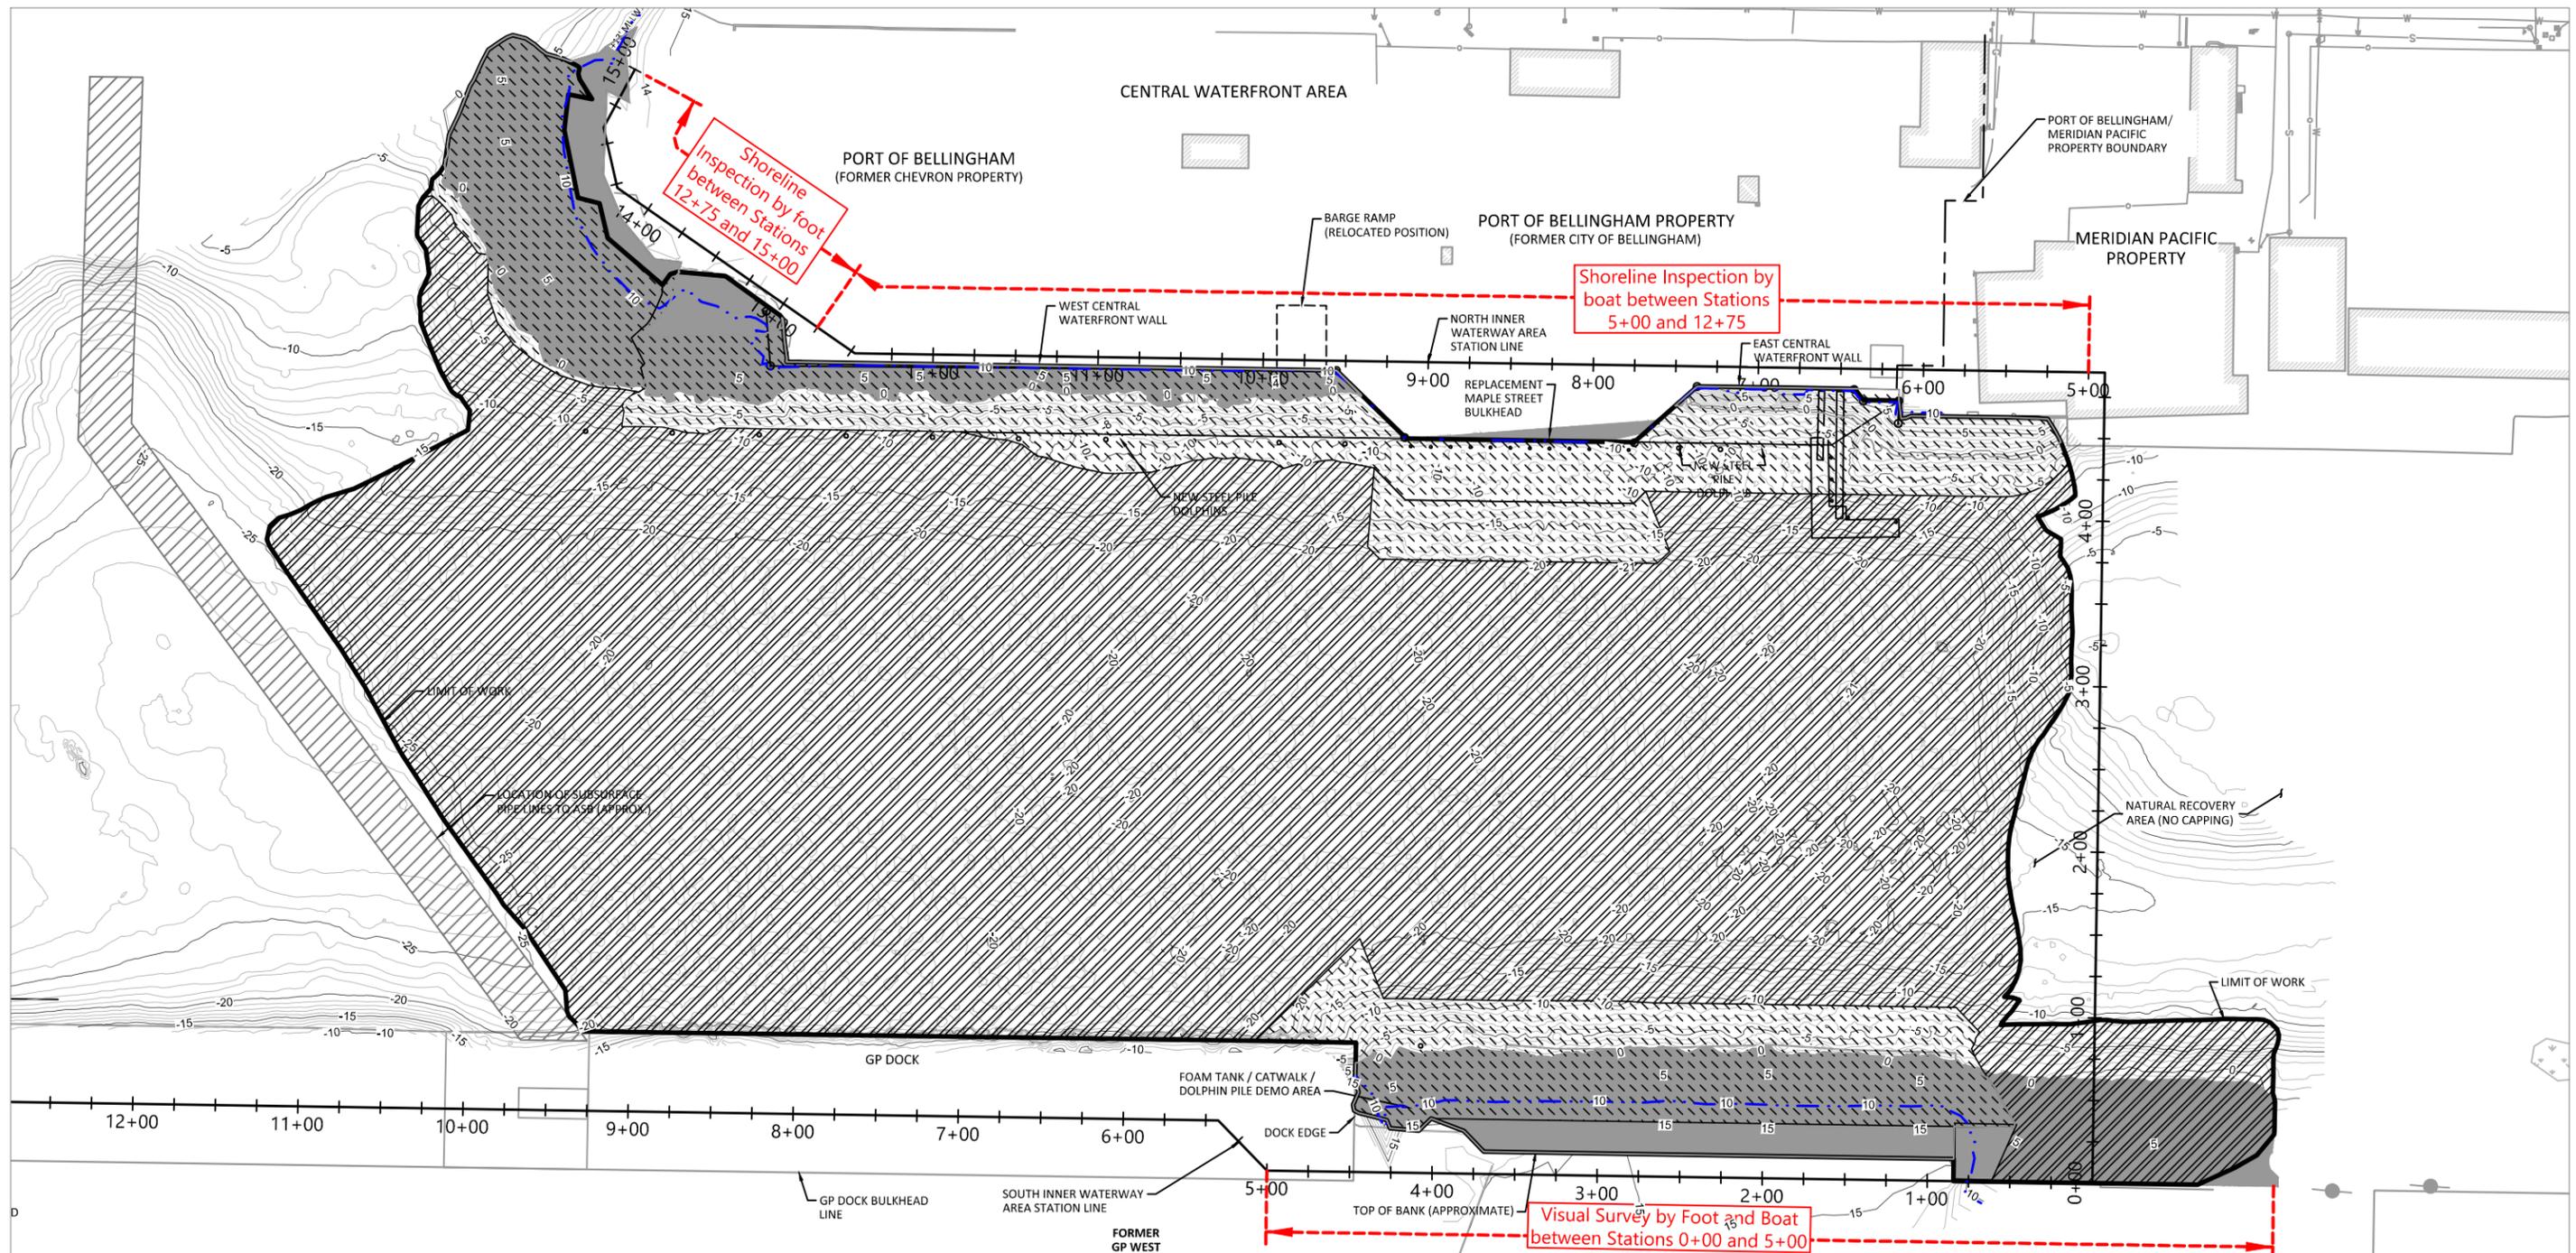
Figure 8a  
 Visual Survey Coverage - Inner Waterway  
 Year 1 Compliance Monitoring Report  
 Whatcom Waterway Cleanup in Phase 1 Site Area

Intertidal engineered sediment caps were visually inspected during periods of low tide over a three-day duration (July 18–20, 2017). Inspections took place both by boat and on foot depending on access to the cap area, as shown on Figures 8a and 8b. Photomaps and corresponding photographs showing the general conditions of the above-water engineered caps are included in Appendix B.

Continuous inspections were conducted in cap areas to look for indications of erosion/settlement, presence of potential contamination/debris, or other disturbances or signs of impact to the integrity and function of the cap. Inspections in containment wall areas were conducted to look for indications of corrosion, groundwater seepage, and other disturbances or signs of impact to the integrity and function of the remedial wall structure. Any disturbance found was documented (i.e., location, description, apparent cause if known) and photographed.

In general, the engineered sediment caps along the Central Waterfront, South Shoreline, and Log Pond shoreline were found to be in good condition:

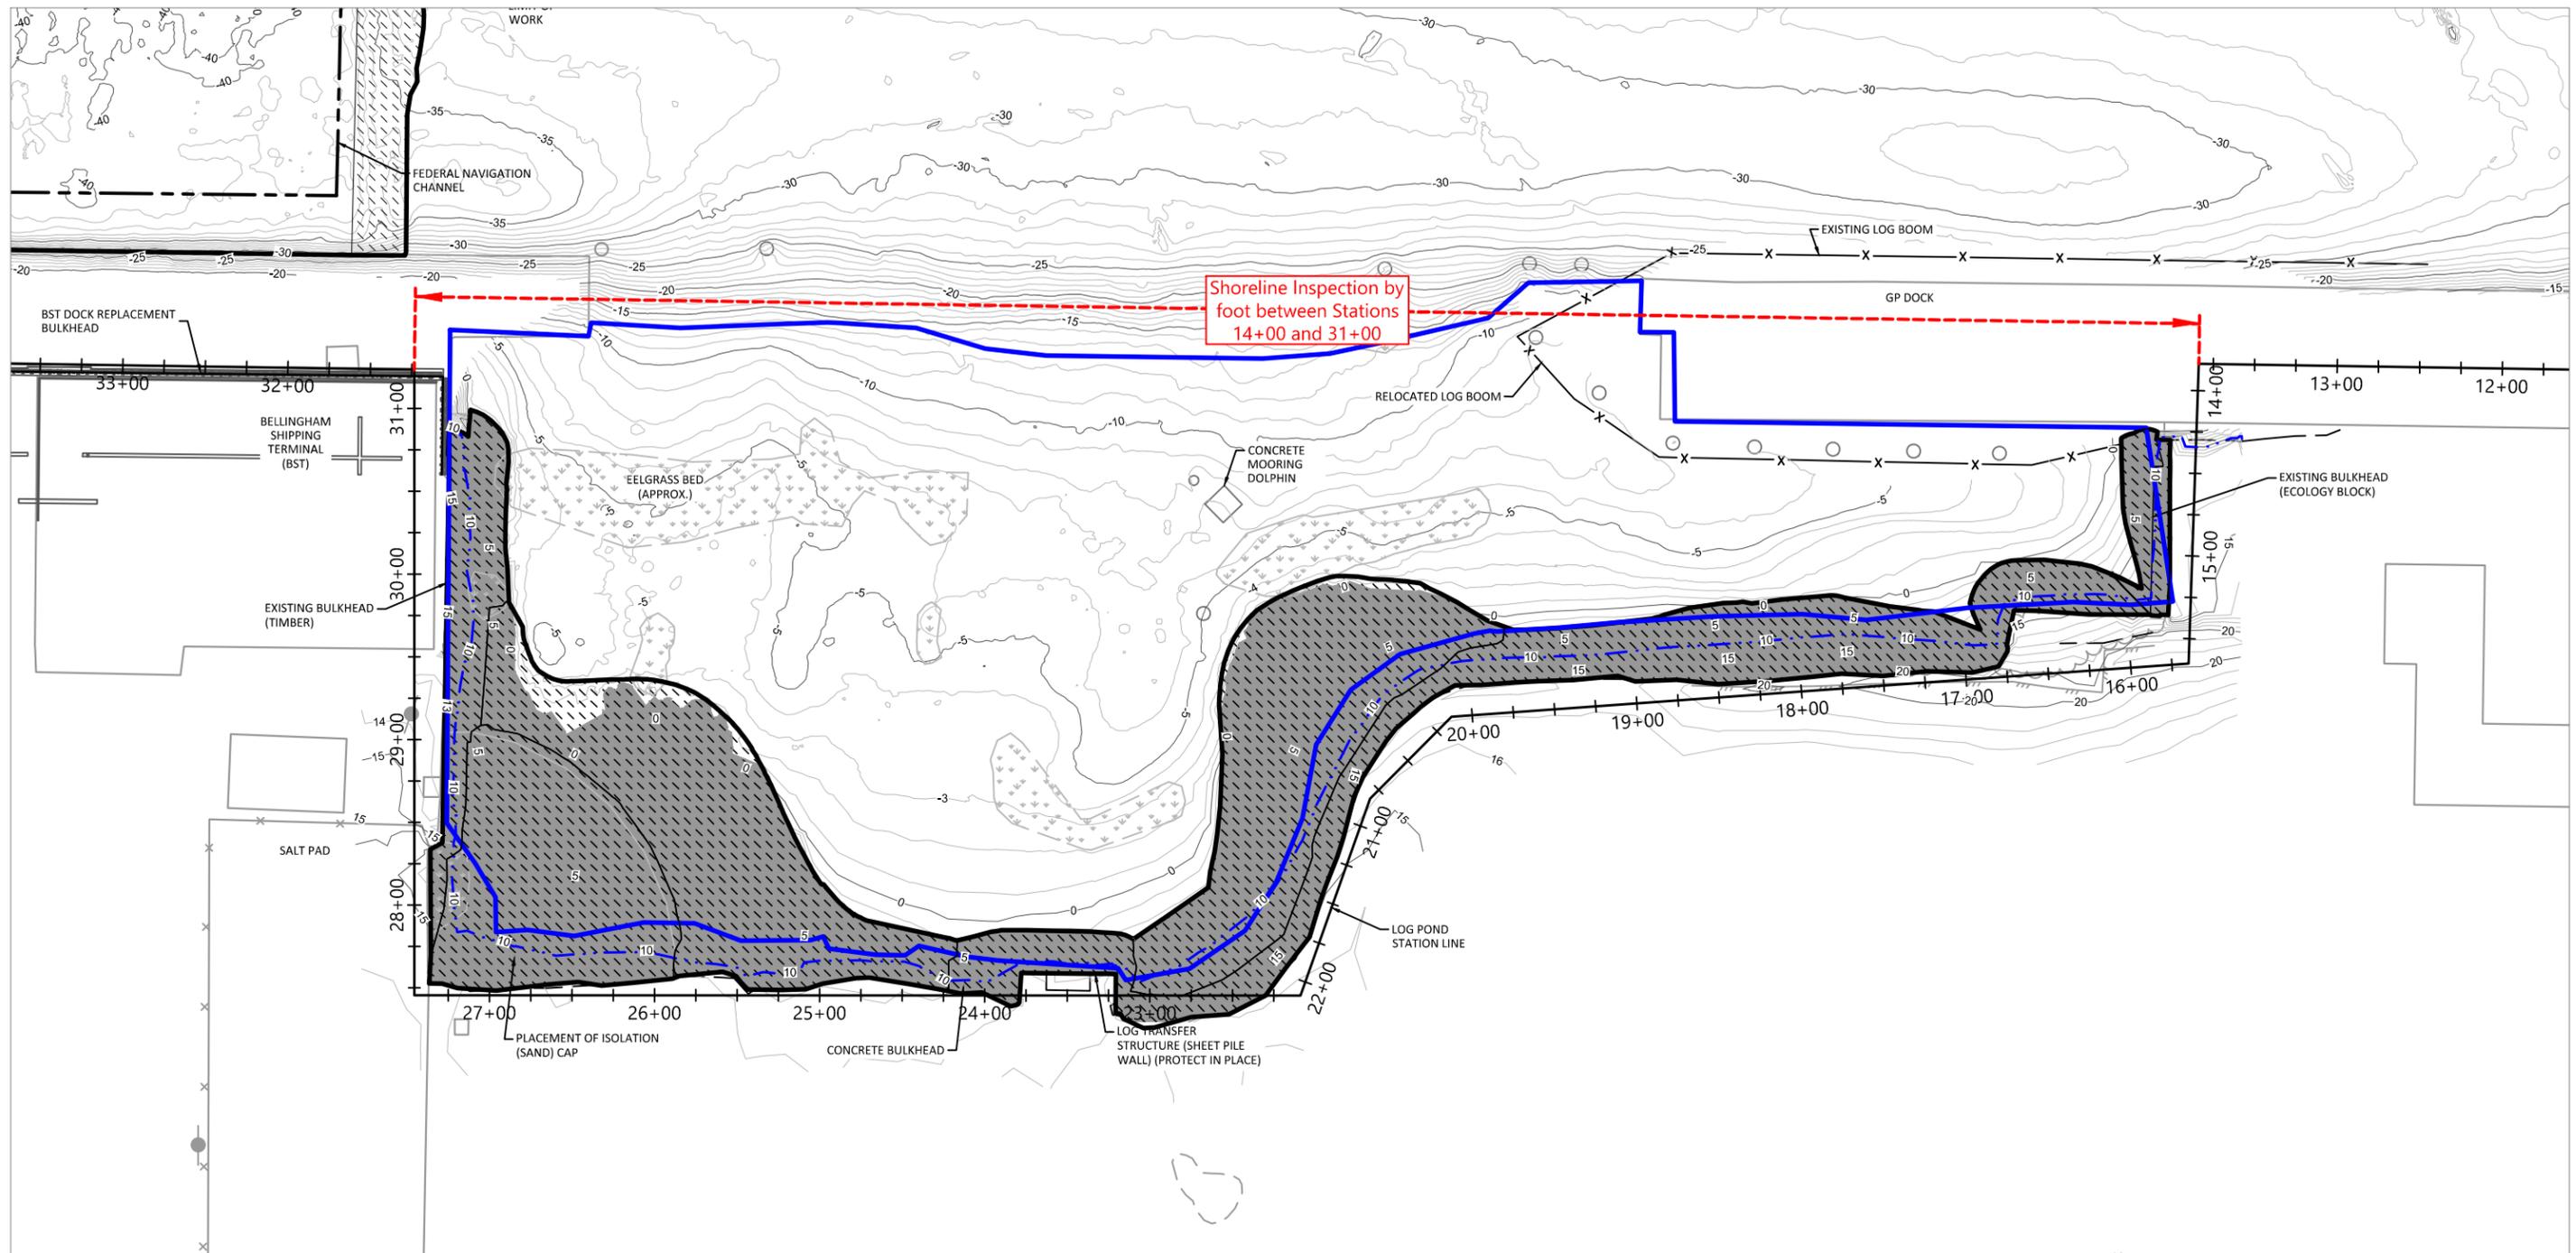
Figure 8b  
 Visual Survey Coverage - Log Pond  
 Year 1 Compliance Monitoring Report  
 Whatcom Waterway Cleanup in Phase 1 Site Area

- There were no signs of contamination or significant groundwater seepage observed during the survey. Some growth of algae and colonization by marine organisms (e.g., barnacles) were noted.
- At some of the Log Pond stations (Stations 21+25 to 21+75), sand was visible on top of the stone armored cap, indicating some movement of capping materials from the thicker Log Pond cap and habitat restoration areas located offshore of the shoreline armoring. Some movement of this type was anticipated as part of the design.

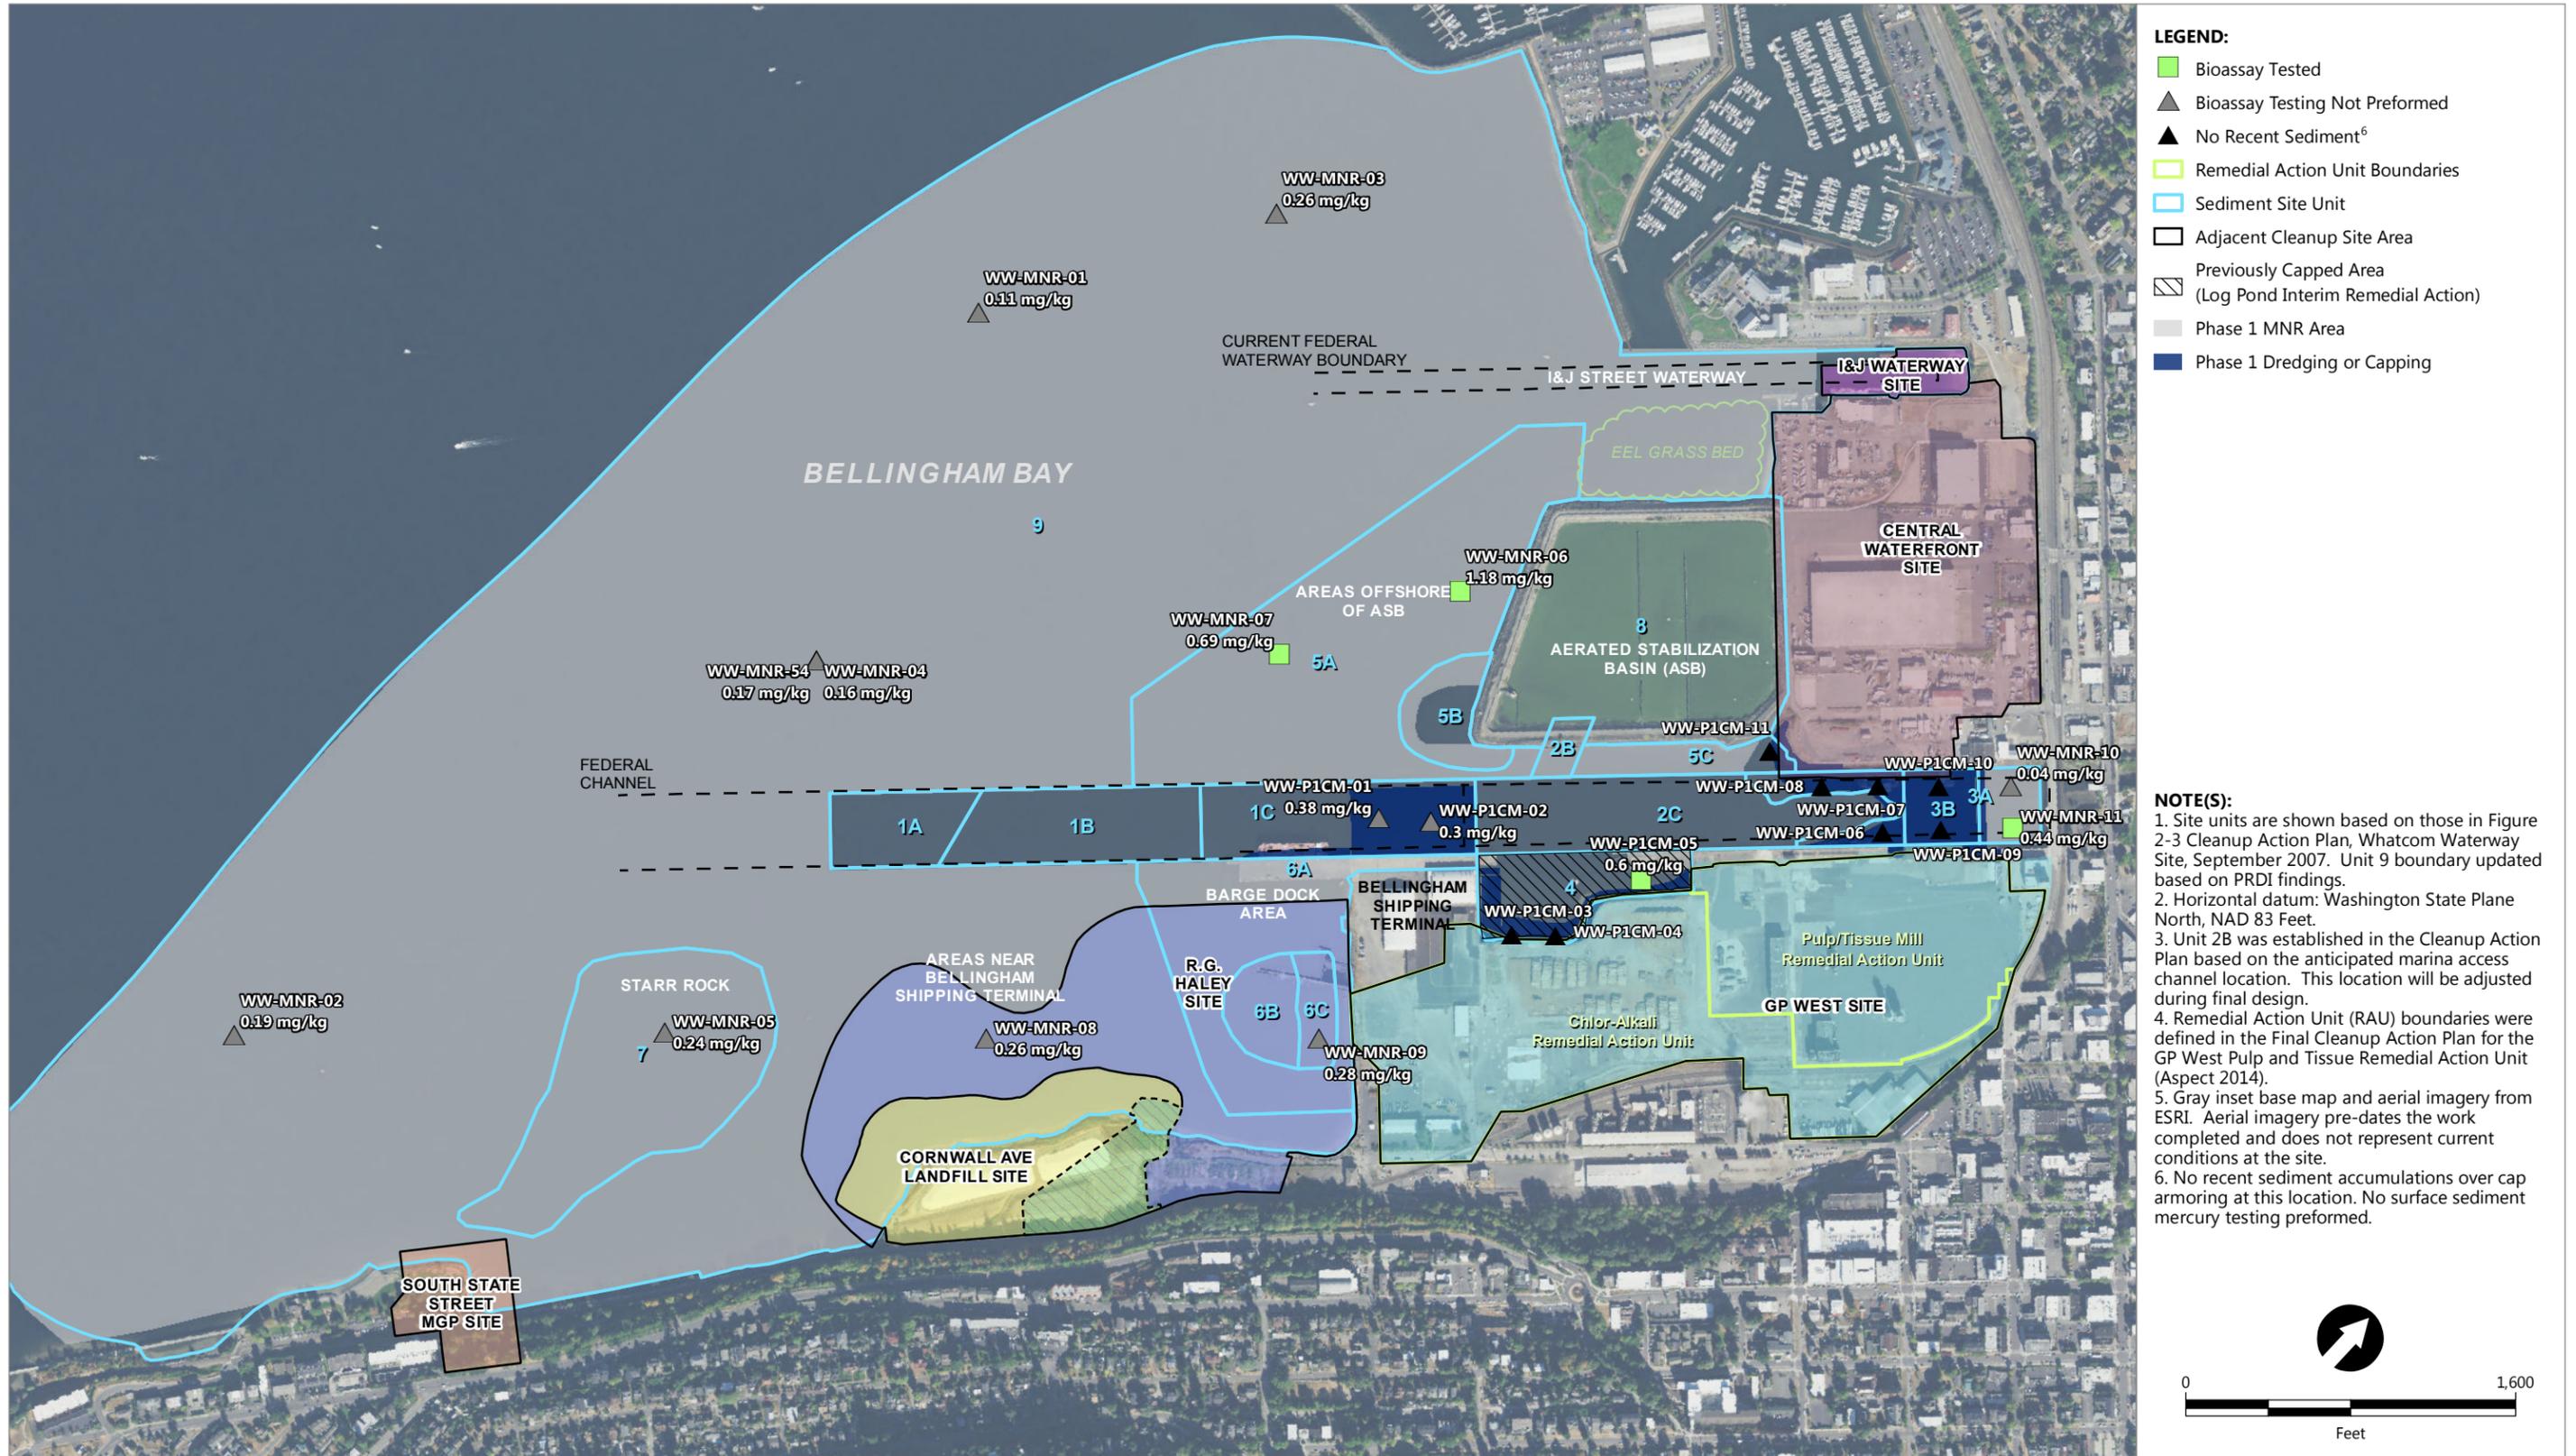
**Figure 9**  
**Surface Sediment Mercury and Bioassay Testing Results**  
 Year 1 Compliance Monitoring Report  
 Whatcom Waterway Cleanup Phase 1 Site Areas

Testing included two acute toxicity tests (the 10-day amphipod survival test and the 96-hour larval echinoderm survival and development test) and one chronic toxicity test (20-day polychaete survival and growth test). The 20-day juvenile polychaete and the 96-hour echinoderm tests were initiated on August 25 and 30, 2017, respectively, within the 56-day holding time. The 10-day amphipod test was initiated on August 30, 2017; however, this test failed due to poor animal health observed in the control treatment. The test was re-run on September 15, 10 days outside of the recommended hold time, and met performance criteria. Given these results concur with the two other bioassay tests, and that all other performance criteria were met, results from the re-run test were determined to be suitable for making management decisions.

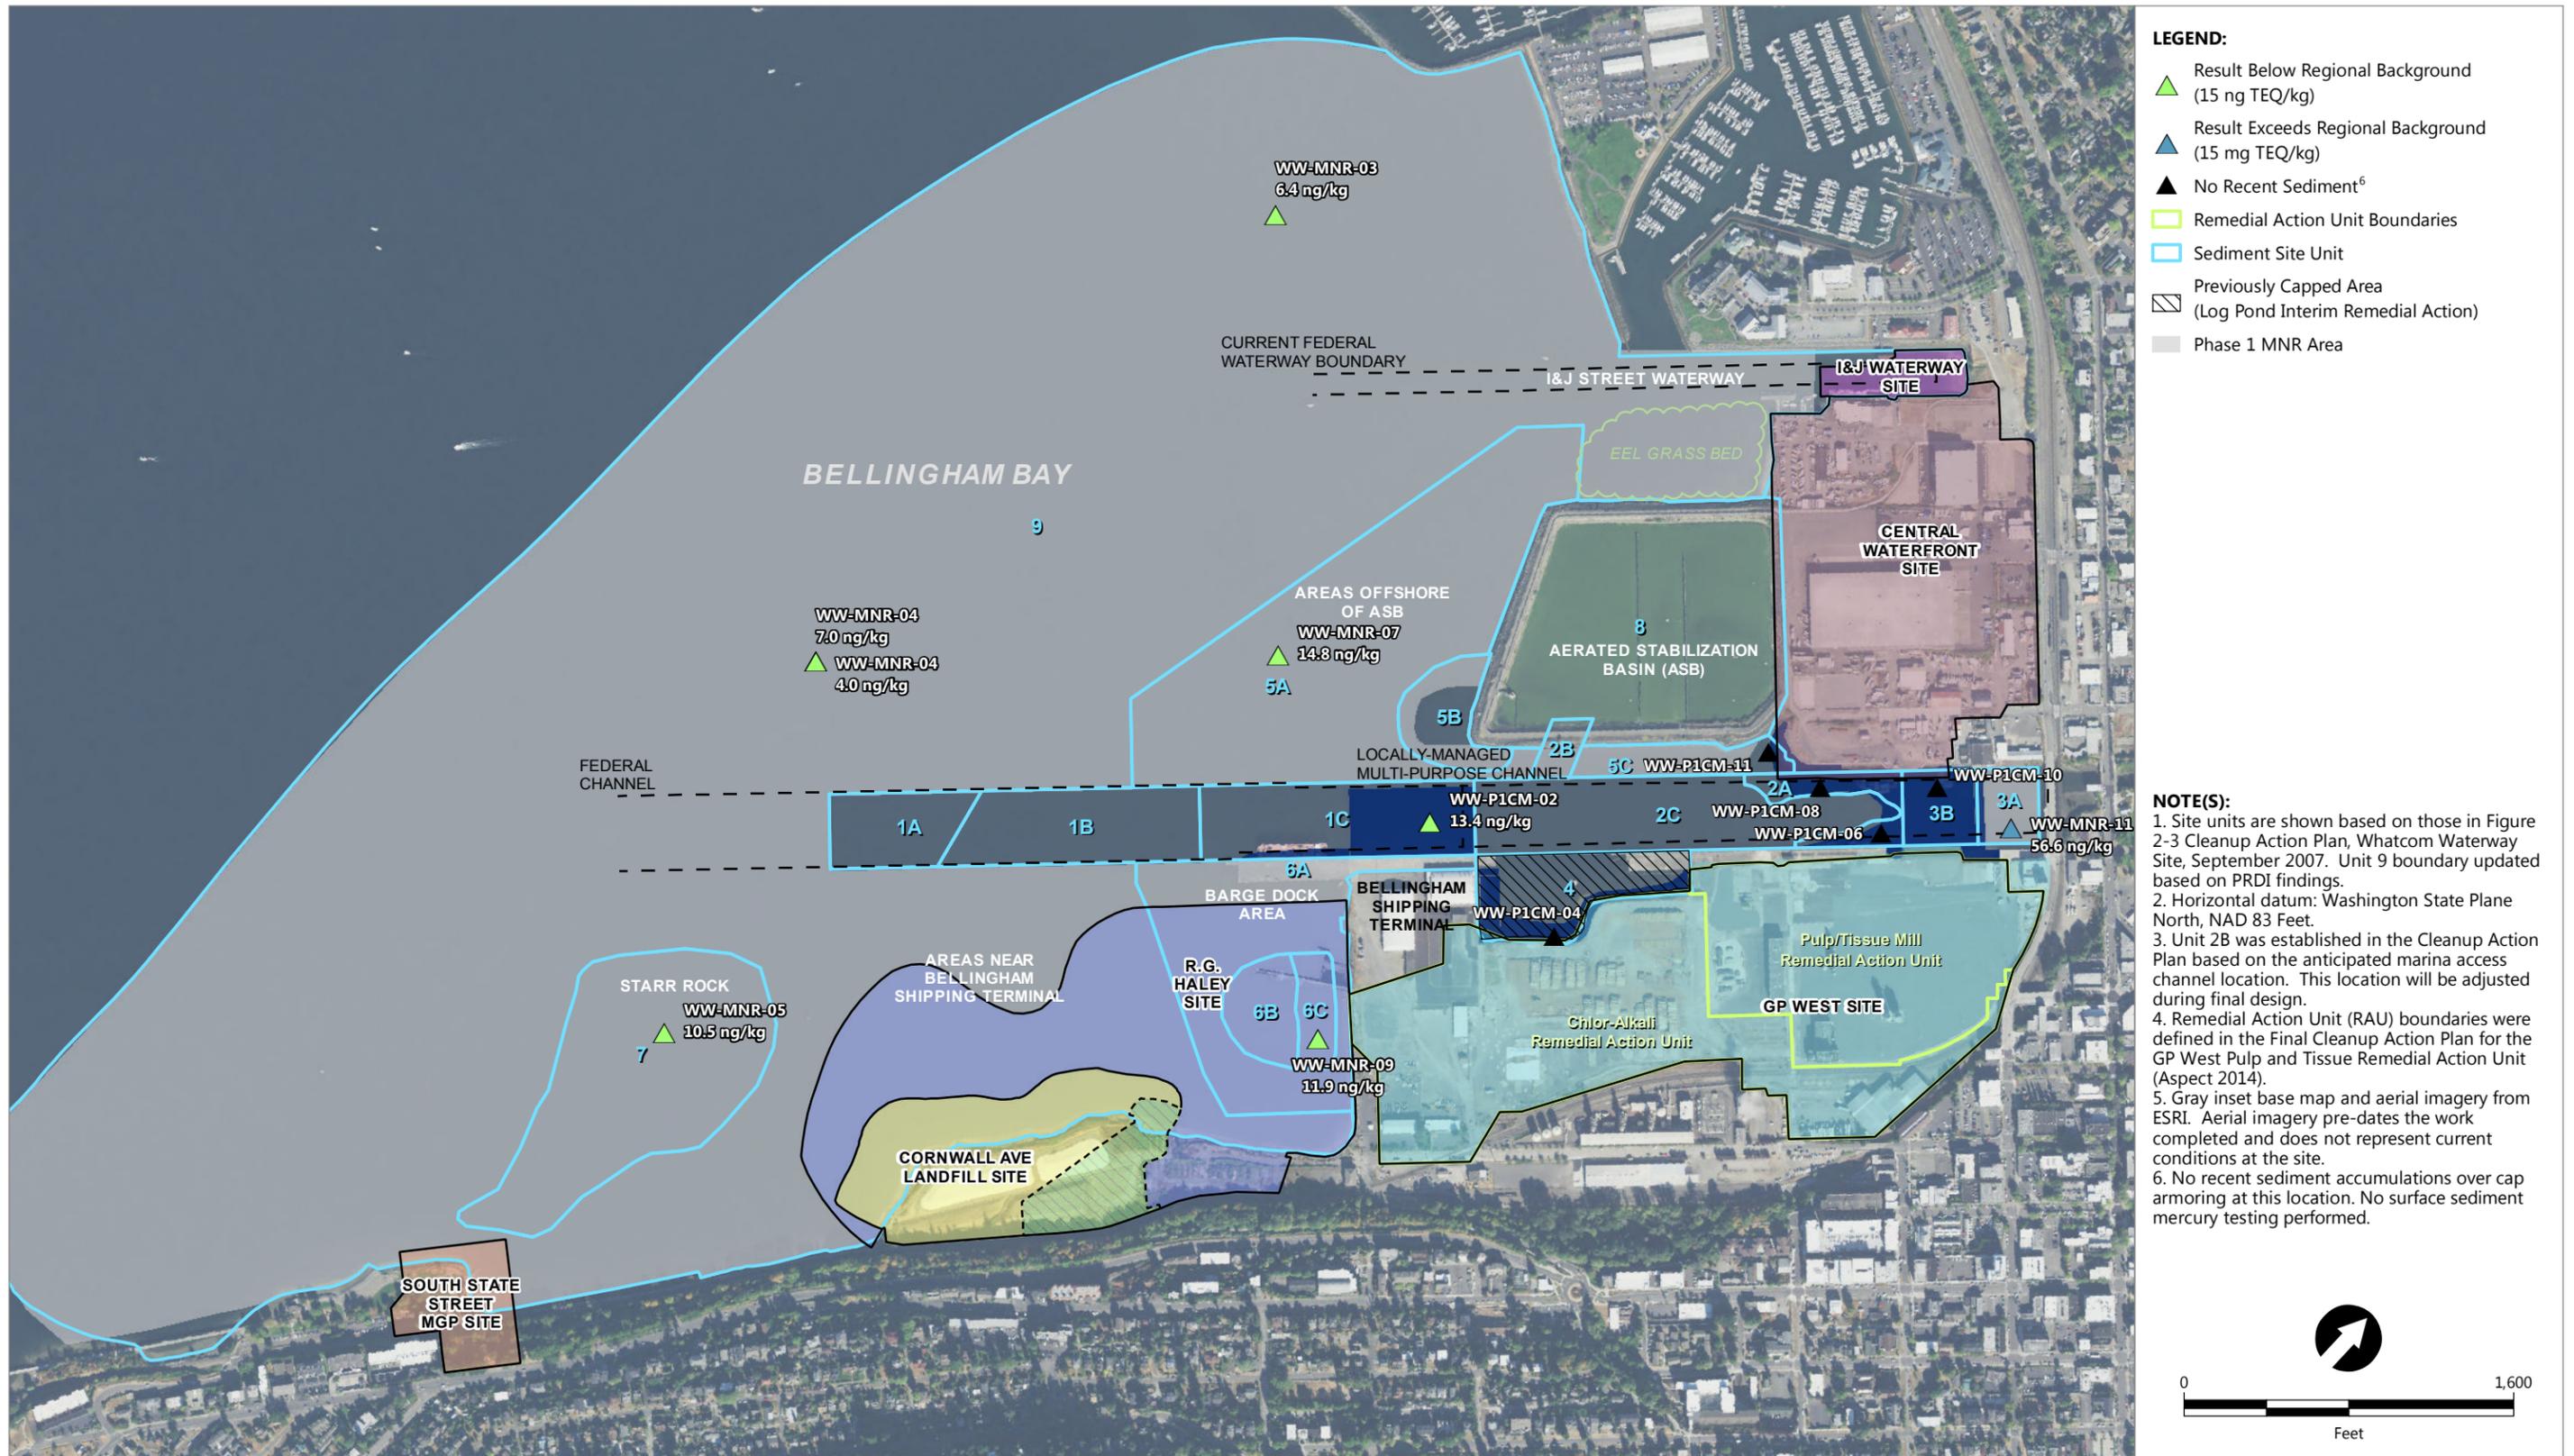
**Figure 10**  
**Surface Sediment Dioxin/Furan Testing Results**  
 Year 1 Compliance Monitoring Report  
 Whatcom Waterway Cleanup Phase 1 Site Areas

D/F concentrations within the five MNR areas and the Phase 1 dredging area were compared to the regional background concentration in Bellingham Bay, defined by the 2015 Ecology study of Bellingham Bay (Ecology 2015). Six samples were below the regional background concentration. A higher concentration was noted at MNR station WW-MNR-11, located in between the Phase 1 capping areas and Roeder Avenue. A specific source for the elevated D/F concentration at this location is not known. However, this location will continue to be evaluated as part of long-term monitoring.

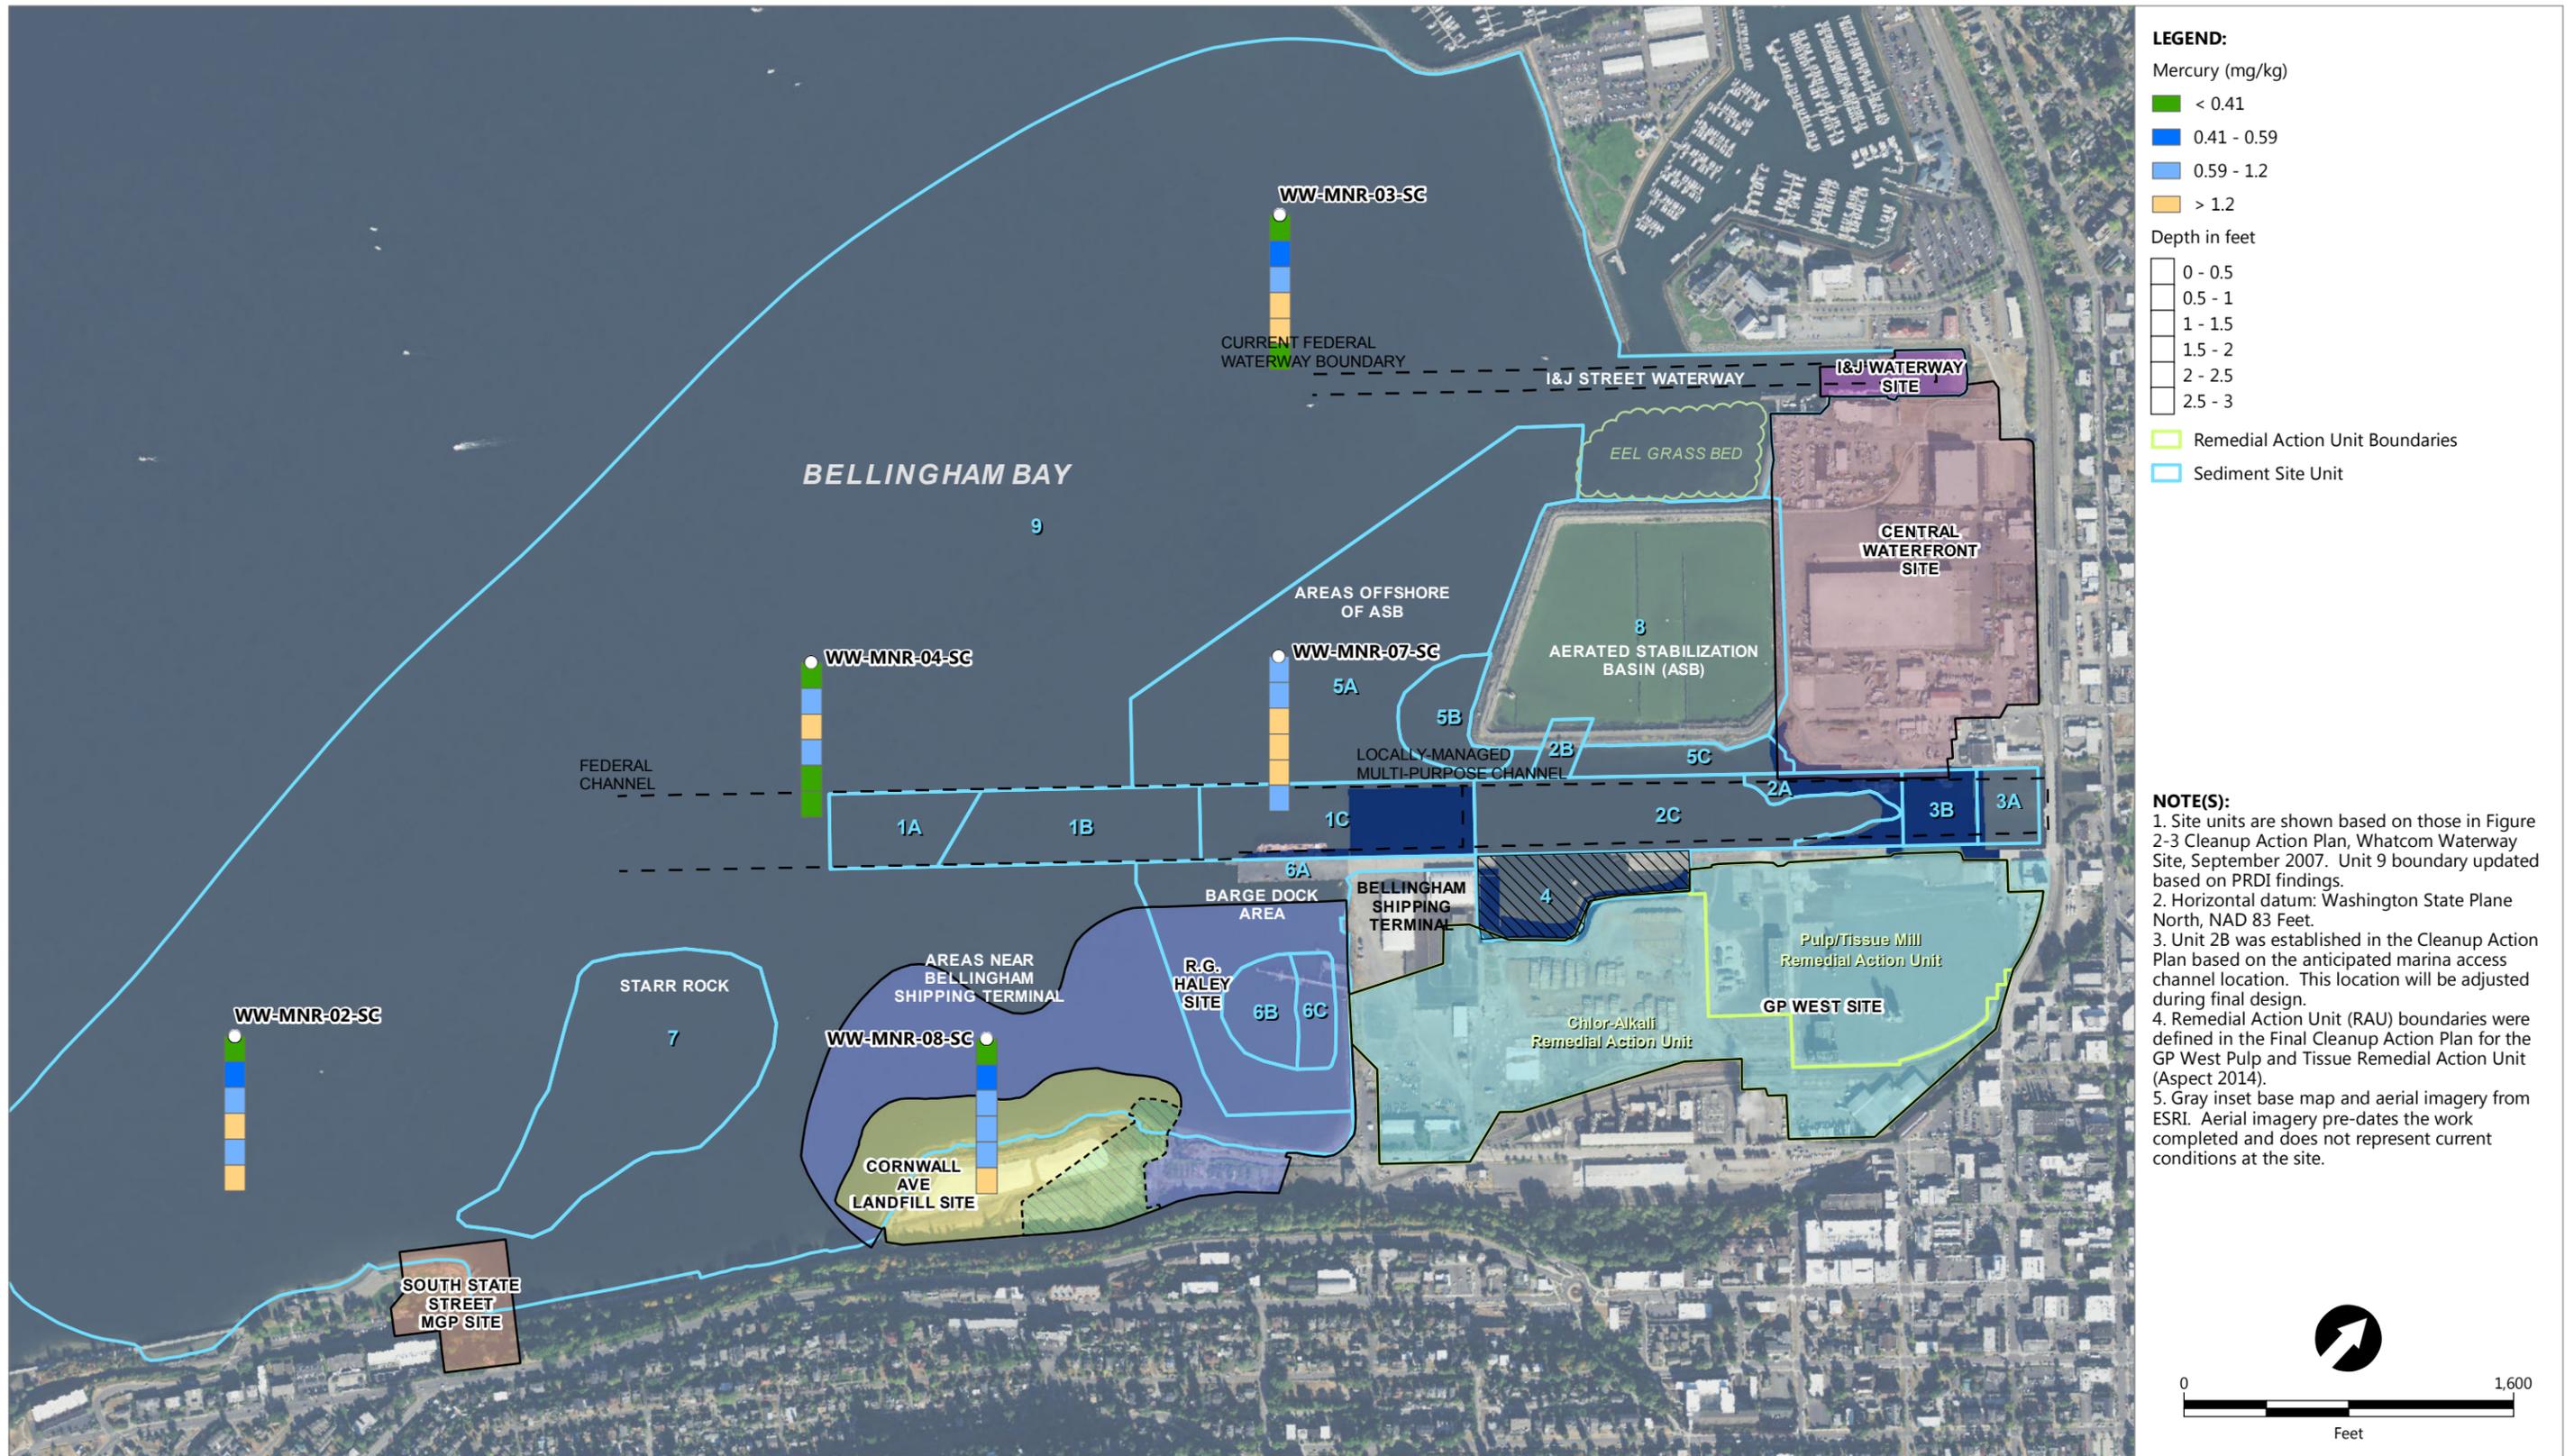
**Figure 11**  
**Subsurface Sediment Mercury Testing Results**  
 Year 1 Compliance Monitoring Report  
 Whatcom Waterway Cleanup Phase 1 Site Areas

- Station WW-MNR-08 located near the Cornwall Avenue Landfill had the thickest layer of cleaner sediments. Sediments exceeding the BSL are covered by 30 inches (76.2 cm) of cleaner sediment at this location. This is more than double the thickness of cleaner sediment that had been observed during 1997 natural recovery studies.
