April 2019  
Whatcom Waterway Cleanup in Phase 1 Site Areas

# Year 1 Compliance Monitoring Report

Prepared for Port of Bellingham

**Prepared by**  
Anchor QEA, LLC  
1201 3rd Avenue, Suite 2600  
Seattle, Washington 98101

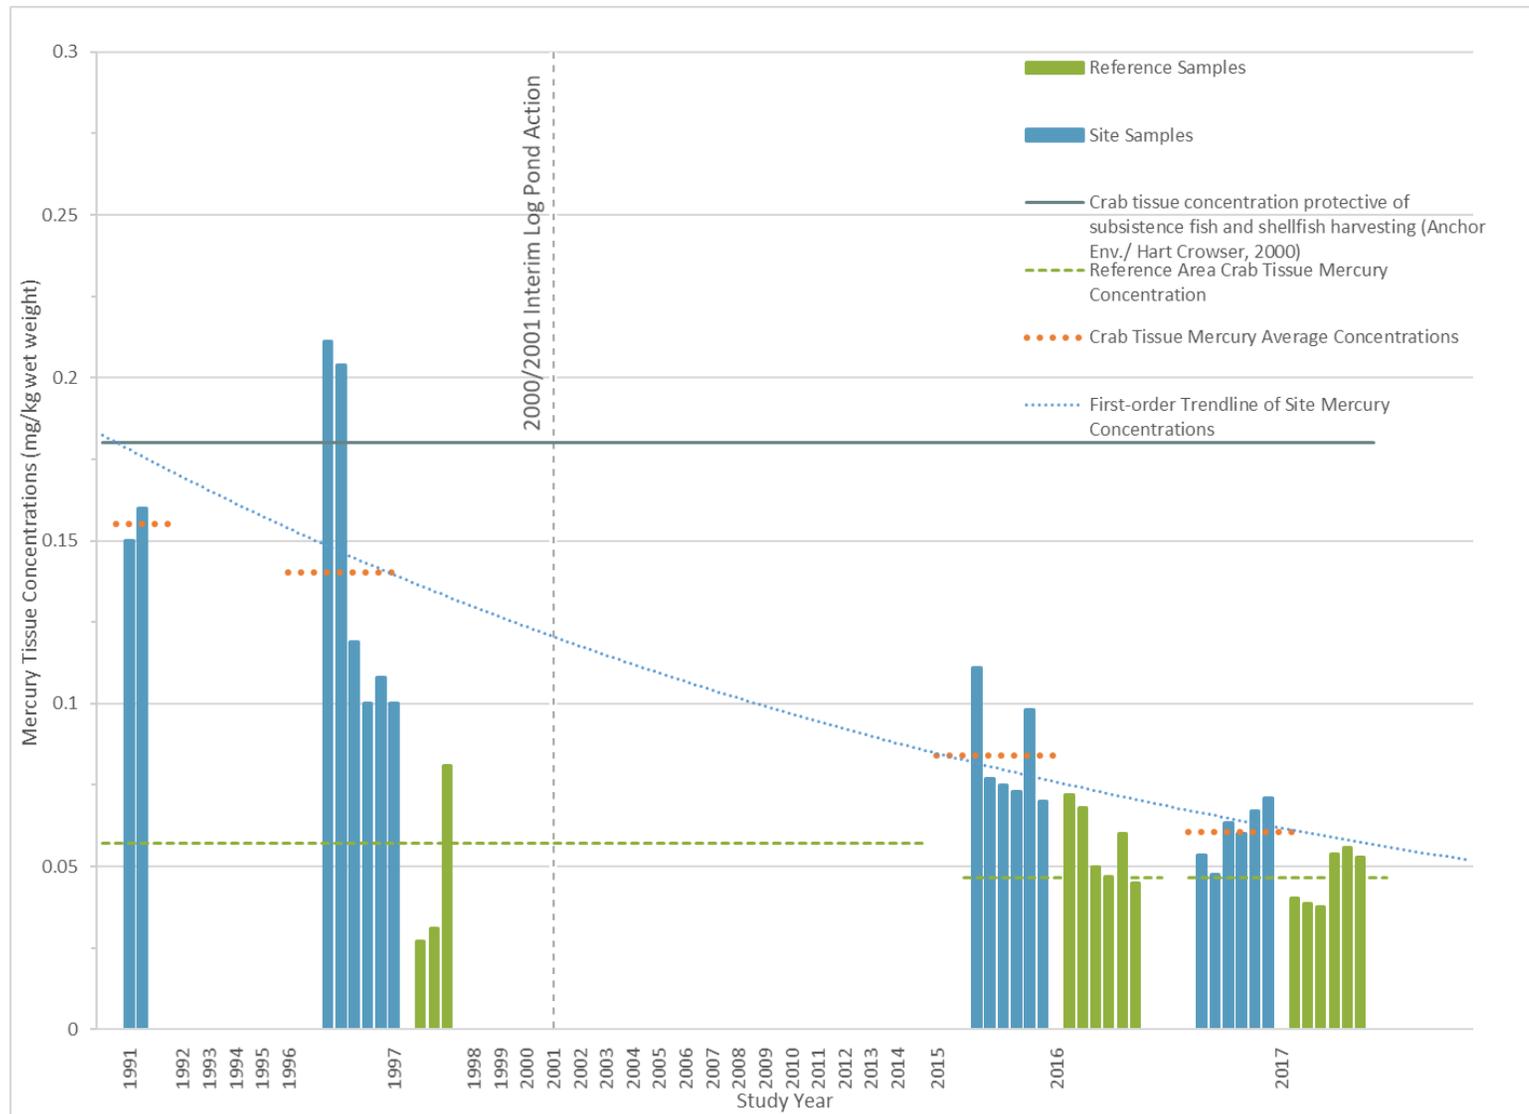
**Figure 12**  
 Mercury Concentrations in Adult Dungeness Crab Tissue  
 Year 1 Compliance Monitoring Report  
 Whatcom Waterway Cleanup in Phase 1 Site Areas

Table 5 and Figure 12 summarize the tissue monitoring data collected for adult crab for both the Site and the reference area stations.

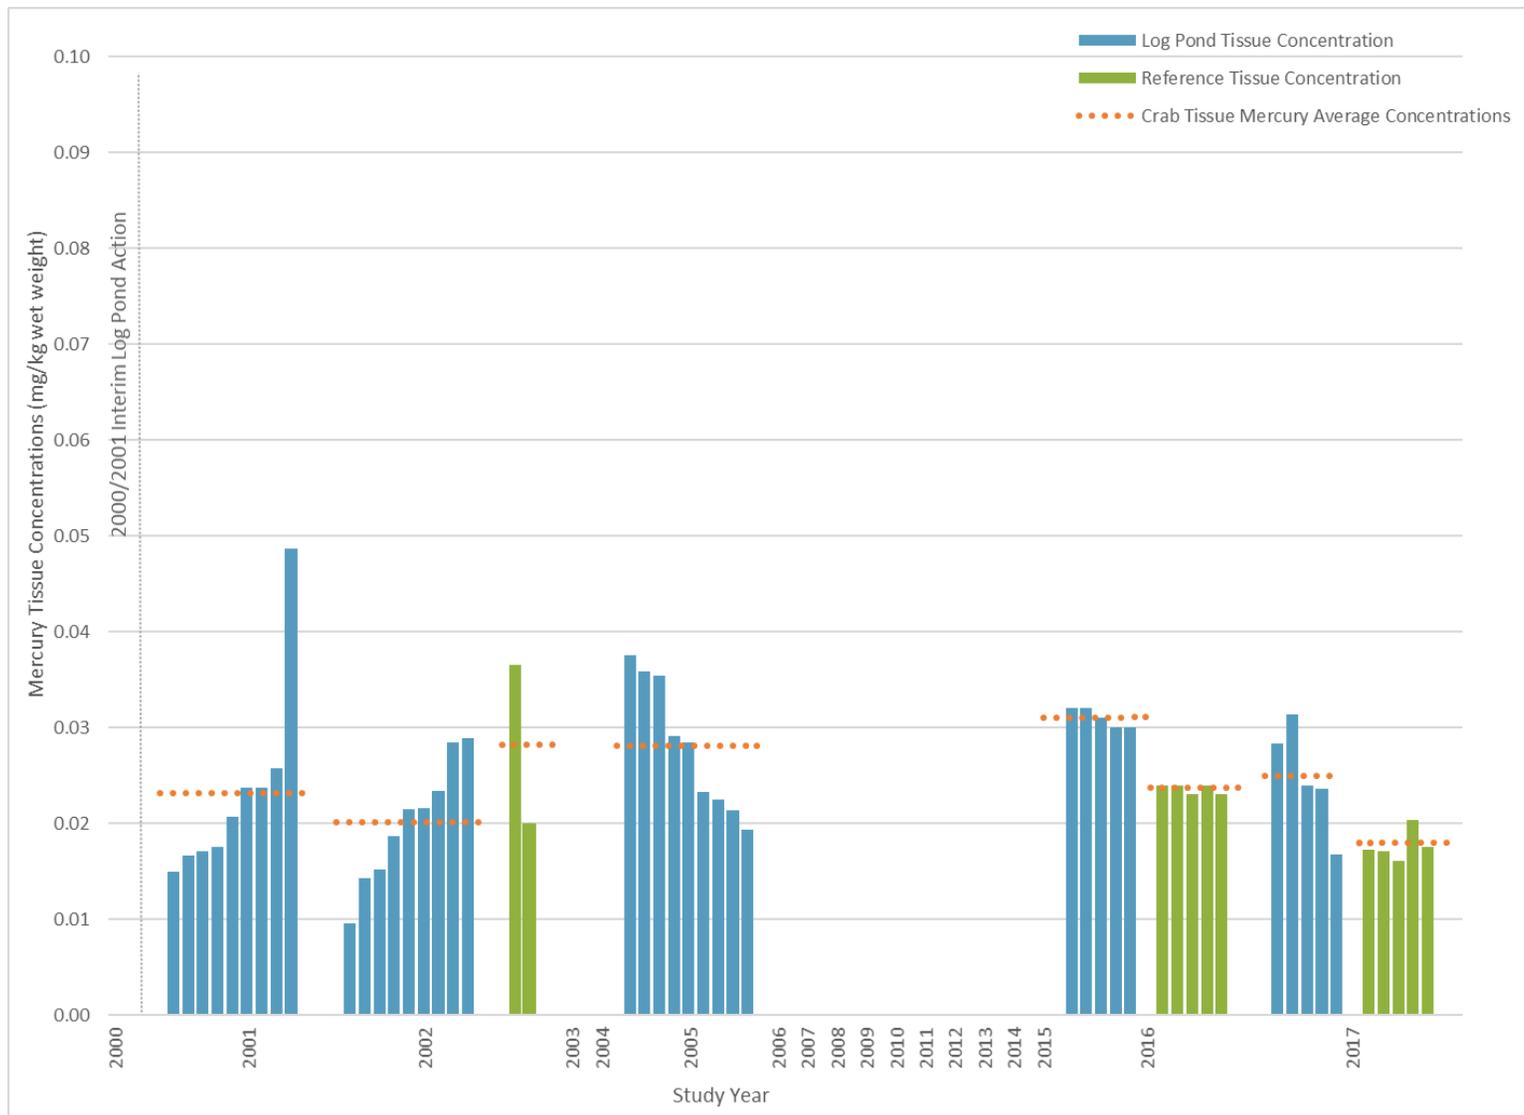
**Figure 13**  
 Mercury Concentrations in Juvenile Dungeness Crab Tissue  
 Year 1 Compliance Monitoring Report  
 Whatcom Waterway Cleanup in Phase 1 Site Areas

Mercury concentration data for the juvenile crab are summarized in Table 7 and Figure 13:

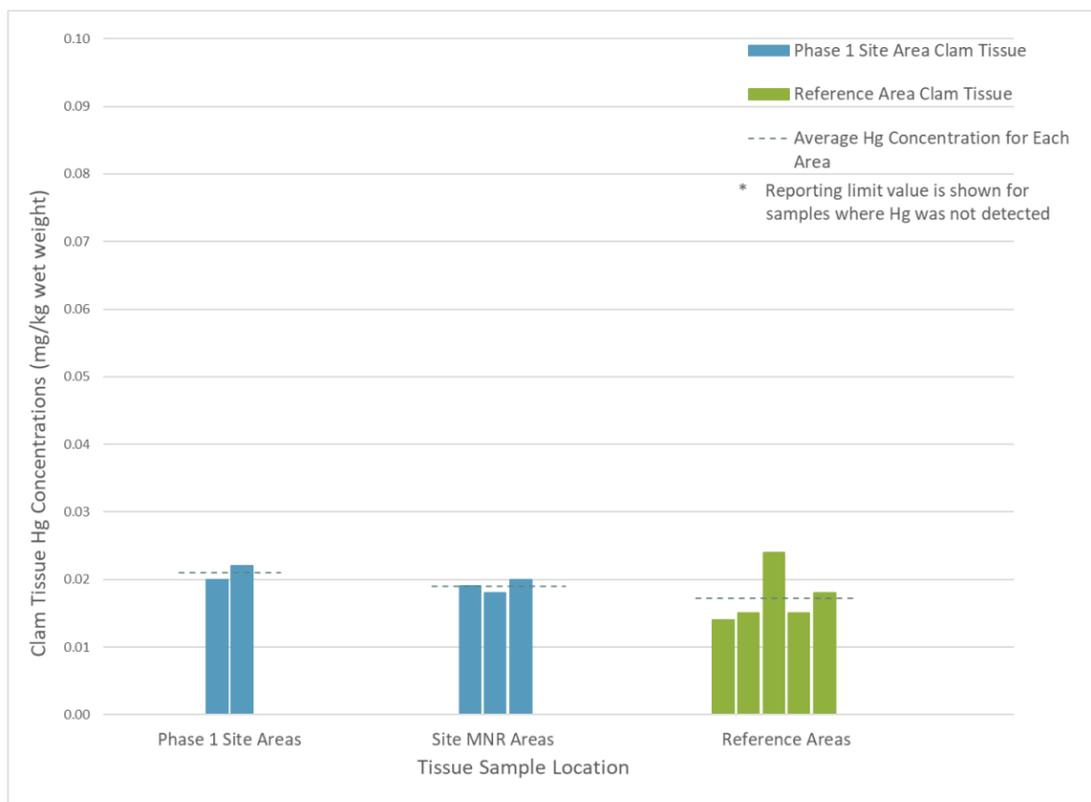
Figure 14a

Table 8 and Figures 14a, 14b, and 14c present the mercury concentrations reported in clam tissue, porewater, and sediment by area type and station:

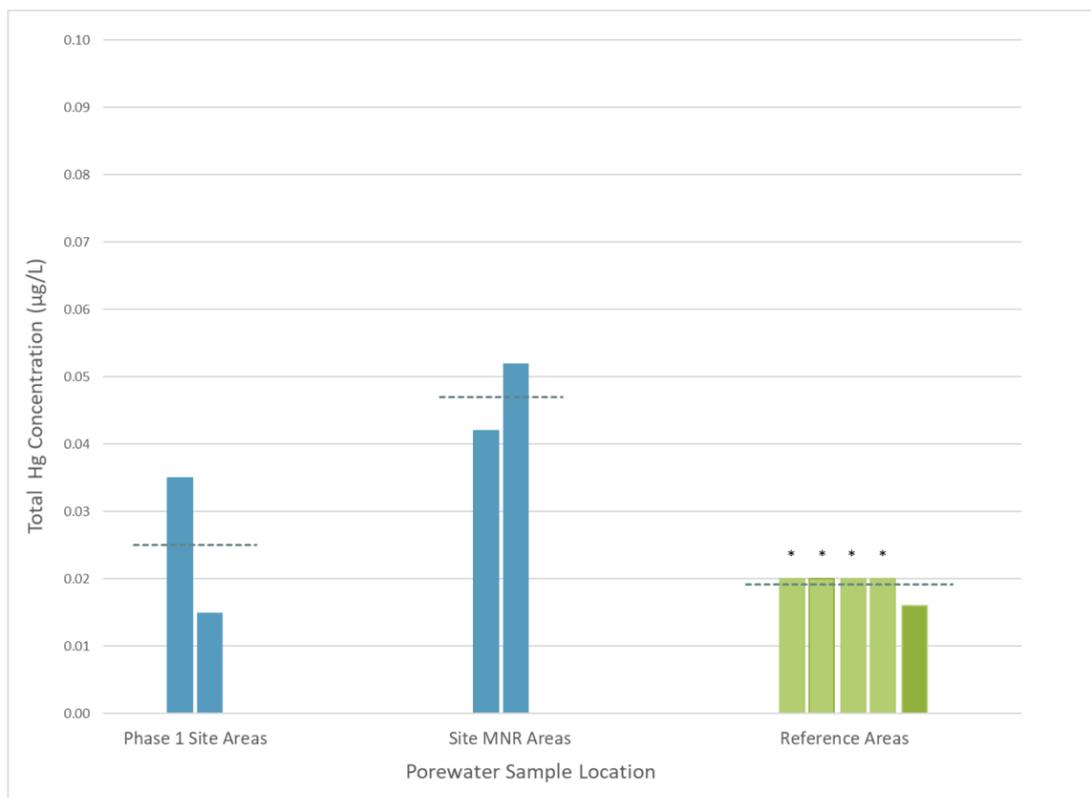
Figure 14c

- During retrieval, elevated turbidity levels were noted in the unfiltered porewater samples. The turbidity was absent in the filtered samples. Based on the observations of elevated turbidity, the unfiltered samples are not considered fit for quantitative use and should only be used qualitatively.

- The total mercury measurements (Figure 14c) are not suitable for quantitative use due to the presence of elevated turbidity in the unfiltered porewater samples. Qualitatively, some differences in total mercury concentrations were noted. But these differences were not reflected in either the dissolved mercury or the clam tissue concentrations.

During future porewater testing, the use of a finer (i.e., 20  $\mu\text{m}$ ) NMDS mesh size is recommended to limit the influence of the turbidity artifact on unfiltered total mercury analyses.
