**RE: REMEDIAL INVESTIGATION/FEASIBILITY STUDY REPORT AND
CLEANUP ACTION PLAN
BELLEVUE PLAZA PROPERTY
117 106TH AVENUE NORTHEAST
BELLEVUE, WASHINGTON
FARALLON PN: 397-034**

Attachment A, Remedial Investigation/Feasibility Study Report and Cleanup Action Plan,
Bellevue Plaza Property, August 21, 2020

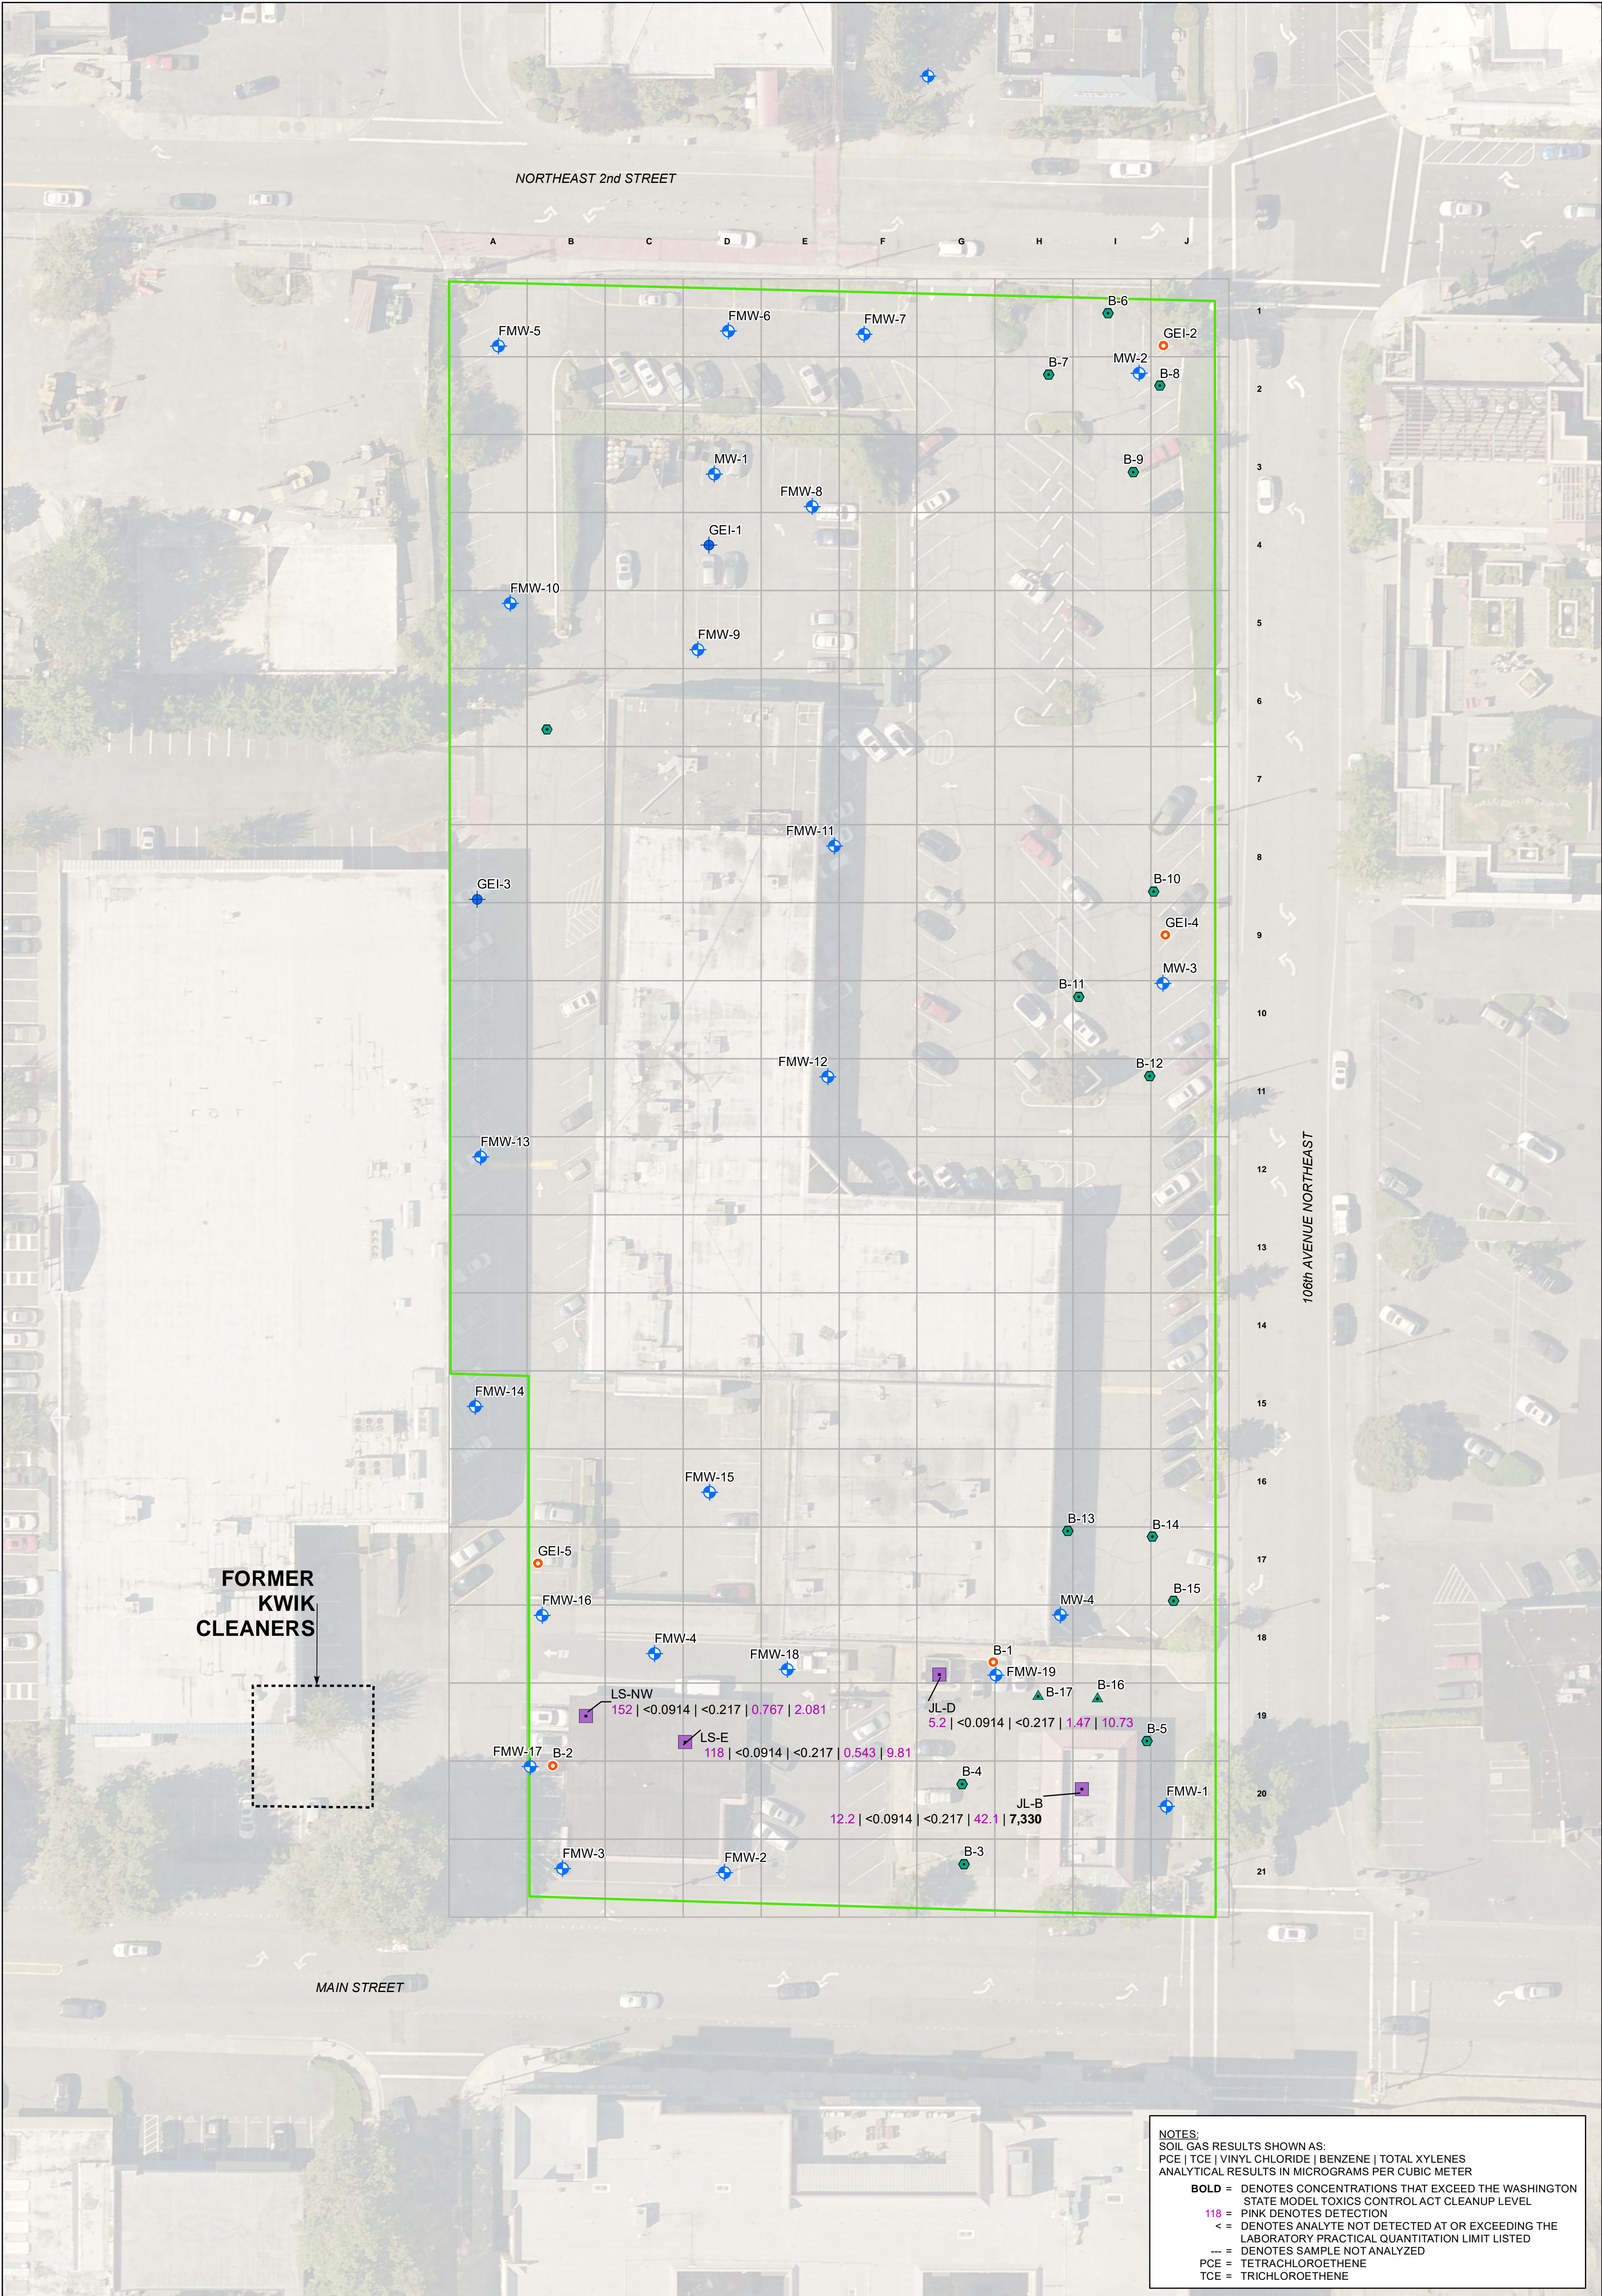
SOIL GAS ANALYTICAL RESULTS - BELLEVUE PLAZA SITE
BELLEVUE PLAZA PROPERTY
117 106th AVENUE NORTHEAST,
10502 AND 10510 MAIN STREET
BELLEVUE, WASHINGTON
