## Draft 2019 Site Investigation Summary

Former Chevron Facility No. 90129 4700 Brooklyn Ave NE, Seattle, Washington

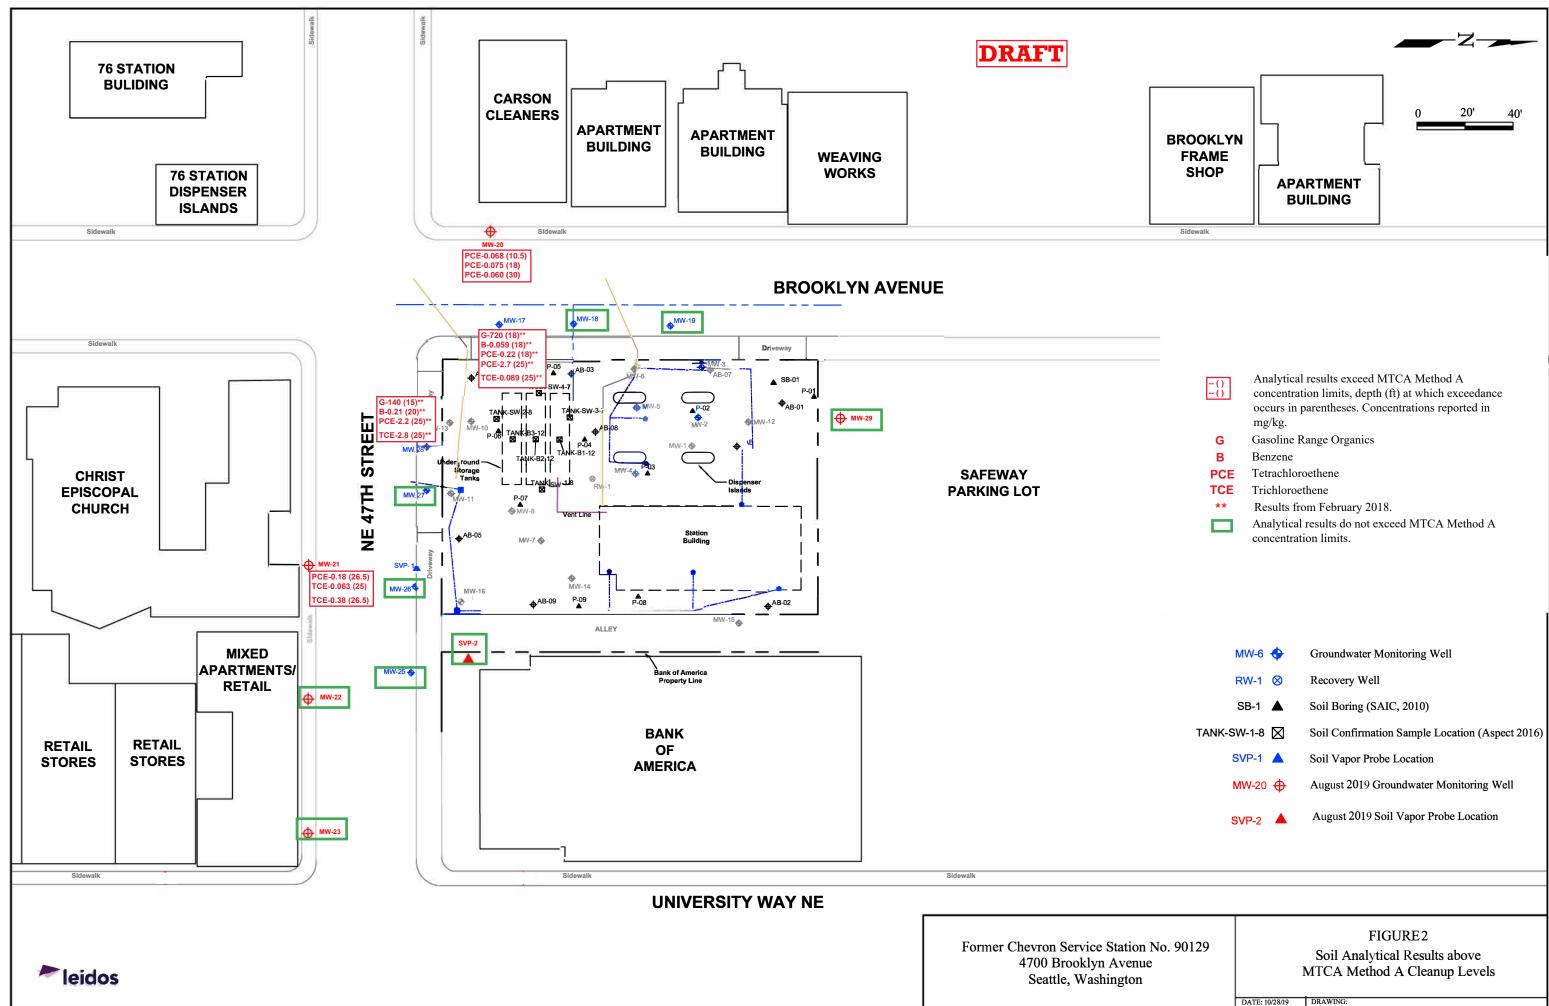
Io. 90129		FIGURE2 Soil Analytical Results above MTCA Method A Cleanup Levels
	DATE: 10/28/19	DRAWING:

All contaminants of concern were found to be below MTCA Method A cleanup levels or below laboratory reporting limits, except for PCE and TCE. PCE was detected in concentrations above MTCA Method A cleanup levels in MW-20 at depths of 10.5, 18.0, and 30.0 bgs, and in MW-21 at 28 feet bgs. TCE was detected in concentrations above MTCA Method A cleanup levels in MW-21 at 26 and 28 feet bgs.

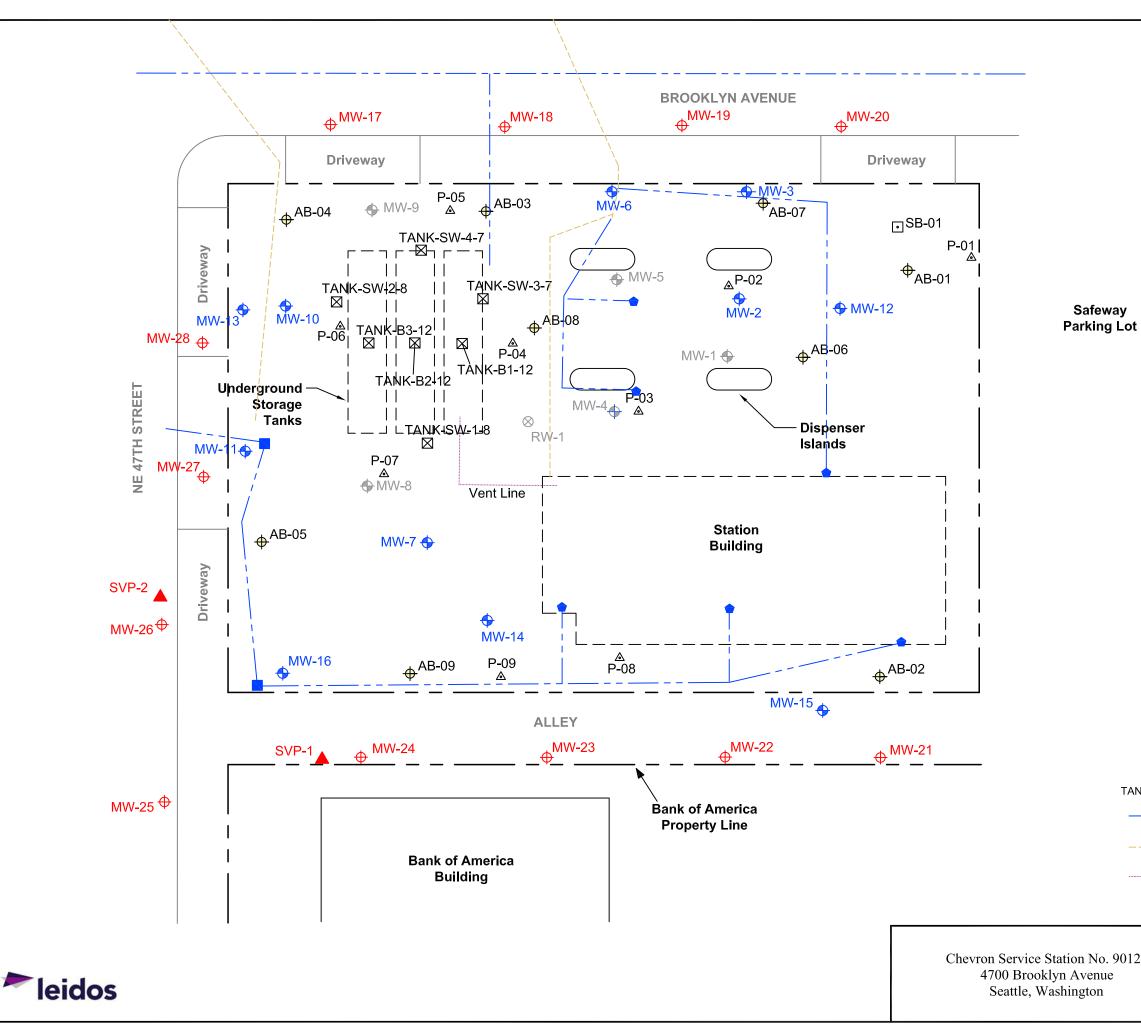
The ground water monitoring well locations and the soil-vapor sampling probe locations shown on Figure 2 are proposed; therefore, actual locations may differ based on permit conditions, construction plans, utilities, or other conditions encountered in the field.

The soil vapor sampling probe locations shown on Figure 2 are proposed; therefore, actual probe locations may differ based on permit conditions or conditions encountered in the field.
