**Non-Time-Critical
Removal Action Report
Monte Cristo Mining Area
Mt. Baker-Snoqualmie National Forest
Snohomish County, Washington**

December 2016

Cascade Earth Sciences
3511 Pacific Blvd SW
Albany, OR 97321

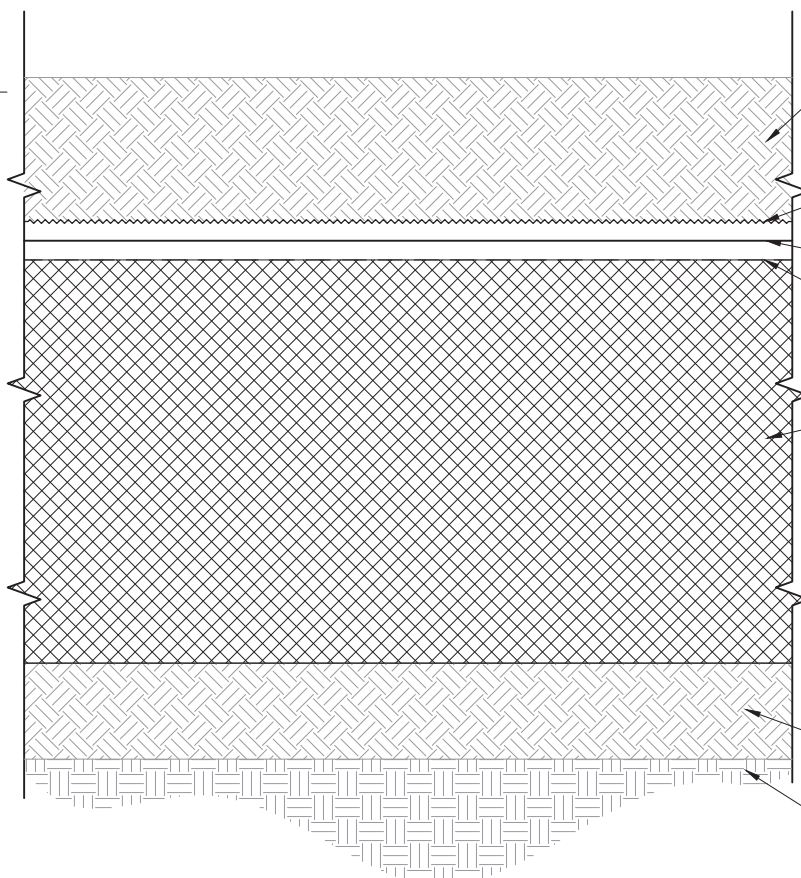
2 LINER ANCHOR TRENCH DETAIL
NOT TO SCALE

After waste material was placed and compacted in the Repository, 6 inches of cover soil was placed as a cushion layer, followed by an 8-ounce non-woven geotextile layer. This was overlain with a 60-mil HDPE liner keyed into the compacted layer to prevent precipitation from entering the Repository following construction and to reduce percolation through the compacted soil base layer. On October 5, 2015, Leak Location Services, Inc. conducted a geomembrane leak location survey of the top liner of the Repository. No leaks or defects were detected during the survey. Following the leak test, drainage geotextile (GSE Environmental FabriNet: 300 mil Geocomposite [upper terrace] and 200 mil [lower terrace]) was placed over the liner (Appendix A; Detail D1) a total of eight vents were installed across the Repository to allow gas to escape from within the Repository (Appendix A; Detail D2).

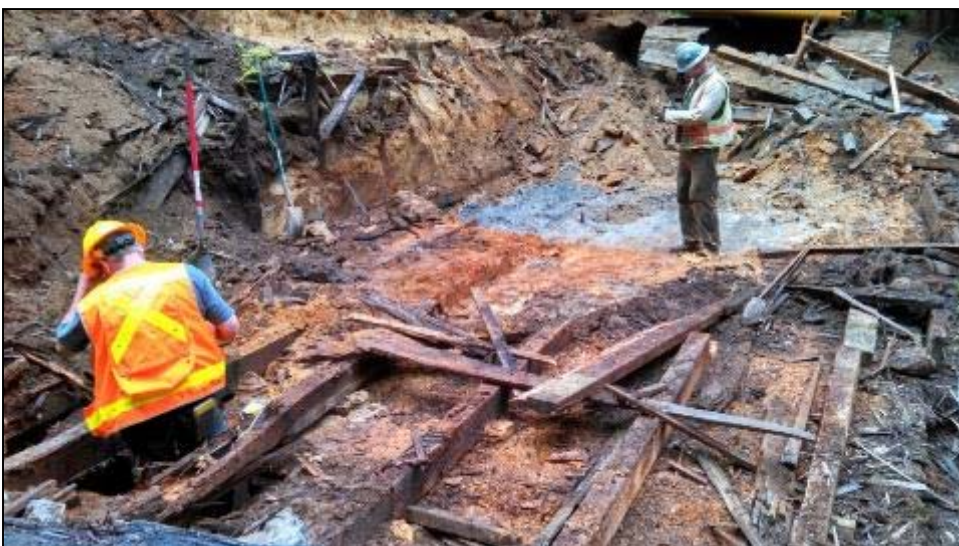
Photograph 45.

Excavation of Level 4 of the mill foundation (CES 7/27/2015).

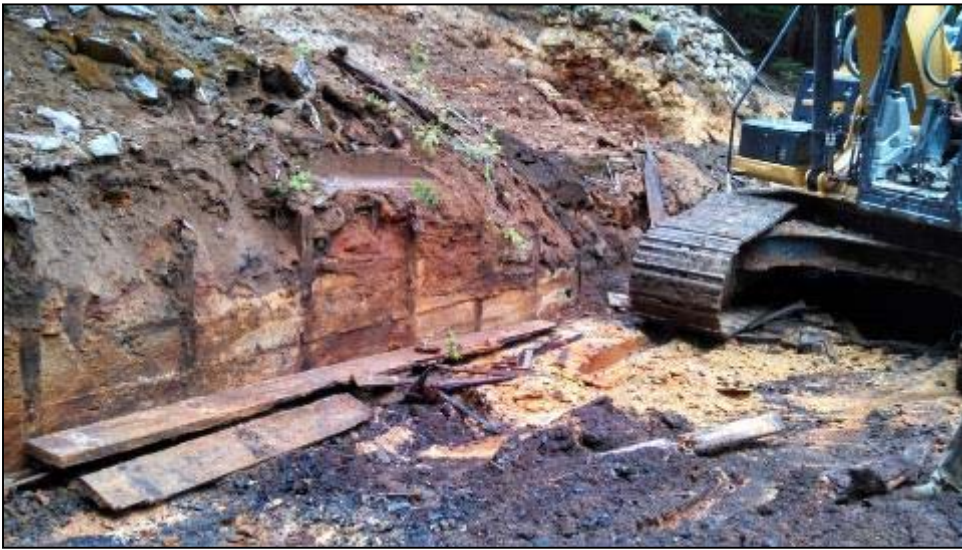
Photograph 46.

Tailings removed from Level 4 and around the foundation wall at the upper Concentrator (CES 7/27/2015).

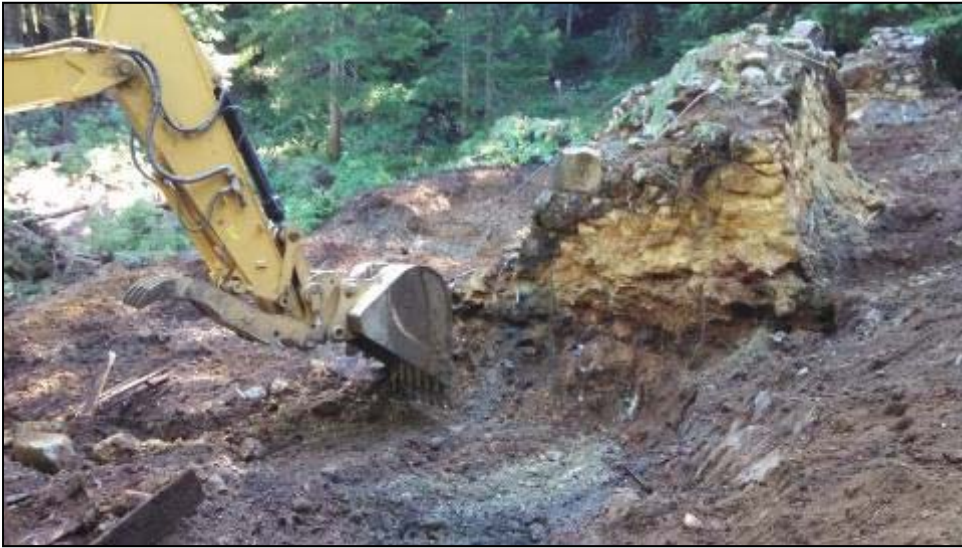
Photograph 47.

Excavation of the upper Concentrator foundation (CES 7/28/2015).

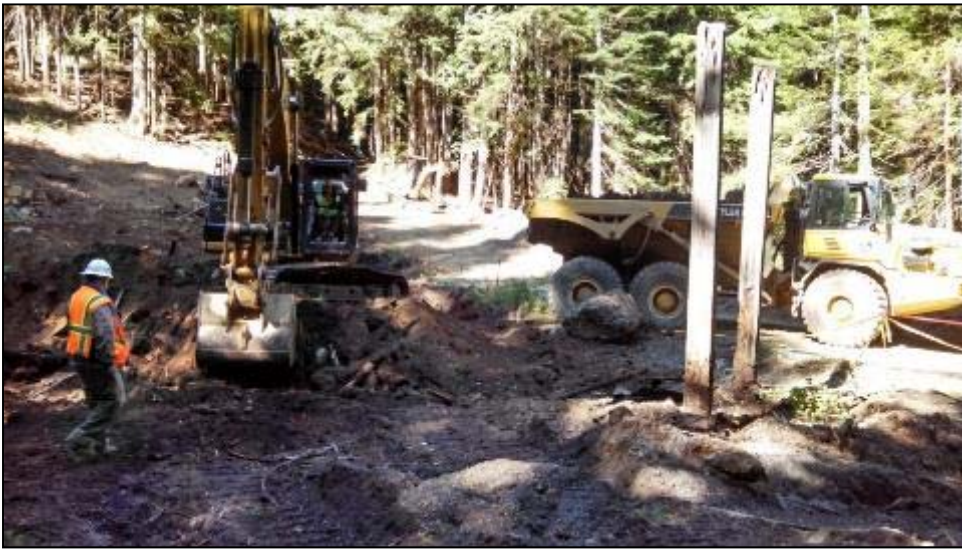
Photograph 49.

Excavation at base of the mill foundation at the Concentrator (CES 8/9/2015).

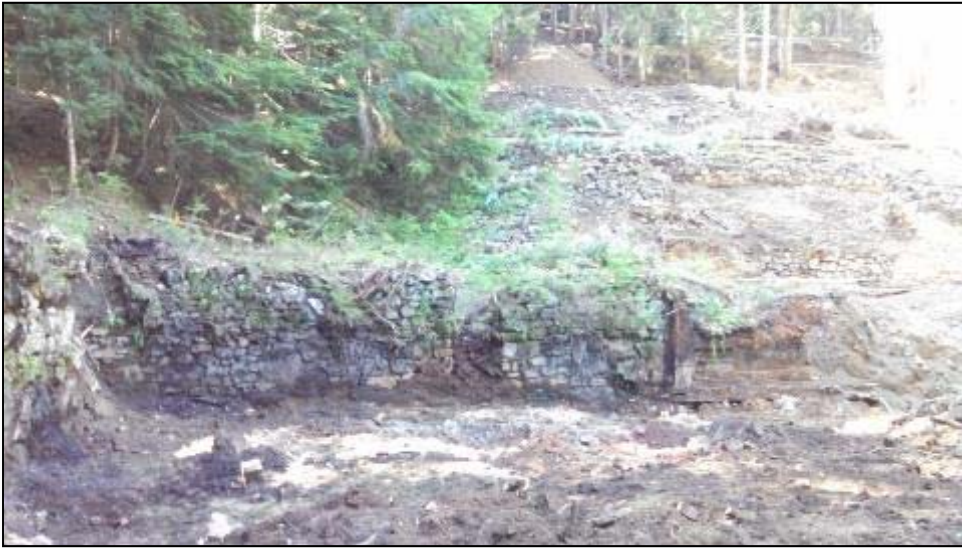
Photograph 50.

Excavation around the foundation walls near the rail terminus at the Concentrator (CES 8/9/2015).

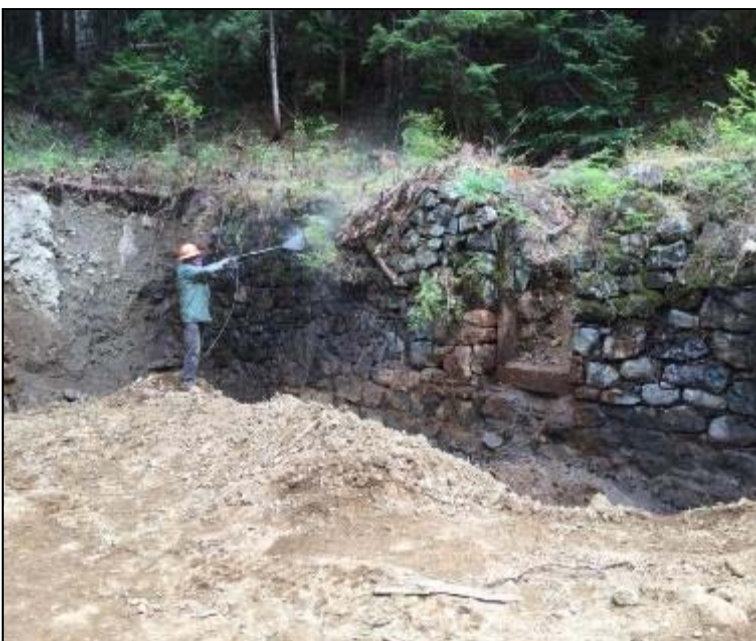
Photograph 56.

Pressure washing foundation walls at the upper Concentrator (CES 8/28/2015).

Tailings were excavated from five terraces at the upper Concentrator, which represented each level of the former 300-tons-per-day United Concentration gravity mill foundation. Tailings in the upper section of the Concentrator were also removed from the coal bunker, rail terminus, Pelton race, and brick piles. Some tailings were left in place in various sections of the upper Concentrator to retain the historic integrity of the remnant concrete, brick and rock wall features. Rock walls of the foundation were pressure washed to remove fines between the stonework.

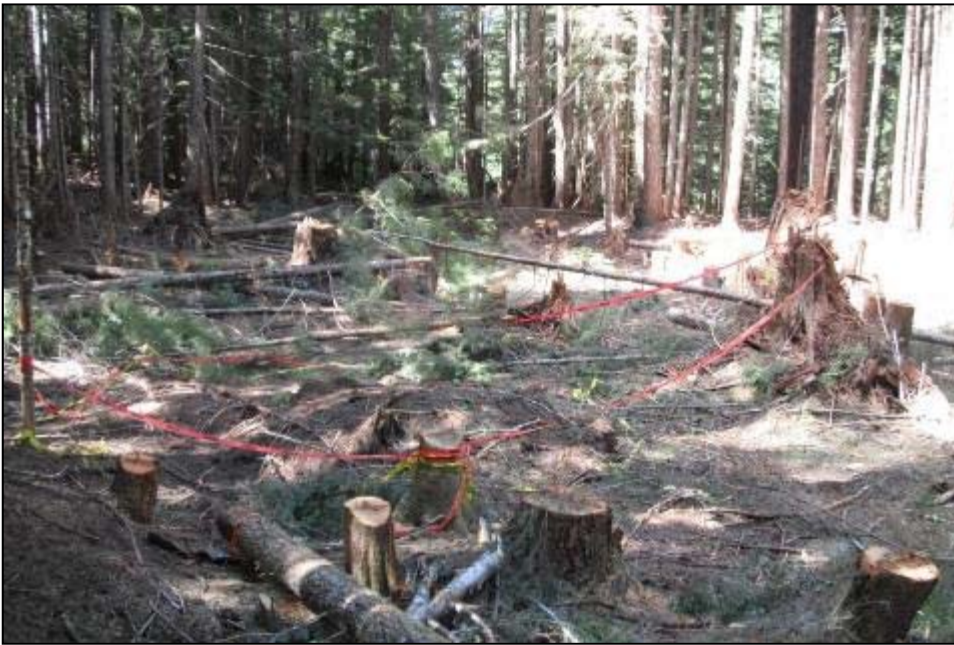
Photograph 63.

12 cubic yards of Dangerous Waste from the slime recovery system with hazard flagging at the lower Concentrator prior to removal (CES 8/7/2015).

5. Consolidate the majority of contaminated materials in an onsite repository. Approximately 12 bank cubic yards (bcy) of tailings from the slime recovery system at the Concentrator that exceeded Dangerous Waste criteria were transported offsite to a facility that accepts hazardous waste.

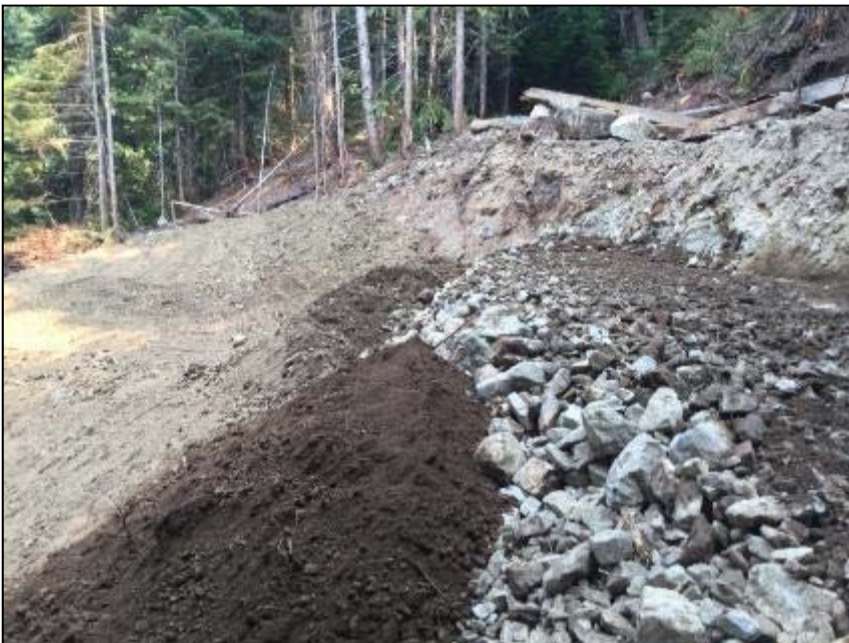
Photograph 79.

Ore Collector backfilled with clean cover soil to Trail #719 to reduce chemical hazards to onsite receptors (CES 8/12/2015).

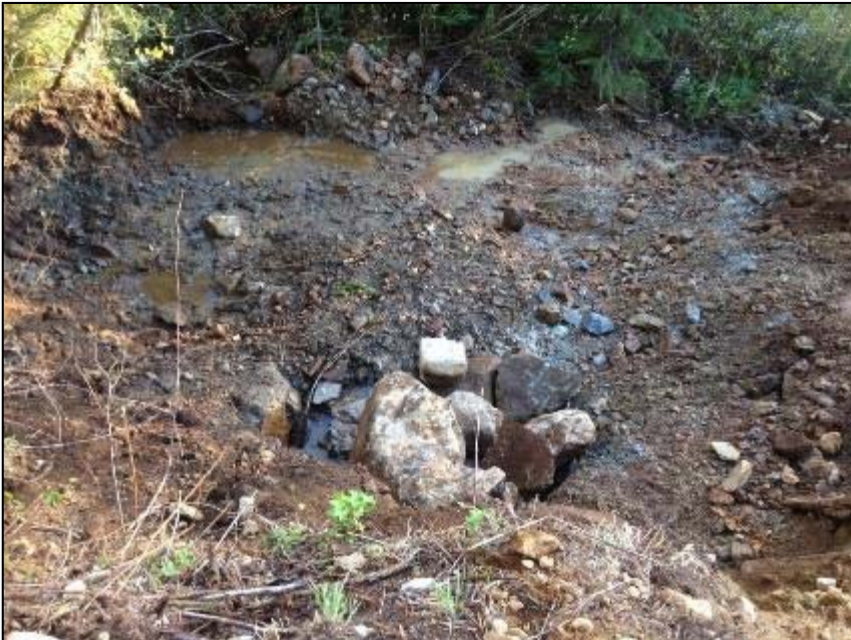
Photograph 108.

Seep area excavated to bedrock. The shaft was filled with large boulders to reduce the physical hazard at the Rainy Mine (CES 9/23/2015).

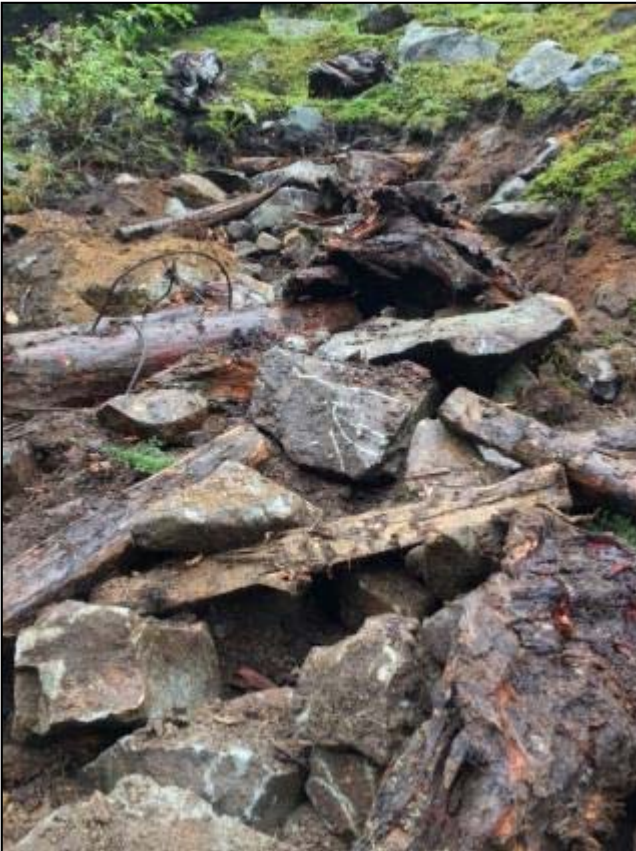
Photograph 120.

No discharge was observed at the Pride of the Woods adit. The portal was collapsed with onsite talus to reduce physical hazards (CES 9/8/2015).

An excavator opened the collapsed adit portal on September 6, 2015 to assess whether water drained from the portal. As the portal was exposed, no evidence of flowing water or seepage was observed at the base of the adit. As such, no diversion was created at the apex of the pile for seepage.

As discussed in Section 2.9.6, an excavator opened the collapsed adit portal to assess whether water drained from the portal. As the portal was exposed, no evidence of flowing water or seepage was observed at the base of the adit. Thus, no diversion was created at the apex of the pile for seepage.

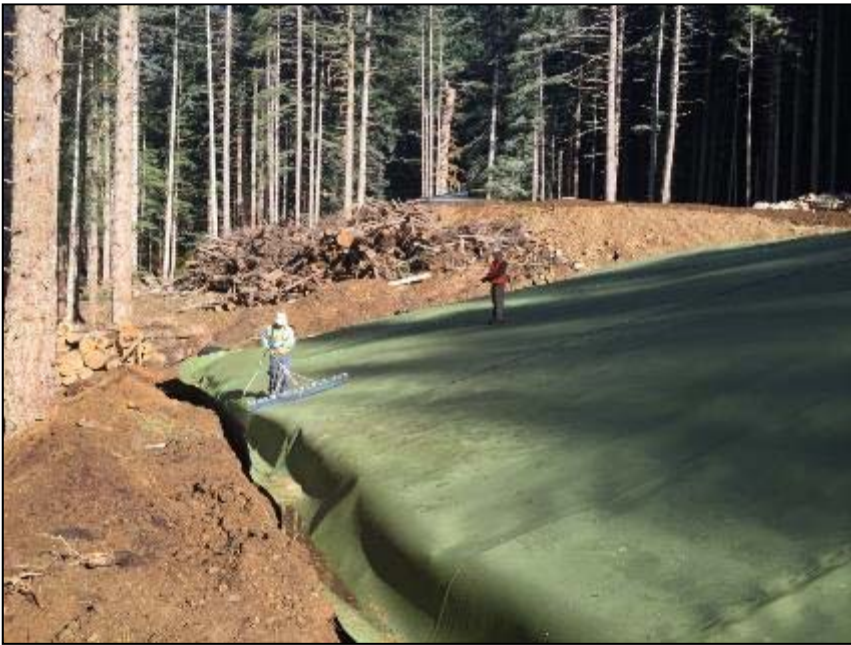
Photograph 177.

Independent leak test of the liner by Leak Location Services, Inc. (CES 10/5/2015).

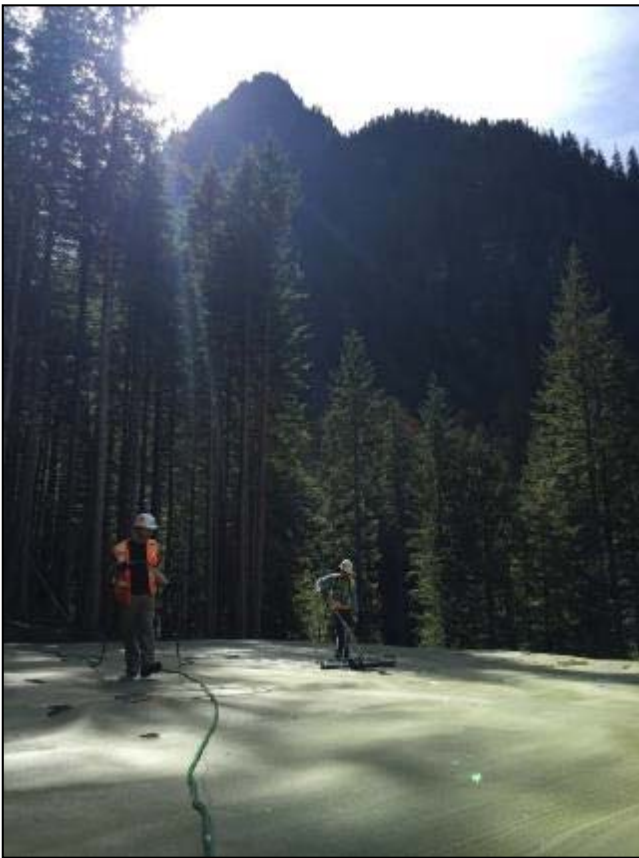
Photograph 178.

Independent leak test of the liner by Leak Location Services, Inc. (CES 10/5/2015).
