# **TECHNICAL MEMORANDUM**

File No.: 306.039

- Prepared for: ATTN: Jing Liu Toxics Cleanup Program Washington State Department of Ecology PO Box 47600 Olympia, WA 98504-7600
- Re: Cornet Bay Marina Model Toxic Control Act (MTCA) Cleanup Mitigation Plan: 2020 Vegetation Assessment Results

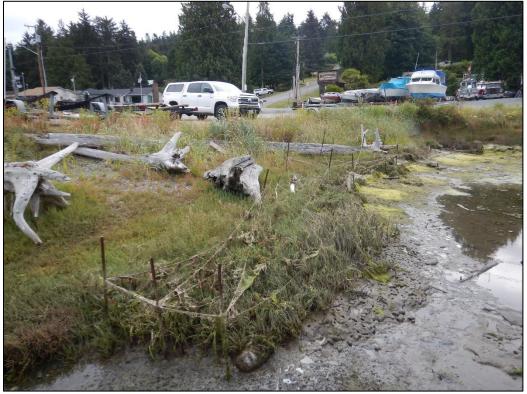
Figure 7. Planted emergent area.

There is no performance standard for emergent vegetation within the wetland enhancement area; however, a general assessment of the emergent vegetation was completed to determine the overall health and success of the plantings. Similar to Year 1 observations, the emergent area predominantly consists of seashore saltgrass (*Distichlis spicata*), Lyngby's sedge (*Carex lyngbyei*), saltmarsh bulrush (*Schoenoplectus maritimus*), and pickleweed (*Salicornia virginica*). Based on visual observations, the planted emergent area has approximately 80 percent aerial coverage.
