**Preliminary Additional Remedial  
Investigation Work Plan**

**DeBock's Main Street Texaco (aka Debock's Auto Repair)  
100 W., 101 W. and 101 E. Wine Country Road  
Grandview, WA  
Facility Site No. 94369212  
Cleanup Site ID No. 6910**

**Prepared by AECOM for:  
Resource Environmental, LLC**

**August 31, 2020**

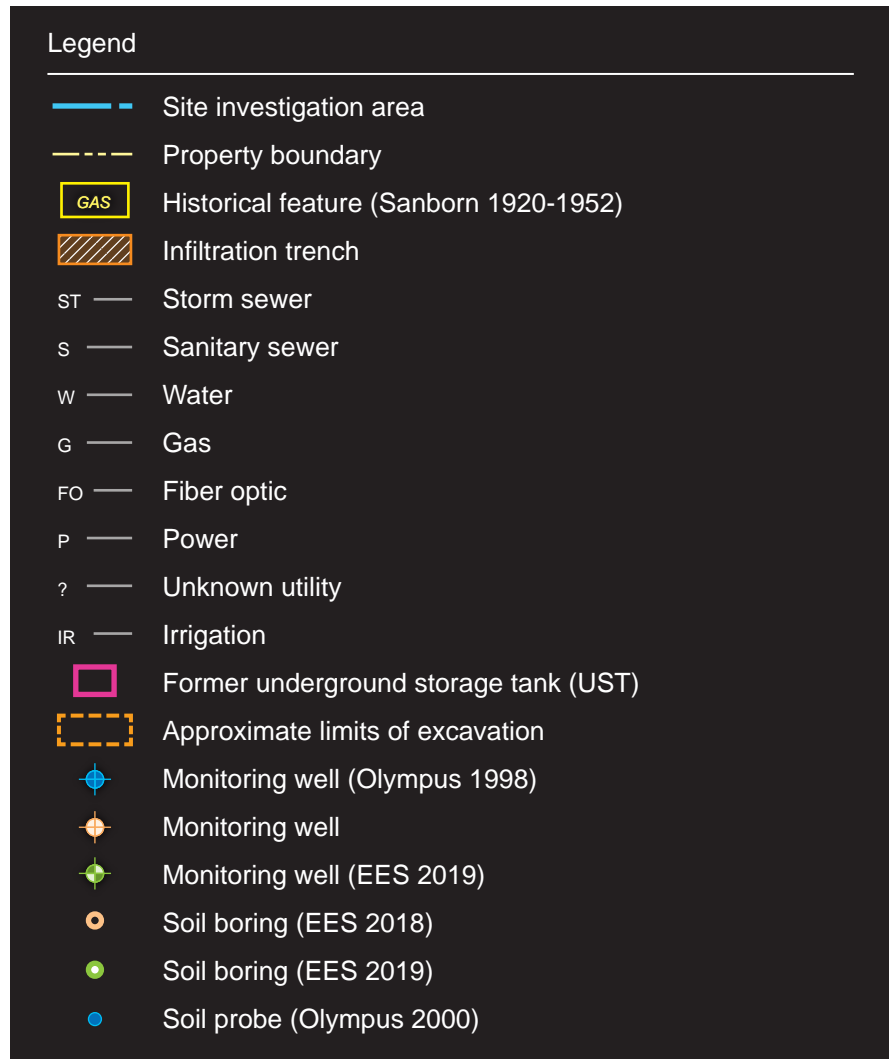
Figure 3  
Site Plan with Historical Features

Source: Google Earth Pro, imagery dated 5/28/17; Utilities from "Utility Layout, Debock's Texaco, 100 West Main Street, Grandview, Washington," EES Environmental Consulting, Inc., 9/19/2019

In April 2020, RELLC was requested to manage a site consisting of multiple parcels located at 100 West, 101 West and 101 East Wine Country Road in Grandview, Washington, where petroleum hydrocarbons have been detected in the soil and groundwater. Chevron is a potentially liable party for the former Texaco station located at 100 W. Wine Country Road (Parcel #230923-12463) referred to as DeBock's Main Street Texaco (aka DeBock's Auto Repair). ExxonMobil is a potentially liable party for the former Humble Oil and Refining Company property located at 101 W. Wine Country Road (Parcel # 230923-12555). Humble Oil and Refining Company owned the property prior to October 1978, at which time AJ Still and Elizabeth Still purchased this property. Gorgeous Property LLC owns the 101 E. Wine Country Road property (Parcel #230923-12401). The State of Washington Department of Ecology (Ecology) issued letters on November 26, 2019 and March 13, 2020 indicating that these entities were potentially liable parties (*Appendix A*). Ecology indicated the "releases at these three properties appear to be commingled, hence Ecology considers them to be one "site" under the Model Toxics Control Act (MTCA)". AECOM has been retained by RELLC to provide environmental assessment services for the area where petroleum hydrocarbons have been detected in groundwater and soil, collectively referred to as the "Site". A Site Location map is shown on *Figure 1*, a Site Vicinity Map is shown on *Figure 2* and a Site Plan with Historical Features is shown on *Figure 3*.

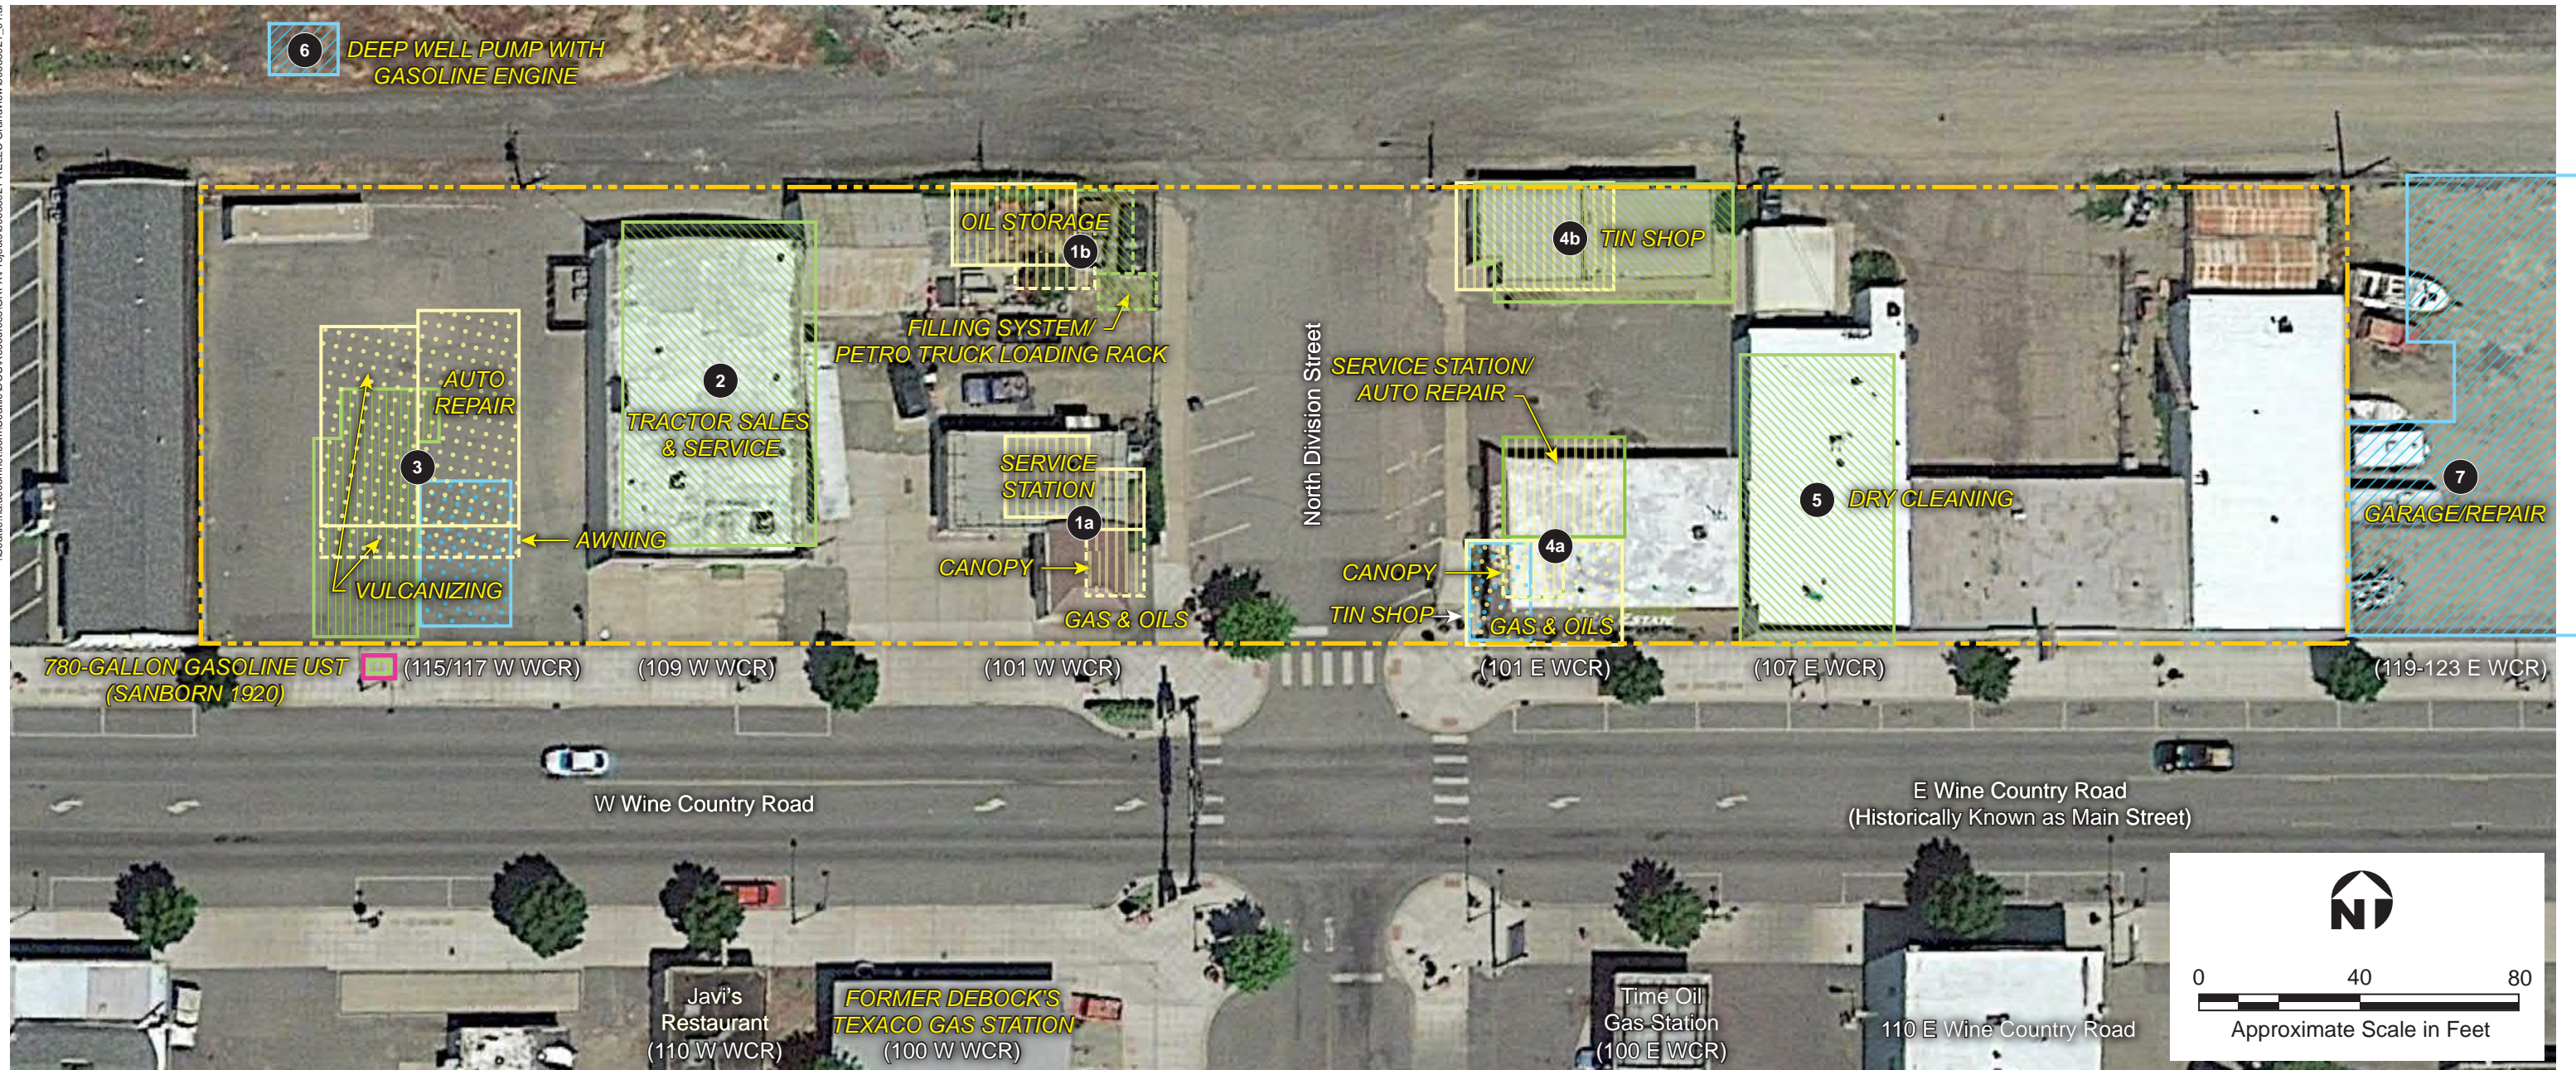
Figure 5  
101 W. and 101 E. Wine Country Road Historical Research

Note: Dates shown are dates of resources reviewed and do not necessarily indicate range of dates that a feature was present.

The 101 E. Wine Country Road property historical service station and fueling operations are depicted on **Figure 5** (Location ID 4a) and are situated in the southwestern portion of this property. These operations were noted between the 1920's through the early 1950's. The new office building was constructed in 1979 and appears to cover the majority of the footprint of the historical service station building.

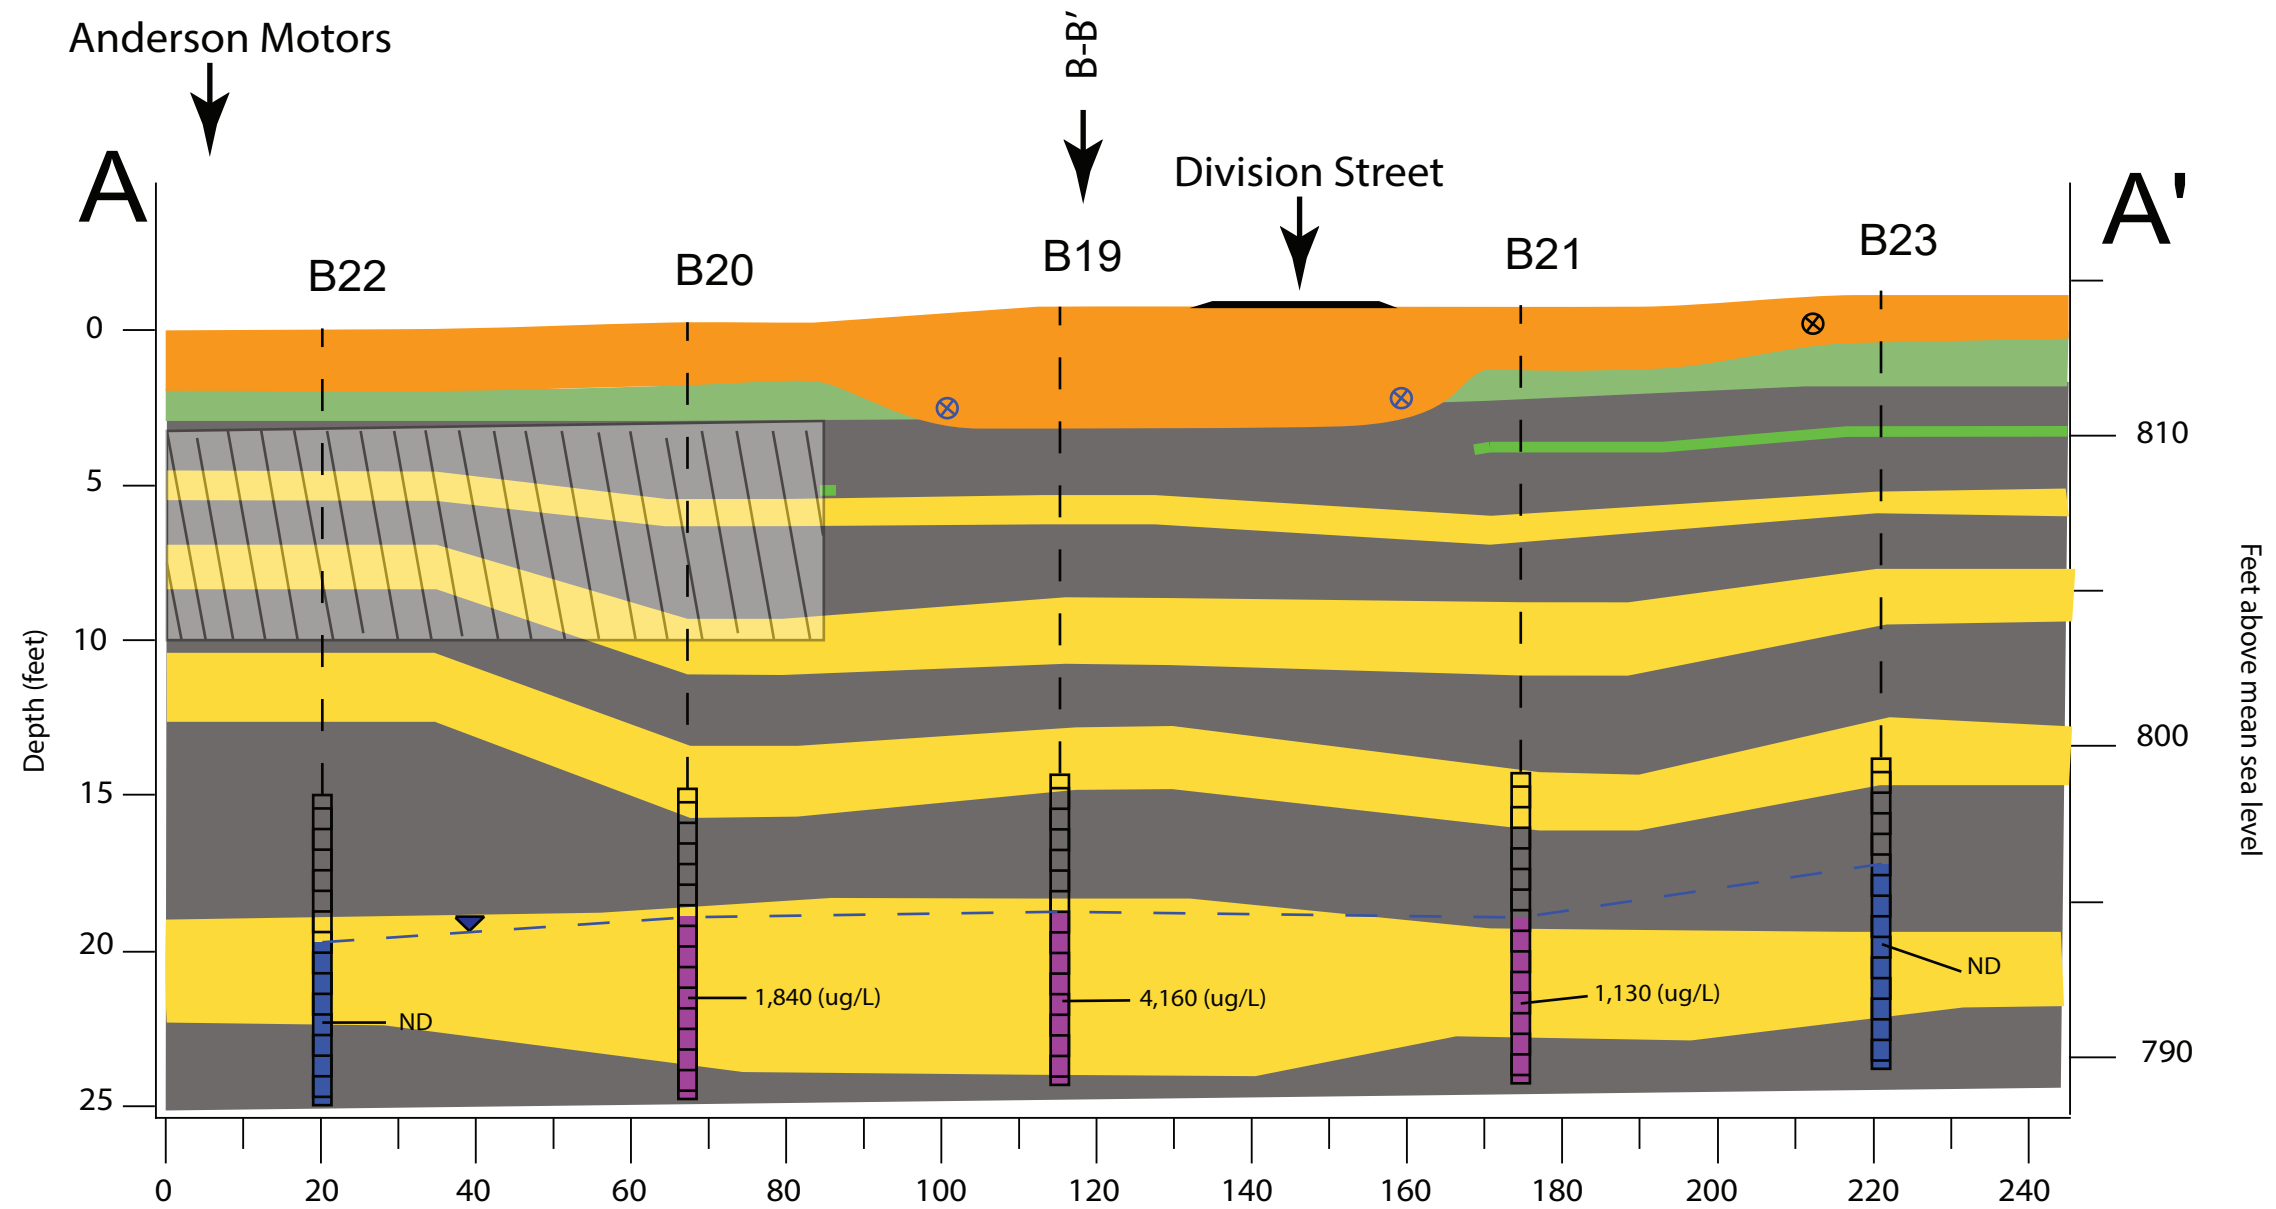
Figure 6  
Cross Section A-A'

Note: Survey elevations are not used in this cross section. Well elevations are estimated.

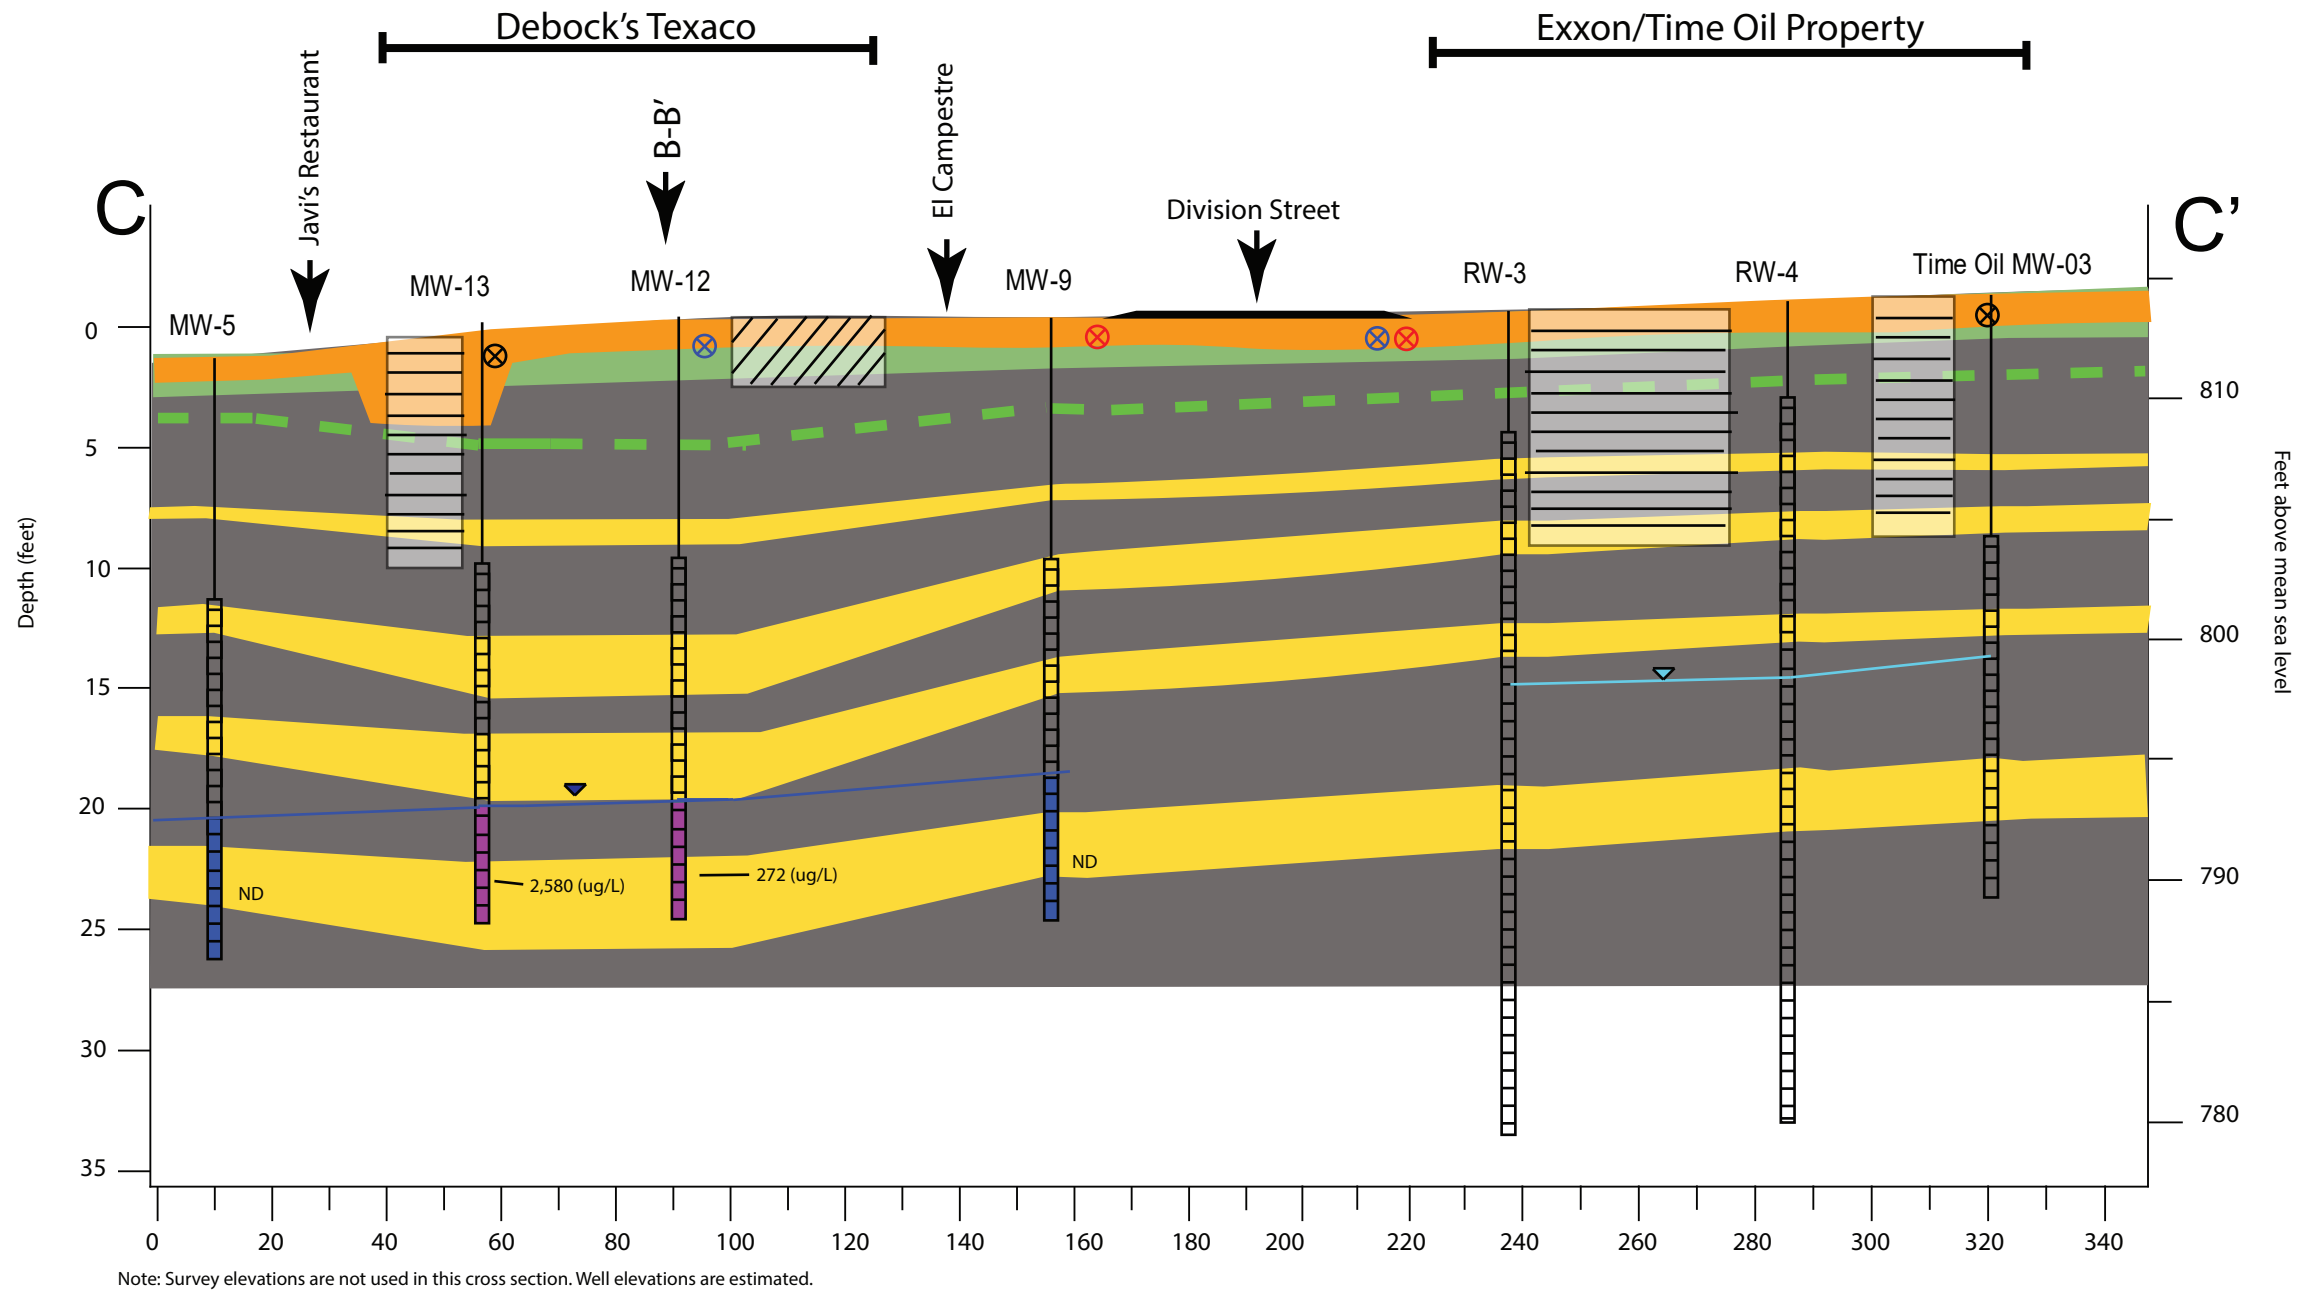
Figure 7  
Cross Section C-C'

Note: Survey elevations are not used in this cross section. Well elevations are estimated.

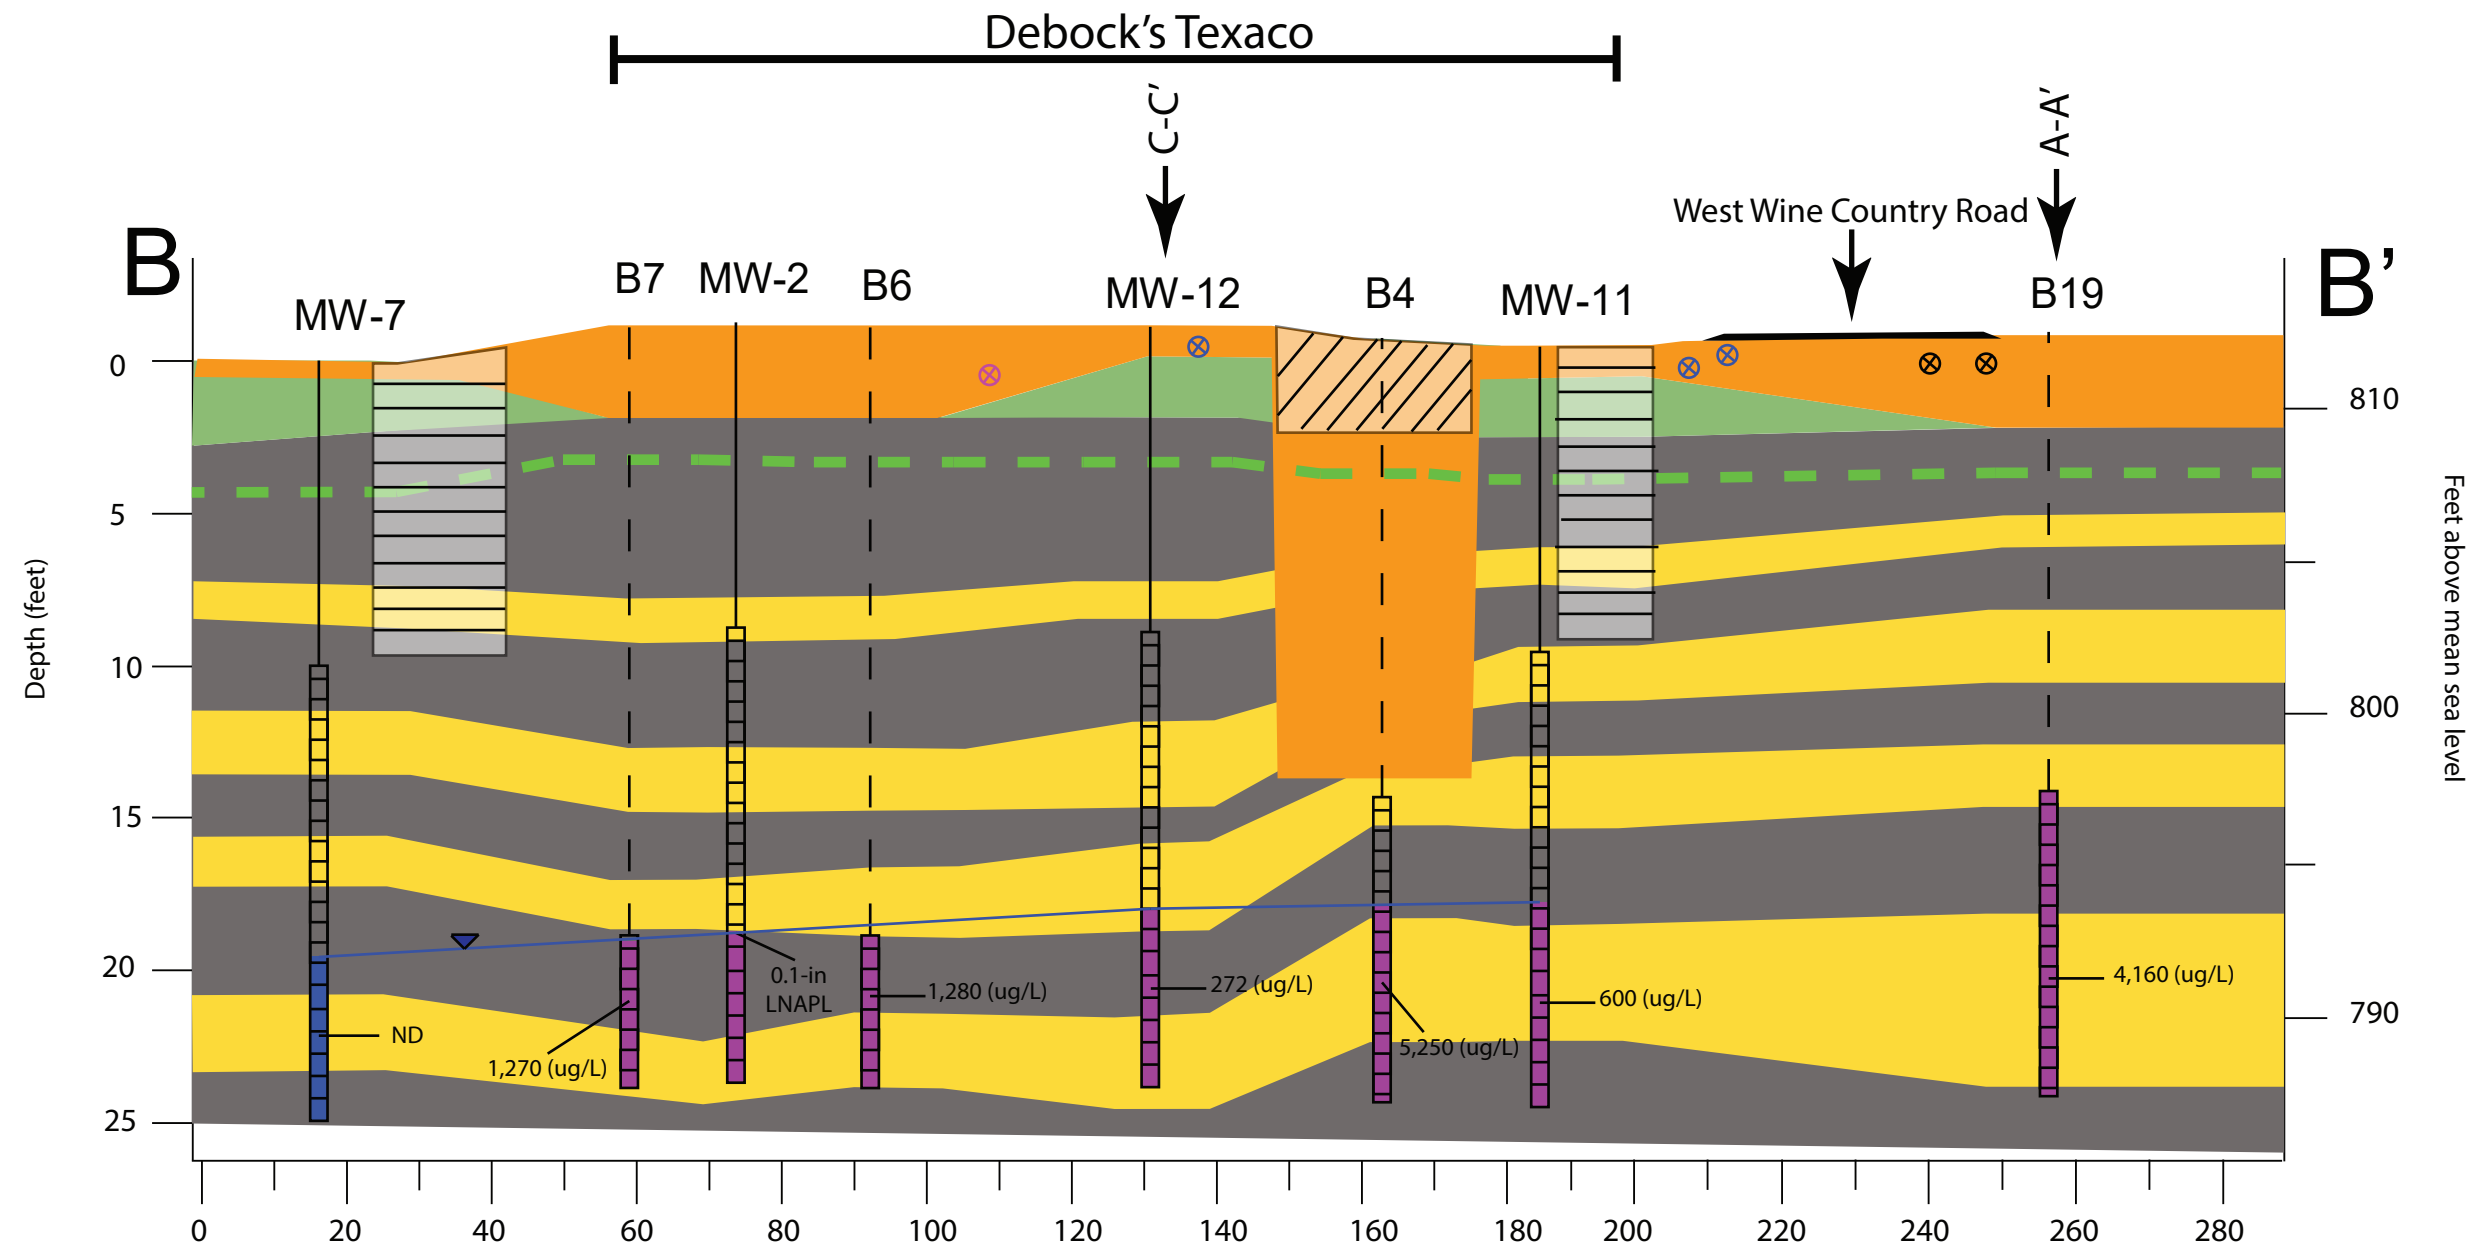
Figure 8  
Cross Section B-B'

Note: Survey elevations were not available for all wells in this cross section. Well elevations are estimated in some cases.
