<b>Vicinity Map</b>	
7100 1st Avenue South Site Seattle, Washington	
	<b>Figure 1</b>

<b>Site Plan</b>	
7100 1st Avenue South Site Seattle, Washington

<b>Remedial Investigation Soil Sampling Locations</b>	
7100 1st Avenue South Site Seattle, Washington	
	Figure 7

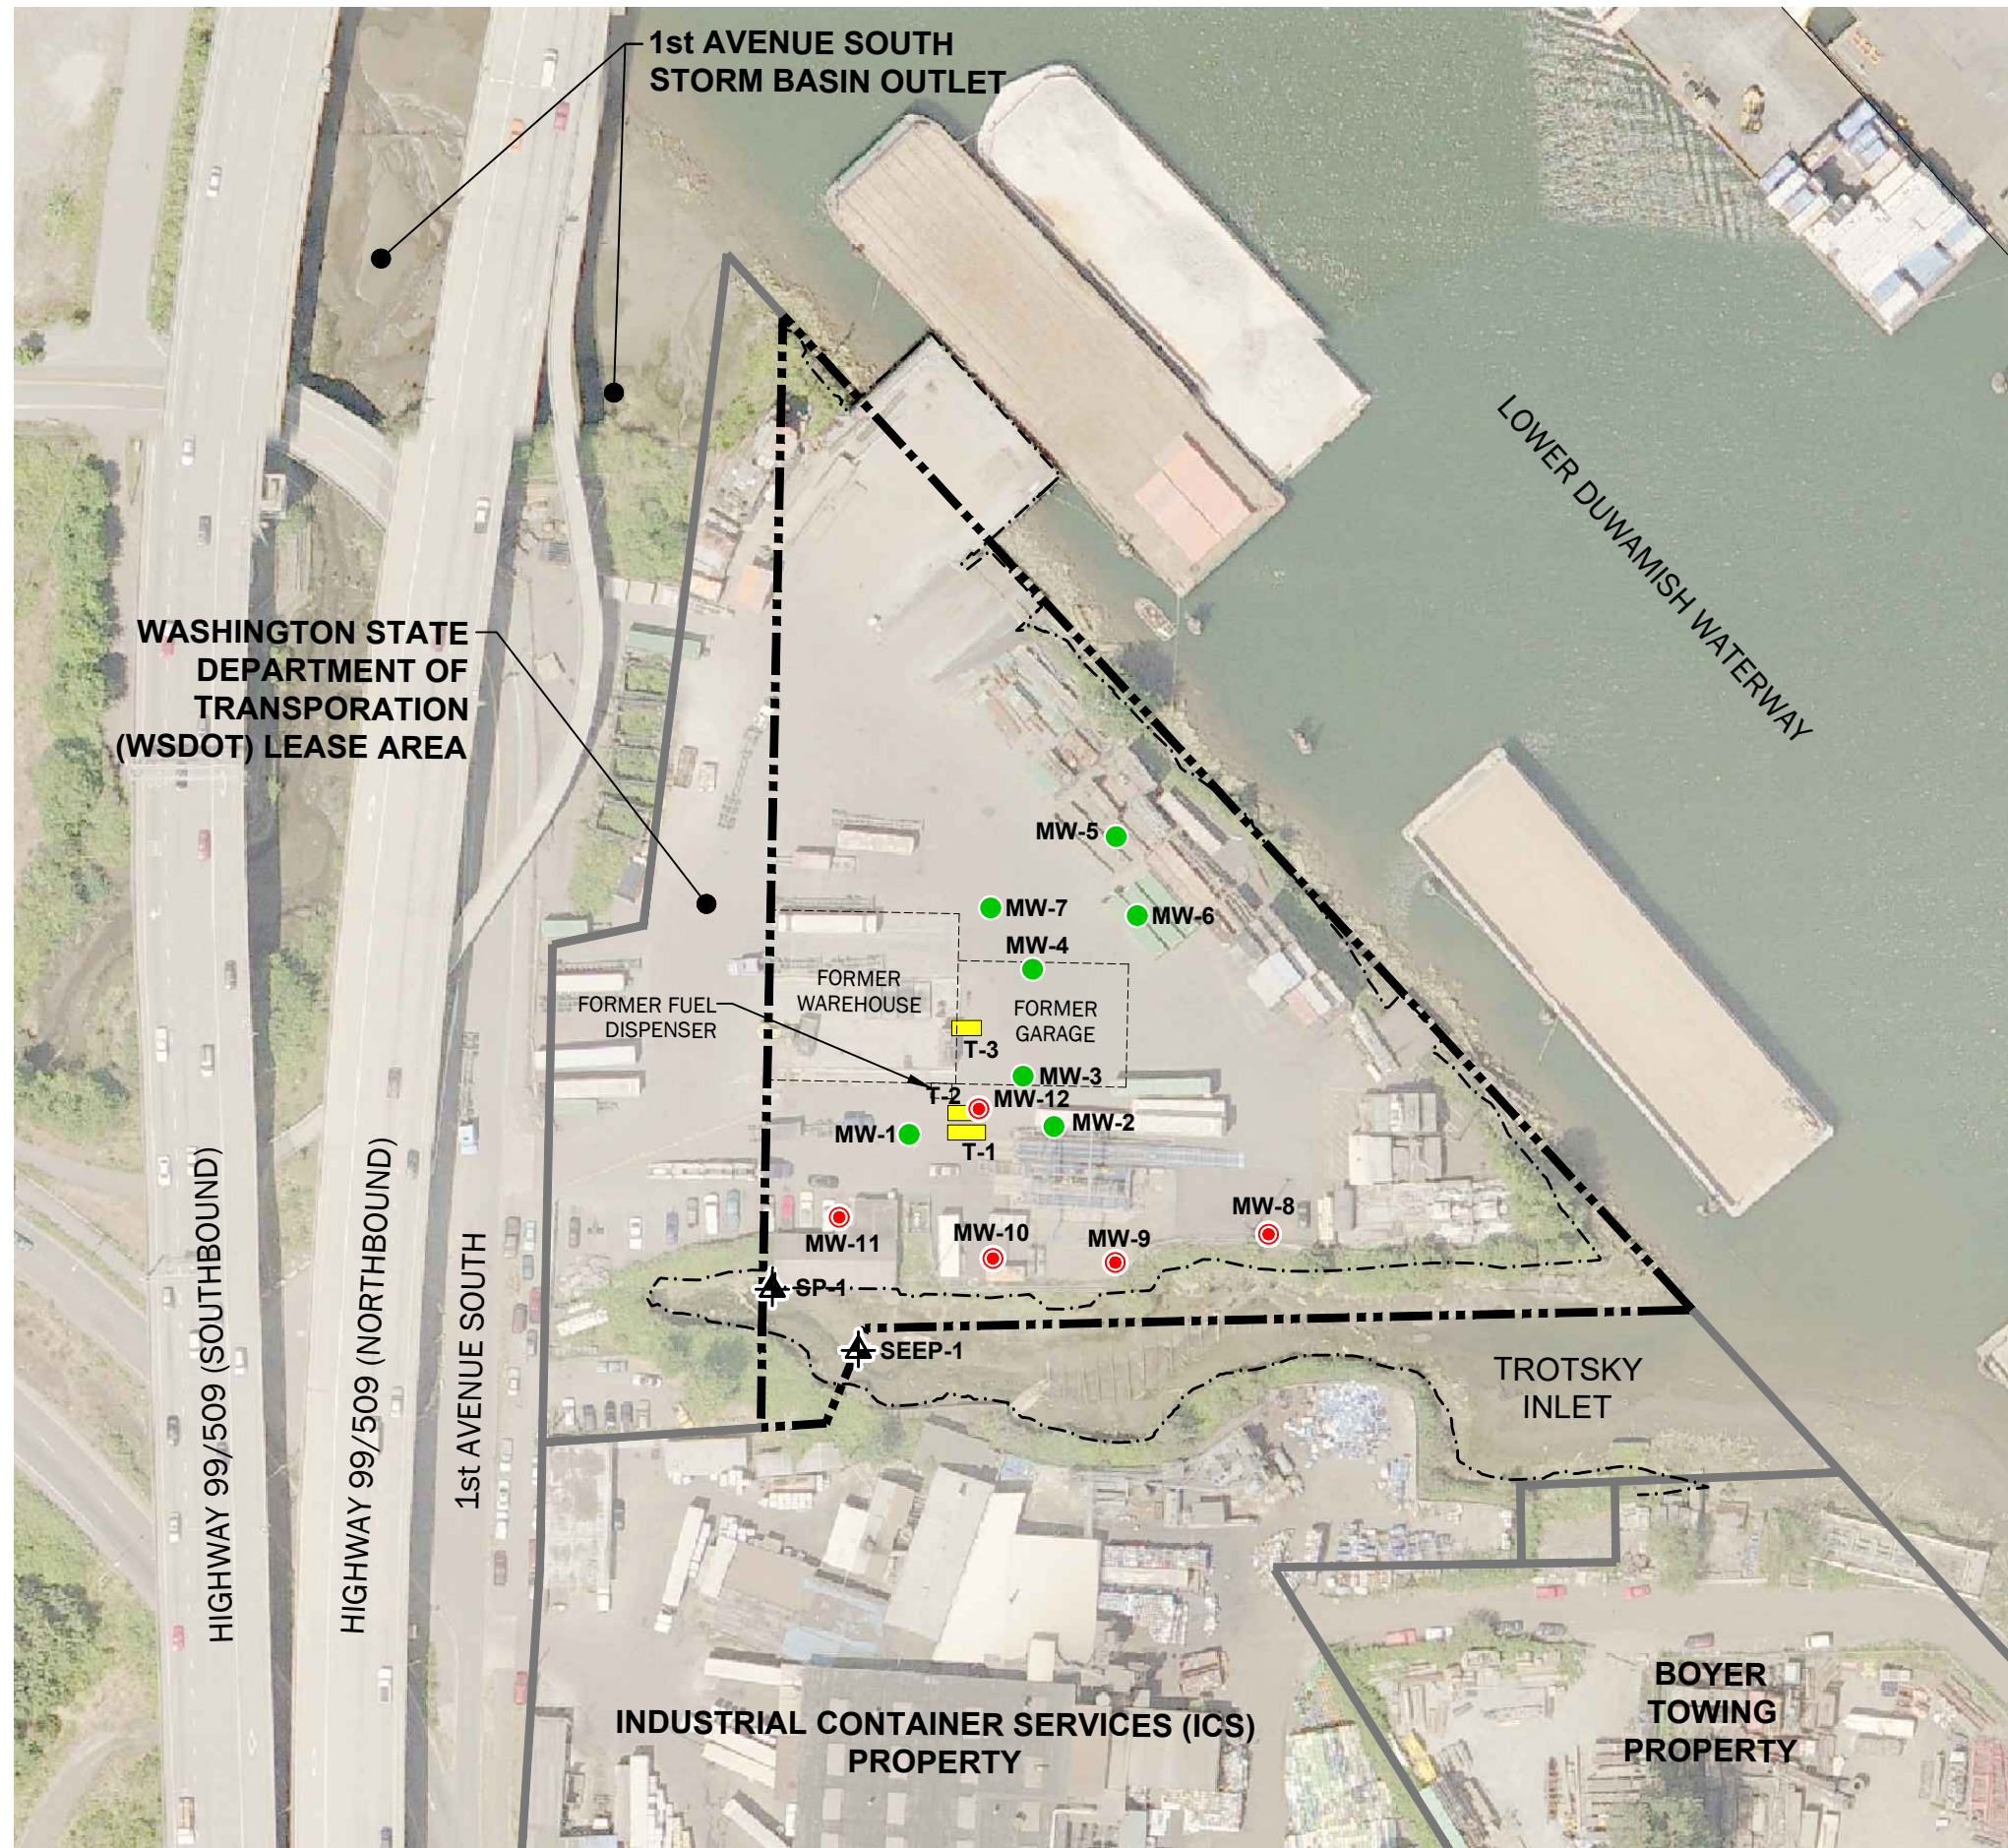
Figure 5

<b>Historical Groundwater and Seep Sampling Locations</b>	
7100 1st Avenue South Site Seattle, Washington

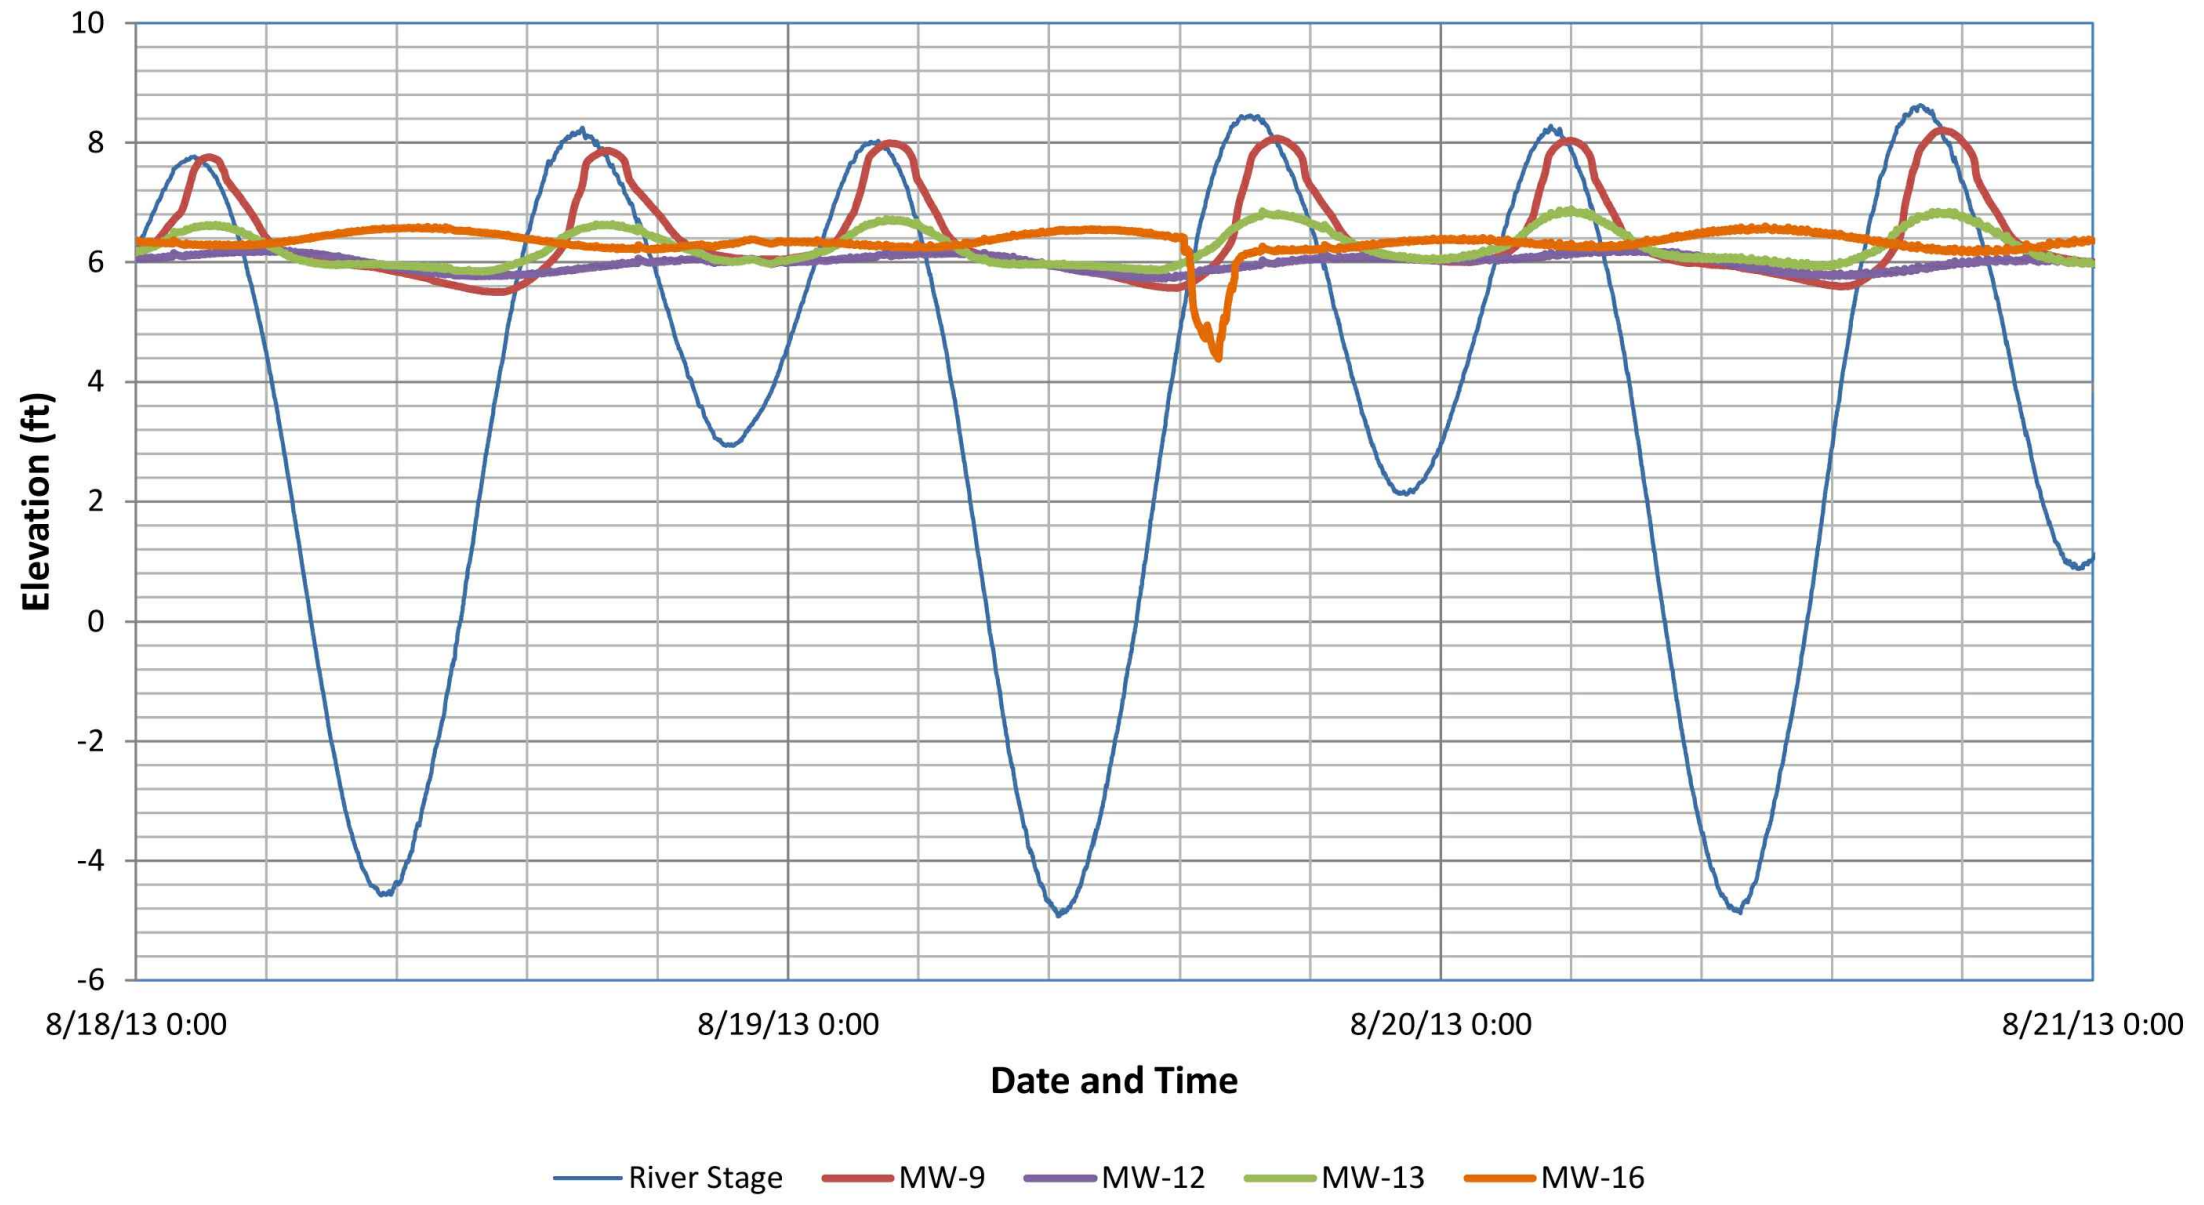
**Notes:**  
 1. Groundwater elevations and River stage were recorded during the 72-hour tidal study between August 18 and 21, 2014.  
 2. Elevation referenced to North American Vertical Datum 1988 (NAVD-88).  
 3. This drawing is for information purposes. It is intended to assist in showing features discussed in an attached document. GeoEngineers, Inc. can not guarantee the accuracy and content of electronic files. The master file is stored by GeoEngineers, Inc. and will serve as the official record of this communication.

<b>Groundwater Elevations and River Stage - Tidal Influenced Monitoring Wells</b>	
7100 1st Avenue South Site Seattle, Washington	
	Figure 12

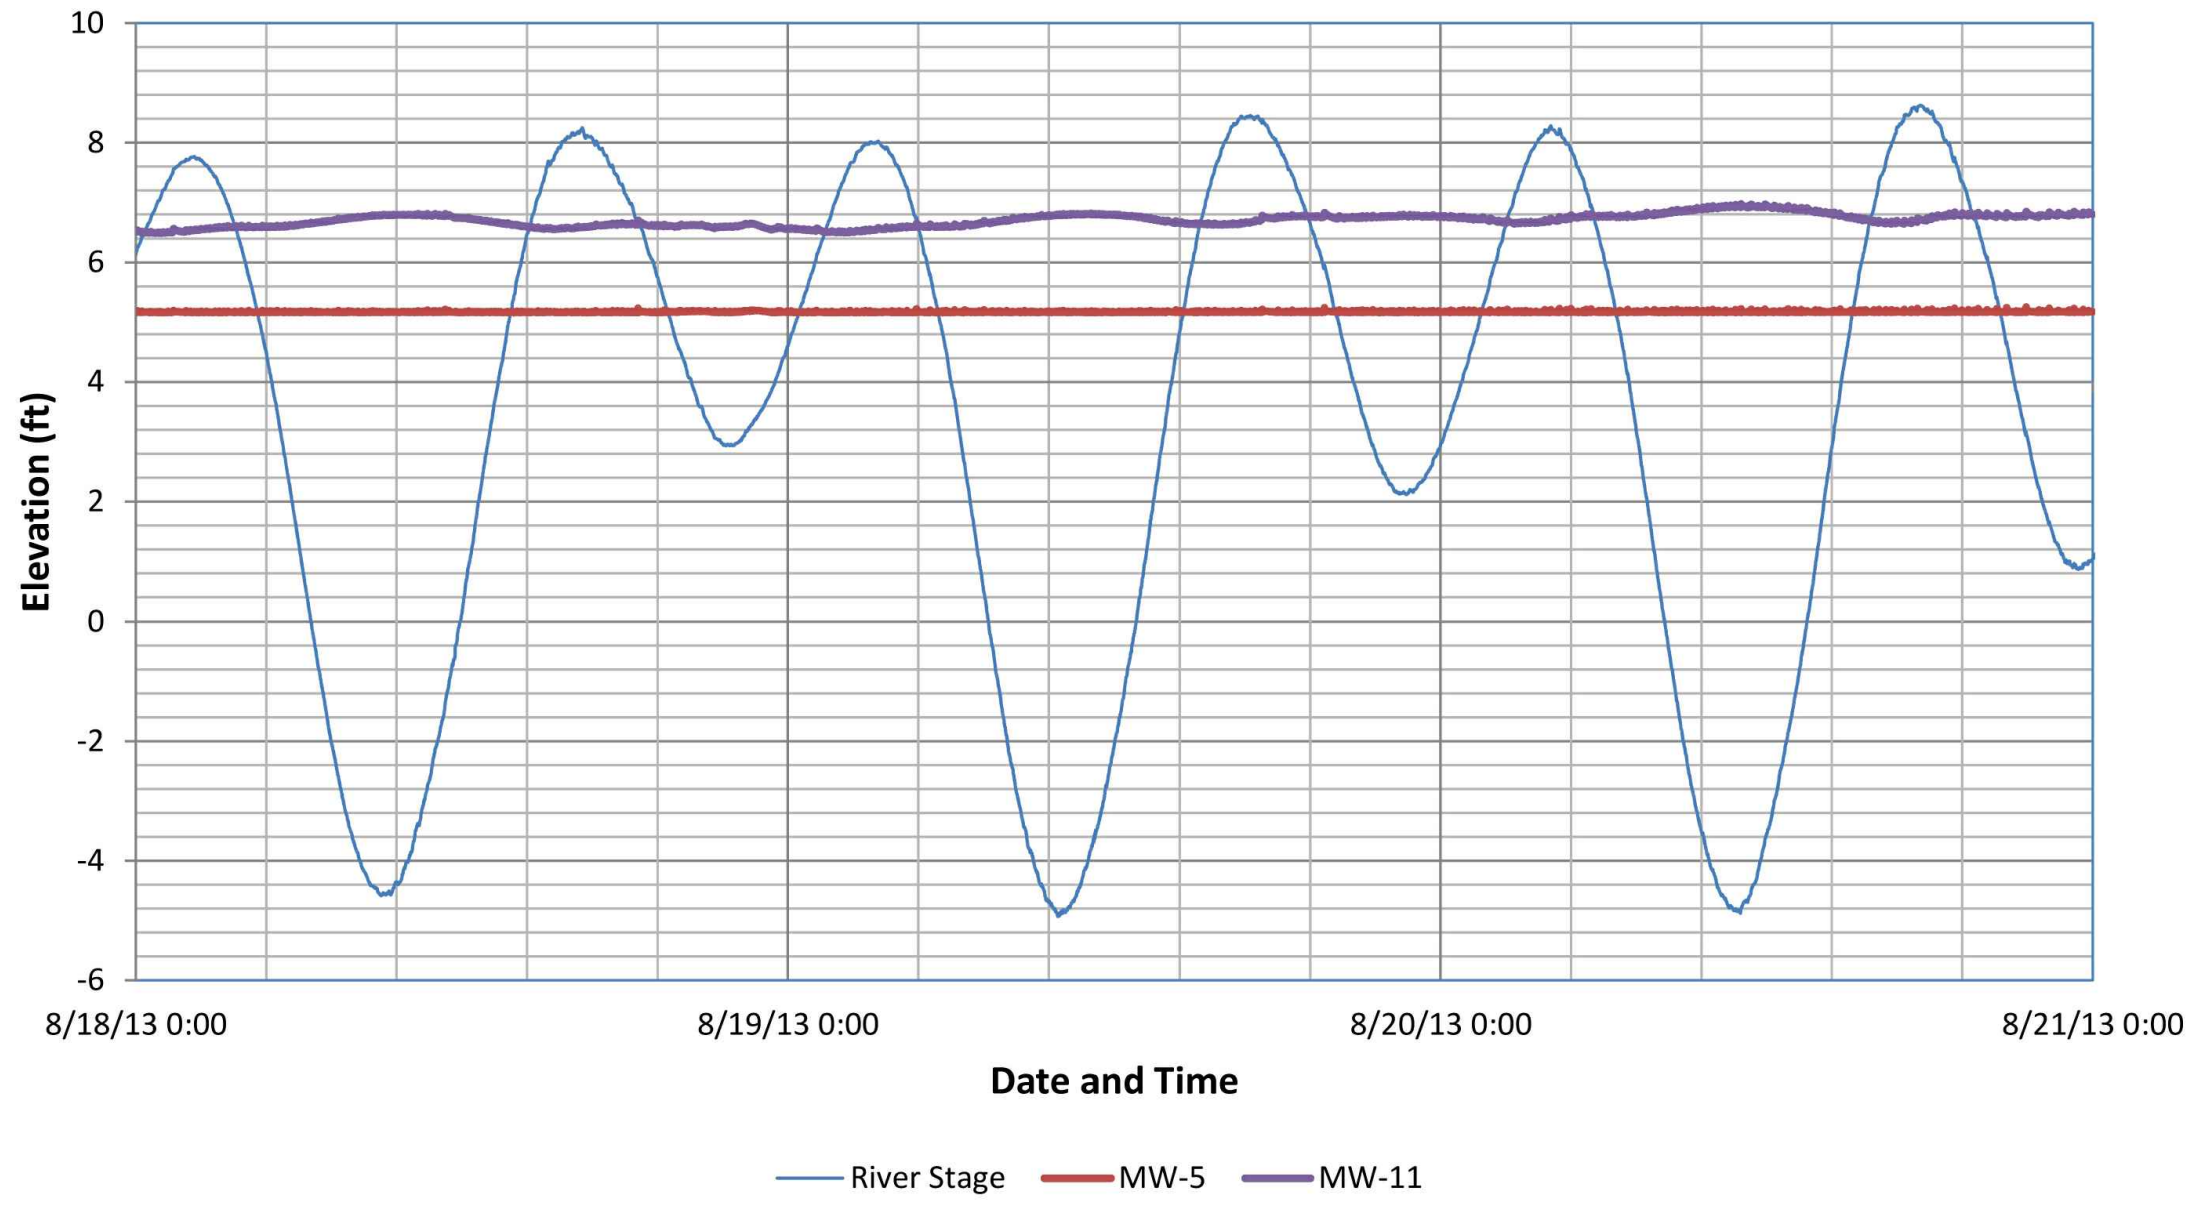
<b>Figure 13</b>

- Notes:**
1. Groundwater elevations and River stage were recorded during the 72-hour tidal study between August 18 and 21, 2014.
  2. Elevation referenced to North American Vertical Datum 1988 (NAVD-88).
  3. This drawing is for information purposes. It is intended to assist in showing features discussed in an attached document. GeoEngineers, Inc. can not guarantee the accuracy and content of electronic files. The master file is stored by GeoEngineers, Inc. and will serve as the official record of this communication.

<b>Groundwater Elevations and River Stage - Non-Tidally Influenced Monitoring Wells</b>	
7100 1st Avenue South Site Seattle, Washington	
<b>GEOENGINEERS</b>
