**Benzene in Soil
Cross-Section A-A'**

7100 1st Avenue South Site
Seattle, Washington

Figure 22

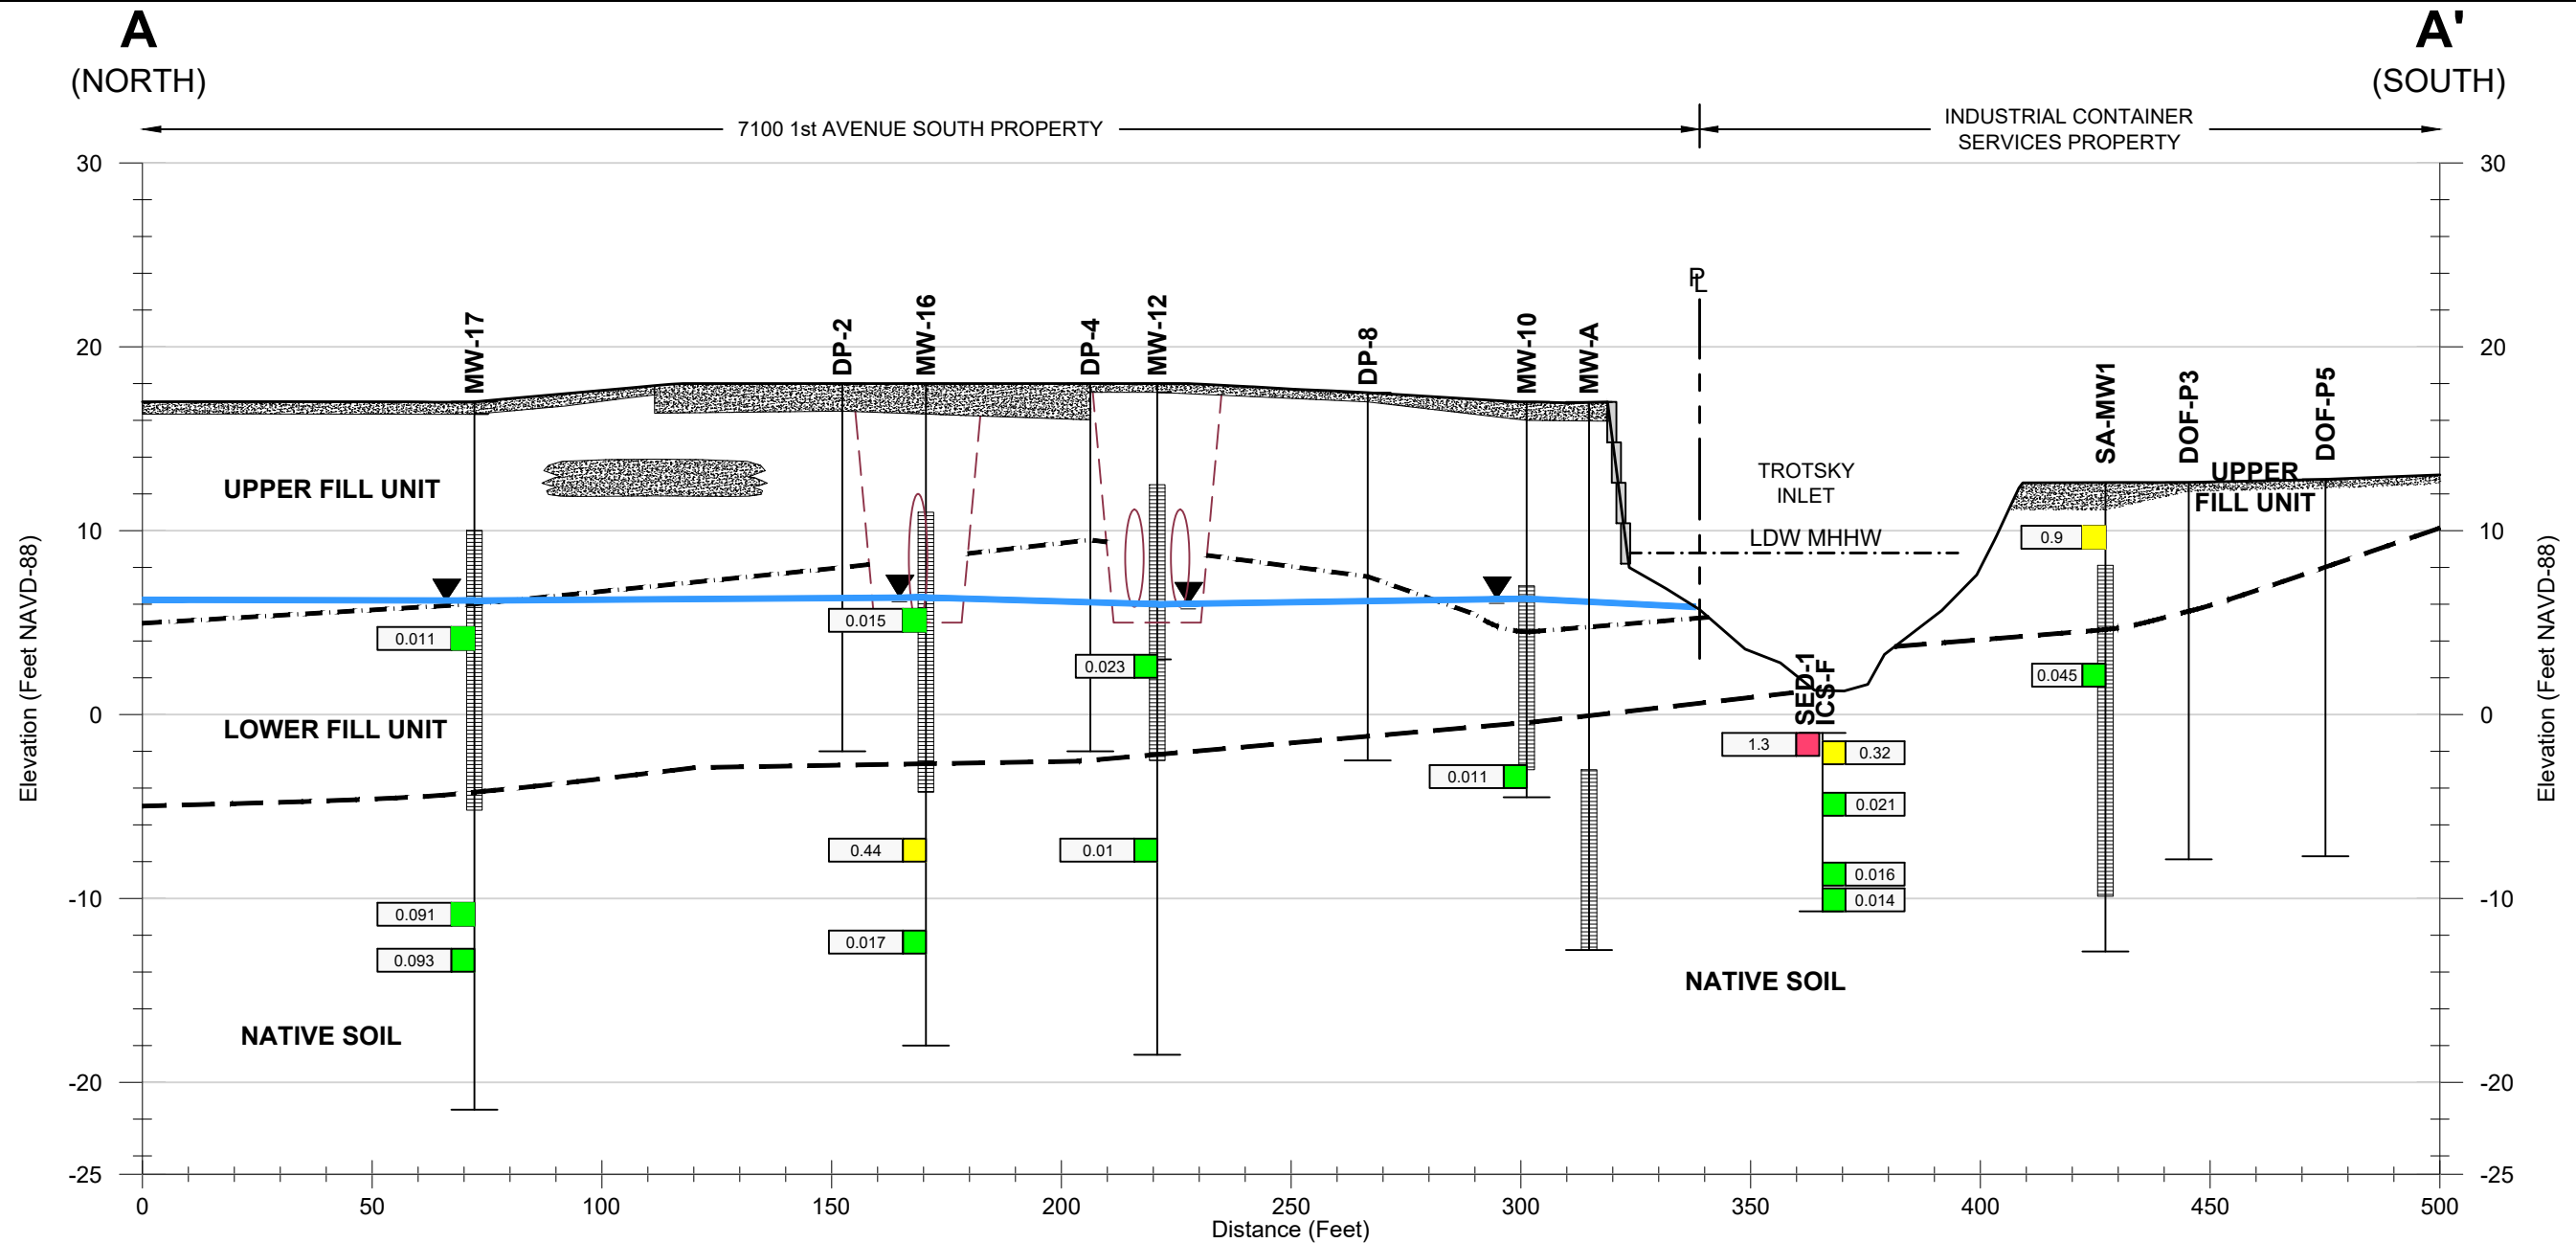
Figure 27

Screening Cleanup Level:
 Vadose Zone Soil = 0.19 mg/kg
 Saturated Zone Soil = 0.11 mg/kg

**Carcinogenic PAHs
Cross-Section A-A'**

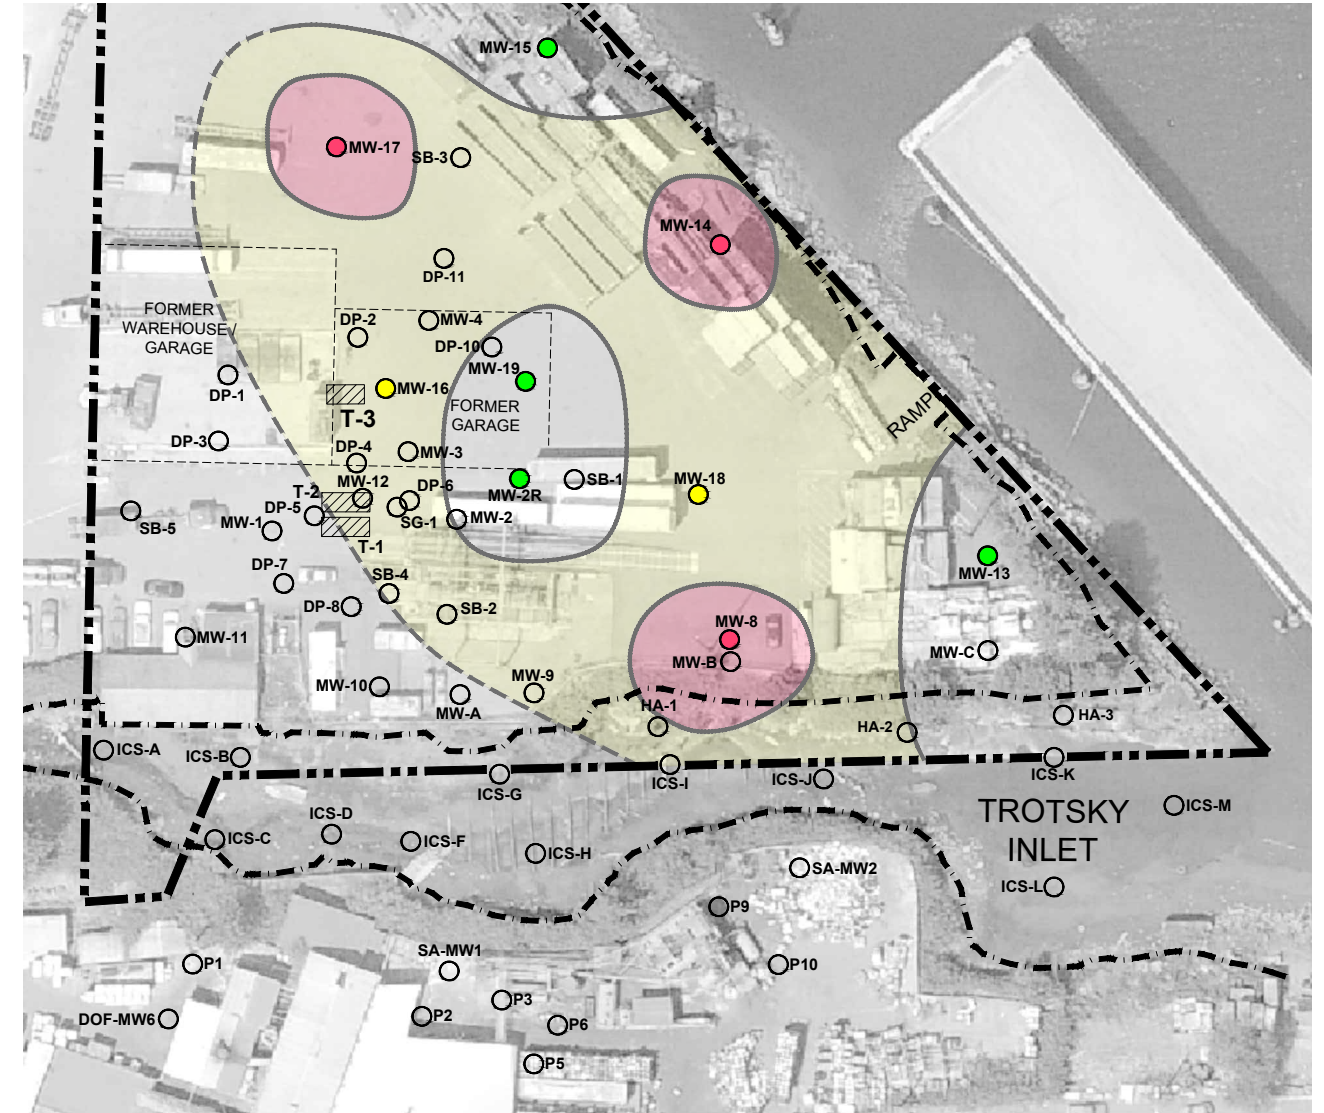
**Soil Analytical Results between approximately -3 and -13 Feet NAVD-88
(Approximately equivalent to 20'-30' below 7100 Site ground surface elevation)**

**Soil Analytical Results below -13 Feet NAVD-88
(Approximately equivalent to greater than 30' below 7100 Site ground surface elevation)**

4,4' -DDD and 4,4' -DDE Pesticides in Soil by Elevation (Below -3 Feet NAVD-88)	
7100 1st Avenue South Site Seattle, Washington	
	Figure 34

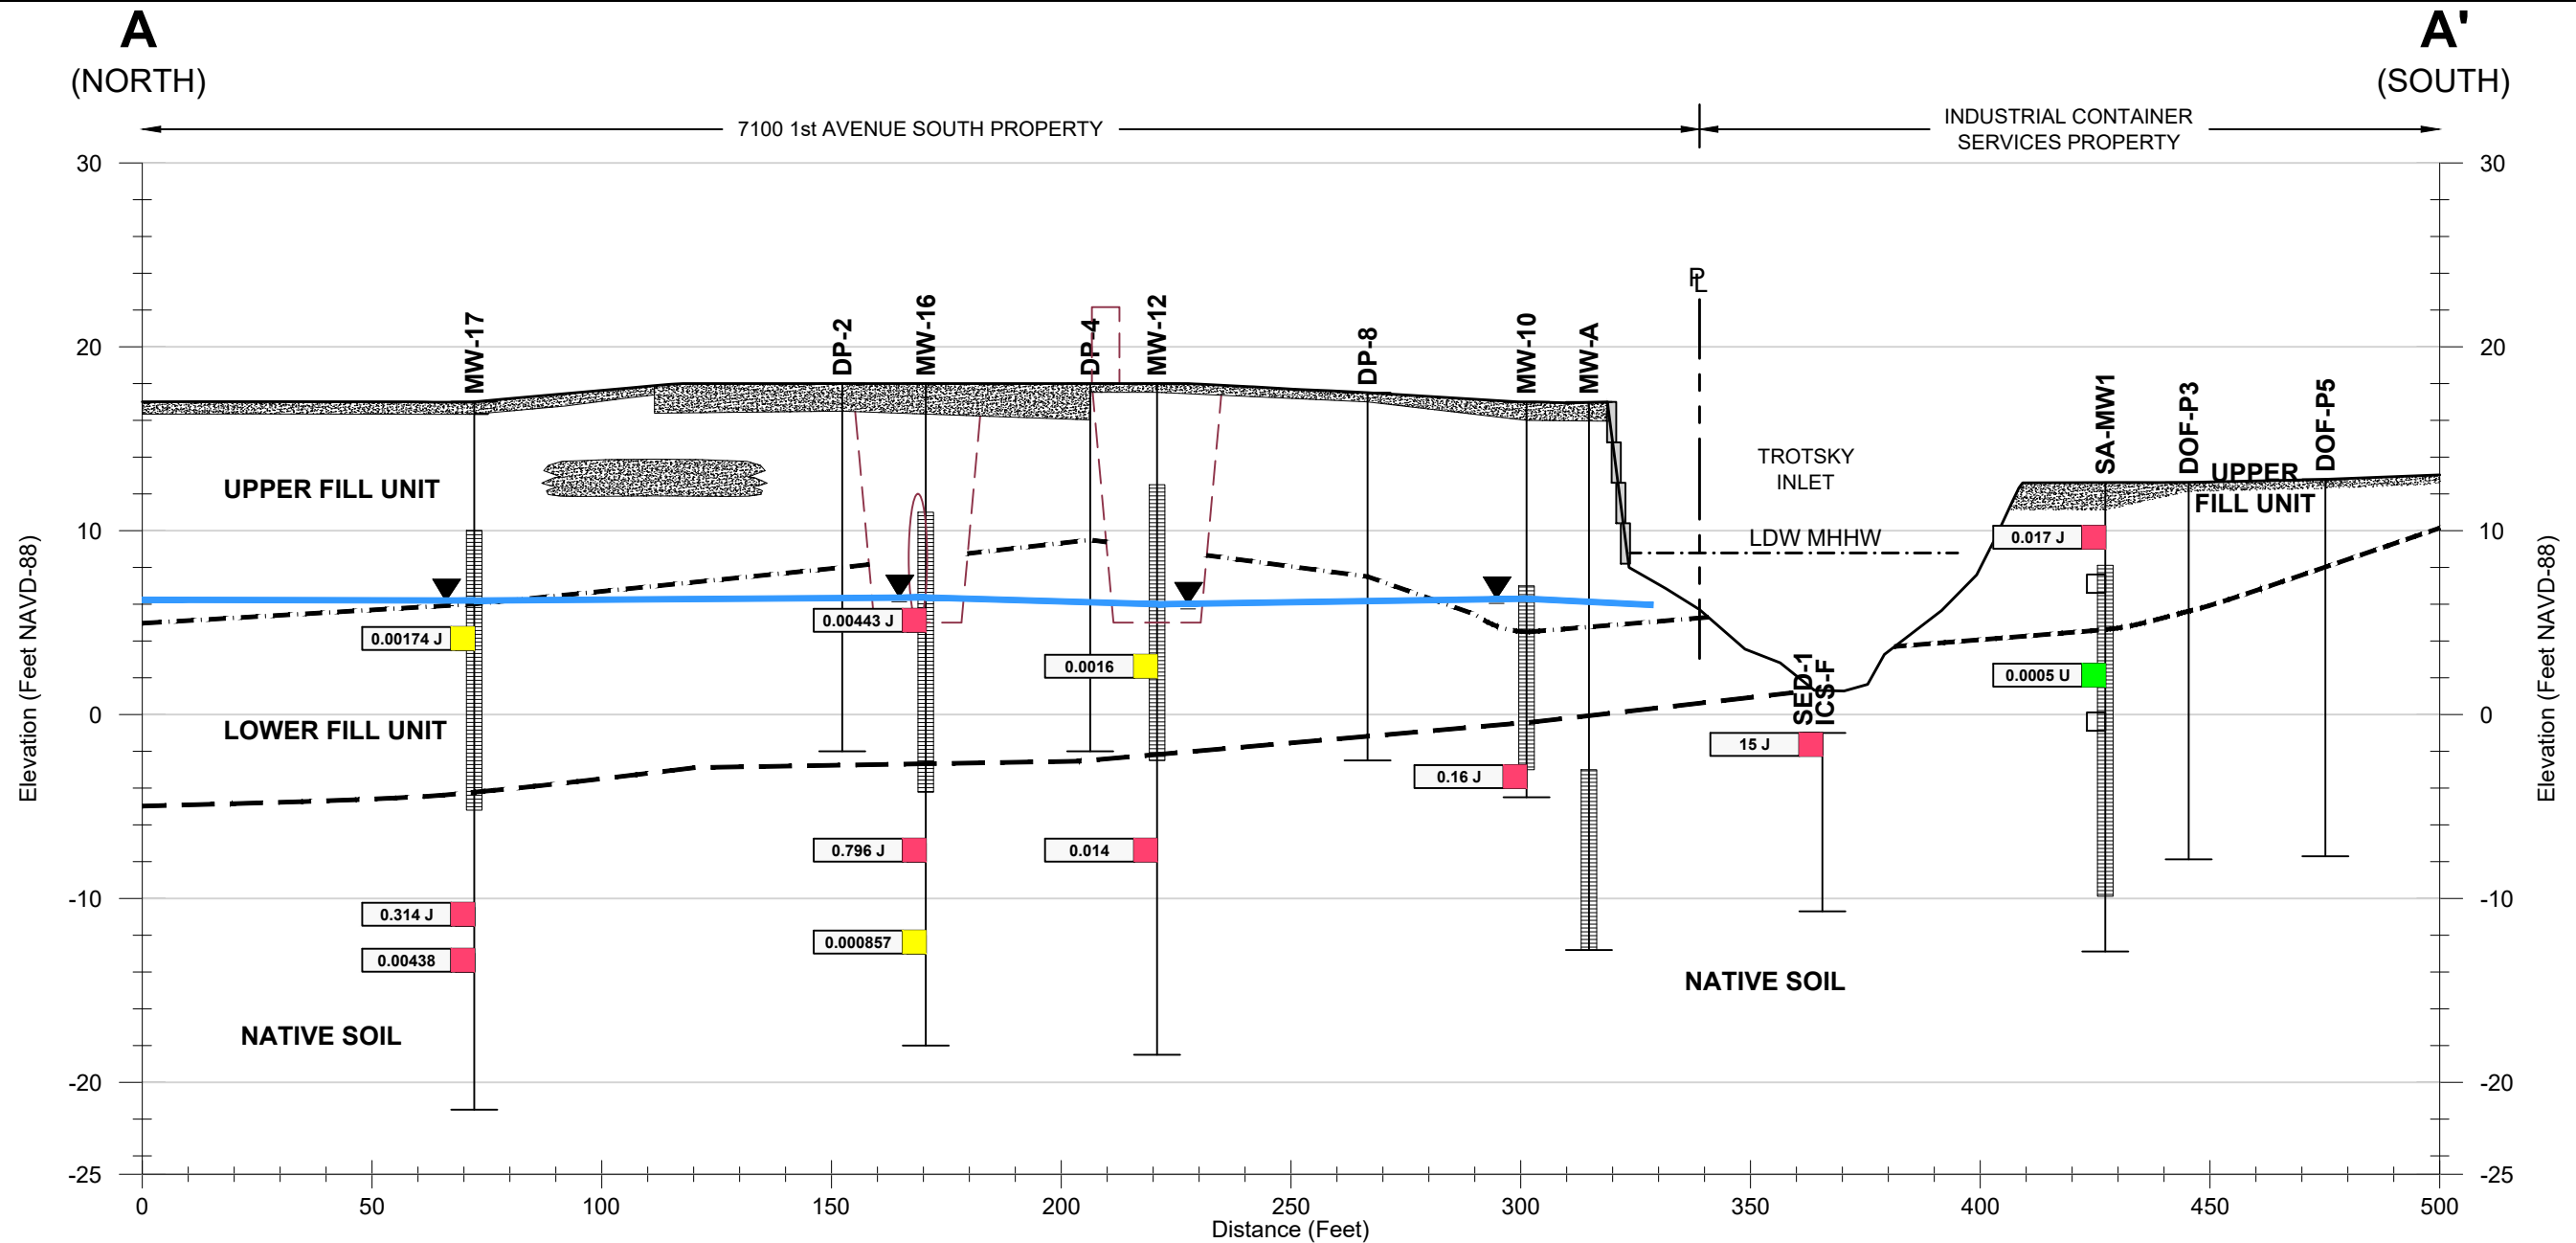
**4,4'-DDD in Soil
Cross-Section A-A'**

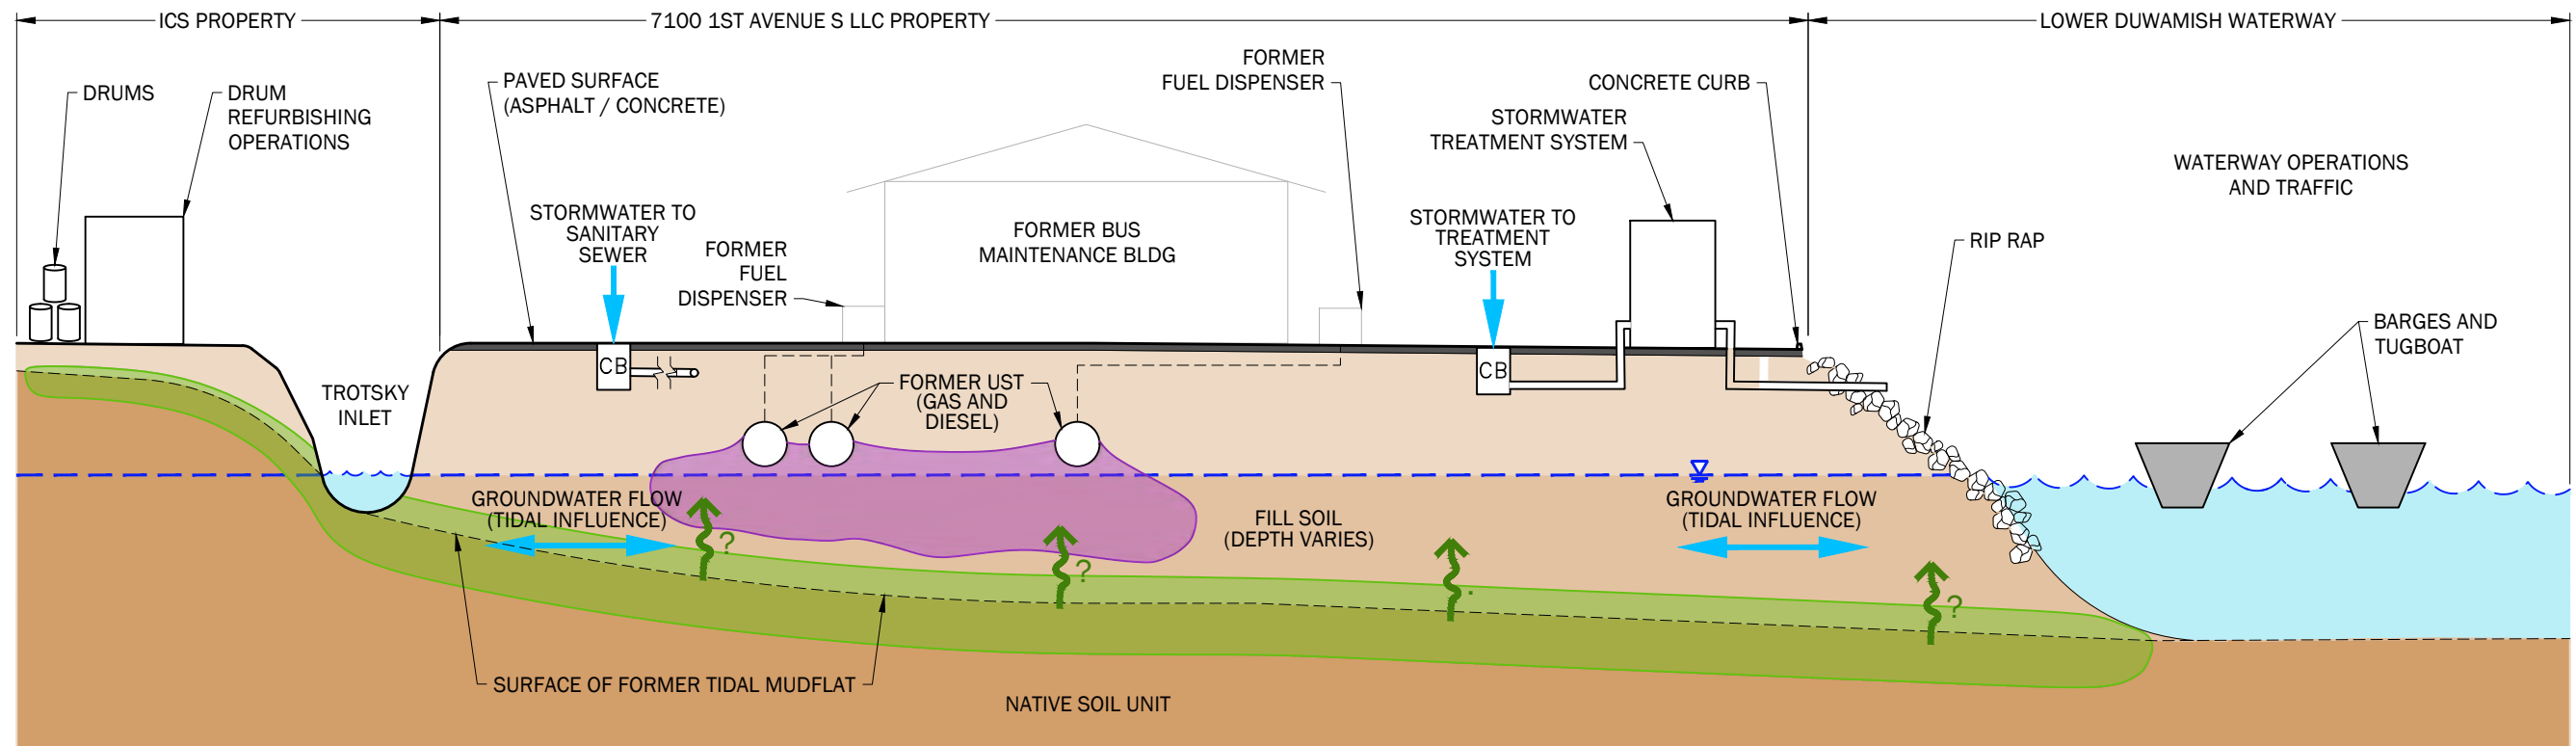
Conceptual Site Model Release Mechanisms and Transport Pathways	
7100 1st Avenue South Site Seattle, Washington	
	Figure 41
