Re: 2019 Annual Progress Report
McFarland Cascade Pole and Lumber Company Site, Tacoma, Washington
Facility Site ID: 1222; Cleanup Site ID: 3643

Re: 2019 Annual Groundwater Monitoring Event
McFarland Cascade Pole and Lumber Company Site, Tacoma, Washington
Facility Site ID: 1222; Cleanup Site ID: 3643

Date:	11/22/2019
Weather:	Foggy to Sunny, ~40° F
Precipitation (prior 24 hrs):	None
Completed By:	M. Tarbert, EIT, Maul Foster & Alongi, Inc.
Engineer of Record:	S. Taylor, PE, Maul Foster & Alongi, Inc.
General Observations:	
<p>This is the fourth annual cap inspection performed as required under the Consent Decree.</p> <p>The cap (asphalt cap, concrete drip pad, building capped areas) all generally appear in good condition.</p> <p>Typical site activities were being performed during the inspection, including movement of lumber poles.</p> <p>No major areas of standing water were observed.</p> <p>There was no visible demarcation fabric.</p>	
Specific Observations: To be noted with photographs, measurements, and locations:	
<p>Pavement Cap:</p> <p>No settling, bulging, or punctures were observed.</p> <p>Some minor linear asphalt cracks are beginning to form and should be closely monit

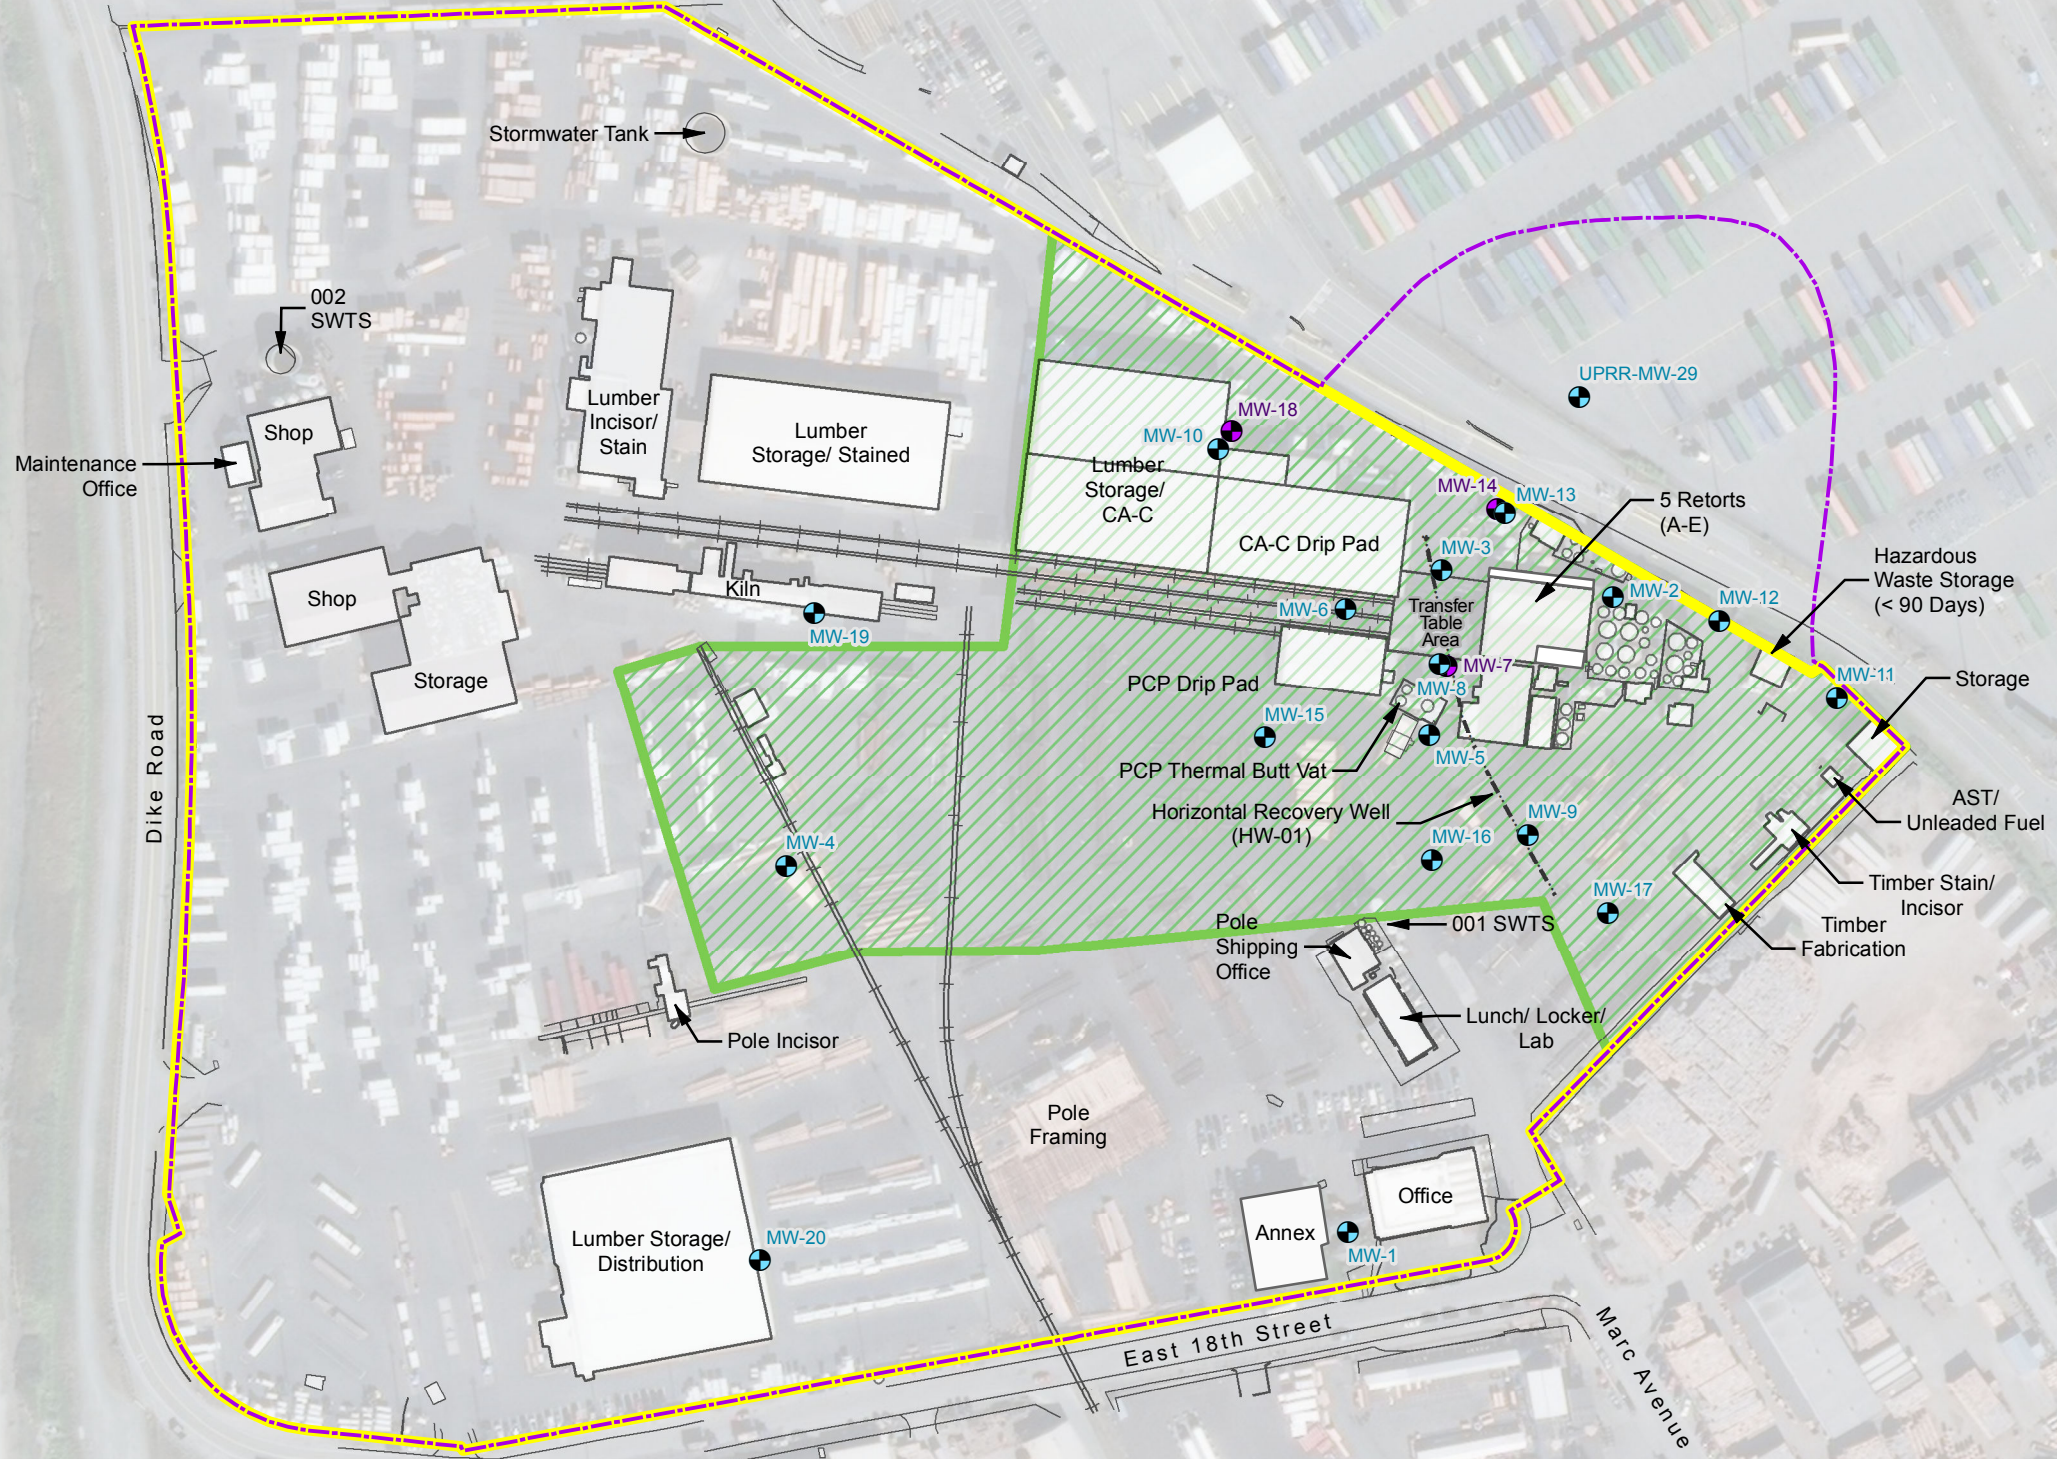
Figure Site Features

The Site includes property, owned by Tyee, at 1640 E Marc Street in Tacoma, Washington (the Property), as well as a portion of an adjoining property owned by the Port of Tacoma. The Property and Site boundaries are shown in the attached figure. MCHI leases the Property from Tyee and operates a treated-wood products manufacturing and processing facility on a portion of the Property. The final remedy for the Site includes O&M of a protective cap covering residual soil contamination in the Restricted Area (see the figure), soil management to be undertaken should soil be excavated or disturbed below the cap, O&M of a horizontal

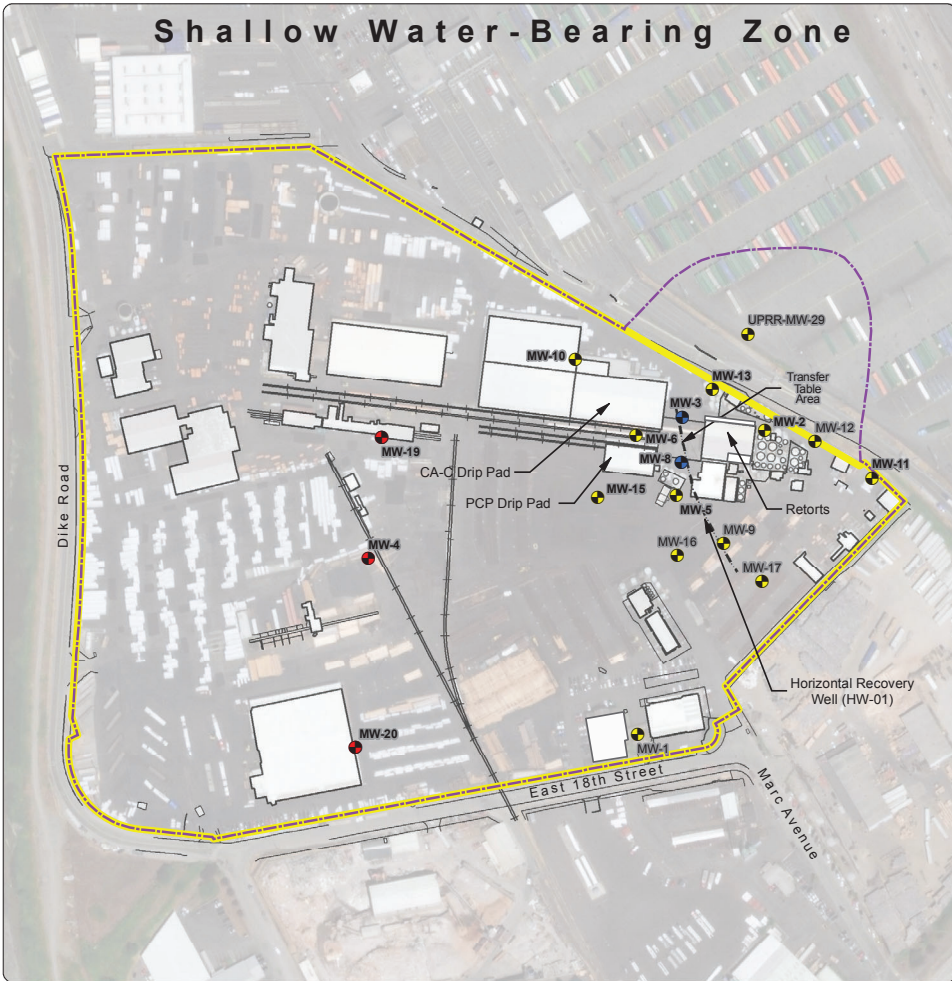
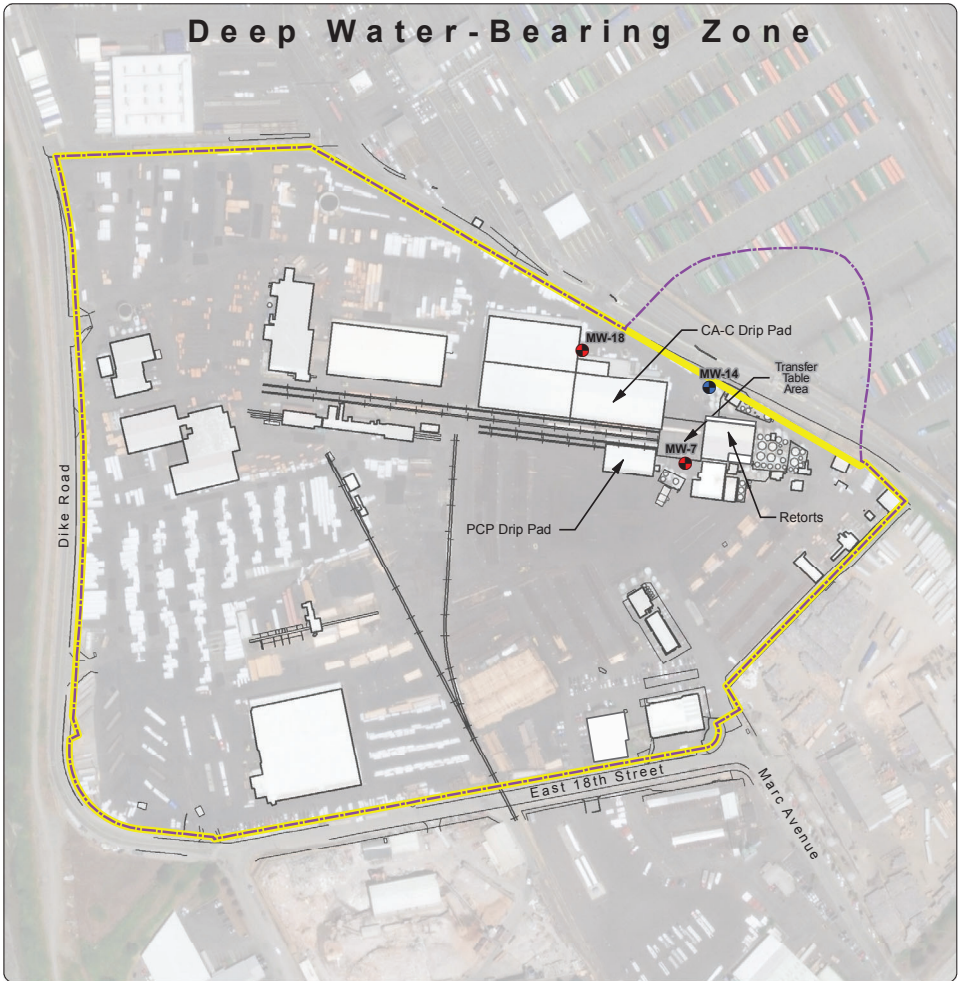
NOTES:
 Water levels in the horizontal recovery well (HW-01) will not be monitored.
 The Port of Tacoma property well, UPRR-MW-29, is not a sentry well and is not included in the compliance monitoring network. It will be monitored during the "Protection," "Performance," and "Confirmational" stages of monitoring to evaluate indicator hazardous substance concentration and hydraulic gradient trends, but will not be evaluated for compliance with RELs or CULs. However, this well is included in the final closure monitoring network and will be monitored for compliance with CULs during the "Final Closure" stage of monitoring.
 CA-C = copper azole - type C.
 CUL = cleanup level.
 PCP = pentachlorophenol.
 REL = remediation level.

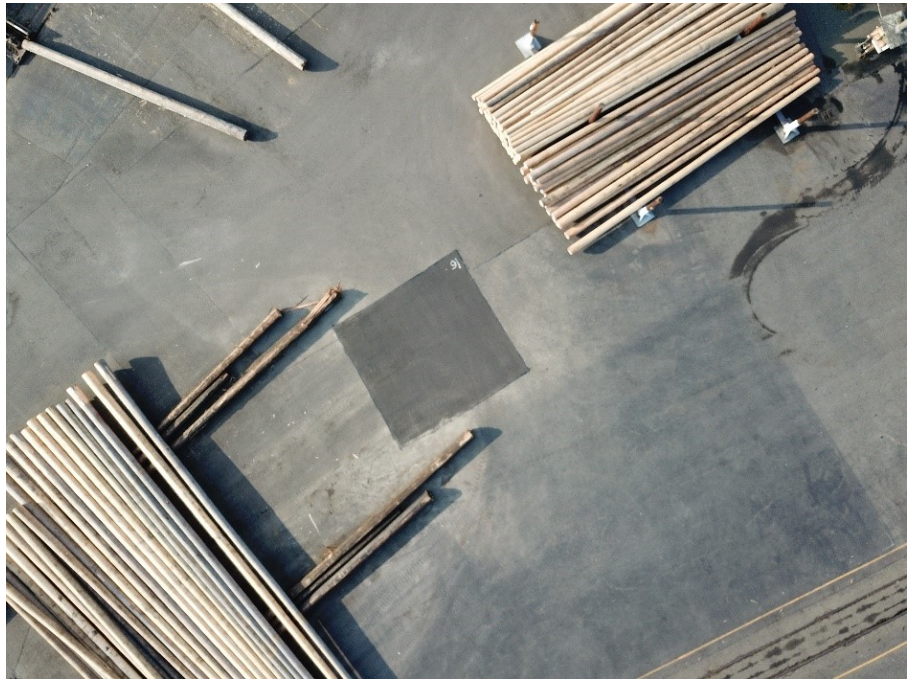
On February 4 through 6, 2019, Maul Foster & Alongi, Inc. (MFA) conducted a groundwater monitoring event at the Cascade Pole and Lumber Company site located at 1640 East Marc Street in Tacoma, Washington (the Site). The monitoring event was conducted on behalf of McFarland Cascade Holdings, Inc. (MCHI) and Tye Management Company, LLC (Tye) to fulfill the annual compliance monitoring requirement under the final cleanup action plan (CAP) (Washington State Department of Ecology [Ecology], 2016), which is included in the June 7, 2016, consent decree (Pierce County Superior Court No. 16-2-08380-9) as an exhibit. Sampling was conducted consistent with the groundwater compliance monitoring plan (CMP) (MFA, 2016a), which is included in the CAP as an appendix, and in accordance with compliance monitoring requirements put forth in the Washington State Model Toxics Control Act (Washington Administrative Code 173-340-410). Completed monitoring activities and sampling results are summarized below.

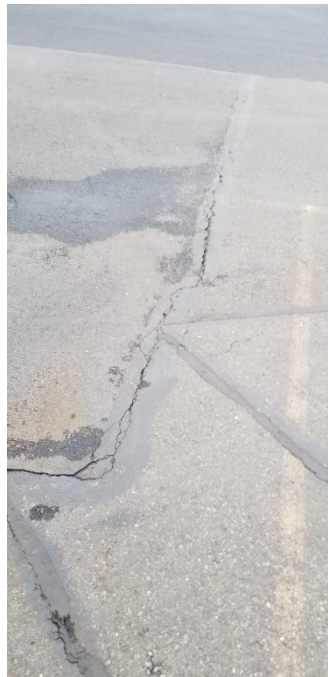
monitoring is required in order to evaluate whether indicator hazardous substance (IHS) concentrations comply with cleanup levels (CULs) at the conditional point of compliance (CPOC), which is located at the Site boundary (see Figure 1).

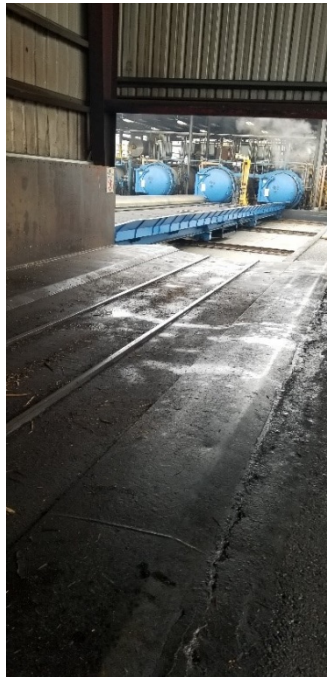
were validated and are considered acceptable for their intended use, with the appropriate data qualifiers assigned (see Attachment D).

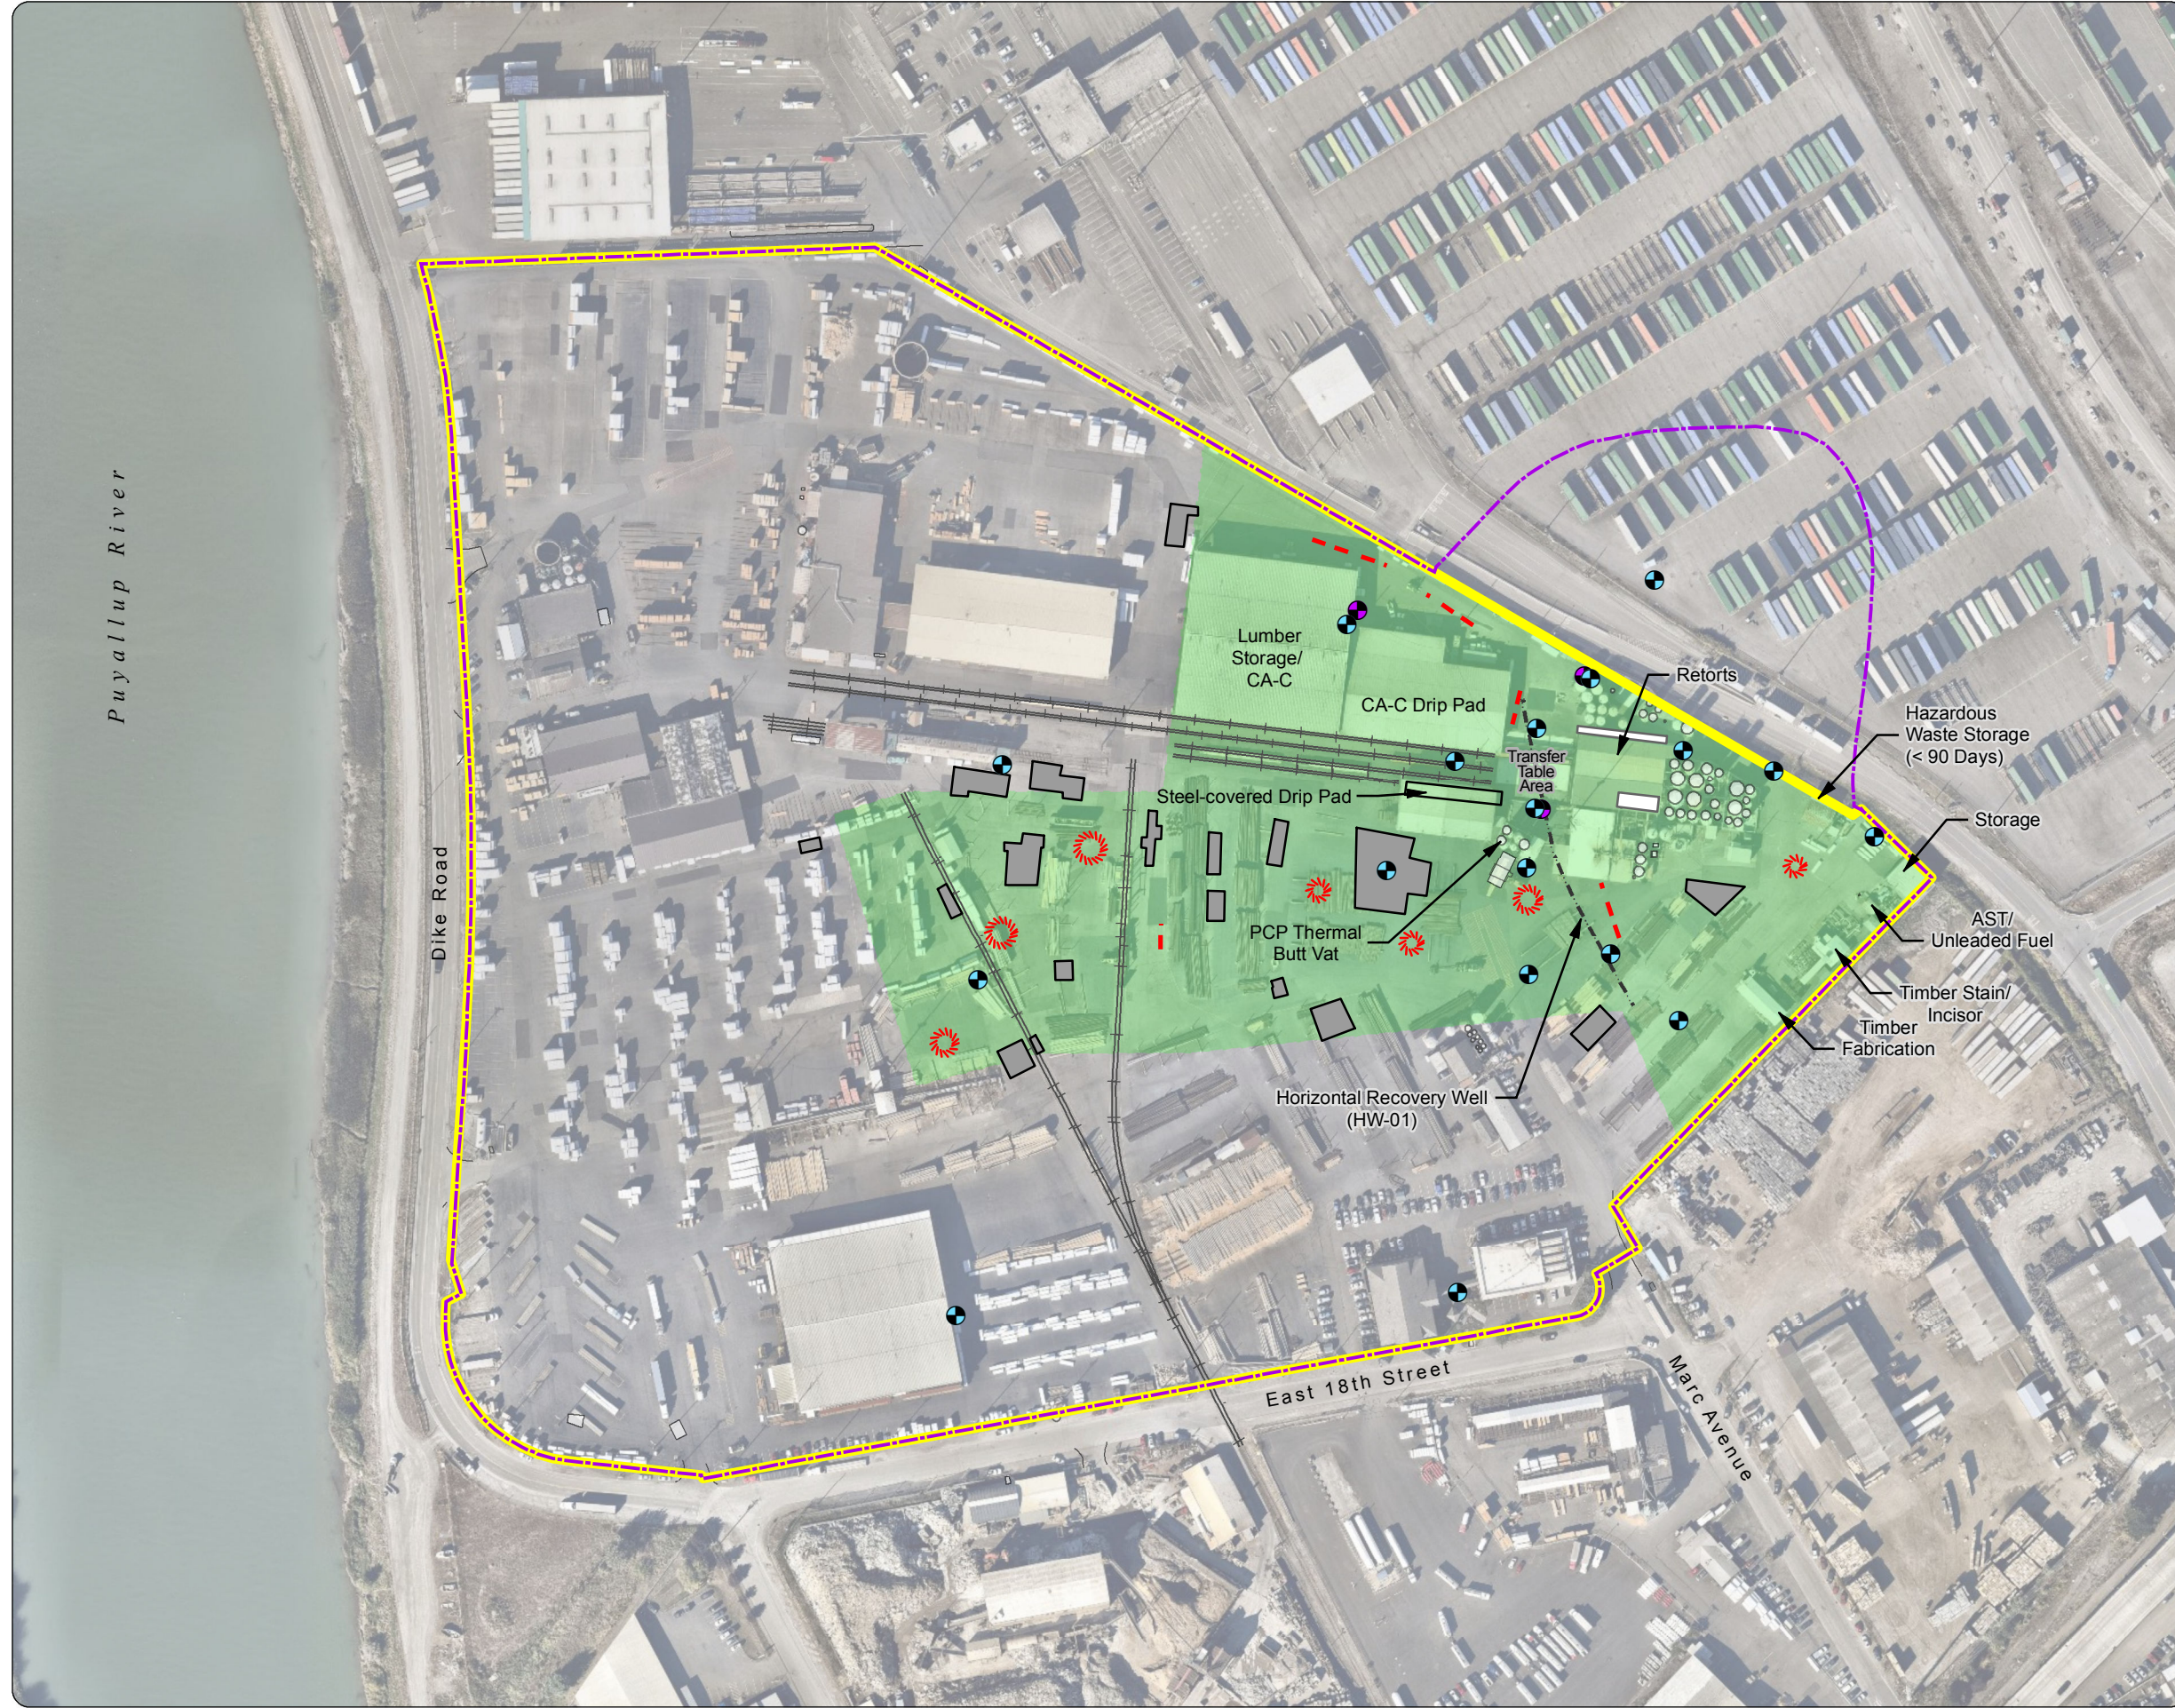
Measurements:	
<p>Areas of recently repaired asphalt are also shown on the attached figure.</p> <p>Approximate extent of areas where observed sealant fatigue and cracks forming are shown on the attached figure.</p>

Linear Crack to Monitor
-

Recent Repair - New Asphalt
-
