Focused Phase II Assessment Report
Pine Lake Dry Cleaners Facility
2830 228th Avenue SE
Sammamish, WA

Prepared for Bryan Syrdal and Alan Green
for submittal to
HomeStreet Bank

Prepared by Urban Environmental Partners, llc

Focused Phase II Environmental Assessment

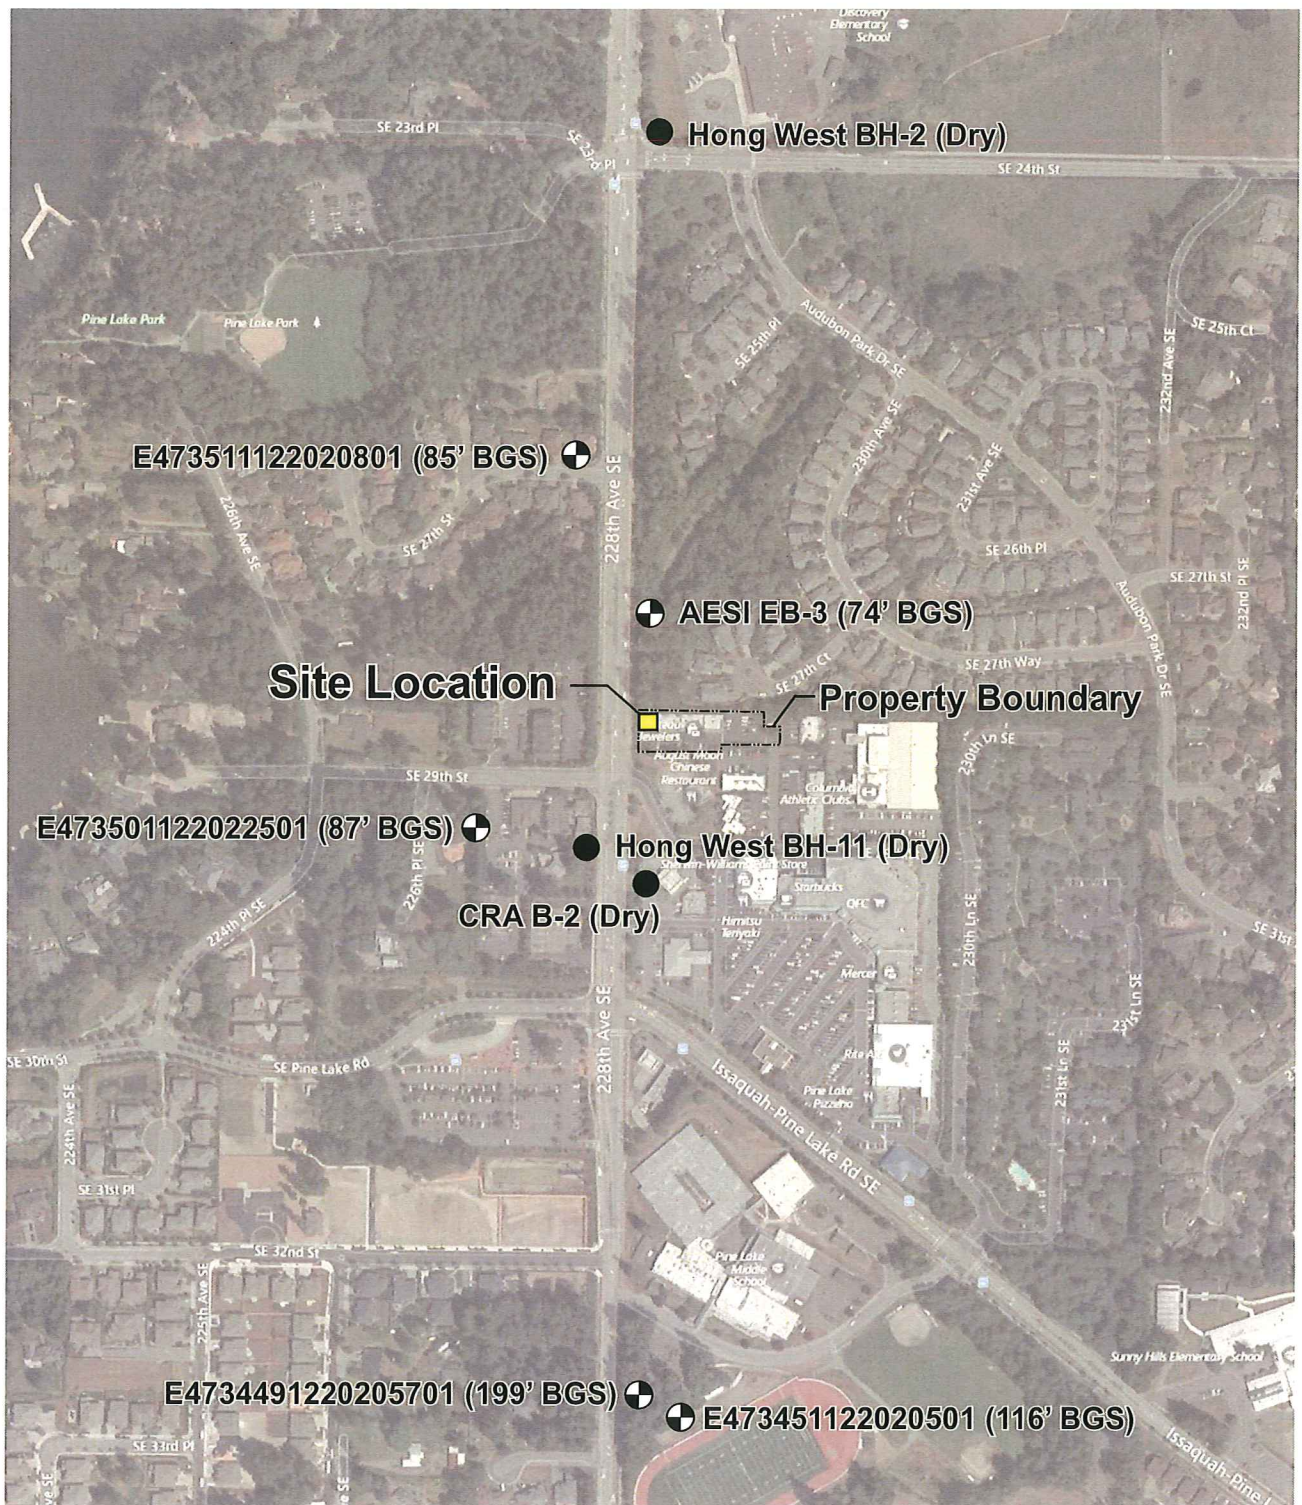
Figure 1 Location of Site and Regional Groundwater Wells

The dry cleaner operation, named Pine Lake Dry Cleaners, is located at 2830 228th Avenue Southeast in Sammamish, Washington, approximately 2 miles south of downtown Sammamish, Washington as shown in Figure 1. The dry cleaner facility is located on the west

end of the Pine Lake Plaza retail strip mall as shown on Figure 1. According to the USGS Topographic Map of the Issaquah, Washington Quadrangle, the Property is located at an approximate elevation of 430 to 455 feet above mean sea level (AMSL), with the highest elevations on the eastern portion of the Property. Based on elevation contour information obtained the King County iMap database, the elevation of the PLC Site is 435 feet (AMSL).

Pine Lake Plaza is currently occupied by a 1990-vintage, one-story building that encloses approximately 7,272 square feet of space, on a 30,501 square foot lot that is one parcel, identified as King County Tax Parcel 102406-91111 . The masonry-framed structure is heated by electricity. Additional improvements at the property include parking areas to the south and east of the building as shown on Figure 1.

The WA DNR geologic database identifies 4 regional groundwater wells that have been installed within approximately 1,400 feet of the project site. The borings for the wells have been drilled to depths of between 85 feet and 199 feet below existing grade elevations, as shown on Figure 1. Database records for the regional wells identify that the regional water table is found approximately at elevation 320 feet (AMSL) in the Advanced Outwash formation. The water table and glacial formations (Till, and Outwash) are depicted on a cross-section figure from Conestoga-Rovers & Associates (CRA) on CRA Figure 5 provided in Appendix A, along with the CRA report.

In addition to the regional wells, several shallow soil borings in the near vicinity of the Site were researched to provide additional geological information. These wells are shown on Figure 1, and include CRA boring B-2, Hong West (HW) Borings BH-2, and BH-11, and AESI boring EB-3. According to DNR records, the CRA boring B-2 was drilled to 40.5 feet, and reported no groundwater in the well installation (a dry well). The HW borings B-2 and B-11 were drilled to 14 feet, and 16 feet respectively, and both borings were determined to be dry wells. The AESI boring EB-3 was drilled to 85 feet bgs from an elevation of approximately 400 feet (AMSL), and the water level in EB-3 was measured at 74 feet bgs. Boring logs for these shallow borings and vicinity wells are provided in Appendix B.
