**Soil Cleanup Summary Report
Former Monroe Auto Wrecking/River's Edge Site
426 Fremont Street
Monroe, Washington**

November 20, 2019

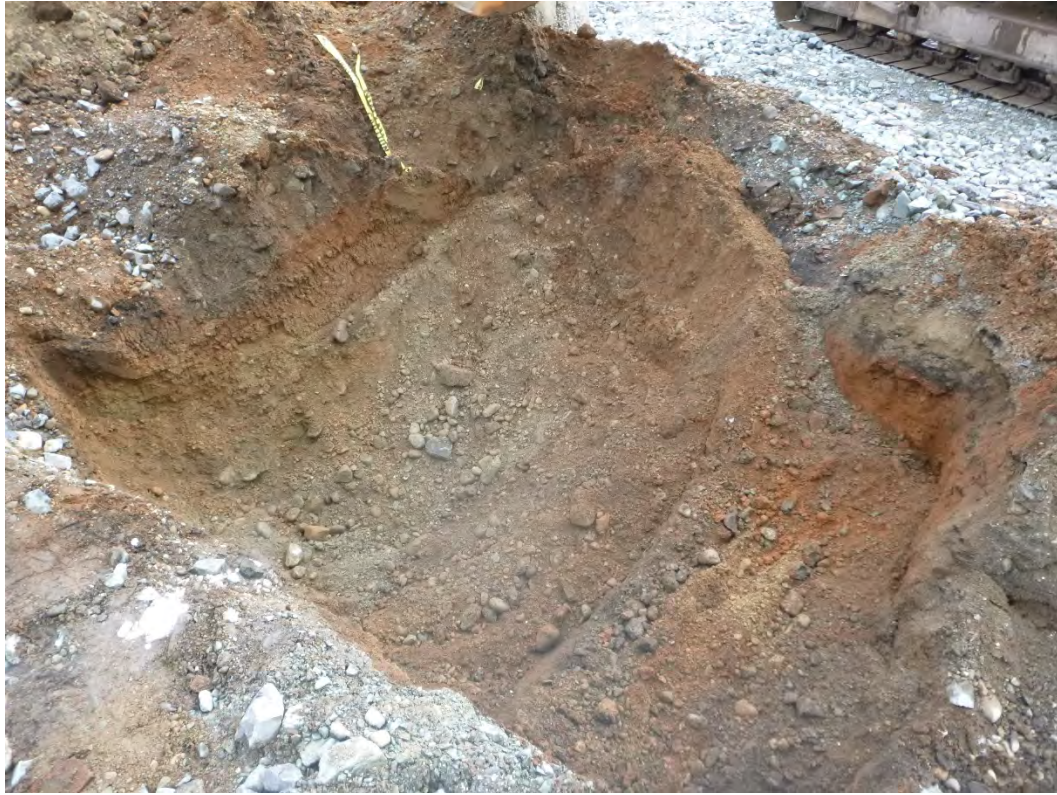
Excavated area looking east.

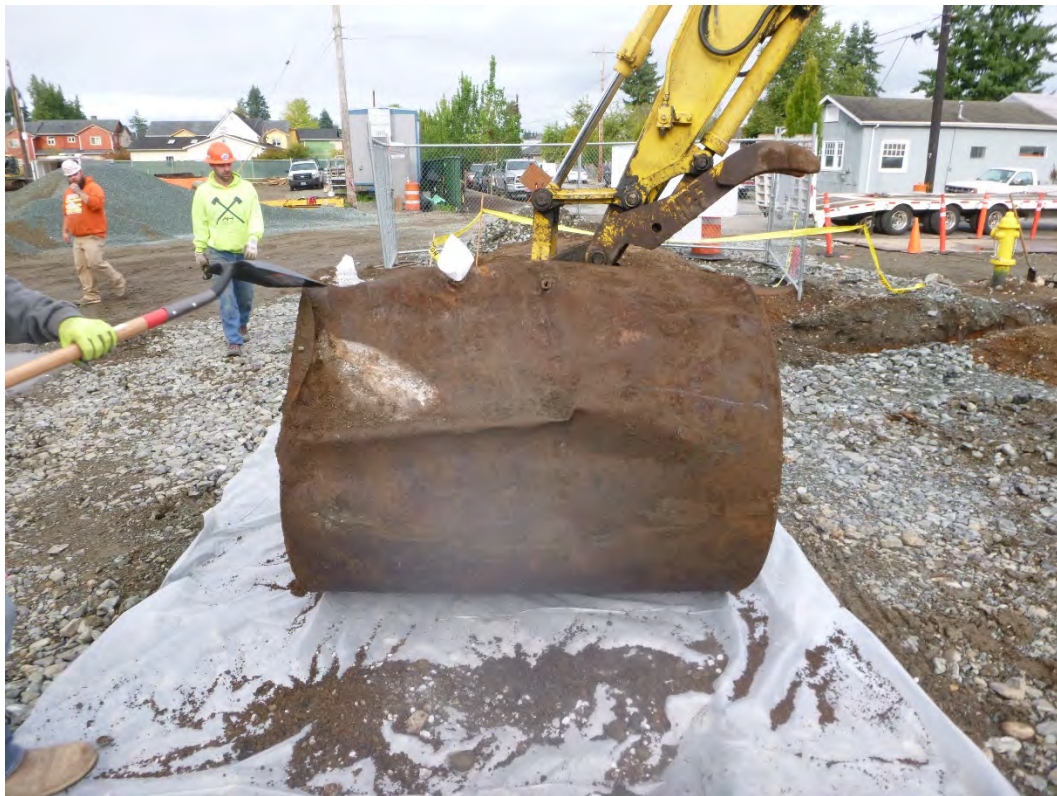
Excavated UST looking west.

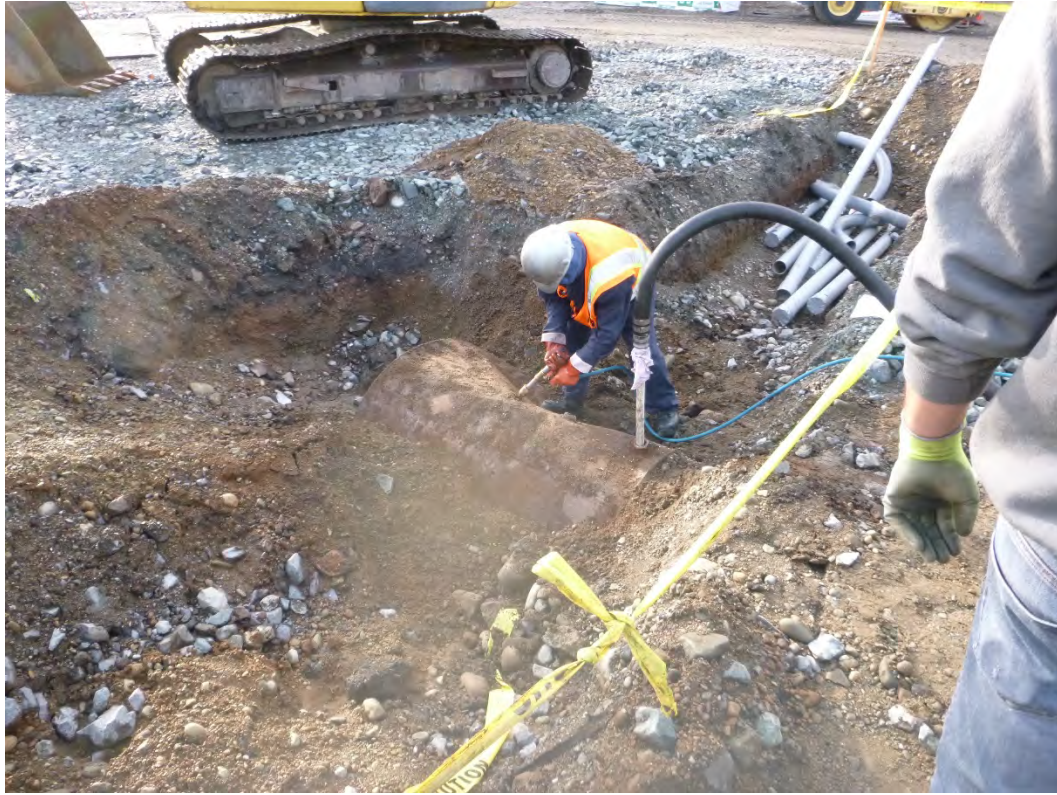
UST decommissioning looking south.

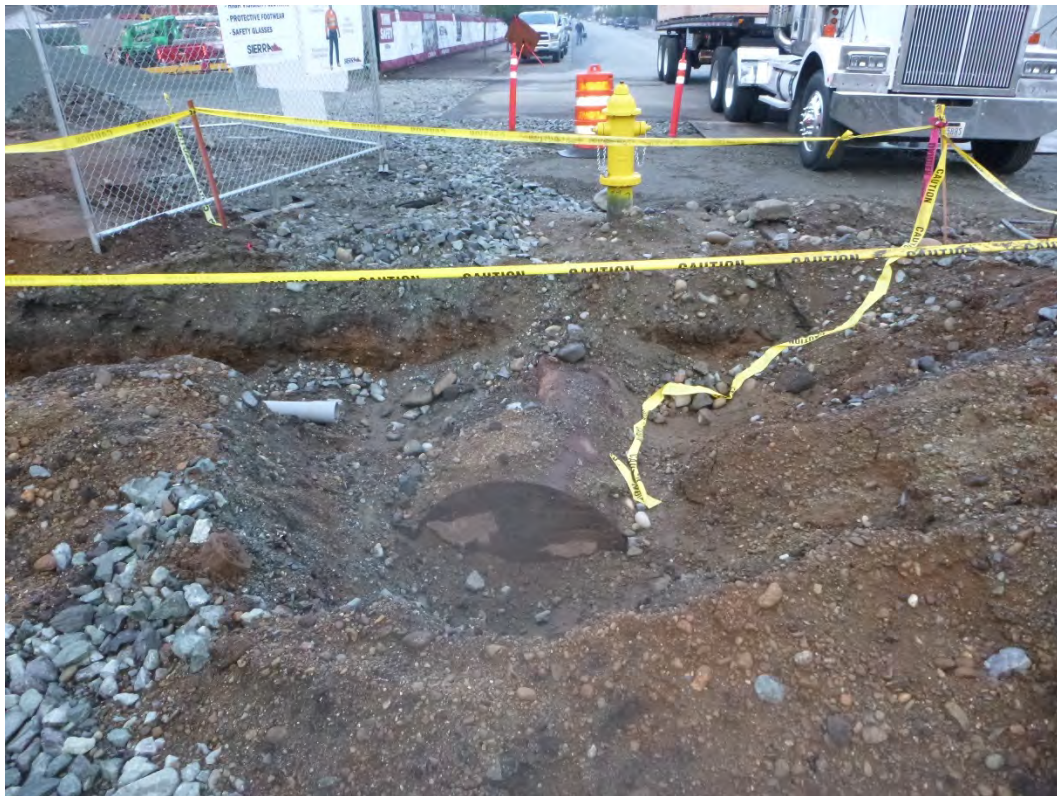
UST *in situ* looking west.

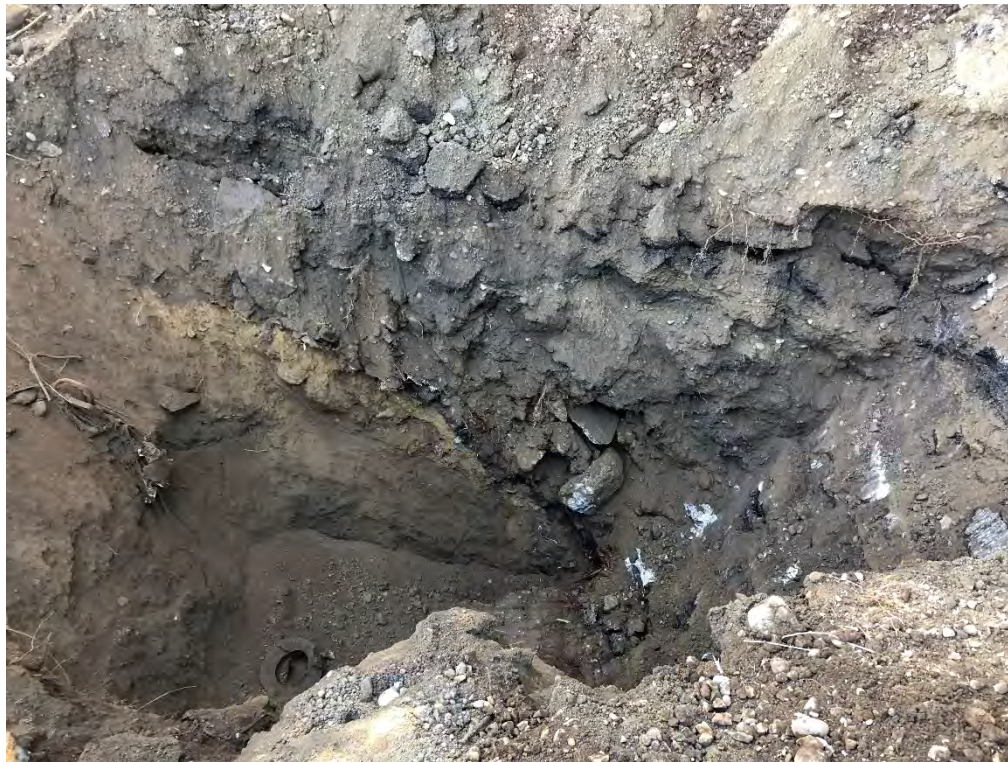
Field screening during excavation in the AOC1 area indicated the presence of two approximately 1-ft-thick black layers consisting of burned wood material, and containing metal debris including car parts, and other materials. The upper black layer was observed at depths between 6.9 ft bgs and 12 ft bgs, and the lower black layer was observed at depths between approximately 11 ft bgs and 17 ft bgs. Both black layers generally sloped downward to the south; the deeper black layer was observed in a portion of the final southern excavation sidewall. The approximate and estimated extent of the black layers is shown on Figure 4.

1. AOC1-SW13 with black layer and buried debris visible.

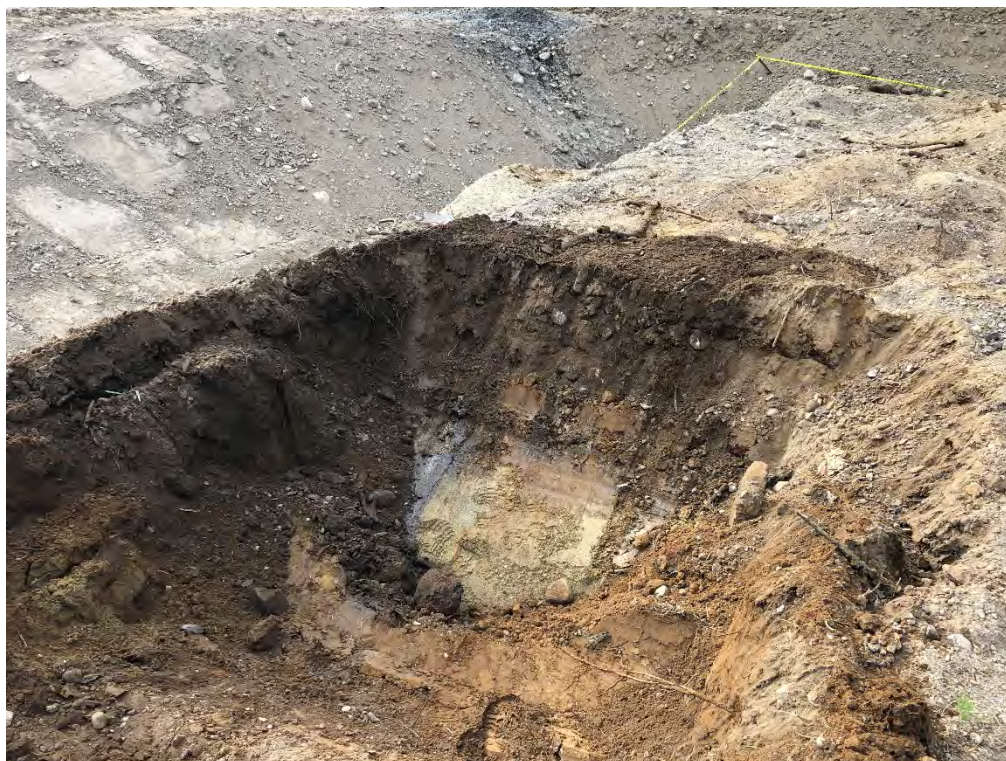
2. AOC3 initial excavation and sidewall sampling location.

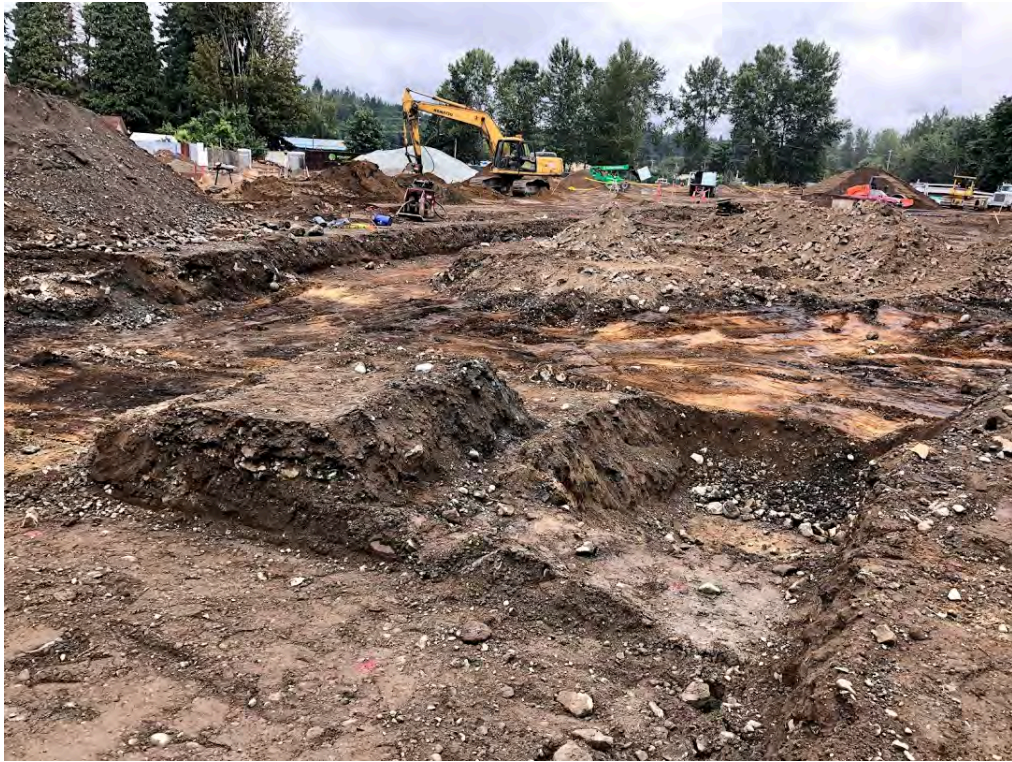
While excavating for Building C's footing on July 2, 2019, construction personnel observed staining and a petroleum-like odor in shallow soil. In accordance with the EMMP, LAI personnel provided oversight, field screening, and oversight of additional excavation in this area. Field screening indicated a slight petroleum odor and staining, but PID readings in soil headspace were at background levels (2 ppm or less) and did not indicate the presence of VOCs. Potentially contaminated soil was excavated in the areas shown on Figure 6 until field screening did not indicate further presence of potentially contaminated soil. The final excavation depths ranged between 2 and 4 ft bgs.

3. Building C and rinse tank area after excavation.

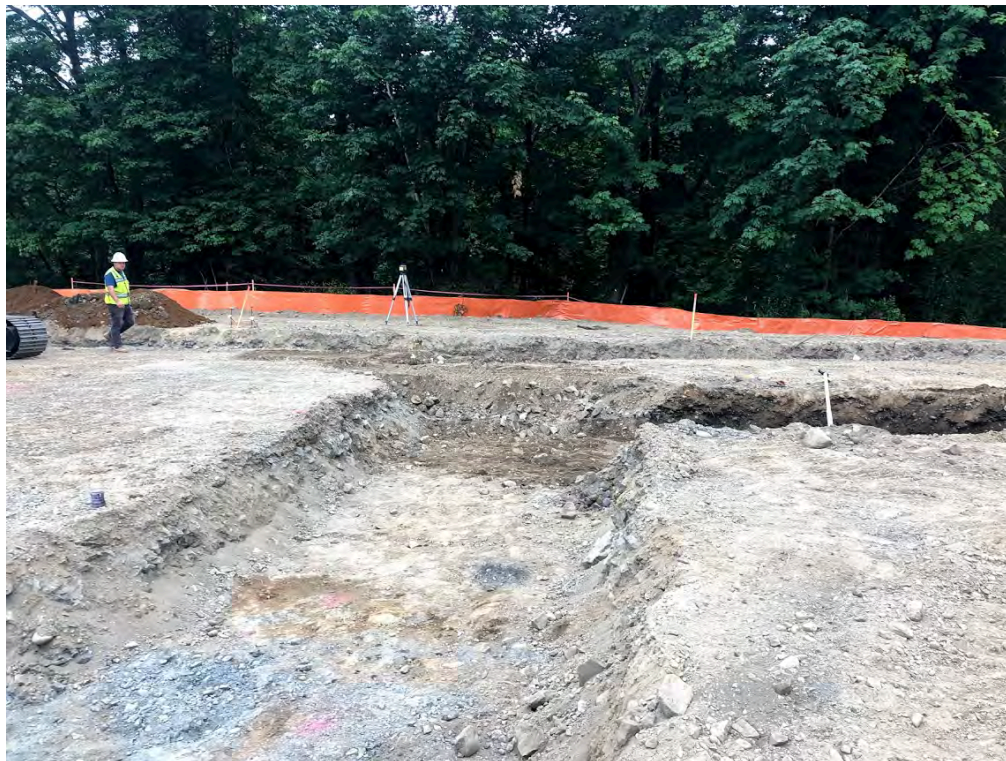
6. Looking south at Building C and rinse tank excavation.

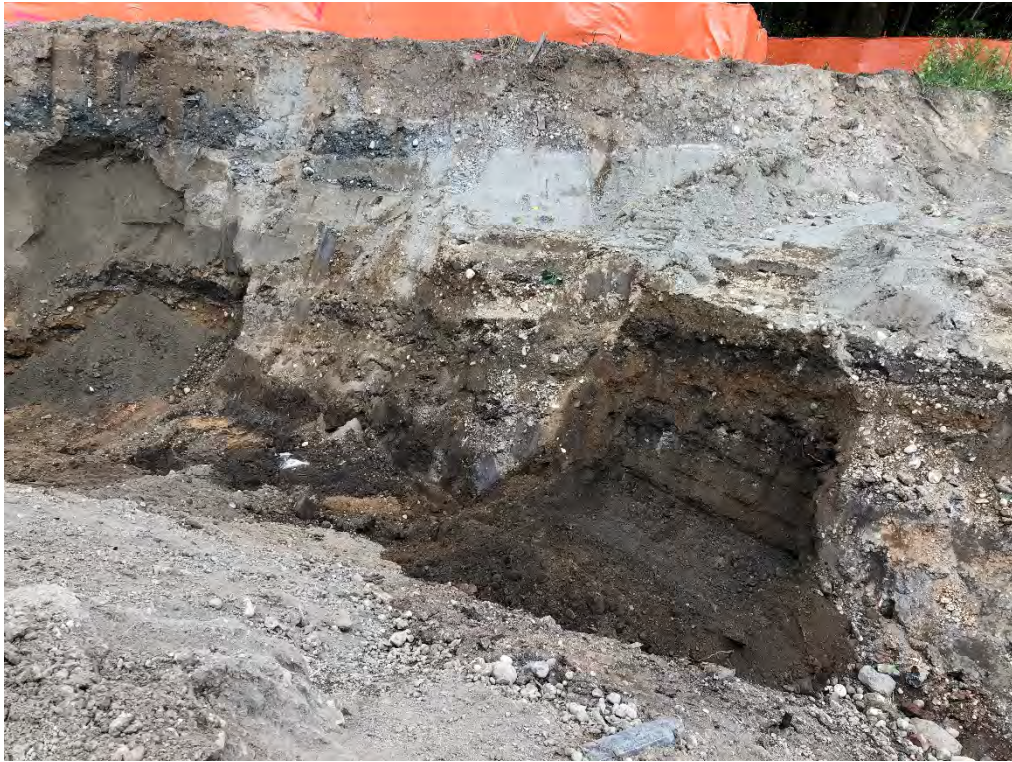
At sampling location AOC1-SW17, analytical results for the sample collected from the 12- to 13-ft bgs interval indicated concentrations of cadmium (4.0 mg/kg) and lead (720 mg/kg) above the respective CULs (2 mg/kg and 250 mg/kg). Based on these exceedances, one soil boring (AOC1-DP) was advanced approximately 9 ft to the south to evaluate the extent of any remaining contaminated soil above 15 ft bgs. The soil boring was advanced using direct-push drilling equipment to approximately 32 ft bgs, and soil was sampled continuously to the maximum depth of the boring. A record of the soil conditions observed during drilling, including soil types, evidence of contamination based on field screening, and other pertinent information are provided in the boring log in Appendix D.

As indicated in the boring log, the black layer was observed at soil boring AOC1-DP at approximately 14 to 15 ft bgs. Soil in this interval was collected for laboratory analysis of TPH-D/-O and metals. Analytical results indicate contaminant concentrations below CULs, including both cadmium (1.3 mg/kg) and lead (180 mg/kg). Based on these data, the elevated metals concentrations documented at excavation sidewall sampling location AOC1-SW17 (12-13) (just north of the location of soil boring AOC1-DP) appear to be limited to a relatively small area. Based on the significant depth, and location of this remaining soil, additional excavation was not practicable.

7. South sidewall of AOC1, with AOC1-SW17 on left and AOC1-SW-18 on right.

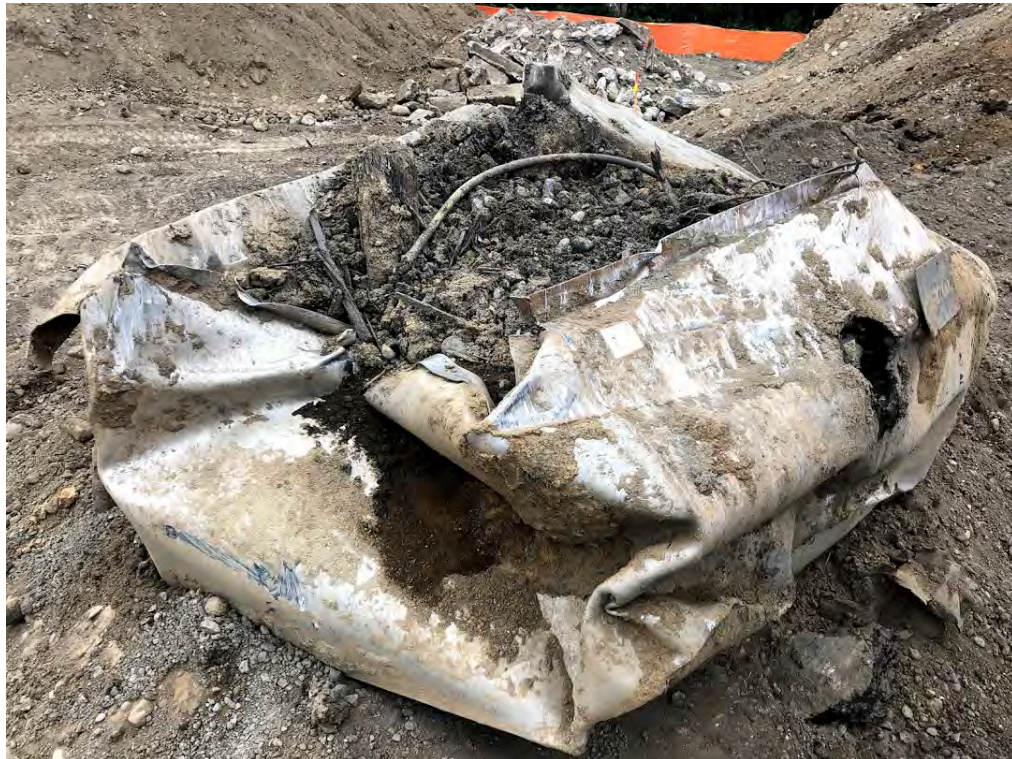
While excavating for Building C’s footing on July 1, 2019, an approximately 4-ft by 3-ft by 3-ft deep metal box, labeled as a “rinse tank”, was uncovered and removed. The bottom of the rinse tank was approximately 5.5 ft bgs. Extending out of the rinse tank was a 6-inch polyvinyl chloride (PVC) pipe filled with fine, clayey soil with observed staining, sheen, and petroleum-like odor. An excavation of the soil surrounding the rinse tank was performed based on field observations and soil screening. Pre-excavation field screening indicated a slight petroleum odor, but PID soil headspace readings were at background levels (2 parts per million [ppm] or less) and did not indicate the presence of VOCs. In the sidewalls and bottom southeast corner of the rinse tank excavation, staining was observed and sheen tests of the stained soil suggested the presence of TPH-D or TPH-O contamination. These soils were removed during excavation.

8. Removed rinse tank from Building C area.
