# UNDERGROUND STORAGE TANK SITE ASSESSMENT REPORT

**RGI PROJECT NO. 2017-015K  
AGREED ORDER NO. 16357**

**ROYSTONE REDEVELOPMENT  
631 QUEEN ANNE AVENUE NORTH  
SEATTLE, WASHINGTON 98109**

**OCTOBER 1, 2020**

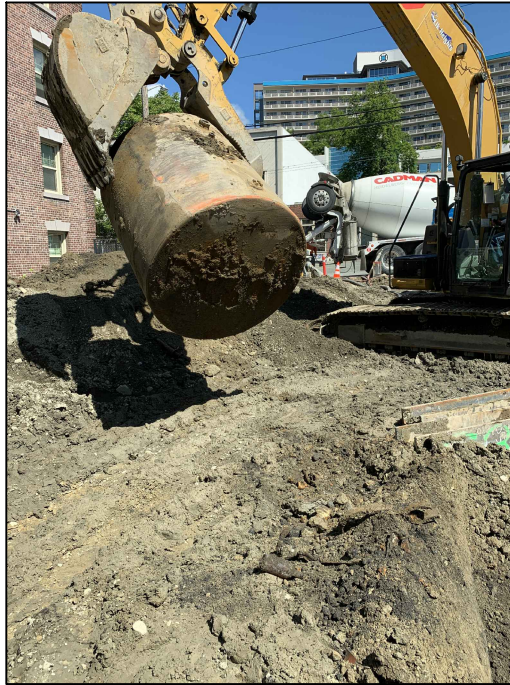
Photograph 1: View of the removal of 1,066-gallon diesel UST4A situated on the west-central portion of the Property. No evidence of holes or a release were encountered.

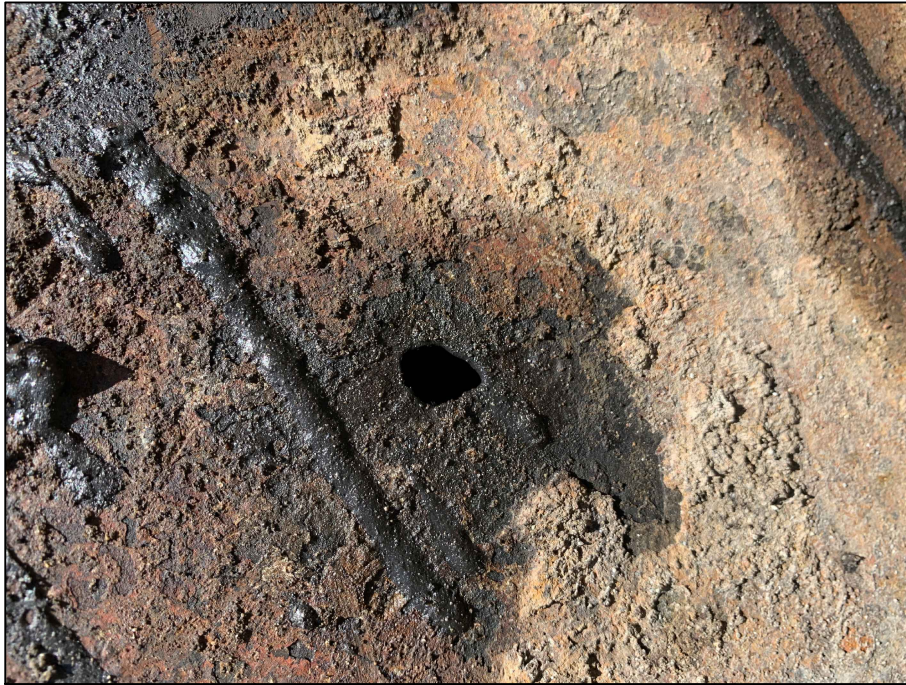
USTA was a horizontal cylinder shaped UST with single wall steel construction that was 6 feet long with a diameter of 3 feet and an approximately 317-gallon capacity. An approximately 3 millimeter hole was observed on the bottom eastern side of USTA with black sludge staining on the outside of the tank. An approximately 0.5-inch hole was also observed at the top eastern side of the UST.

Photograph 3: View of the approximately 0.5-inch hole located on the top east side of USTA.

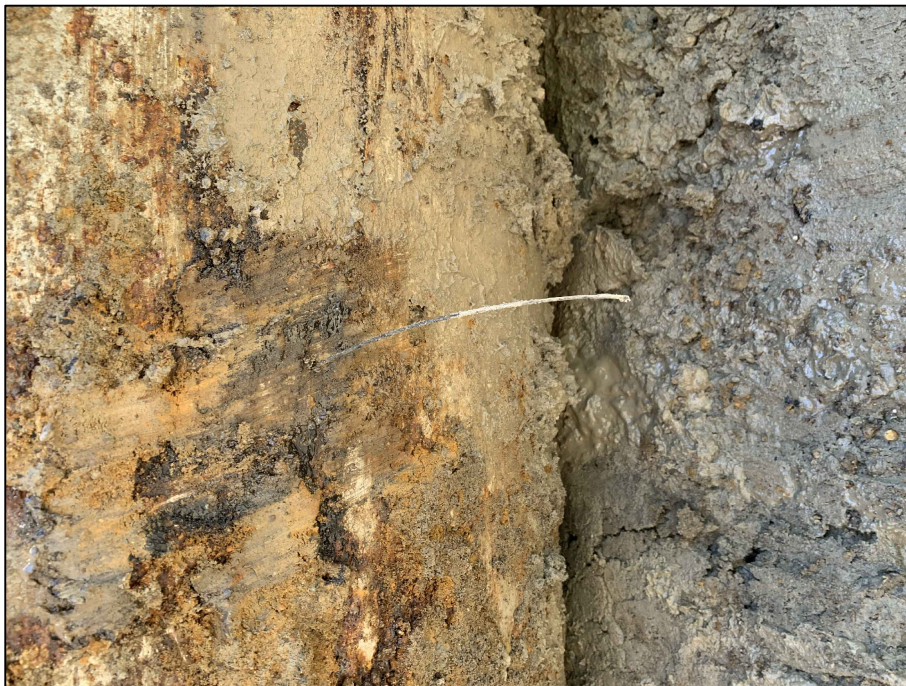
Photograph 4: View of the approximately 3 millimeter hole located on the bottom east side of USTA.

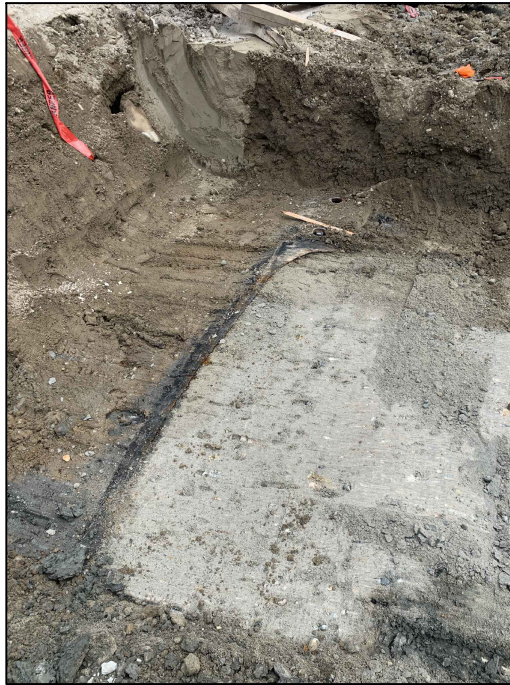
Photograph 5: View of a large hole on the top of UST6B where the UST was likely cut prior to filling the UST with CDF.

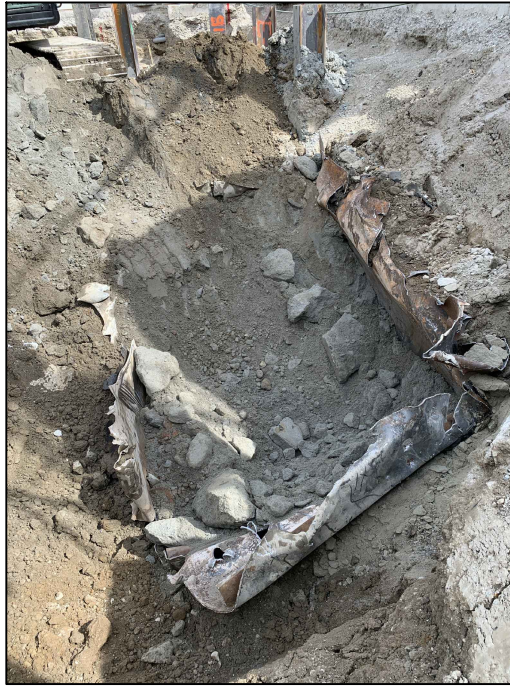
Photograph 7: View of CDF being excavated from inside UST6B.

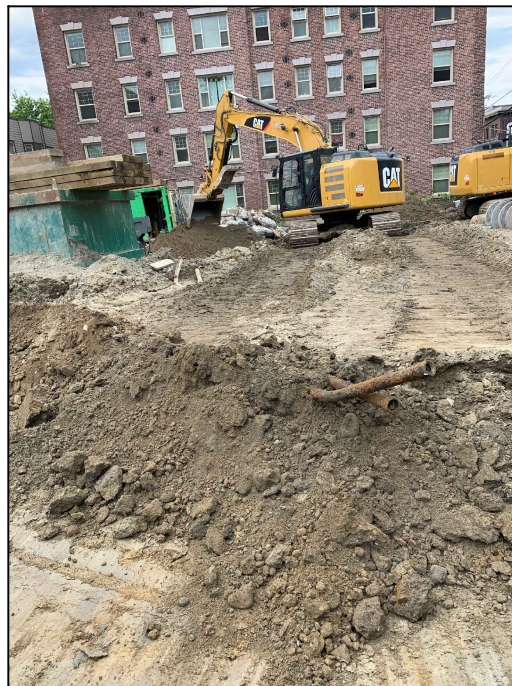
Photograph 8: View of suspected product piping encountered on the east-central portion of the Property near former boring DP3. It was not confirmed which UST this pipe belonged to.

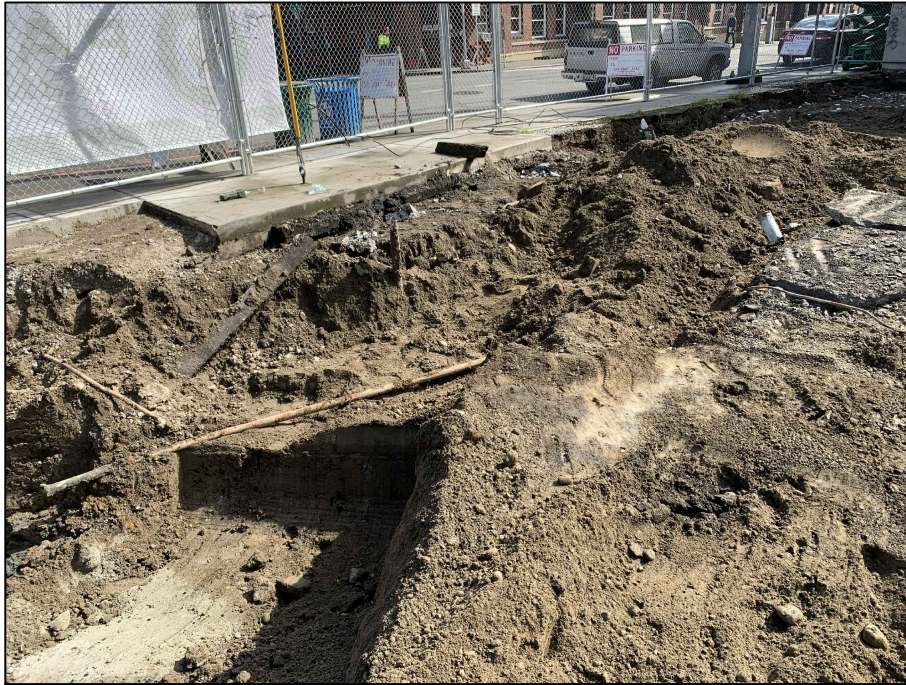
On March 25, 2020, RGI identified a pump island directly beneath the asphalt in a location west of the reported location of UST6B on the eastern portion of the Property. Remnants of dispensers 1 and 2 and associated product piping were observed in this location. The dispensers and product piping appeared to be associated with former UST5Ba based on the location of UST5B reported in previous reports. However, it was later determined that the piping was more likely associated with UST6B based on the location of UST6B.

Photograph 9: View of a former pump island and associated product pipe situated on the east-central portion of the Property, which may have been associated with UST6B.

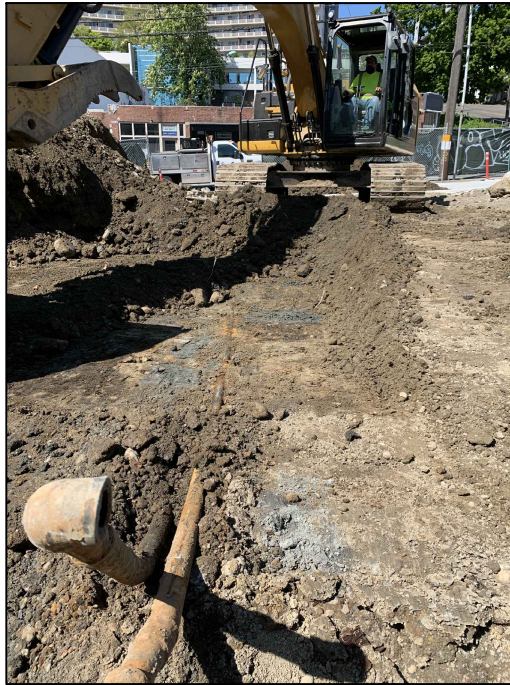
Photograph 11: View of suspected product pipe situated on the southwest portion of the Property, which may have been associated with former UST4.
