Remedial Investigation, Feasibility Study, and Interim Remedial Action Report

**Modera River Trail Property
15881 Northeast 85th Street
Redmond, Washington**

August 12, 2020

TRC Environmental Corporation
1180 NW Maple Street, Suite 310
Issaquah, Washington 98027
(425) 395-0010

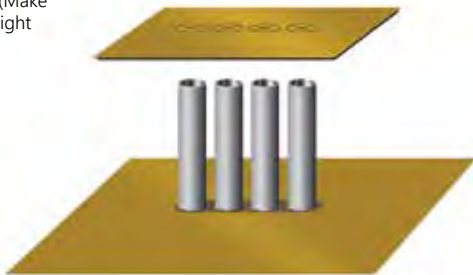
Fig. 7

Cut a patch large enough to overlap 12" in all directions and slide over penetrations (Make openings as tight as possible.)

- A) Cut a patch large enough to overlap 12" in all directions (Fig. 7) of penetrations.
- B) Mark where to cut openings and cut four to eight slices about 3/8" less than the diameter of the penetration for each.
- C) Force patch material over penetration to achieve a tight fit and form a lip.
- D) Once patch is positioned, seal the perimeter to the membrane by applying 2-sided Raven Butyl Seal Tape in-between the two layers. (Fig. 8)
- E) After applying Raven Butyl Seal Tape between the patch and membrane, tape around each of the penetrations and the patch with VaporSeal™ 4" tape. (Fig. 9) For additional protection apply POUR-N-SEAL™ or an acceptable polyurethane elastomeric sealant around the penetrations. (Fig. 10)

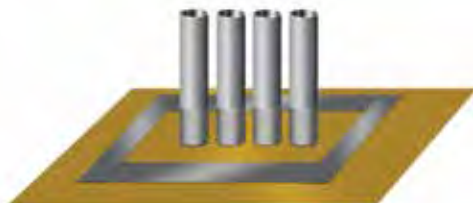
Fig. 9

After applying Raven Butyl Seal Tape between the patch and membrane, tape around the perimeter of the penetration and the patch with VaporSeal™ 4" Tape.

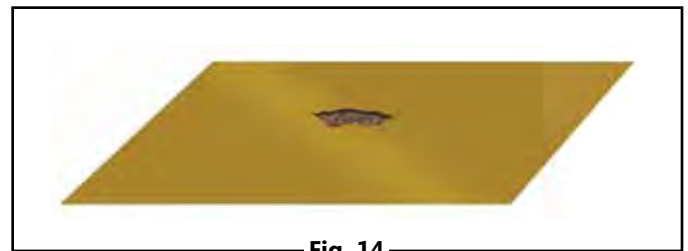
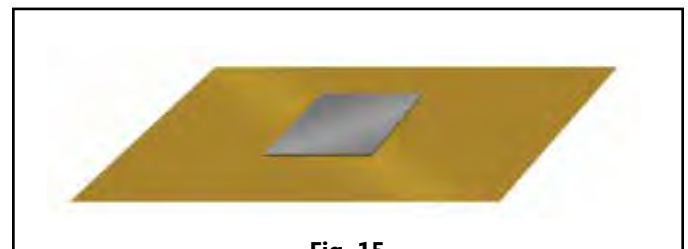
Fig. 14

- 1.7. Proper installation requires all holes and openings are repaired prior to placing concrete. When patching small holes, simply cut a 12" long piece of 12" wide VaporSeal™ tape. Remove release liner and center over the opening. Apply pressure to create a seal (Fig. 14-15).
- 1.8. When installing VaporBlock® Plus™ around pipe penetrations, vertical columns, electrical ducts and other obstructions, you will find it necessary to cut it to the nearest outside edge. This cut can be easily sealed with 12" wide VaporSeal™ tape, by simply centering it over the cut, 6" on either side. Once the tape is placed correctly, apply pressure to assure a complete seal (Fig. 16).

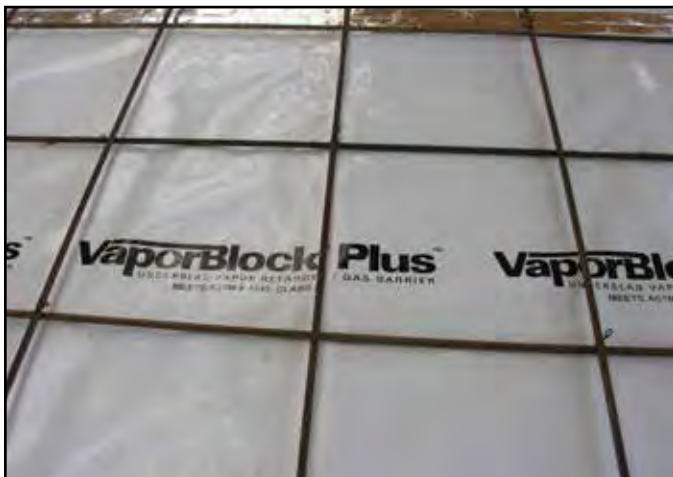
VaporBlock® Plus™ Gas & Moisture Barrier can be identified on site as gold/white in color printed in black ink with following logo and classification listing (Fig. 18)

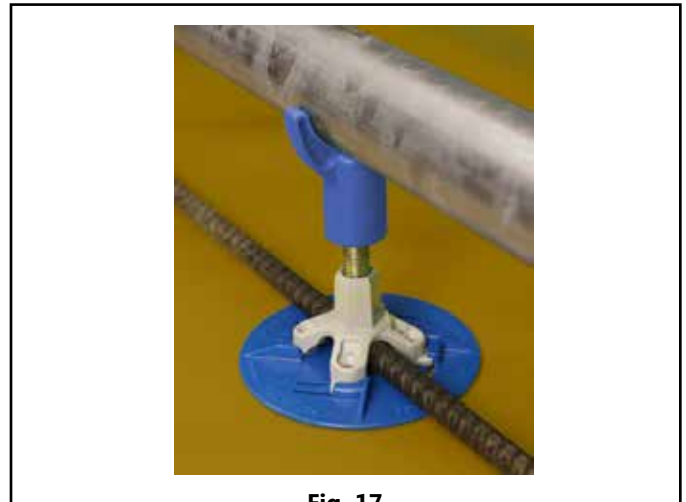
Fig. 17

- 2.4. To avoid penetrating VaporBlock® Plus™ when installing screed supports, utilize non-penetrating support, such as the Mako® Screed Support System (Fig. 17). Avoid driving stakes through VaporBlock® Plus™. If this cannot be avoided, each individual hole must be repaired per figures 14-15.
