### FINAL CLEANUP REPORT

Former Industrial Petroleum Distributors 1117 West Bay Drive Olympia, Washington

**September 27, 2002**

IPD - Project No: 20-170-01

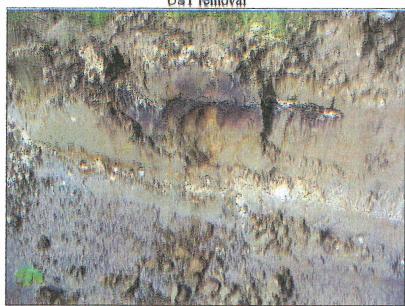
UST removal

On April 29, 2002, the main building and the pump house building were demolished in preparation for the contaminated soil excavation work. Then, on May 13, 2002, AEG and subcontractor, Advance Environmental began excavation of contaminated soils in the area of the former UST. The limits of the excavation were determined utilizing a portable Photo-ionization detector (PID) and a sheen test. The approximate size of the excavation pit extended 23 feet, east to west and 36 feet, north to south. The final depth of the excavation pit was approximately 11 feet below ground surface (bgs) uniformly across the bottom of the excavation pit area. Approximately 362 tons of petroleum contaminated soil (PCS) was removed from the excavation pit and transported to Olympic View Landfill in Bremerton, Washington for disposal. Refer to Appendix B for Site Diagrams.

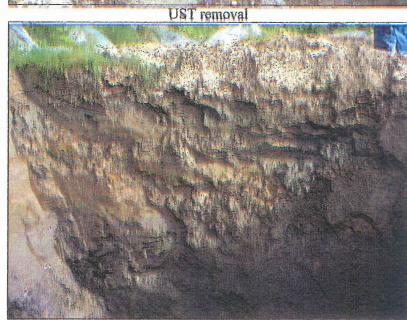
Side wall of UST pit

Clearance samples were collected from the sidewalls and bottom of the excavation pit and submitted to an independent laboratory for NWTPH-HCID analysis (Table 1). Based on the non-detect laboratory results, the excavation pit was backfilled with imported pit-run gravel and compacted to 95% compaction rate. Refer to Appendix C for Laboratory Documents.

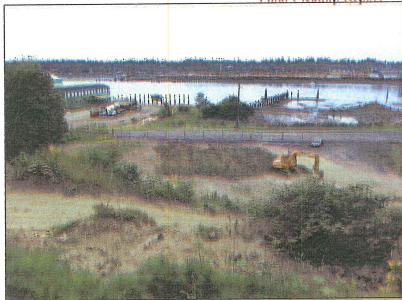
Subject property looking east during excavation

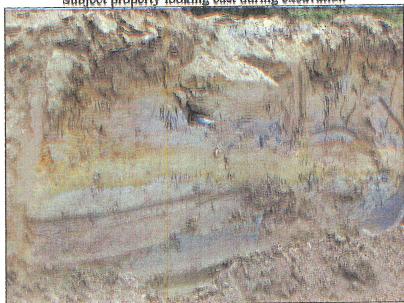
Excavation wall close-up

The additional excavation along the north wall initially indicated minor levels of affected soil and, as with the west wall, additional contaminated soils were scraped from the entire length of the north sidewall. Field observations indicated localized areas of contaminated soil that continued to increase in degree of petroleum saturation to the north. The depth of contaminated zone ranged from 3 feet to 7 feet bgs and was relatively uniform throughout the new excavation area. The contaminated area was confined to the eastern portion of the former AST farm from the sump area to the terminal end of the driveway. Clearance samples were collected from the newly excavated sidewalls and submitted for laboratory analysis. Refer to Appendix C for Laboratory Documents.

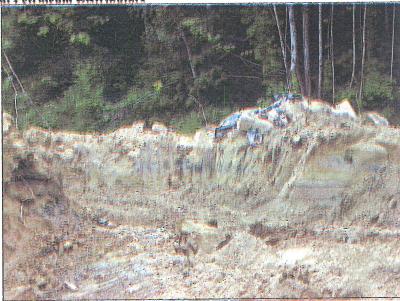
Excavation wall

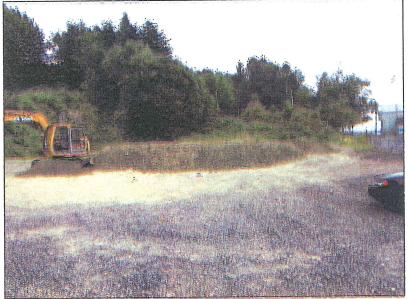
PCS Stockpile

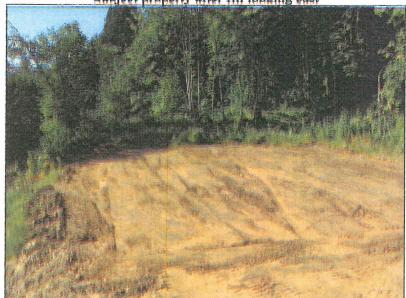
Top of subject property after fill

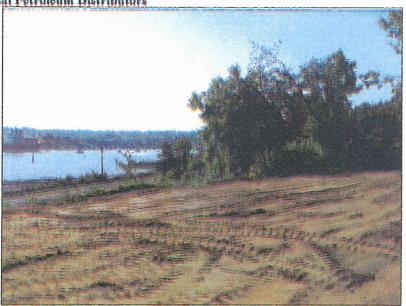
Subject property after fill looking southeast

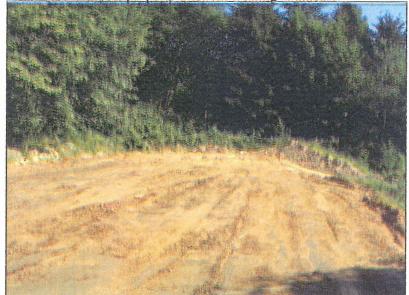
Top of subject property after fill
