October 13, 2020
Project 2004-004.002

Re: Semi-annual Groundwater Monitoring Report – September 2020, Former Provisioner’s Express, Inc. Facility, 2102 West Valley Highway North, Auburn, Washington, Ecology Facility ID 91612121, Cleanup Site ID 6847, VCP Project No. 3206

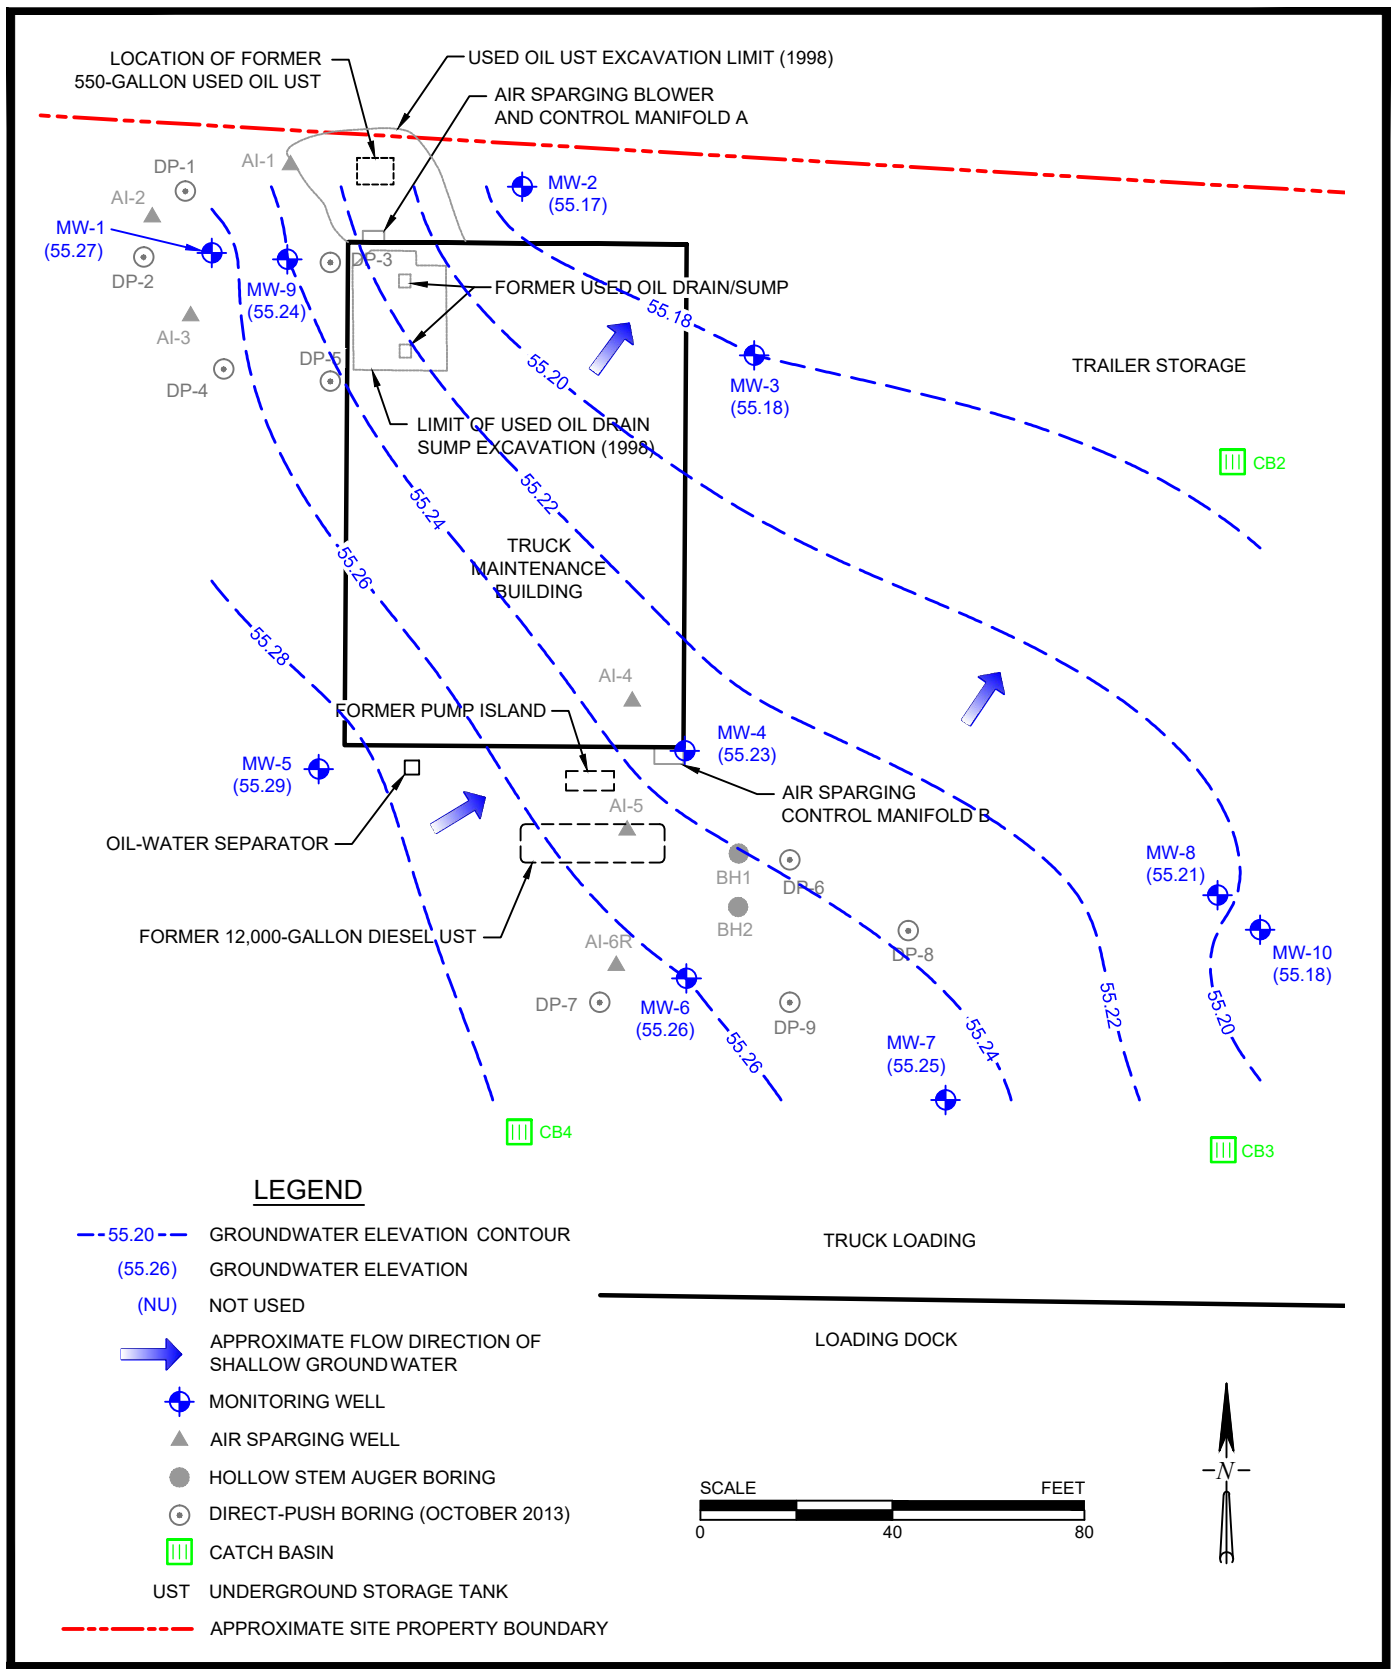
DATE	9/23/20
SCALE	AS SHOWN
DESIGNED BY	DJL
APPROVED BY	DJL
DRAWN BY	SRM
PROJECT NUMBER	2004-004.002
FIGURE NUMBER	3

Based on the depth-to-water measurements collected on September 3, 2020 from the ten (10) monitoring wells, a groundwater elevation contour map was generated for the Site (Figure 3) using field measurements and data from well surveys completed on September 19, 2017 (MW-1 through MW-9) and February 5, 2019 (MW-10). Groundwater elevation data indicated a predominantly northeast groundwater flow direction, consistent with flow directions observed in previous groundwater monitoring events. The horizontal groundwater gradient was calculated to be less than 0.01 feet per foot (ft/ft) during the September 3, 2020 groundwater monitoring event.

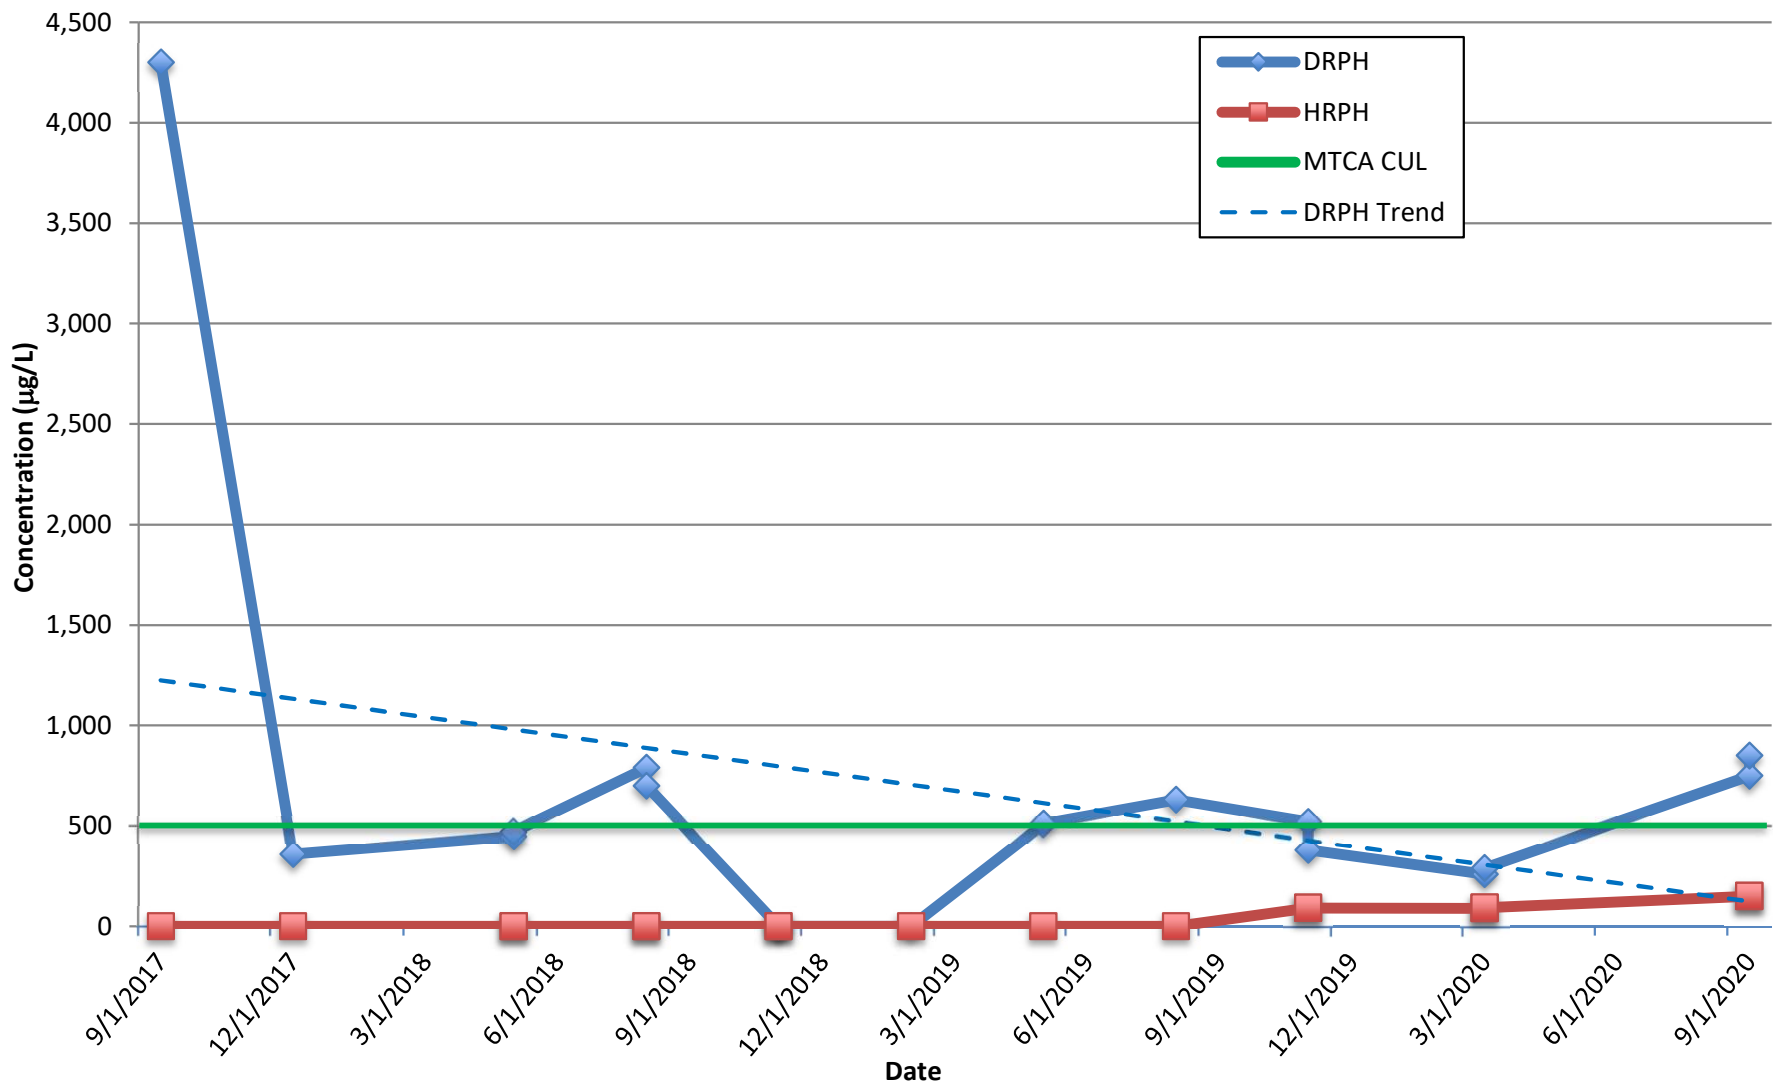
MW-9 DRPH and HRPH Concentration Time Series

In Ecology's Opinion Letter dated December 20, 2018 (Ecology, 2018) groundwater analysis trend charts were requested for monitoring wells MW-1, MW-3, MW-6, MW-8, and MW-9. Currently, only MW-9 is being monitored. A copy of the groundwater analysis trend chart for MW-9 is provided as Attachment C. The trend chart indicates the following:

- Laboratory analyses for samples collected from MW-9 indicate an overall declining trend since well installation in September 2017. TPH-o has never been reported in groundwater samples collected from MW-9 at concentrations above the MRL. Groundwater quality data for TPH-d were not compliant with Ecology MTCA Method A during the September 2020 monitoring event.
