Property Location Maps
Duwamish Marine Center Property
6365 First Avenue South
Seattle, WA 98018

Site Diagram, PLS, Inc. Survey
Duwamish Marine Center Property
6365 First Avenue South
Seattle, Washington

Historical Practices/Businesses
Duwamish Marine Center Property
6365 First Avenue South
Seattle, Washington

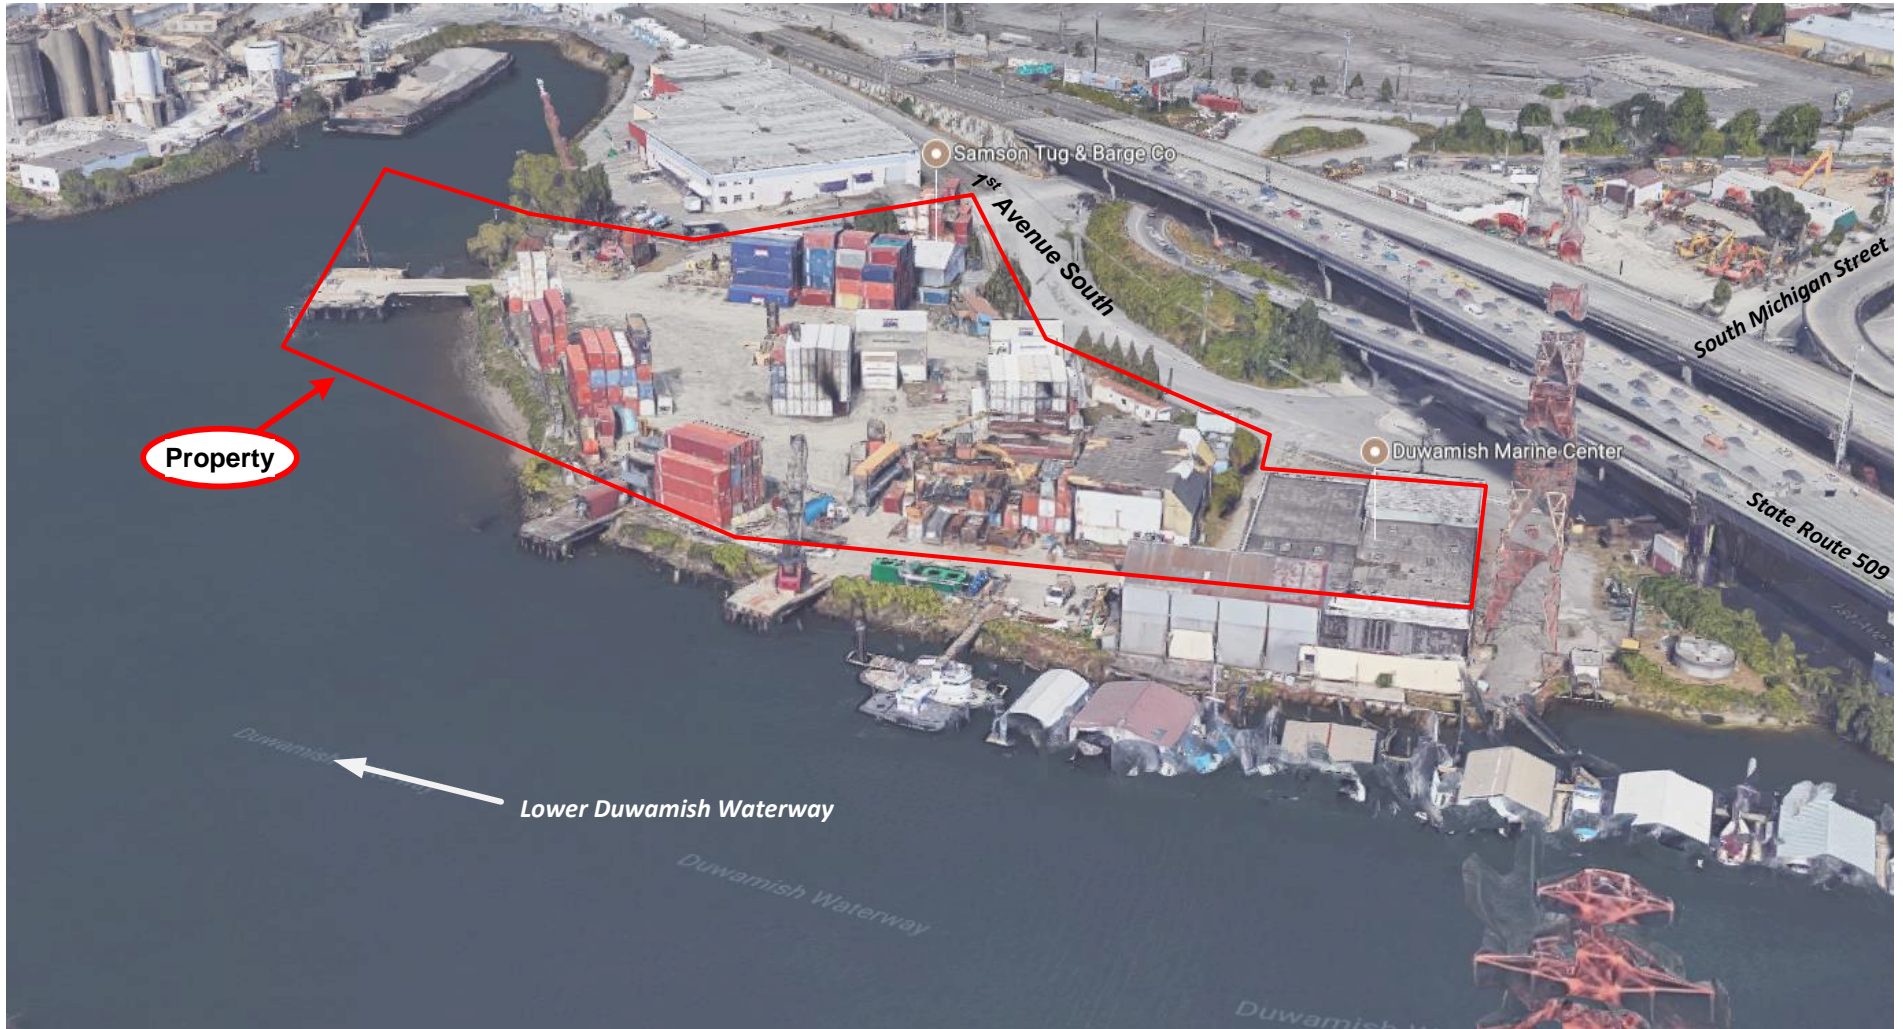
Figure
1-3

Site Aerial Photo, Oblique View
Duwamish Marine Center Property
6365 First Avenue South
Seattle, WA 98018

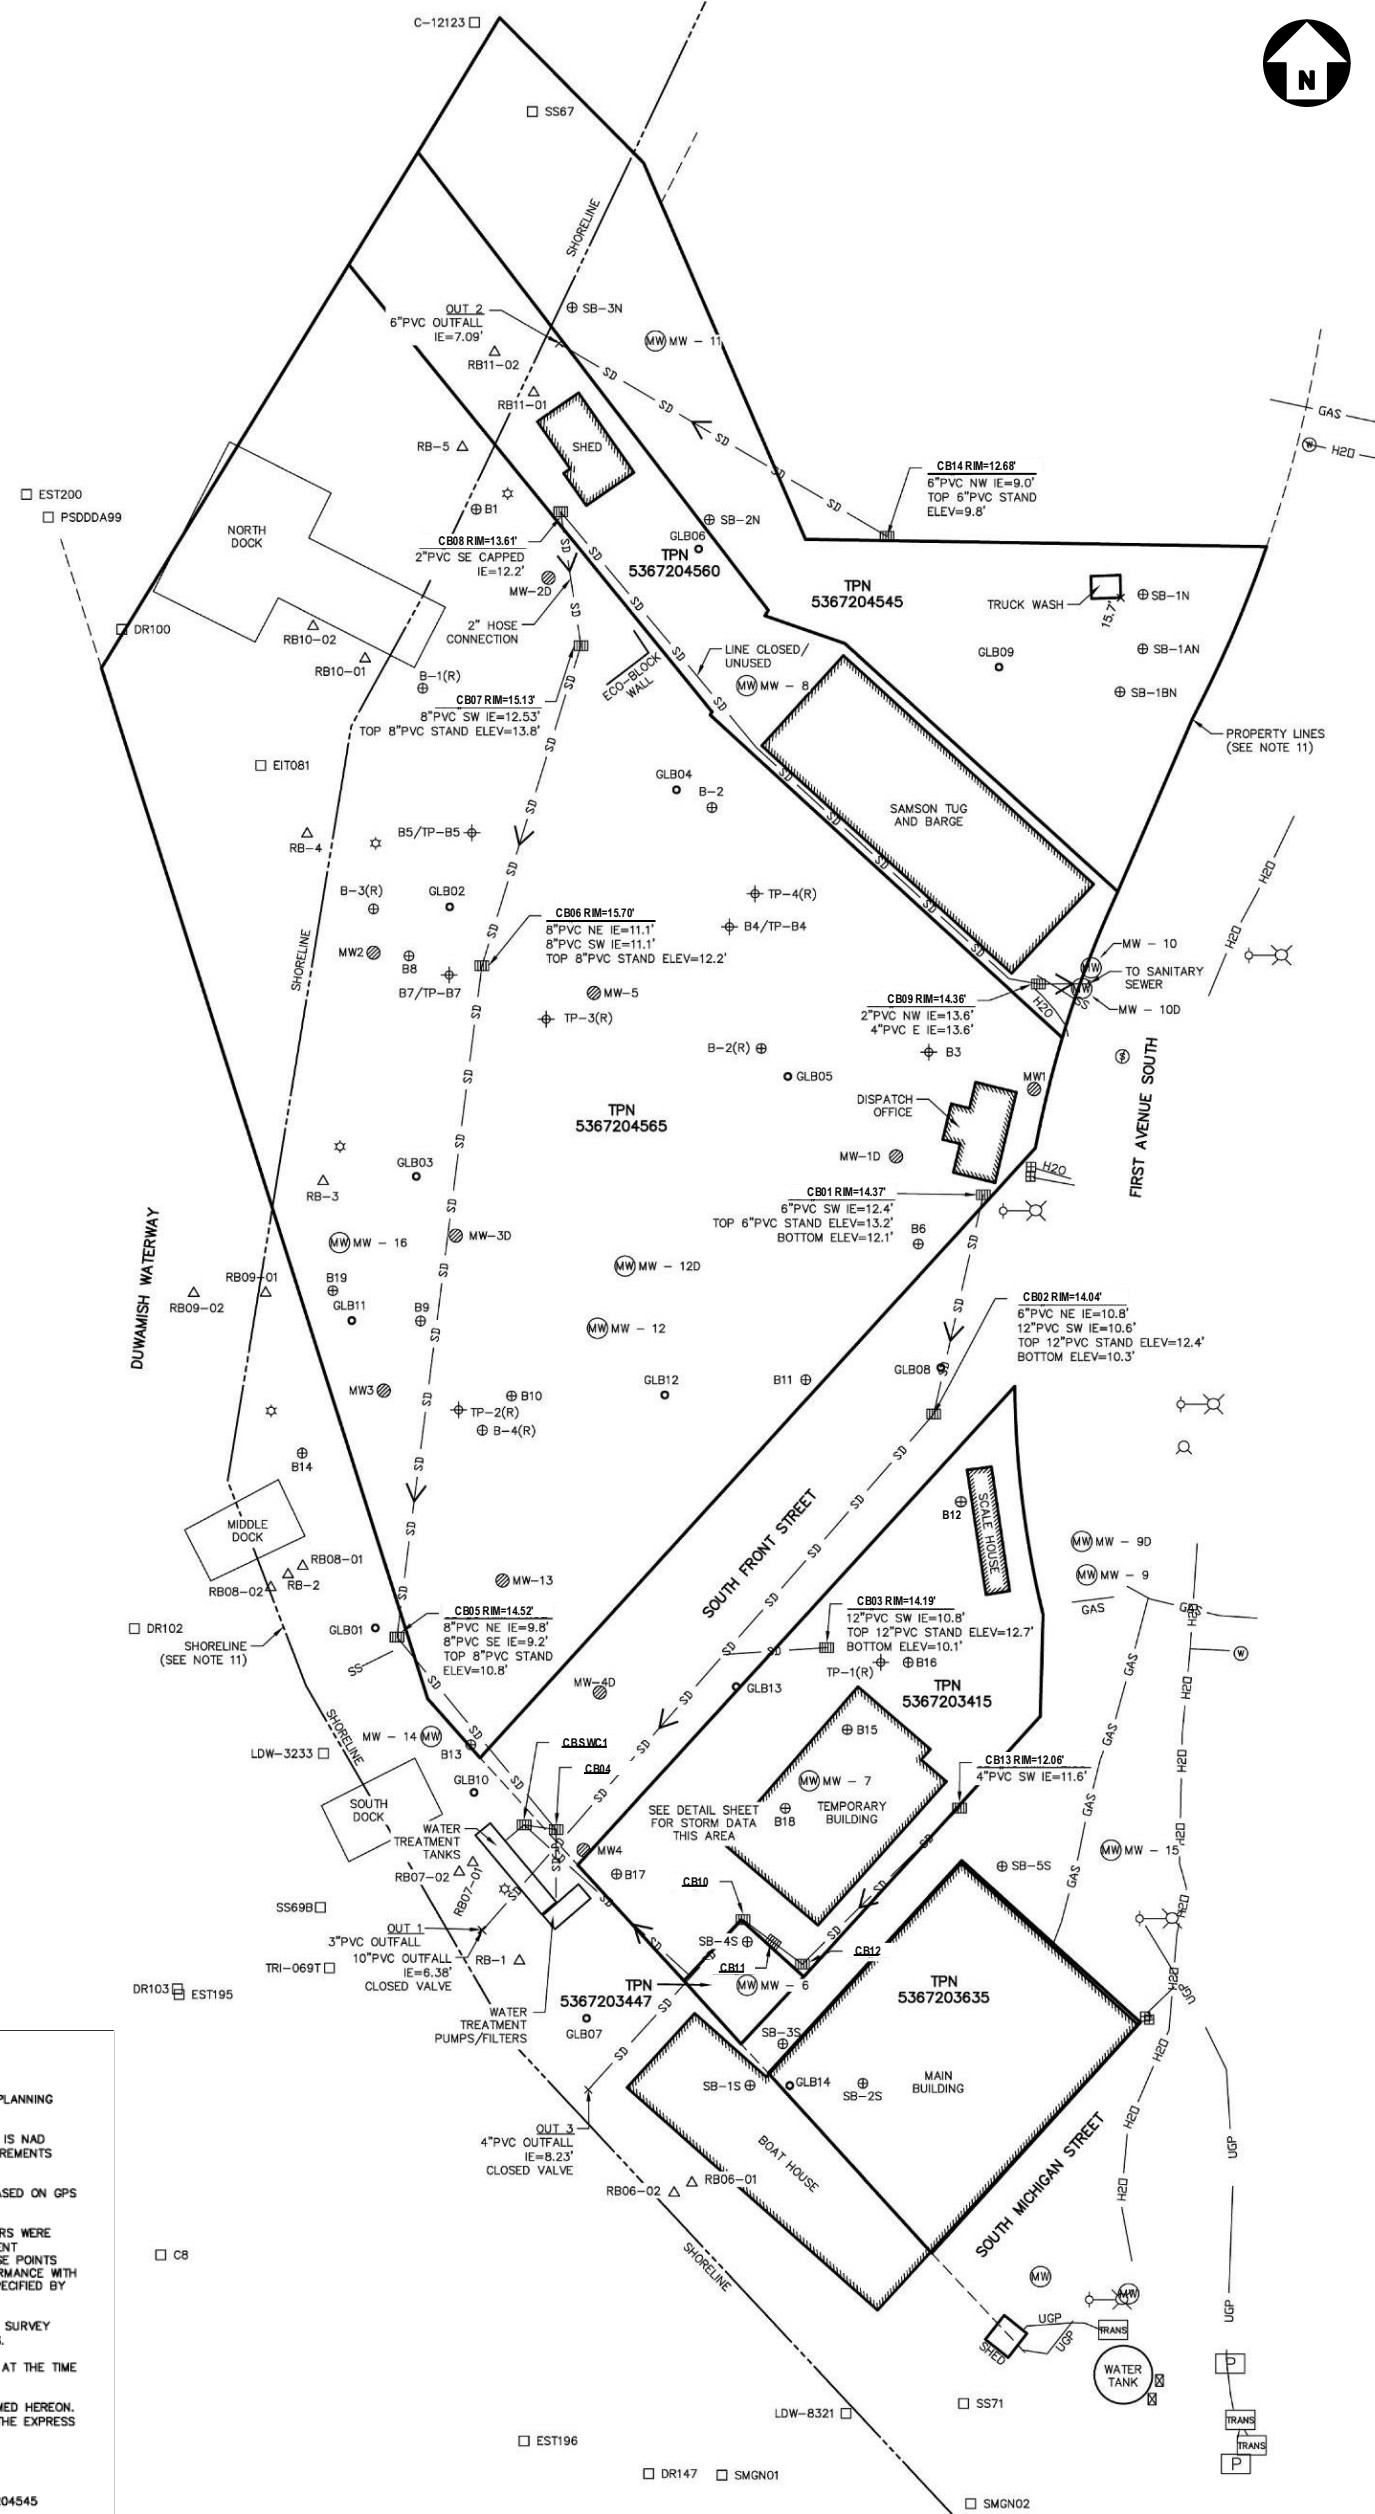
Figure
2

- 1.) **PURPOSE OF SURVEY:** THE PURPOSE OF THIS SURVEY WAS TO DEVELOP A PLANNING AND DESIGN BASE FOR USE BY OTHERS.
- 2.) **HORIZONTAL DATUM:** THE OVERALL HORIZONTAL DATUM FOR THIS PROJECT IS NAD 83/91, WASHINGTON COORDINATE SYSTEM, NORTH ZONE, BASED ON GPS MEASUREMENTS USING THE WASHINGTON STATE REFERENCE NETWORK.

- 10.) **THE UNDERGROUND UTILITIES SHOWN HEREON HAVE BEEN LOCATED FROM A COMBINATION OF:** 1.) THE FIELD SURVEYED LOCATION OF VISIBLE SURFACE UTILITY STRUCTURES SUCH AS MANHOLE LIDS, GRATES, GAS AND WATER VALVE LIDS, ETC... 2.) AS-BUILT RECORDS AND MAPS OBTAINED FROM CLIENT, AND 3.) THE FIELD SURVEYED LOCATION OF PAINT OR OTHER MARKS OR MARKERS PLACED BY AN UNDERGROUND UTILITY LOCATOR SERVICE. WE MAKE NO GUARANTEE THAT THE UNDERGROUND UTILITIES SHOWN COMPRISE ALL SUCH UTILITIES IN THE AREA, EITHER IN SERVICE OR ABANDONED, NOR THAT ARE IN THE EXACT LOCATION SHOWN. AN UNDERGROUND UTILITY LOCATING SERVICE WAS NOT HIRED BY PLS, INC. NOR OTHERS TO SURFACE MARK UTILITY LINES FOR THIS PROJECT.

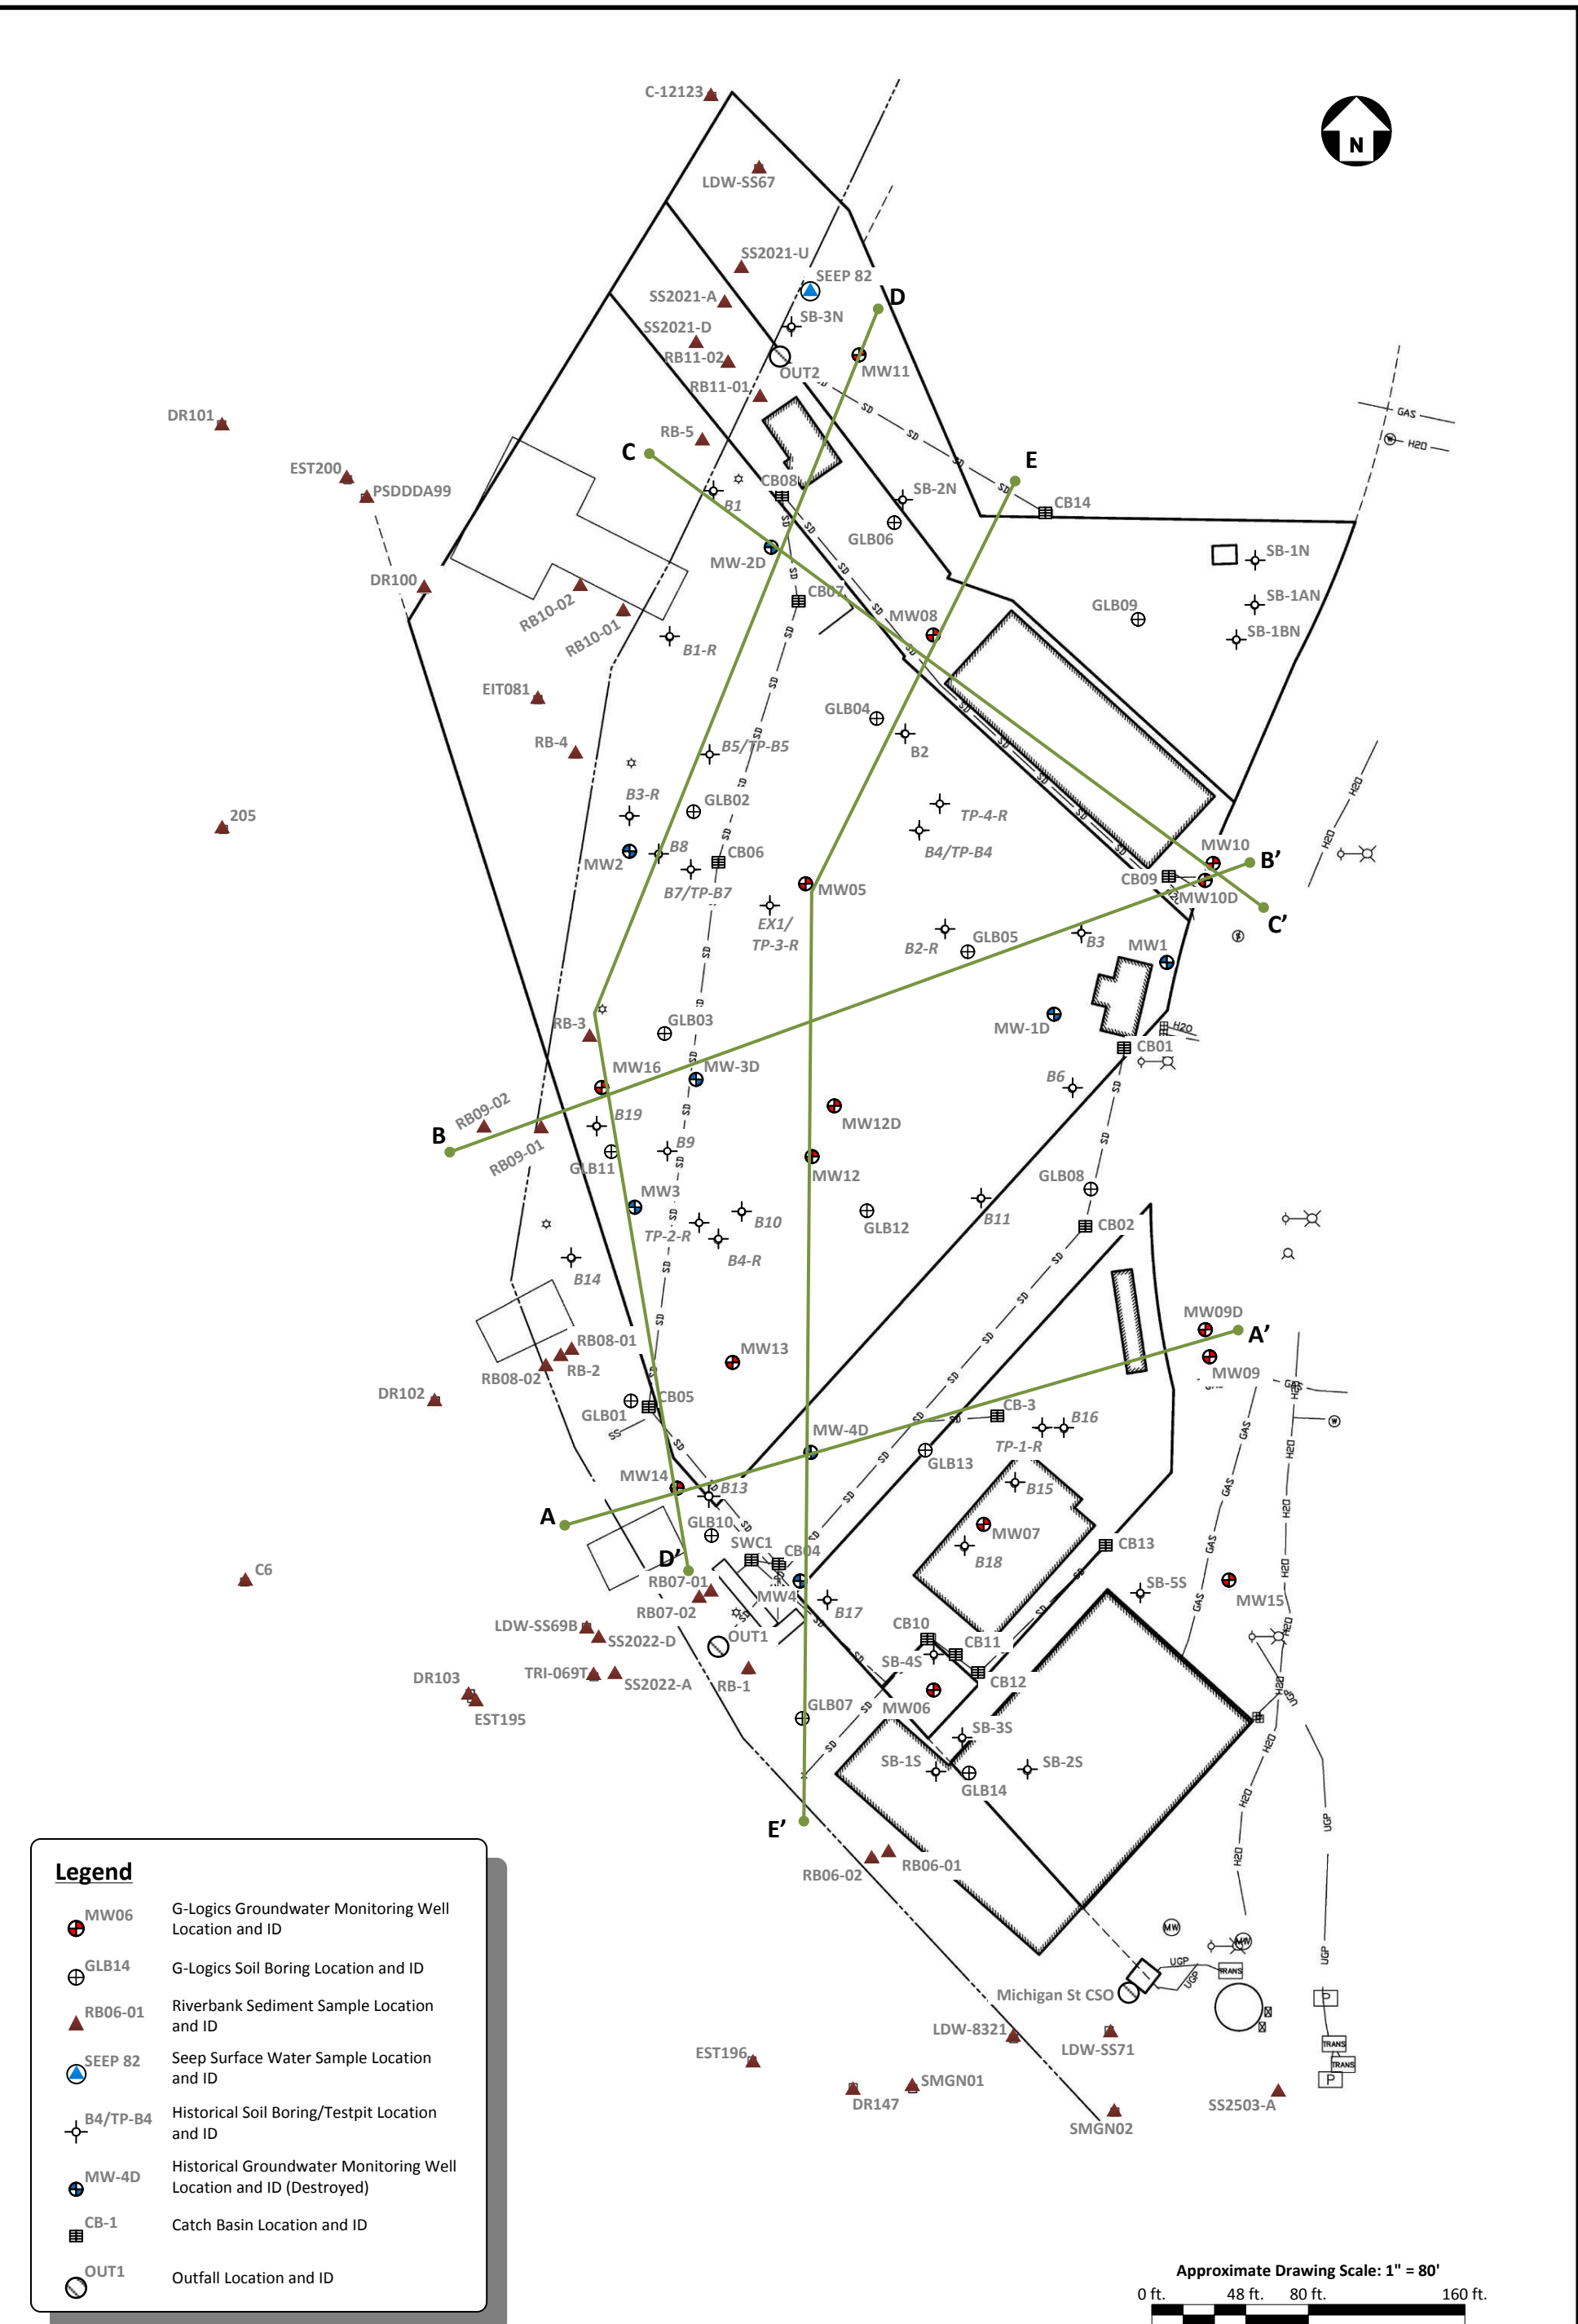
Figure 7-1

Cross Section Lines
 Duwamish Marine Center Property
 6365 First Avenue South
 Seattle, Washington

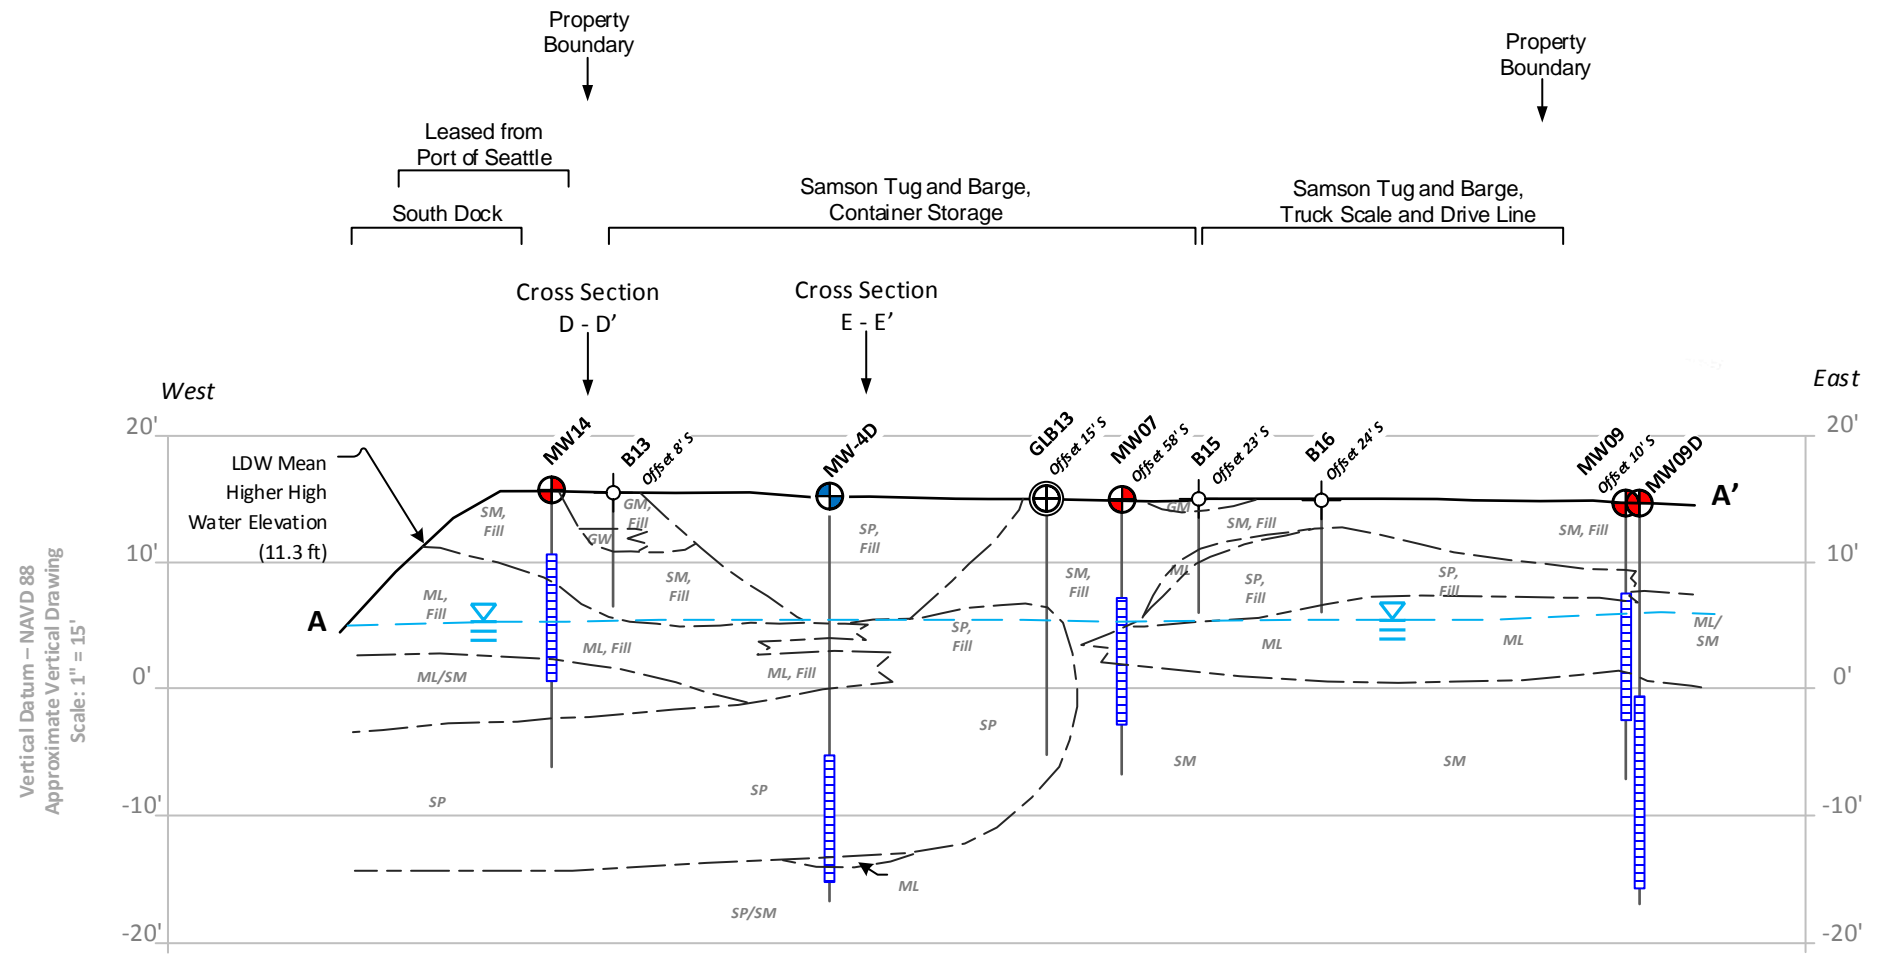
Figure
7-2

Approximate Water Table Elevation (Based on G-Logics Tidal-Influence Study dated June 21, 2019)
	Cross Section Line, Approximate Ground Surface
	Approximate Geologic Contact Based on USCS Soil Classification
	Boring/Well/Probe Location
	Boring Depth
	Well Screen Interval

Cross Section A to A'
Duwamish Marine Center Property
6365 First Avenue South
Seattle, Washington

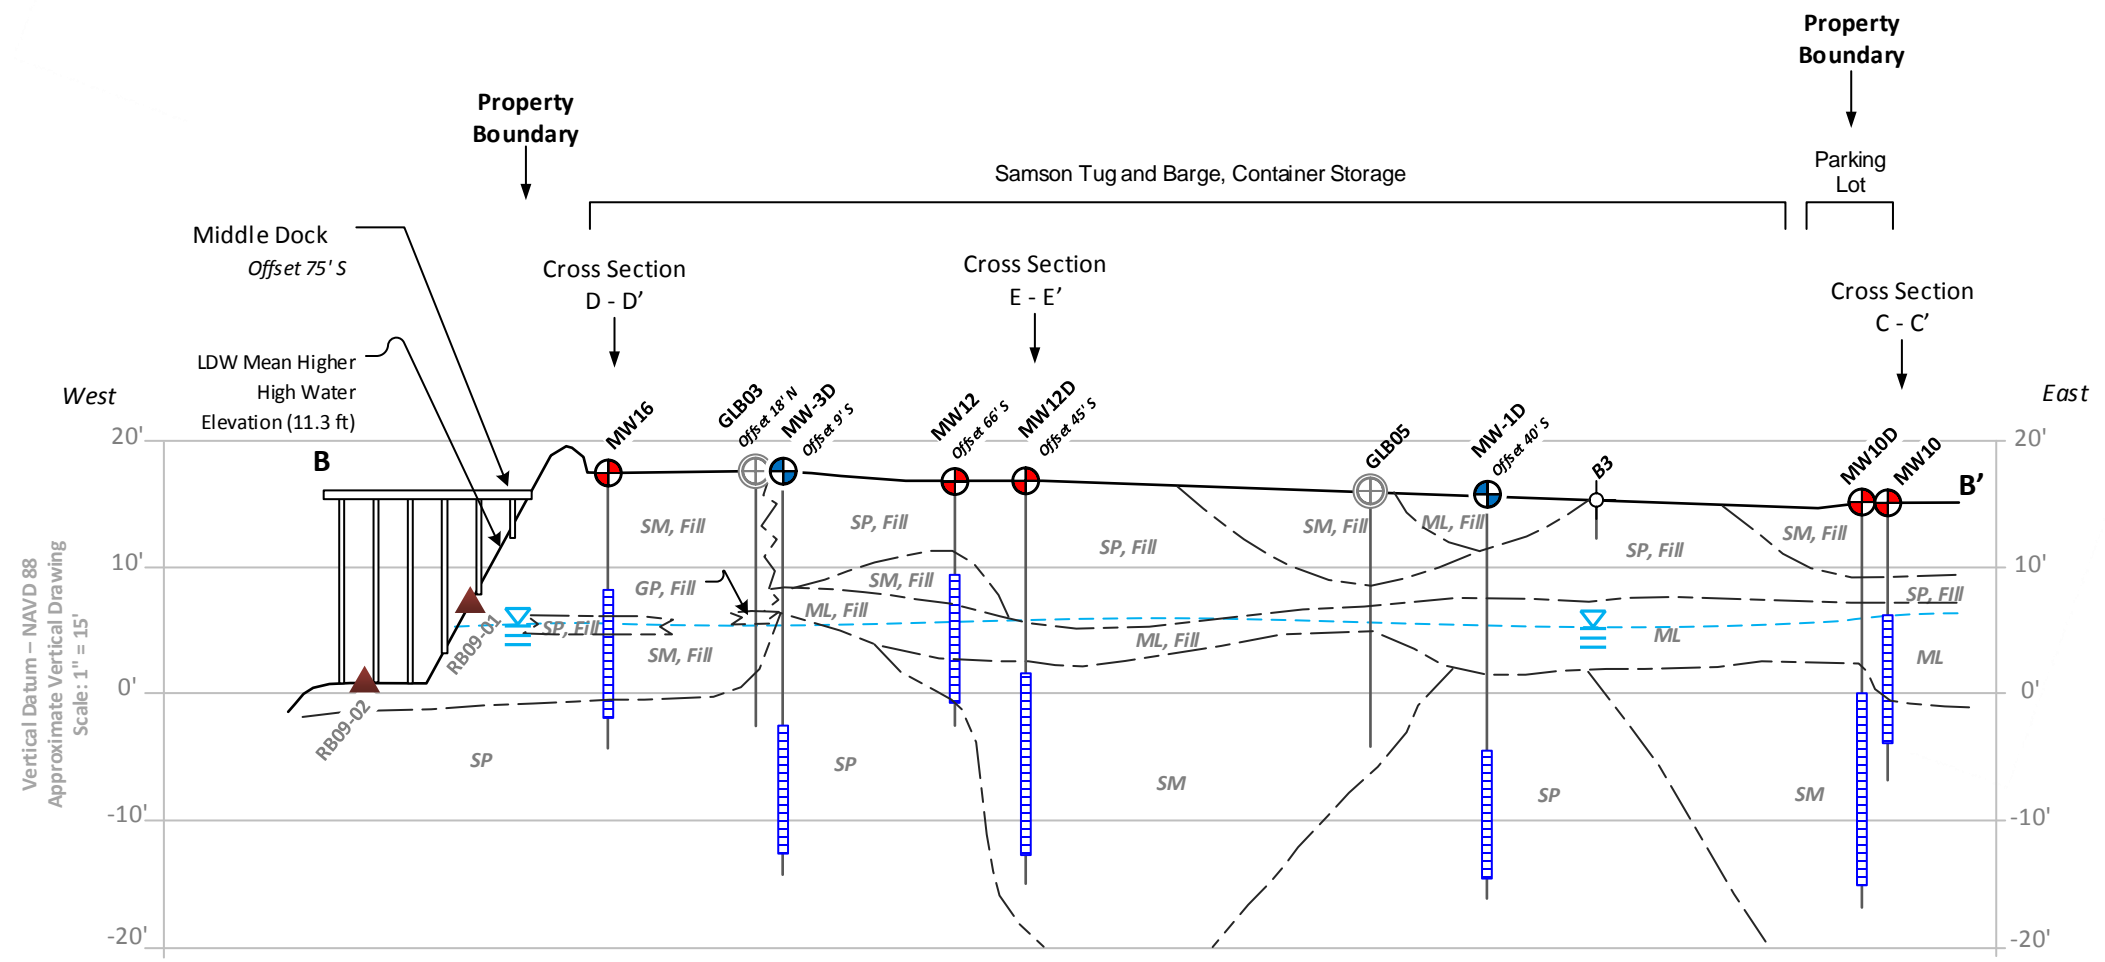
Figure
7-3

Cross Section B to B'
Duwamish Marine Center Property
6365 First Avenue South
Seattle, Washington

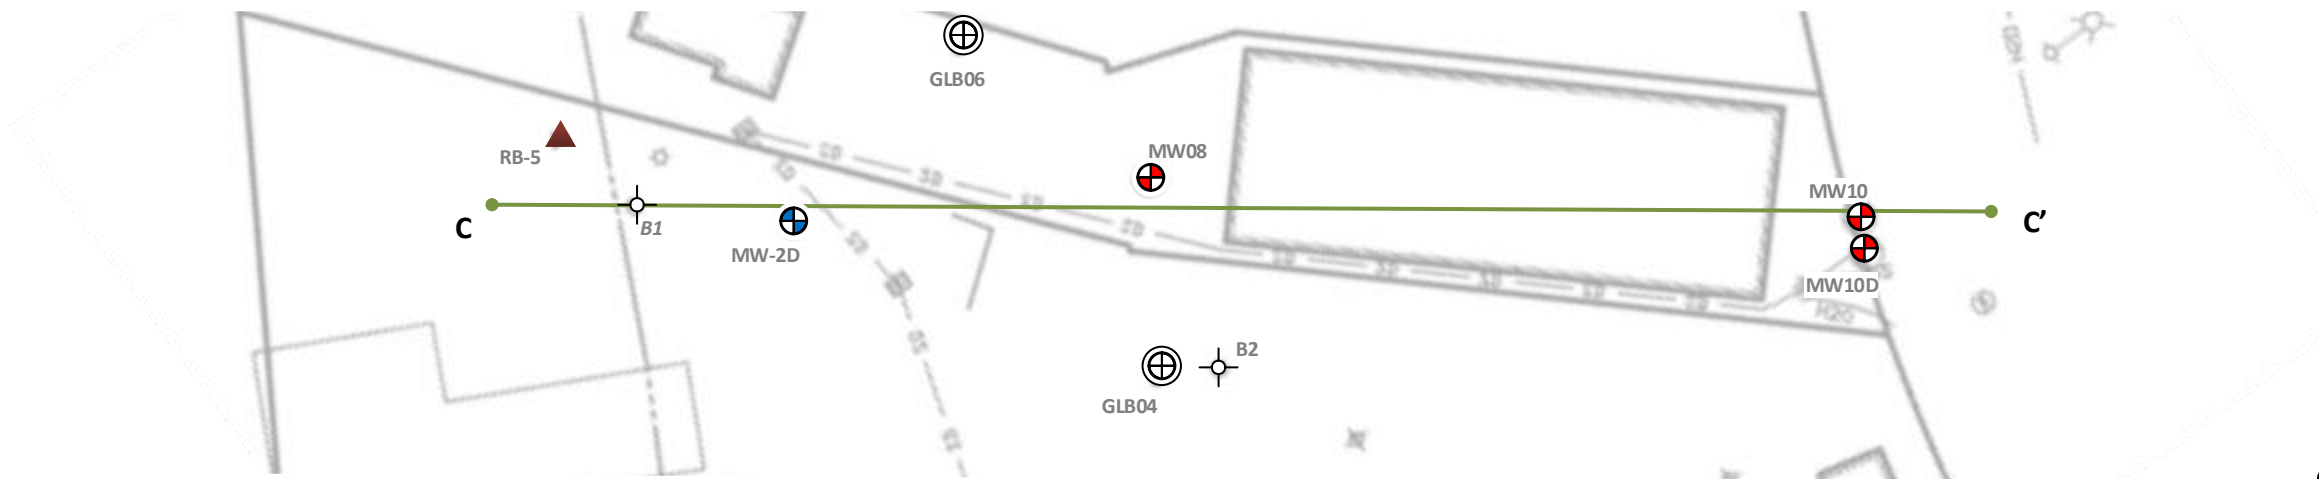
Cross-Section Legend	
	Approximate Water Table Elevation (Based on G-Logics Tidal-Influence Study dated June 21, 2019)
	Cross Section Line, Approximate Ground Surface
	Approximate Geologic Contact Based on USCS Soil Classification
	Boring/Well/Probe Location
	Boring Depth
	Well Screen Interval
Note: See boring logs for full geologic description

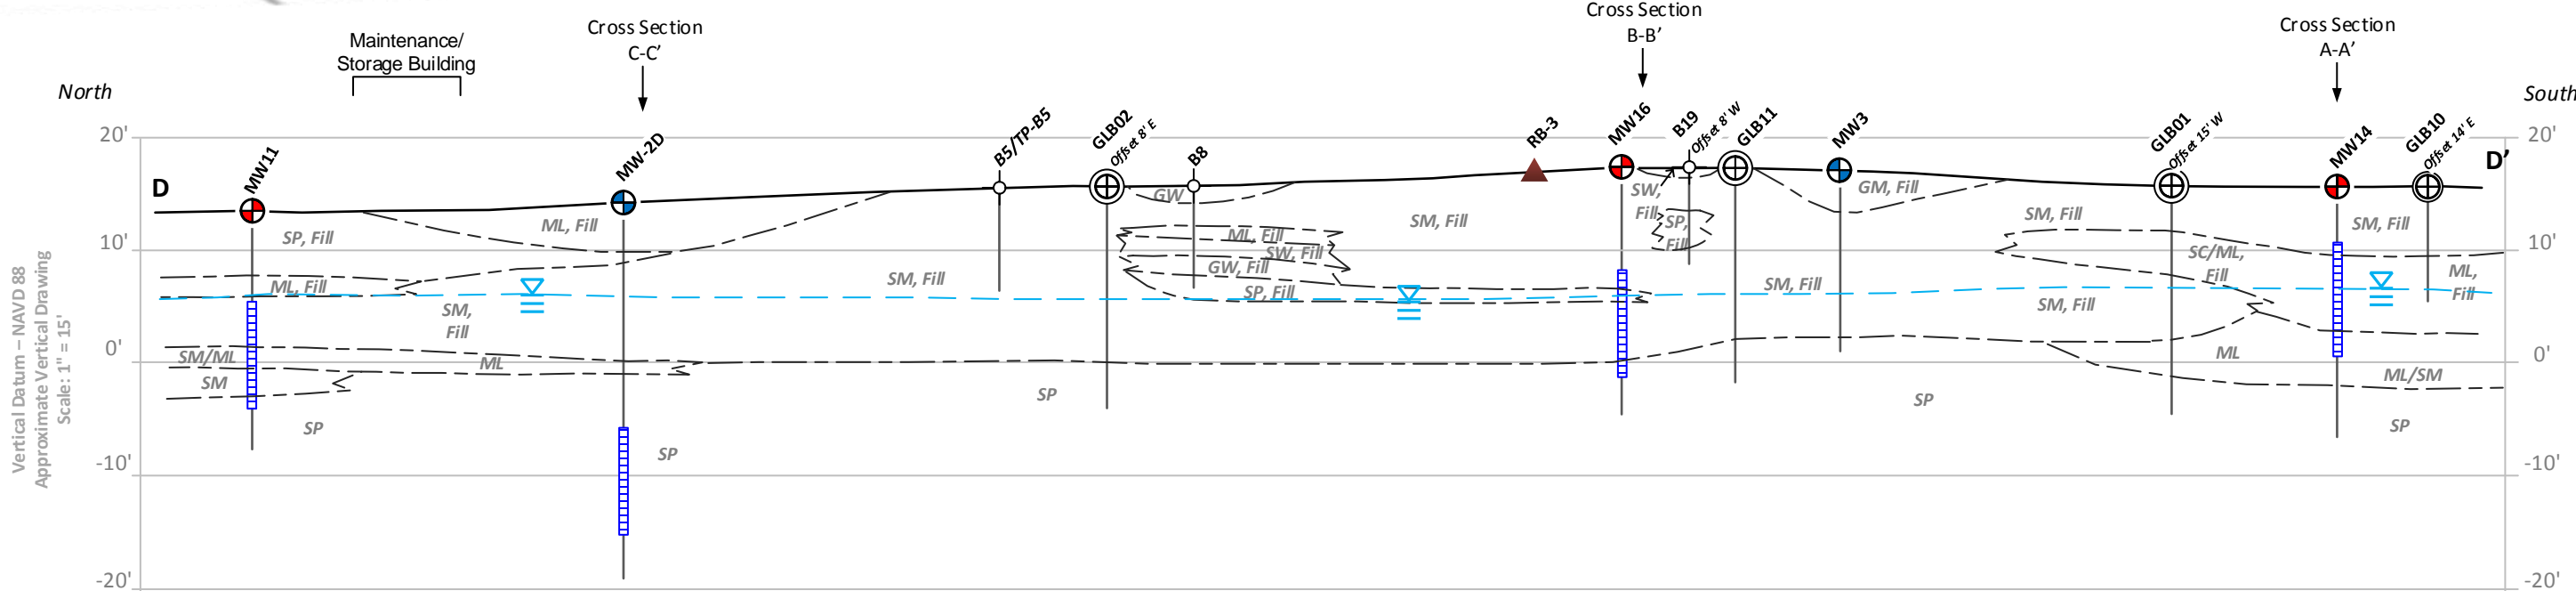
Figure
7-5

Cross Section D to D'
Duwamish Marine Center Property
6365 First Avenue South
Seattle, Washington

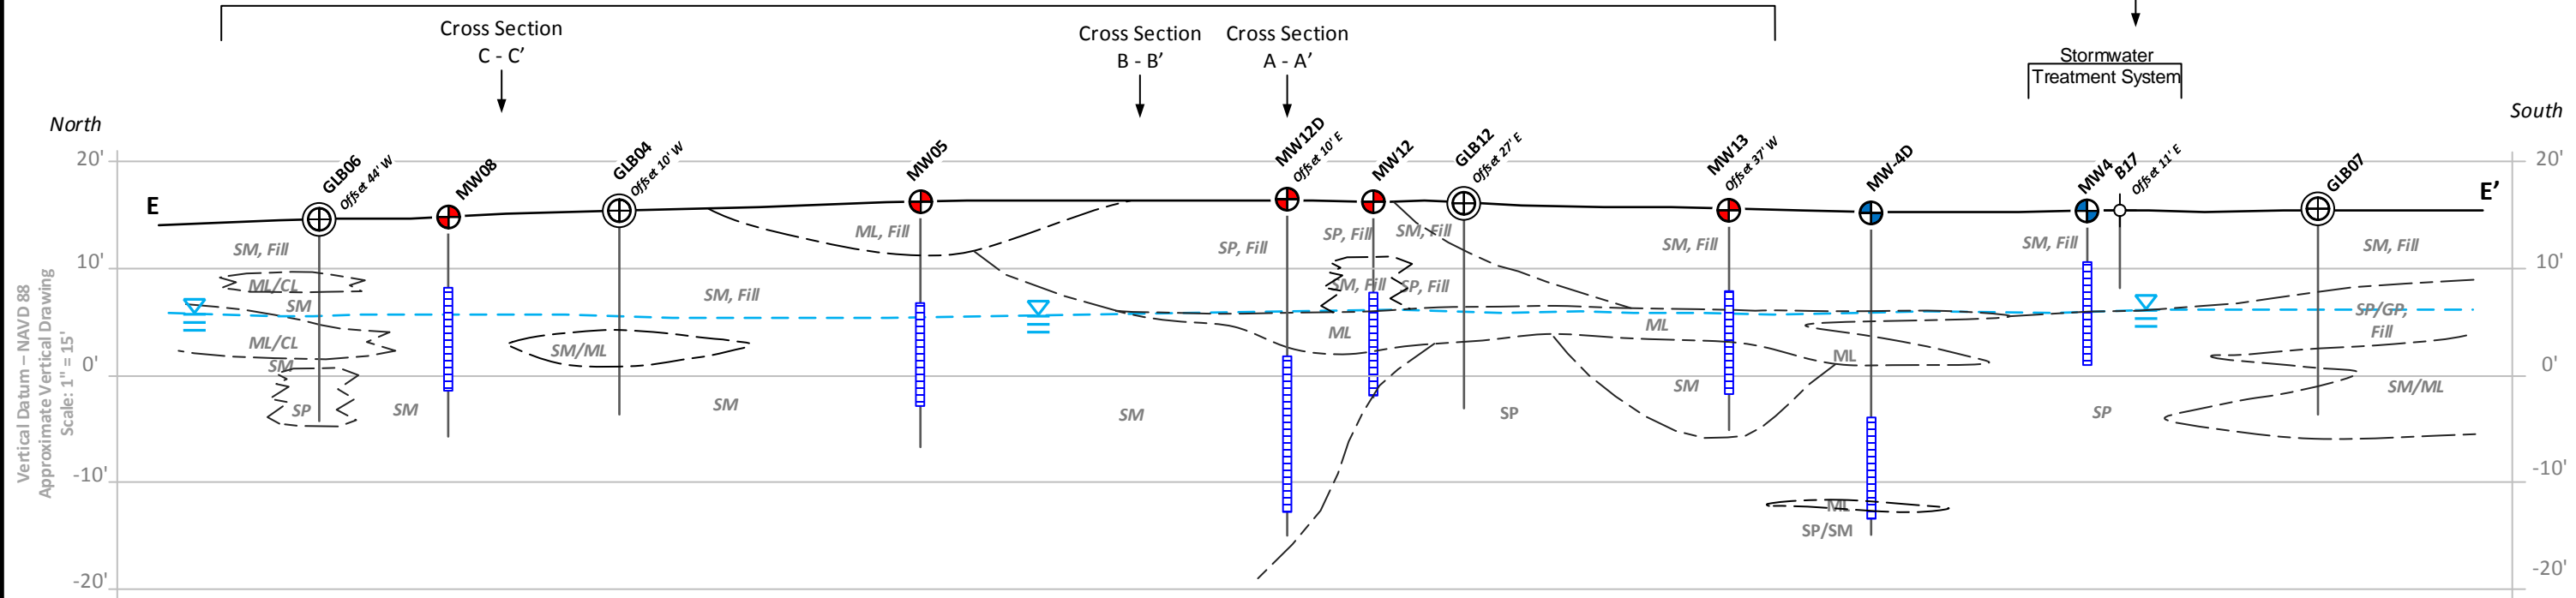
Figure
7-6

Cross Section E to E'
Duwamish Marine Center Property
6365 First Avenue South
Seattle, Washington

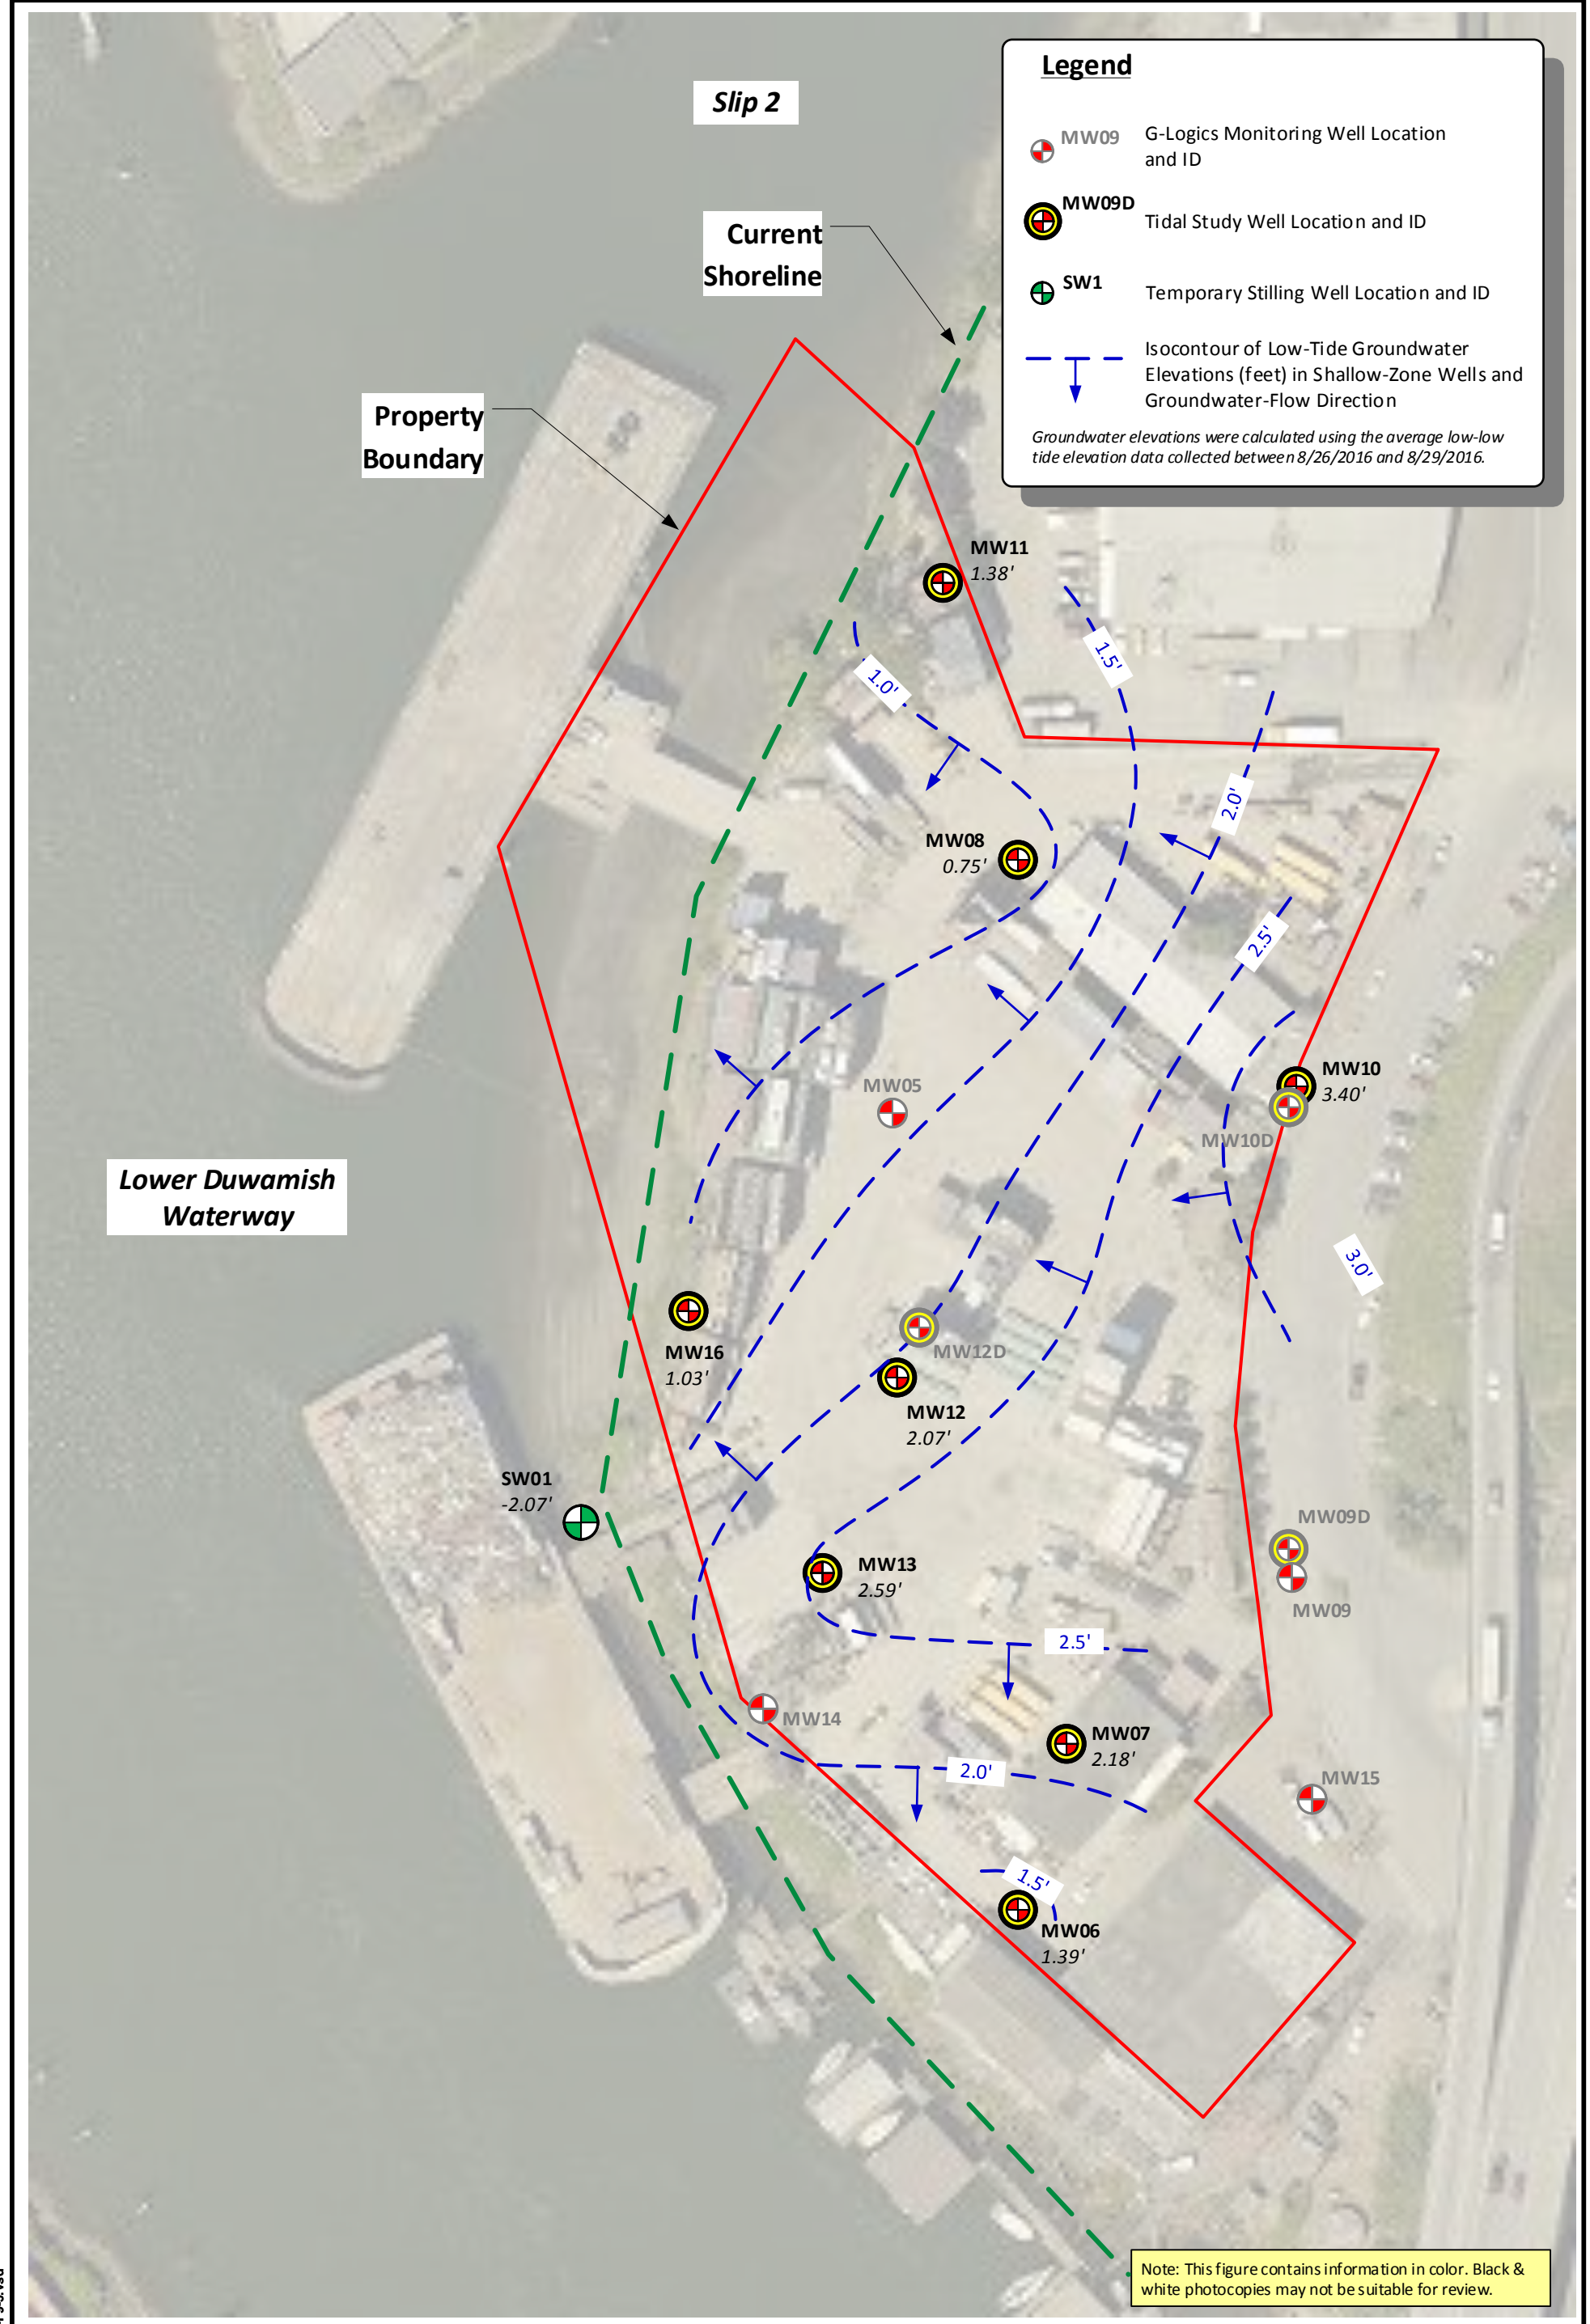
Figure
 9-3

Low Tide Groundwater Isocontours
Duwamish Marine Center Property
 6365 First Avenue South
 Seattle, Washington
