Property Location Maps
Duwamish Marine Center Property
6365 First Avenue South
Seattle, WA 98018

Site Diagram, PLS, Inc. Survey
Duwamish Marine Center Property
6365 First Avenue South
Seattle, Washington

Historical Practices/Businesses
Duwamish Marine Center Property
6365 First Avenue South
Seattle, Washington

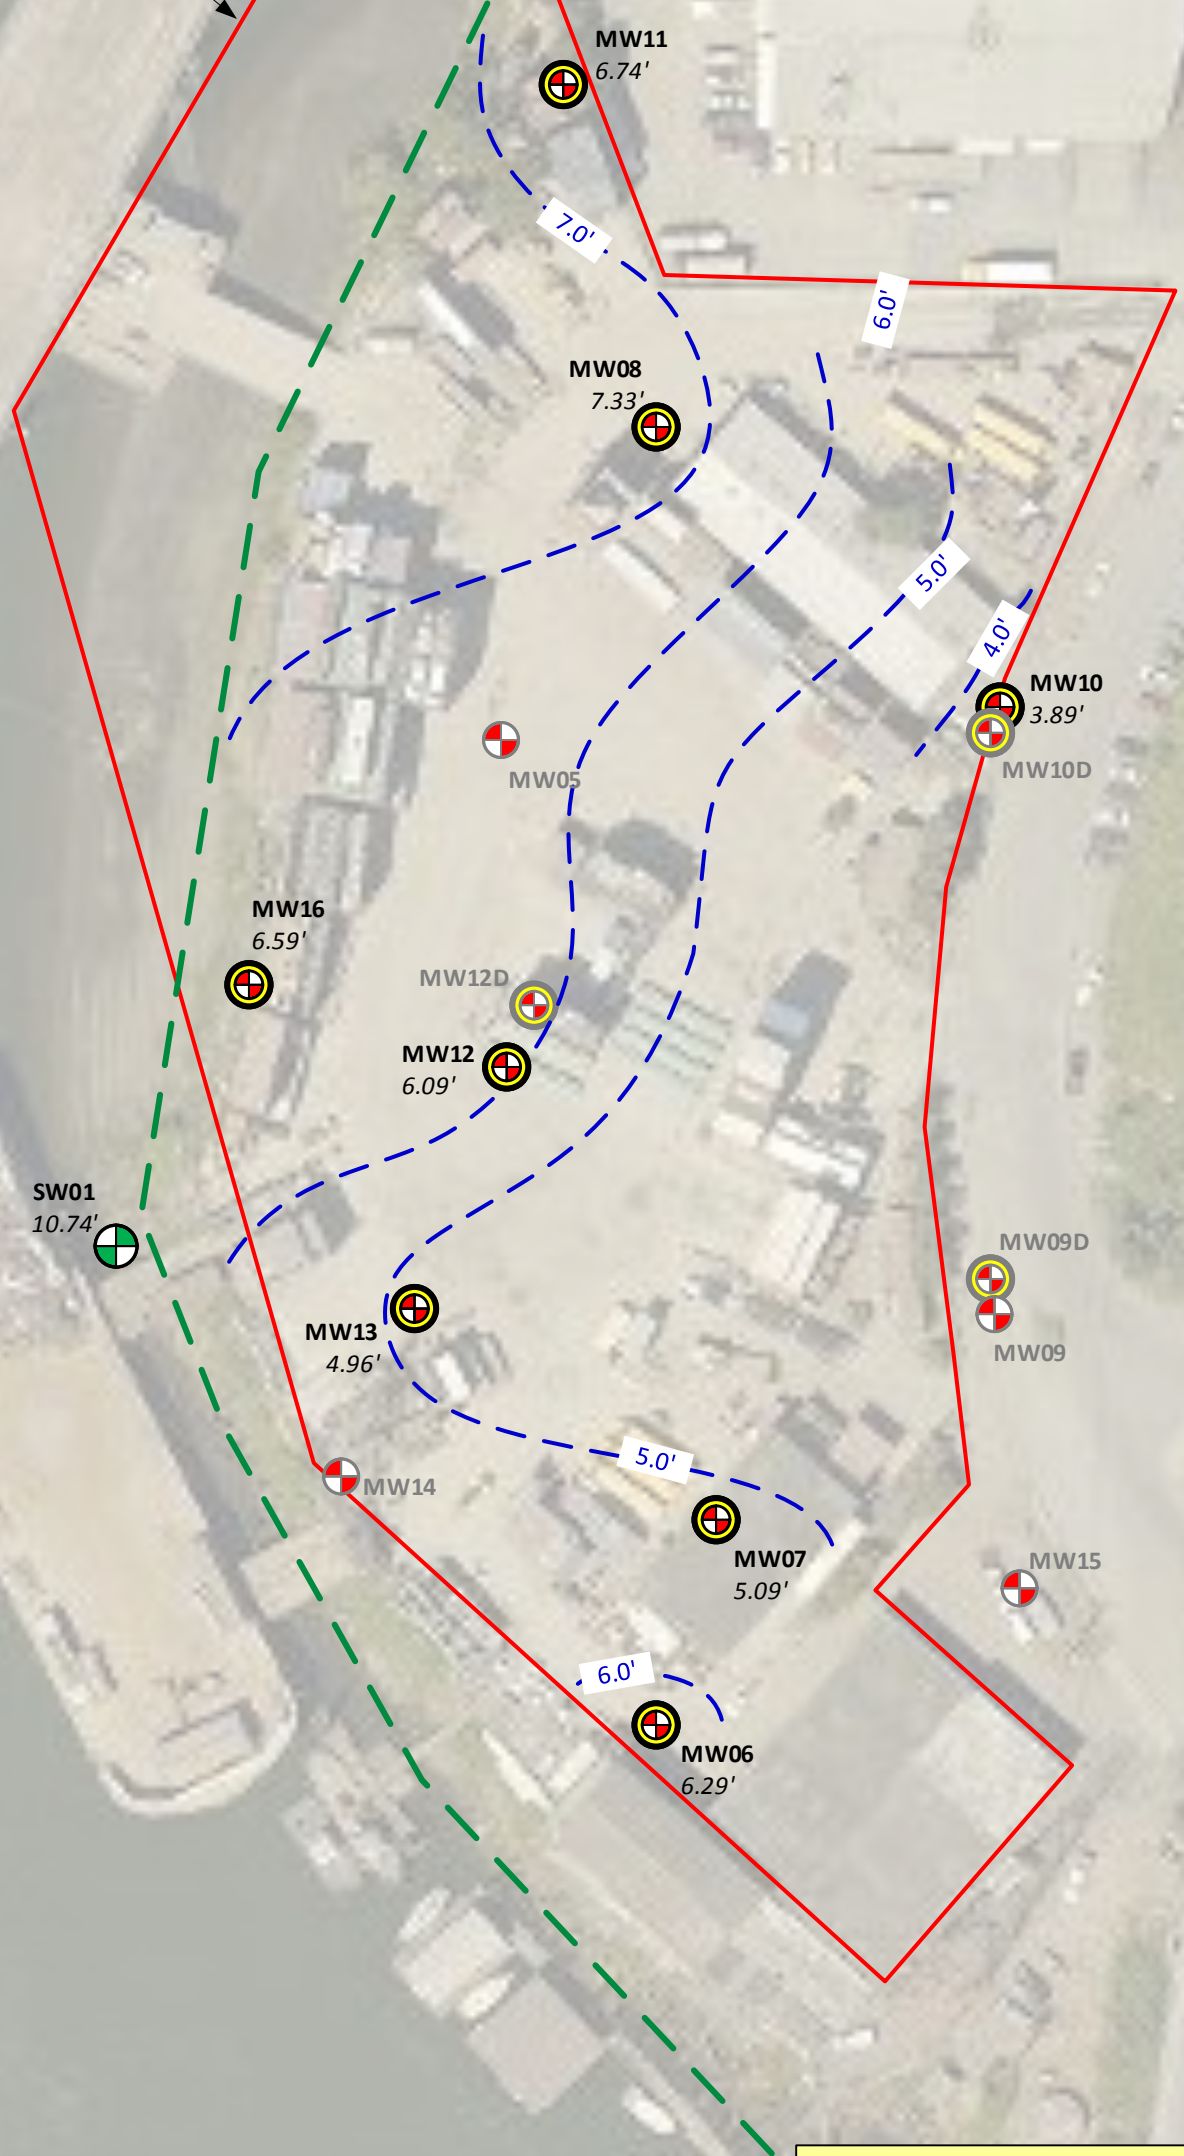
Figure 9-5

Isocontour of Groundwater-Elevation Fluctuations for Shallow-Zone Wells (feet)

Groundwater fluctuations were calculated using the high and low-low tide elevation data collected between 8/26/2016 and 8/29/2016.

Average Groundwater Fluctuations
Duwamish Marine Center Property
 6365 First Avenue South
 Seattle, Washington

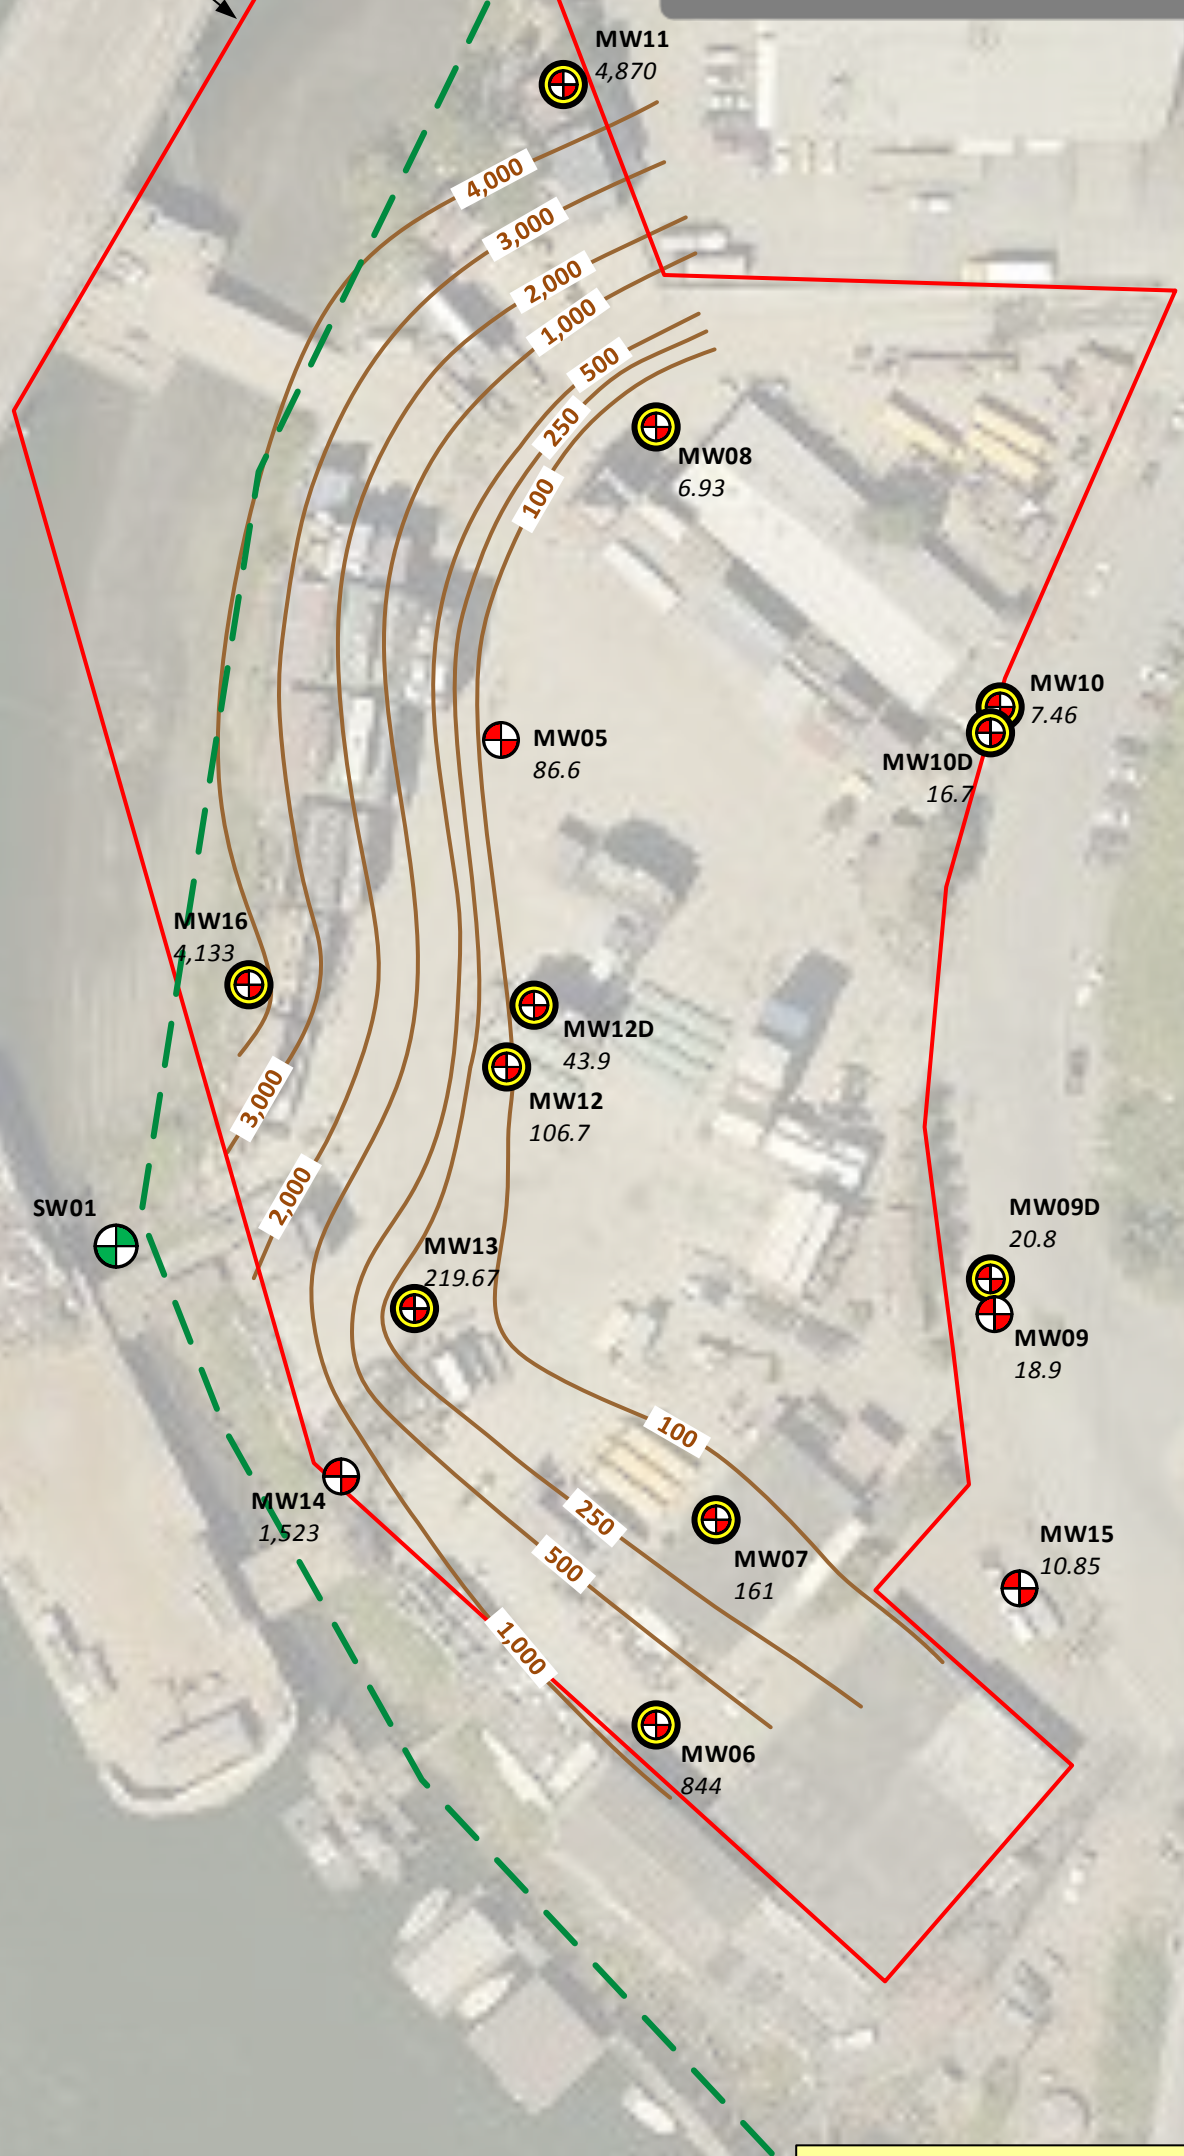
Figure 9-7

Isocontour of Average Chloride Concentrations (mg/L)

Chloride concentrations are averages based on G-Logics groundwater-sampling events.

Average Chloride Isocontours
Duwamish Marine Center Property
 6365 First Avenue South
 Seattle, Washington

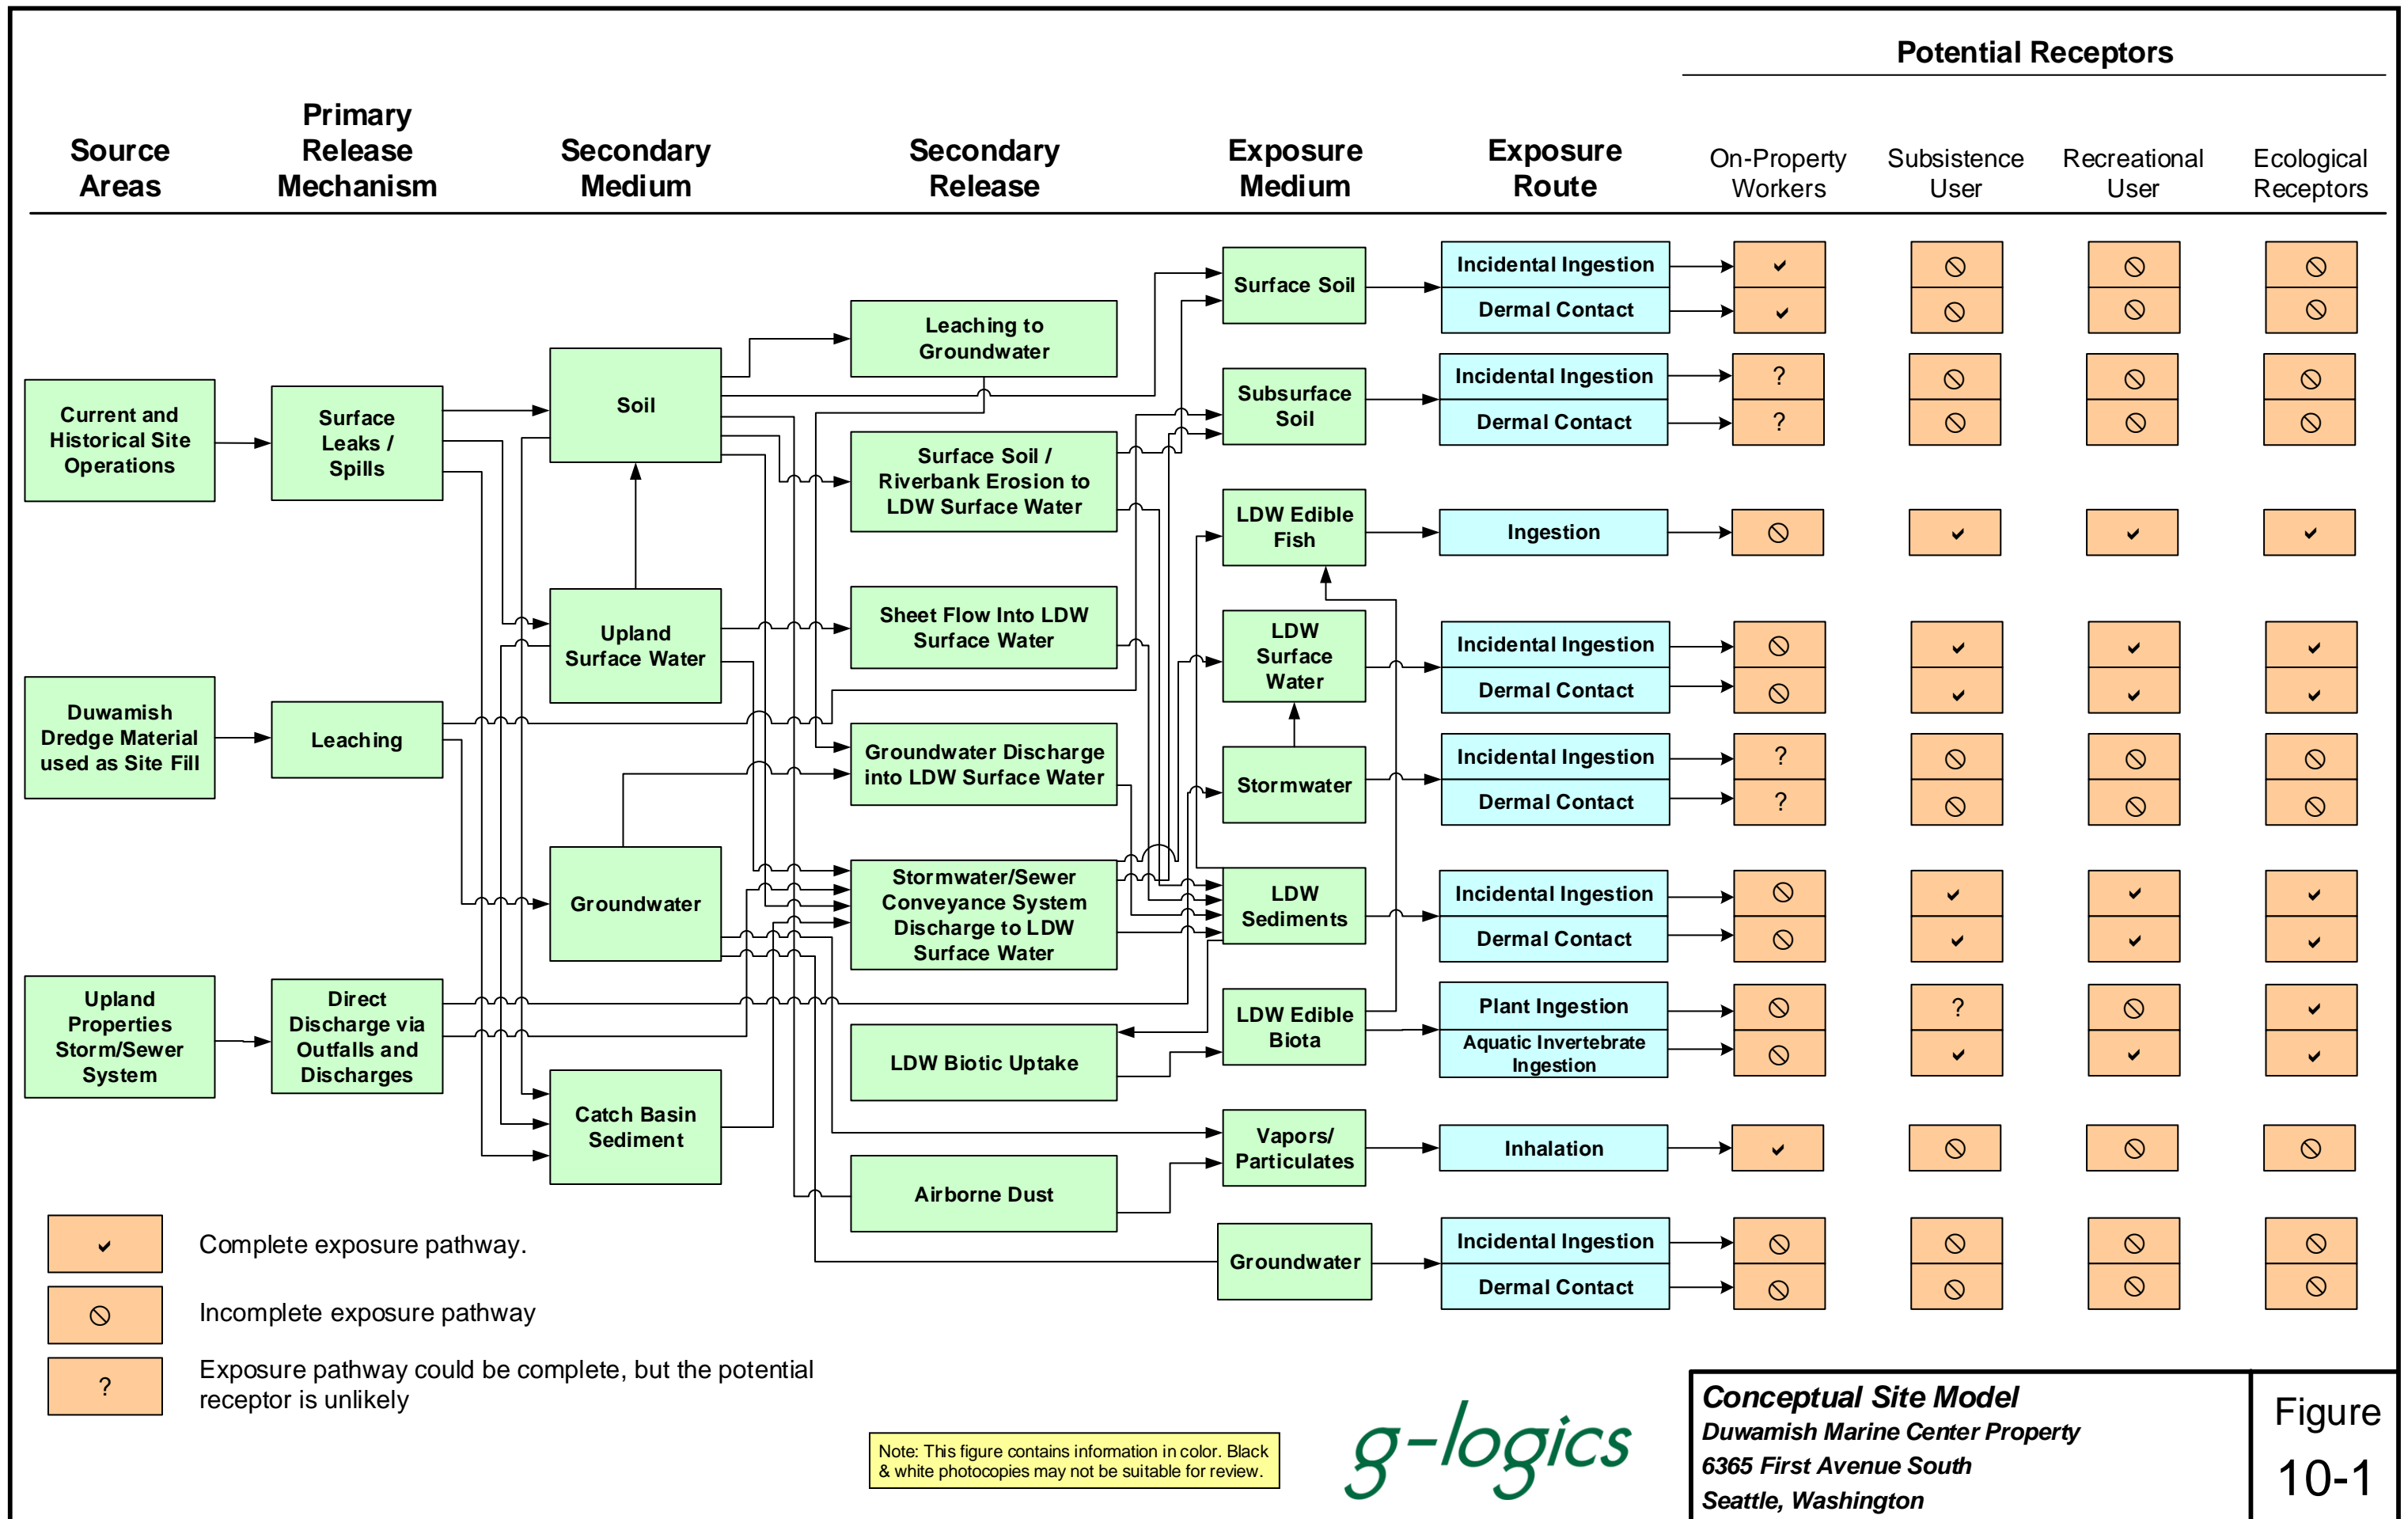
Figure
 10-1

Complete exposure pathway.

Incomplete exposure pathway

Conceptual Site Model
 Duwamish Marine Center Property
 6365 First Avenue South
 Seattle, Washington

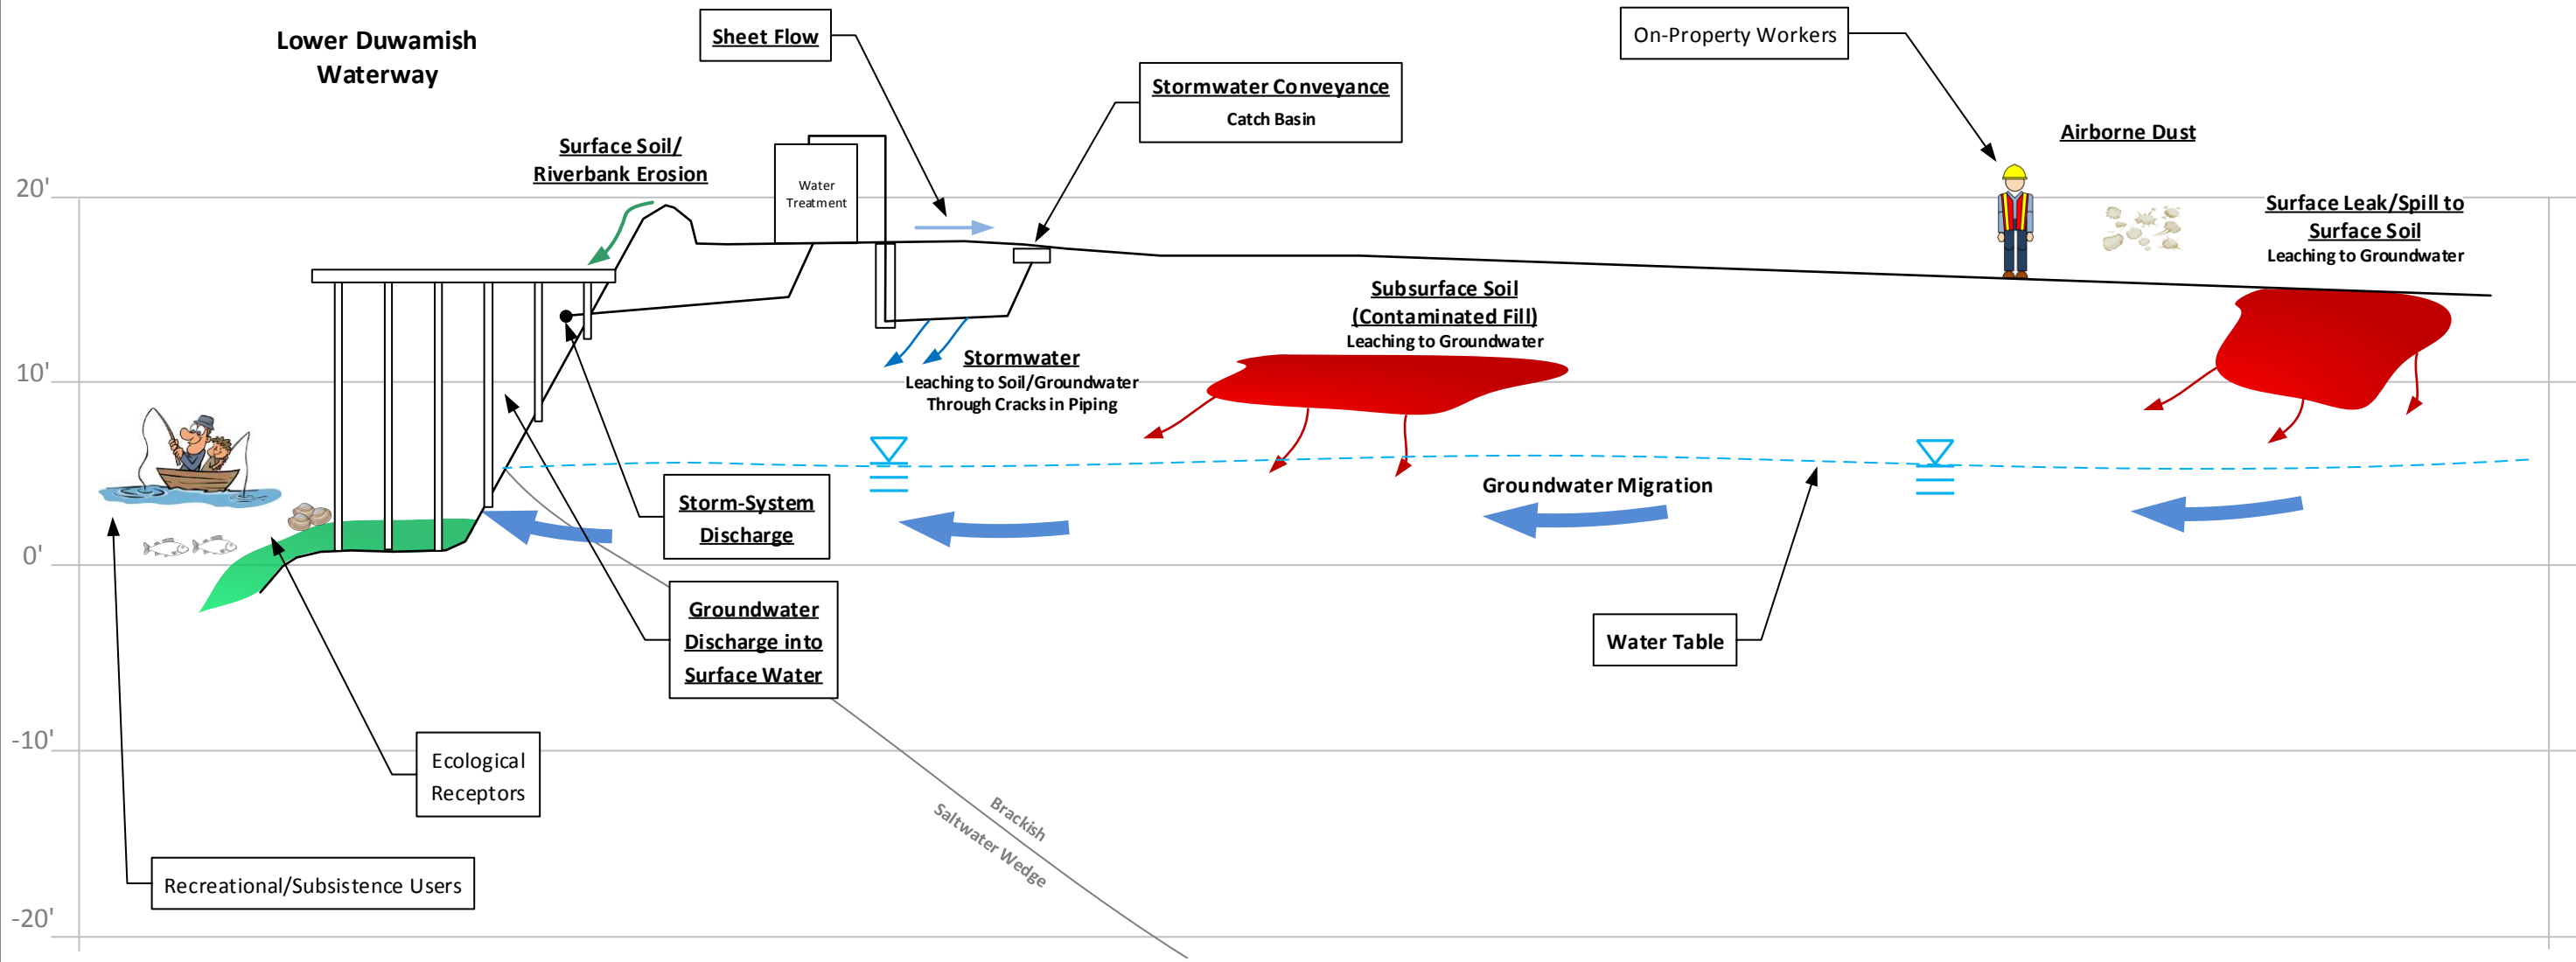
Figure
10-2

Conceptual Site Model Figure
Duwamish Marine Center Property
6365 First Avenue South
Seattle, Washington
