**Independent Remedial Action Report
Addendum
Lot 2, Custom-Bilt Metals
233 D Street
Auburn, Washington**

October 2002

21-1-12074-004

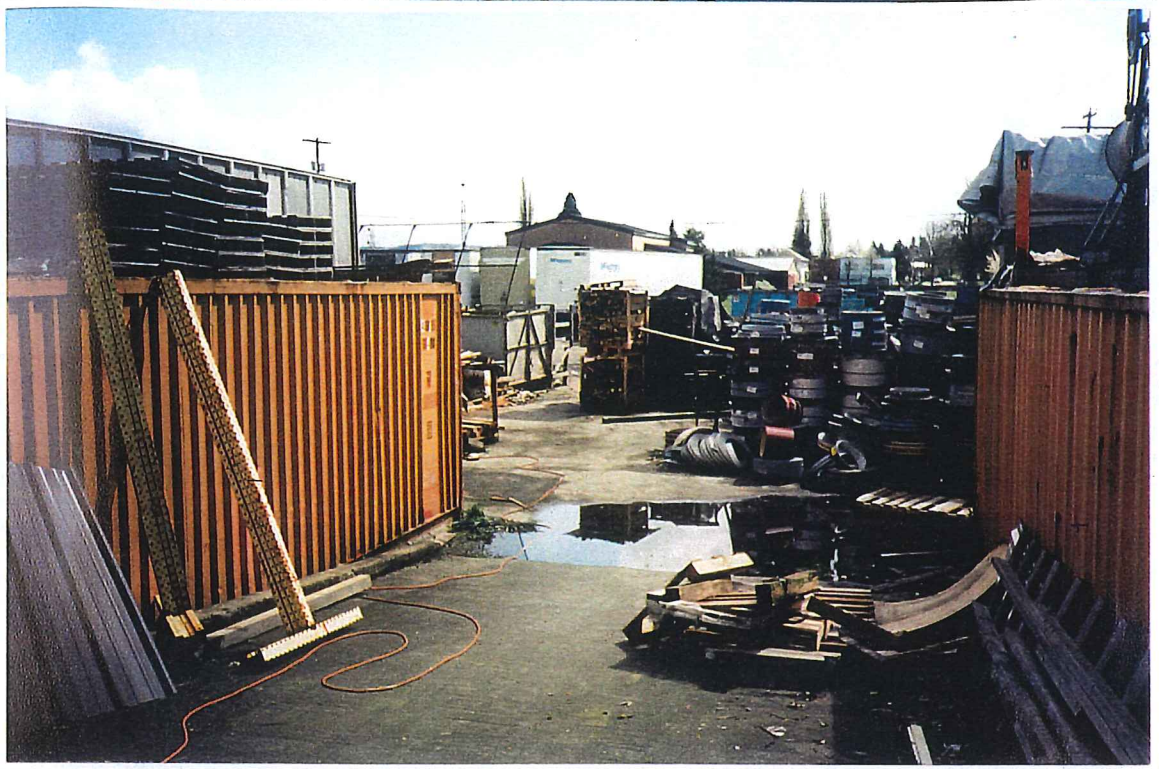
Photo #1: View of equipment and rolls of steel stored on the asphalt slab located just south of the concrete "up ramp," facing south. This photograph was taken prior to remediation. Photo taken on 4/18/01.

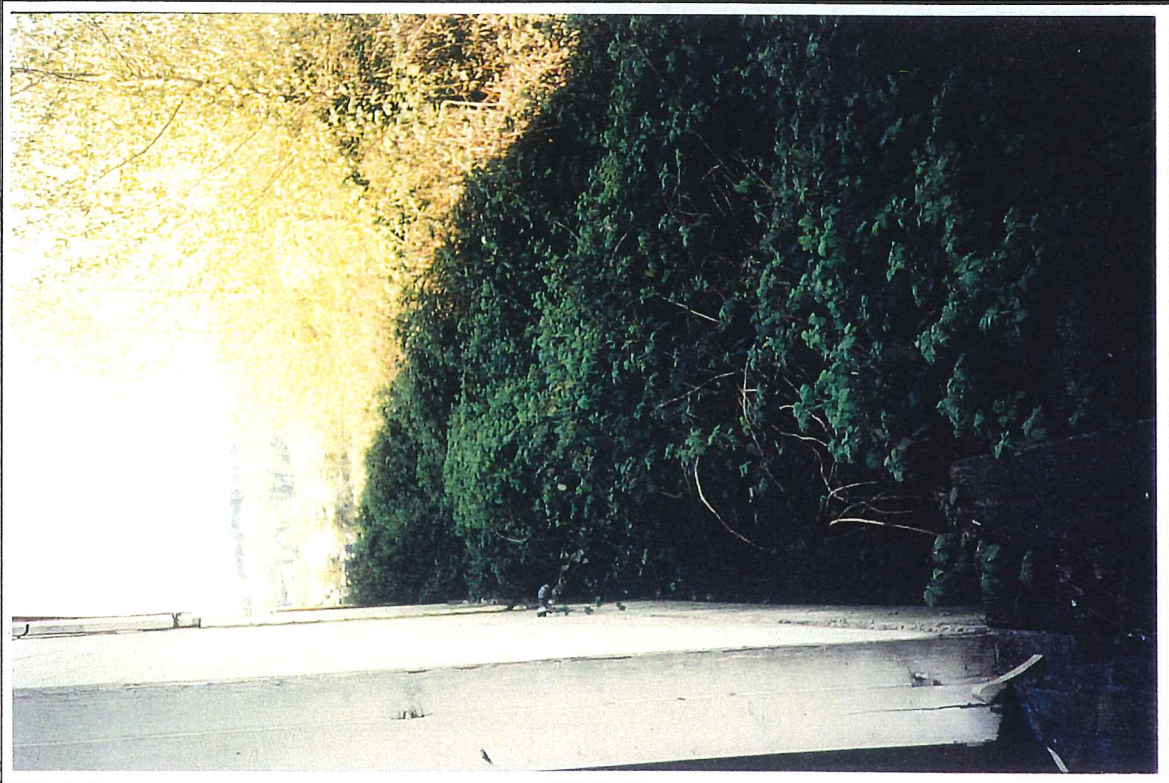
Photo #2: View of overgrown brambles located adjacent to the north of the Custom-Built Metals building, facing west. The brambles were cleared out prior to the Phase II Environmental Site Assessment. Photo taken on 4/18/01.

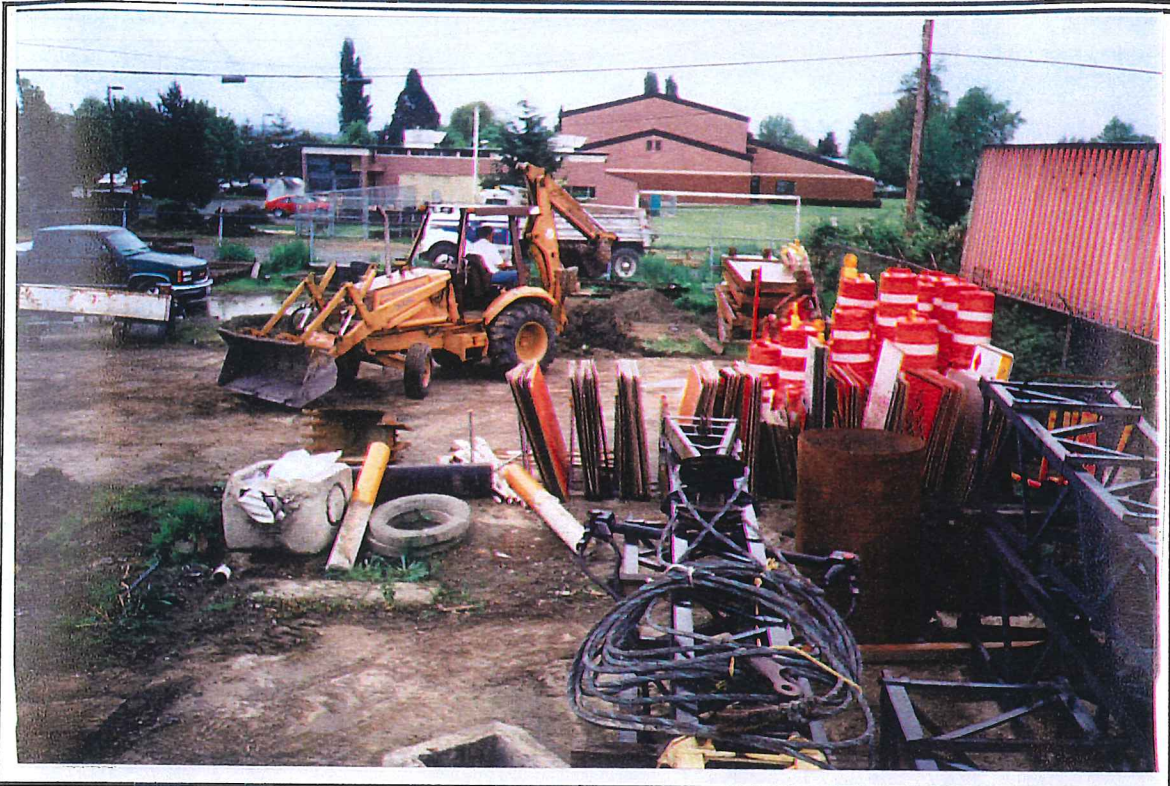
Photo #3: Property stored on the Westwater Construction site prior to remediation, facing south towards the school. This photograph was taken while assessing the two concrete slabs. Photo taken on 5/15/01.

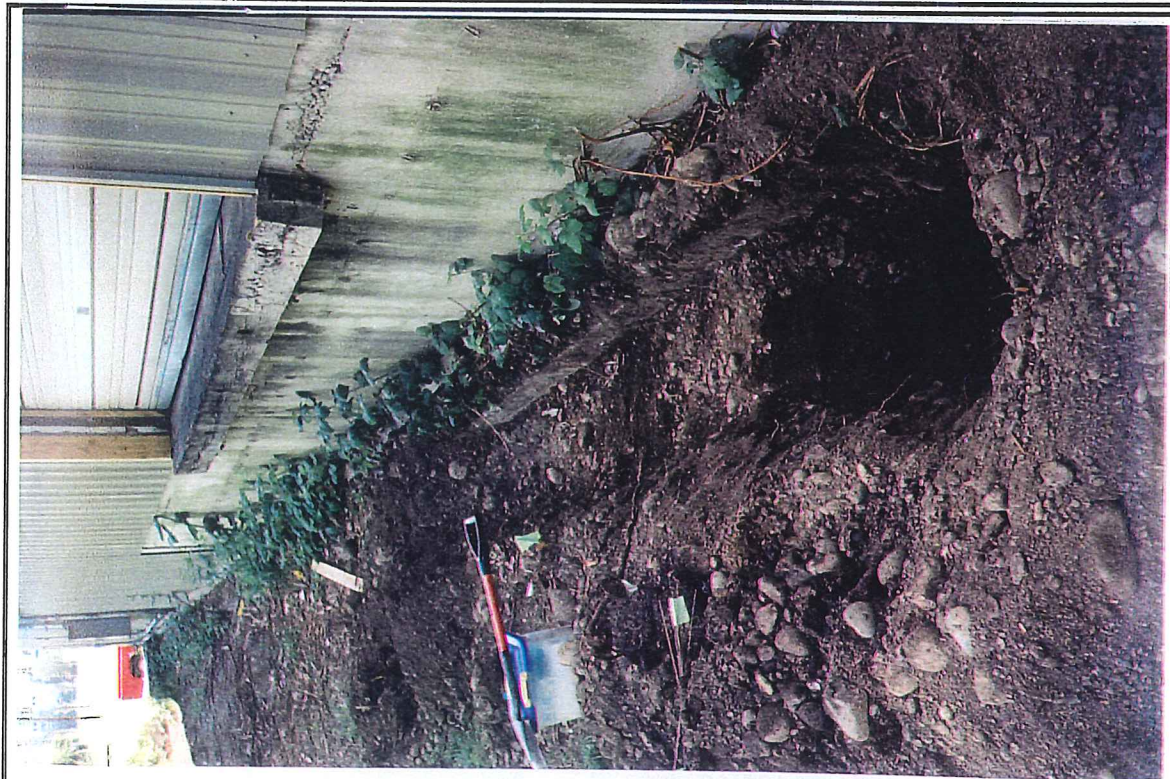
Photo #4: Assessing the soil adjacent to the north of the Custom-Bilt Metals building, facing east. Photo taken on 5/15/01.

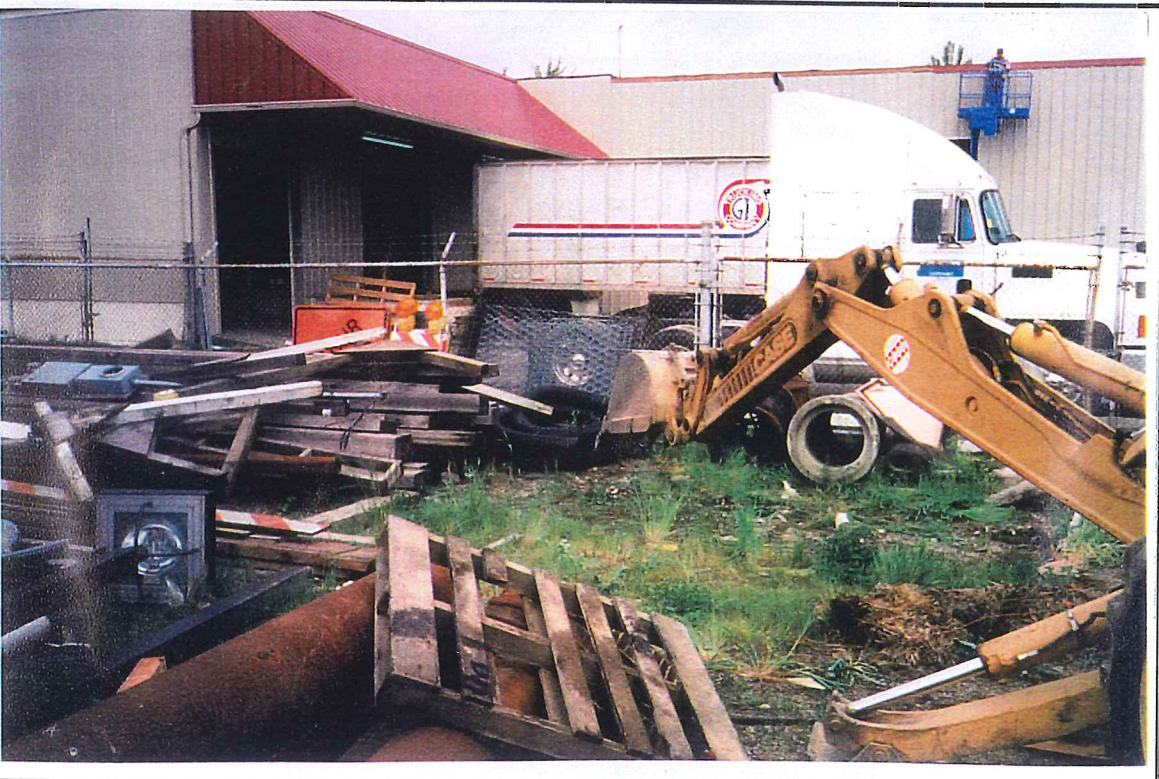
Photo #6: Assessing the soil near the northern portion of the Westwater Construction site prior to remediation, facing north. Photo taken on 5/15/01.

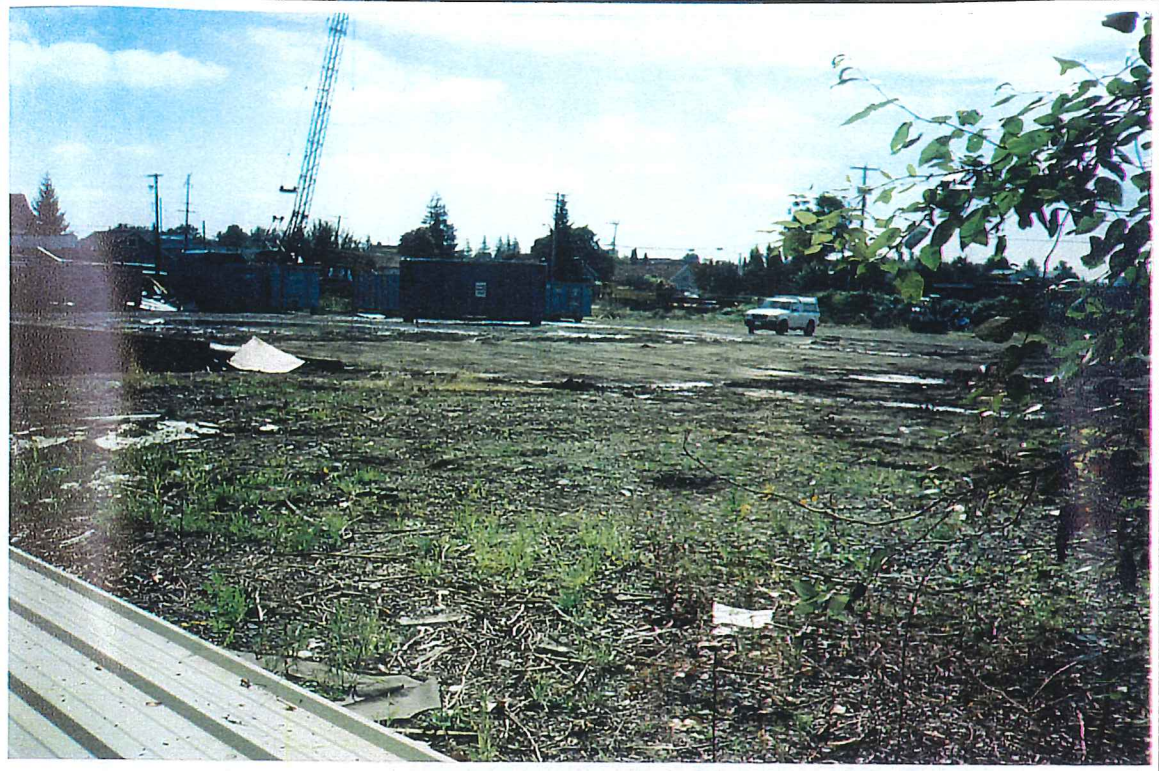
Photo #7: View of the Custom-Bilt Metals property after removing most of the equipment located south of the building, facing southeast. Photo taken on 7/5/01.

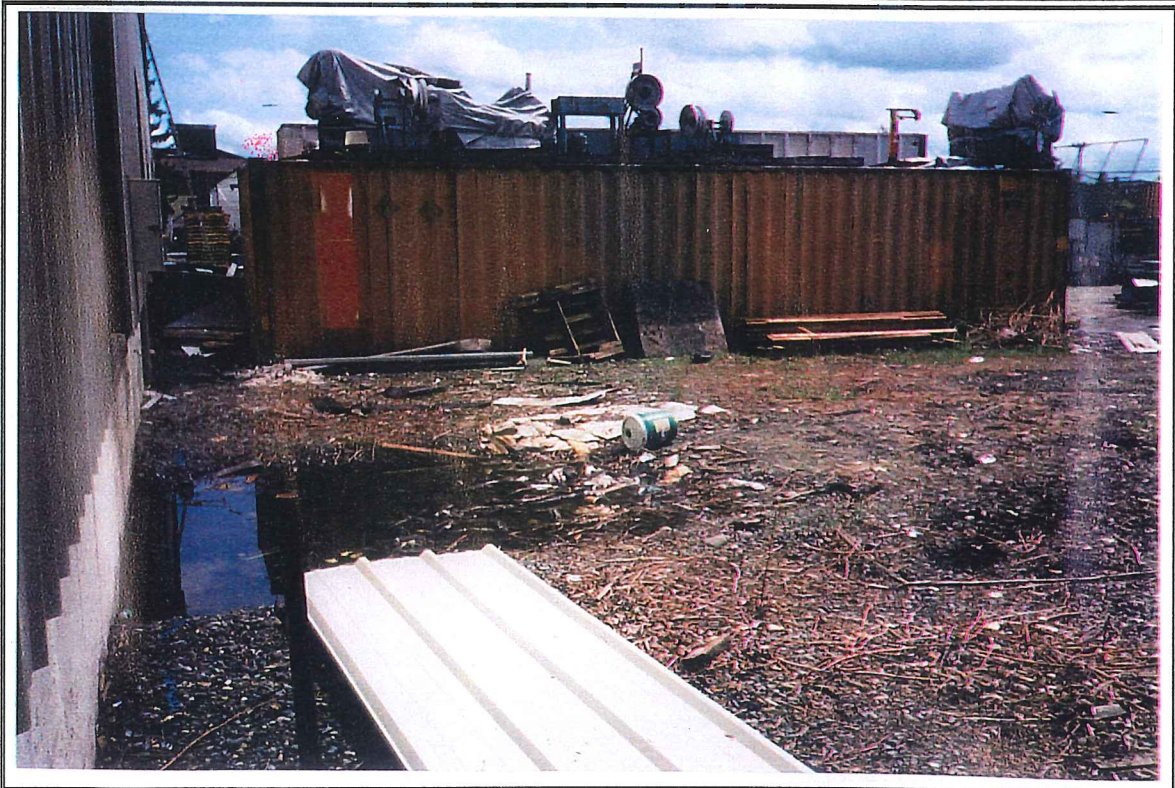
Photo #8: Photograph depicting equipment stored near the southwest corner of the Custom-Bilt Metals building prior to remediation, facing east. Several oil stains were observed in this area. Photo taken on 7/5/01.

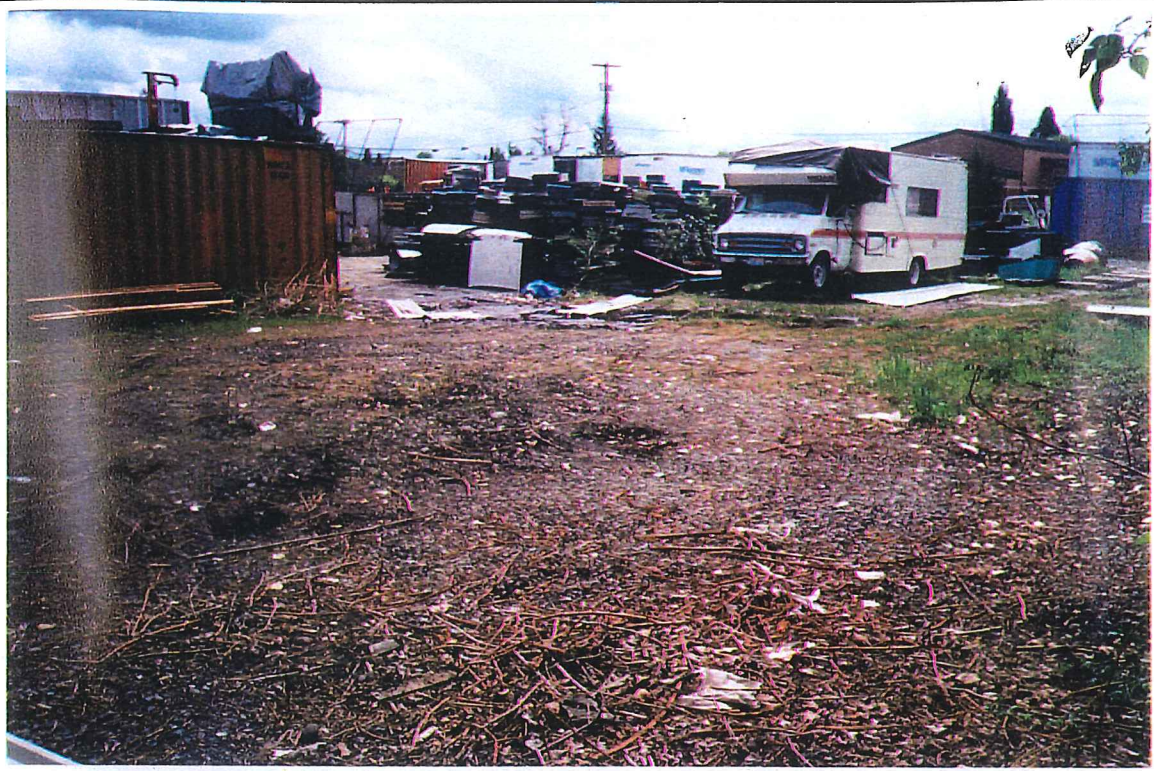
Photo #9: Photograph depicting stained area (in the foreground) near the southwest corner of the Custom-Bilt Metals building prior to soil remediation, facing southeast. Photo taken on 7/5/01.

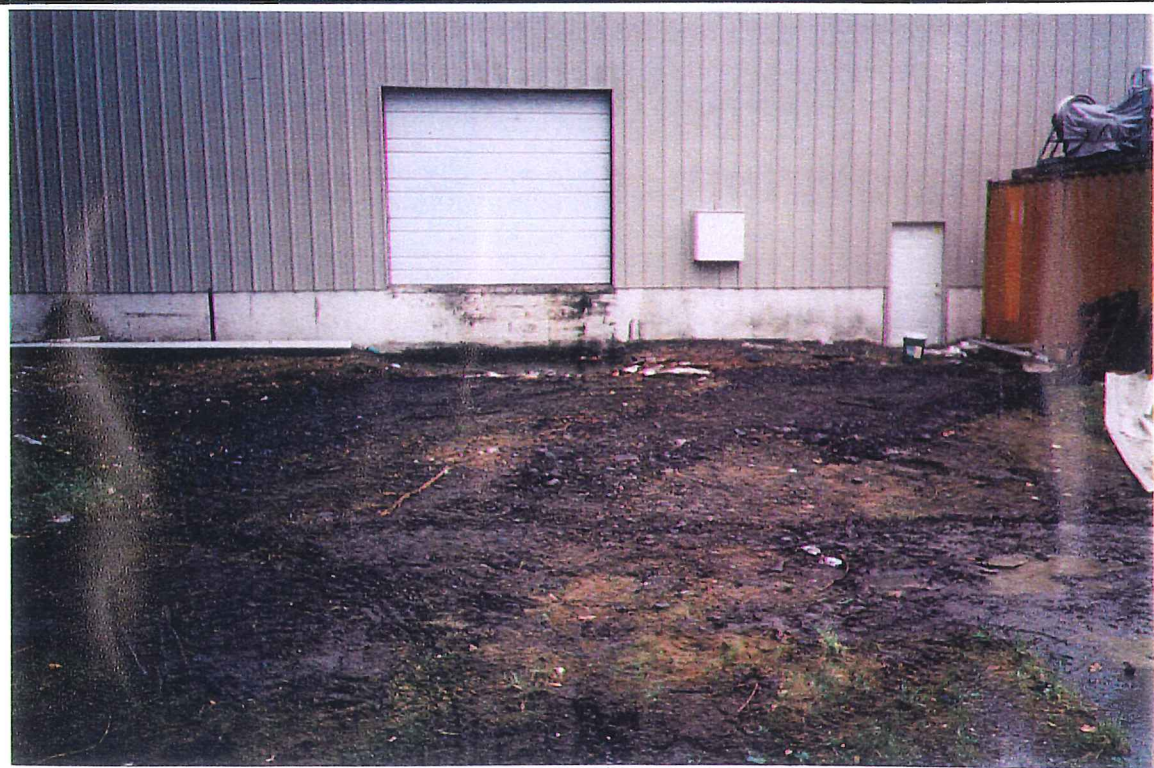
Photo #10: View of stained soil located south of the southwest corner of the Custom-Bilt Metals building prior to soil remediation, facing north. Photo taken on 7/5/01.

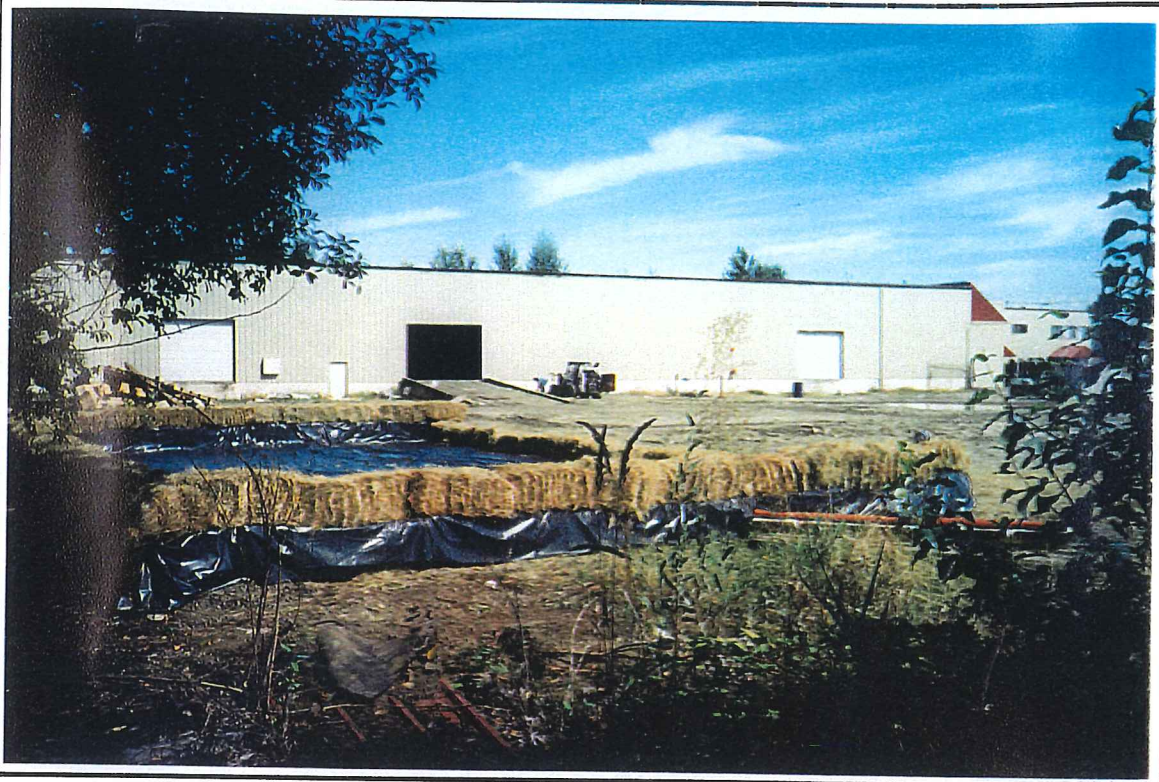
Photo #11: Photograph depicting the constructed storage area for the stockpiled soil prior to soil remediation, facing north. Photo taken on 7/5/01.

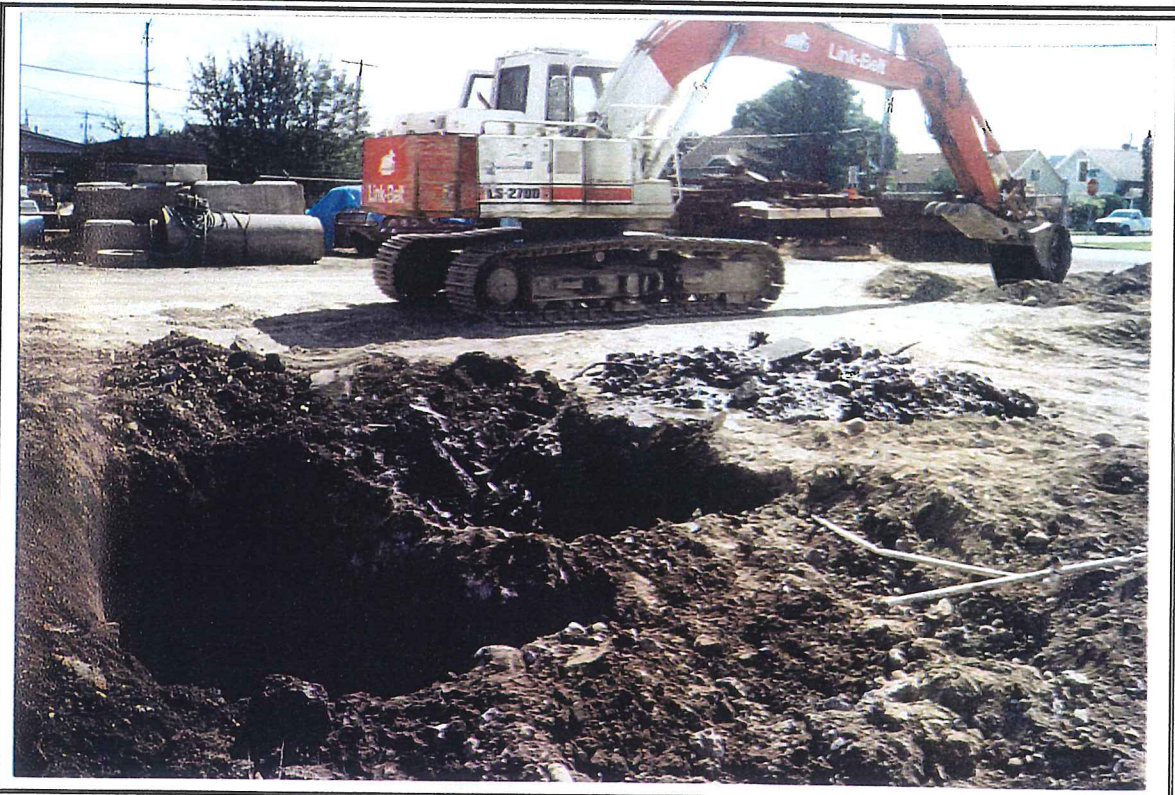
Photo #12: View of the concrete lined pit located just east of the concrete slabs on the Wastewater Construction site, facing southeast. The pit was full of old tin, bricks, metal pipes, automobile parts, wire and fill material. Photo taken on 8/29/01.

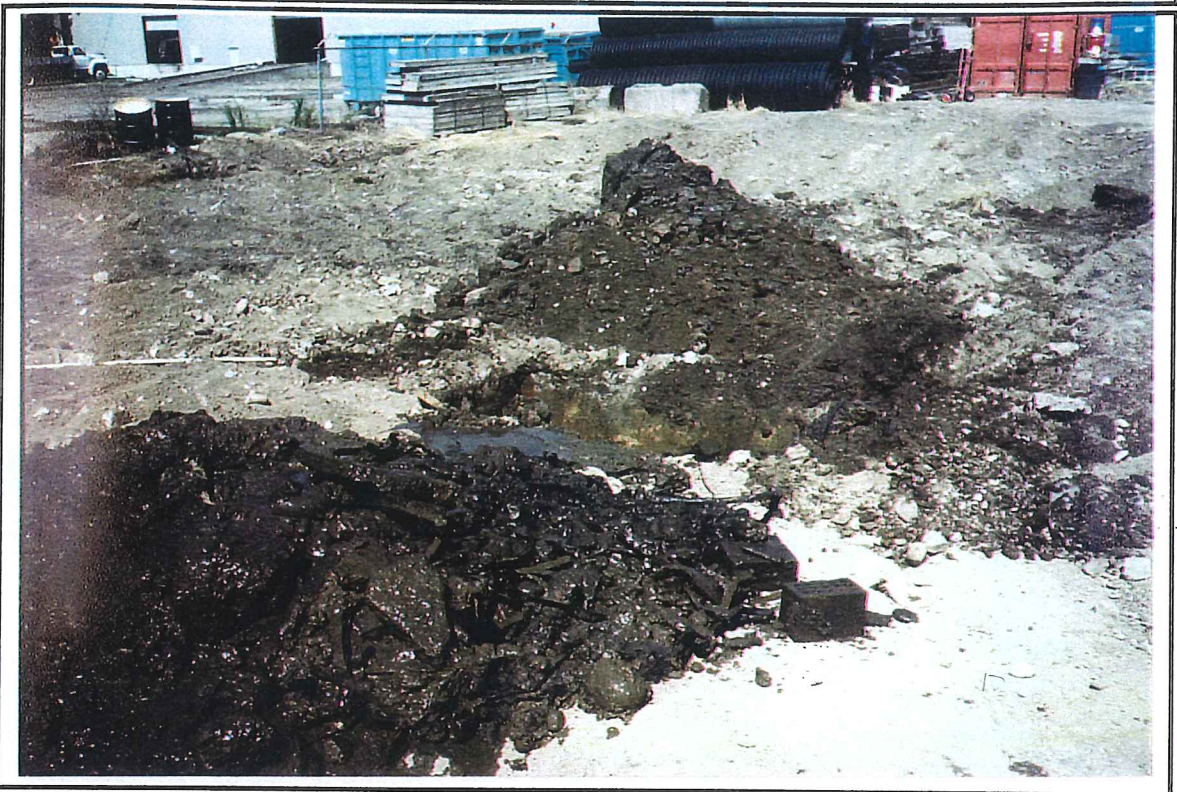
Photo #13: View of some of the industrial debris placed in the concrete pit shown in Photograph #12, facing northwest. Photo taken on 8/29/01.

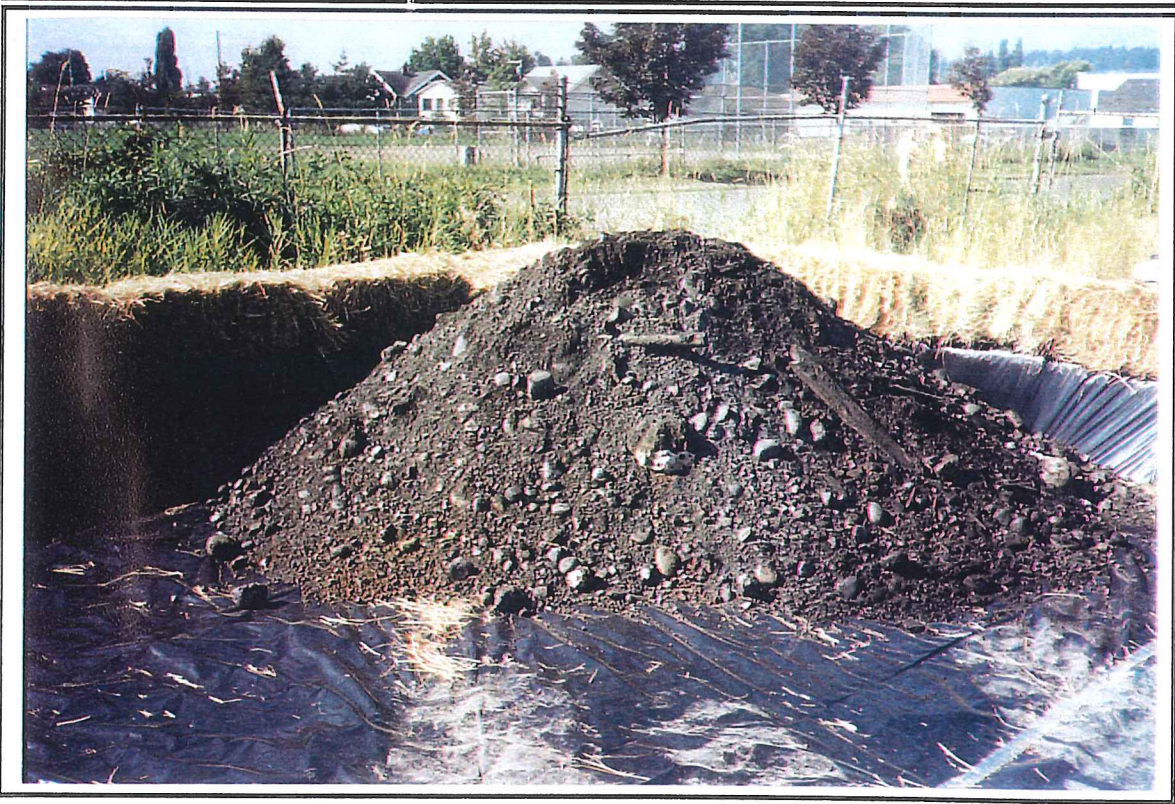
Photo #14: Photograph depicting the first load of contaminated fill material excavated from the subject property, facing southeast. This material was unearthed adjacent to the two concrete slabs on the Westwater Construction Site. Photo taken 8/29/01.

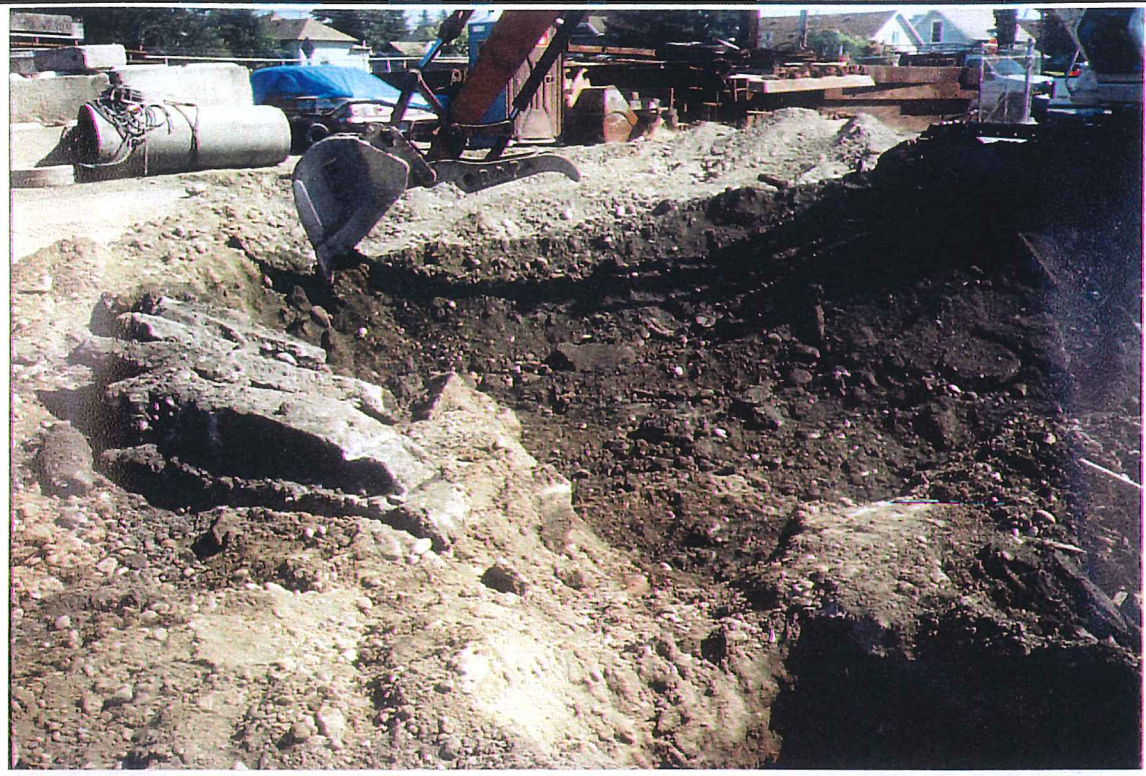
Photo #15: View of several old concrete footings unearthed on the central portion of the Westwater Construction site, facing southeast. PAH contaminated soil is depicted in the right portion of the photograph under the excavator. Photo taken on 8/29/01.

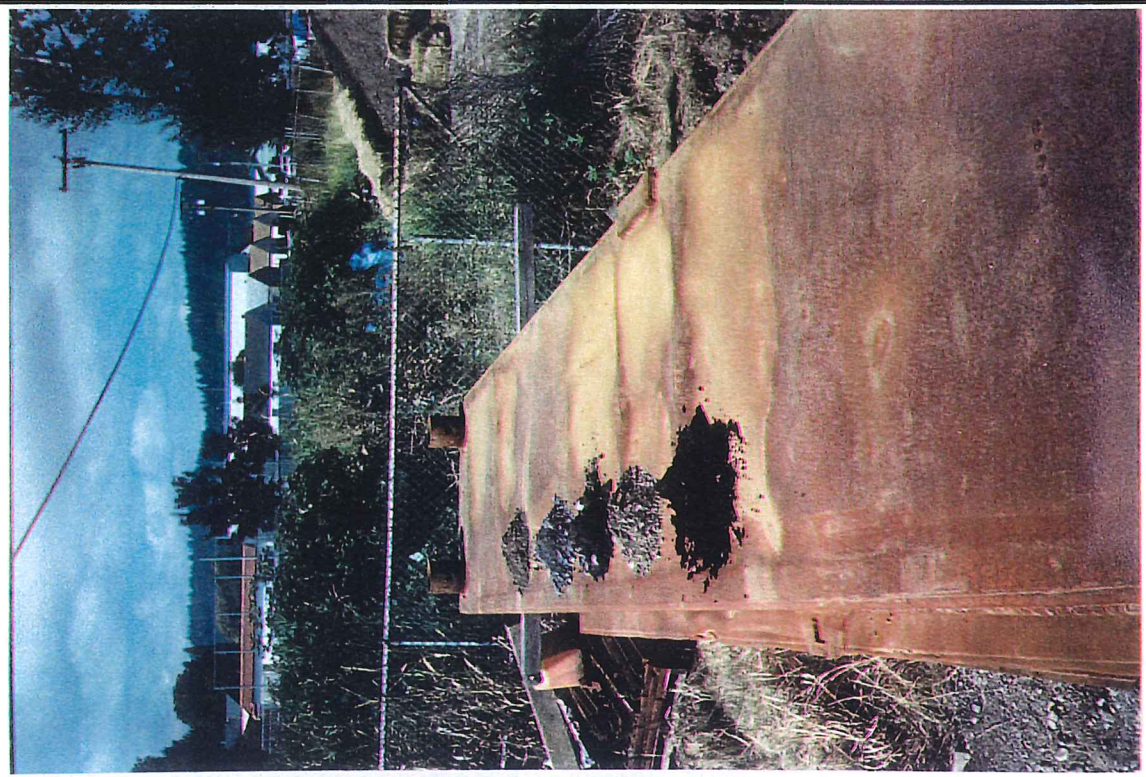
Photo #16: Photograph depicting the types of soil (fill) unearthed on the subject property, facing southwest. From the foreground; peaty soil, clean sandy gravel fill, heavy oil contaminated fill, blue-grey PAH contaminated fill, and cinders. Photo taken on 8/29/01.

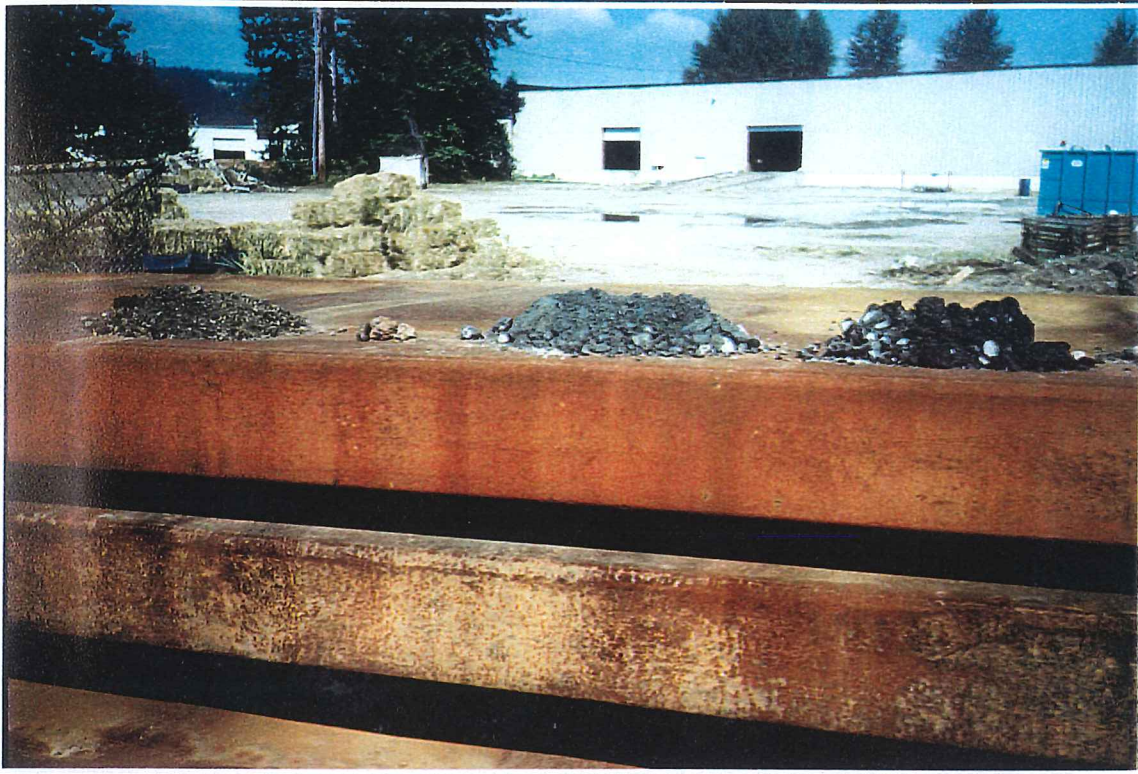
Photo #17: Photograph depicting, (from right to left), an example of the heavy oil contaminated fill, PAH contaminated fill, and cinders, facing northwest. Photo taken on 8/29/01.

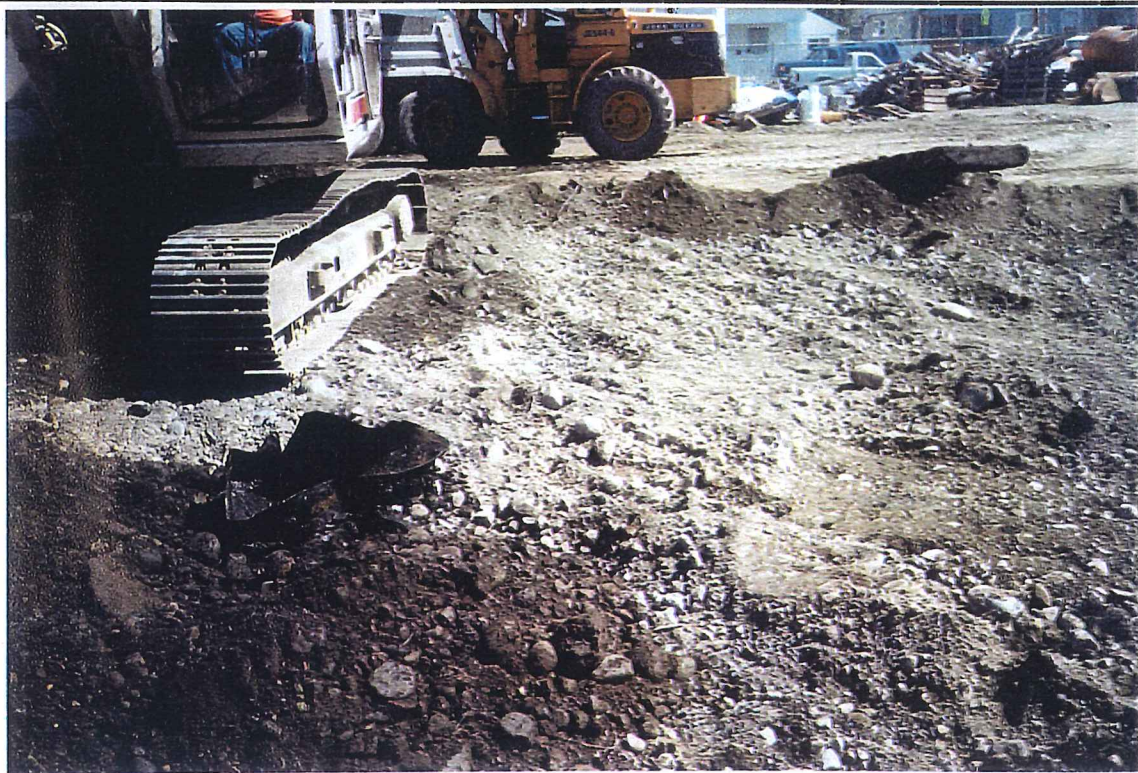
Photo #18: Chunk of metal debris unearthed near the northwest corner of the Westwater Construction site, facing east. Photo taken on 8/30/01.

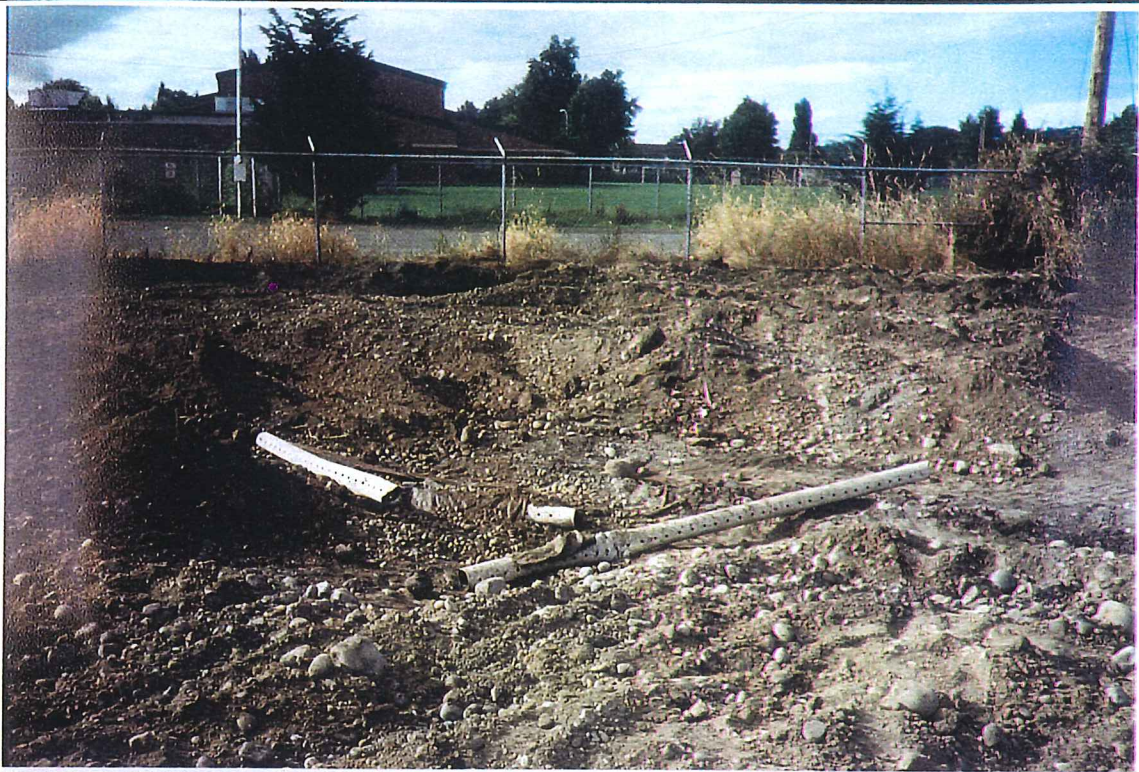
Photo #19: Industrial metal pipe with drilled holes unearthed near the southeast corner of the Westwater Construction site, facing south towards the school. Photo taken on 8/30/01.

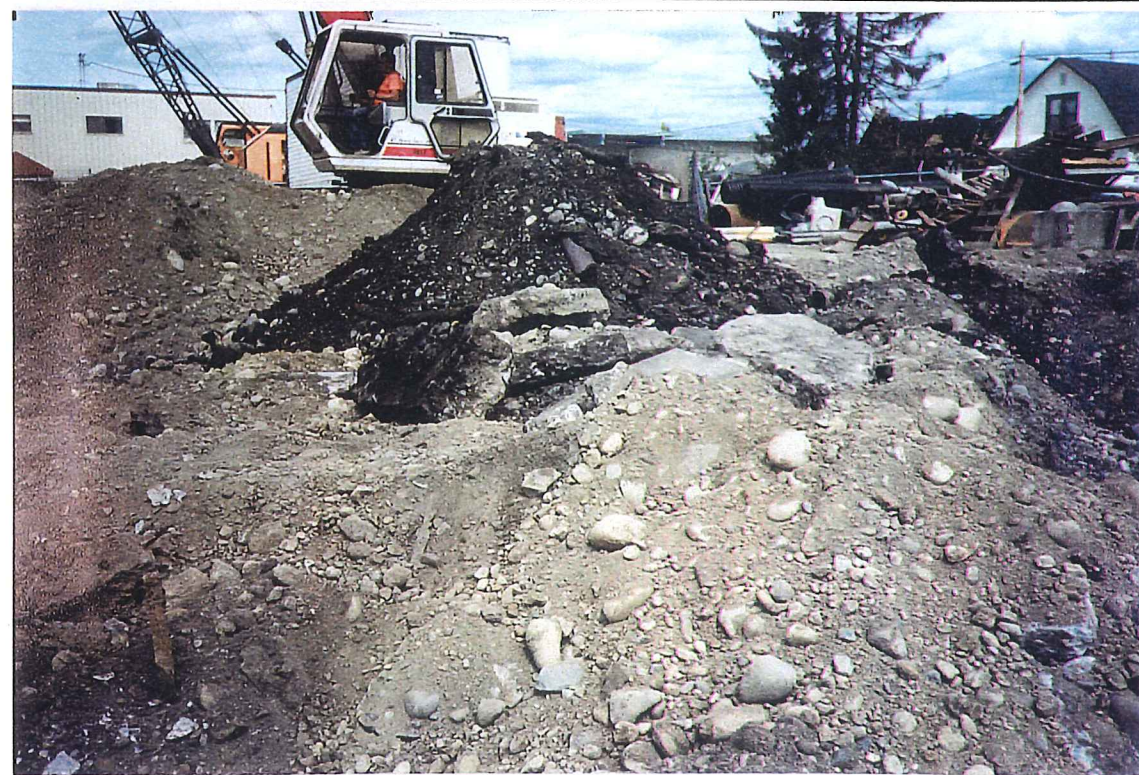
Photo #20: Unearthed industrial related debris (clay drainage pipe, brick, concrete, metal pipes), and petroleum hydrocarbon and PAH contaminated fill material located north of the removed gasoline underground storage tank on the Westwater Construction site, facing northeast. Photo taken on 8/31/01.

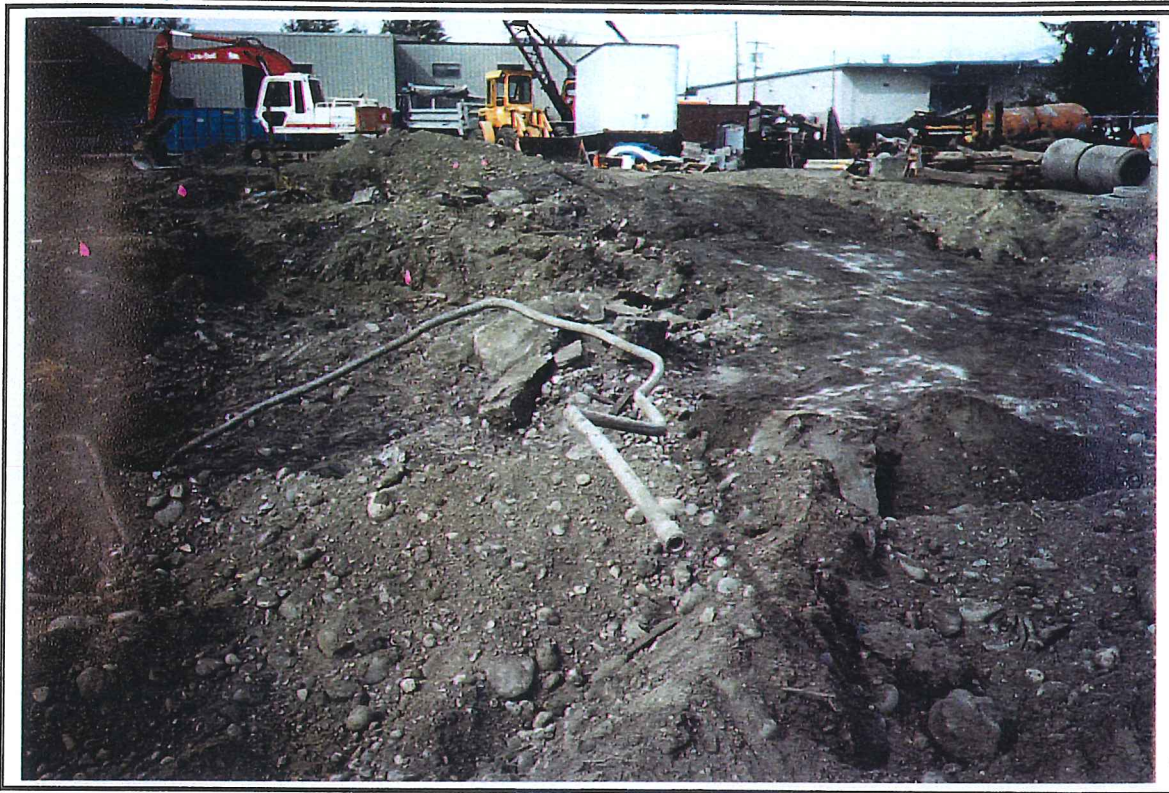
Photo #21: Metal steam lines unearthed adjacent to the removed fuel storage tank on the Westwater Construction site, facing north. The old foundation of the demolished home is depicted on the right side of the photograph. Approximately 1-1/2 feet of fill material contaminated with heavy oil and lead was scraped from off of the slab and disposed of. Diesel fuel contaminated soil was remediated left of the slab. Photo taken on 8/31/01.

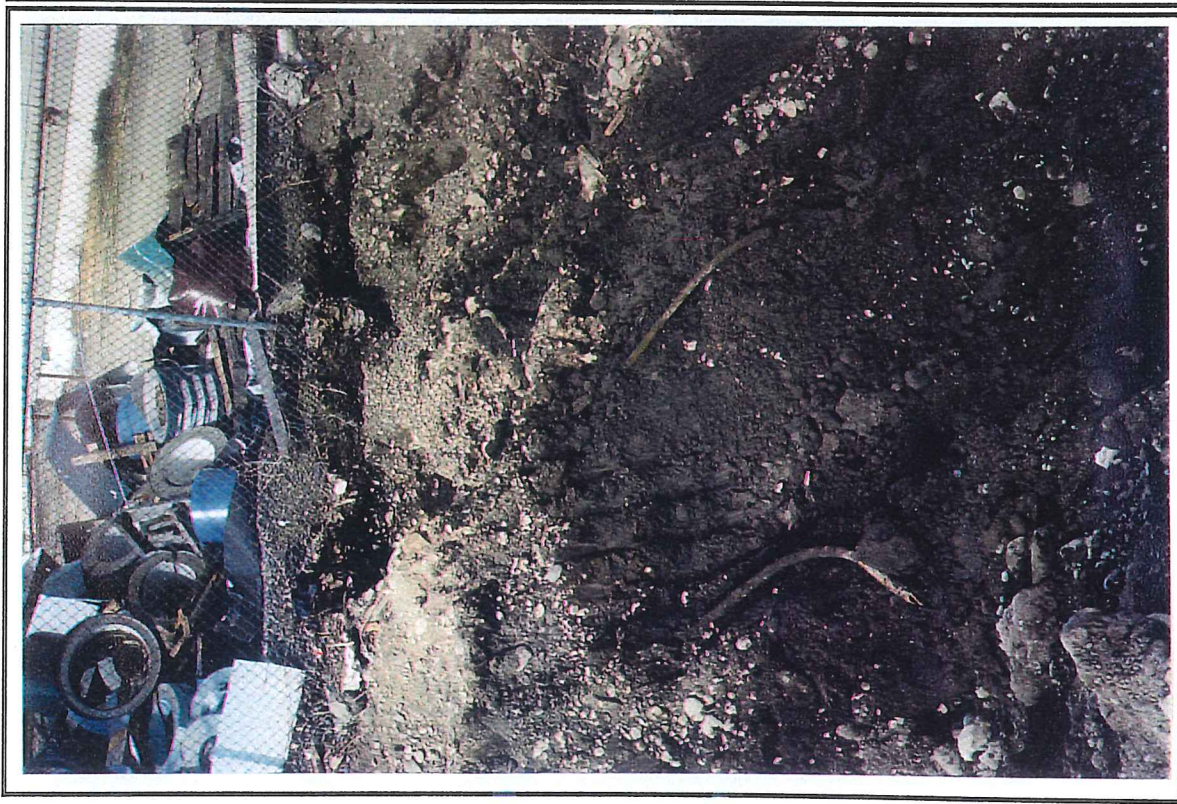
Photo #22: Two water or steam lines unearthed near the northwest corner of the Westwater Construction site, facing northwest. Photo taken on 9/4/01.

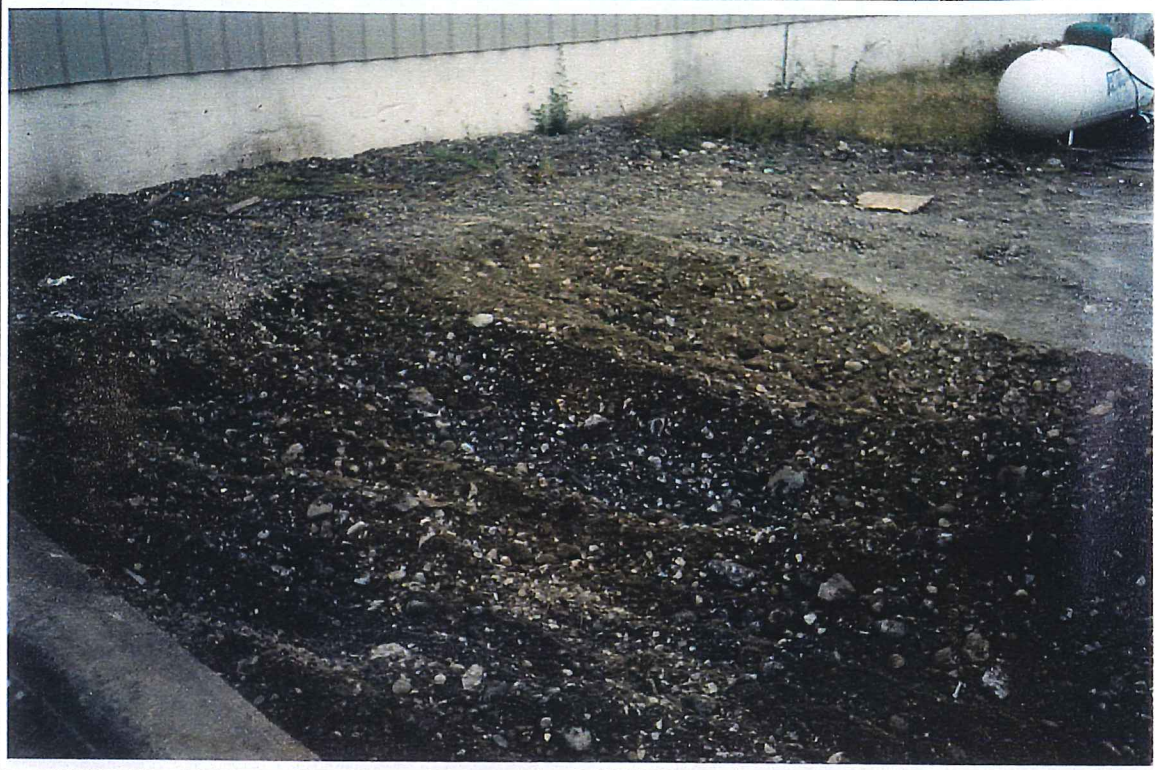
Photo #23: PAH contaminated fill material scraped away adjacent to the south of the Custom-Bilt Metals building, facing northeast towards the building. The color of the PAH contaminated soil is blue-grey. Photo taken on 9/4/01.

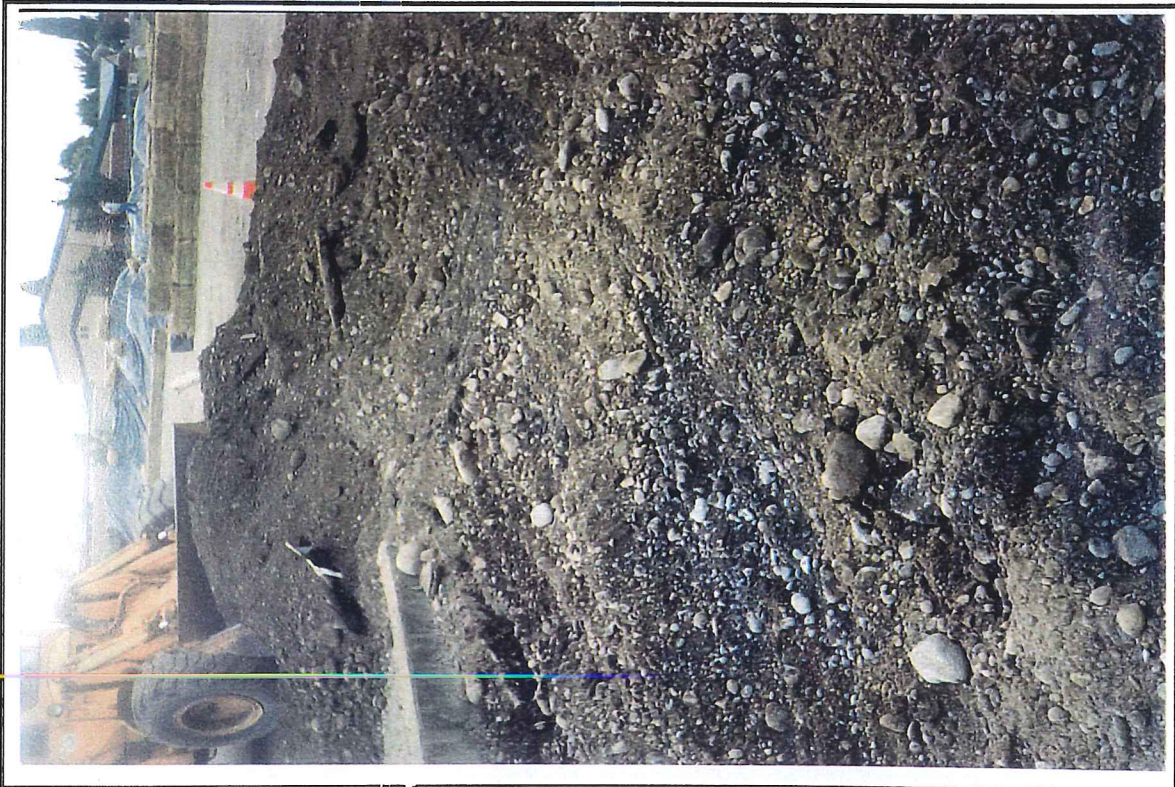
Photo #24: PAH contaminated fill material, (blue-grey color), scraped away adjacent to the west of the concrete "up ramp" located south of the Custom-Bilt Metals building, facing south. Photo taken on 9/4/01.

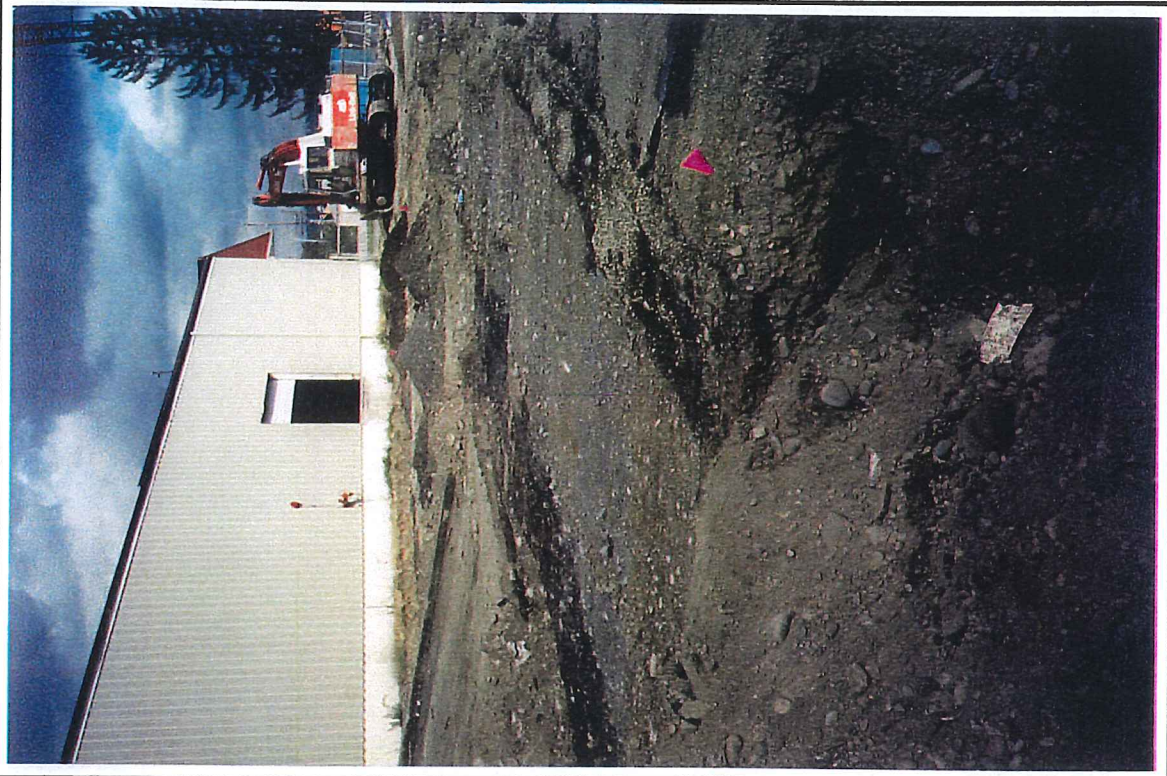
Photo #25: PAH and heavy oil contaminated fill material scraped away beneath the removed asphalt slab, facing northeast. A pile of PAH contaminated fill material, (blue-grey), is located in the background of the photograph, (removed and disposed of). Photo taken on 9/5/01.
