**Independent Remedial Action Report
Addendum
Lot 2, Custom-Bilt Metals
233 D Street
Auburn, Washington**

October 2002

21-1-12074-004

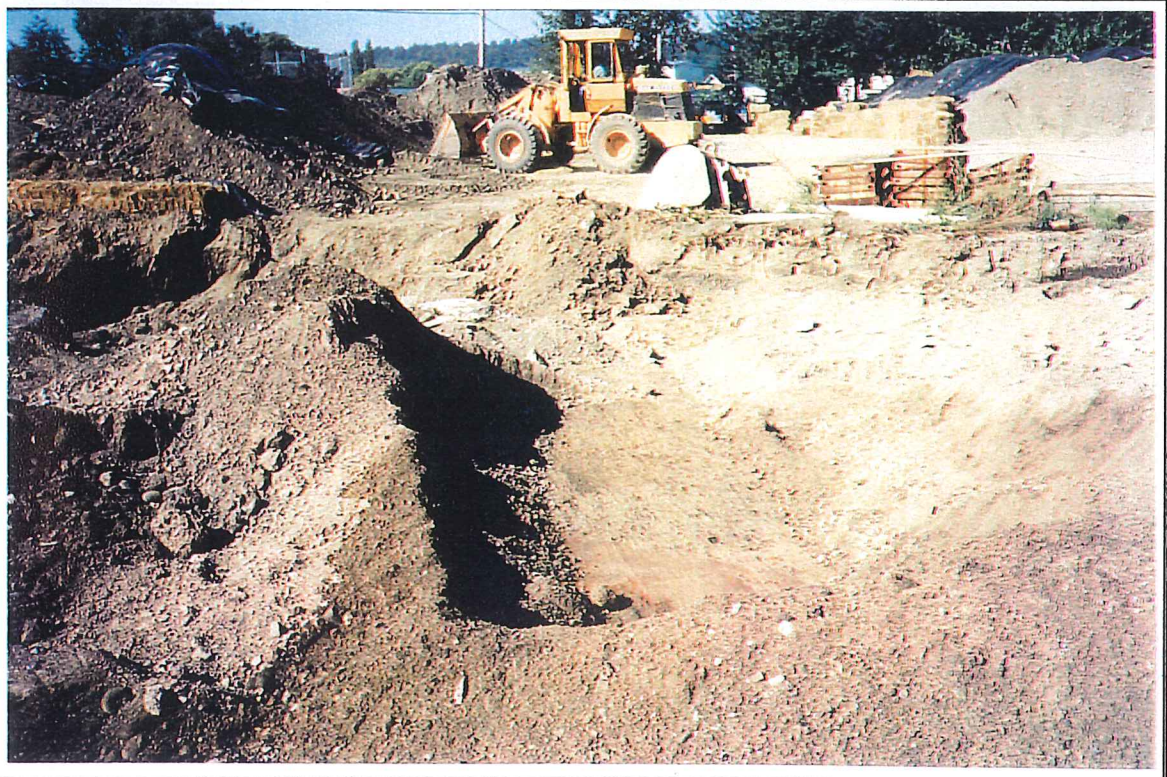
Photo #26: Photograph depicting light brown to grey cinders, facing west. The cinders were located adjacent to and beneath the two concrete slabs near the west boundary of the Westwater Construction site. The cinders were very light and porous. Photo taken on 9/10/01.

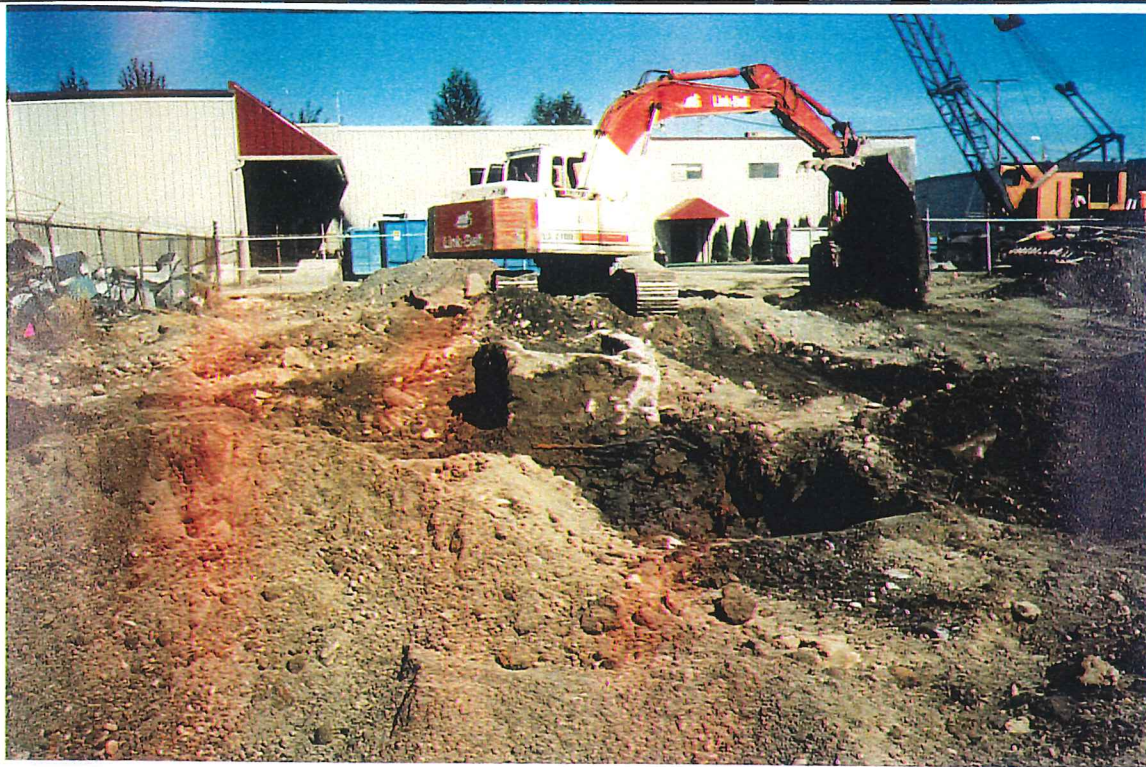
Photo #27: View of one of the two concrete lined pits excavated and demolished on the Westwater Construction site, facing north. The oily debris inside the pit was disposed of. Photo taken on 9/10/01.

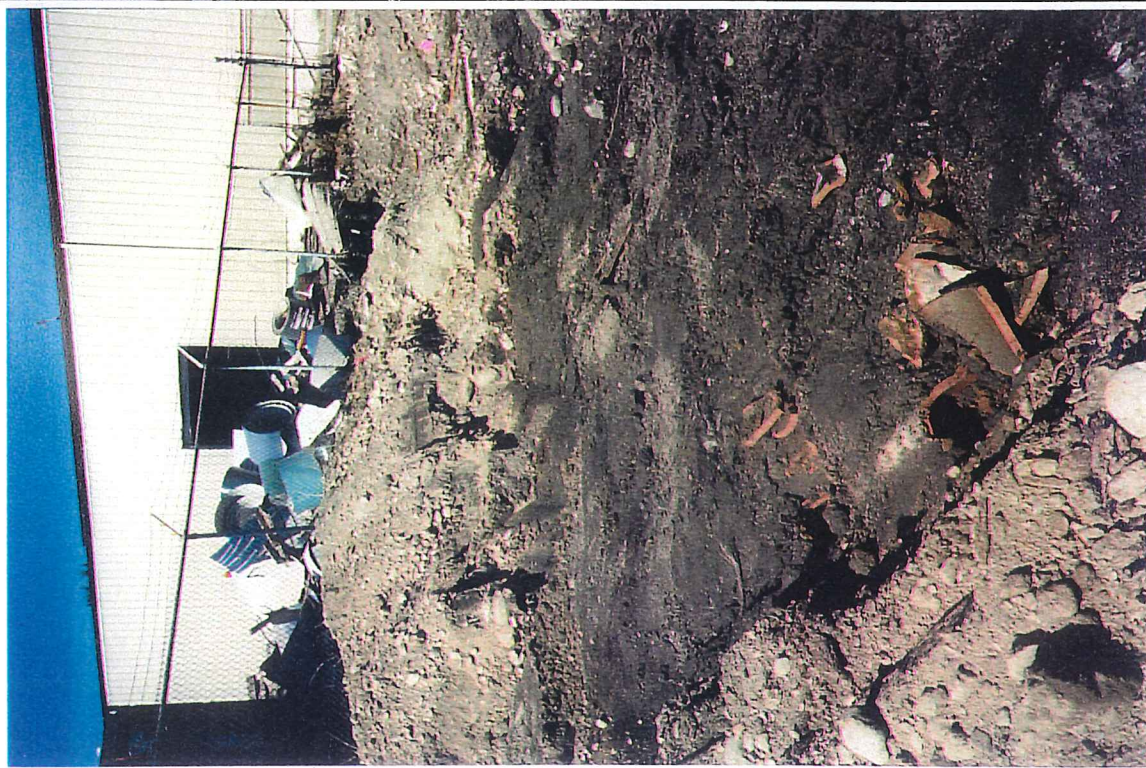
Photo #28: Clay sewer or stormwater drainage pipe unearthed near the northwest corner of the Westwater Construction site, facing northwest. Photo taken on 9/10/01.

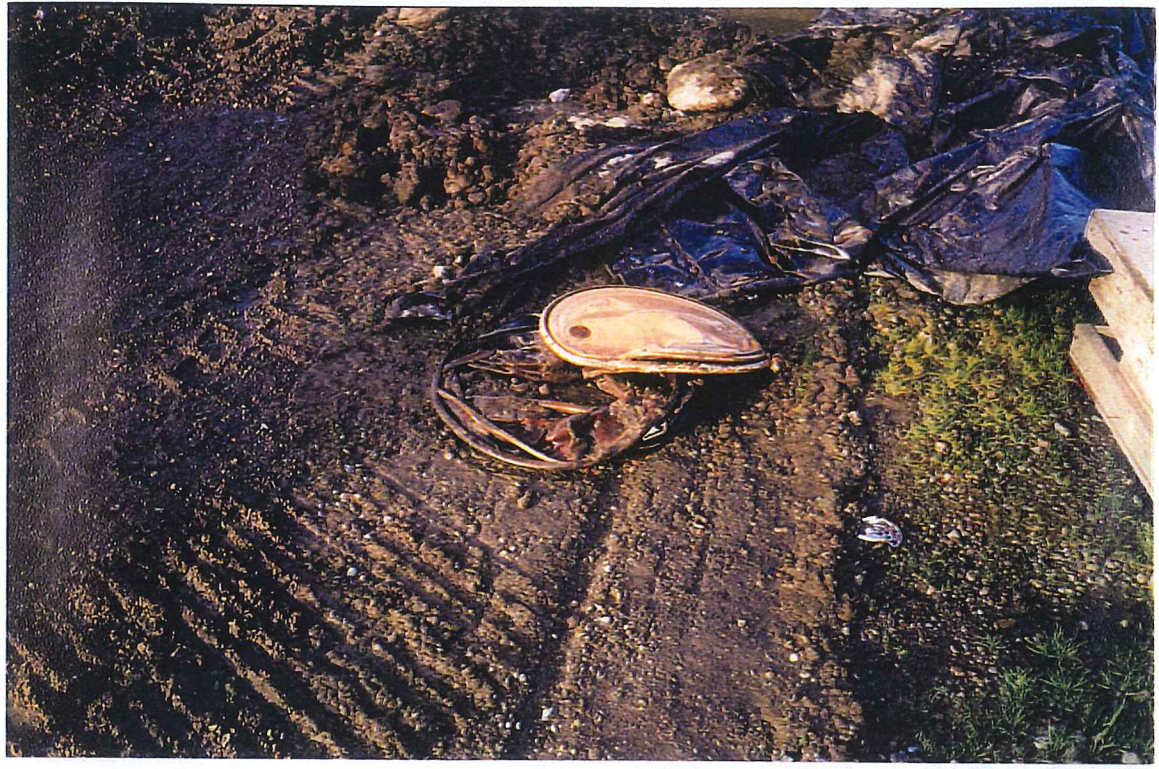
Photo #29: Remnants of an old, crushed metal 55-gallon drum unearthed on the Custom-Bilt Metals parking lot, top view. The drum was buried approximately 1-1/2 feet below ground surface. Photo taken on 1/7/02.

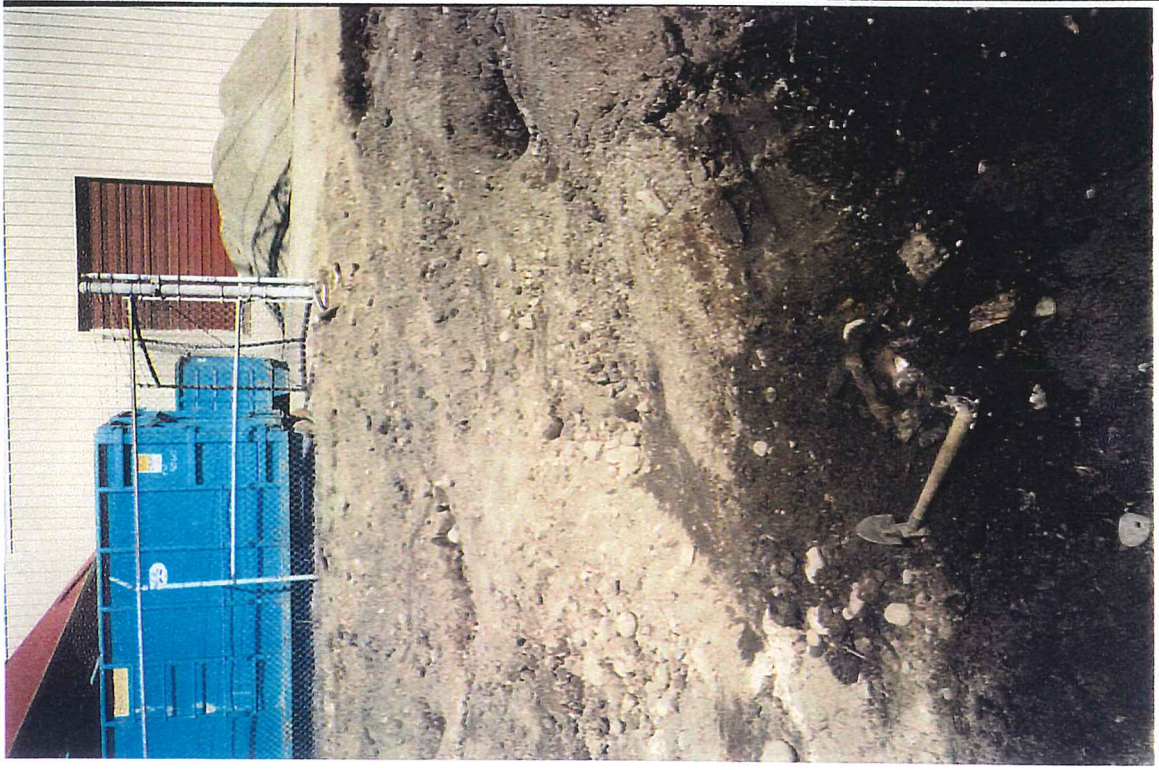
Photo #30: Pile of old tin, steel, and glass artifacts unearthed near the northern boundary of the Westwater Construction site, facing north. Photograph taken on 9/10/01.

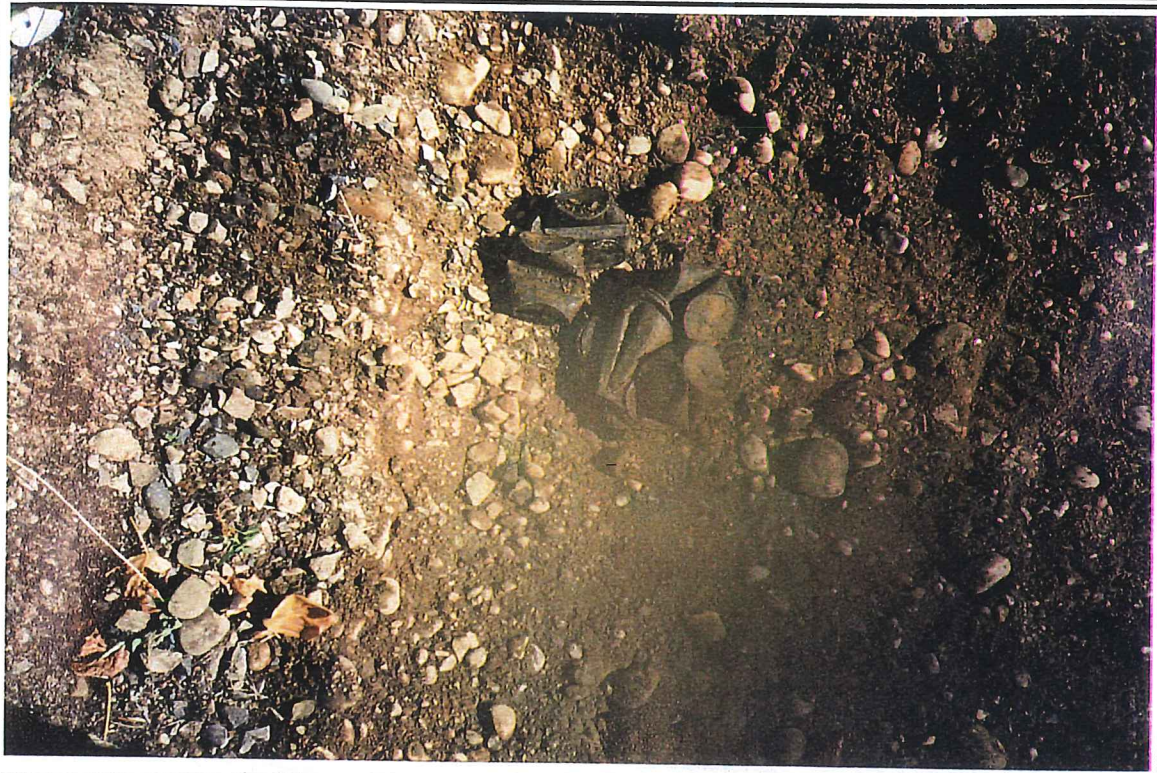
Photo #31: Pile of old tin cans unearthed adjacent to the south of the Custom-Bilt Metals, (near the southwest corner of the building), top view. Photo taken on 10/7/01.

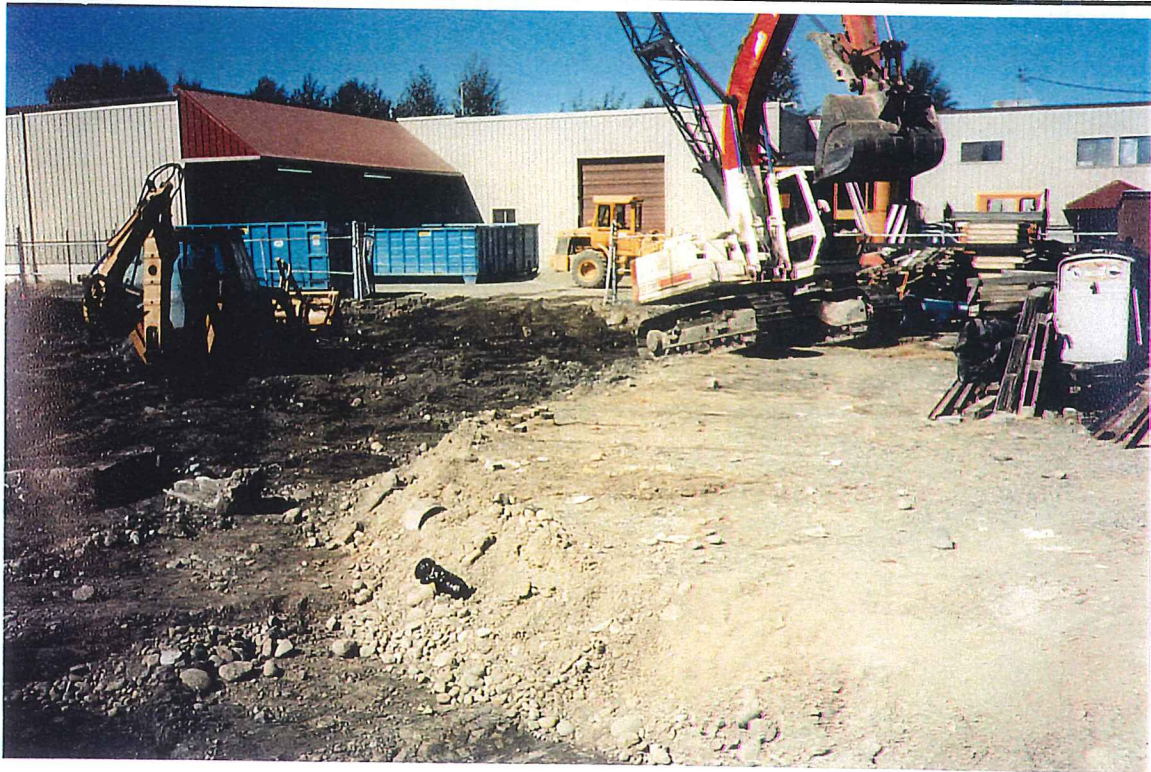
Photo #32: Photograph depicting the approximate 1 to 1-1/2 foot thick layer of clean fill material placed on top of the petroleum hydrocarbon/PAH contaminated fill, facing northwest. The clean fill was scraped off, stockpiled, tested, and used as backfill on the site. Photo taken on 9/10/01.

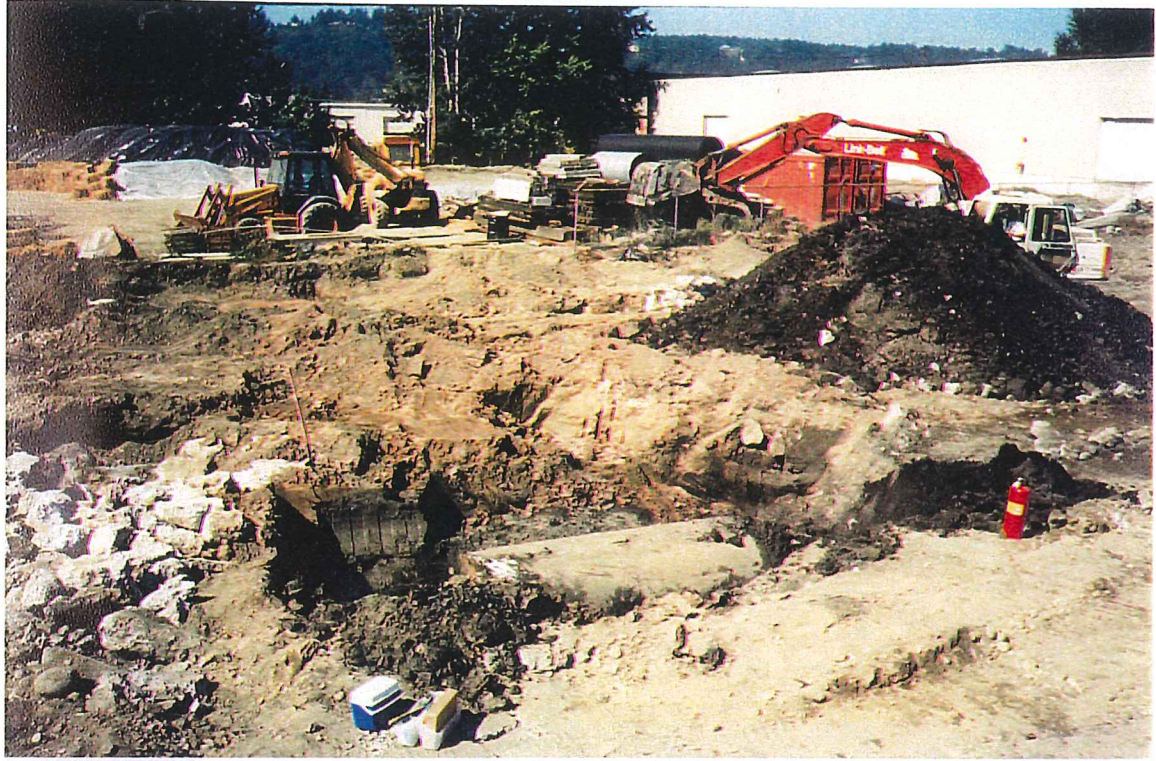
Photo #33: View of the 2,000-gallon gasoline underground storage tank excavated near the center of the Westwater Construction site, facing northwest. Photo taken on 9/14/01.

During excavation of contaminated soil on Lot 2, a 2,000-gallon gasoline UST was uncovered approximately 55 feet northeast of monitoring well MW-3. The tank, which was covered by a concrete slab, contained about 250 gallons of water mixed with weathered gasoline. The contents were pumped out and transported to a permitted off-site disposal facility. Upon removal from the ground, the tank appeared to be in good condition with no corrosion holes observed along the seams, ends, sides, and bottom of the tank. The tank was then cleaned and disposed of in accordance with UST regulations.

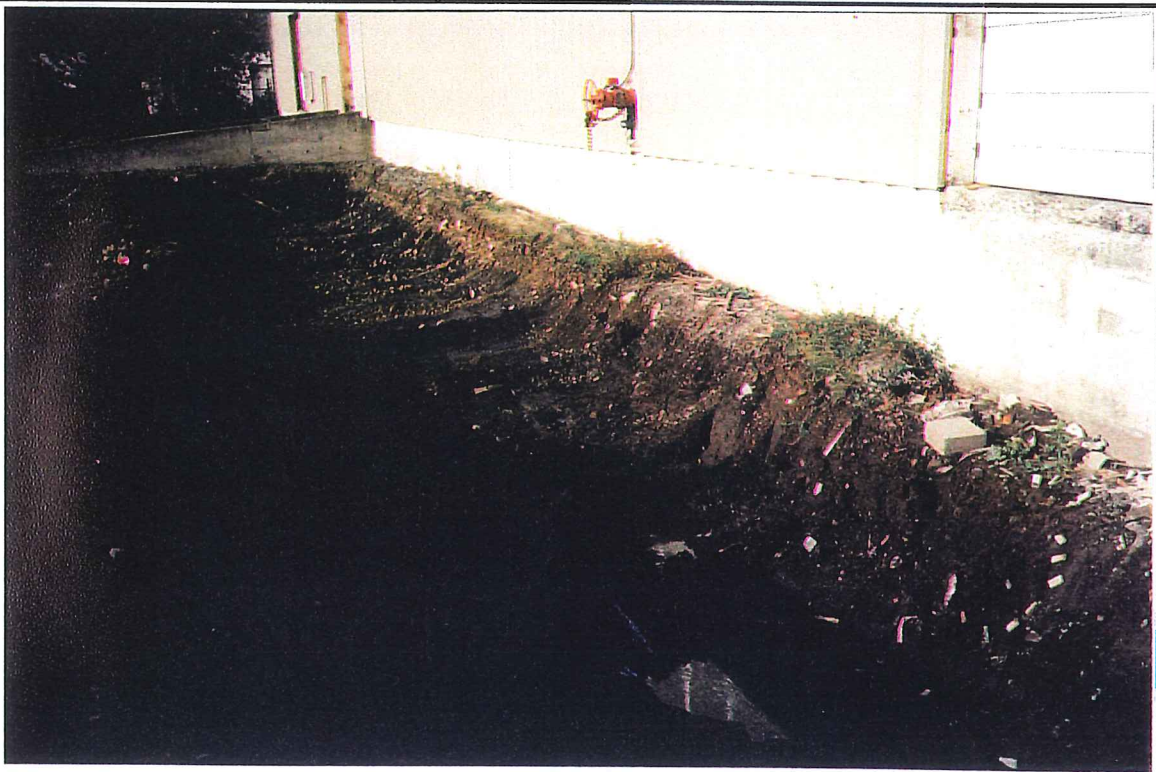
Photo #34: Photograph depicting soil/fill layer located adjacent to the foundation of the Custom-Bilt Metals building, facing west. Heavy oil contaminated soil was identified adjacent to the foundation (left of the red fire valve). Photo taken on 10/7/01.

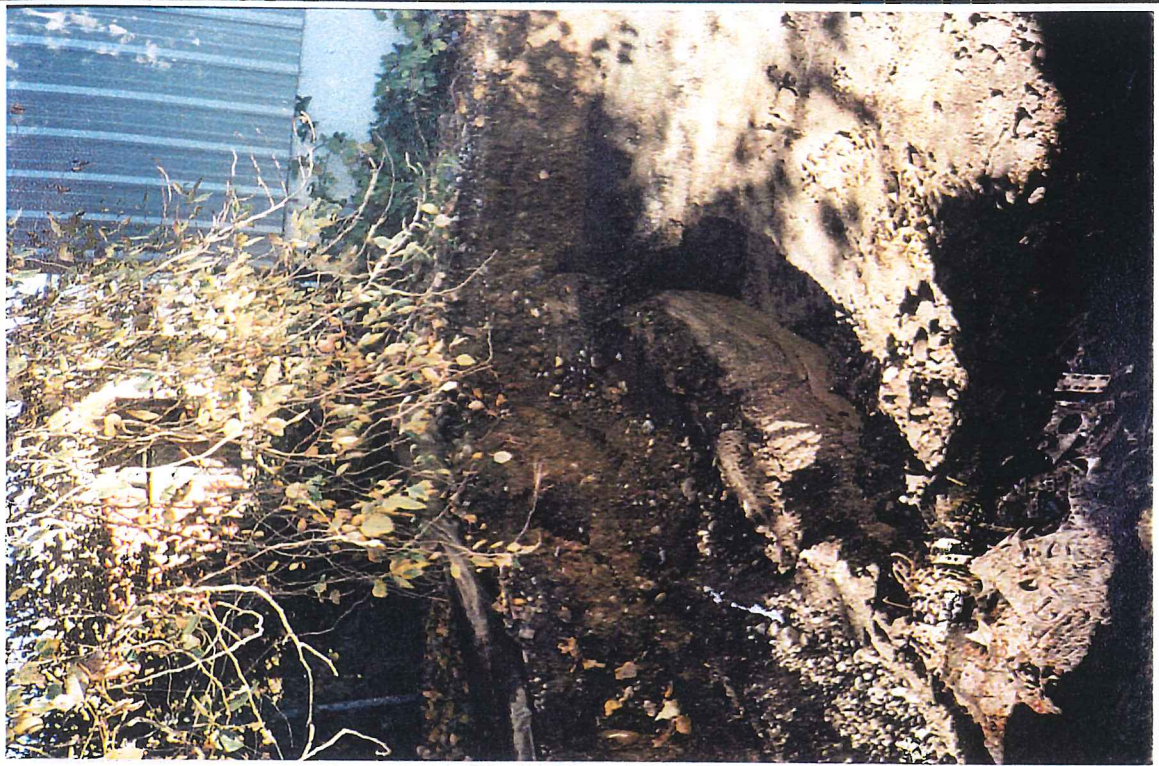
Photo #35: Photograph depicting old stamped tin sheets, facing northwest towards the southwest corner of the Custom-Bilt Metals building. An approximate 1 foot thick layer of cinders was identified in this area. Photo taken on 10/7/01.

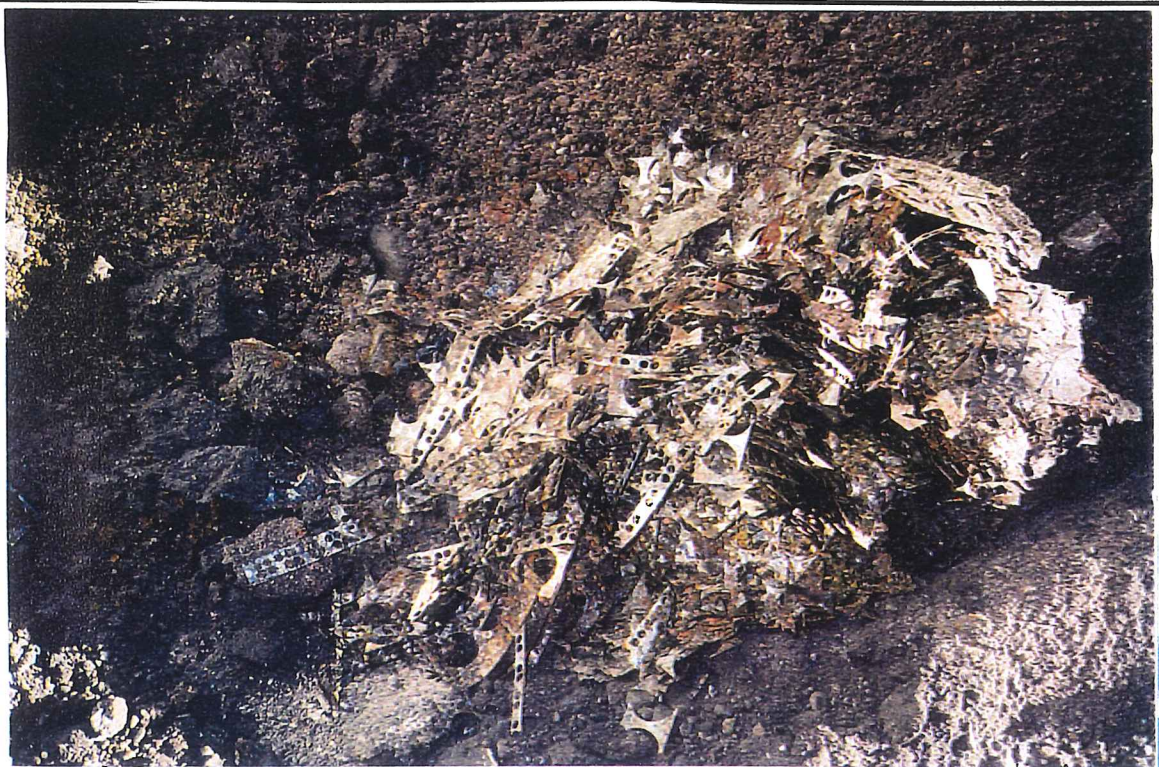
Photo #36: View of an old sheet tin pile, adjacent to the southwest corner of the Custom-Bilt Metals building, top view. Photo taken on 10/7/01.

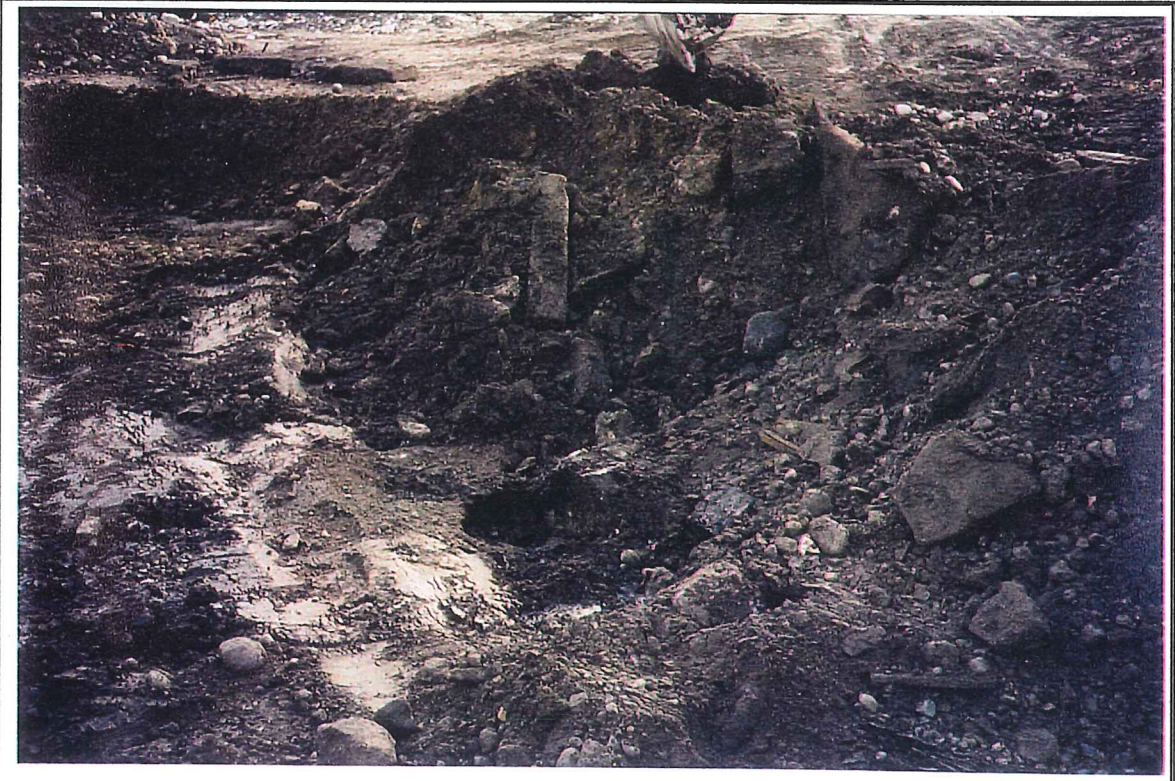
Photo #38: Photograph depicting heavy oil stained concrete rubble and PAH contaminated fill material located south of the Custom-Bilt Metals building, facing east. Photo taken on 11/9/01.

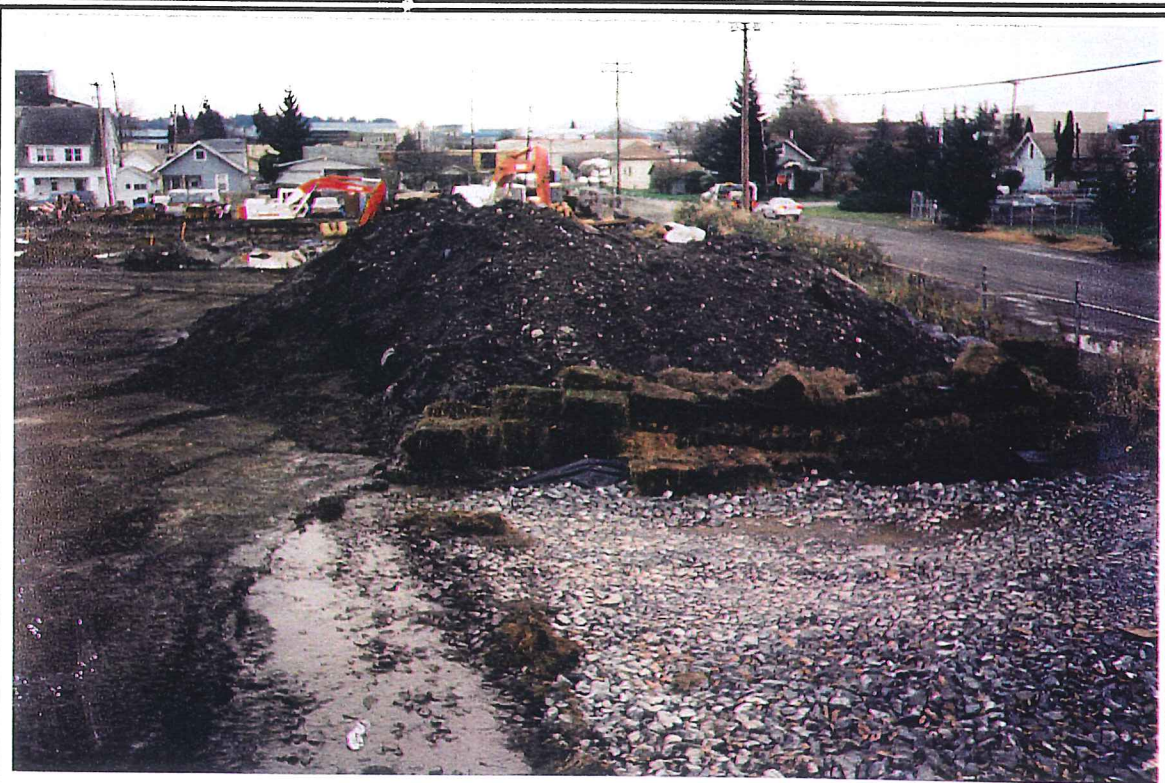
Photo #40: View of contaminated fill material in stockpile #4 prior to loading and transporting to TPS Technologies, Inc. for disposal, facing east. Photo taken on 12/20/01.

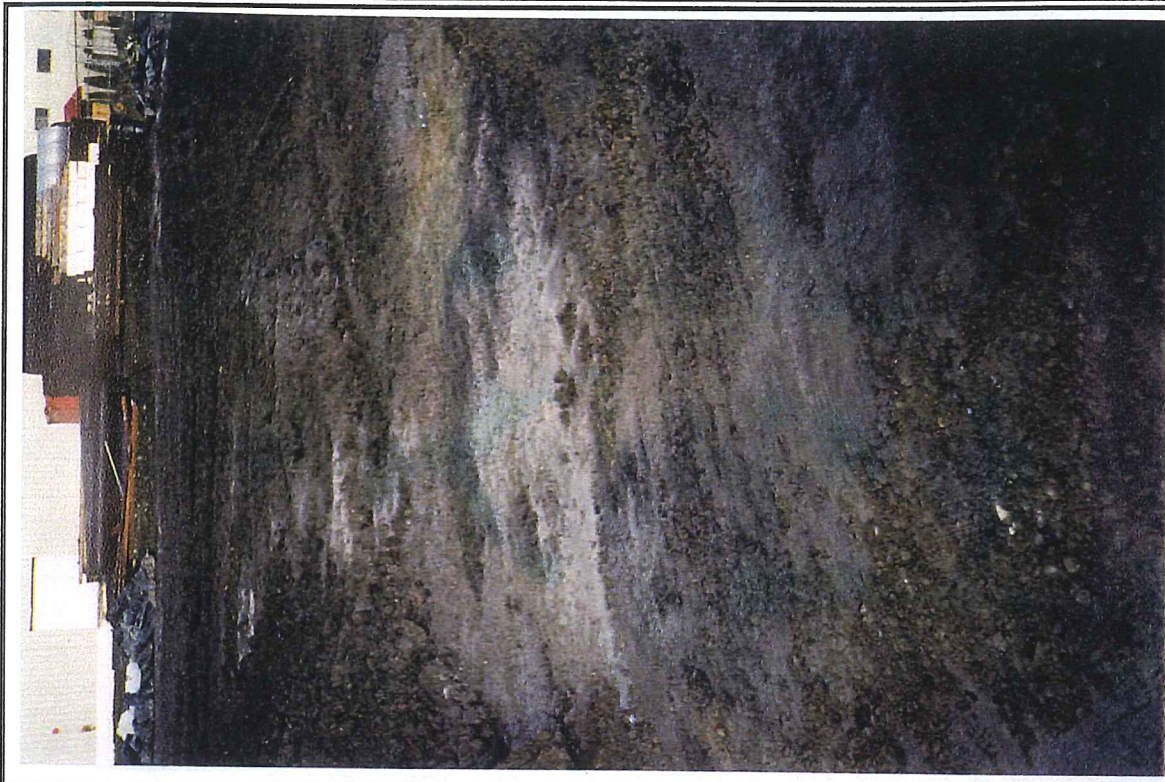
Photo #41: View of the blue-grey PAH contaminated fill layer located adjacent to the north of stockpile #4, facing north. The contaminated material was scraped off and disposed of. Photo taken on 12/20/01.

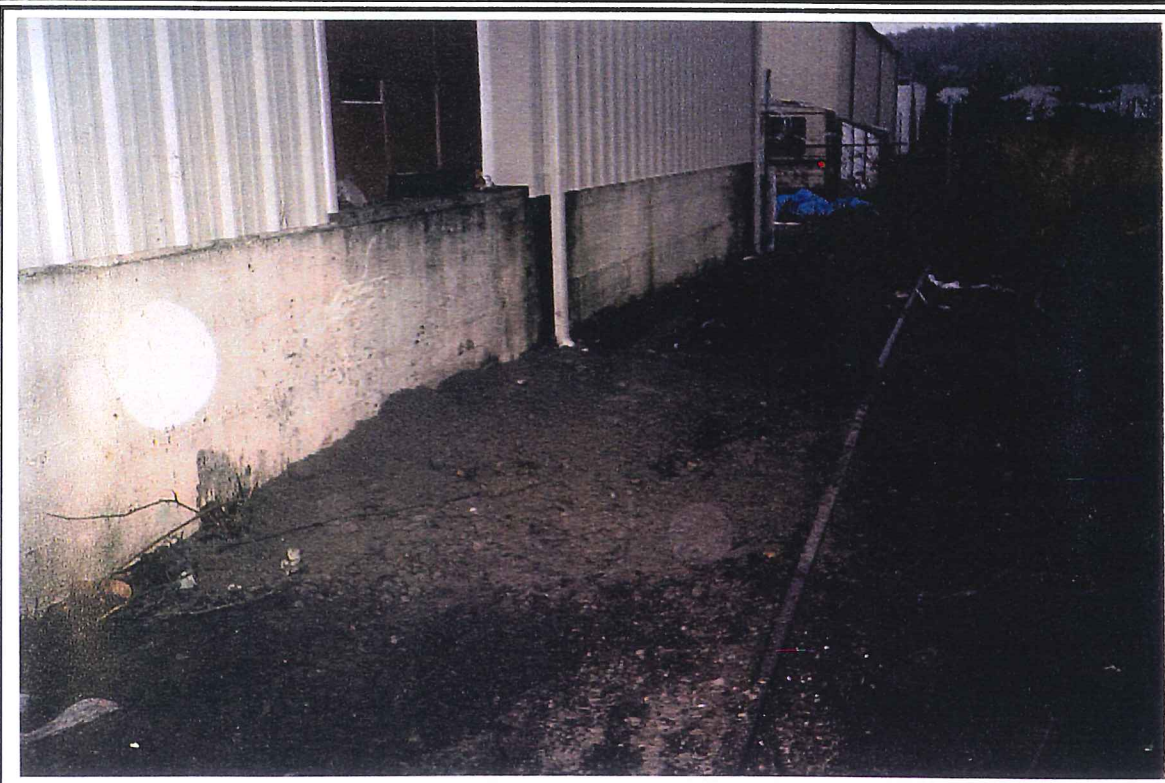
Photo #42: Photograph depicting the north wall of the Custom-Bilt Metals building and abandoned railroad track, facing west. The area located beneath the load out dock was remediated. Photo taken on 1/7/02.

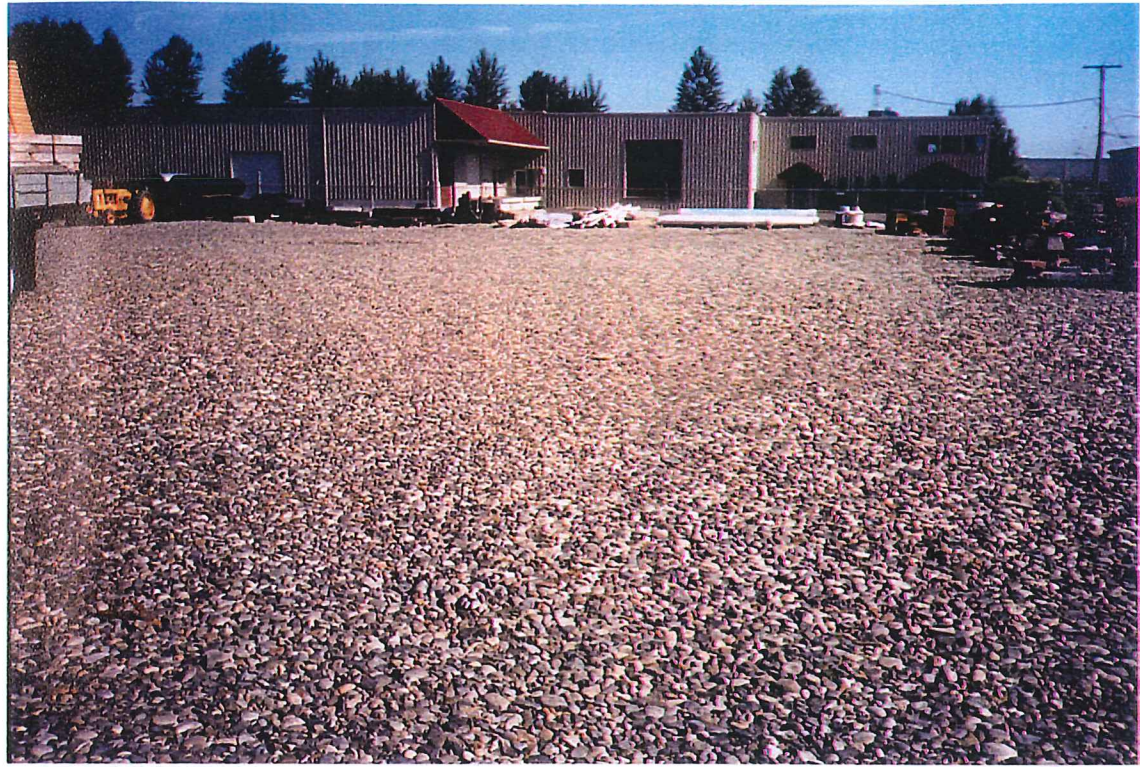
Photo #43: Photograph depicting clean crushed rock placed and graded over the remediated area on the Westwater Construction site, facing north. Approximately 2 feet of crushed rock was placed on the yard. Photo taken on 6/20/02.

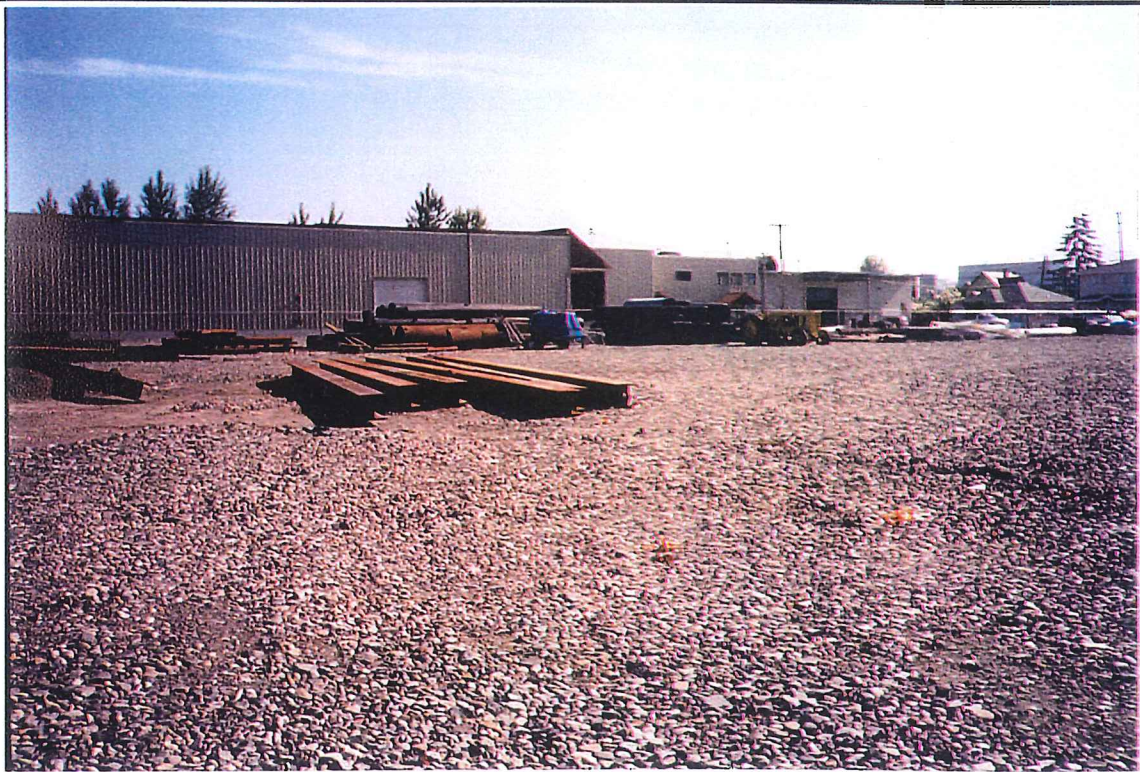
Photo #44: View of approximately 1 to 2 feet of crushed rock placed and graded over the Custom-Bilt Metals yard, facing northeast. Photo taken on 6/20/02.

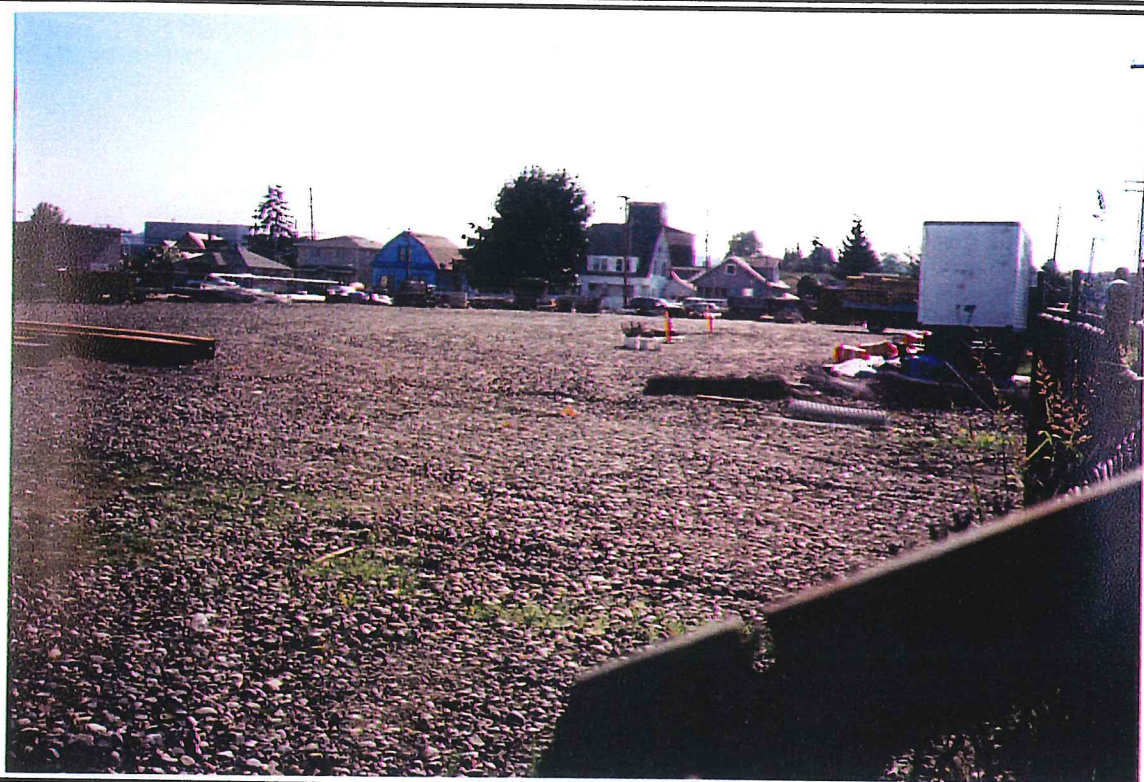
Photo #45: Crushed rock placed and grated over the Custom-Bilt Metals and Westwater Construction yards, facing east. Photo taken on 6/20/02.

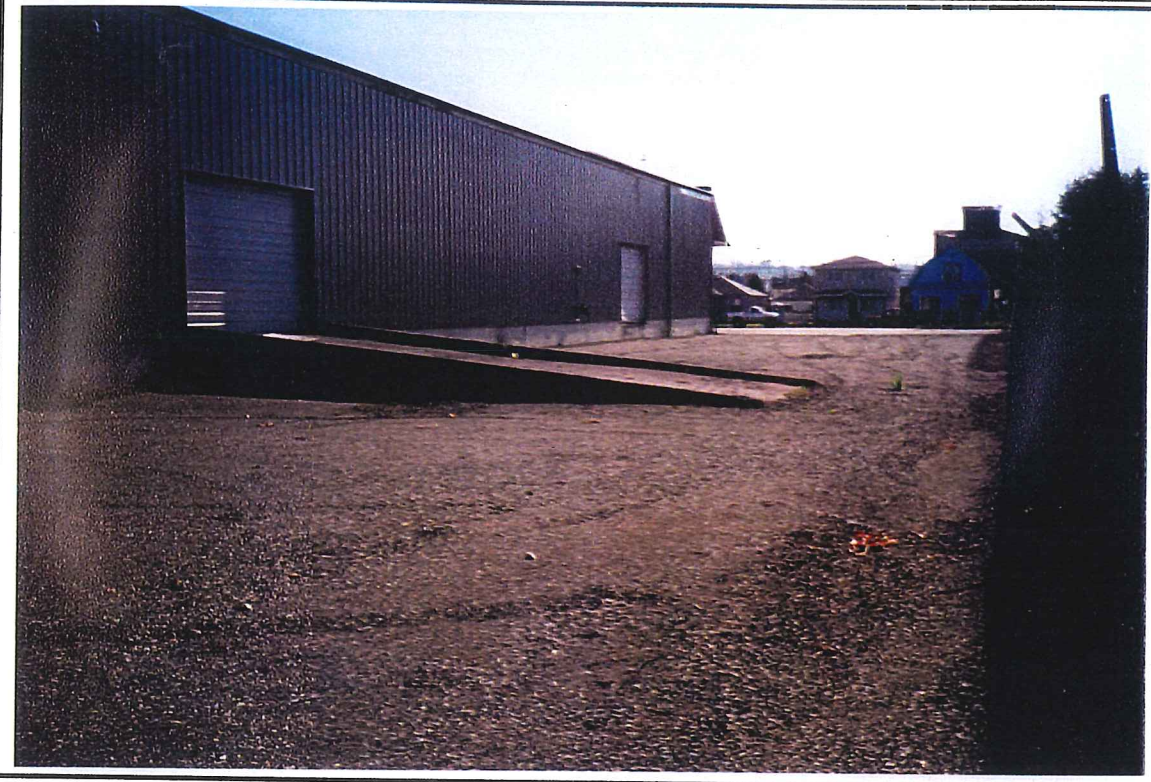
Photo #47: Final fill and grade located south of the Custom-Bilt Metals building, facing east. Photo taken on 6/20/02.

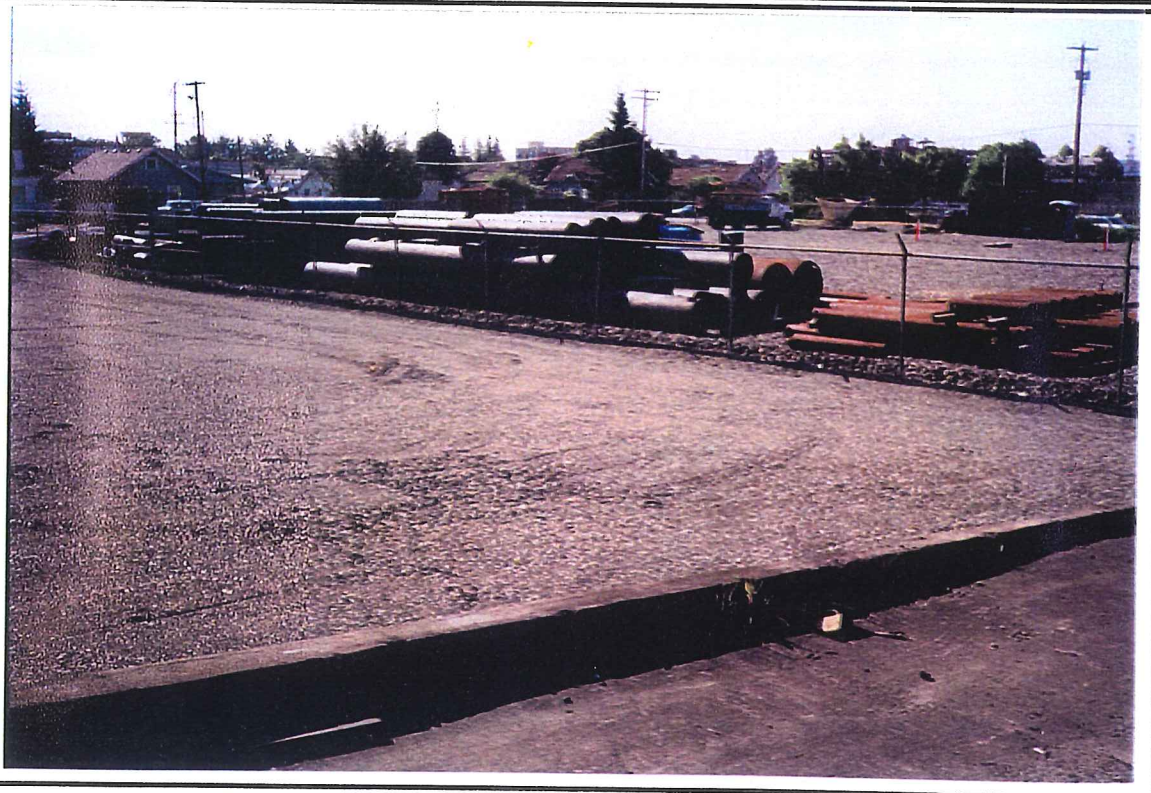
Photo #48: New chain-linked fence installed approximately 40 feet south of the Custom-Bilt Metals building separating the property currently occupied by Westwater Construction, facing southeast. Photo taken on 6/20/02.
