**Remedial Investigation Report  
Boeing Field Chevron  
10805 East Marginal Way South  
Tukwila, WA 98168  
Ecology Facility/Site No.: 2551  
Agreed Order No.: DE-10947**

**G-Logics Project 01-0410-M  
Copyright 2020 G-Logics, Inc.  
All Rights Reserved**

G-Logics is pleased to present this Remedial Investigation (RI) report for the subject property. This report documents the purpose, approach, and results of subsurface exploration efforts conducted to assess the nature and extent of soil, groundwater, and soil-gas impacts beneath the Property and Site. G-Logics requests that Ecology review this document and confirm that the presented information is sufficient to prepare a Feasibility Study, in accordance with the Site's existing Agreed Order.

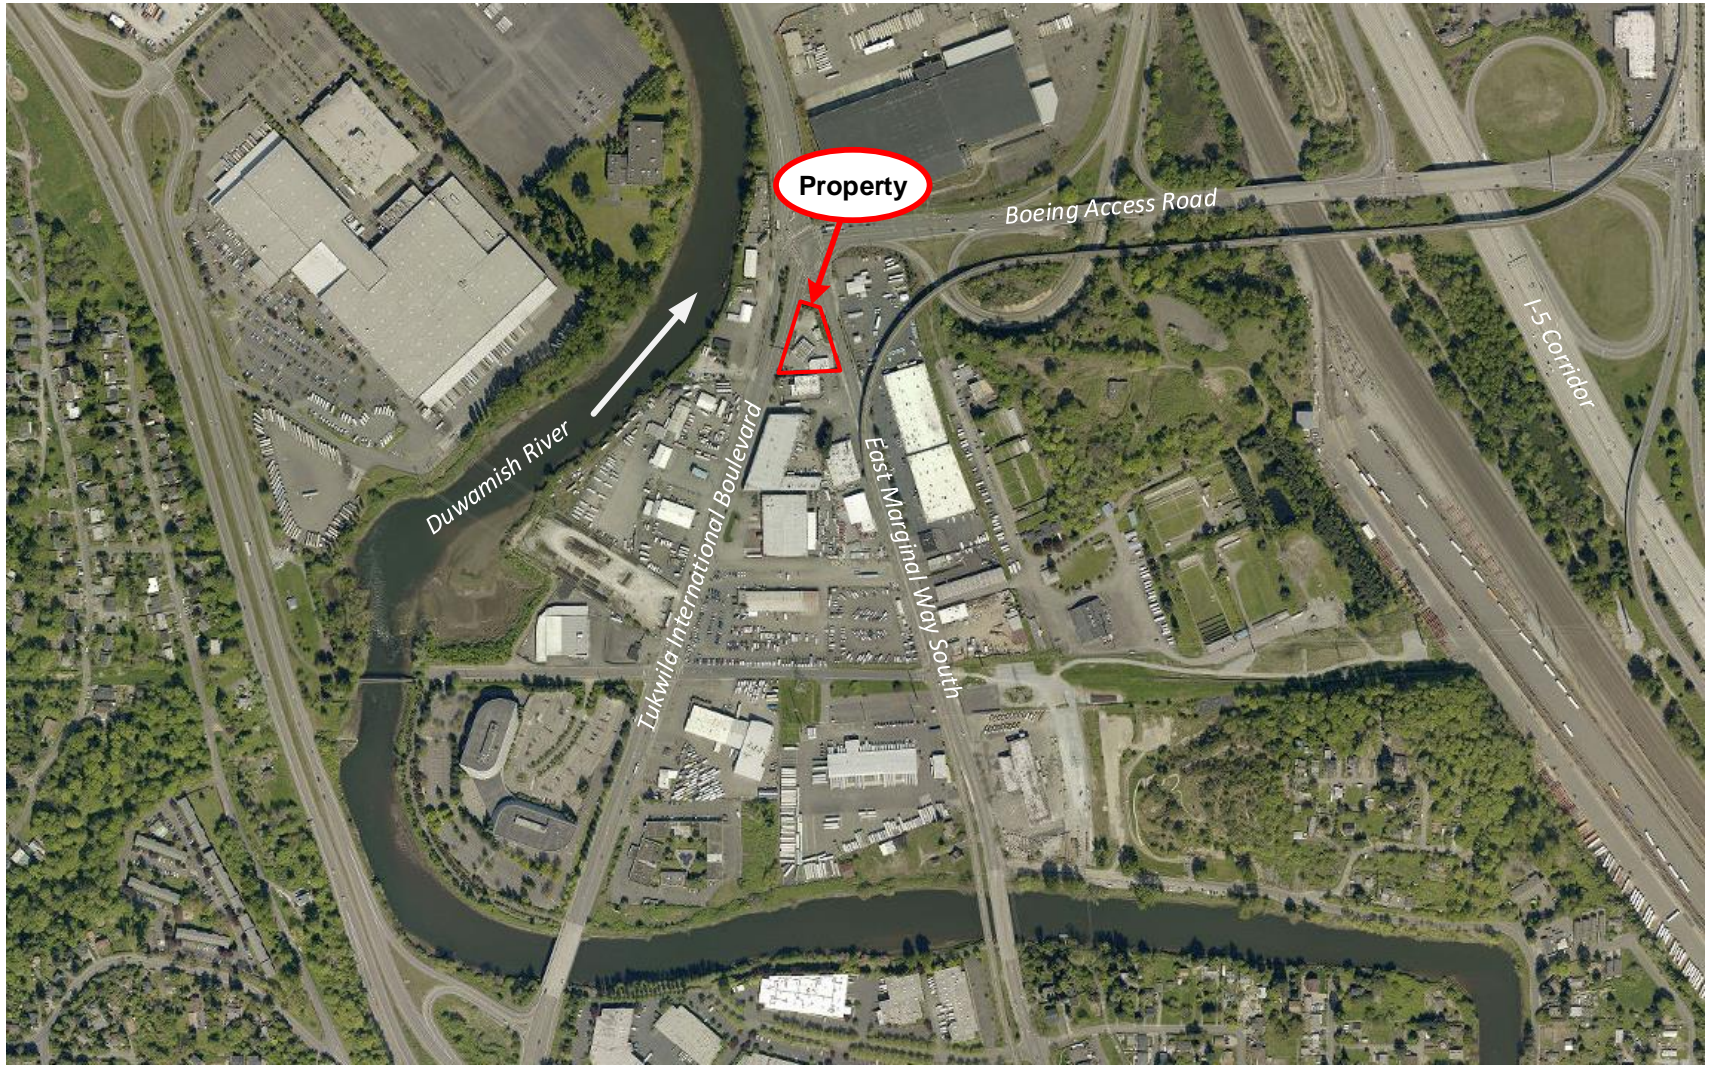
Figure  
1-2

**Site Aerial Photo Map**  
**Boeing Field Chevron**  
**10805 East Marginal Way South**  
**Tukwila, Washington**

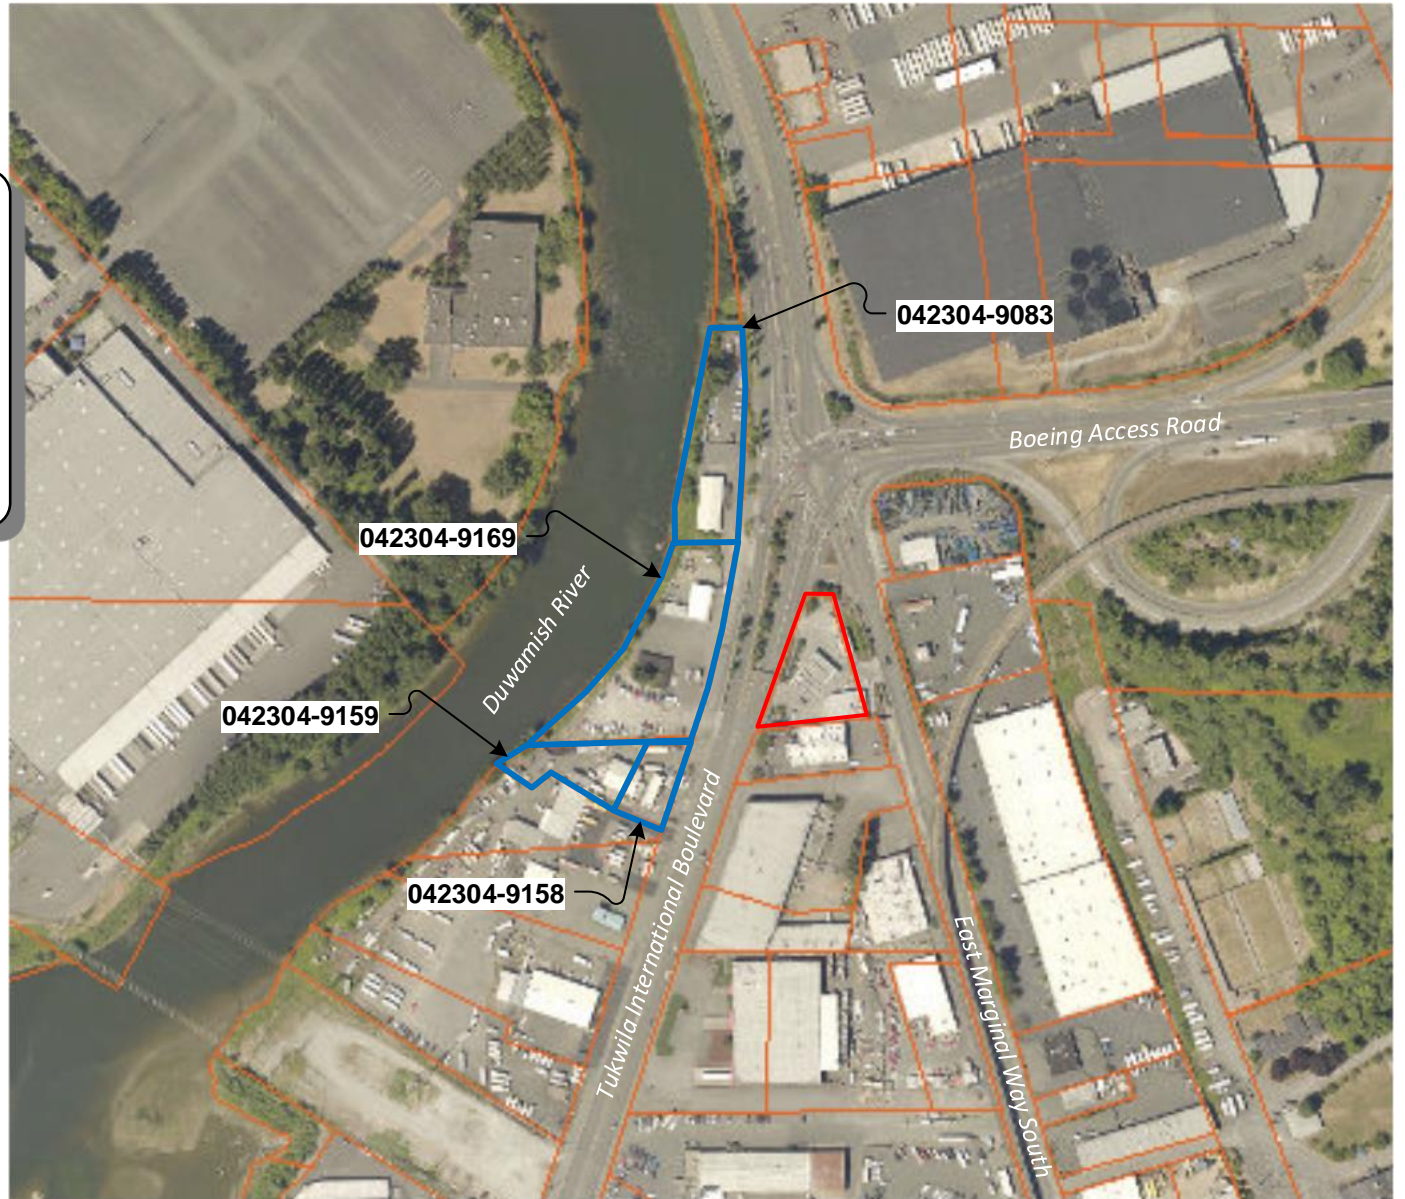
**Figure**  
**1-4**

Neighboring Property Boundary and Tax Parcel Number (see Report Section 2.5.2)

**Downgradient Neighboring Properties**  
**Boeing Field Chevron**  
**10805 East Marginal Way South**  
**Tukwila, Washington**

The property to the immediate south of Boeing Field Chevron is occupied by a mixed-use building containing office spaces and a food-manufacturing facility (Mighty-O Donuts). Currently, G-Logics understands that the office spaces in the building are vacant. The property to the east currently is occupied by a bulk propane distributor (Blue Star Gas). To the west (across TIB) are several commercial properties, including auto repair and storage lots and a neon-sign manufacturer.

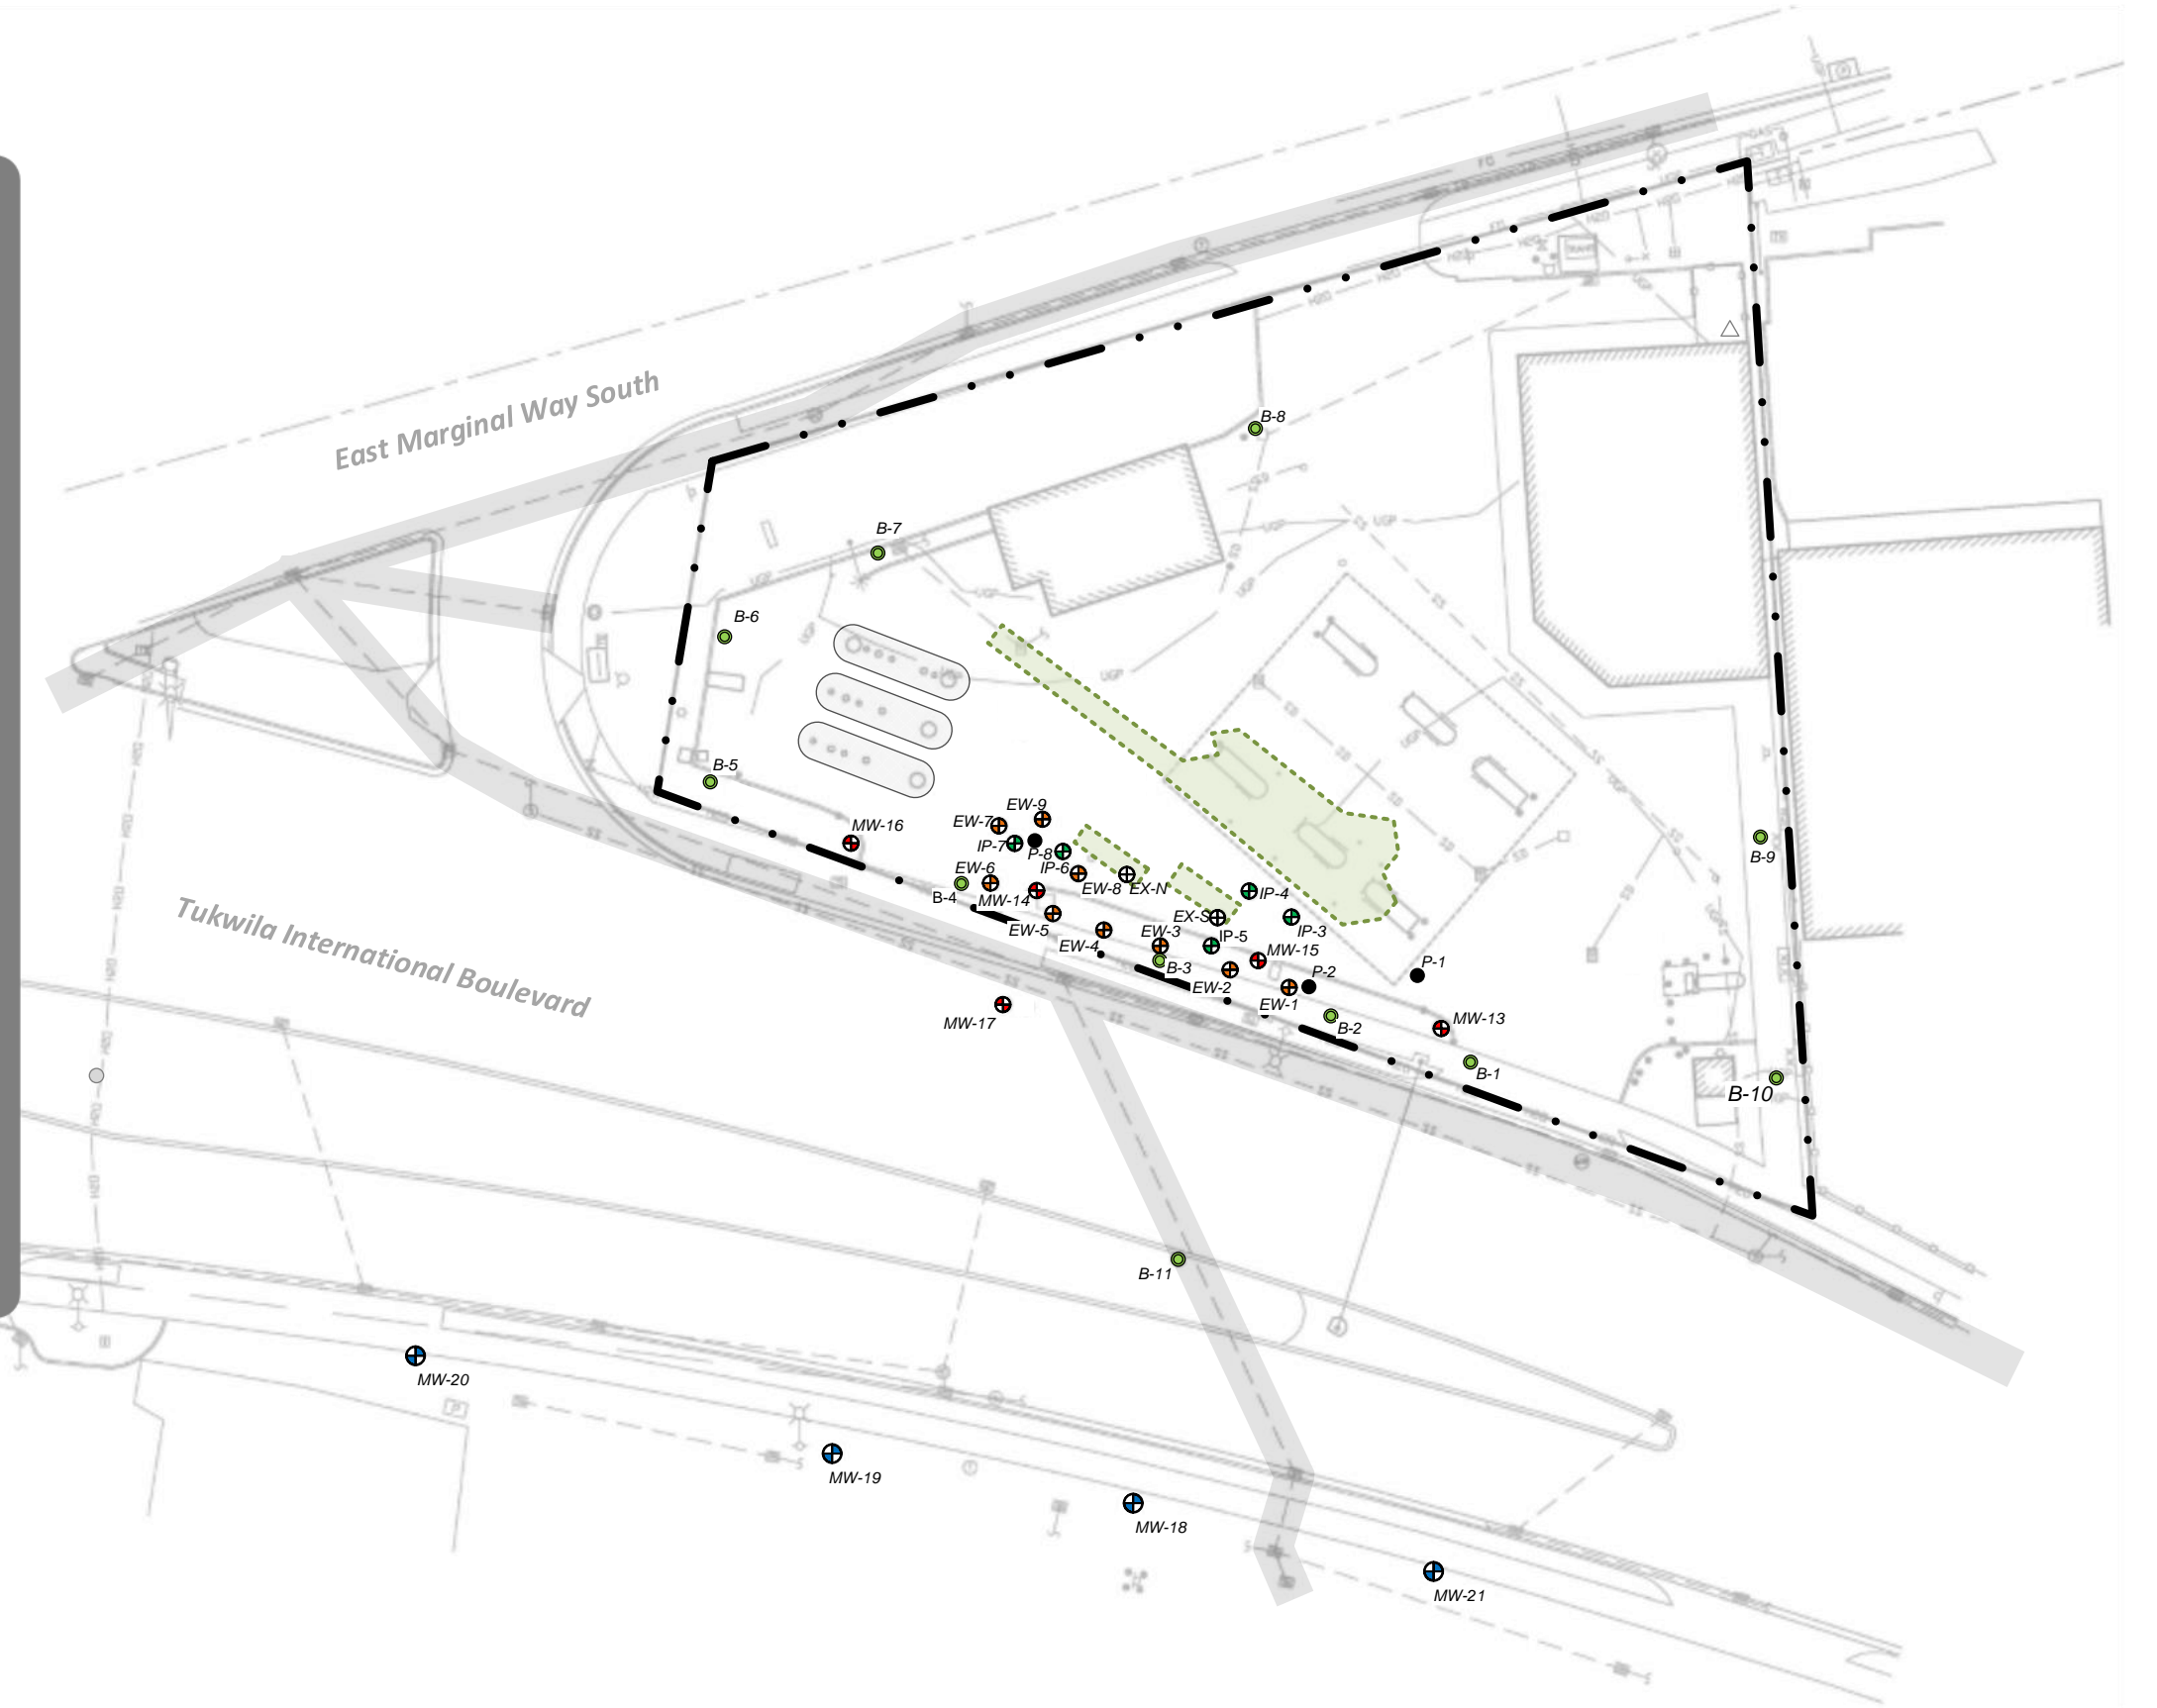
Project File: 01-0410-M F2-4 Exploration Locations, 2004-2015.vsd

Understood Utility Trench Locations (Adjacent to Property)

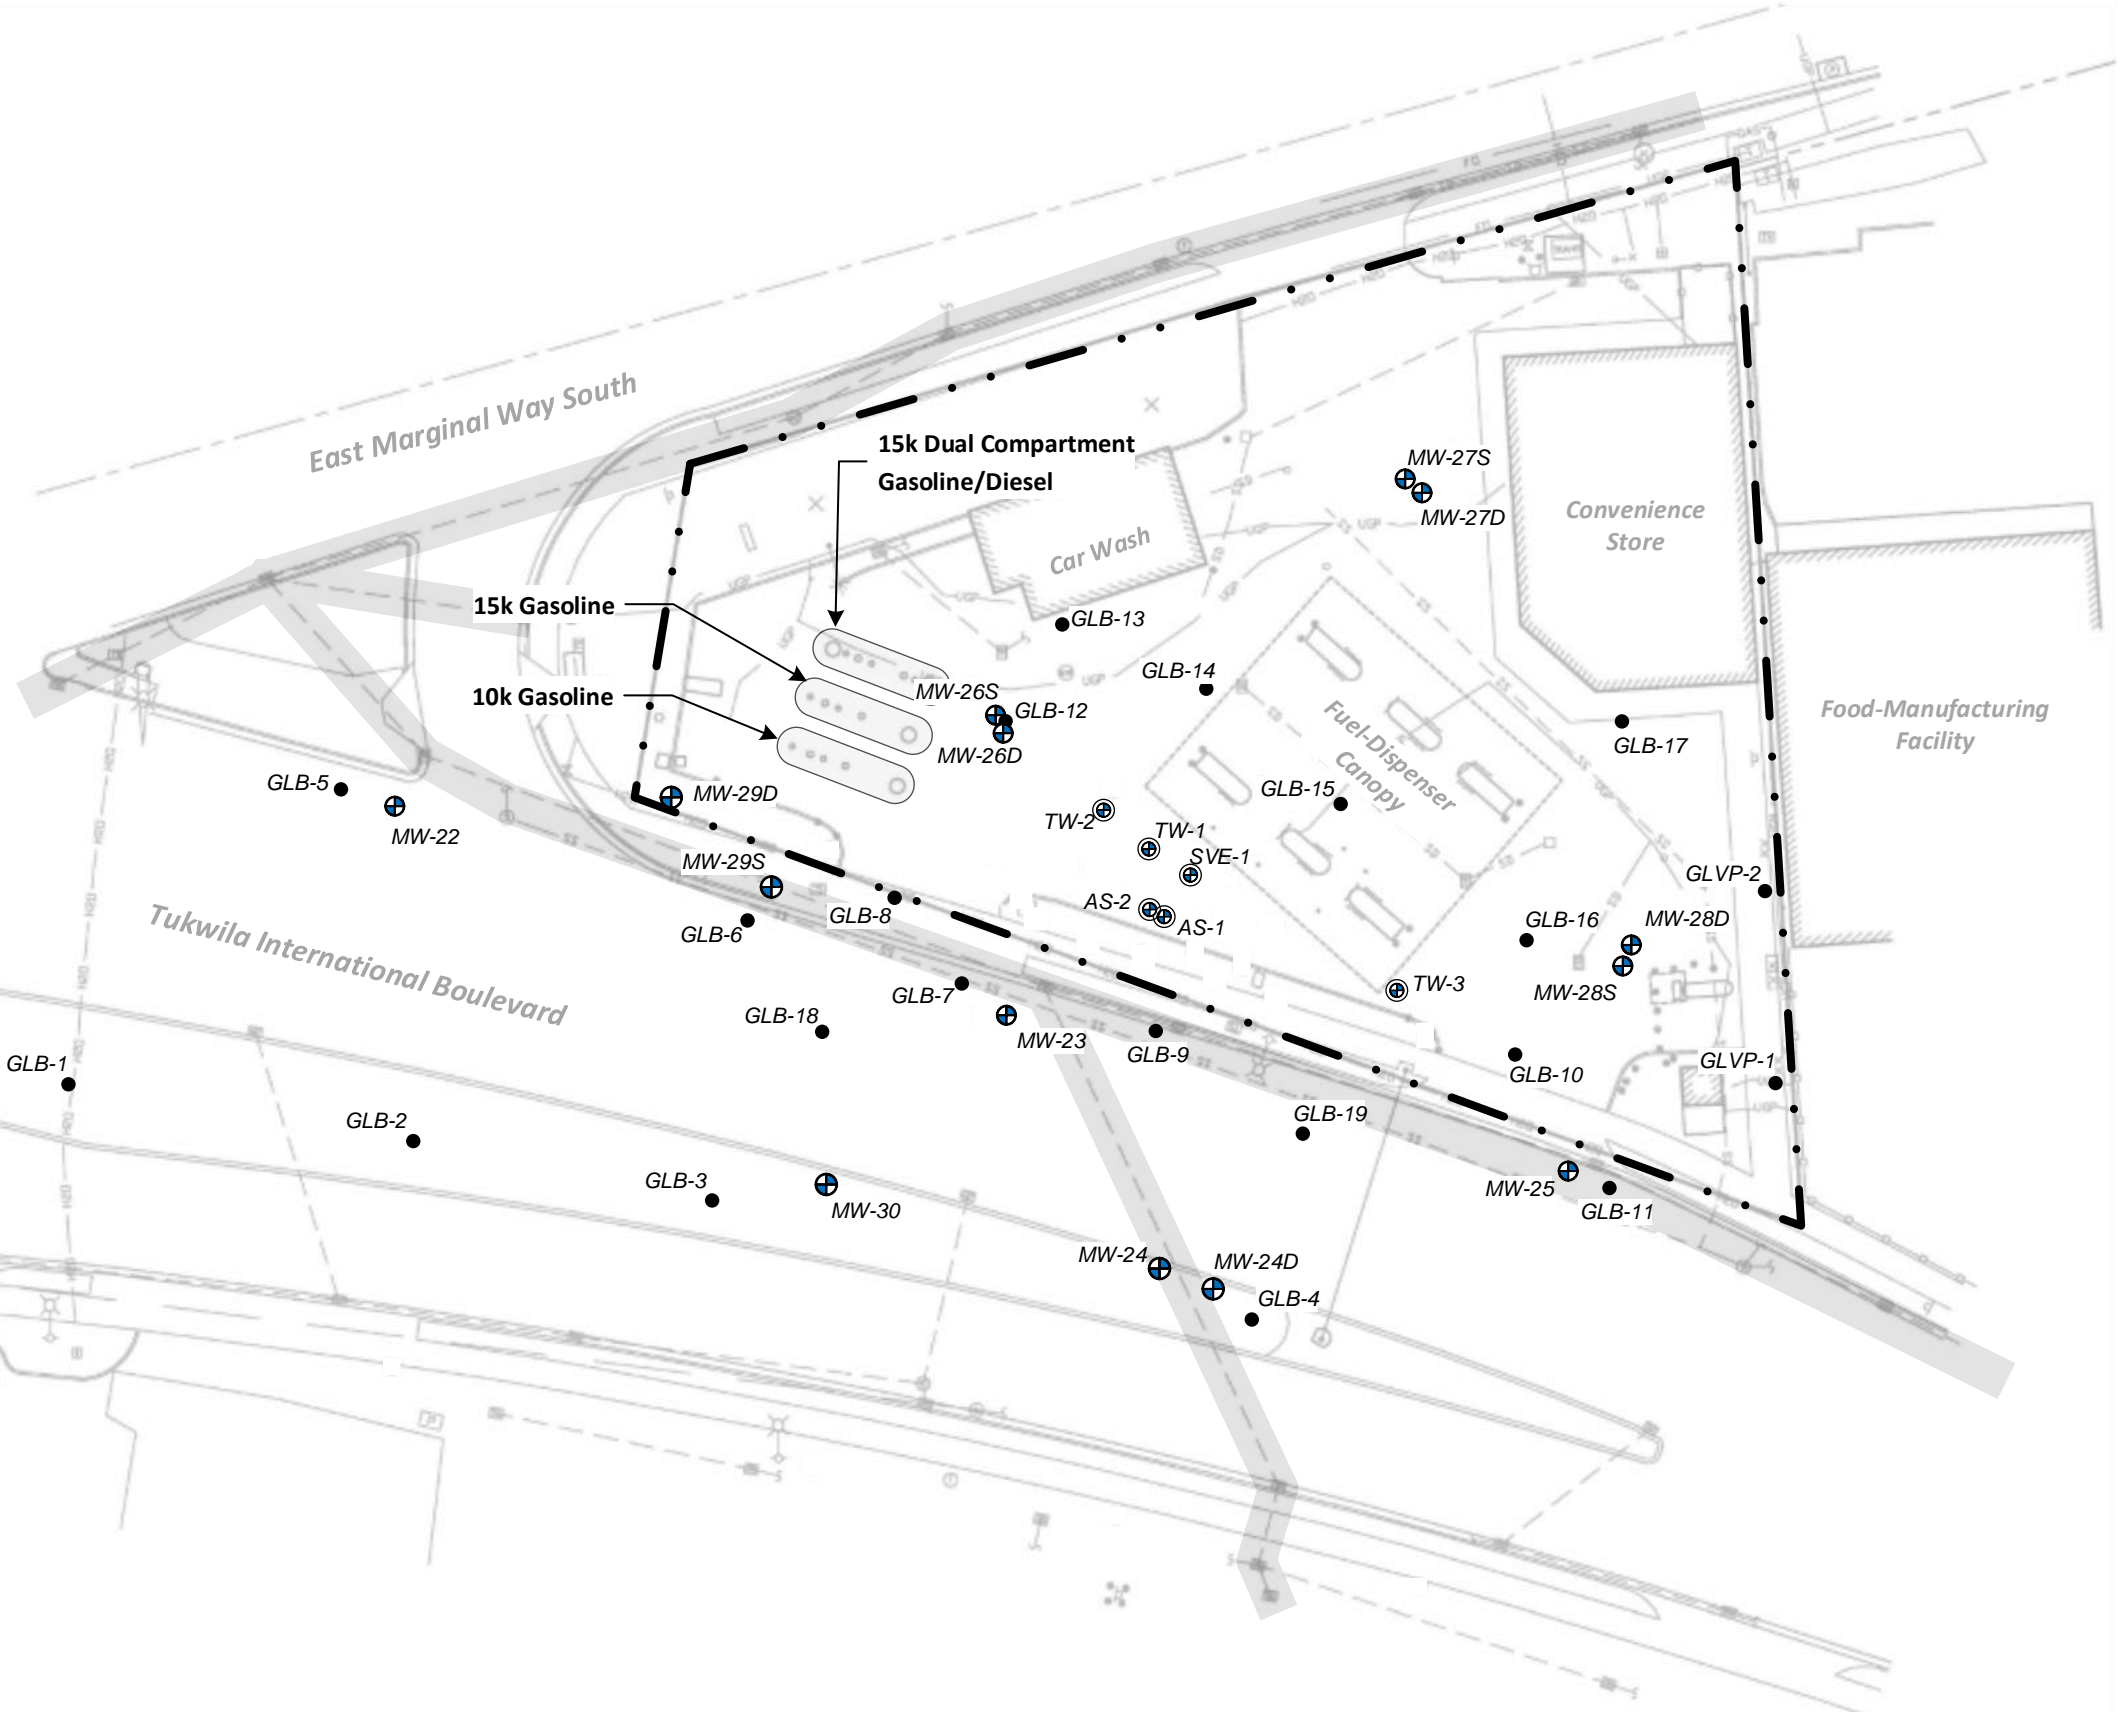
Project File: 01-0410-M F2-5 RI Locations, 2016-2019.vsd

Understood Utility Trench Locations (Adjacent to Property)

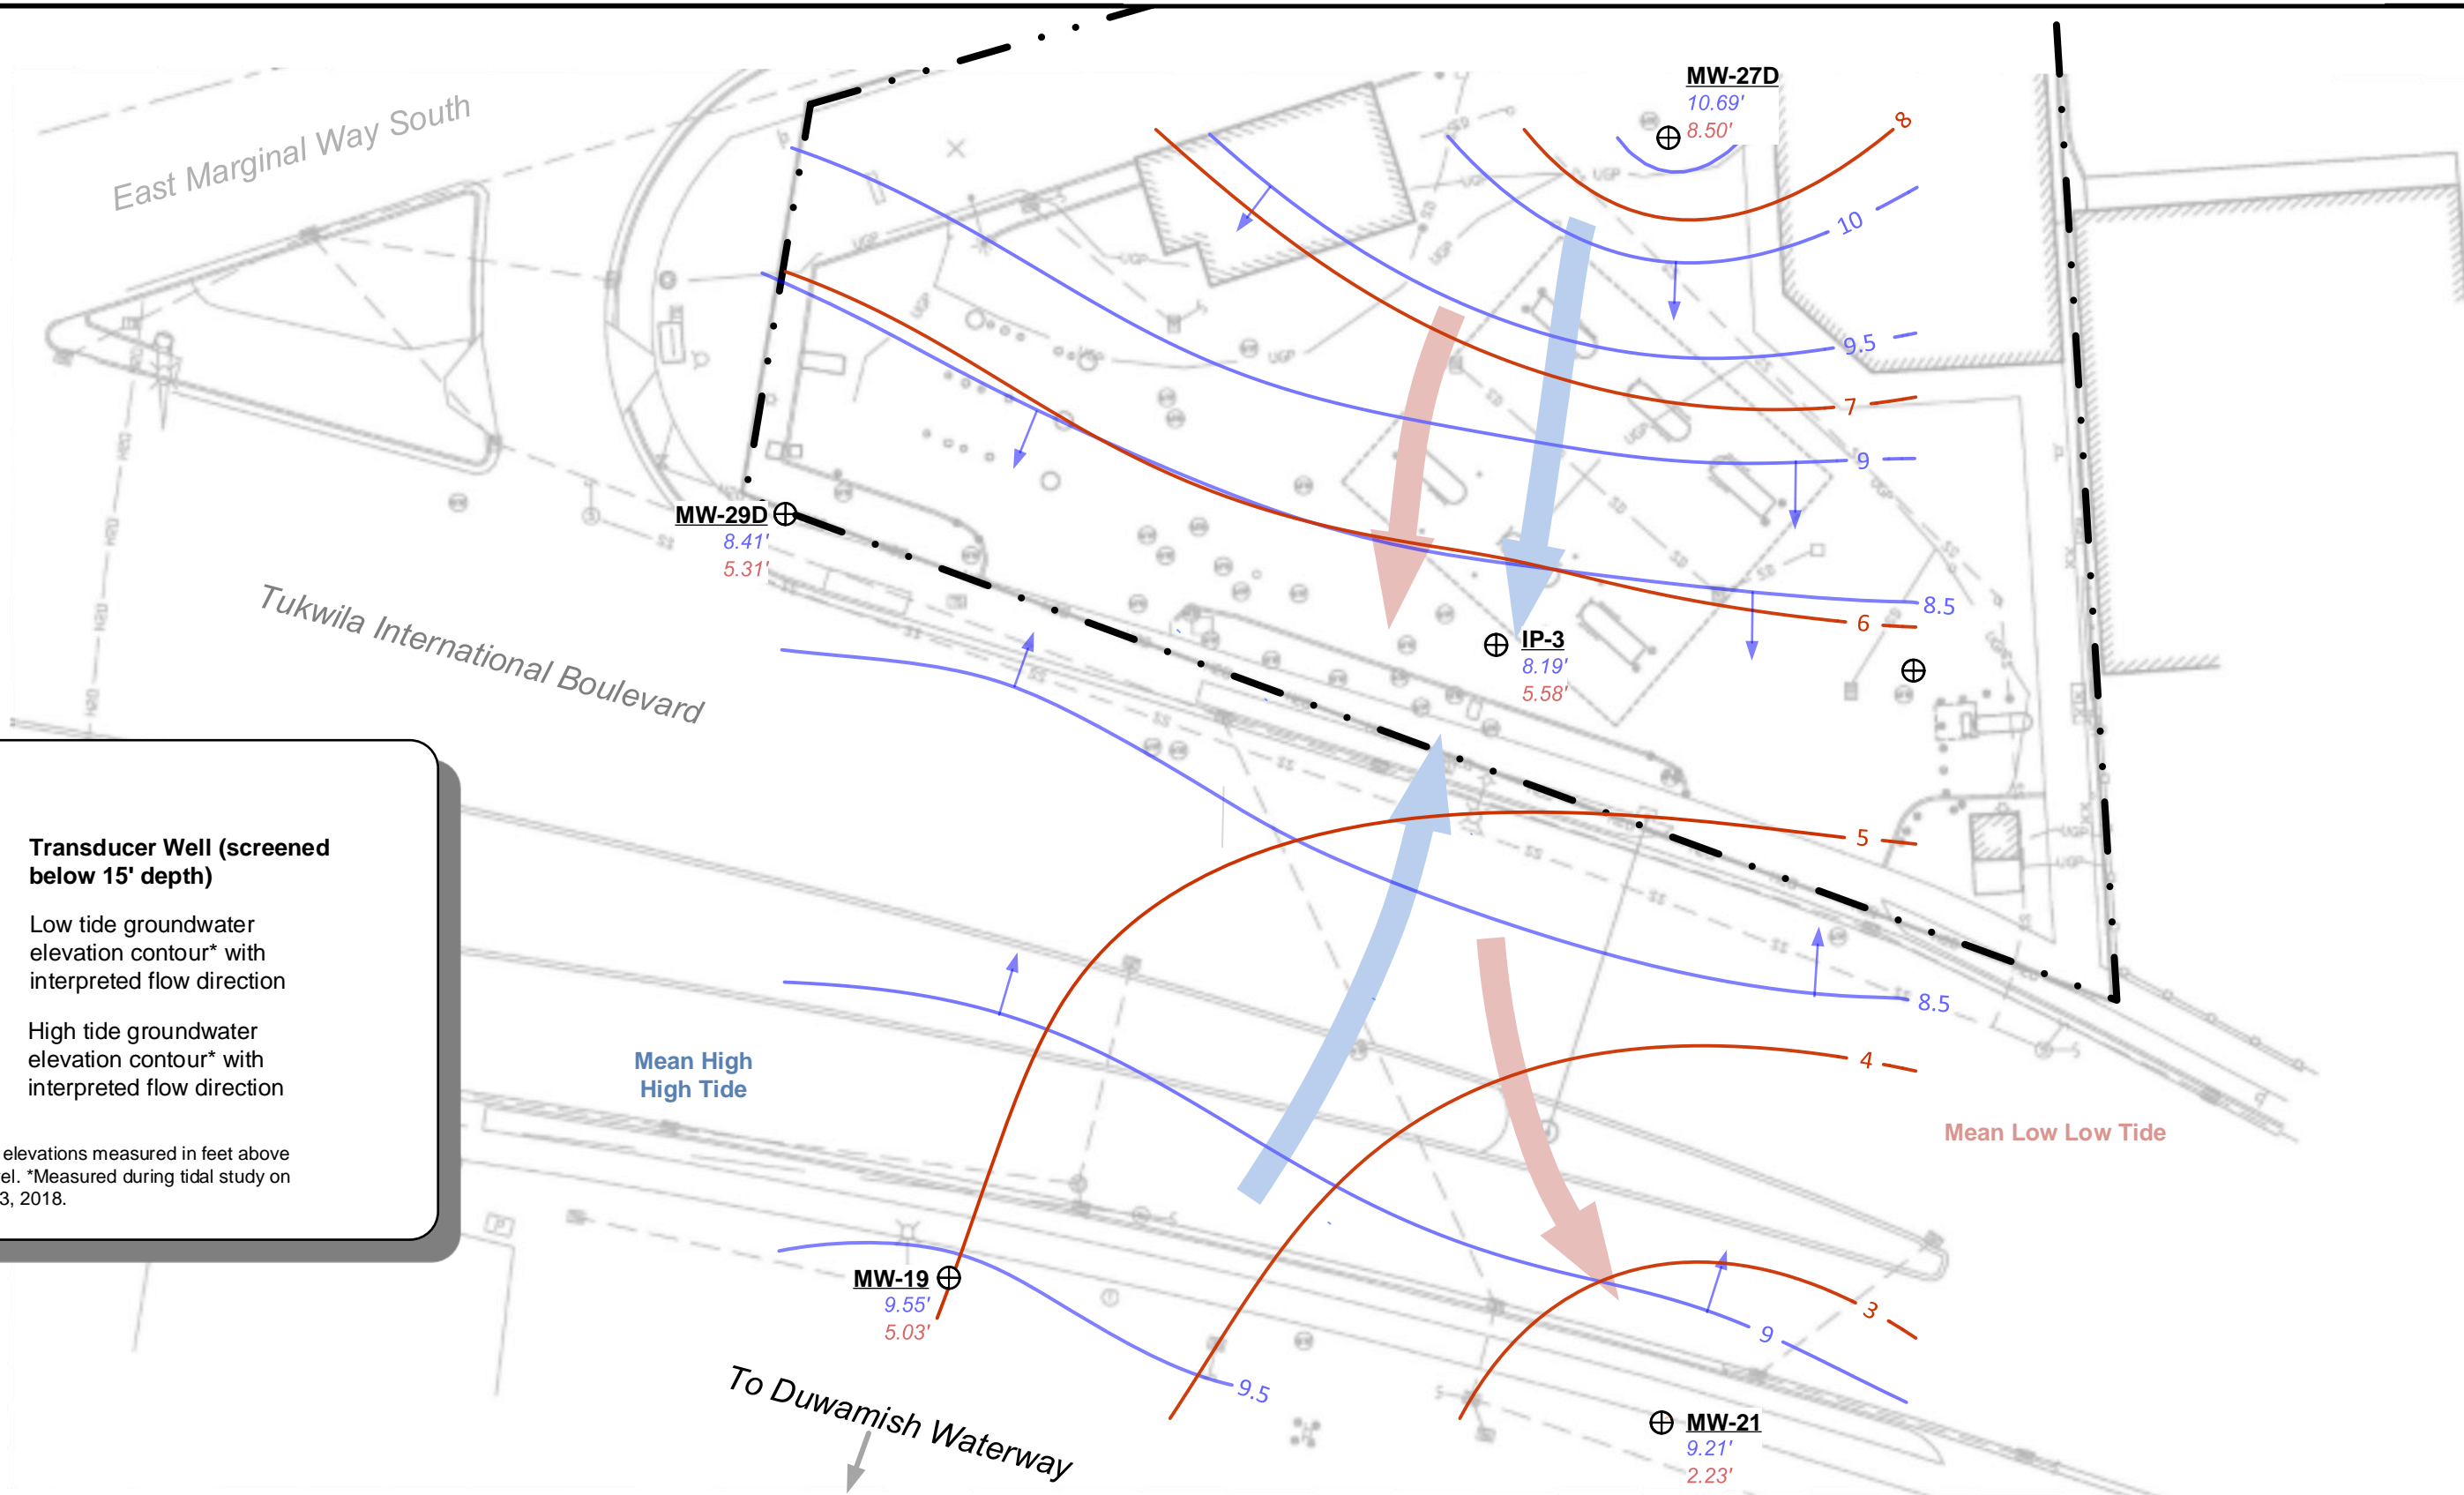
Figure 9-2

- MW-19 Transducer Well (screened below 15' depth)
- Low tide groundwater elevation contour\* with interpreted flow direction
- High tide groundwater elevation contour\* with interpreted flow direction

**Lower Saturated Zone Groundwater Elevation Contours, High and Low tide, 2018**  
 Boeing Field Chevron  
 10805 East Marginal Way South  
 Tukwila, Washington
