PERIODIC REVIEW REPORT FINAL

BRUMFIELD TWIDWELL Facility Site ID#: 94658144 Cleanup Site ID#: 6914

301 E Pioneer Avenue Montesano, Washington 98563

December 2020

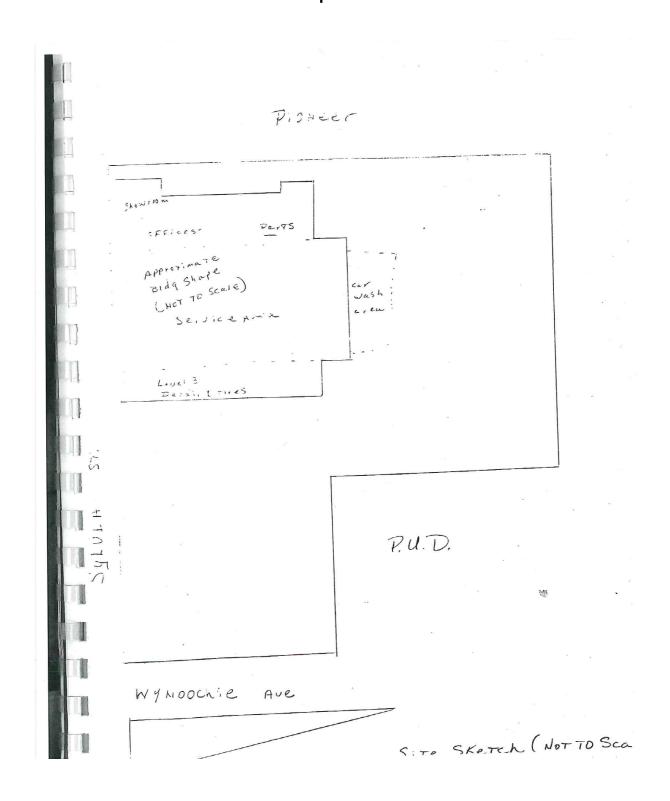
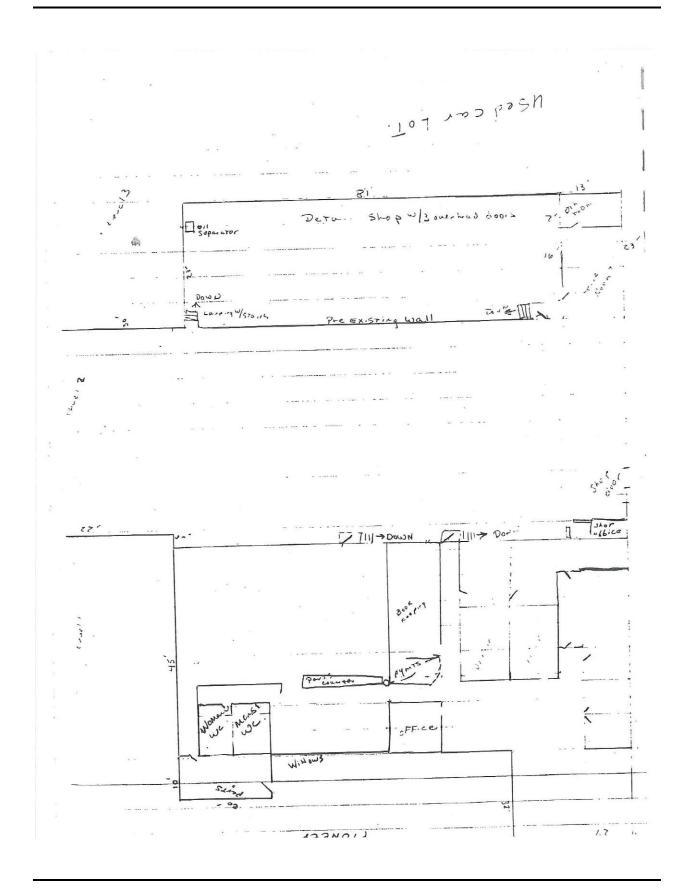
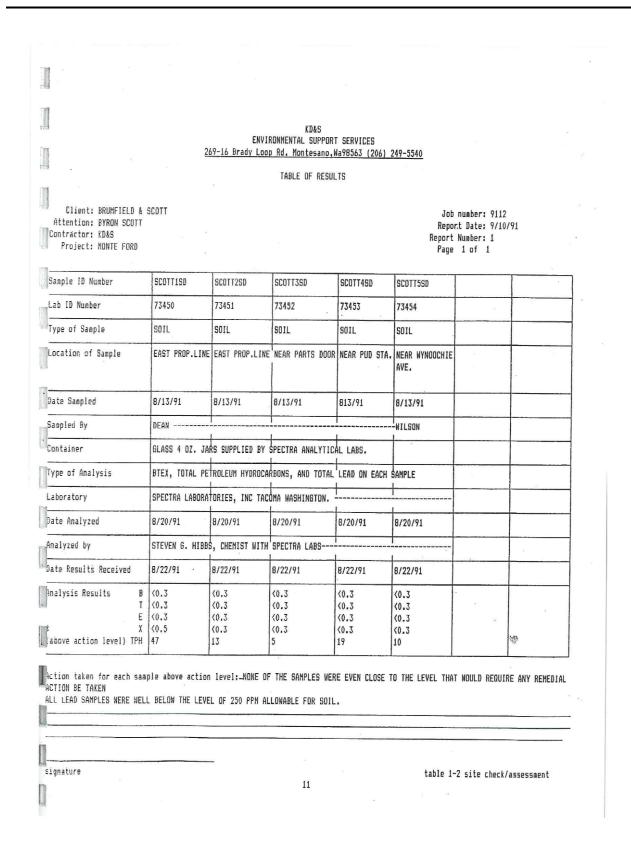
6.3 1991 – Underground Storage Tanks Decommissioning: Approximate Locations of USTs and Soil Sample Results

In 1991, KD&S Environmental Services (KD&S) performed a Phase I and II Environmental Site Assessment (ESA) investigation. According to the KD&S reports, the original building constructed in 1927 was expanded in Phases in 1936, 1939, and 1989, which included the pouring of concrete floors. These modifications prompted the removal/closure of four USTs that had been in use up to that time. Tank #1 (500 gallon) was closed in-place by filling with sand slurry, Tank #2 (5,000 gallon) and Tank #4 (500 gallon) were also closed in-place by filling concrete slurry and Tank #3 (10,000 gallon) was removed. No soil samples were collected during the decommissioning of Tank #s 1, 2, and 4. However, five soil samples were collected during the decommissioning of Tank #3 and soil samples were analyzed for benzene, toluene, ethylbenzene, and xylenes (BTEX), and total petroleum hydrocarbons (TPH) using the hydrocarbon identification (HCID), EPA Method 418.1 Method. All the results were below the Model Toxics Control Act (MTCA) Method A cleanup levels. A figure showing the approximate locations of USTs and soil sample results are included as Appendix 6.3.

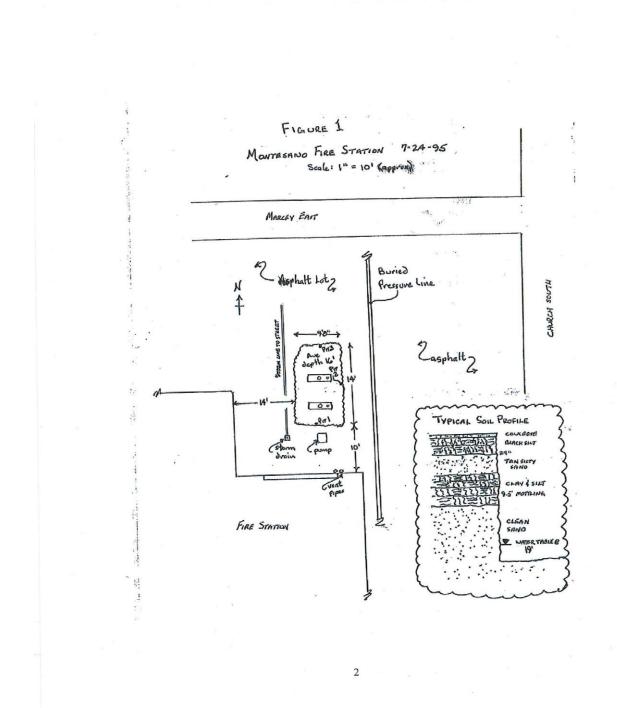
6.4 1995 – Montesano Fire Station USTs Decommissioning: Approximate Location of USTs, Locations of Soil Samples, and Sample Results

The Montesano Fire Station is located on Pioneer Avenue north of Brumfield Twidwell Site. In 1995, Northwest Testing Company (NTC) decommissioned two 300-gallon unleaded gasoline USTs at the Montesano Fire Department Station located directly up-gradient from the Brumfield Twidwell property. Northwest Testing reported that the contaminated soil with gasoline-range total petroleum hydrocarbons (TPH-G) and BTEX exceeding MTCA Method A cleanup levels were left in place. A composite soil sample from the east sidewall of the tank excavation and composted to the surface to a depth of 19 feet below ground surface (bgs) contained TPH-G at 15,800 mg/kg. There were extremely high levels of BTEX as well, up to 1,000 mg/kg benzene, 3,130 mg/kg of toluene, 1,600 mg/kg of ethylbenzene, and 4,450 mg/kg of xylenes. Northwest testing indicated that samples from the base of the excavation could not be obtained but that the soil appeared to be contaminated. Groundwater was assumed to be impacted but no testing was conducted. Approximate locations of two USTs and soil sample results are included as Appendix 6.4.

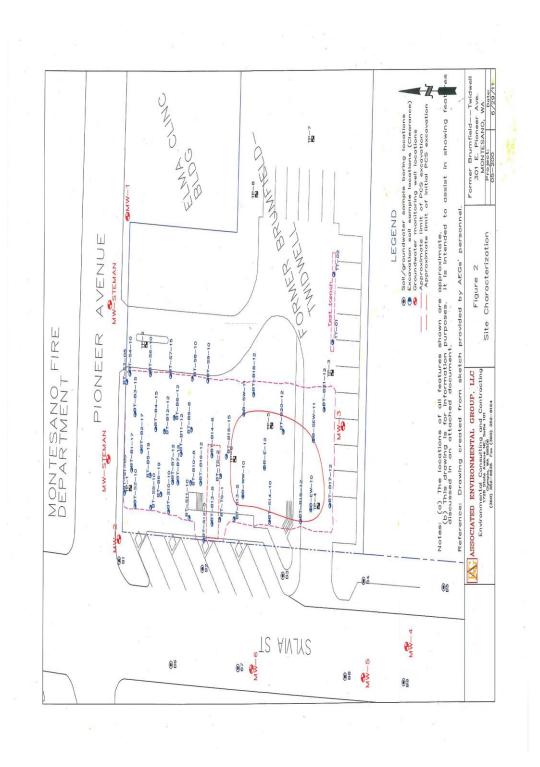
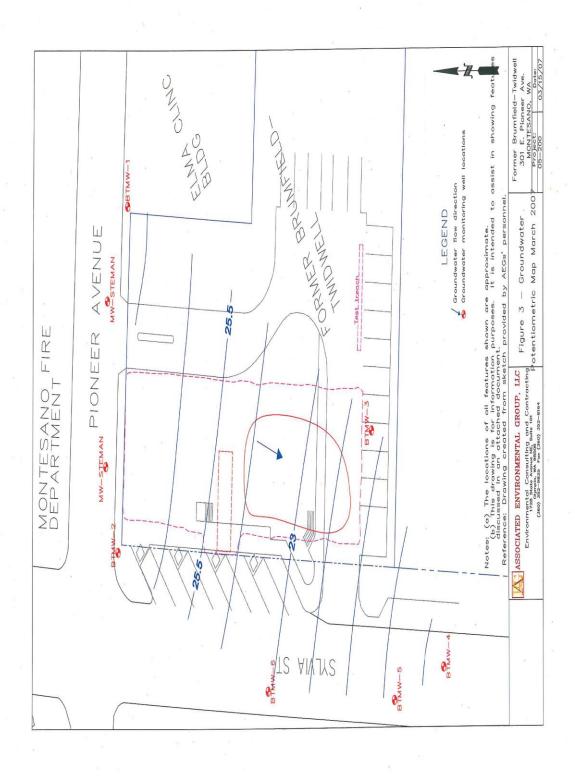
6.6 Site Charecterization Soil Sample Locations: All Phases of Investigation and Water Level Elevation Contour Map

During the soil excavation activities, another UST, approximately 10,000 gallon in capacity, was <u>discovered</u> in the western portion of the Site. It was determined that this tank may have been a "waste oil" tank. The tank was decommissioned by removing it from the ground. The soils beneath the tank indicated signs of being heavily impacted by petroleum contamination and were subsequently excavated for disposal. The results of confirmation soil samples collected beneath the tank, showed no detectable concentrations of petroleum contamination. The approximate extent of contaminated soil excavation is shown on Figure 2 in Appendix 6.6.

In March 2006, nine Geoprobe borings along Sylvia Street to further characterize the subsurface conditions in the area. Analytical results of soil samples collected during this phase of Supplemental Remedial Investigation at off-Site areas indicated that the east side of Sylvia Street was impacted to the north of the City of Montesano PUD property (near boring B-7) and the west side of Sylvia Street was impacted to the Pick-Rite Thriftway parking lot to the west were also impacted. Pick-Rite Thriftway conducted a separate investigation of the Thriftway property along with monitoring wells. Because of the findings from this Geoprobe borings, two additional groundwater monitoring wells (BTMW-5 and BTMW-6) were installed on the west side of Sylvia Street to supplement the four existing on-Site wells. Locations of all the soil borings and soil samples collected during various stages of subsurface investigation and Interim Remedial Action at the Site are shown in Figure 2, Site Characterization included in Appendix 6.6.

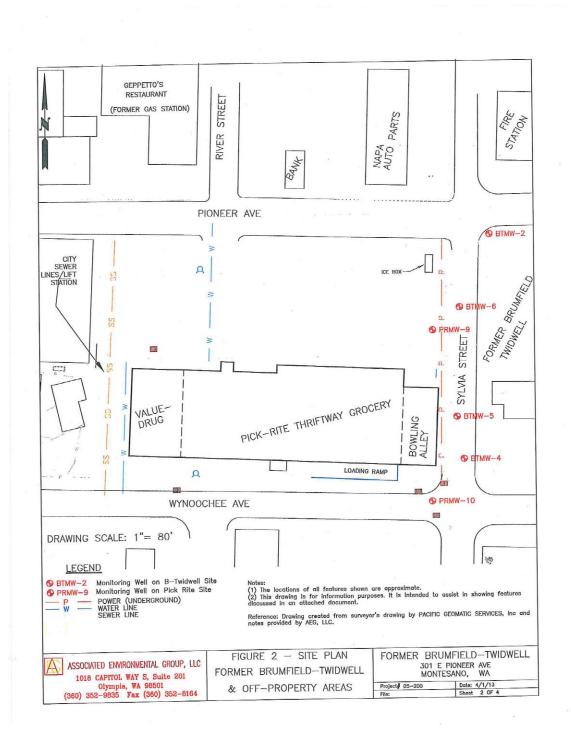
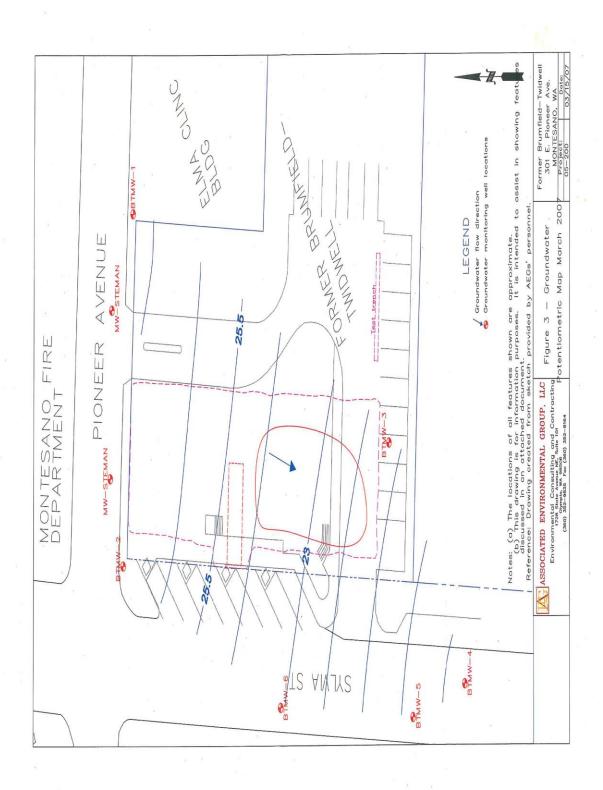
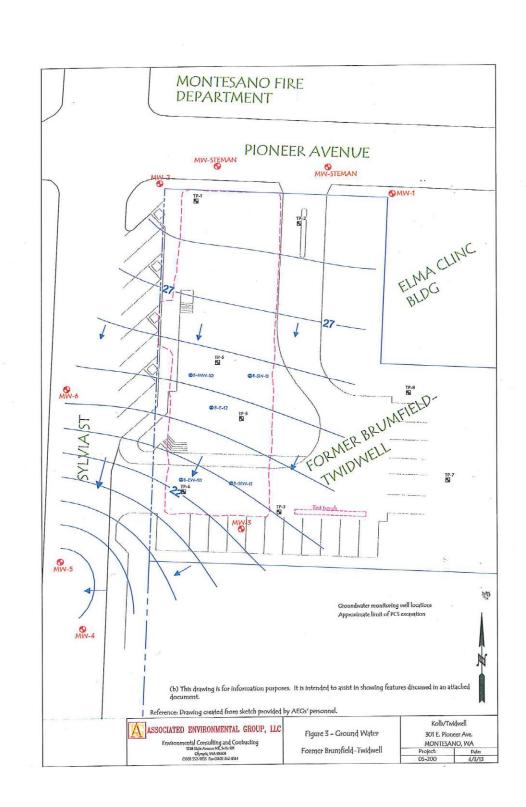
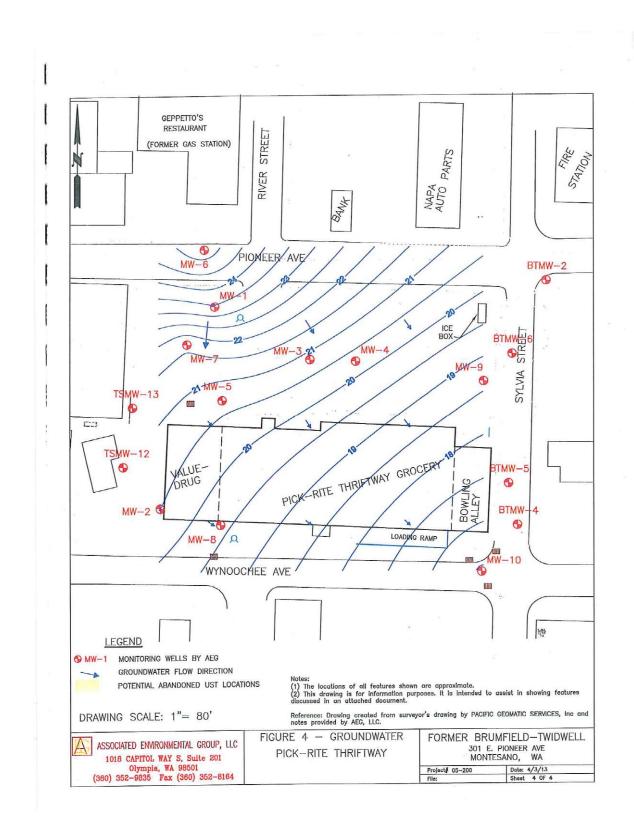
6.7 2006 – 2011 Annual Groundwater Monitoring: Groundwater Monitoring Well Locations, Groundwater Sample Results, and Groundwater Level Contour Maps

As required by the AO, annual groundwater monitoring activities began in 2006 and continued until post-remedial action quarterly monitoring that was begun in April 2012. Two additional off-Site (PRMW-9 and PRMW-10) not specified in the required annual monitoring were added to the quarterly monitoring in 2012 as part of the confirmation monitoring following the remedial action at the Site. Initially groundwater sample results indicated elevated levels of TPH-G and BTEX above MTCA Method A cleanup levels in BTMW-2. However, after the Interim Remedial Action, there was decreasing trend in the concentrations in BTMW-2 and other downgradient wells. The groundwater monitoring well locations and groundwater sample results are included as Appendix 6.7.

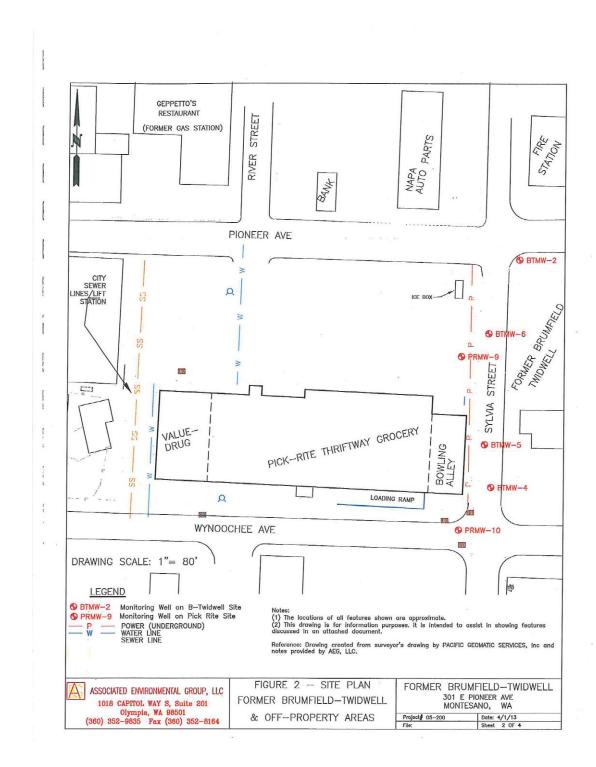
6.8 In-Situ Bioremediation: Approximate Locations of Oxygen Releasing Compound Injection Points

- Removal and disposal of two 10,000-gallon USTs.
- One 5,000-gallon and two 500-gallon USTs were closed-in-place.
- Excavation and off-Site disposal of approximately 2,079 tons of petroleum contaminated soil.
- In-situ bioremediation was used to accelerate the microbial degradation of remaining petroleum hydrocarbon impacted soil and groundwater. A total of 1,000 pounds of Oxygen Releasing Compound (ORC) was injected into the subsurface at 10 injection points (three near well PRMW-9, two near well BTMW-5, three near well BTMW-2, and two near well BTMW-6) at the Site. Locations of ORC injection points are shown on Figure 2 in Appendix 6.8.

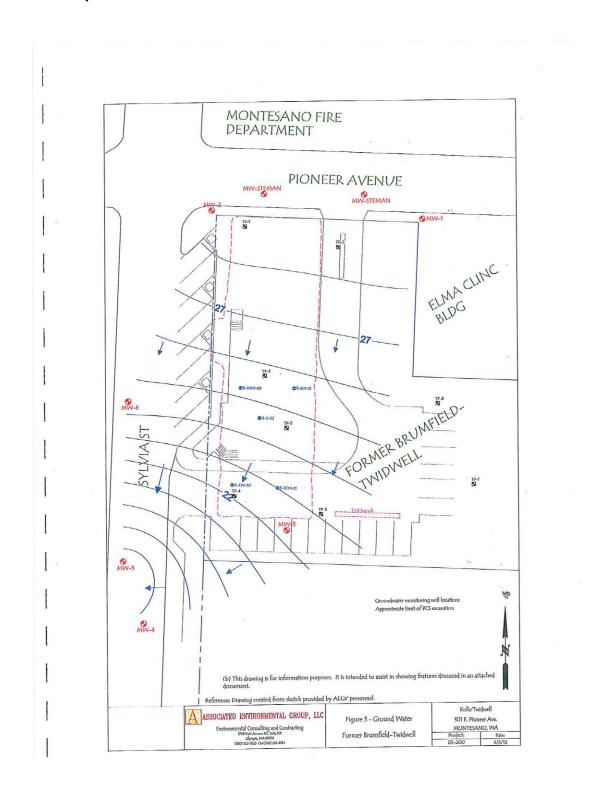
6.9 Post-Remedial Action Groundwater Monitoring: Locations of Groundwater Monitoring Wells, Groundwater Level Contour Map, and Groundwater Sample Results

Results of TPH-G concentrations in well BTMW-2 (871 μ g/l to 1,860 μ g/l) were above the MTCA Method A cleanup level of 800 μ g/l. However, the TPH-G concentrations decreased during this quarterly monitoring period from 1,860 μ g/l to 871 μ g/l. In addition, ethylbenzene and total xylenes were detected below the MTCA Method A cleanup levels. All other contaminant concentrations were either below the MTCA Method A cleanup levels or below the laboratory detection limits.

TPH-G (482 μ g/l to 1,430 μ g/l), ethylbenzene (2.0 μ g/l to 9.1 μ g/l) and xylenes (9.4 μ g/l to 45 μ g/l) were detected in the groundwater samples collected from the off-Site well PRMW-9. However, ethylbenzene, and xylenes concentrations were below their MTCA Method A cleanup levels of 700 μ g/l and 1,000 μ g/l, respectively. The TPH-G concentration decreased from 1,430 μ g/l to 482 μ g/l during the quarterly monitoring period (April 2012 to January 2013). The TPH-G concentration of 482 μ g/l during January 2013 sampling event was below the MTCA Method A cleanup level of 800 μ g/l. No other COCs were detected above the laboratory detection limits. Groundwater monitoring well locations, groundwater elevation contour map and water sample results are included in Appendix 6.9.

Based on the presence of other contaminant sources in the Site vicinity, it was concluded that the petroleum related contamination found in wells BTMW-2 and PRMW-9 was from off-Site sources and the groundwater monitoring was discontinued and not requiring any more additional monitoring.

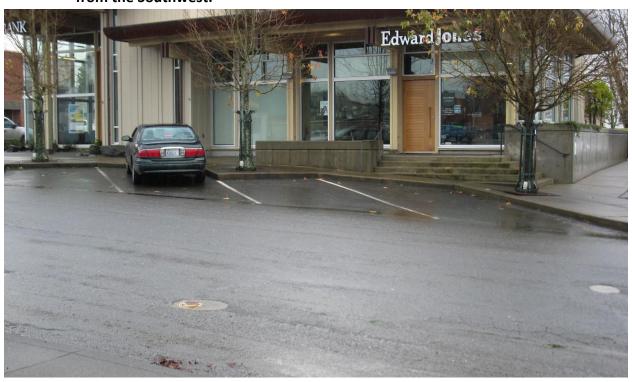
Photo 5: Abandoned Soil Boring and Groundwater Monitoring Well Locations on Sylvia Street – from the Southwest.

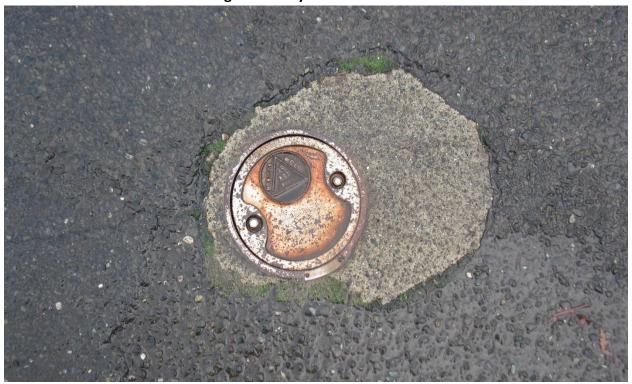
Photo 6: Groundwater Monitoring Well on Sylvia Street.
