Technical Memorandum

RE: **Groundwater Monitoring Results & Restrictive Covenant Release Tacoma Town Center/Jefferson Avenue Site (VCP Project No. SW1315) 2100-2300 Jefferson Avenue Tacoma, Washington Project No. 1848001.010.013**

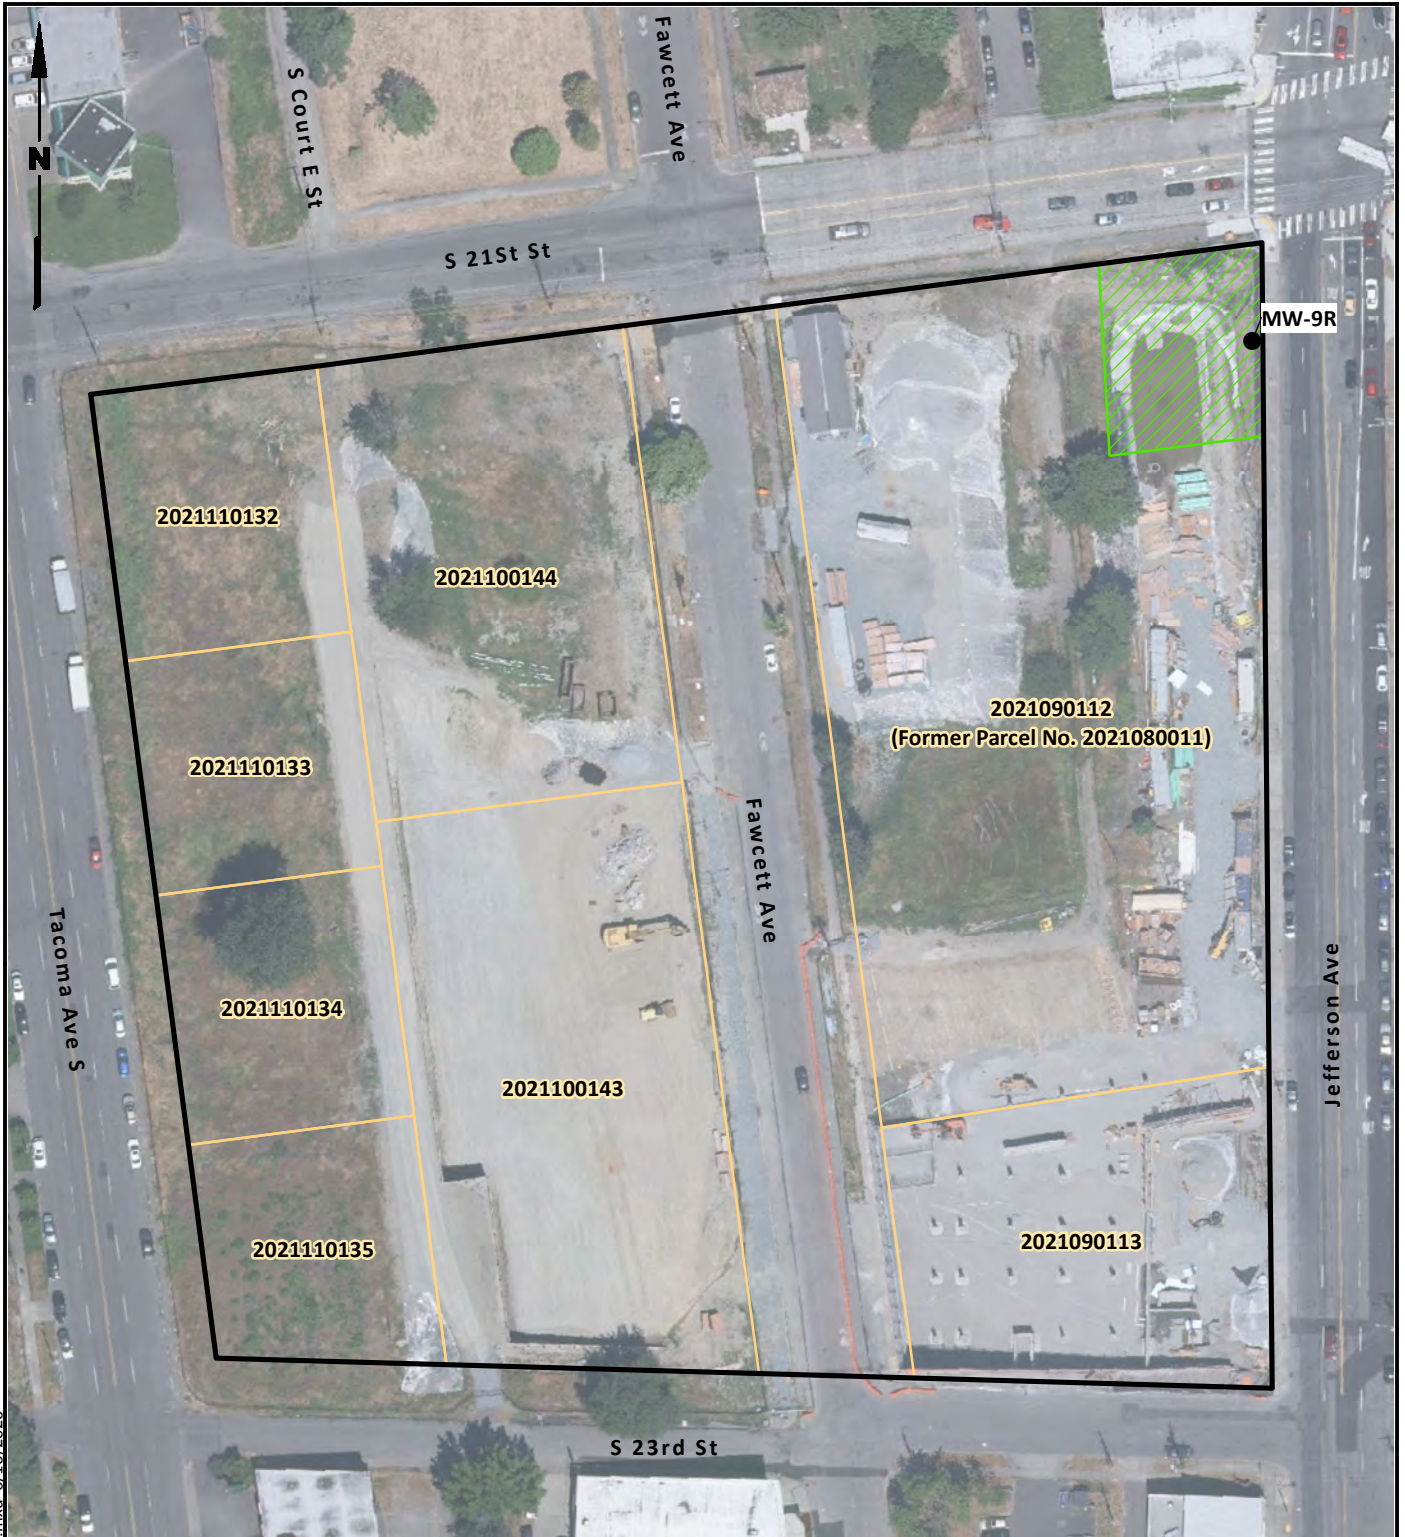
Figure
2

Site Plan

concentrations in groundwater identified at MW-9 in the northeastern most portion of Parcel 2021080011 (now inactive and superseded by current Parcel No. 2021090112, as shown on Figure 2) above the Model Toxics Control Act (MTCA) Method A Cleanup Levels (CULs) for unrestricted land use. The groundwater impacts were limited to this single well (MW-9). The Covenant restricts the extraction of the groundwater located beneath the defined area for domestic use, for purposes other than temporary construction dewatering, investigation, monitoring, or remediation (Figure 2). In accordance with the issuance of the NFA and Ecology's determination that groundwater monitoring at the site was no longer required, MW-9 was decommissioned to accommodate development construction activities at the site.
